12-0M4304, Drainage System 1

Caltrans Maintenance Facility, Existing Pump Plant Yard located off Walnut Ave.

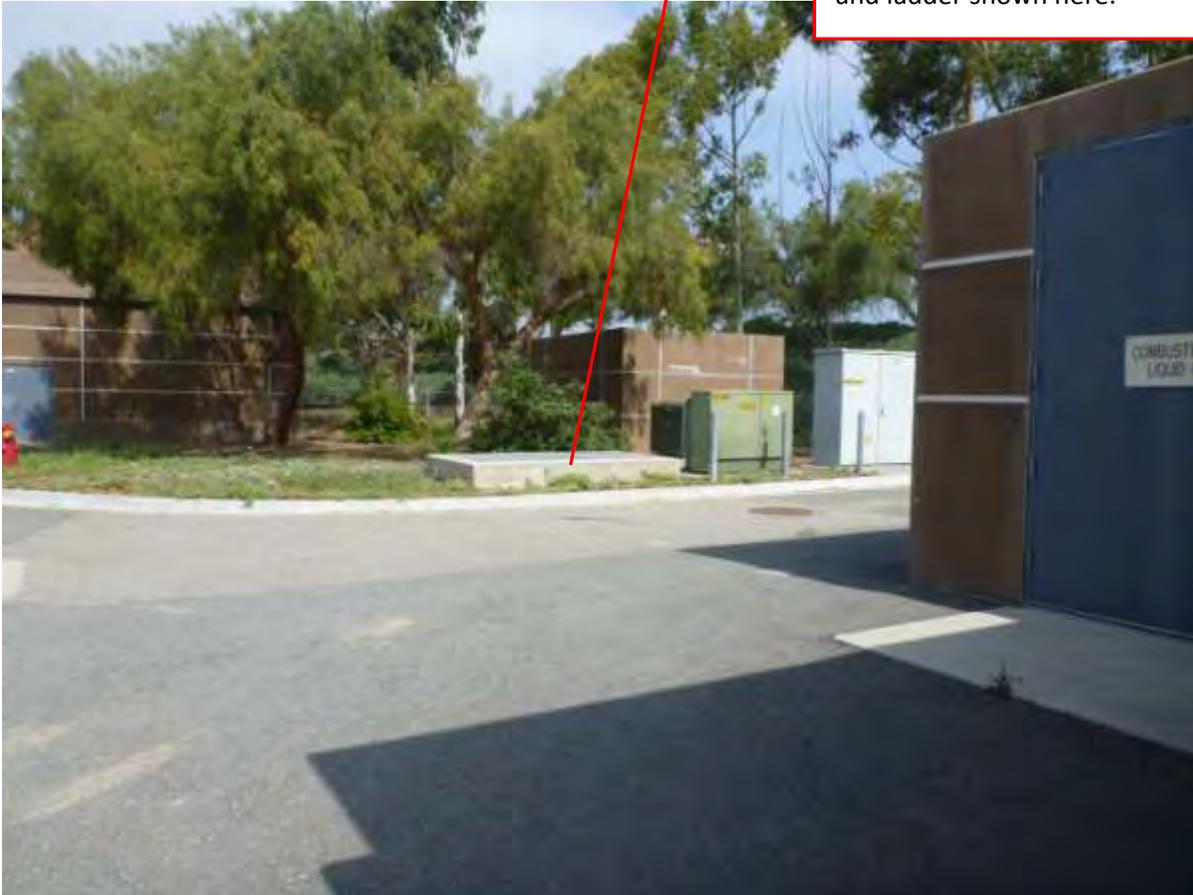
Photo #1

Photo looking northwest, showing the access location through the grated vault

This vault leads to the downstream (southeast) end of System 1 – segment c

Access available through the existing grated entrance vault and ladder shown here.

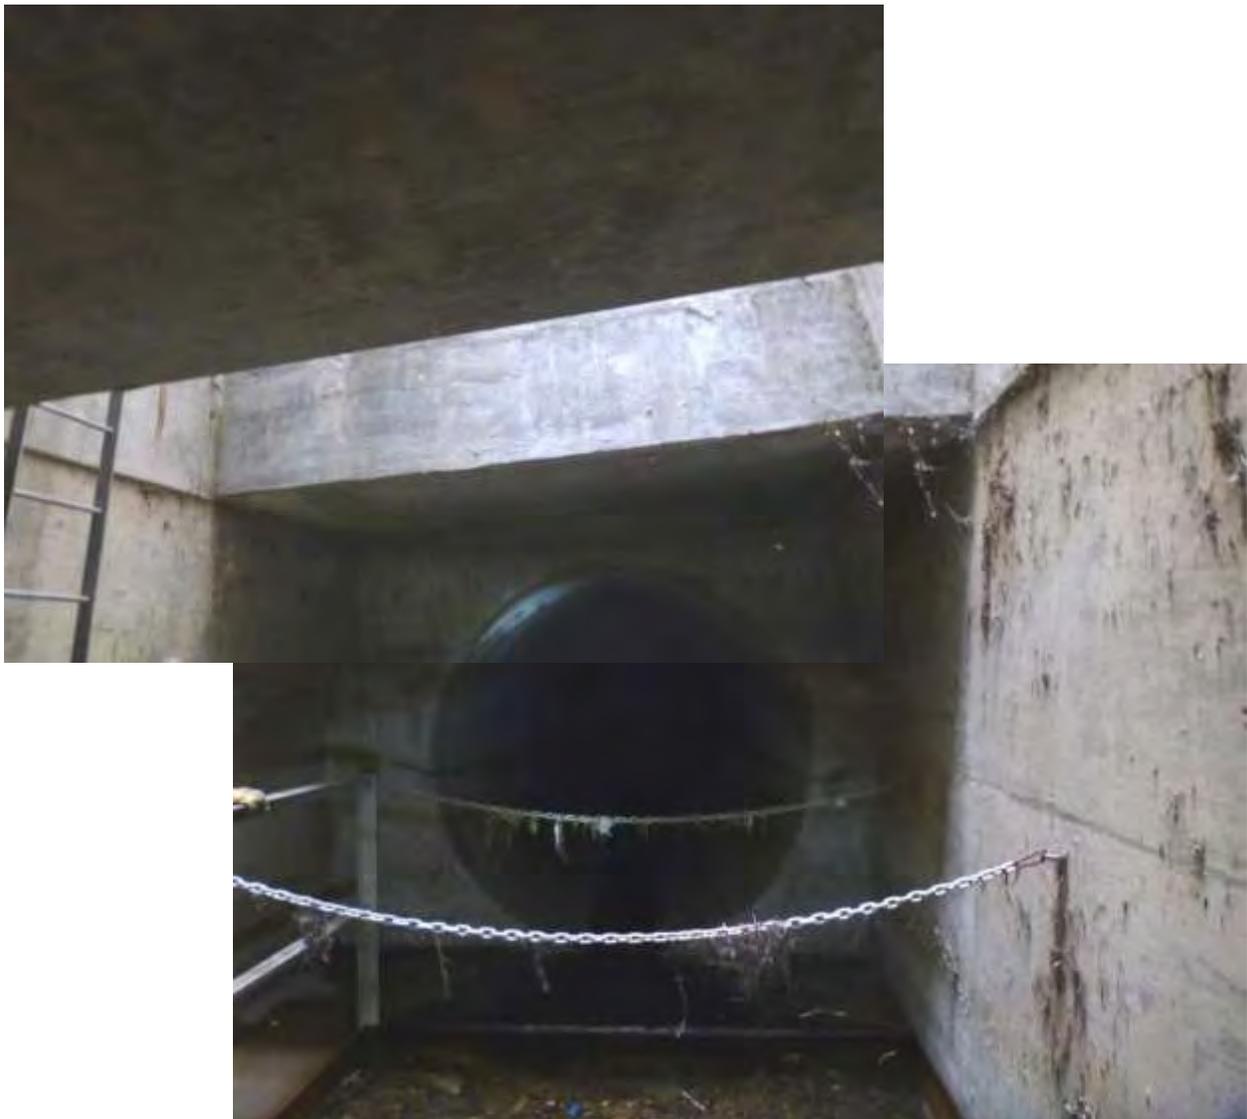
Photo #2

Photo showing the underside of the grated vault entrance with ladder; and pipe entrance of the existing 84" RCP (System 1 – segment c)

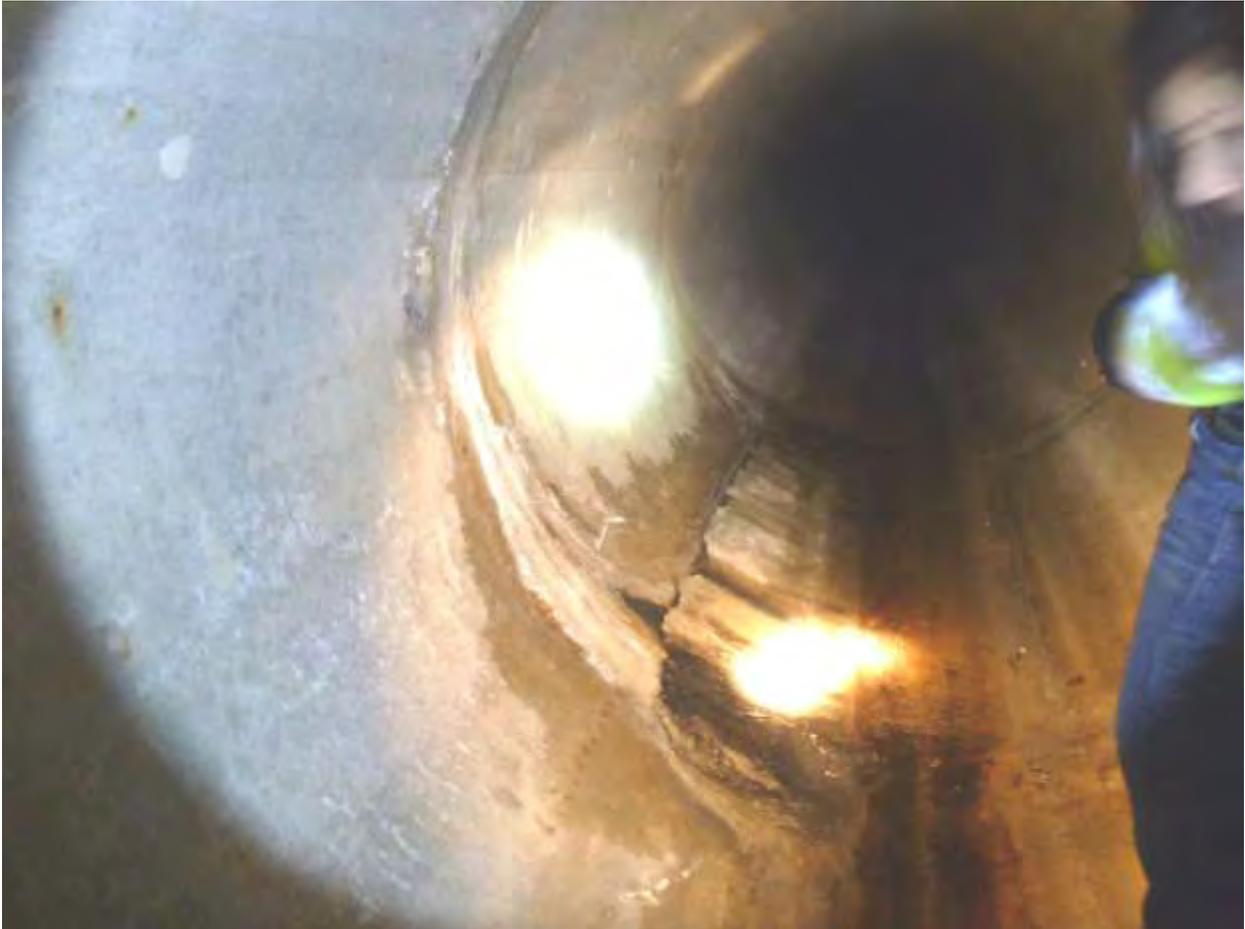
Photo #3

12-0M4304, Drainage System 1-Segment c
Looking northwest (upstream), existing 84" RCP Culvert
Near proposed pipe joint seal and spall repair area
Photo taken 5/22/12

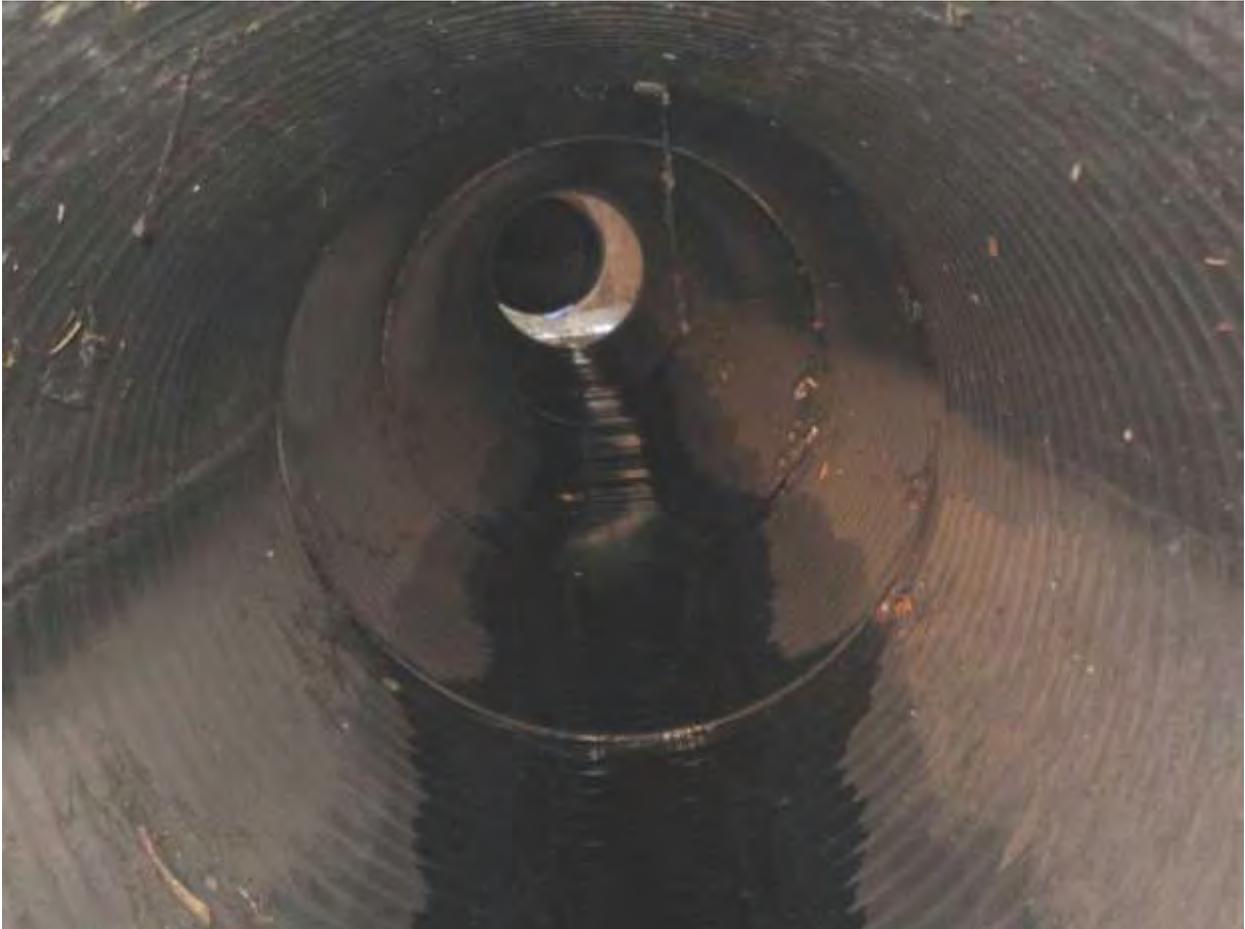
Photo #4

12-0M4304, Drainage System 1
Looking northeast (upstream), existing HDPE Culvert
Proposed location of CIPP lining
Photo taken 5/04/09
