Road Safety Assessment Report

D-3 State Route 16, from I-505 to County Road 78 near Brooks

03-Yol-16-PM 18.6/31.7

April 2012

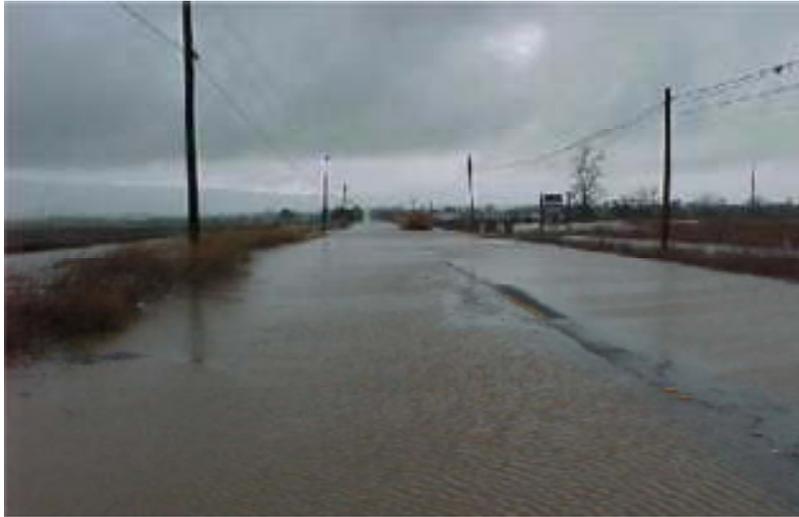
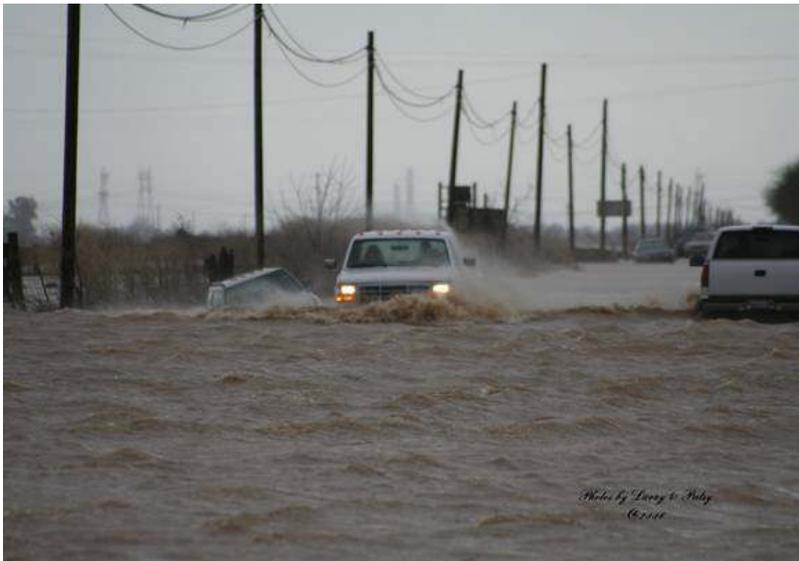
WILLOW CREEK SLOUGH CROSSING DURING FLOOD CONDITIONS IN 2006

SR 16 is closed by the California Highway Patrol (CHP) under flooding conditions between Madison and Esparto – typically between the CR 89 intersection and Willow Slough. The towns that flood in the valley upstream of Esparto typically share information with downstream towns when the flood stages have arrived, and therefore the Esparto and Madison authorities have the ability to mobilize and prepare for the impending flood, including barricading the portion of SR 16 at CR 89 and at CR 21A. There have been isolated cases of motorists bypassing the barricades. If SR 16 is inundated, the flooding many times affects I-505 as well. Any proposed flood protection improvements proposed for SR 16 must also consider the effects on I-505, as it is the principle access route for emergency responders.

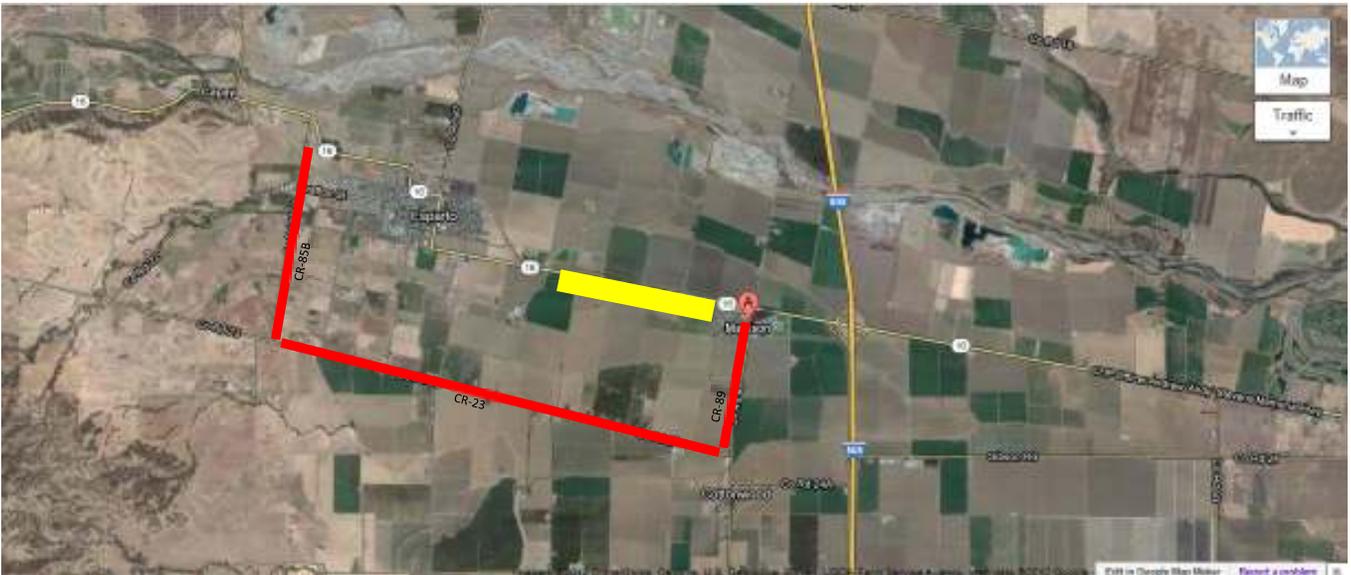
POSSIBLE DETOUR OF FLOODED AREA

The area blocked by flooding on SR 16 shown above can be bypassed via a detour of CR 89 to CR 23 to CR 85B as shown in the image to follow, titled “Possible Detour of Flooded Area.” Although the roads that comprise this detour route also experience flooding, the flood depth and duration tend to be less than SR 16.

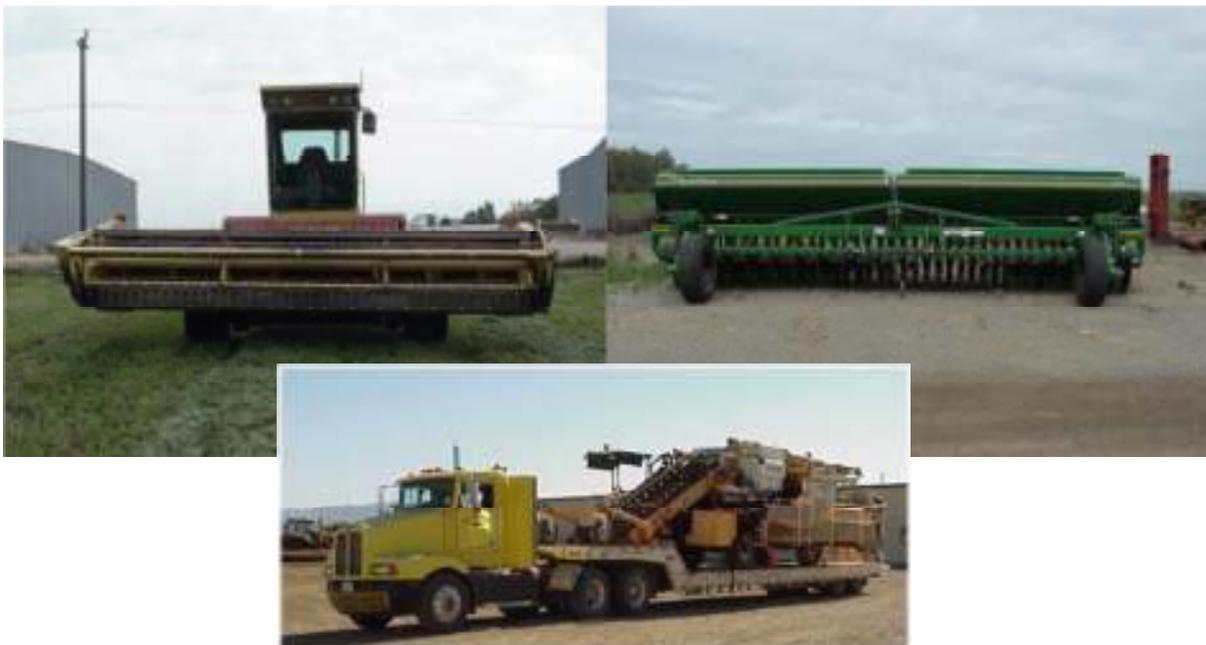
EXAMPLES OF FARM EQUIPMENT

Implements of husbandry essential for farming operations must occasionally travel SR 16. For example, from Esparto to I-505, there are at least 9 formally recognized driveways/access points for farm vehicles. However, farm vehicle travel can be anticipated anywhere within the study corridor. The size and weight of these vehicles require careful consideration in highway design to ensure that they can be safely accommodated as they travel between fields. Many farm vehicles travel at relatively low speeds, have very low ground clearances, and extreme widths up to 20 feet.

During the field reviews by the RSA team, many areas of the roadway were noticed to be “scuffed” near the pavement edge. This damage is consistent with what likely occurs when farm vehicle operators steer as far right as possible, probably with one wheel on the shoulder, to avoid encroaching into the opposing lane of travel. At one location, “Capay Curve” (near Second Street in Capay), some farming equipment is required to intrude into the oncoming traffic lane to avoid hitting the guardrail on the outside of the curve.

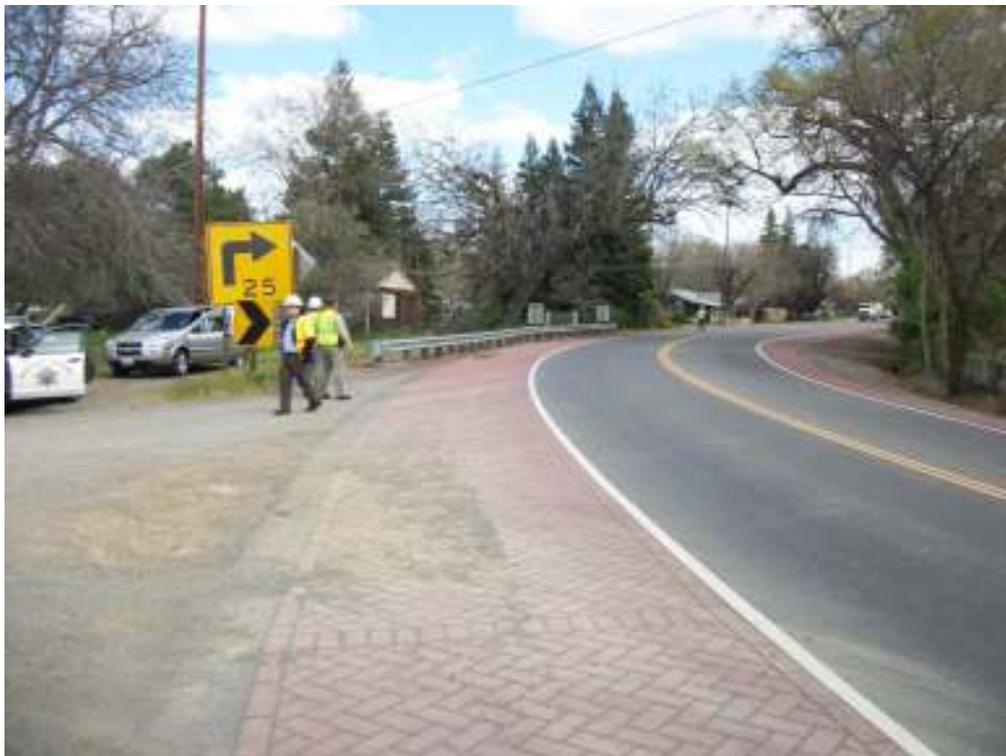
SITE OF FATAL ACCIDENT

Seven sideswipe and 6 head-on crashes occurred from October 2007 to September 2010. Two of these occurred in the tangent section between Esparto and Madison in the vicinity of CR 88B and resulted in 3 fatalities. More recently, a fatal crash occurred at Capay Curve, when an eastbound tractor-trailer crossed the centerline near the middle of the curve. According to published studies, these types of centerline crossover crashes account for about 20 percent of fatal crashes on two-lane rural roads. On SR 16, 4 crossover crashes have been identified in the last 10 years – 2 in the vicinity of Second Street/Capay Curve and 2 in the vicinity of CR 88B.

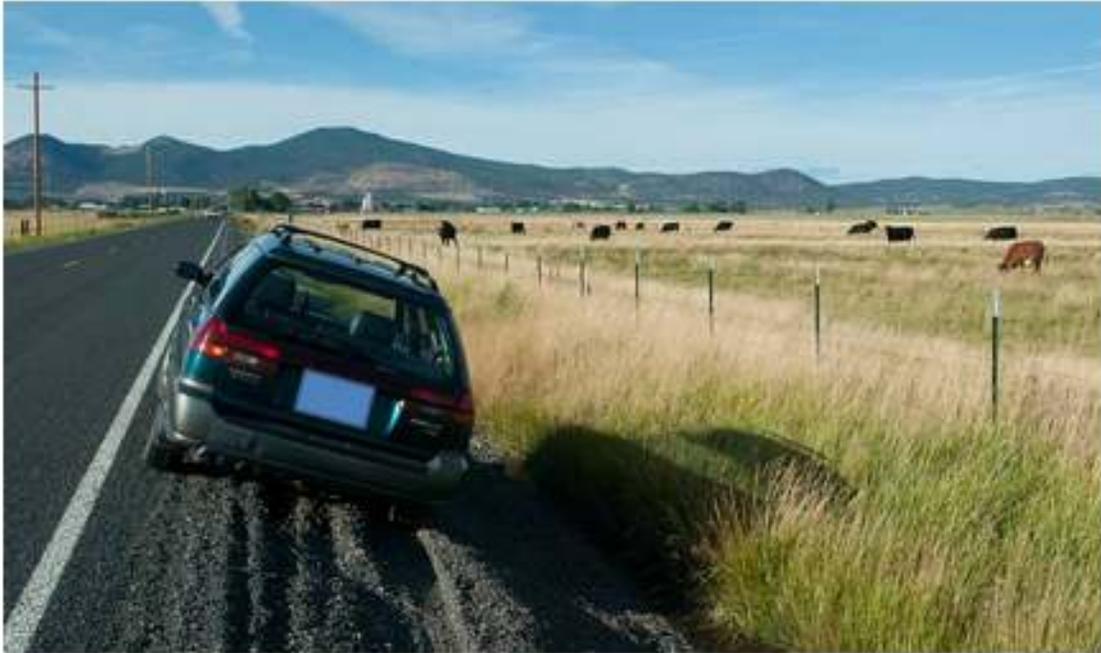
PICK-UP TRUCK STOPPED ON SHOULDER OF WB SR 16 JUST WEST OF MADISON

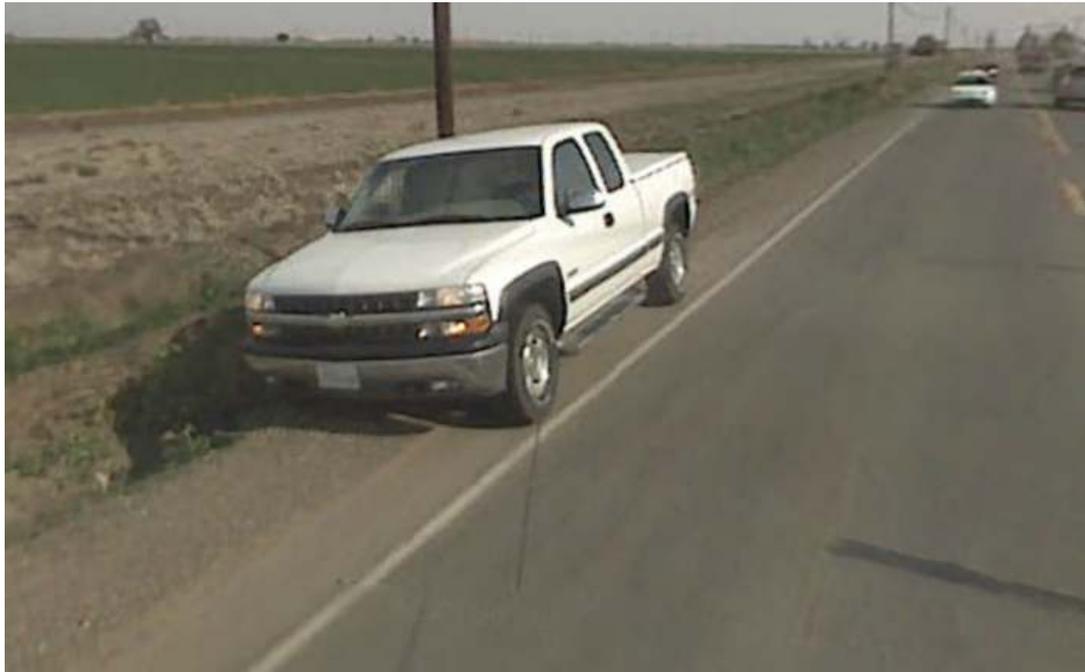
[Note that right side of truck is very close to vee ditch.]

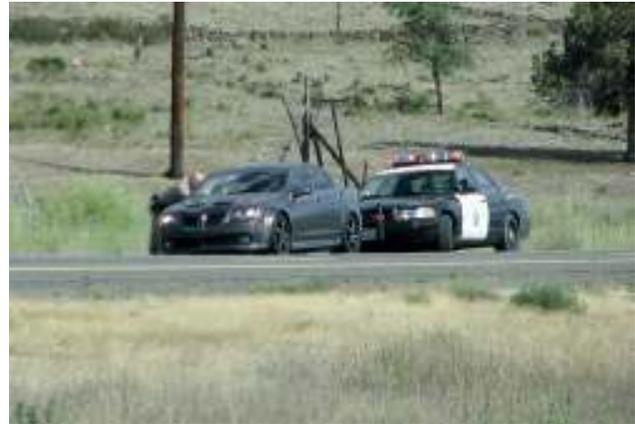
CHP ENFORCEMENT ON SR 16 SHOULDER

State Route 16, within the designated project area, consists of unimproved shoulders, narrow shoulder widths, and few clearly delineated safe stopping locations or pull offs, most notably from the community of Capay west to the community of Brooks. This, combined with limited sight segments, lends to reduced traffic violation enforcement and delayed emergency responses. The safety of soft and/or sloped shoulders, most notably during hours of darkness, severely limits safe stopping locations for law enforcement stops, whereby law enforcement officers wait until the violator

reaches urban areas where the roadway shoulders are improved or visible. Additionally, violators are unwilling to pull off the mainline roadway risking damage to their vehicle or running off the roadway when the condition of the shoulder is unknown. The reduced capability of traffic violation enforcement increases violation frequencies and decreases the overall roadway safety throughout the roadway segment. Unenforced traffic laws diminish compliance. Additionally, emergency vehicle travel is encumbered by the lack of quick and safe areas to pull right and slow, as required by California law. As a result, emergency vehicles are unable to traverse the segment quickly and safely.

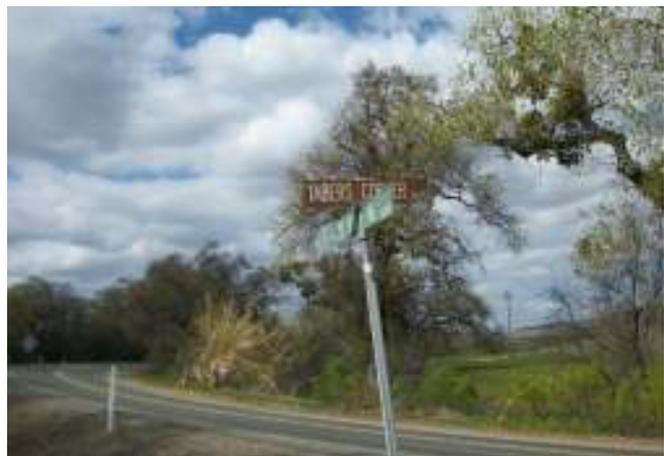
TABER CURVE

The RSA team reviewed the geometry and the operation of these curves. The Taber Curve has a history of roadway departures, and the team observed skid marks from a recent roadway departure in the eastbound approach to the curve. However, because of the wide recovery area, the vehicle was able to regain control and return to the roadway at the tangent section east of the curve.

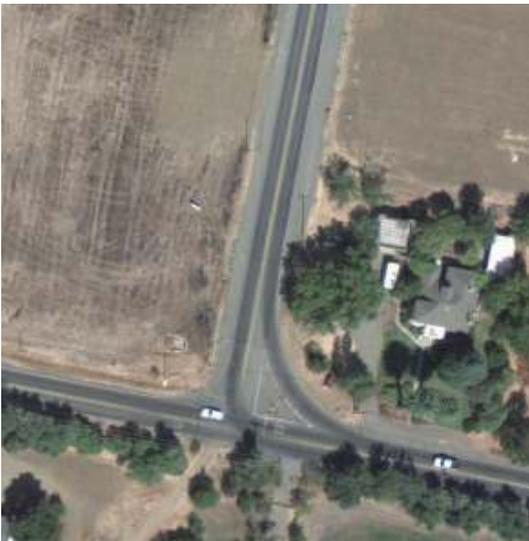
INTERSECTION 1

Intersection 1 is the 3-way “tee” intersection at the south end of Esparto, where CR 21A and SR 16 come together. Here, “westbound” SR 16 traffic turns to the north in a moderate-speed, “free” right turn, i.e., no yield or stop control. Drivers making the opposing turn (east to north) may falsely assume that they have the right of way and that “westbound” drivers will stop or yield.

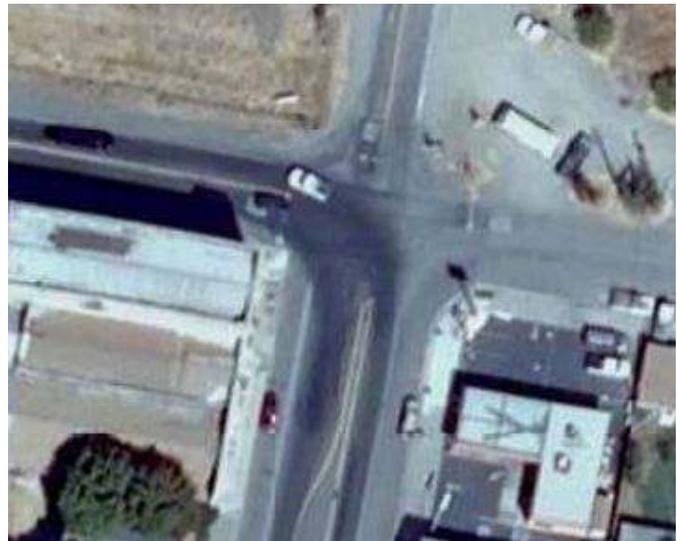
INTERSECTION 2

Intersection 2 is a traditional 4-way “cross” intersection at the north end of town, where “westbound” SR 16 motorists turn left (north to west) without being required to yield or stop. Drivers approaching from any of the other three directions (“eastbound” SR 16, southbound CR 87, and westbound Woodland Avenue) all have stop sign control. Drivers unfamiliar with the area may logically assume that “westbound” motorists will also be governed by stop sign control, when in fact they are not. The resulting confusion may cause drivers on any of those other three approaches to enter the intersection thinking that “westbound” traffic will not conflict with their movement.

The other possible scenario is that the unfamiliar motorist approaching the intersection in the “westbound” direction, seeing cars stopping on the other legs, may think he must also stop. This creates a potentially hazardous condition if drivers of following cars are familiar with the unopposed left turn and are not expecting the vehicle ahead to slow or stop.

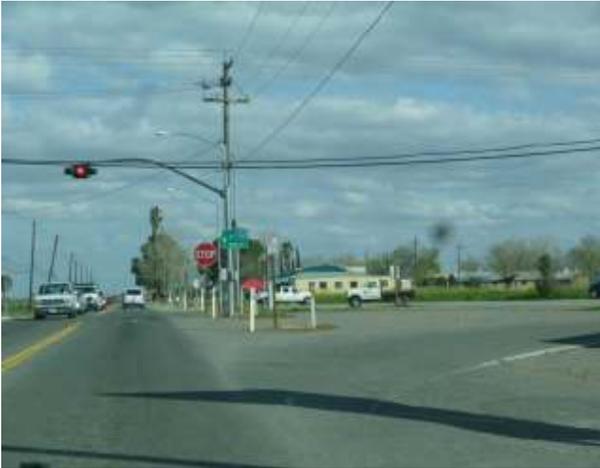
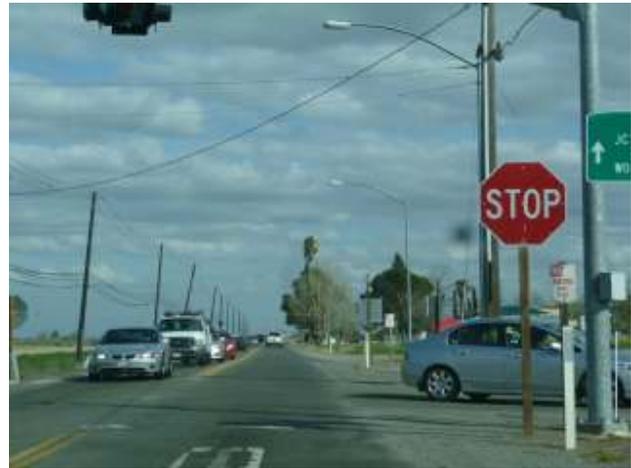
EXISTING SIGNAGE AND PAVEMENT MARKINGS AT INTERSECTION OF CR 89 AND SR 16

Compounding these factors is the deteriorated condition of pavement markings, which makes the intersection difficult to navigate, particularly at night. The intersection is marked with advance signage informing the driver of the upcoming stop condition and these signs are well lit at night, but tend to be less conspicuous during the day.

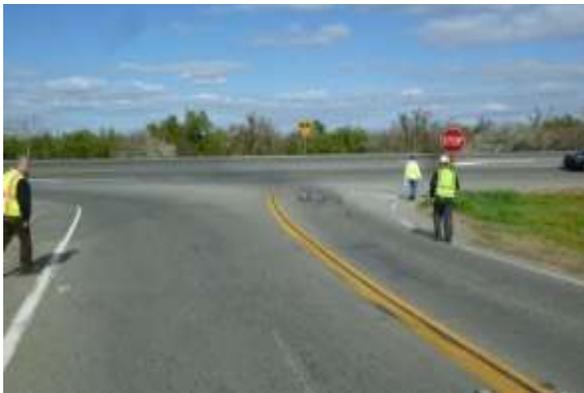
“T” INTERSECTION OF CR 85B & SR 16

An informal bypass around Esparto via CR 21A ties back into SR 16 at CR 85B with a “T” intersection. The RSA team found issues related to limited sight distance looking east when traveling north on CR 85B and difficulty turning left from CR 85B to westbound SR 16. This maneuver poses several concurrent challenges: first, identifying a safe gap in traffic on SR 16, and second, turning left “up” the slope in the middle of a curve to the left and without the benefit of a dedicated acceleration lane. The maneuver is particularly troublesome to some aging drivers whose visual acuity may be poor, ability to judge size and

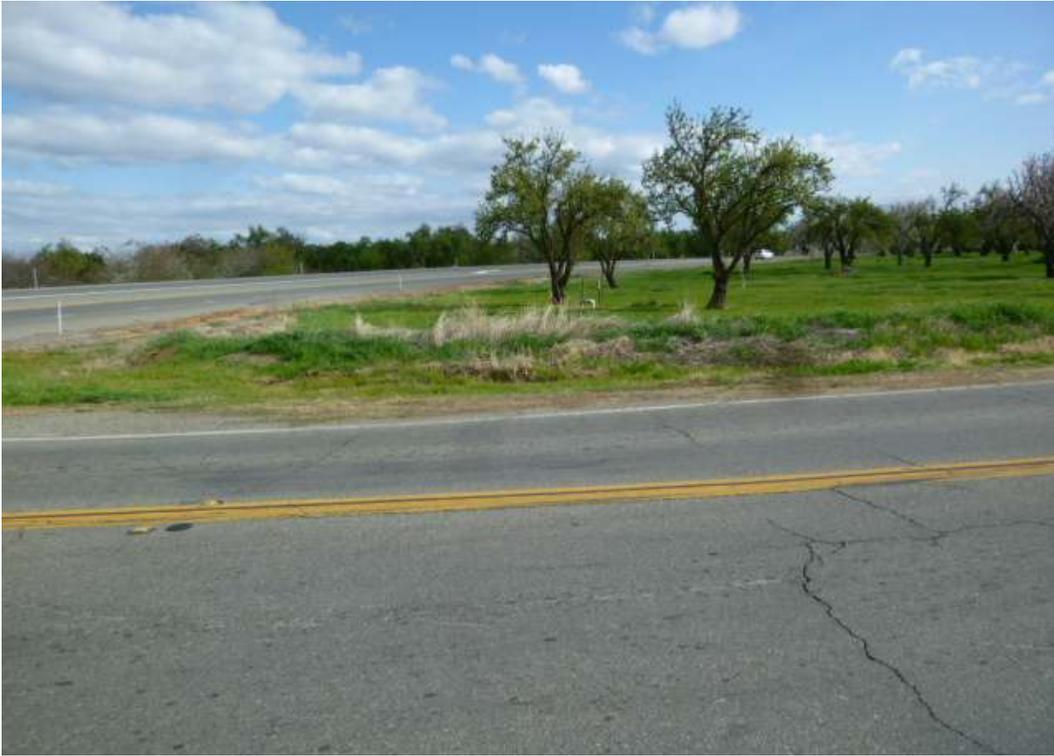
VIEW LOOKING EAST FROM CR 85B THROUGH THE ORCHARD

motion is diminished, capability to multi-task is severely taxed, and whose head and neck flexibility makes it difficult to quickly scan the environment. The most significant sightline obstruction is a small number of trees in an orchard on the east side of CR 85B. The “upslope” condition is simply a result of entering SR 16 curve at a right angle and driving “up” the fully super-elevated section of the curve.

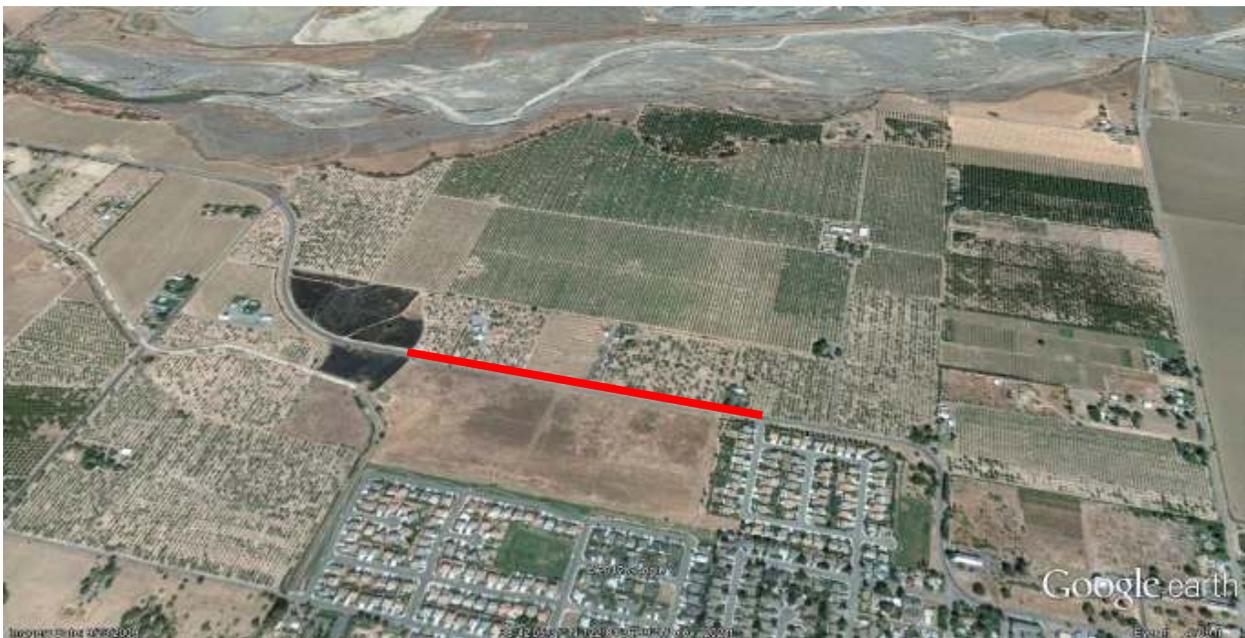
The existing SR 16 has only a few locations where vehicles are allowed to pass legally. In addition, these passing zones are relatively short. In some locations, the passing zones transition into reduced speed zones, curves, or areas of limited sight distance. For example, west of Capay, eastbound traffic has approximately 1,400 feet of passing zone which immediately transitions into the reduced speed zone leading to the Capay curve. Another example is just west of Esparto where approximately 2,000 feet of passing zone is flanked by slow-speed curves on each side. This is just enough distance to entice drivers to attempt to pass slower moving vehicles while requiring them to dramatically slow their speed immediately after completing the pass. The Caltrans Highway Design Manual requires a minimum of 1,950 feet for passing sight distance. The American Association of State Highway Transportation Officials 2011 Geometric Design for Highways and Streets (AASHTO Green Book), Table 3-5, Minimum Passing Zone Lengths, recommends a minimum of 800 feet for two-lane conventional highways. Admittedly, the two examples and a majority of the passing zones in the project limits meet this minimum; however, the quick transition into reduced speed zones create a situation that may result in increased crash frequency.

APPROXIMATE LENGTH OF PASSING ZONE WEST OF ESPARTO (~2,000 FEET) FLANKED BY SLOW-SPEED CURVES ON EACH SIDE

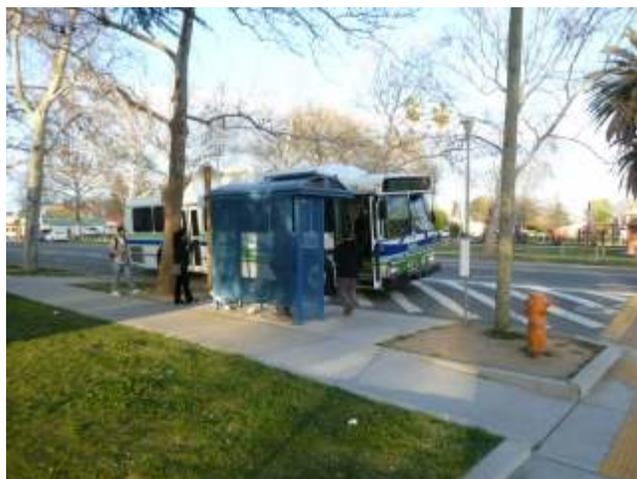
DOWNTOWN ESPARTO BUS STOP

During the RSA team's nighttime review, the team noticed that lighting is very limited at the crosswalk locations and the yellow striping and lettering prior to the crosswalks was barely visible. In addition, the RSA team observed that the bus stops in downtown Esparto at the Community Center are located such that pedestrians will pass in front of the buses, thus obstructing views from following traffic.

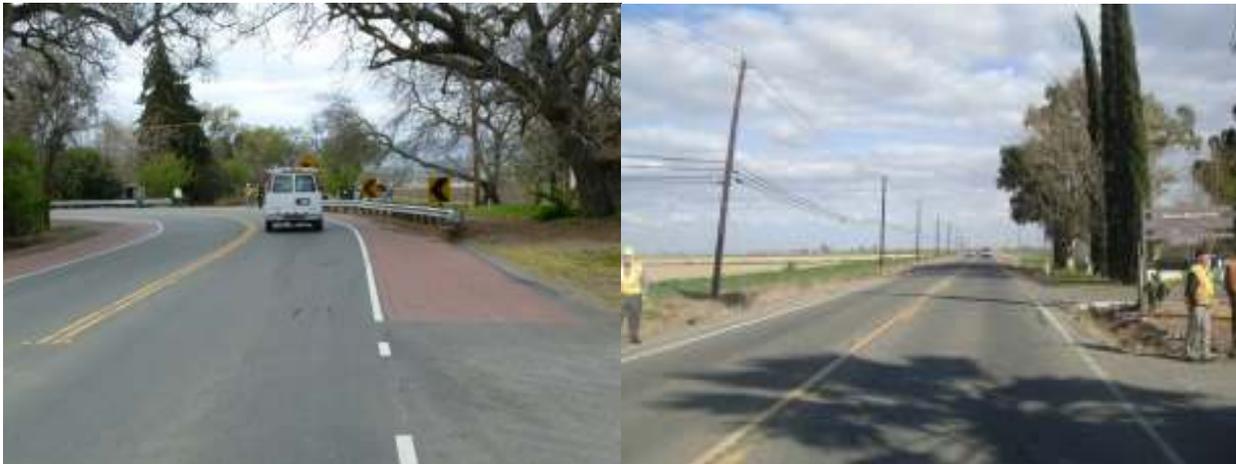
EXISTING PAVEMENT MARKINGS, STRIPING, AND SIGNAGE ALONG SR 16

The SR 16 corridor from I-505 to Brooks has had some intermittent roadway upgrades that includes new pavement, pavement markers, and flashing beacons. However, the intermittent nature of the installation of these elements leaves a number of long stretches where the striping is fading, signs are losing their retro-reflectivity, and raised pavement markers are missing or losing reflectivity. Location of the signs is a factor in warning drivers of changing conditions ahead. The RSA team found that some signs were located in areas that surprise drivers rather than warn them. Because of the rural nature of this corridor, roadway lighting is almost non-existent, which makes driving at night sometimes difficult to recognize when the roadway may be turning or the motorist is approaching a decision point. In the Cities of Esparto and Capay, the striping and signing was adequate (apart from the concerns regarding striping contrast, coloring, and hashed striping bulbouts).

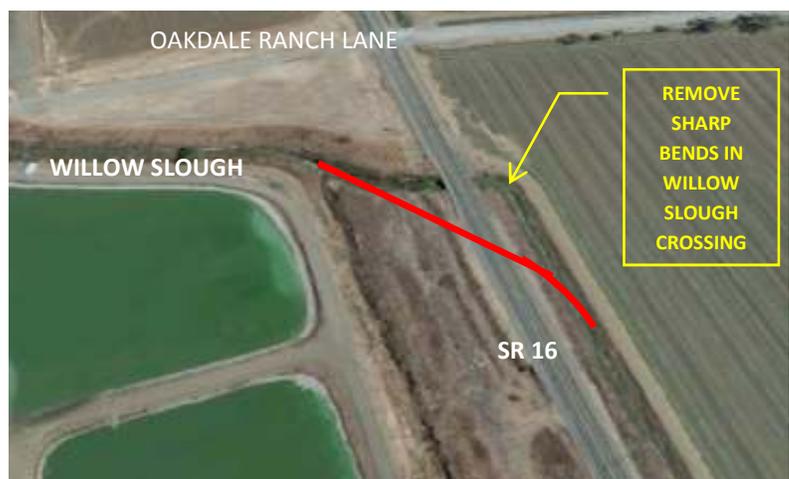
**LOOKING EASTBOUND OVER SR 16 WITH
WILLOW SLOUGH CROSSING**

The undersized crossing of Willow Creek significantly contributes to the flooding of the SR 16. It appears that the hydraulic constraint of the crossing causes overflow into the drainage ditches and overtopping of the roadway. Replacing the bent crossing will reduce the turbulence, providing more laminar flow, in the vicinity of the crossing that can increase the capacity of the crossing. Furthermore, the headwalls and entrance conditions should be designed to enhance the hydraulic capacity of the crossing associated with the suggested crossing.

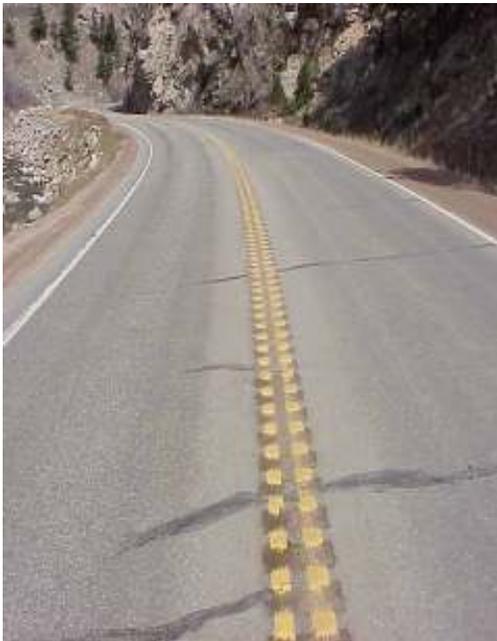
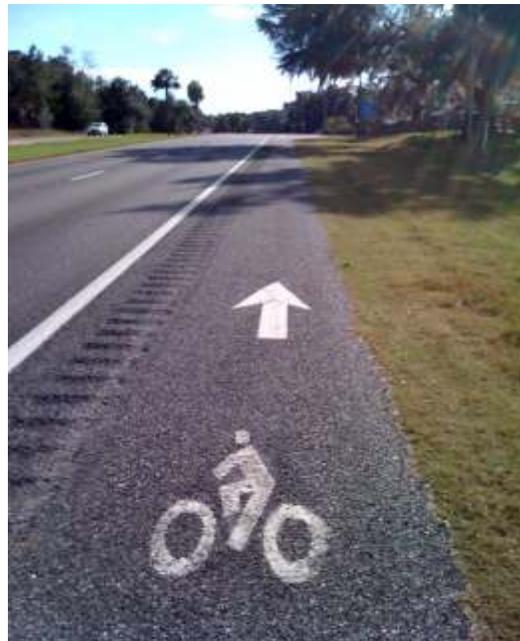
EXAMPLES OF RUMBLE STRIPS

If bicycle use of the shoulder is not properly considered, the width or offset of the rumbles may be problematic for a bike rider. If silt is allowed to accumulate, the undulations can become clogged and may be less effective. There can occasionally be community concerns about noise impacts for abutting residences.

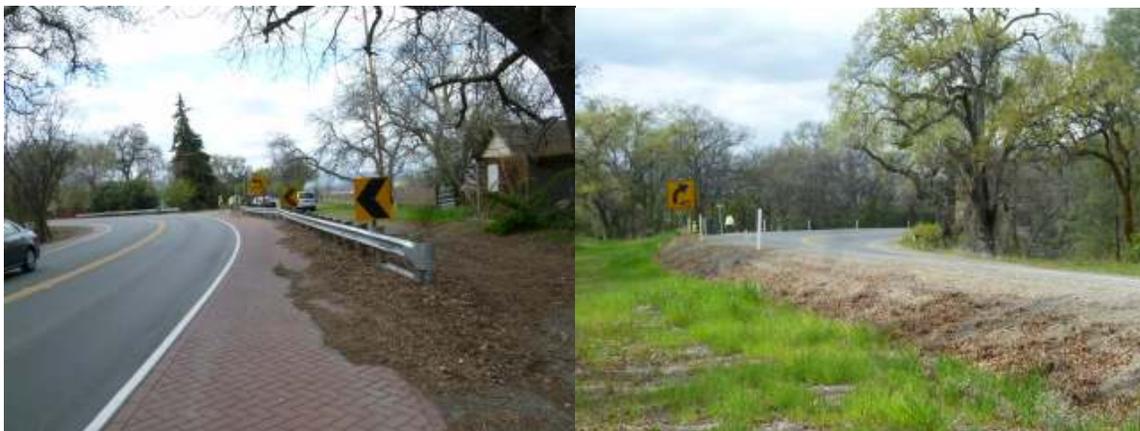
Metal beam guardrail has been installed at a few locations within the study limits. There are other locations within the project limits where installing guardrail to shield a roadside hazard might be appropriate. For example, where it would be impractical to relocate or redesign a drainage ditch within the CRZ, shielding the ditch with guardrail might be considered. In locations where guardrail now exists such as the north side of the Capay Curve, the length and offset of the guardrail should be reviewed to ensure that its placement is optimal. Casual observation suggests that moving the guardrail further from the edge of the travel lane might be feasible at Capay Curve, allowing more recovery area for runoff-the-road vehicles and additional horizontal clearance for wide loads and farm vehicles. Another example location where installing guardrail might be appropriate is on the inside (north side) of the curve at Taber's Corner, where Taylor's Creek meanders close to the roadway.

RS-5 Modify existing guard rail and install new guard rail at select locations

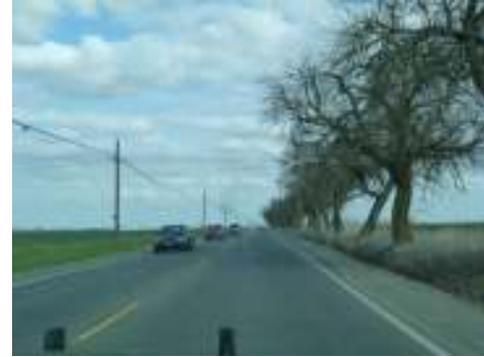
There are locations, such as: Capay Curve, Taber Curve, and the tree-lined straight roadway stretch east of the casino with native trees and creeks that could lead to severe crash impacts for vehicle runoffs. Native trees and creeks are environmental resources that typically require avoidance efforts. Consider protecting potential runoffs with the placement of metal beam guardrail at these locations. These should be considered on a case by case basis. There are other hazards, such as mailboxes and drainage ditches that should be relocated based on their collision potential.

RS-6 Protect roadway run-offs against hazards such as adjacent creeks and native trees with guardrail; remove fixed obstacles adjacent to roadway

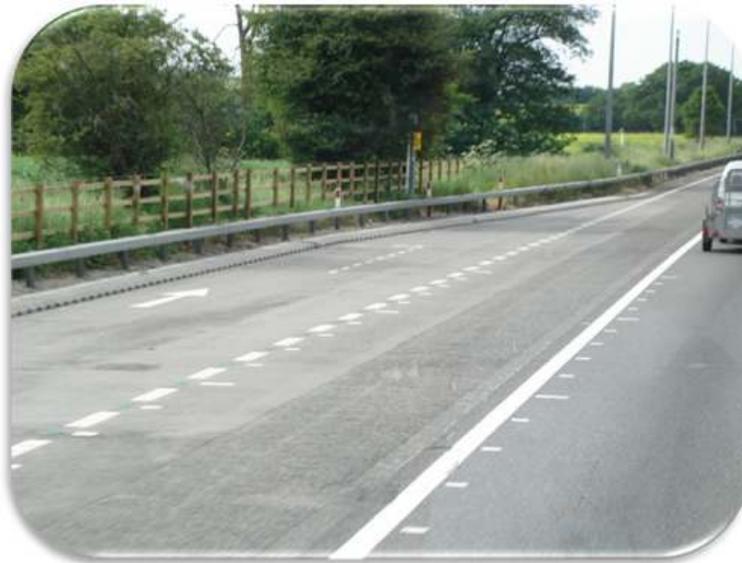
EMERGENCY REFUGE AREA ON FACILITY WITH ACTIVE TRAFFIC MANAGEMENT

This countermeasure suggests installing paved turnouts every mile or two outside of Esparto and Capay where sufficient existing right of way is available. Lengths of the turnouts can vary in length (depending on available shoulder area) with approximately 15 feet wide either paved (recommended) or stable gravel with good drainage. On a two-lane highway where passing is limited, Section 21656 of the California Vehicle Code requires slow moving vehicles followed by five or more vehicles to turn off at designated turnouts or wherever sufficient area for a safe turnout exists. However, along this corridor safe turnouts do not exist. Turnouts should be located where there is stopping sight distance for approaching drivers to see vehicles leaving and re-entering the through lanes. Advance signing indicating turnout ahead will prepare a motorist to start slowing and searching for the turnout. Law enforcement, fire, and EMS can use turnouts for enforcement purposes, accident investigations, etc. without blocking a lane. Potential signs to use can be “Slower Traffic Use Turnouts,” “Turnout Ahead,” “Turnout ¼ mile,” or “Turnout 500 feet.”

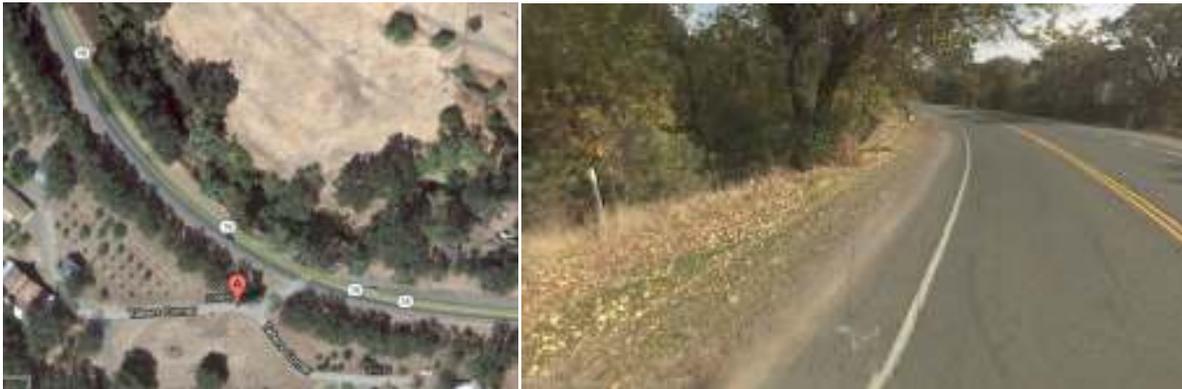
TABER'S CURVE

It is common practice to use delineators along the outside edge of roadway curves. The use of these delineators should be standardized throughout the project limits for consistency and clarity of warning to the drivers.

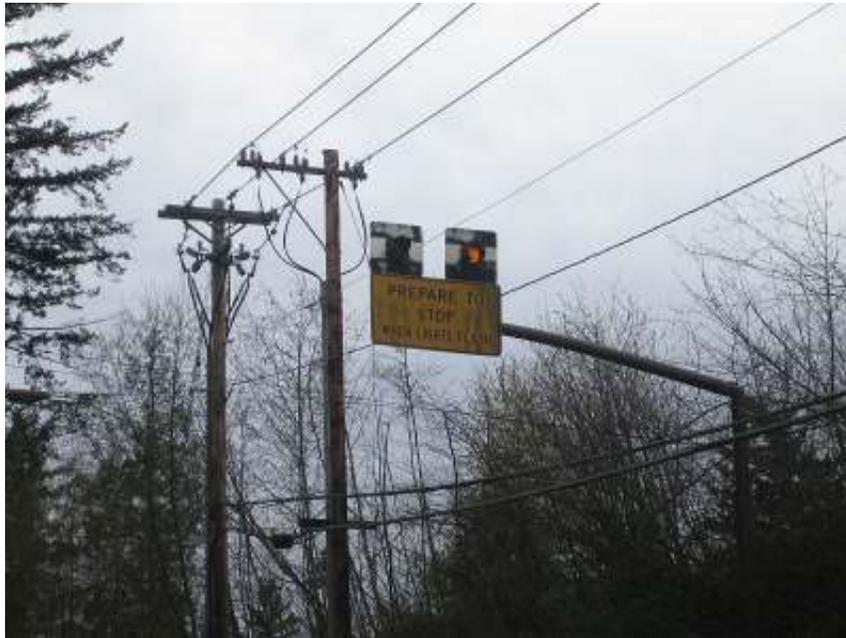
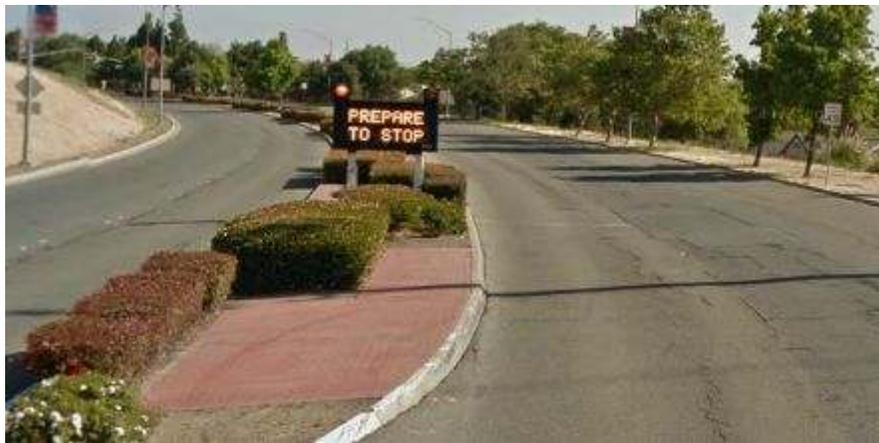
EXAMPLES OF ADVANCE WARNING SIGNALS

Install an advance warning signal for the red light signal at the CR 89 and SR 16 intersection that would activate if the traffic signal is in or will be entering a red/stop phase in the users direction in order to alert the user of their need to stop and/or be alert to slowed or stopped traffic ahead. Alternatively, or in addition to the advance warning light, installing a prioritized stop light and installing transverse rumble strips could also be considered. This intelligent transportation system would only trigger with the proper phase of the signal increasing the value of information to the approaching user.

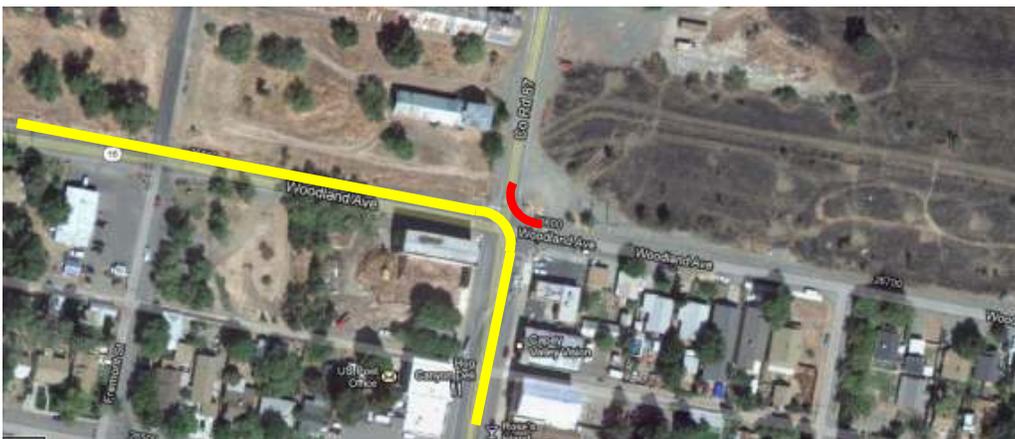
SUGGESTED ELIMINATION OF INTERSECTION AT WEST END OF ESPARTO

There is a three-way stop at the four-legged intersection at the west end of Esparto’s Downtown district. This intersection was originally a four-way-stop intersection that was temporarily converted to a three-way stop (westbound SR 16 does not stop) in order to facilitate the demolition of a structure in the southwest quadrant of the intersection. The intersection reverted back to its original condition (four-way stop) after the building demolition was completed, but westbound traffic was used to not stopping, so the intersection was converted back to a three-way stop. This application of a three-way stop to a four-legged intersection has the potential for collisions that could be redressed with the installation of a roundabout. Roundabouts have statistically shown to reduce the severity of crashes at intersections. Roundabouts typically trade high-severity, high-speed “T-bones” (90-degree broadside crashes at high speeds, typical of 4-legged signalized or unsignalized intersections) for low-severity, low-speed sideswipes. The impact of backups during peak travel periods should be compared to evaluate a roundabout application at this location. The roundabout would also require additional land in one of the three currently vacant parcels.

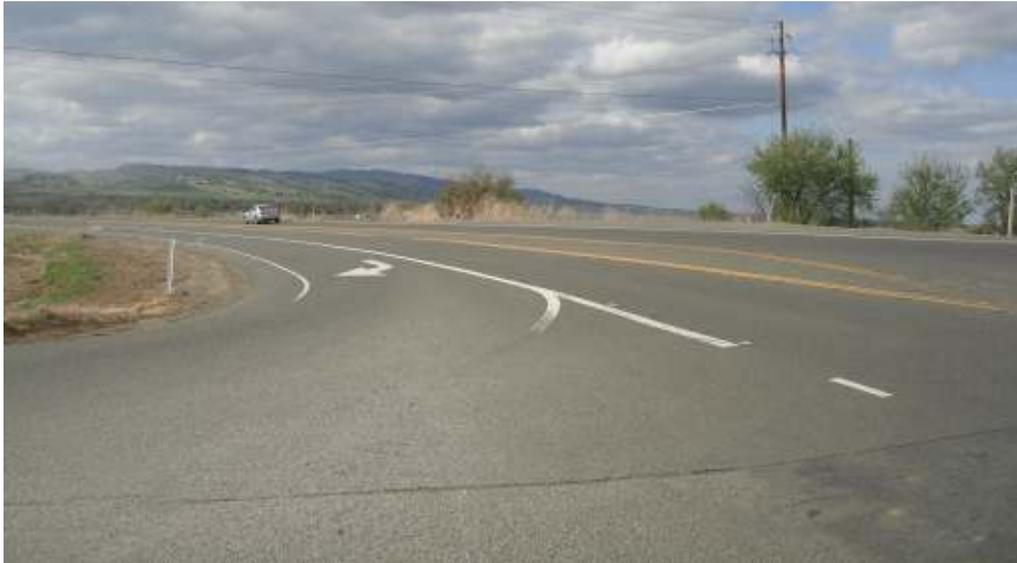
SR 16 LOOKING WEST FROM THE INTERSECTION WITH CR 85B

At this time, there is no acceleration lane at the SR 16/CR 85B intersection. An acceleration lane of appropriate length could be added to provide a refuge for the left-turning movement from CR 85B to westbound SR 16. Both local and regional travelers appear to use this bypass around Esparto. The highway alignment may have to shift slightly to accommodate the addition of the acceleration lane.

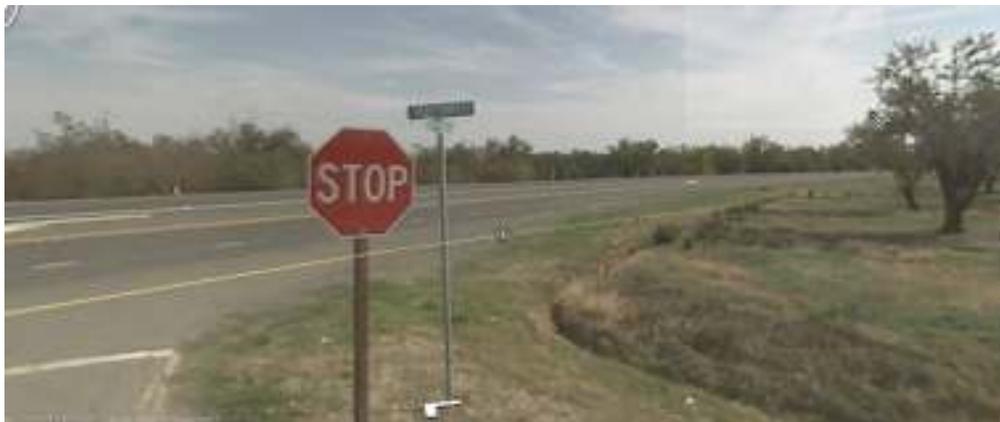
LOOKING EAST FROM THE INTERSECTION OF CR 85B AT SR 16

The one-way stop at CR 85B has limited intersection sight distance that compromises left turns from CR 85B to westbound SR 16. There are a few trees, possibly as few as three or four that if removed would increase the sight distance available for the previously mentioned movement.

I-9 Remove or trim trees at CR 85B intersection with SR 16

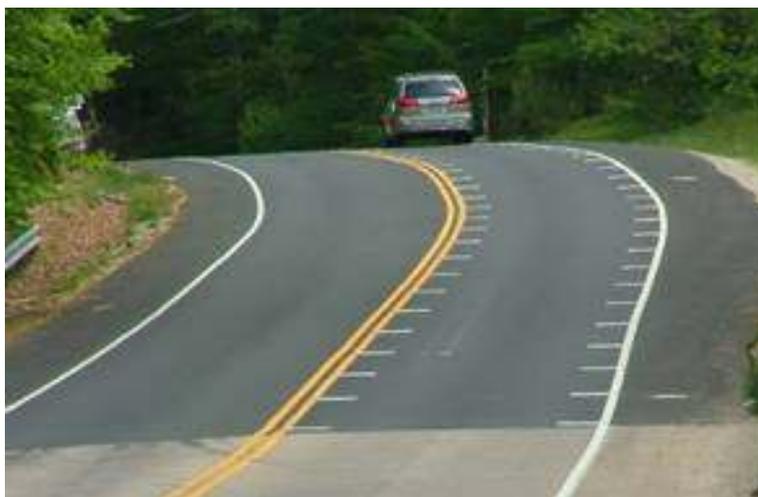
EXAMPLE OF OPTICAL BARS

The MUTCD considers the two treatments in this section as “experimental” and does not approve them for general use. The MUTCD advises agencies to obtain FHWA approval before installing any experimental treatment. Visit <http://mutcd.fhwa.dot.gov> for information on how to submit a request for experimentation.

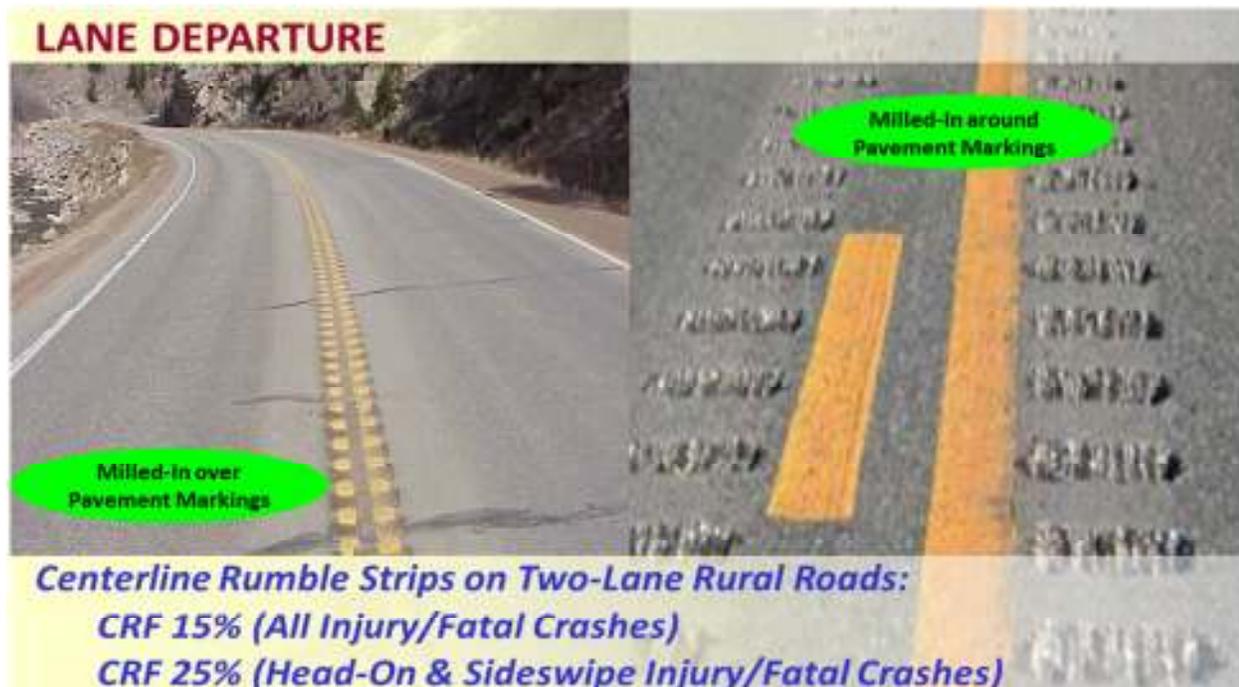
Several areas of the project, while marked as no-passing zones with striping and signs, continue to experience passing violations. This countermeasure suggests installing milled-in centerline rumble strips in the no-passing zones along the project, which offer a positive audible and tactile message of improper lane travel. Milled-in rumble strips demonstrate a higher safety benefit than thermoplastic.

The crash modification factor on rural roads for reduction of head-on type crashes is 0.45 for all crashes, or an expected 55% reduction. The crash modification factor on rural roads for reduction of head-on type crashes is 0.74 for minor injury crashes, or an expected 26% reduction.

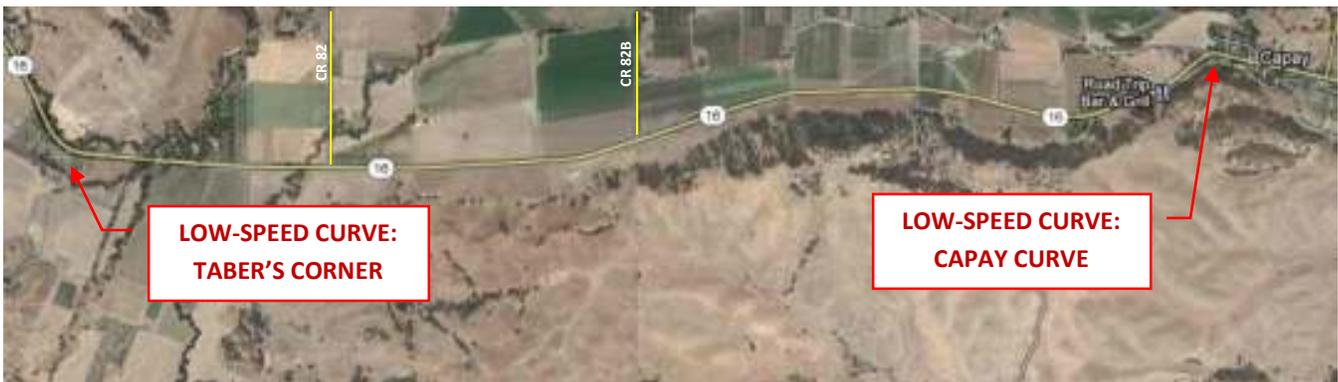
LOCATIONS OF LOW-SPEED CURVES

Caltrans guidelines specify that passing lanes should have 1,950 feet passing sight distance. There is already one location between Esparto and Capay that is in agreement with this requirement; however, this location is bound by low-speed curves that compromise the integrity of the passing lane. The other longer location west of Capay could be identified as a passing zone due to its potential to provide passing zones well in advance of the lower-speed curves (see figure below). The passing zones could be provided between CR 82 and 82B, for example. There are other areas of passing or increased passing zone lengths could be achieved if geometric improvements were to be provided between the two low speed curves shown below. The preferred approach would be to locate the eastbound passing zones closer to Taber’s Corner and the westbound passing zones closer to Capay Curve to allow the respective direction of traffic ample room to reduce speed while approaching the low speed curves ahead.

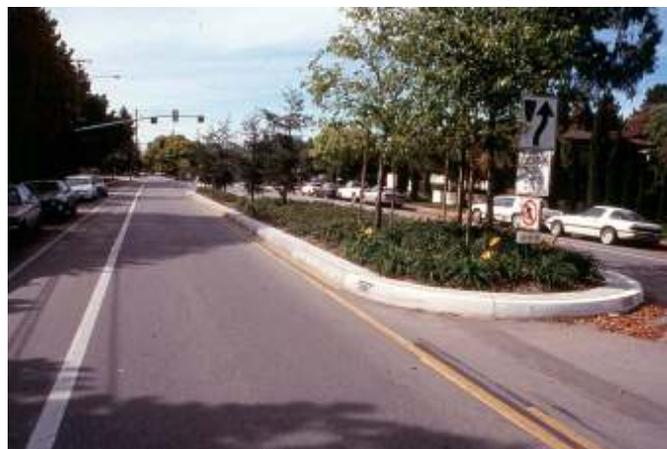
EXAMPLE RAISED MEDIAN

Raised medians, if installed in Esparto and Capay, would provide a refuge area for pedestrians while providing incremental benefit in traffic calming. The placement of the median could mitigate unsafe pedestrian crossing during busy peak traffic periods by reducing the average waiting time for impatient pedestrians crossing through gaps too short for safe crossing. The median could also help channelize the crossing of pedestrians to the crosswalk in the vicinity of the high school in Esparto. The impact of the additional space needed for the median would need to be weighed against its impact on adjacent residents and businesses.

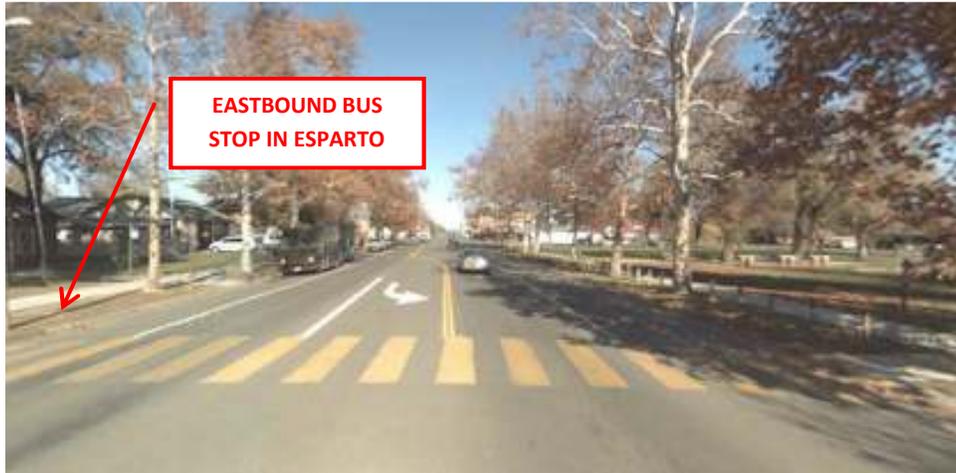
EASTBOUND BUS STOP IN ESPARTO

There is an eastbound and westbound bus stop in Esparto located upstream of the pedestrian crosswalk at an unsignalized intersection that blocks motorists vision of the pedestrian crosswalk. A simple solution would be to relocate the bus stop downstream of the crosswalk to eliminate stopped buses from blocking the visibility the crosswalk.

PS-4 Relocate bus stops in Esparto to far side of intersections
