Road Safety Assessment Report

D-3 State Route 16, from I-505 to County Road 78 near Brooks

03-Yol-16-PM 18.6/31.7

April 2012

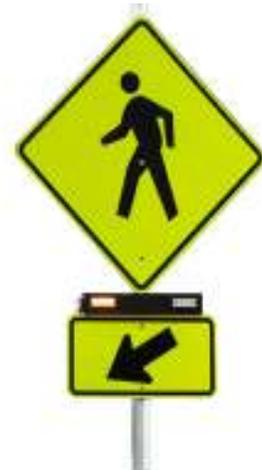
EXAMPLE RAPID FLASH BEACON (RRFB)

Consider installing rapid flash beacons at pedestrian crossings in the towns of Esparto and Capay to increase the awareness and reaction to the presence of pedestrian crossings at the various unsignalized intersections in Esparto and Capay. Rectangular Rapid Flash Beacon (RRFBs) are user-actuated amber LEDs that supplement warning signs at uncontrolled intersections or mid-block crosswalks. They can be activated by pedestrians manually by a pushbutton or passively by a pedestrian detection system. RRFBs use an irregular flash pattern that is similar to emergency flashers on police vehicles and may be installed on either two-lane or multi-lane roadways. These devices could be considered at the crosswalk in downtown Esparto.

PS-5 Install rapid flash beacons at pedestrian crossings in the towns of Esparto and Capay

“An Analysis of the Effects of Stutter Flash LED Beacons to Increase Yielding to Pedestrians Using Multilane Crosswalks,” and “The Use of Stutter Flash LED Beacons to Increase Yielding to Pedestrians at Crosswalks,” presented at the Transportation Research Board Annual Meeting in 2008, summarized the results of two studies on the effects of RRFBs when used to supplement standard pedestrian crossing warning signs at crosswalks. The former found that going from a no-beacon arrangement to a two-beacon system, mounted on the supplementary warning sign on the right side of the crossing, increased yielding from 18 percent to 81 percent. There was a further increase in yielding behavior, with a four-beacon system (with two beacons each on both the right and left sides of the crossing) to 88 percent. It also evaluated the sites over a one-year period,

and found that there was little to no decrease in yielding behavior over time. The MUTCD gave interim approval to RRFBs for optional use in limited circumstances in July 2008. The interim approval allows for usage as a warning beacon to supplement standard pedestrian crossing warning signs and markings at either a pedestrian or school crossing; where the crosswalk approach is not controlled by a yield sign, stop sign, or traffic-control signal; or at a crosswalk at a roundabout. A rough cost of \$50,000 is required for the hardware and installation of rapid flash beacons (exclusive of power supply) per crosswalk.

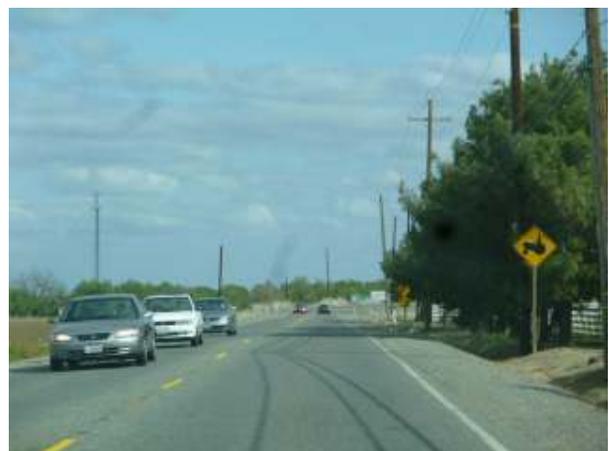
SINGLE EXISTING FARM VEHICLE SIGNAGE

There currently is a single sign to indicate the presence of farm equipment and vehicles on Highway 16. Additional placement of signs and different types of signs would reinforce the presence of vehicles making drivers more likely to anticipate slower moving farm equipment. Additionally, If VMS signs were to be located in a strategic locations then warning drivers could be coordinated with seasons and timeframes when farm vehicles and equipment are in greater use (i.e. harvesting season).
