# ASBESTOS AND LEAD-CONTAINING PAINT SURVEY

**FIFTH AVENUE BRIDGE (33-0027)  
OAKLAND, CALIFORNIA**

CALTRANS CONTRACT 04A2912  
TASK ORDER NO. 05  
EA No. 04-1706U1

MARCH 2008

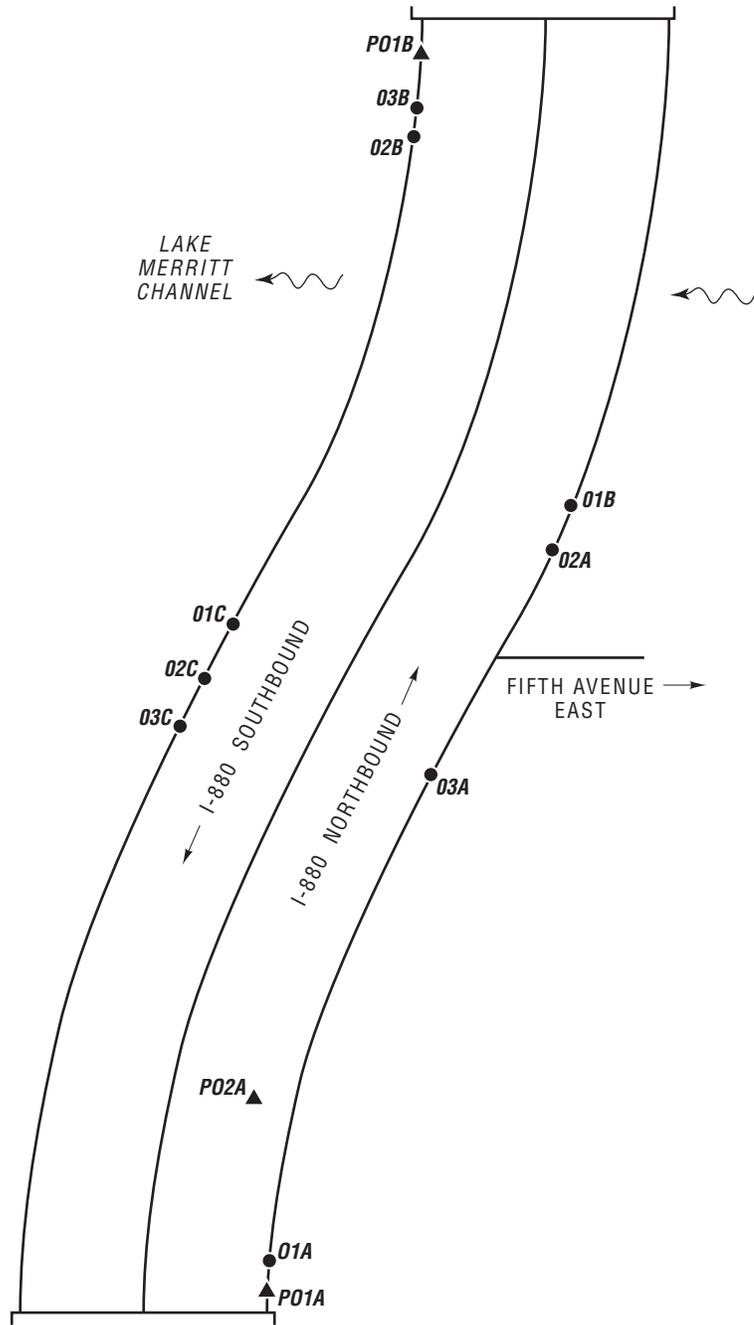
Figure 2

- Approximate Asbestos Sample Location
- ▲ Approximate Paint-Chip Sample Location

**SITE PLAN**

Samples were collected from locations as shown in the Site Plan (Figure 2). Suspect asbestos and LCP sample identification numbers are presented in Tables 1 and 2, respectively. Materials represented by the samples collected are presented in the Site Photographs.

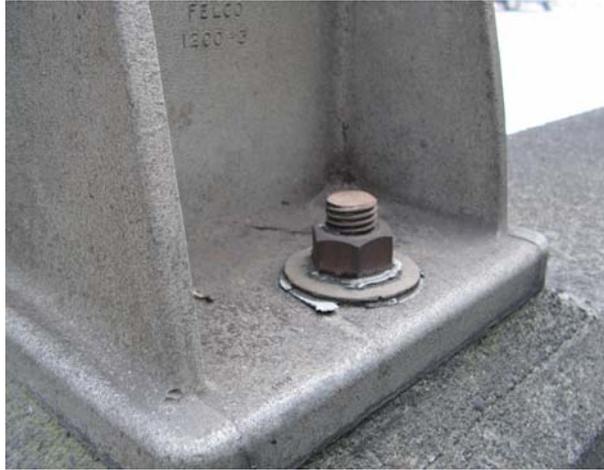
**Photo 4 – Barrier rail bolt thread compound**

The laboratory analyses for asbestos indicated that chrysotile asbestos at concentrations of 40% and 2% were detected in samples representing nonfriable asbestos sheet packing used as bridge barrier rail shims and barrier rail thread compound, respectively. We were not able to quantify the amount of shim and thread sealant compound materials due to safety concerns (i.e., traffic). No asbestos fibers were observed in samples of the remaining suspect material at the project location. Laboratory results for the asbestos samples are summarized on Table 1. Reproductions of the laboratory report and chain-of-custody documentation are presented in Appendix A.

NESHAP regulations do not require that asbestos-containing sheet piling and bolt thread compound (Category I nonfriable/nonhazardous materials) identified during our survey be removed prior to demolition or treated as hazardous waste. However, the disturbance of these materials is still covered by the Cal/OSHA asbestos standard (Title 8, CCR Section 1529). We recommend that a licensed demolition contractor registered with Cal/OSHA for asbestos-related work (or a licensed and certified asbestos abatement contractor) perform demolition activities if the asbestos-containing sheet piling and bolt thread compound identified during our survey is left in-place during demolition. Contractors are responsible for informing the landfill of the contractor's intent to dispose of asbestos waste. Some landfills may require additional waste characterization. Contractors are responsible for segregating and characterizing waste streams prior to disposal.

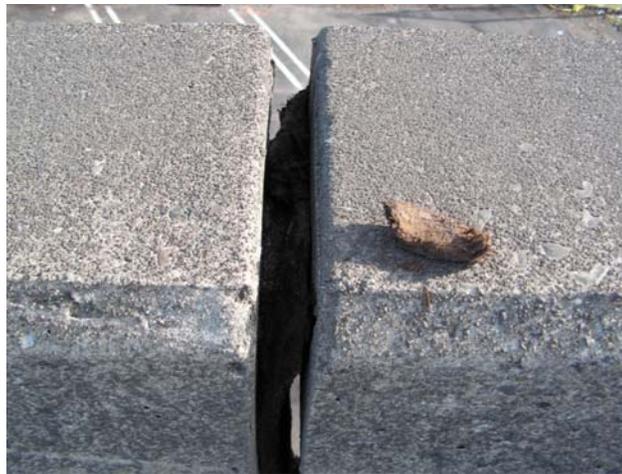
**Photo 5 – Expansion joint fill material (span)**

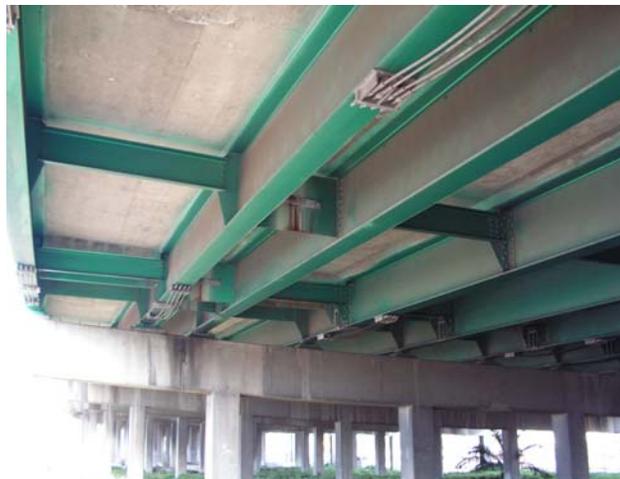
Laboratory analyses indicated that bulk samples representing intact green/multi-layer paint used on the bridge girders exhibited total lead concentrations of 59,000 to 100,000 mg/kg and soluble (TCLP) lead concentrations of 230 to 300 mg/l.

**Photo 6 – Bridge deck girders beneath southern portion of span**

We recommend that all paints at the project location be treated as lead containing for purposes of determining the applicability of the Cal/OSHA lead standard during any future maintenance, renovation, and demolition activities. This recommendation is based on LCP sample results and the fact that lead was a common ingredient of paints manufactured before 1978 and is still an ingredient of some industrial paints. Construction activities (including demolition) that disturb materials containing *any* amount of lead are subject to certain requirements of the Cal/OSHA lead standard contained in Title 8, CCR Section 1532.1. We recommend that personnel with lead-related construction certification as supervisors or workers, as appropriate, from the California DPH perform any required trigger tasks as defined in Title 8 CCR Section 1532.1(d). Common trigger tasks include manual scraping or sanding, heat gun applications, power tool cleaning, spray painting with lead paint, abrasive blasting, welding, cutting, grinding, and torch burning. Contractors should consult the Cal/OSHA lead standard for additional guidance.

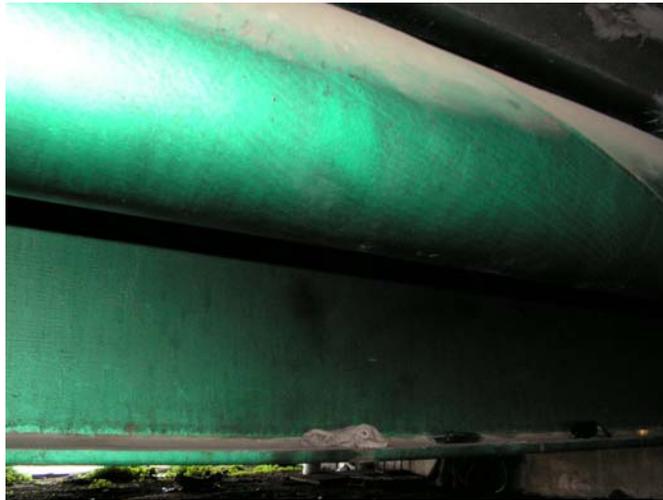
**PHOTOGRAPH 7**

Laboratory analyses indicated that a bulk sample representing intact green/multi-layer paint used on the bridge drain piping exhibited a total lead concentration of 220,000 mg/kg and a soluble (TCLP) lead concentration of 450 mg/l.

**Photo 7 – Drain pipe beneath southern portion of span**
