LIVERMORE BRIDGES 33-0140 AND 33-0012 ALAMEDA COUNTY, CALIFORNIA

GEOCON PROJECT NO. E8370-06-01

SEPTEMBER 2006

Subject: ASBESTOS SURVEY
LIVERMORE BRIDGES 33-0140 AND 33-0012
STATE ROUTE 580 IN ALAMEDA COUNTY, CALIFORNIA

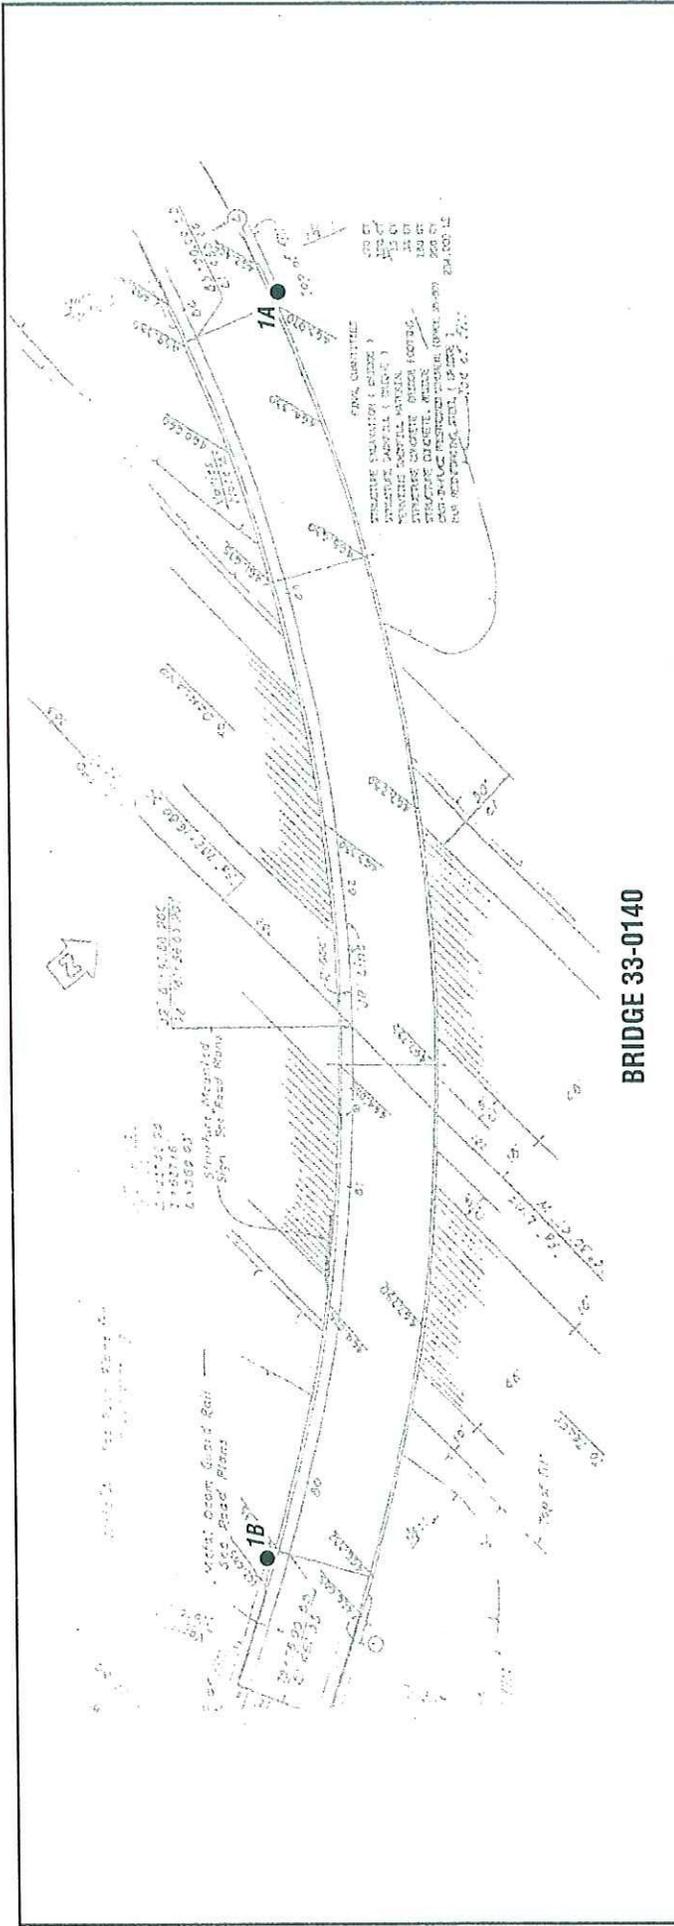
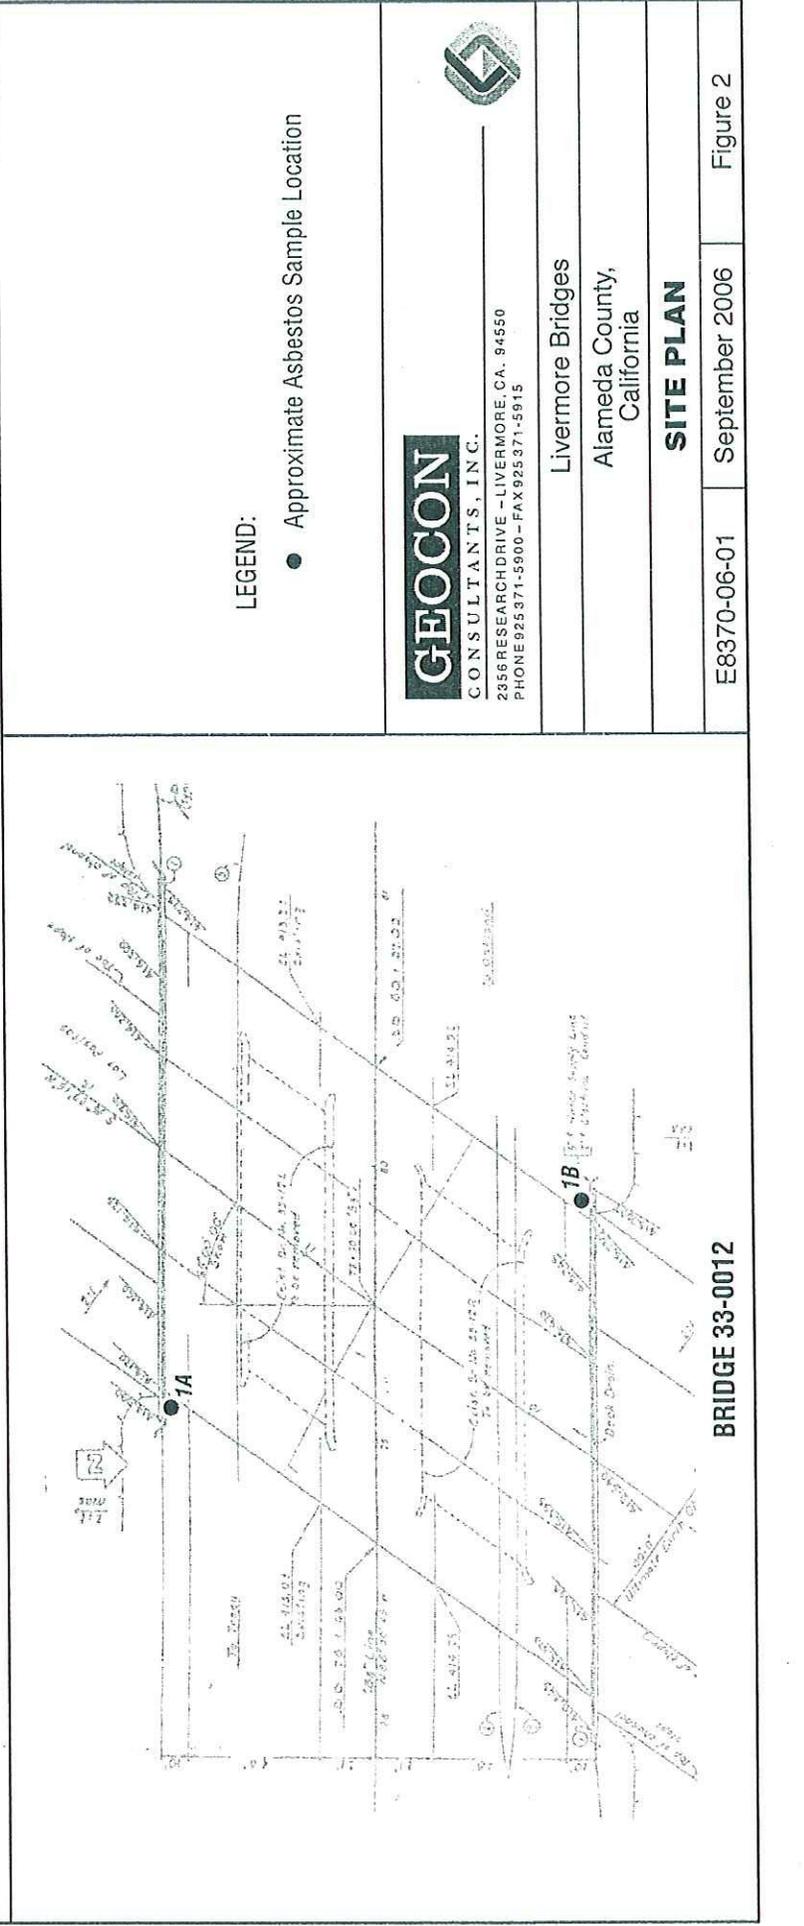
E8370-06-01 September 2006 Figure 2

Geocon sample identification numbers, material descriptions, friability assessments, and photo references are summarized as portions of Table 1. Sample locations are presented on the Site Plan, Figure 2. Photos of the materials sampled are presented with Site Photographs 1 through 6.

SITE PLAN

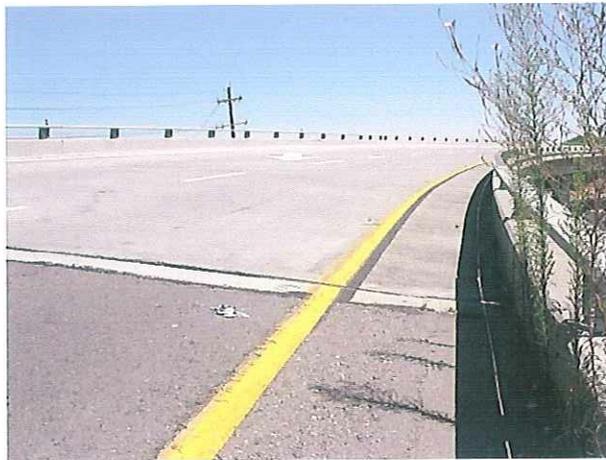
Geocon did not observe barrier rail shims on Bridge 33-0140. However, a thorough inspection of the Bridge 33-0140 barrier rails was not possible due to safety concerns (i.e., traffic). Any barrier rail shims encountered on Bridge 33-0140 should be *assumed* to be ACM unless sampling and analysis indicate otherwise.

Photo 1 – Bridge 33-0140 (barrier rails inaccessible)

Asbestos barrier rail shims may be present on Bridge 33-0140. A thorough inspection of the Bridge 33-0140 barrier rails was not possible due to safety concerns (i.e., traffic).

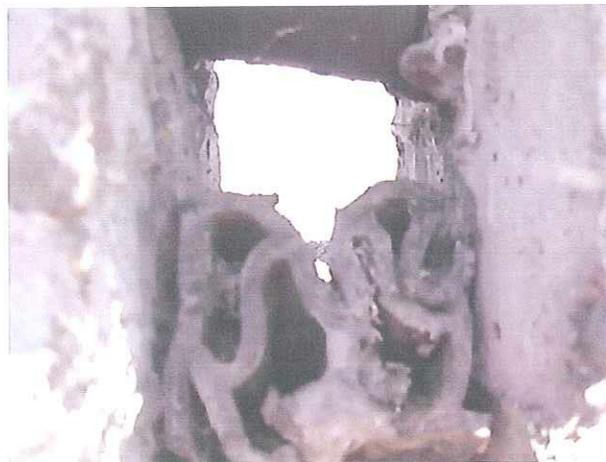
Photo 2 – Bridge 33-0140 deck joint (non-suspect)

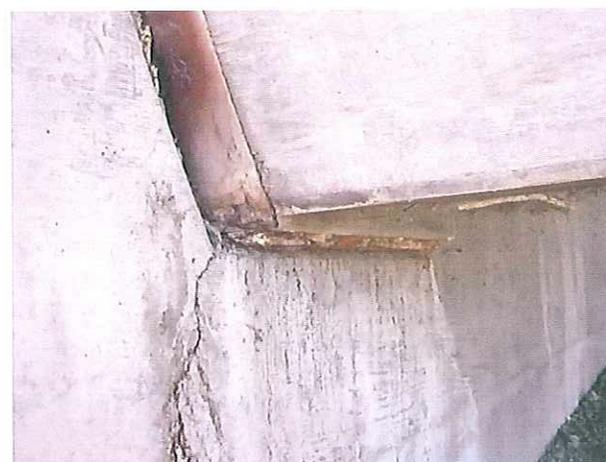
Bridge No.	Sample No.	Description of Material	Approximate Quantity	Friable	Site Photo	Asbestos Content
33-0140	0140-1A	Abutment expansion joint material	NA	NA	3	ND
	0140-1B					ND
33-0012	0012-1A	Barrier rail shims	Unable to safely quantify	No	6	30% chrysotile
	0012-1B					30% chrysotile

Photo 3 – Bridge 33-0140 abutment joint

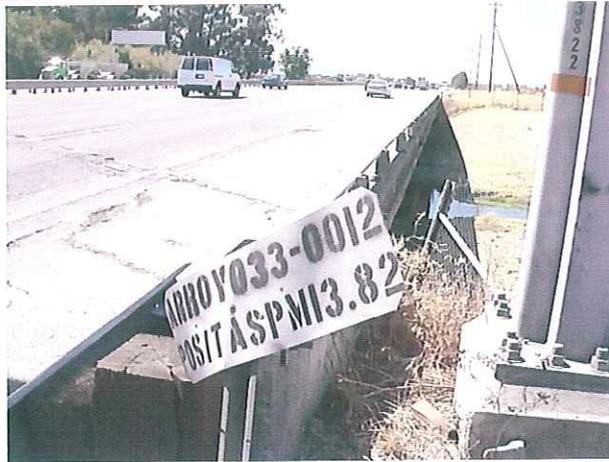
Photo 4 – Bridge 33-0012

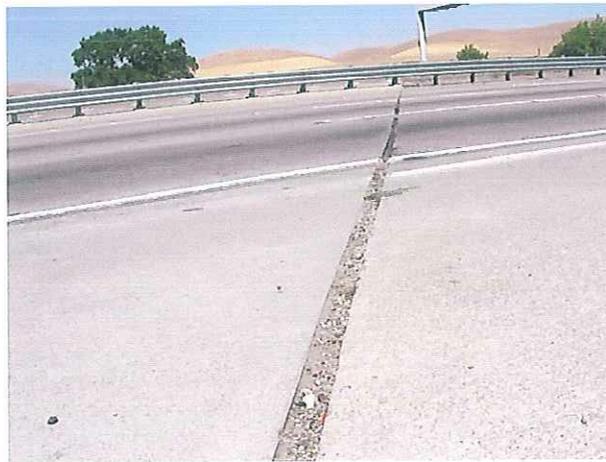
Photo 5 – Bridge 33-0012 deck joint (non-suspect)

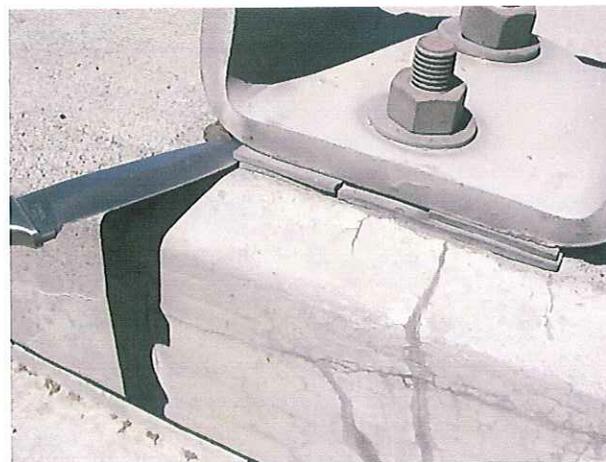
Chrysotile asbestos at a concentration of 30% was detected in samples representing nonfriable asbestos sheet packing used as barrier rail shims on Bridge 33-0012. Geocon was unable to safely quantify the barrier rail shims due to safety concerns (i.e., traffic).

Photo 6 – Bridge 33-0012 barrier rail shims

NESHAP regulations do not require that asbestos-containing sheet piling (a Category I nonfriable/nonhazardous material) identified during this survey be removed prior to demolition or be treated as hazardous waste. However, the disturbance of the material is still covered by the Cal/OSHA asbestos standard (Title 8, CCR Section 1529). The disturbance of the material must be performed by a licensed contractor registered with Cal/OSHA for asbestos-related work (or by a certified asbestos abatement contractor) following Cal/OSHA asbestos work requirements. Contractors are responsible for informing the landfill of the contractor's intent to dispose of asbestos waste. Some landfills may require additional waste characterization. Contractors are responsible for segregating and characterizing waste streams prior to disposal.

Geocon also recommends the notification of contractors (that will be conducting demolition, renovation, or related activities) of the presence of asbestos in their work areas (i.e., provide the occupants and contractor[s] with a copy of this report and a list of asbestos removed by asbestos abatement contractor[s] during subsequent abatement activities). Contractors not involved in asbestos abatement should be instructed not to disturb asbestos during their work.
