**Weekly Update**  
Sept 4 – 10

**Repair Work**

Devil's Slide (post mile 39.14)

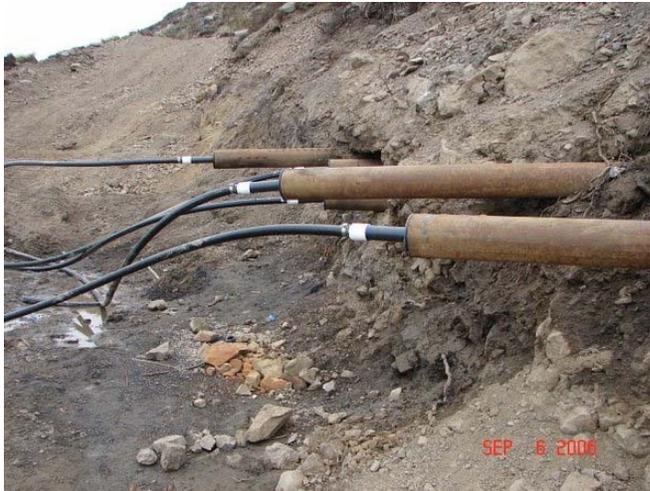
Horizontal drains with extensions

- Extensions were added to the horizontal drains in preparation for connecting to a manifold.

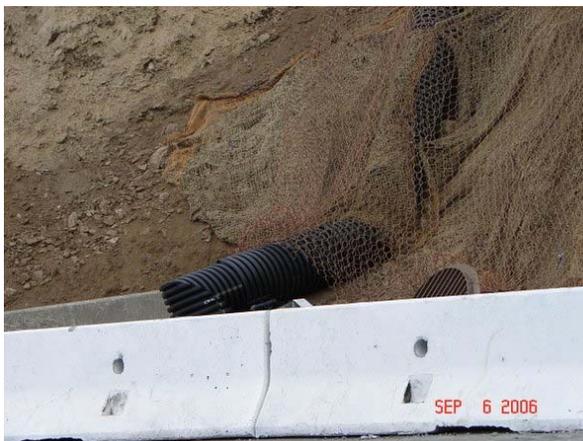
Drain below the rock catchment ditch

- Work completed for the rock catchment drainage system above the road.

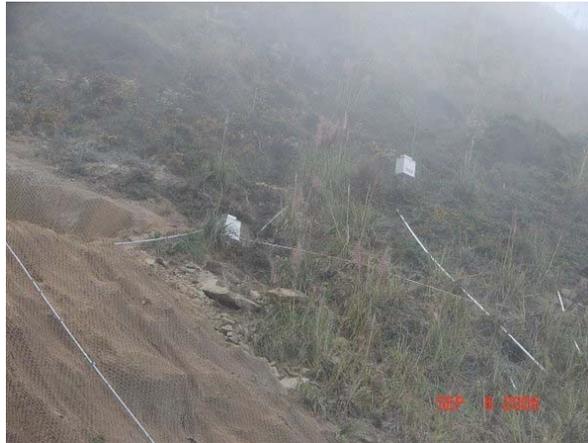
Part of the slide sensor system above the road

- Work on the slide sensor system continued. Still waiting some long lead time components.

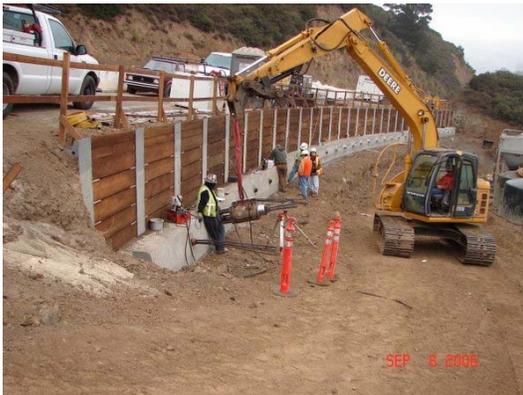
Stressing the last tie back

- Stressing and grouting of the 29 tie backs was completed this week.

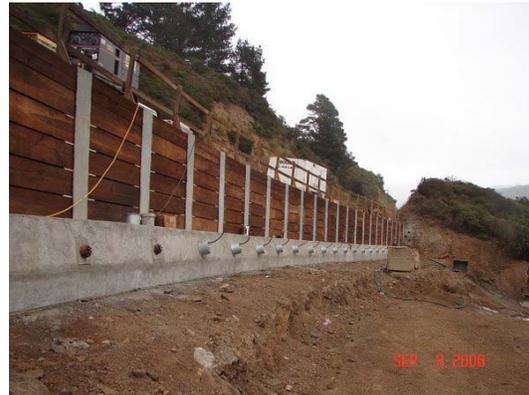
Completed capped tie backs
