Devil's Slide/Hwy 1 Storm Repair

Daily Updates from Bijan Sartipi

Daily Update
May 26

Devil's Slide (post mile 39.14)

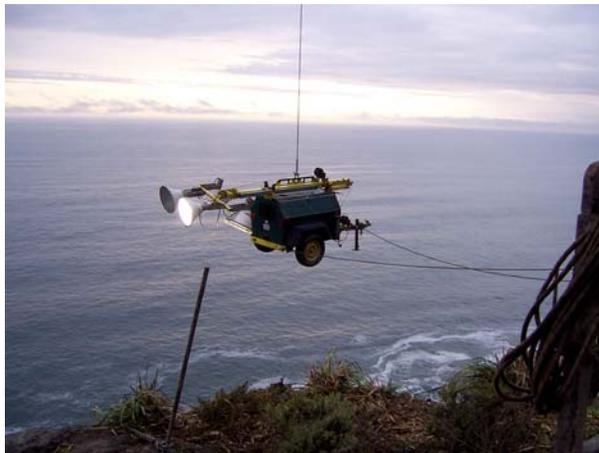
- Below the road, drill and install work for rock dowels continues.

Portable light rig suspended from crane to illuminate rock dowel work area at night.

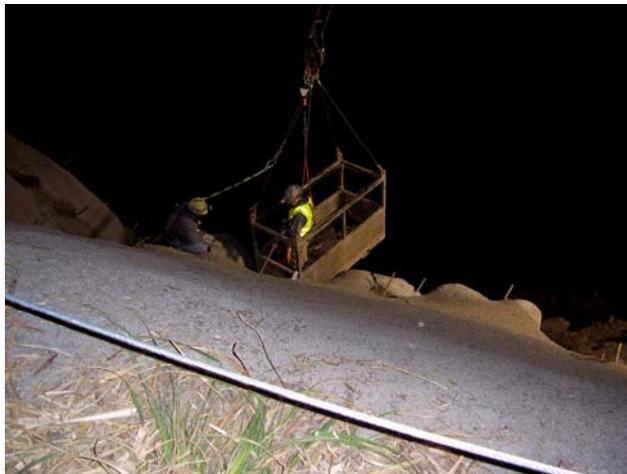
Night crew performing rock dowel work.

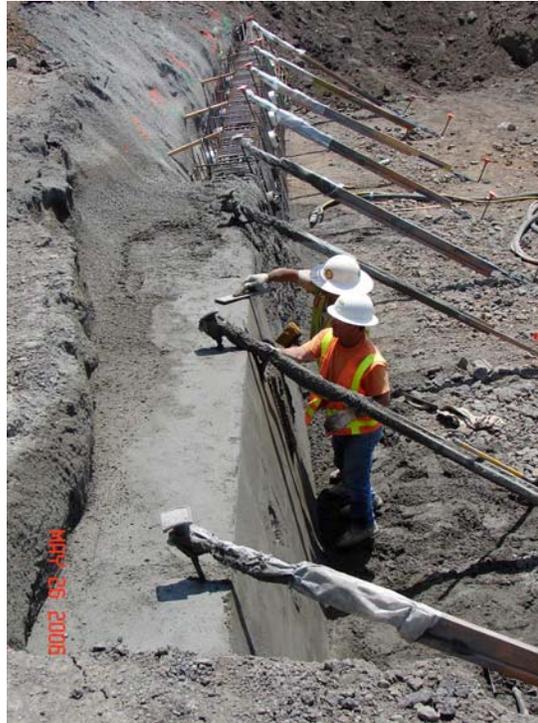
- With rebar work finished, shotcreting for the north portion of whaler wall A started to-day. The photograph below shows only a portion of the first bracing wall below the road. The wall is being constructed in sections to avoid interfering with rock dowel work.

Shotcrete work on the north portion of wall A

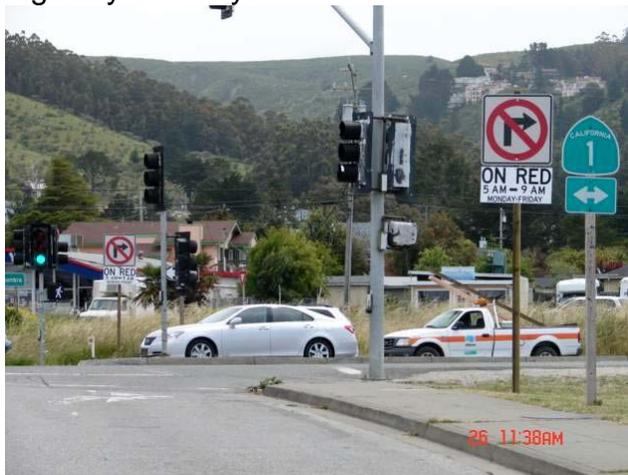
- Signs preventing right turns on red between 5:00 a.m. and 9:00 a.m. Monday through Friday were installed at the intersection of Capistrano and Highway 1 to-day.

No right on red turn signs at Capistrano.

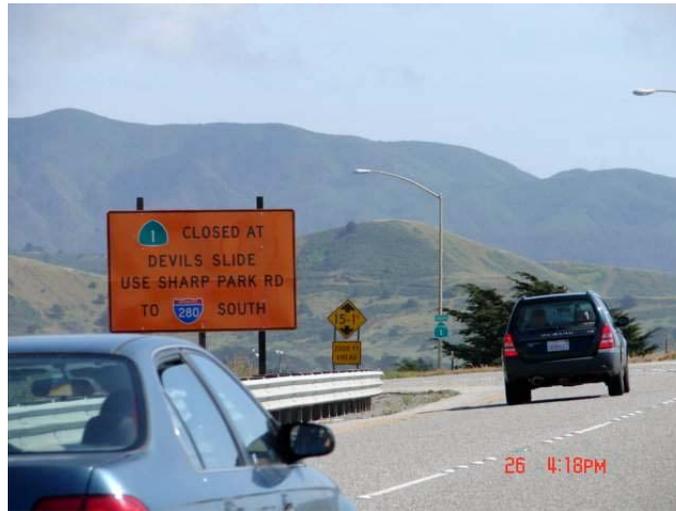
- Additional detour sign installed in Pacifica for Highway 1 south bound motorists.

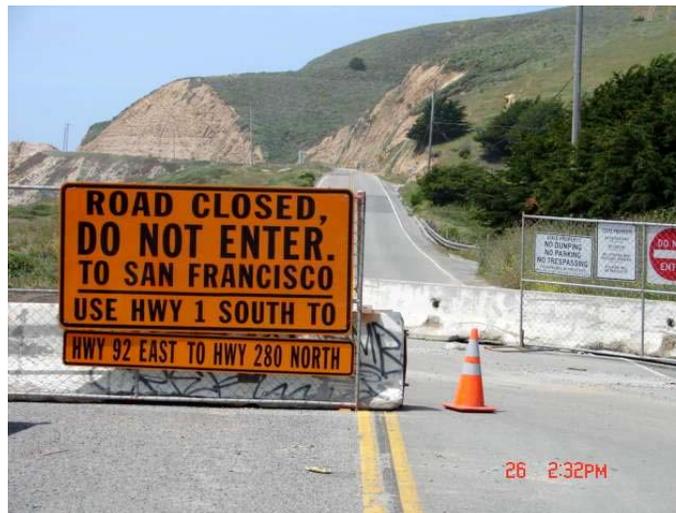
- Detour information installed in Montara for northbound motorists on Highway 1.
