# Devil's Slide/Hwy 1 Storm Repair

Daily Updates from Bijan Sartipi

Daily Update  
June 1

Devil's Slide (post mile 39.14)

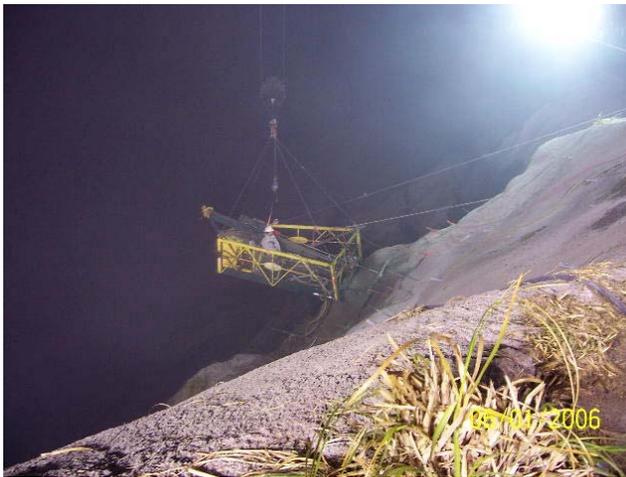
Overnight rock dowel installation below the road.

- Rock dowel installation below the road is now complete.

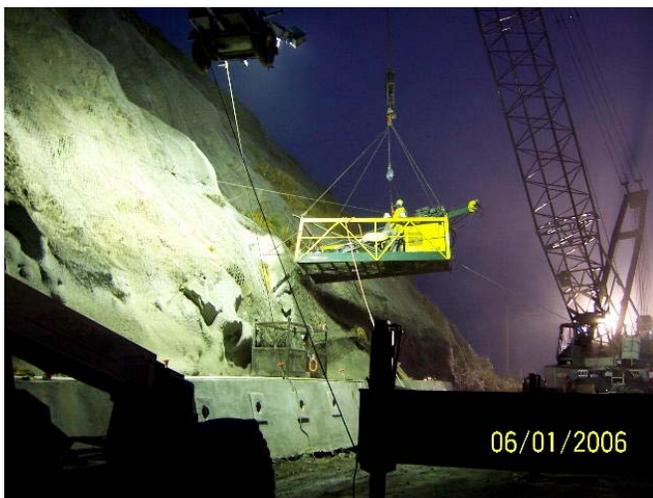
Installing rock anchors to secure steel netting above the road.

- Work started on securing steel netting above the road. The netting is attached to rock anchors drilled about 20 feet deep and is needed to prevent loose rocks falling onto the highway.

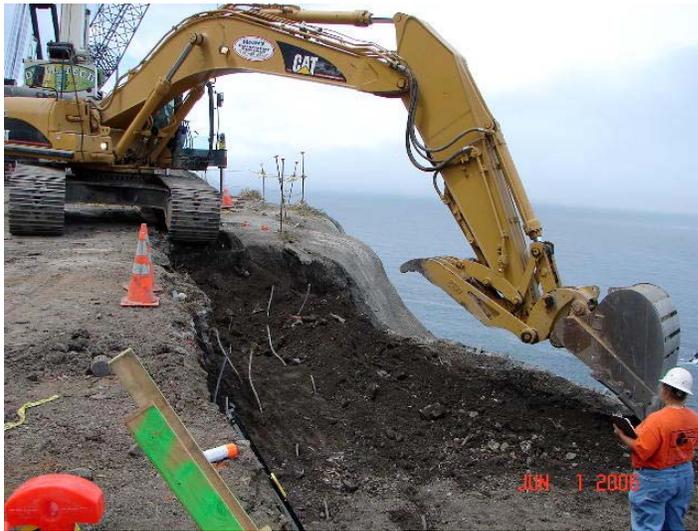
Continuing excavation for the first wall below the road.

- Excavation for whaler wall 'A' continued to-day.

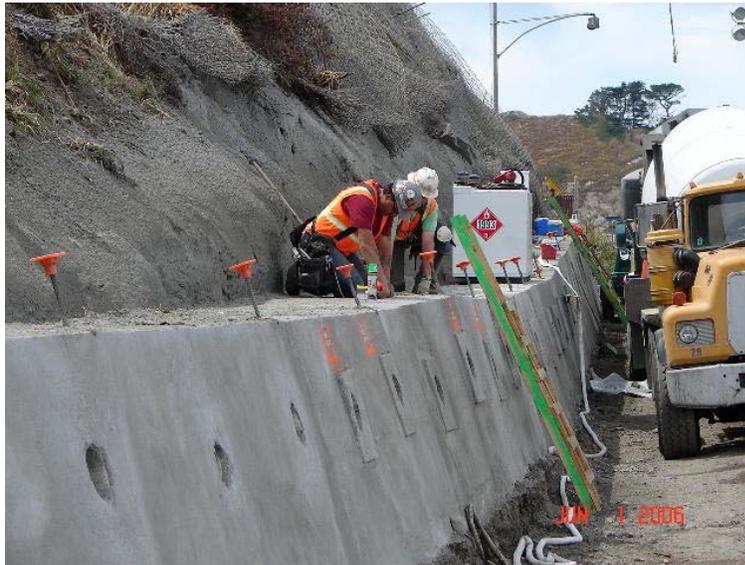
Layout for wall 'D'

- Layout for the second bracing wall above the road, wall 'D', began to-day.

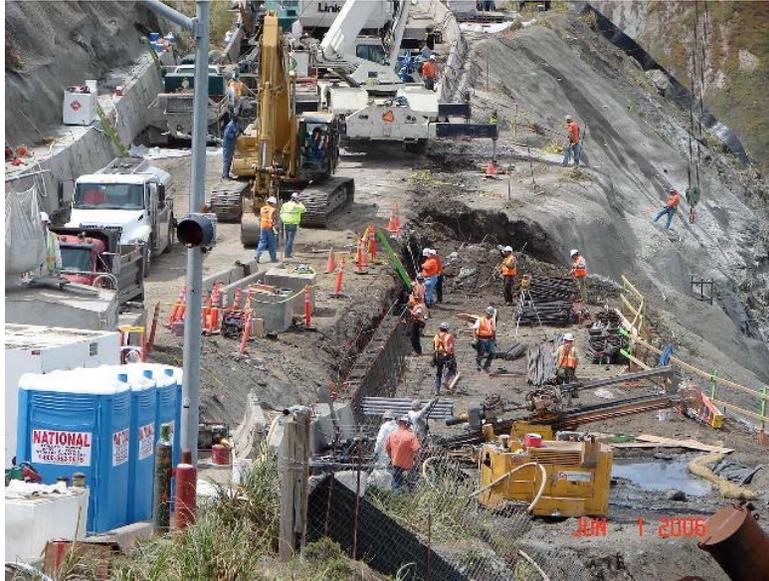
Right foreground, drilling for tie backs while crews continue to construct bracing wall 'A'. Background right, slope surface secured by a layer of shotcrete.

- Drilling and installation of 150 feet log tie backs continued to-day at the north end of whaler wall 'A'.
