Devil's Slide/Hwy 1 Storm Repair

Daily Updates from Bijan Sartipi

Daily Update
June 2

Devil's Slide (post mile 39.14)

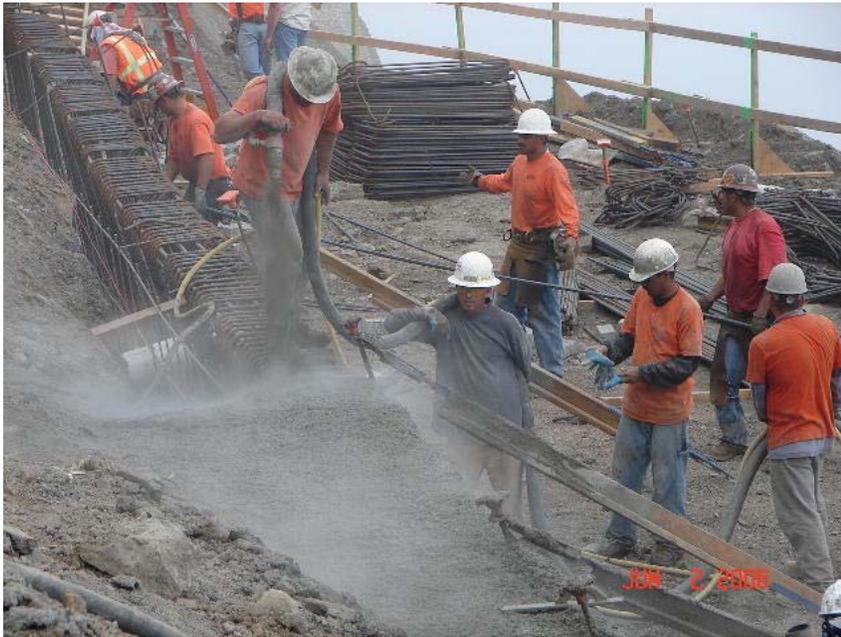
Rebar and concrete work taking place simultaneously on a section of whaler wall 'A'.

- Shotcreting below the road continued to-day
- Rebar installation and shotcreting another section of whaler wall 'A' took place.

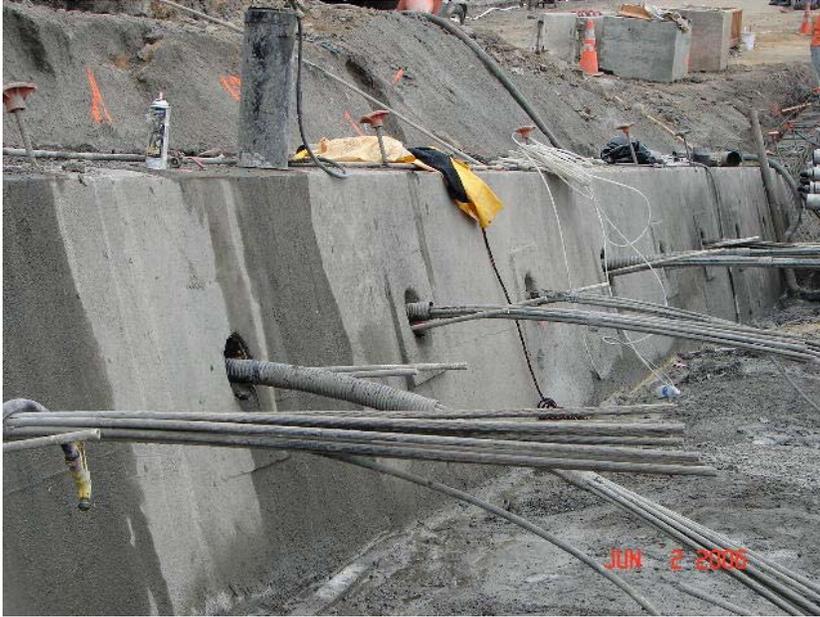
150 feet long tie backs installed through wall 'A'.

- Drilling and installation of tie backs for wall 'A' continued.

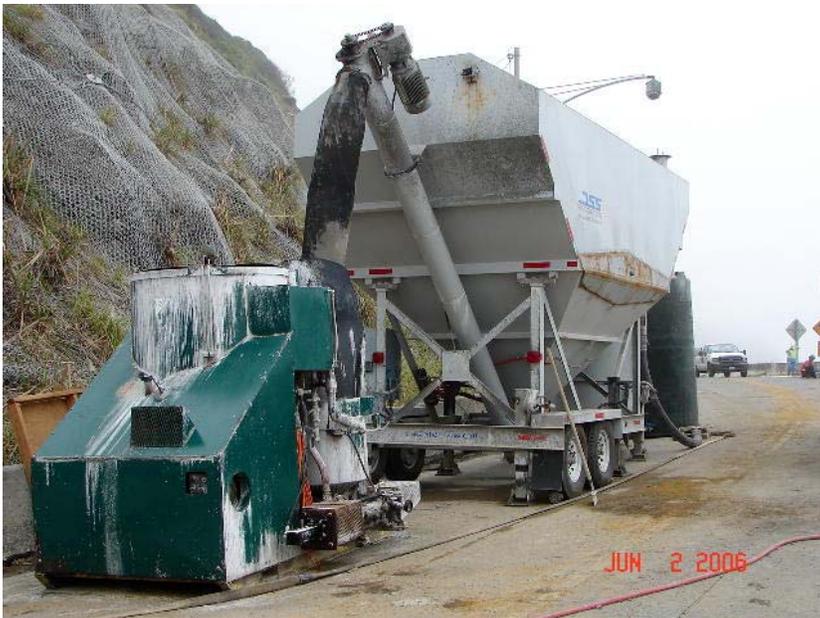
Equipment for mixing and pumping grout to secure tiebacks in place.

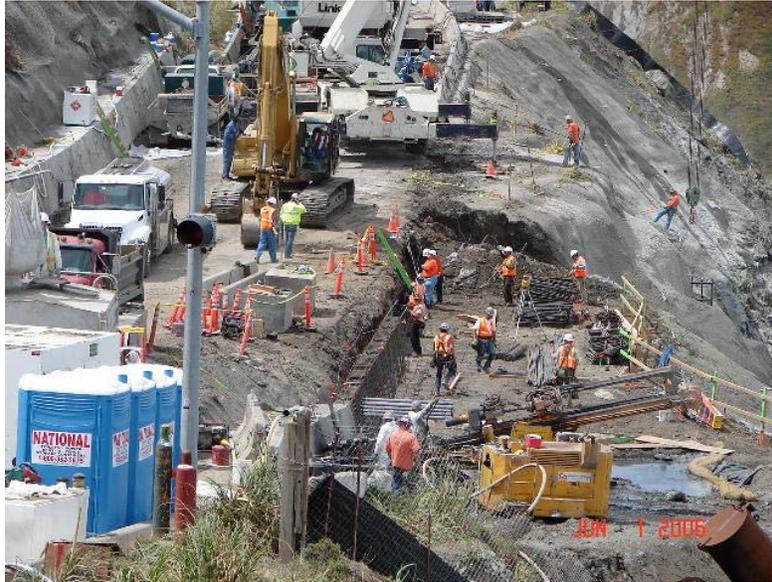
Right foreground, drilling for tie backs while crews continue to construct bracing wall 'A'. Background right, slope surface secured by a layer of shotcrete.
