Devil's Slide/Hwy 1 Storm Repair

Daily Updates from Bijan Sartipi

Daily Update
June 22

Devil's Slide (post mile 39.14)

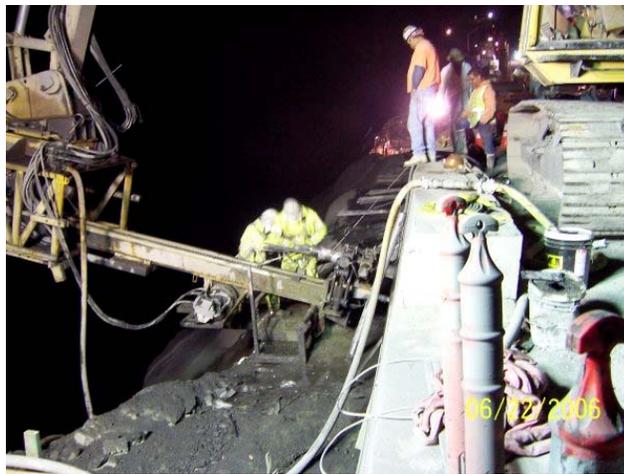
- Whaler wall 'A' (upper level ocean side) – drilling with reach over rig continued. 52 of 59 tie backs now installed. Tie back stressing continues.

Reach over rig drilling at wall A

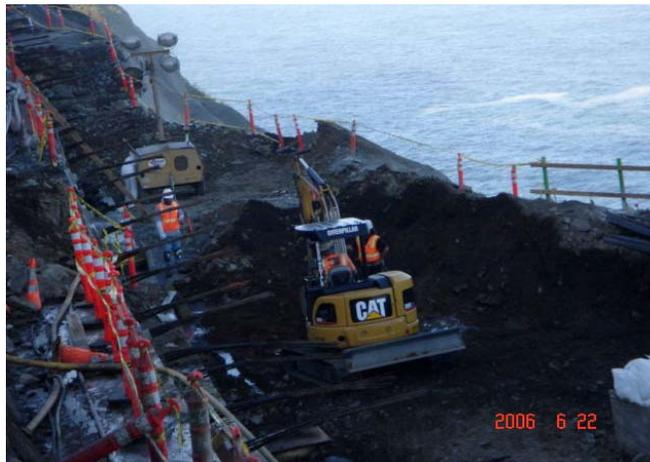
- Whaler wall 'B' (lower level ocean side) – Excavation work continues.

Excavating a 'bench' for the drill rig at wall B

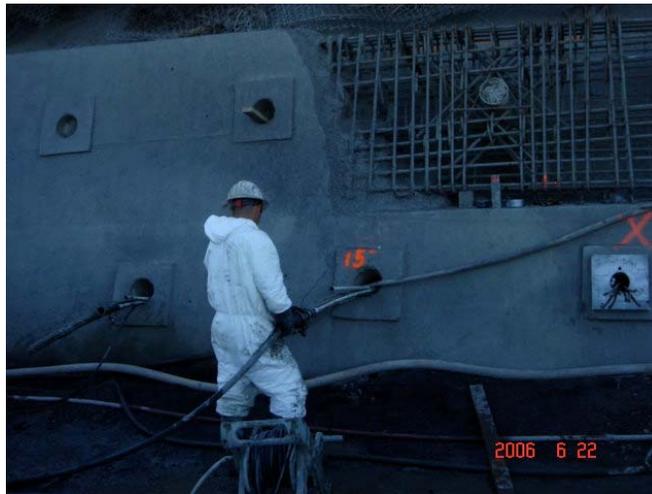
- Whaler wall 'C' (lower level cliff side) – drilling continued. 28 of 34 tie backs now installed.

Injecting grout for level C tie backs

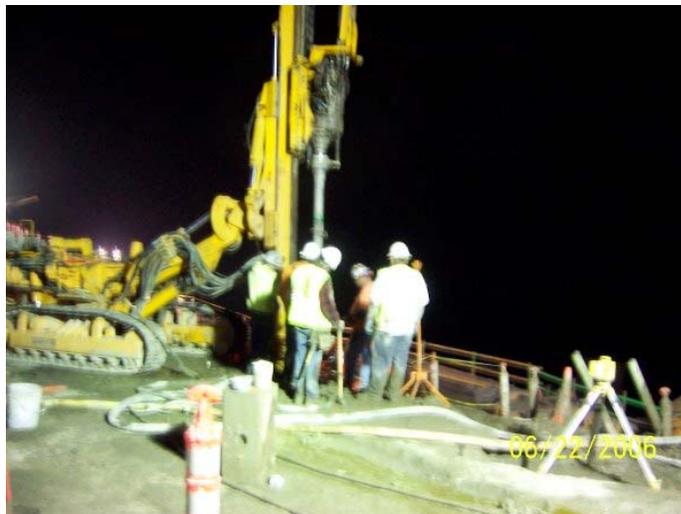
- Compaction grouting continued behind wall A

Compaction grouting operation behind wall A
