Devil's Slide/Hwy 1 Storm Repair

Daily Updates from Bijan Sartipi

Daily Update
June 24 and 25

Devil's Slide (post mile 39.14)

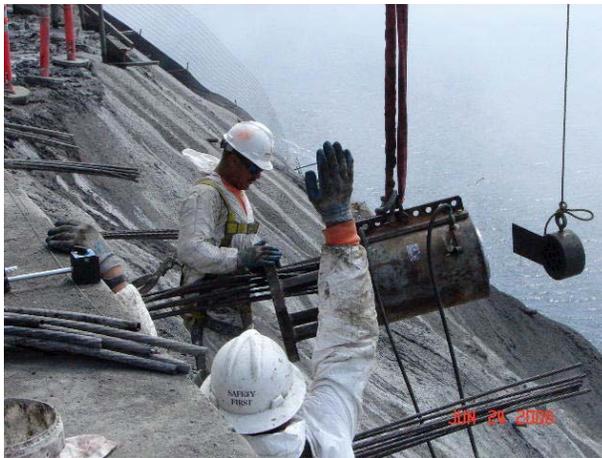
- Whaler wall 'A' (upper level ocean side) – drilling with reach over rig continued. 59 of 59 tie backs now installed. Tie back stressing continues.

Stressing wall A tie backs

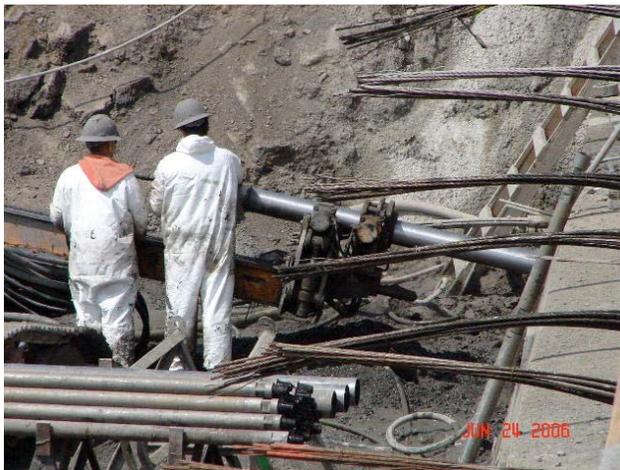
- Whaler wall 'B' (lower level ocean side) – Drilling and shotcreting on different sections of wall B this weekend.

Drilling at wall B

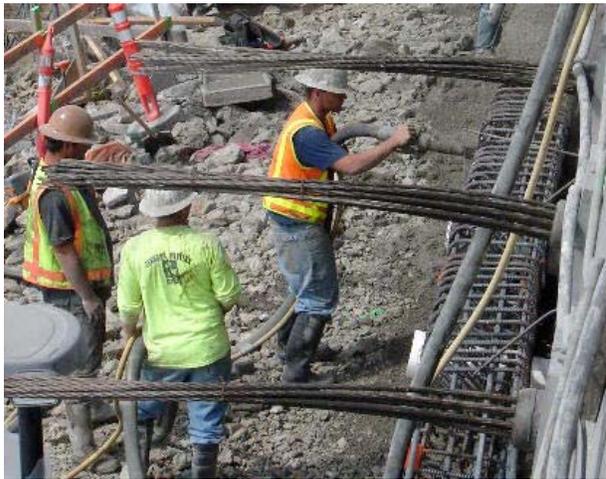
Shotcreting wall B

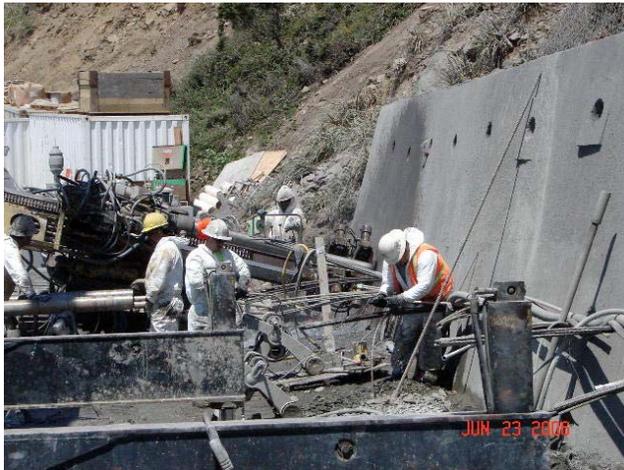
- Whaler wall 'C' (lower level cliff side) – drilling continued. 34 of 34 tie backs now installed.

Drilling at wall C

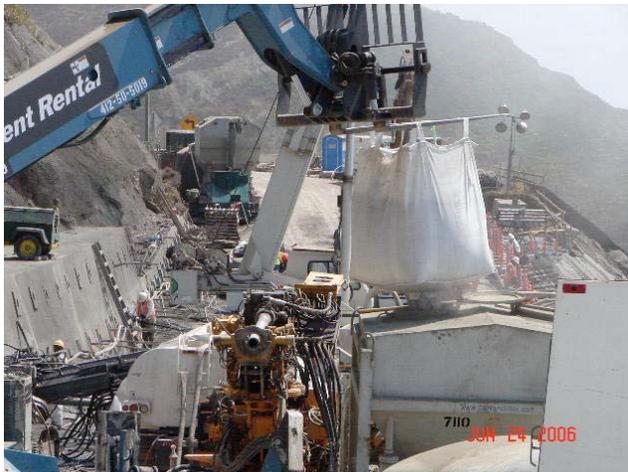
- Compaction grouting continued behind wall A.

Loading mixer to prepare grout
