Devil's Slide/Hwy 1 Storm Repair

Daily Updates from Bijan Sartipi

Daily Update
June 26

Devil's Slide (post mile 39.14)

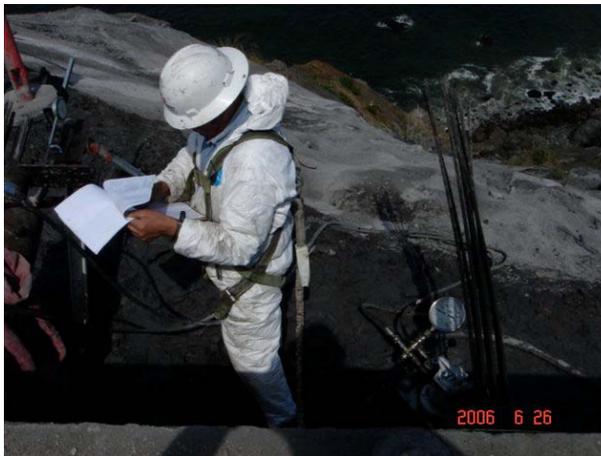
- Whaler wall 'A' (upper level ocean side) – 59 of 59 tie backs now installed. 49 of 59 tie backs stressed.

Stressing wall A tie backs

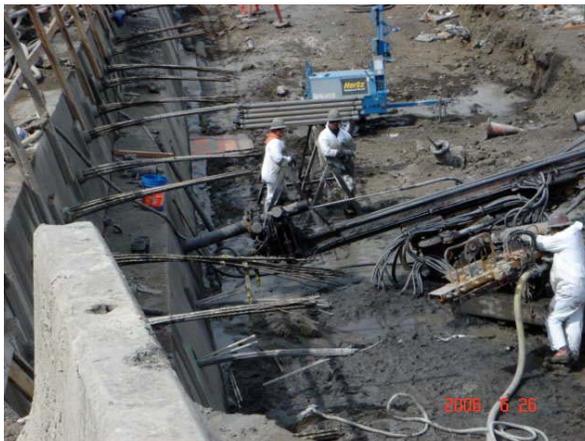
- Whaler wall 'B' (lower level ocean side) – Drilling for tie backs continues. 4 of 58 installed. Excavating a 'bench' to create a work area continued.

Drilling at wall B

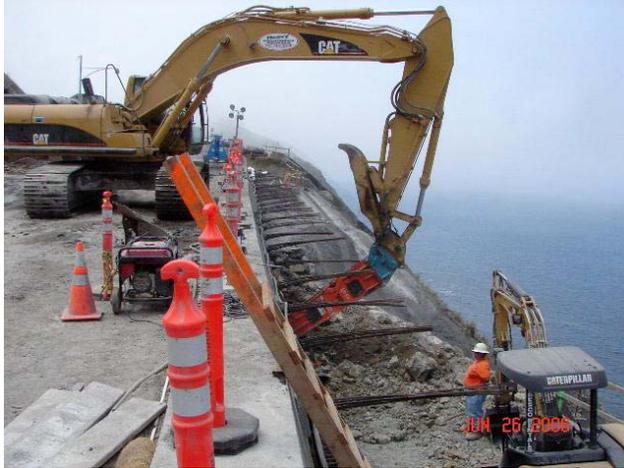
Excavating a bench at level B

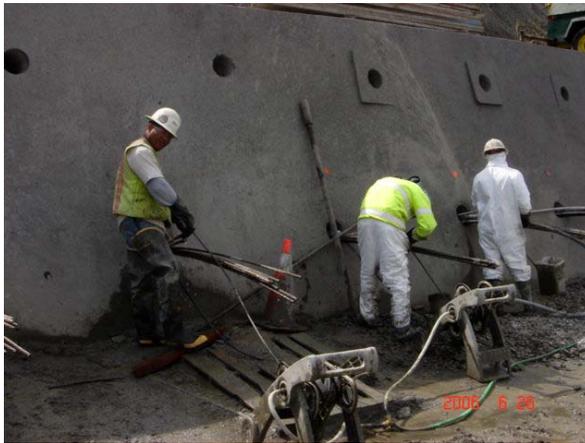
- Whaler wall 'C' (lower level cliff side) – 34 of 34 tie backs now installed. Grouting of tie backs took place today.

Grouting tie backs at wall C
