Devil's Slide/Hwy 1 Storm Repair

Daily Updates from Bijan Sartipi

Daily Update
June 30

Devil's Slide (post mile 39.14)

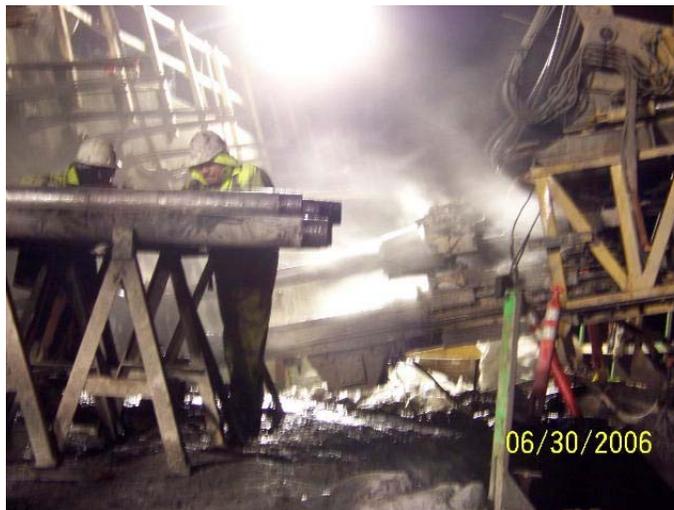
Night shift drilling – level B

- Level 'A' (upper level ocean side) – Re-tightening of tie back cables continued following completion of compaction grouting June 28.
- Level 'B' (lower level ocean side) – Drilling for tie backs continues. 20 of 58 installed. Rebar installation was completed today. Shotcreting continued.

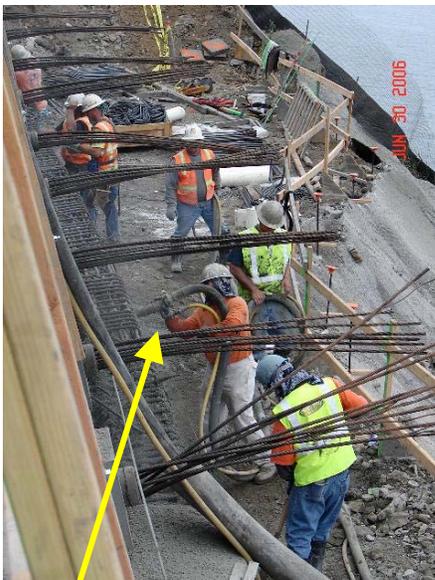
Shotcreting – level B

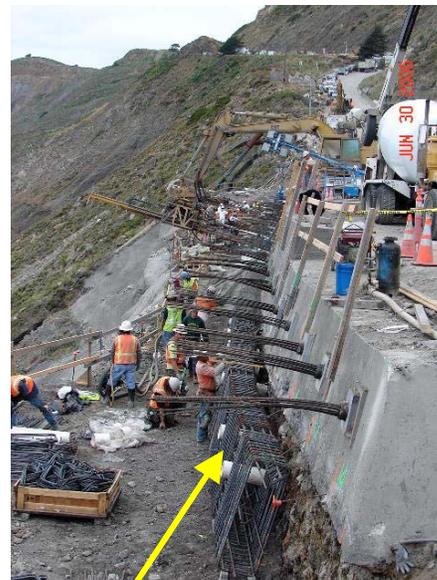
Completing rebar work – level B north

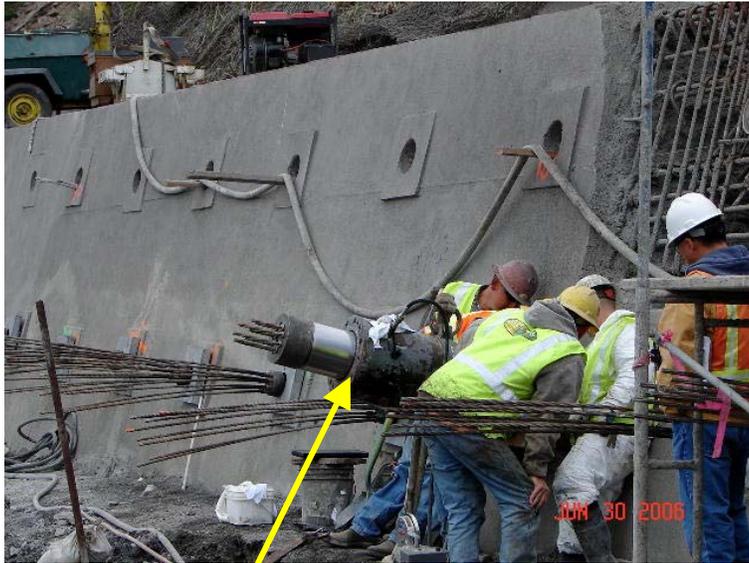
Level 'C' – Using hydraulic ram to apply a force of about 300,000 lbs. to the cables.

- Level 'C' (lower level cliff side) – 34 of 34 tie backs now installed, 18 of which are now stressed.

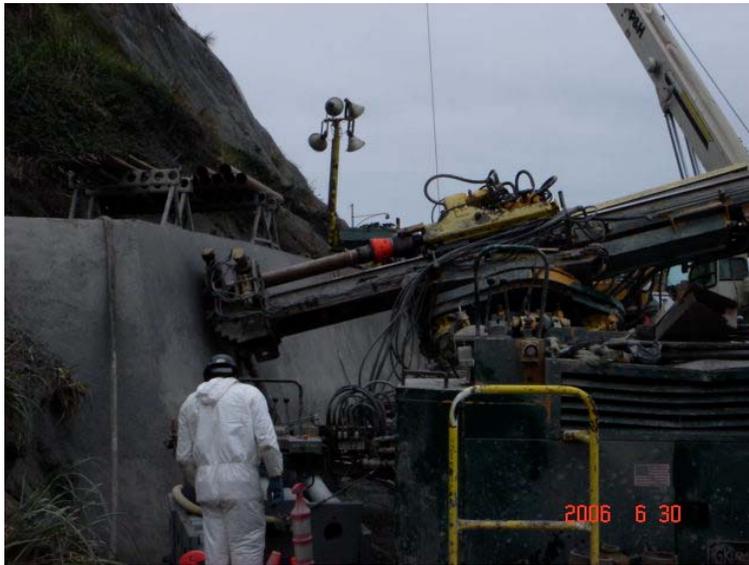
Level 'D' – first drilling at north end of the wall

- Level 'D' (upper level cliff side) – Drilling at this level started today and rebar installation continued.
