Devil's Slide/Hwy 1 Storm Repair

Daily Updates from Bijan Sartipi

Daily Update
July 11

Devil's Slide (post mile 39.14)

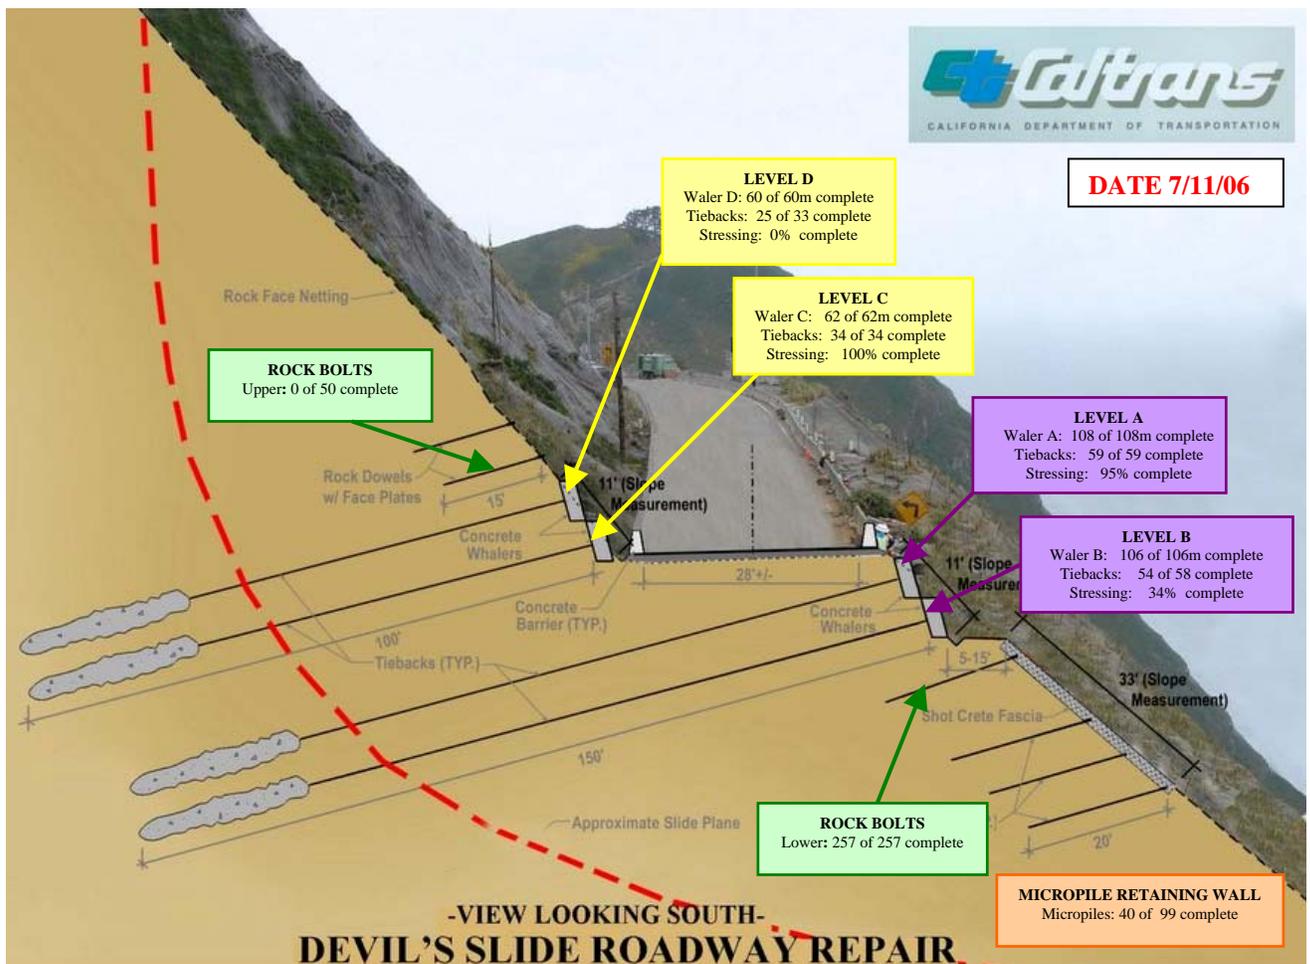
- Waler wall construction and tie back installation summary.

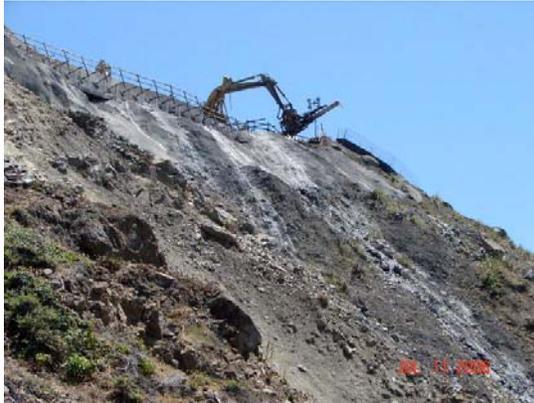
- Level 'B' (lower level ocean side) – Drilling for tie backs continued using the reach over rig. 54 of 58 tie backs now installed. Tie back stressing also continued.

Level B drilling – view from below

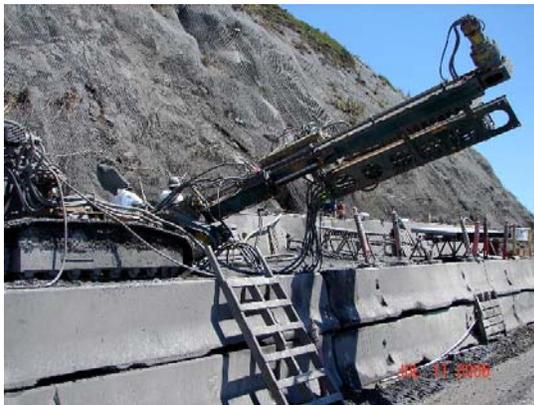
- Level 'D' (upper level cliff side) – Drilling for tie backs continued today from the temporary bench. 25 of 33 now installed.

Level D drilling

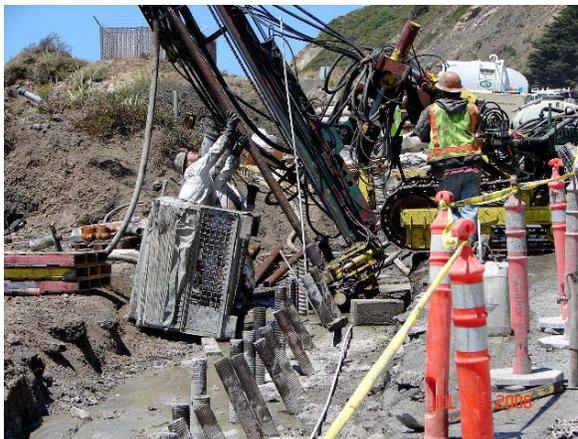
- Drilling and driving steel piles continued today. 40 of 99 now installed.

Drilling for micropiles

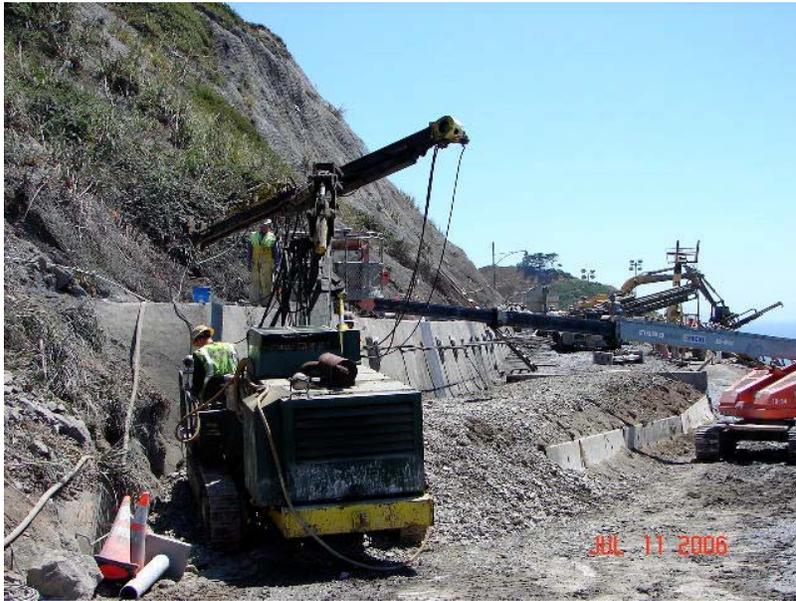
- Drilling started today for the installation of 50 rock bolts above level D. These 15 feet long bolts will knit fractured rocks together reducing the risk rocks falls.

Starting drilling for rock bolts above level D
