Devil's Slide/Hwy 1 Storm Repair

Daily Updates from Bijan Sartipi

Daily Update
July 18

Devil's Slide (post mile 39.14)

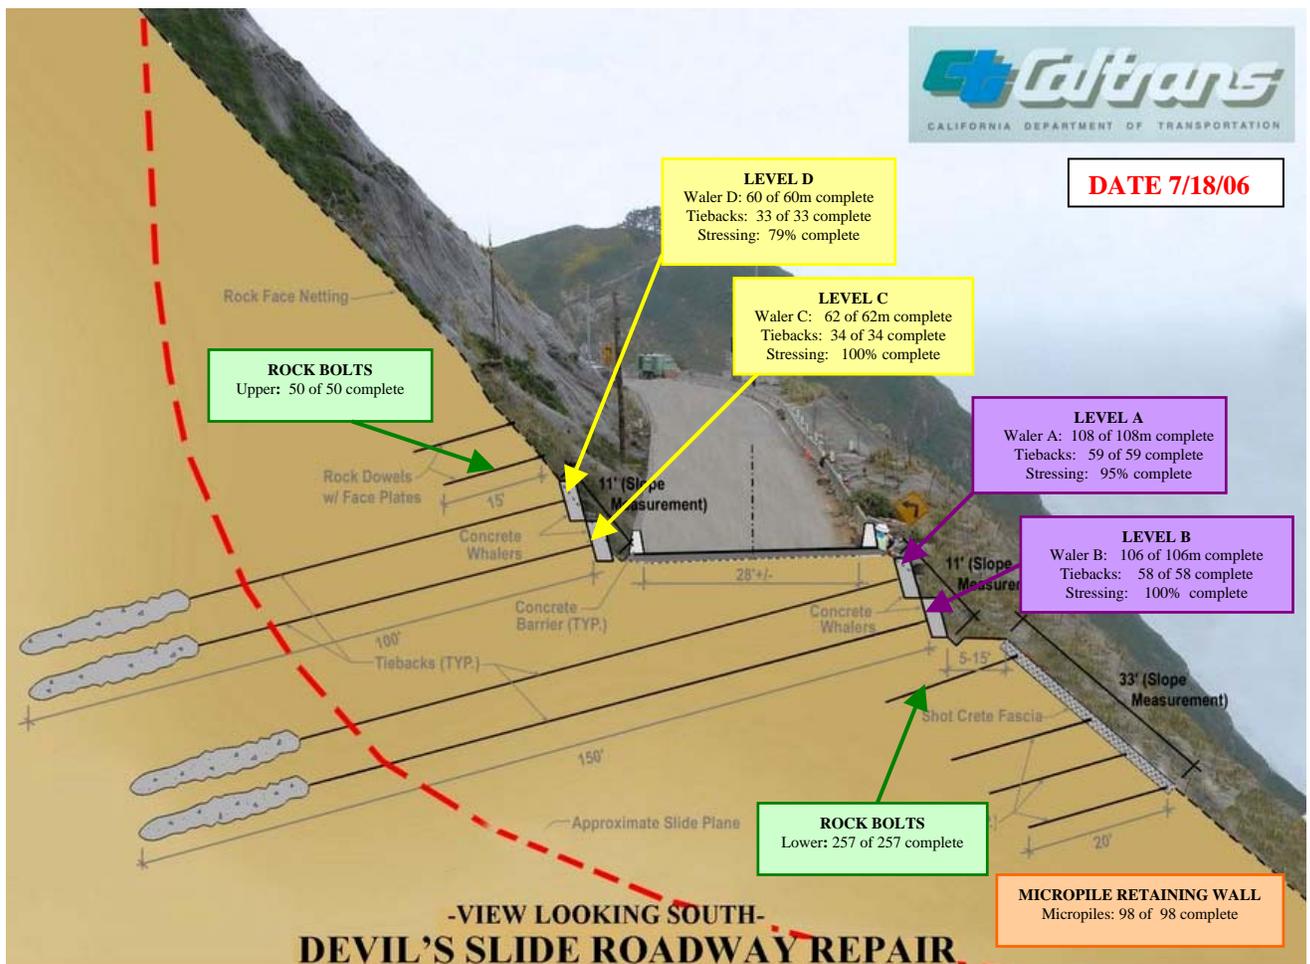
- Waler wall construction and tie back installation summary.

Notes: One micropile eliminated due to interference with drain for a total of 98.

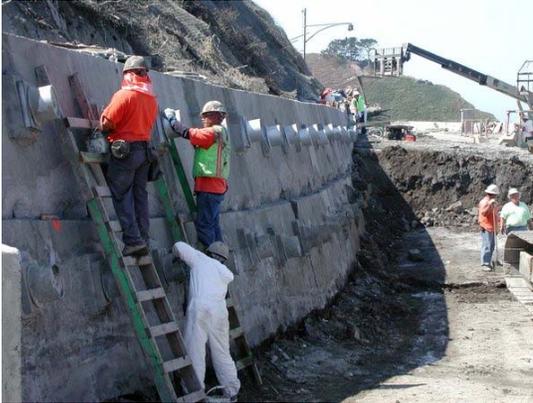
Capping off completed tie back cables

- Level 'D' (upper level cliff side) – Cable stressing continued today. More of the temporary was removed.

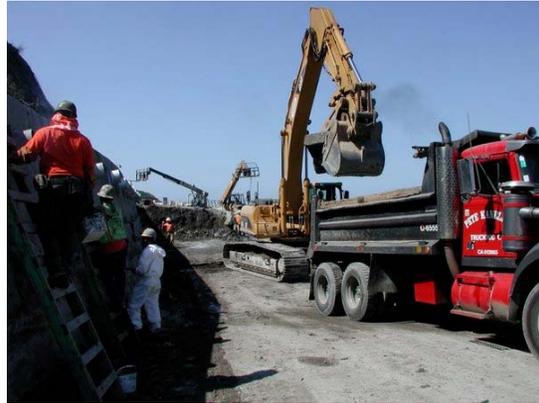
Removing more of the temporary bench

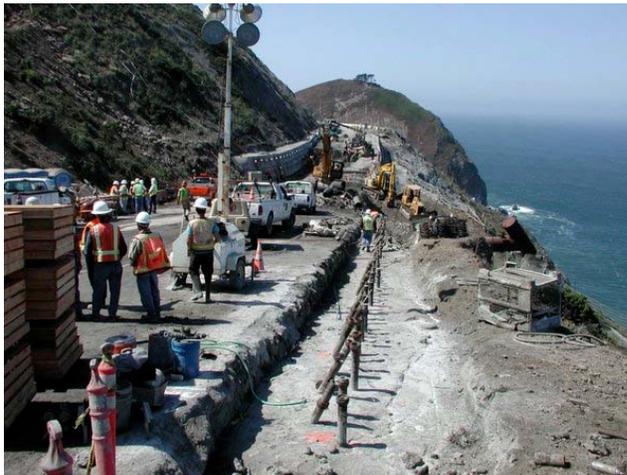
A concrete cap will be formed over the micropiles

- Grading and clean up in preparation for forming the concrete cap.

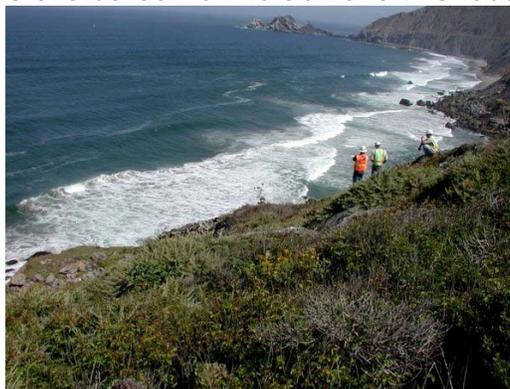
Examining the steep drain outfall location

- The surface drain outfall pipe will be extended down the cliff to prevent erosion. Crews evaluated how to achieve this today.
