# Devil's Slide/Hwy 1 Storm Repair

Daily Updates from Bijan Sartipi

**Daily Update**  
July 1 and 2

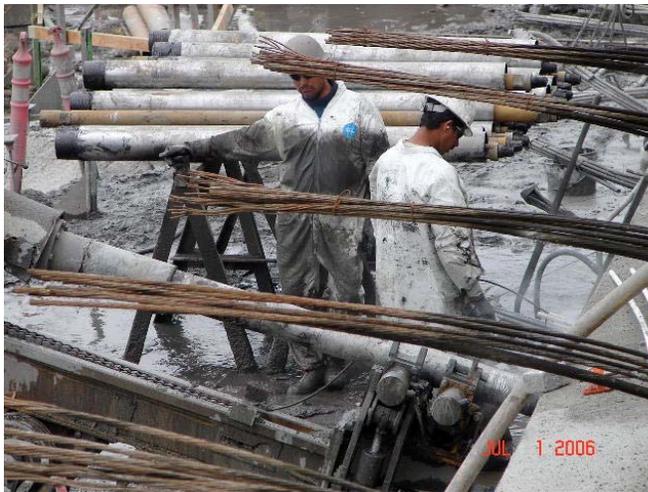
- Level 'B' (lower level ocean side) – Drilling for tie backs continued this weekend using two drill rigs. Cable stressing also started at this level.

Drilling – level B

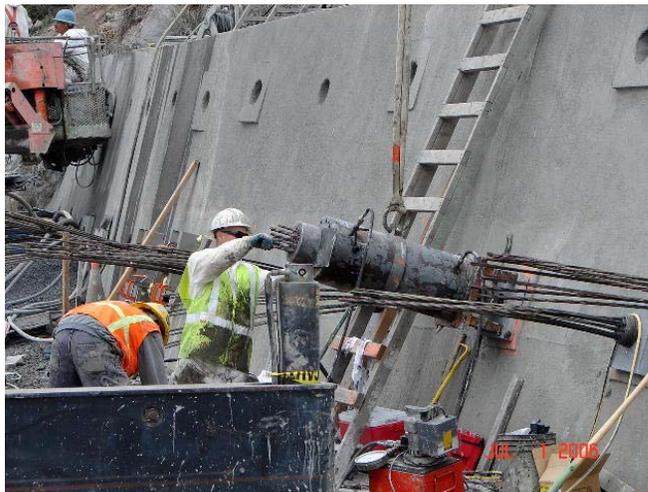
- Level 'C' (lower level cliff side) – Cable stressing continued throughout the weekend.

Level 'C' – cable stressing

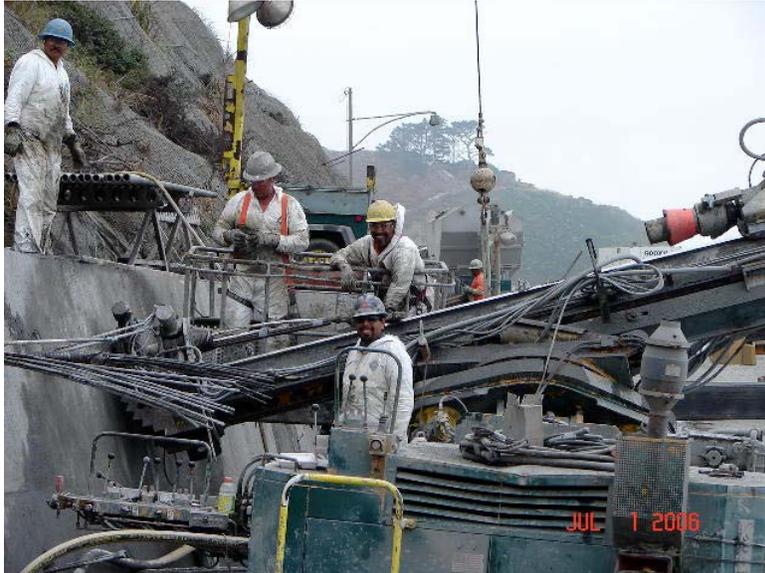
- Level 'D' (upper level cliff side) – Drilling continued over the weekend. The drill rig is supported on a platform to position it correctly for the upper level.

Level 'D' – Drilling

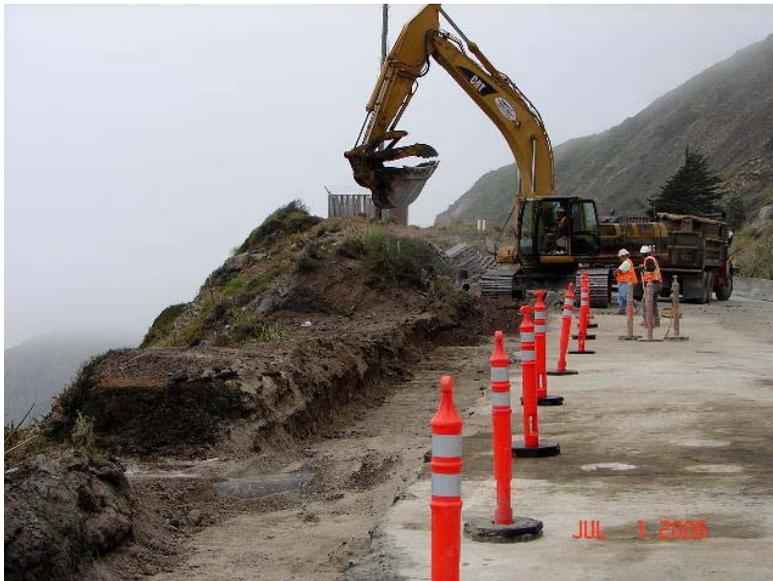
- Excavation started to prepare a bench area for construction work.

Excavating for a retaining wall at north end of site
