Route 84 Safety Improvement Project (Niles Canyon 2)

State of California
Department of Transportation
District 4

State Route 84: Niles Canyon Projects

ALA - 84 (Niles Canyon 2)
 Shoulder Widening
 from Alameda Creek Bridge to I-680
 Length: 4.4mi
 Cost: \$34.2 M (SHOPP/Safety)
 RTL: Spring 2012
 Env. Doc: EIR/CE
 Construction Schedule: Summer 2012 - Fall 2014

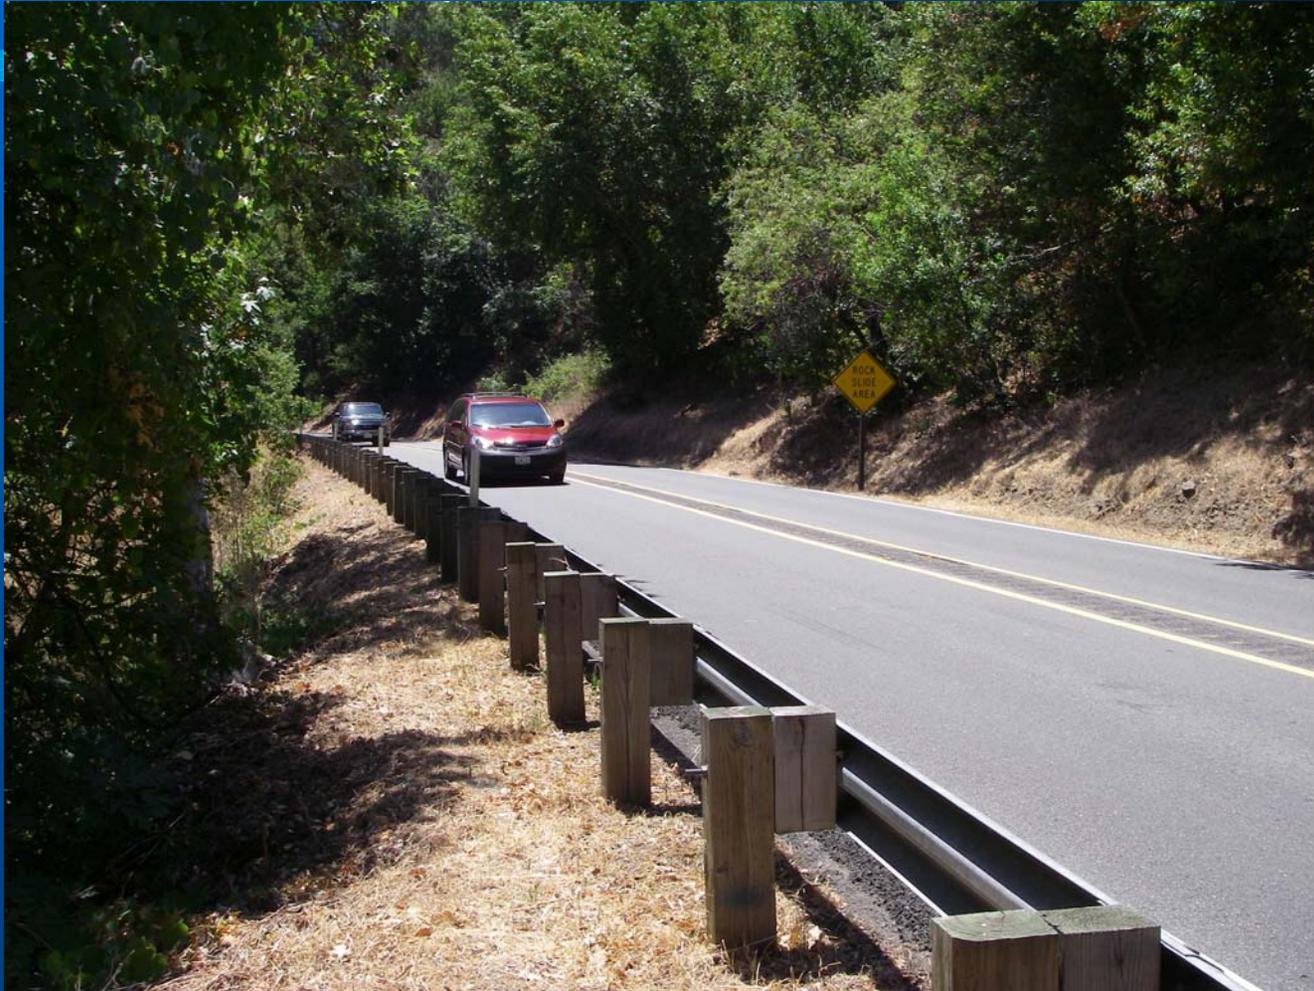
Sta 22+00

EXISTING CONDITIONS

- Two-lane conventional highway in a rural setting
- Narrow shoulders (2-8 feet in width)
- Typically curving horizontal alignment
- Generally bounded by a steep canyon wall, Alameda Creek, and railroad
- Regulatory speed is 45 MPH; curve warning speed signs to 30-35 MPH at spot locations
- 14,000 AATD with 2.5% truck traffic

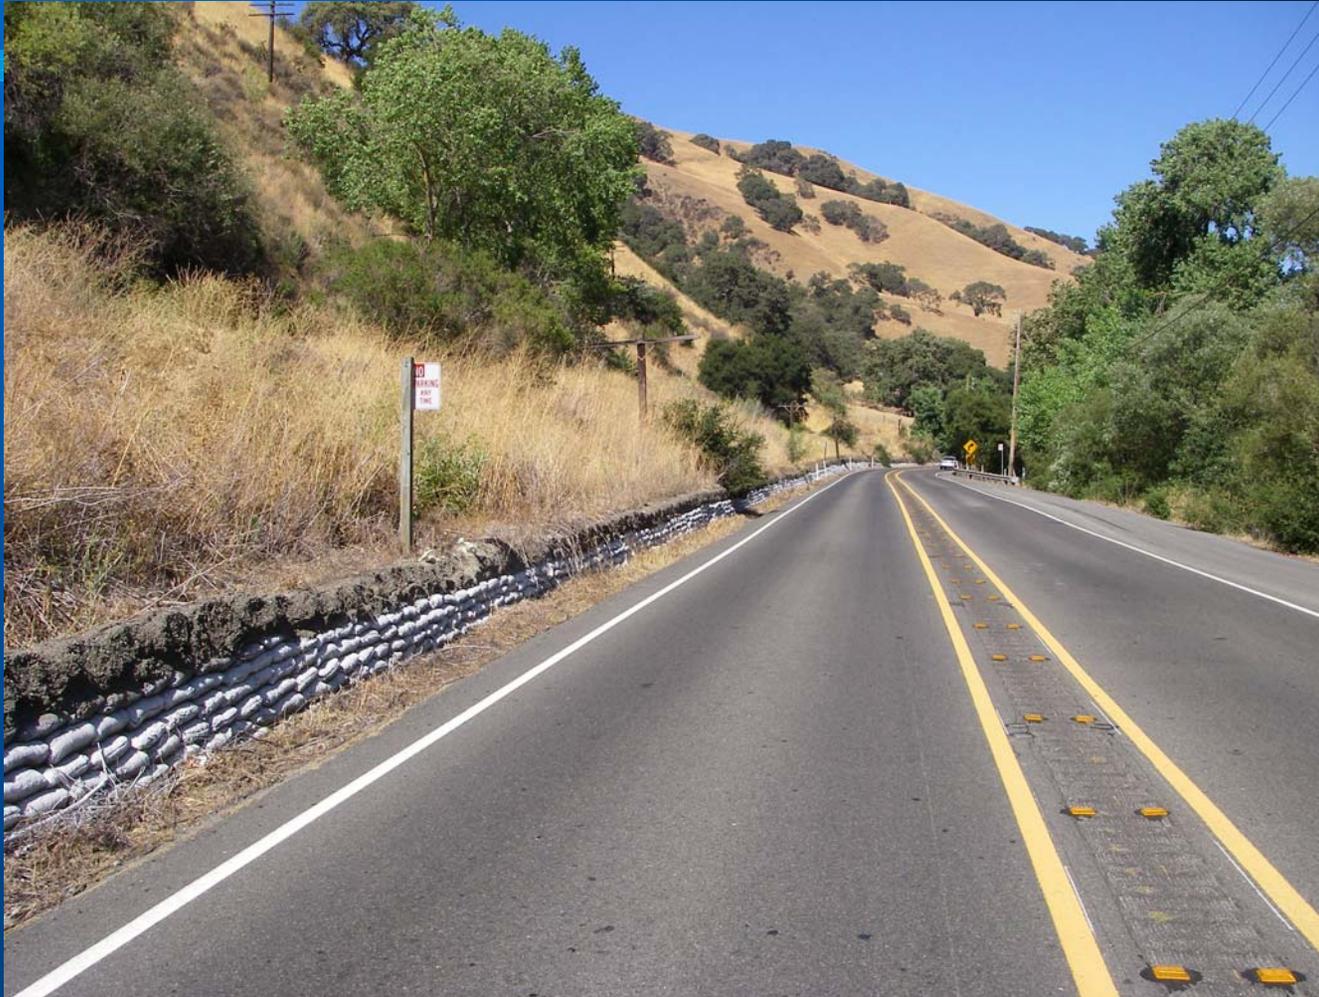
Sta 146+80 Railroad & sack wall on left

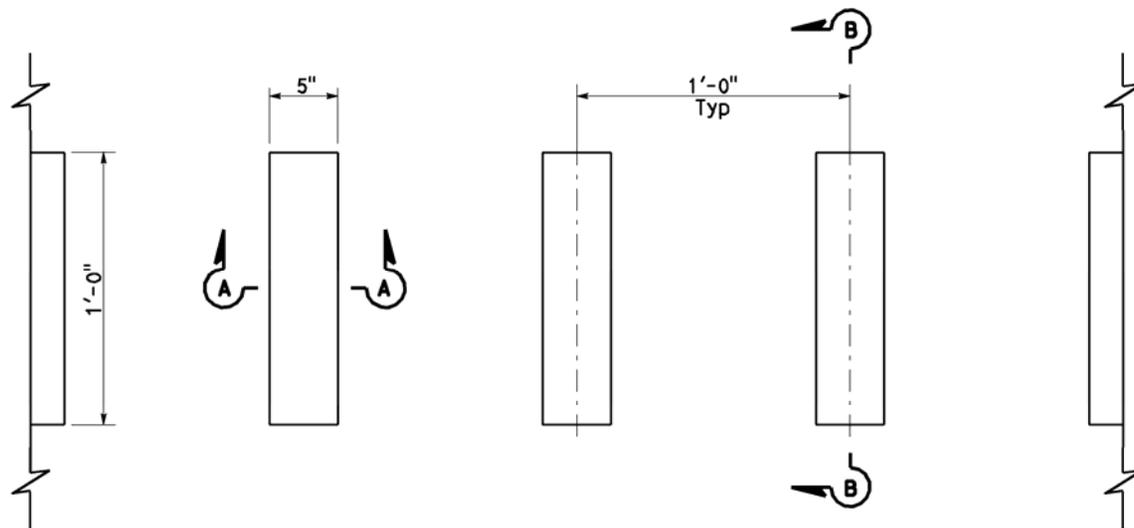
STANDARD PLAN A40B (GROUND IN RUMBLE STRIP)

SECTION A-A

SECTION B-B

PLAN
GROUND-IN INDENTATIONS

- In March 1999 Caltrans placed a moratorium on the installation of ground in rumble strip due to concerns expressed by the bicycle community.
- In September 1999 Caltrans began a study with the goal of developing a shoulder rumble strip that was effective in reducing run-off the road accidents and could be traversed by bicyclists.
- Completed in May 2001, the study evaluated several designs and recommended use of a ground in rumble strip that became Standard Plan A40B that is used throughout the State today where bicycle travel is permitted.

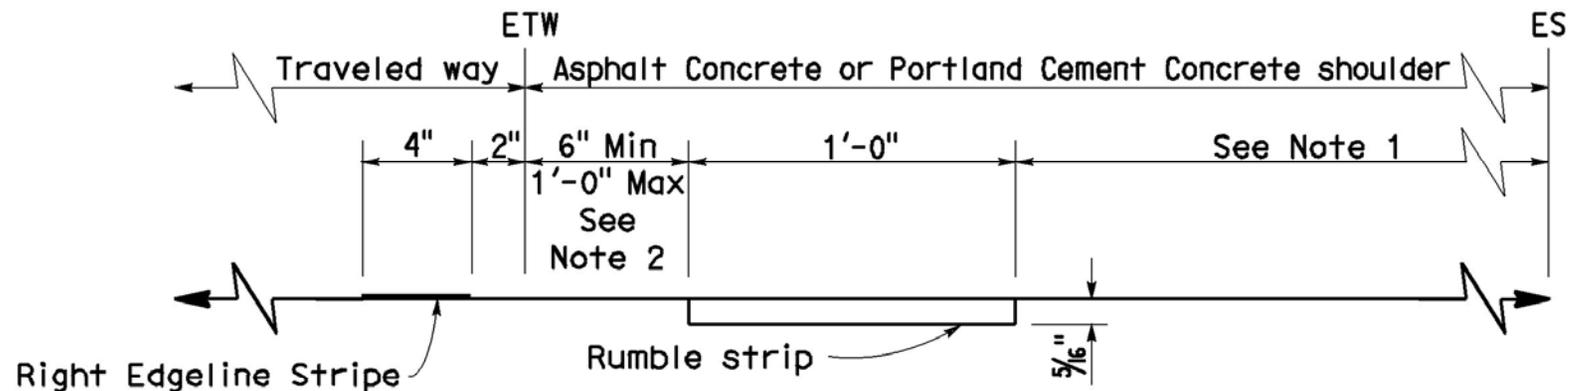
STANDARD PLAN A40B (GROUND IN RUMBLE STRIP)

RUMBLE STRIP PLACEMENT RIGHT OF DIRECTION OF TRAVEL

TYPICAL GROUND-IN RUMBLE STRIP SHOULDER PLACEMENT

1. Where bicycles are permitted, shoulder rumble strips should not be used right of direction of travel unless a minimum of 5'-0" of clear shoulder width for bicycle use is available between the rumble strip and the outer edge of the shoulder. Where bicycles are not permitted, a minimum of 4'-0" of distance is required between the rumble strip and the outer edge of the shoulder.
2. Unless otherwise shown on the plans or specified in the special provisions, the 6" offset from the edge of traveled way to the edge of the rumble strip shall be used for rumble strip placement right of the direction of travel.

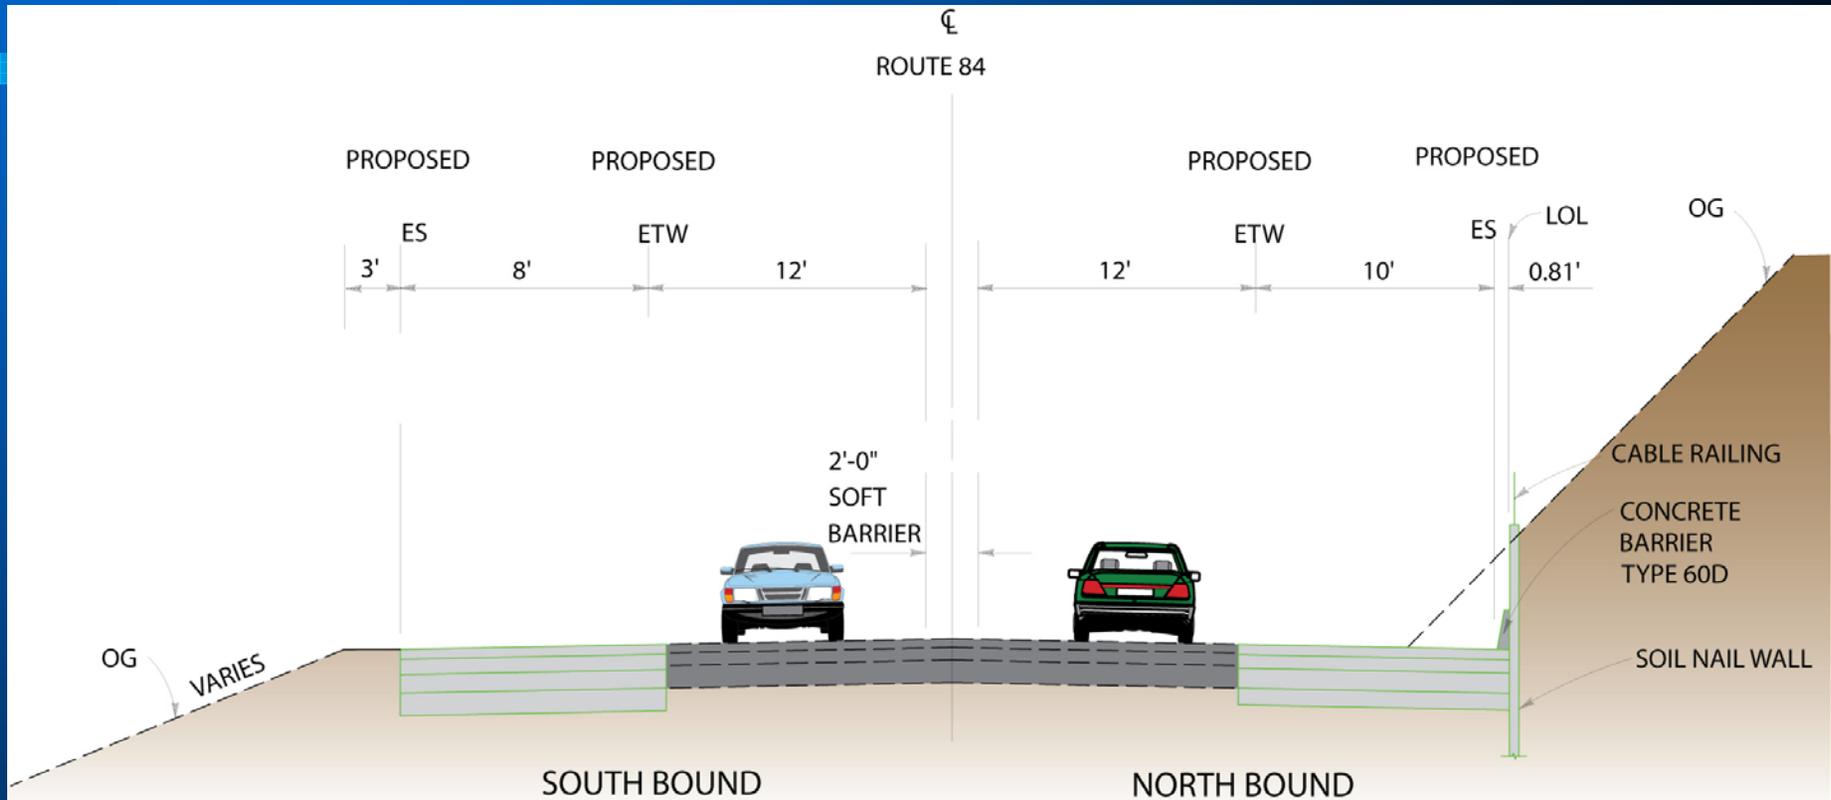
TYPICAL CROSS SECTION (CUT SLOPE)

TYPICAL CROSS SECTION
P.M. 13.66
SECTION A A

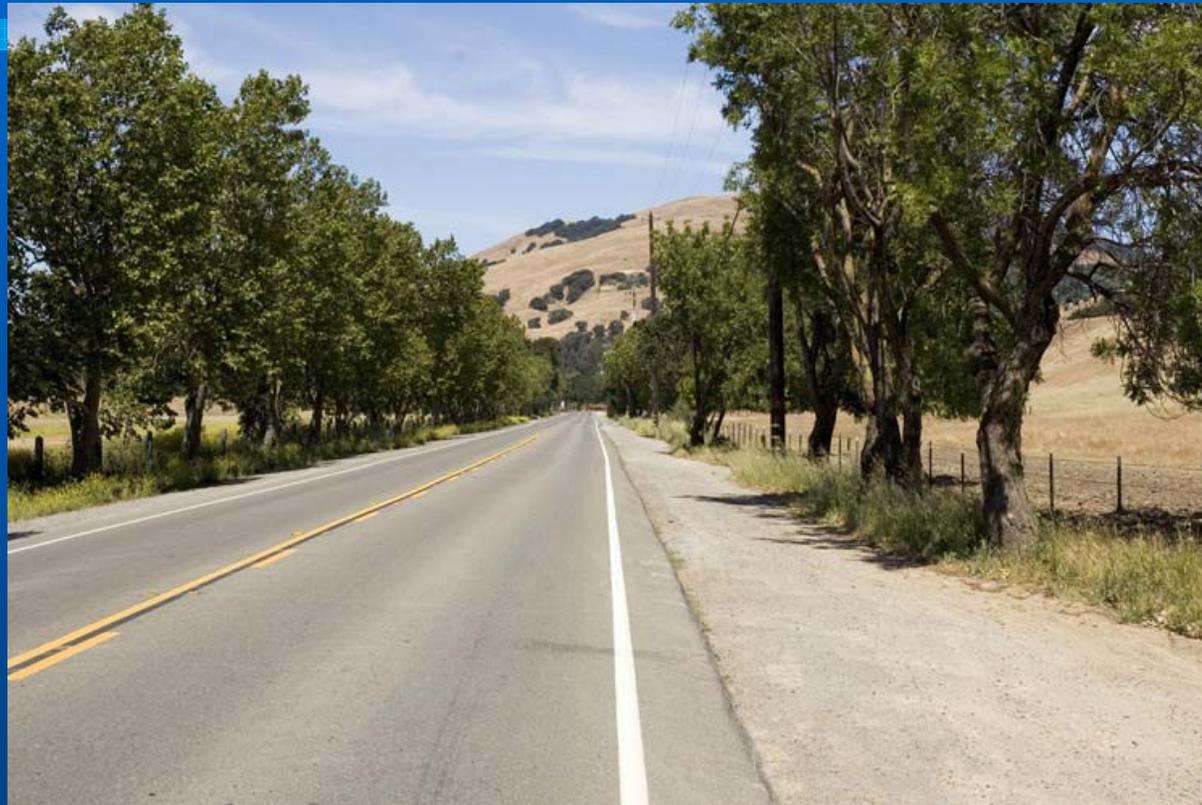
KEY VIEWPOINT – PALOMA WAY

**View
looking
west, just
west of the
I-680
offramp.**

- **Walnut tree removal along the northern half of the tree allee**
- **Walnut trees on the north side are in declining in health**
- **Save healthy Sycamore trees to the south**
- **Opens up views of the rolling hills beyond**

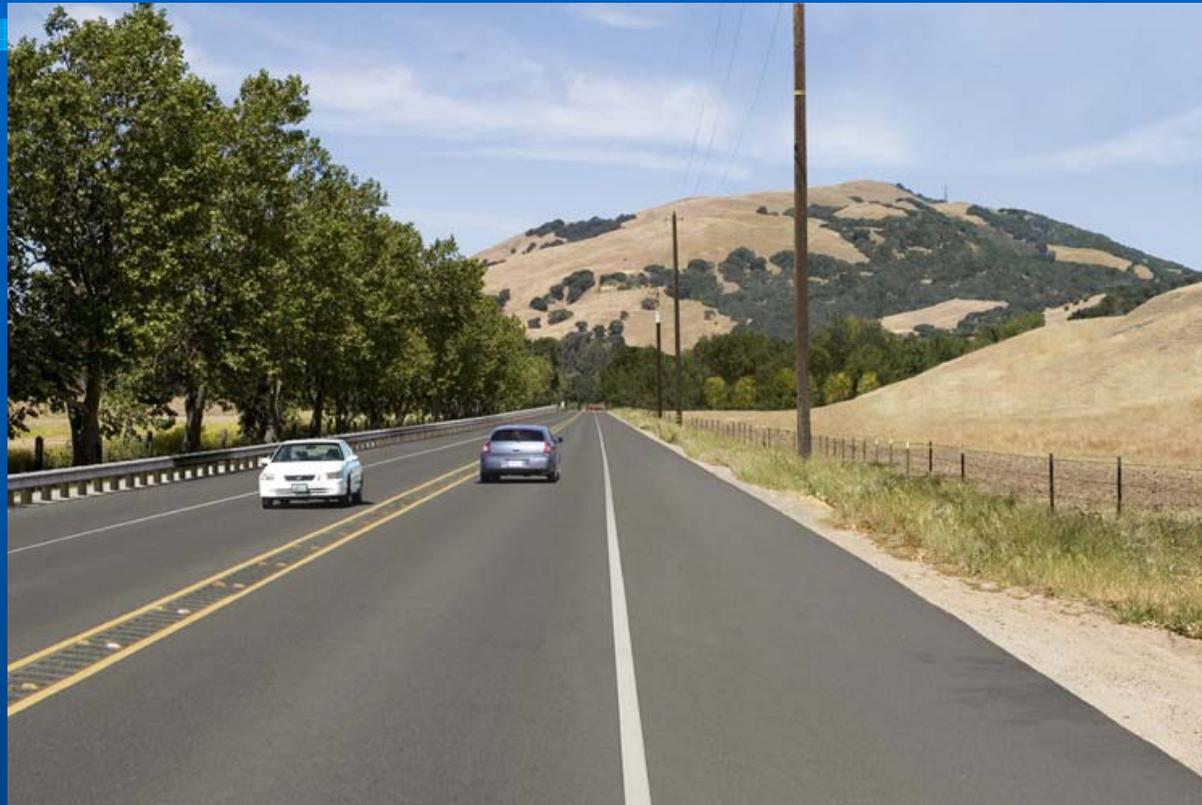
KEY VIEWPOINT – PALOMA WAY

**View
looking
west, just
west of the
I-680
offramp.**

- **Walnut tree removal along the northern half of the tree allee**
- **Walnut trees on the north side are in declining in health**
- **Save healthy Sycamore trees to the south**
- **Opens up views of the rolling hills beyond**

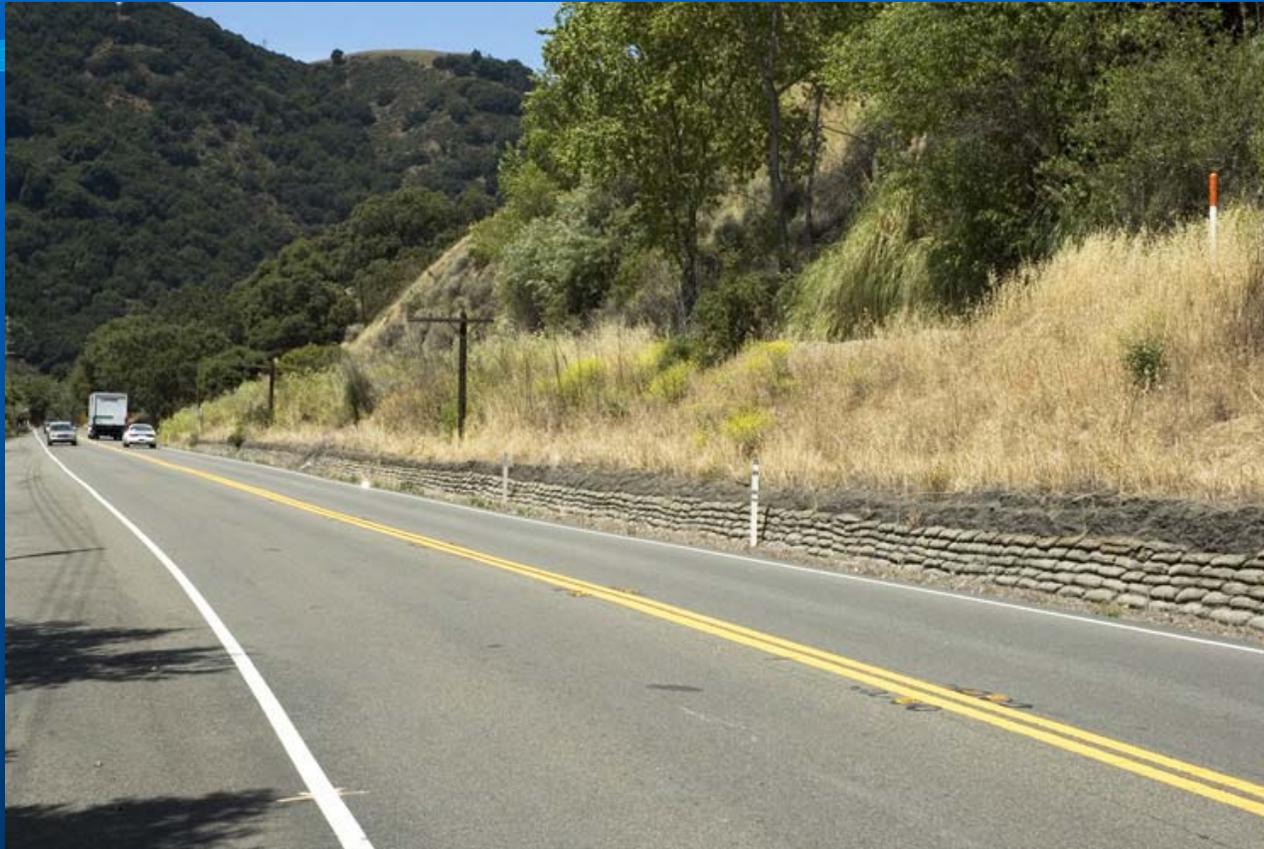
KEY VIEWPOINT – AT POST MILE 16.0

View looking westward, from a viewpoint just 1.0 mile east of the Niles Canyon Railroad maintenance yard.

- Install an 8-12 foot tall upslope retaining wall with rusticated ashlar masonry treatment
- Retain as much existing vegetation to the extent possible
- Relocate historic telegraph poles
- Stain concrete safety barrier to blend with wall

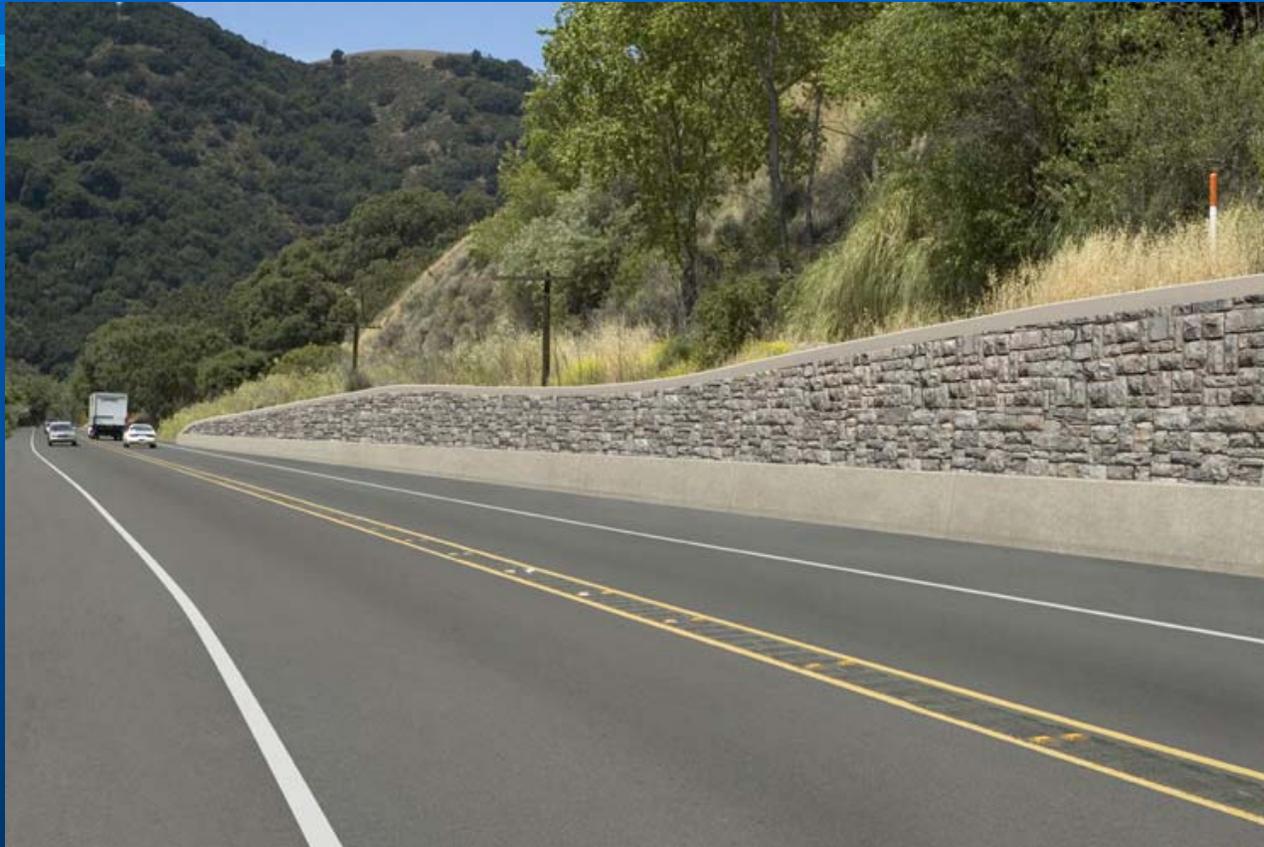
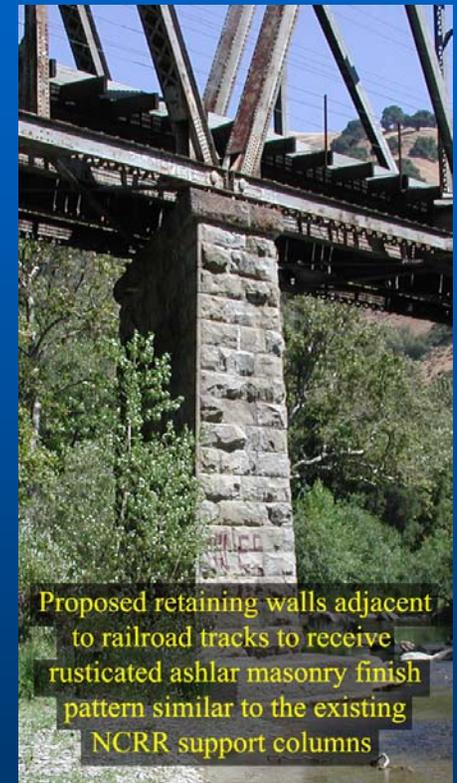
KEY VIEWPOINT – AT POST MILE 16.0

Proposed retaining walls adjacent to railroad tracks to receive rusticated ashlar masonry finish pattern similar to the existing NCRB support columns

View looking westward, from a viewpoint just 1.0 mile east of the Niles Canyon Railroad maintenance yard.

- Install an 8-12 foot tall upslope retaining wall with rusticated ashlar masonry treatment
- Retain as much existing vegetation to the extent possible
- Relocate historic telegraph poles
- Stain concrete safety barrier to blend with wall

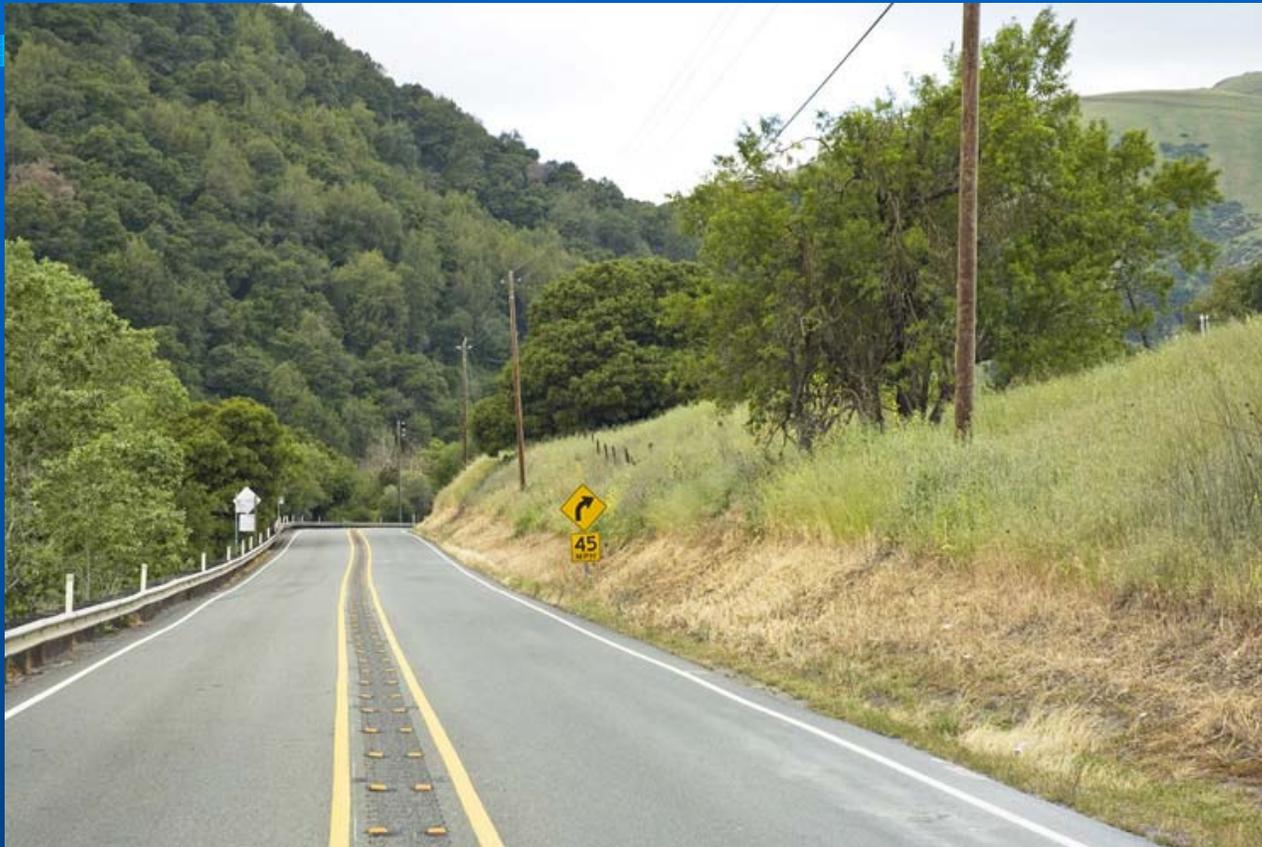
KEY VIEWPOINT – NEAR POST MILE 15.5

View looking west at a location ± 0.5 mile east of the Niles Canyon Railroad maintenance yard.

- Install a maximum 20 foot tall upslope retaining wall, and 4-10 foot tall downslope wall
- Retain as much existing vegetation to the extent possible
- Stain concrete safety barrier to blend with wall
- Upslope wall to have rusticated ashlar masonry treatment

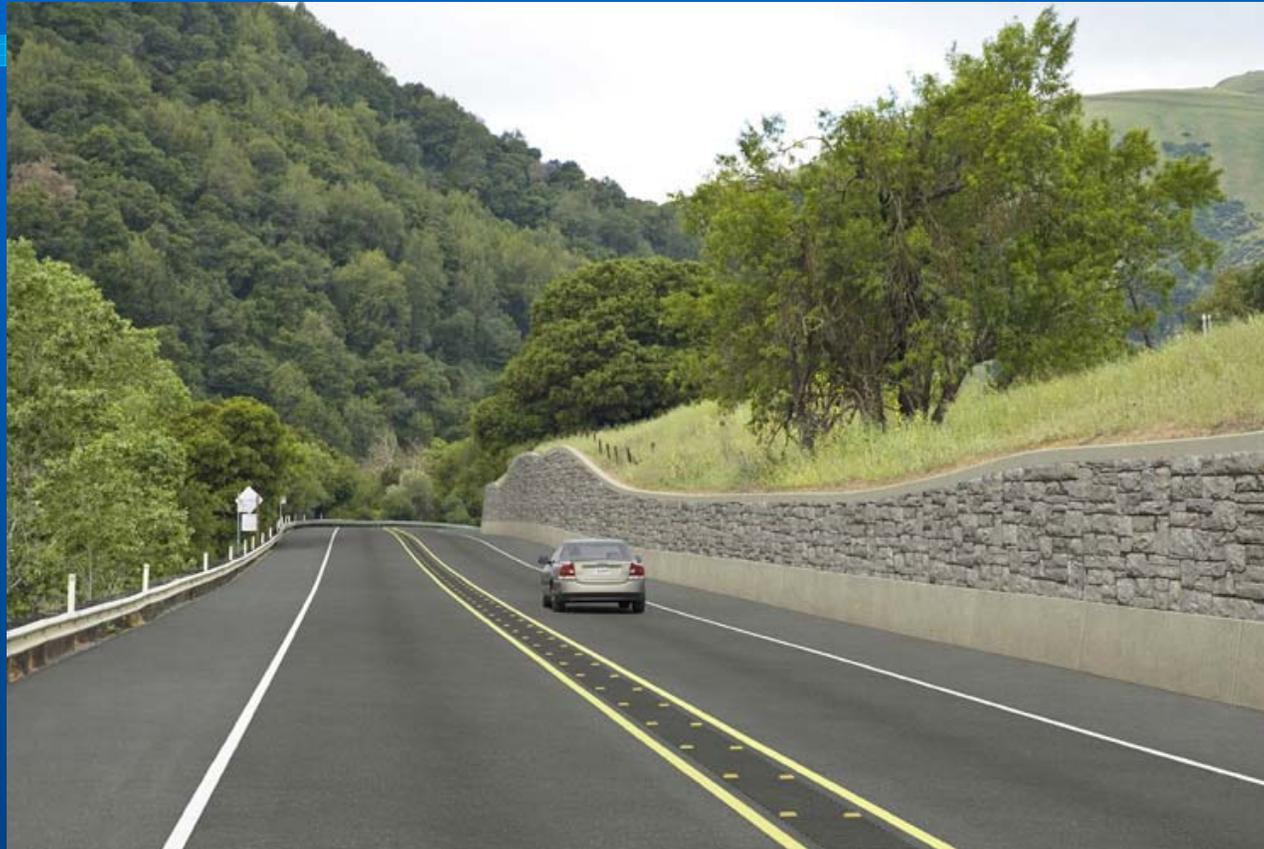
KEY VIEWPOINT – NEAR POST MILE 15.5

View looking west at a location ± 0.5 mile east of the Niles Canyon Railroad maintenance yard.

- Install a maximum 20 foot tall upslope retaining wall, and 4-10 foot tall downslope wall
- Retain as much existing vegetation to the extent possible
- Stain concrete safety barrier to blend with wall
- Upslope wall to have rusticated ashlar masonry treatment

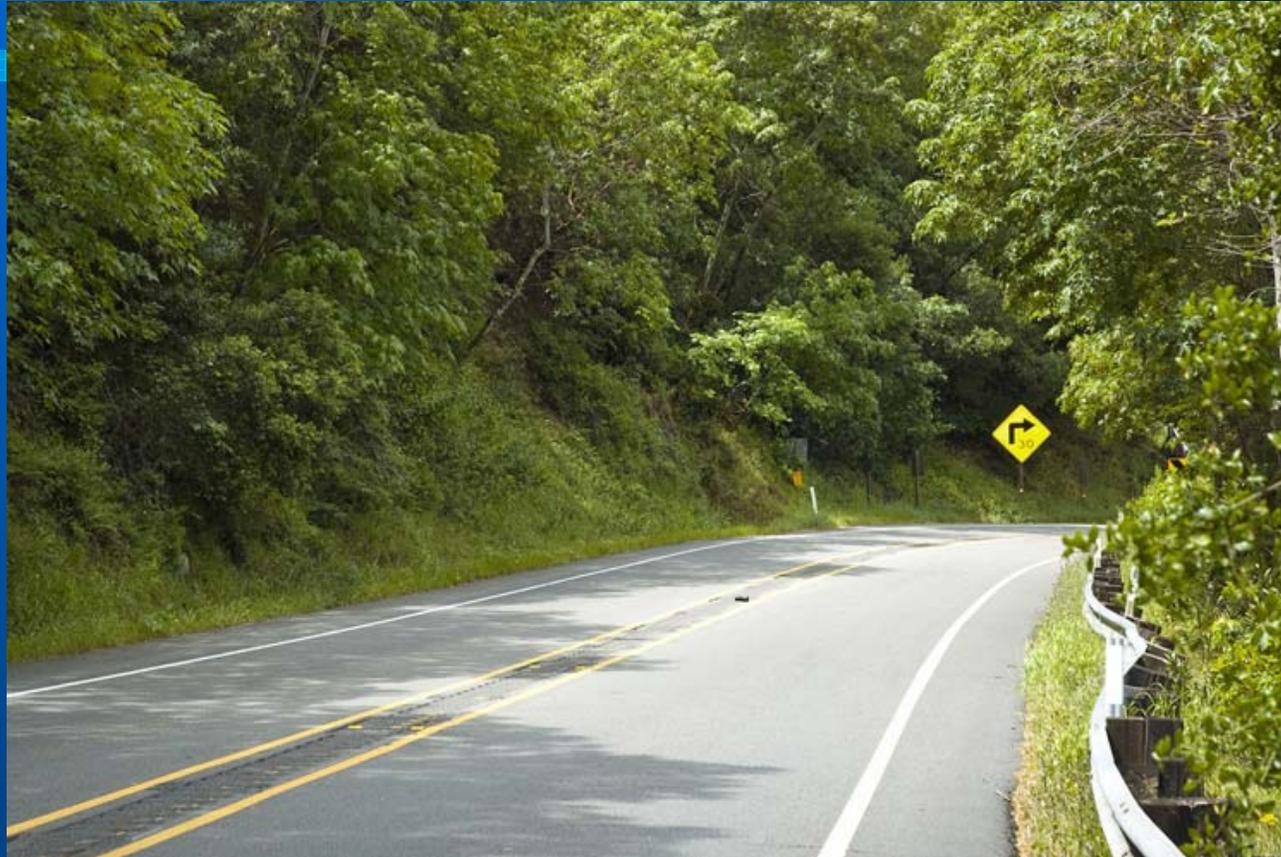
KEY VIEWPOINT – NEAR POST MILE 14.1

View looking west, just west of where the aqueduct appears adjacent to the roadway.

- Install upslope retaining walls 9 to 17 foot tall, and a 6 to 10 foot tall downslope wall
- Retain as much existing vegetation to the extent possible
- Stain concrete safety barrier to blend with wall
- Removing the trees increases safety, sight distance and visibility

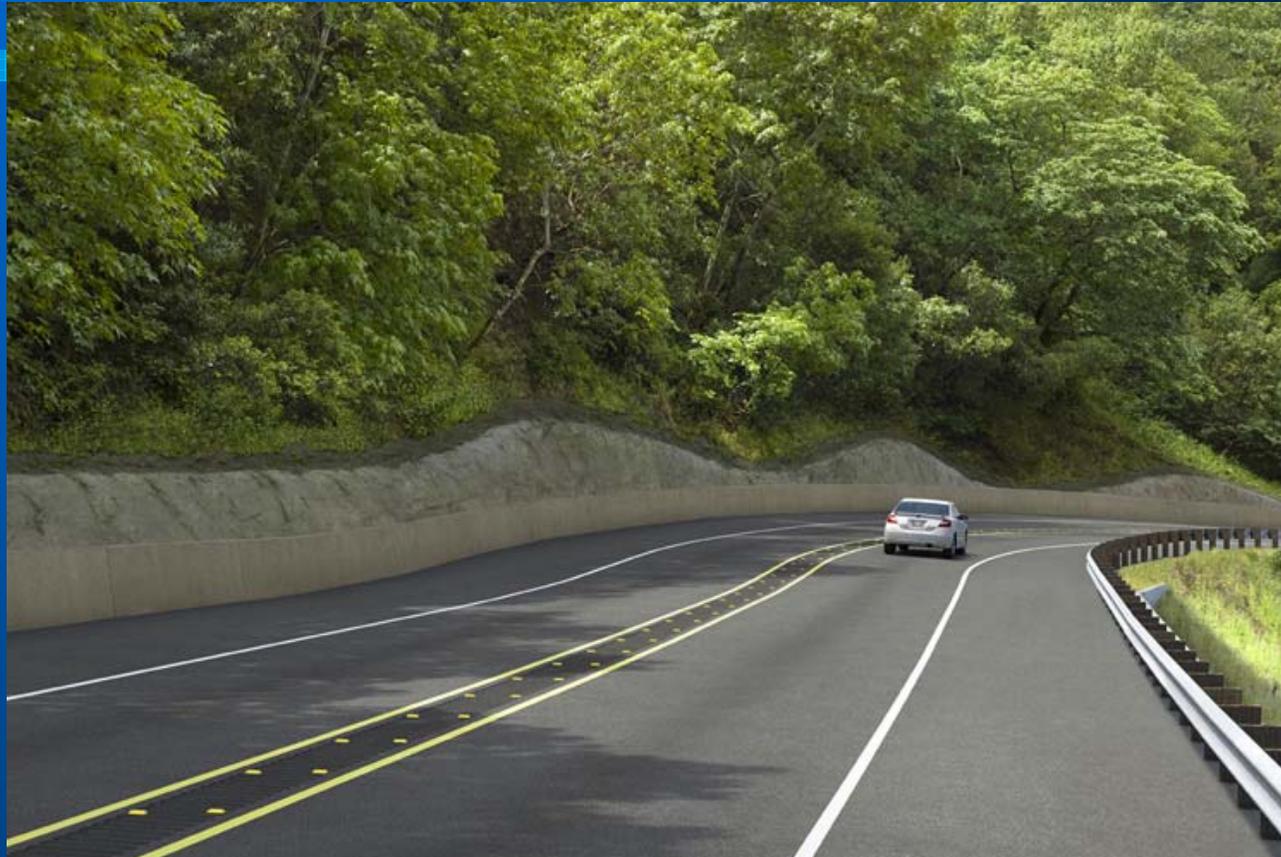
KEY VIEWPOINT – NEAR POST MILE 14.1

View looking west, just west of where the aqueduct appears adjacent to the roadway.

- Install upslope retaining walls 9 to 17 foot tall, and a 6 to 10 foot tall downslope wall
- Retain as much existing vegetation to the extent possible
- Stain concrete safety barrier to blend with wall
- Removing the trees increases safety, sight distance and visibility

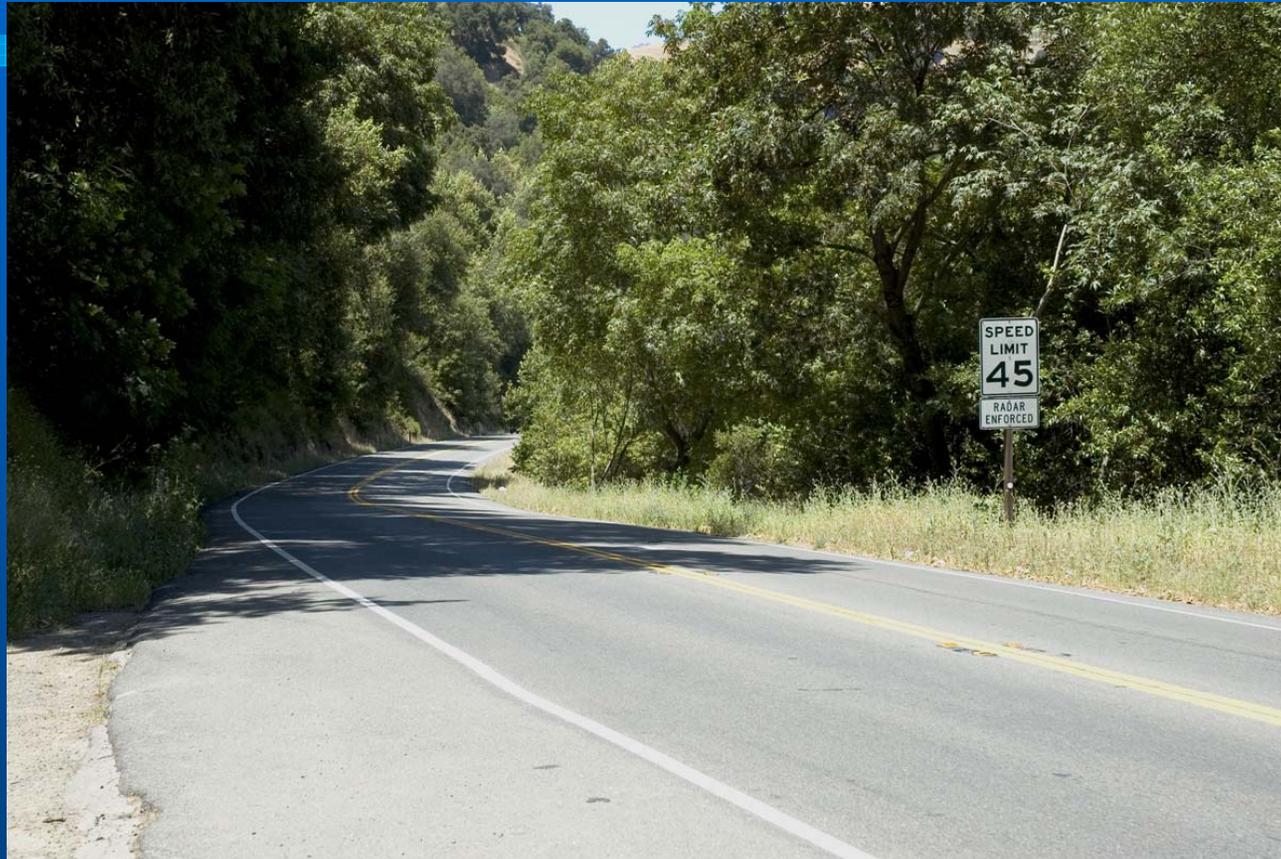
KEY VIEWPOINT – NEAR POST MILE 14.1

View looking west, west of where the aqueduct appears adjacent to the roadway.

- Install upslope retaining walls 9 to 17 foot tall, and a 6 to 10 foot tall downslope wall
- Retain as much existing vegetation to the extent possible
- Stain concrete safety barrier to blend with wall

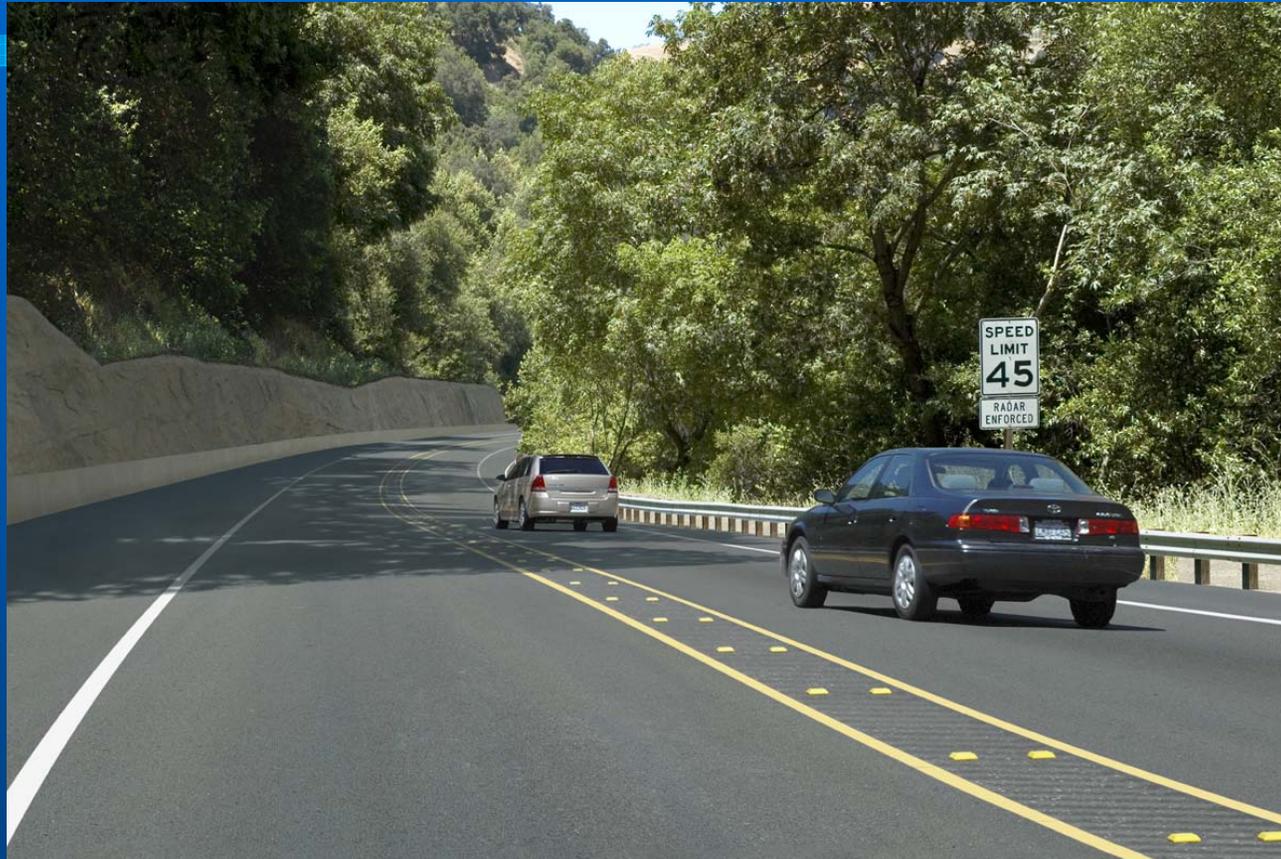
KEY VIEWPOINT – NEAR POST MILE 14.1

View looking west, west of where the aqueduct appears adjacent to the roadway.

- Install upslope retaining walls 9 to 17 foot tall, and a 6 to 10 foot tall downslope wall
- Retain as much existing vegetation to the extent possible
- Stain concrete safety barrier to blend with wall

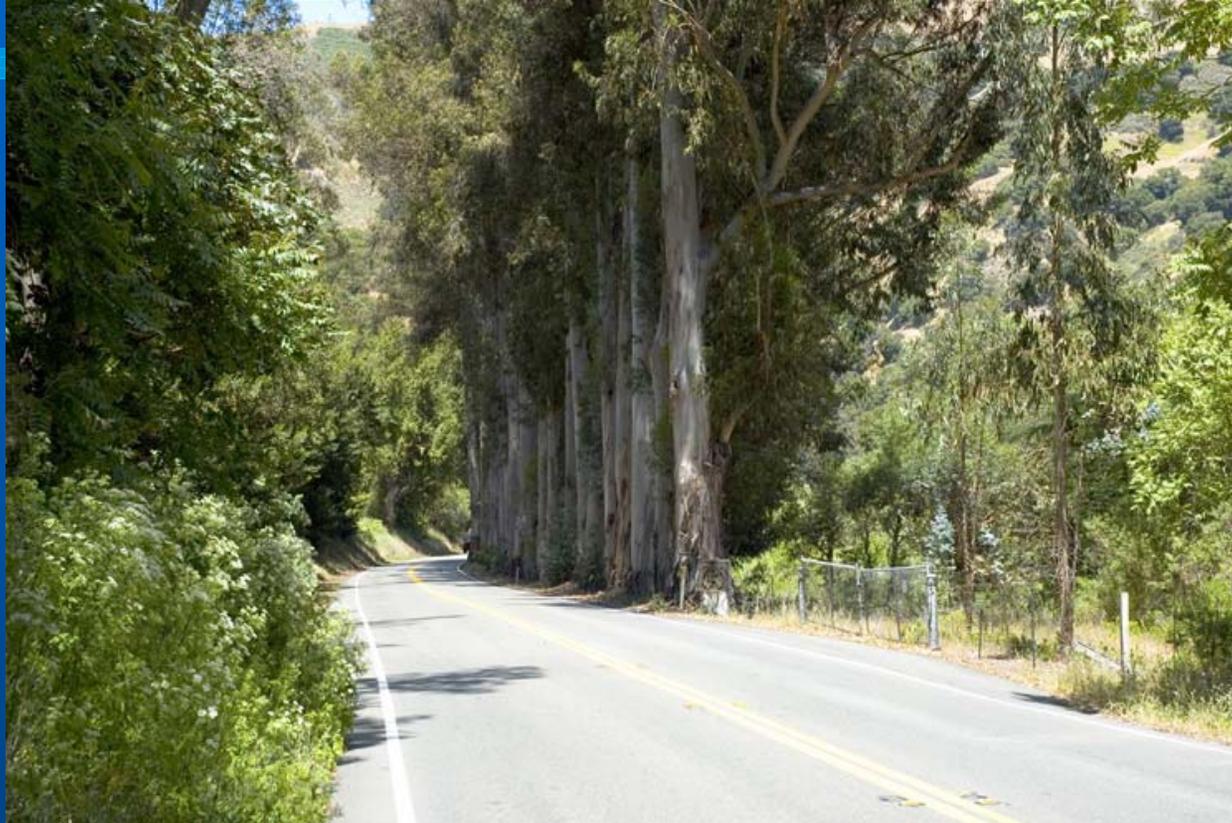
KEY VIEWPOINT – NEAR POST MILE 14.0

View
looking
west from
the location
of the
Eucalyptus
trees.

- Removal of the Blue Gum eucalyptus trees along the east side of Route 84
- The grouping of eucalyptus were studied and not found to be identified as possessing historic significance, nor were they considered a scenic resource
- Removing the trees increases safety, sight distance, visibility and opens up a scenic vista
- Install upslope retaining walls 10 to 14 foot tall

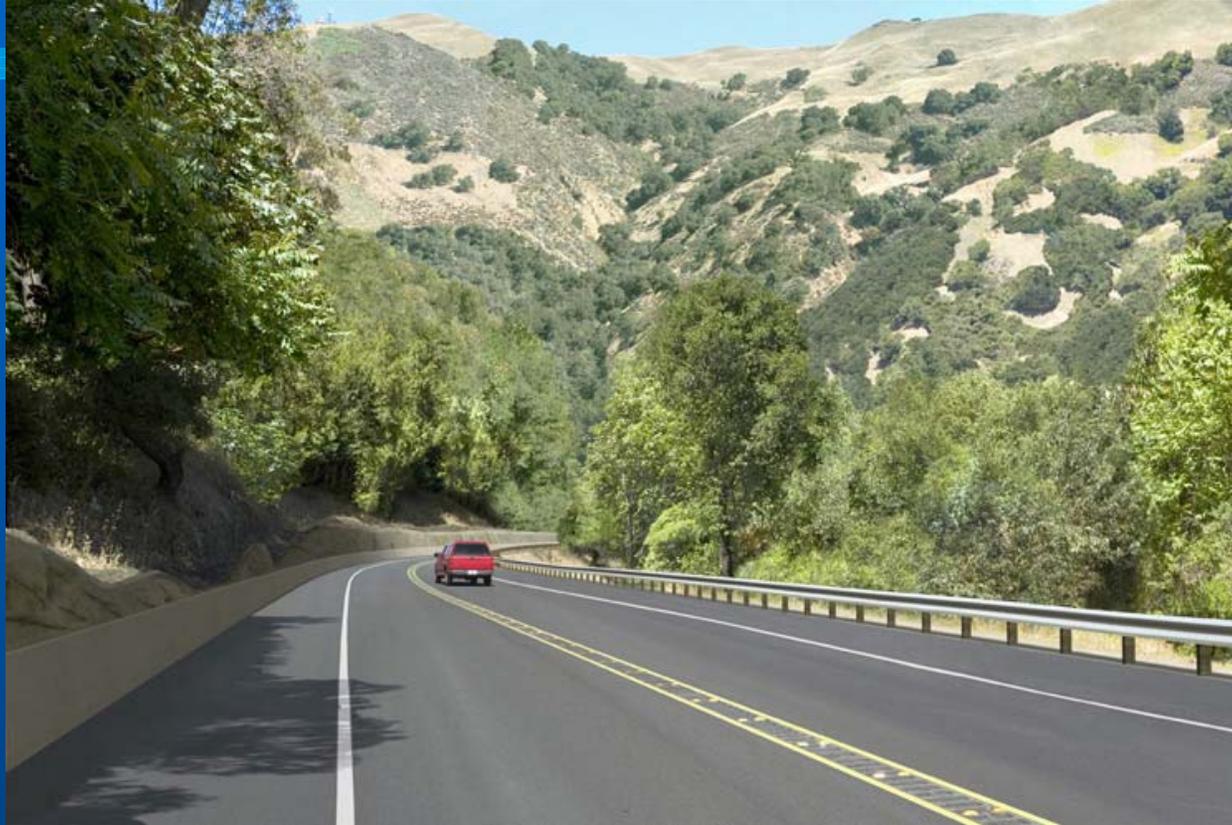
KEY VIEWPOINT – NEAR POST MILE 14.0

View
looking
west from
the location
of the
Eucalyptus
trees.

- Removal of the Blue Gum eucalyptus trees along the east side of Route 84
- The grouping of eucalyptus were studied and not found to be identified as possessing historic significance, nor were they considered a scenic resource
- Removing the trees increases safety, sight distance, visibility and opens up a scenic vista
- Install upslope retaining walls 10 to 14 foot tall
