Supplemental Finding of Adverse Effect

Fulton Mall Reconstruction Project

City of Fresno, California

Project ID TCSPL-5060(263)

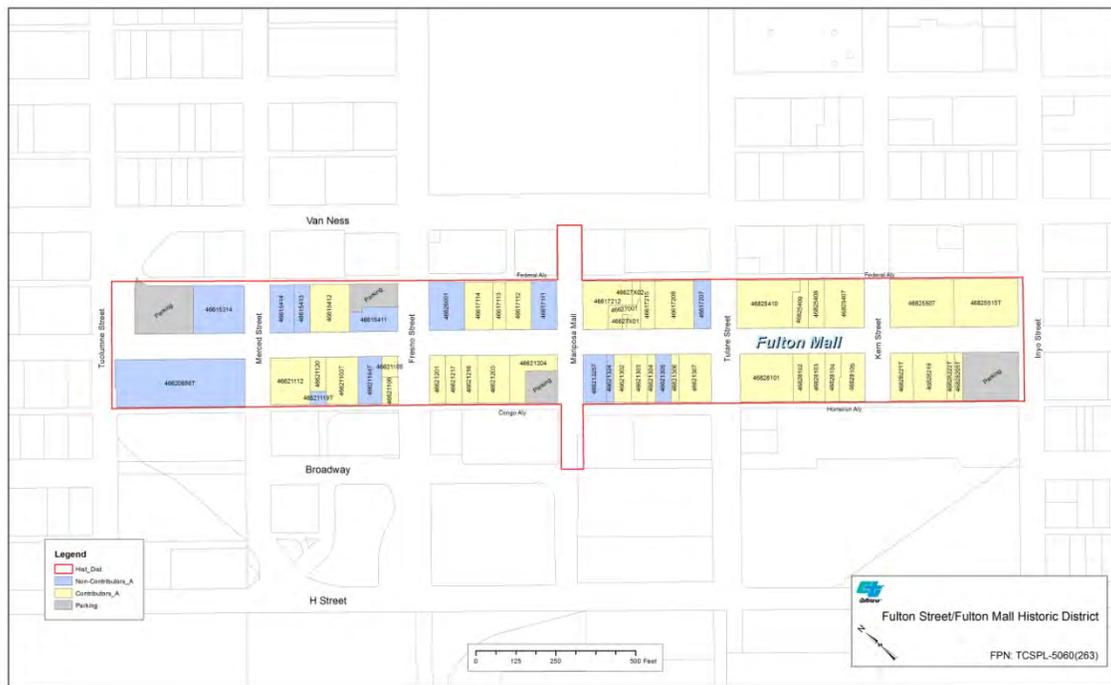
Figure 1: Fulton Street/Fulton Mall Historic District

Merced streets (see Figure 1 below). Of the 51 buildings within the historic district boundaries, 39 are considered contributors (see Table 1).

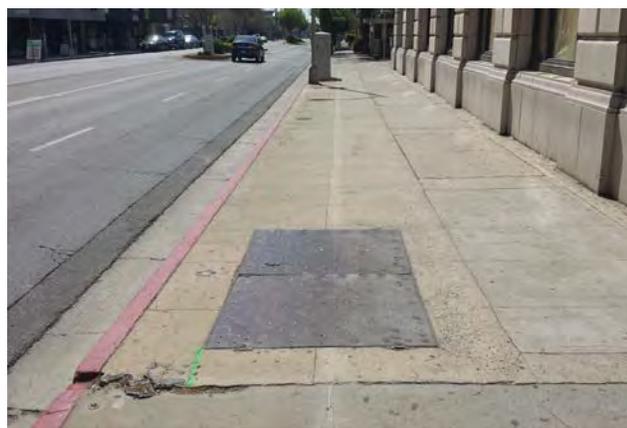
Figure 2: Bank of Italy Basement Feature

more sensitive/ vibration minimizing concrete removal techniques, including saw cutting and utilization of hand tools to remove existing concrete, will be used within the six foot buffer zone at all basement location as identified in the Ground Penetrating Radar Report (see Appendix F). Because of these measures, basement ceilings will be maintained and no structural damage is expected. In addition to ensuring that no structural damage will occur, these vibration minimizing construction techniques will preserve any existing sidewalk vault

lights covered by the construction of the Fulton Mall Historic Landscape.¹⁰ Any sidewalk vault lights uncovered during construction will be either rehabilitated or reconstructed to SOIS and incorporated into the new sidewalk design, as feasible, or documented and encased in a manner

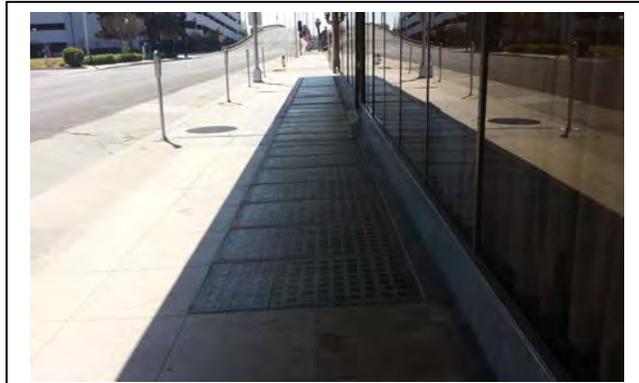
Figure 4: San Joaquin Light and Power Corporation Building Basement Vault Lights

The concrete reconfiguration planned at this location, which includes the introduction of sidewalk bulb-outs adjacent to this property, will not directly impact the building or its extant basement areas, including sidewalk vault lights fronting Tuolumne and Fulton Streets. To ensure that the sidewalk vault lights will not be impacted by the proposed sidewalk construction ESA fencing will be placed around them and monitored by a qualified architectural historian and/or a historic architect who meets the Secretary of the Interior's Professional Qualification Standards.

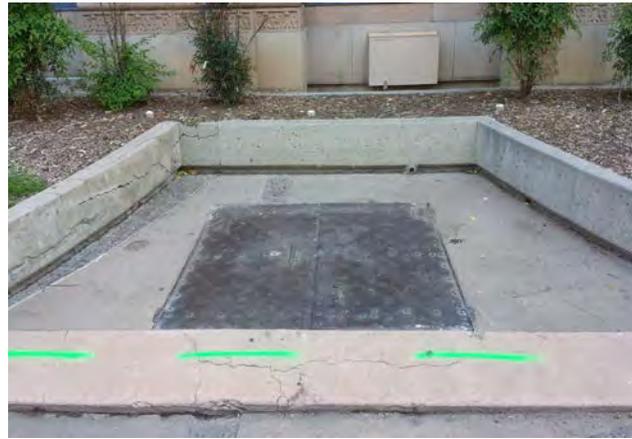
Figure 5: Pacific Southwest/Security Bank Basement Feature

removal techniques, including saw cutting and utilization of hand tools to remove existing concrete, will be used within the six foot buffer zone at all basement location as identified in the Ground Penetrating Radar Report (see Appendix F). Because of these measures, basement ceilings will be maintained and no structural damage is expected. In addition to ensuring that no structural damage will occur, these vibration minimizing construction techniques will preserve any existing sidewalk vault lights covered by the construction of the Fulton Mall Historic Landscape. Any sidewalk vault lights uncovered during construction will be either rehabilitated or reconstructed to SOIS and incorporated into the new sidewalk design, as feasible, or documented and encased in a manner so as to ensure preservation in place. The sidewalk elevator basement doors fronting Mariposa Mall (see Figure 5) will be protected with Environmentally Sensitive Area (ESA) fencing.

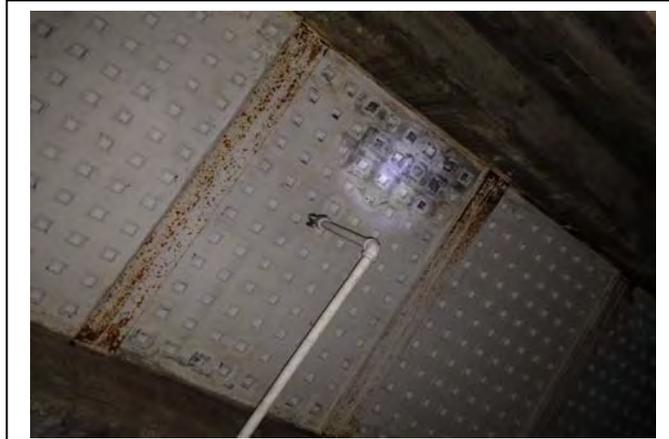
Figure 12: Radin Kamp/ J.C. Penney Building Sidewalk Vault Lights- beneath Fulton Mall.

Under all Alternatives, utility work will take place in close proximity to the Radin Kamp/ J.C. Penney Building and will include the removal, relocation, and/or abandonment of existing utilities lines exposed during construction activities and the introduction of new utility lines. New utility infrastructure will include subsurface conduits for lighting, communications and traffic signals; small diameter water and sanitary sewer laterals to serve the water fountains (decorative and drinking); and new storm drain inlets and laterals. The existing utility infrastructure was placed, as part of the 1964 design and construction of the Fulton Mall, around the extant basements so as to avoid damage to or intrude into them (see Figures 6-11 & 14-16). The placement of new utility infrastructure will likewise be installed around existing basement areas, incorporating a buffer zone of at least six feet, in which no new utility infrastructure will be placed. Additionally, more sensitive/ vibration minimizing concrete removal techniques, including saw cutting and utilization of hand tools to remove existing concrete, will be used within the six foot buffer zone at all basement location as identified in the Ground Penetrating Radar Report (see Appendix F). Because of these measures, basement ceilings will be maintained and no structural damage is expected. In addition to ensuring that no structural damage will occur, these vibration minimizing construction techniques will preserve the existing sidewalk vault lights currently located along the Fulton Mall corridor (what was Fulton Street- see Figure 12). The 1964 concrete will be removed and the extant sidewalk vault lights will be either rehabilitated or reconstructed to SOIS and incorporated into the new sidewalk design, as feasible, or documented and re-encased in a manner so as to ensure preservation in place.

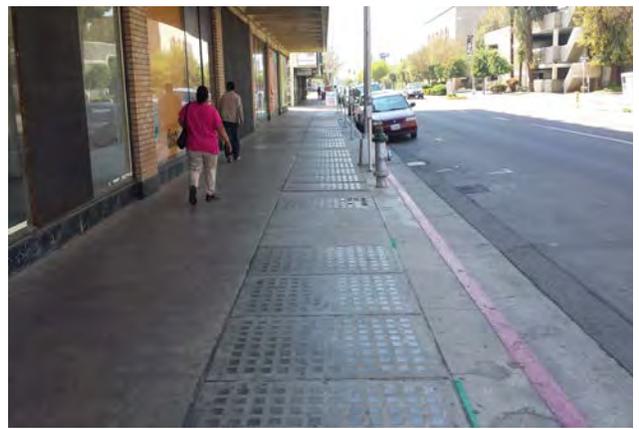
Figure 13: Radin Kamp/J.C. Penney Building Sidewalk Vault Lights

To further ensure that inadvertent vibration impacts do not affect adjacent properties during construction, a vibration mitigation and monitoring workplan will be prepared prior to construction. The workplan will establish appropriate vibration thresholds for adjacent resources, identify adequate vibration minimizing construction techniques beyond the identified basement buffer zones, and establish a preconstruction survey that would include meetings with property owners and photographing the existing exterior conditions of all historic properties to establish a baseline against which any change could be measured. An appropriate vibration specialist as defined in the vibration mitigation and monitoring workplan will monitor construction activities to ensure no structural and/or cosmetic damage is caused by vibration impacts. Additionally, a qualified principal architectural historian and/or historic architect will monitor general construction activities and establish and enforce ESA fencing.

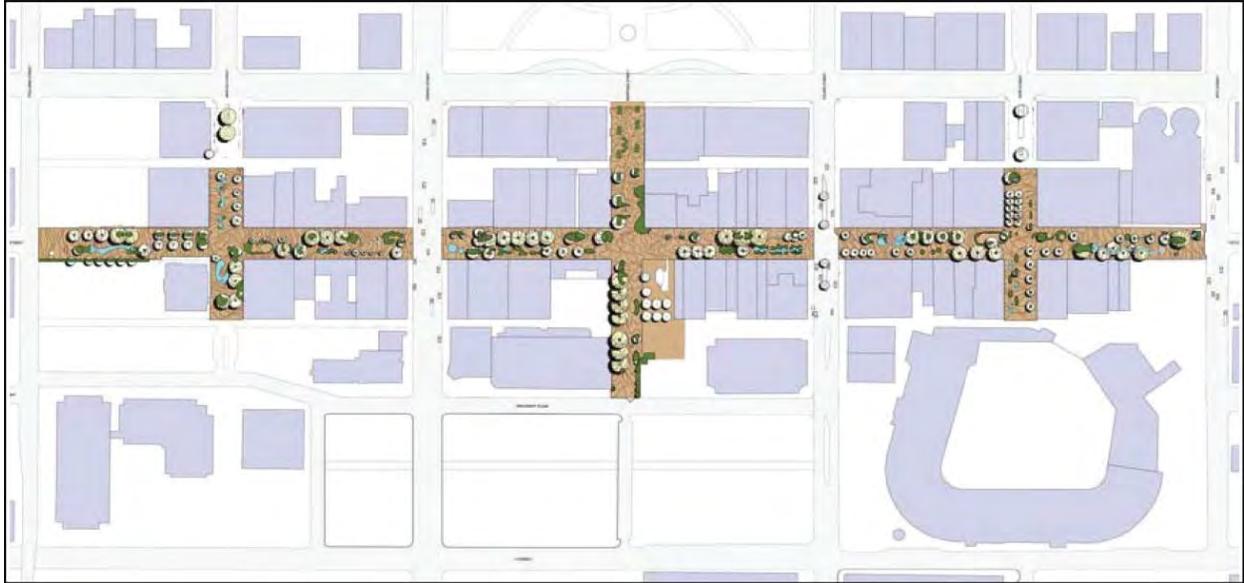
3

This alternative would keep the Fulton Street, Merced Street, Mariposa Street, and Kern Street Malls in their original pedestrian-only configurations. The entire mall as envisioned and realized by Garrett Eckbo, including features and details (fountains, pavement, plantings, lighting, and so on), would be renovated, and the existing artwork restored in place. Various design improvements such as more lighting, new restrooms, and better way-finding signage would be introduced. No on-street parking spaces would be added with this alternative. The Fulton Mall Historic Landscape's historic pedestrian use would remain unchanged, as would its historic character and setting, if the proposed design improvements are completed in a manner consistent with the *Secretary of the Interior's Standards for the Treatment of Historic Properties*.

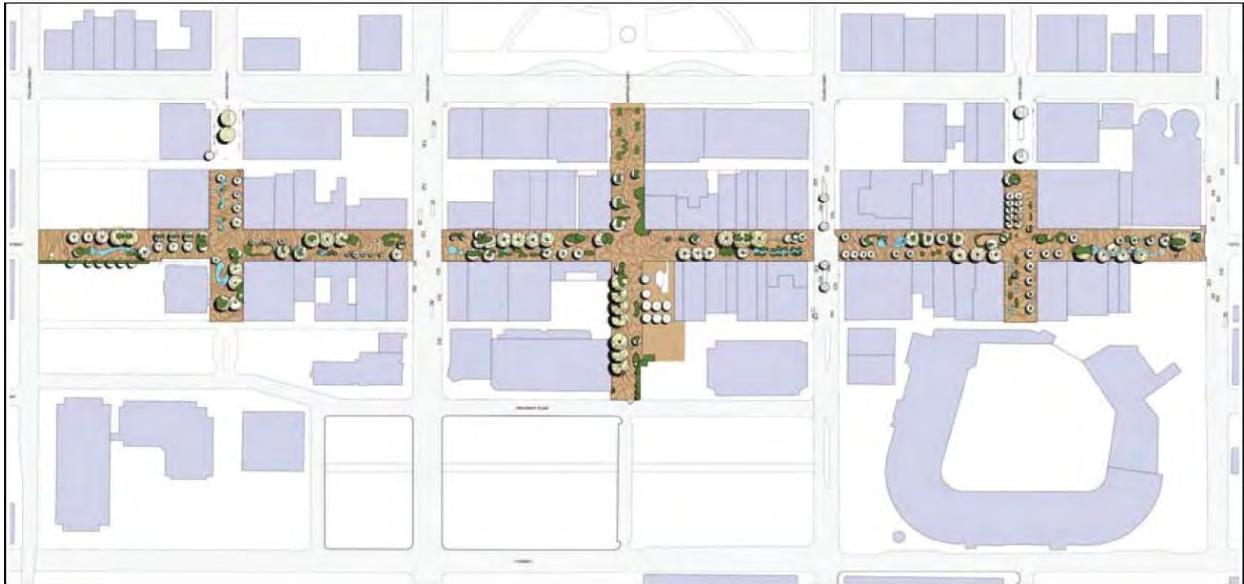
4

This alternative is identical to Alternative 3—Restoration and Completion, with the addition of direct, ongoing subsidies to properties and businesses to make up for the economic impact of the continued lack of access and visibility within the project area. The City of Fresno estimated that the amount of subsidy needed, based on the difference in projected economic performance between Alternative 1 and Alternative 3, would likely be \$276 million or more over 30 years. No on-street parking spaces would be added with this alternative. The Fulton Mall Historic Landscape’s historic pedestrian use would remain unchanged, as would its historic character and setting, if the proposed design improvements are completed in a manner consistent with the *Secretary of the Interior’s Standards for the Treatment of Historic Properties*.

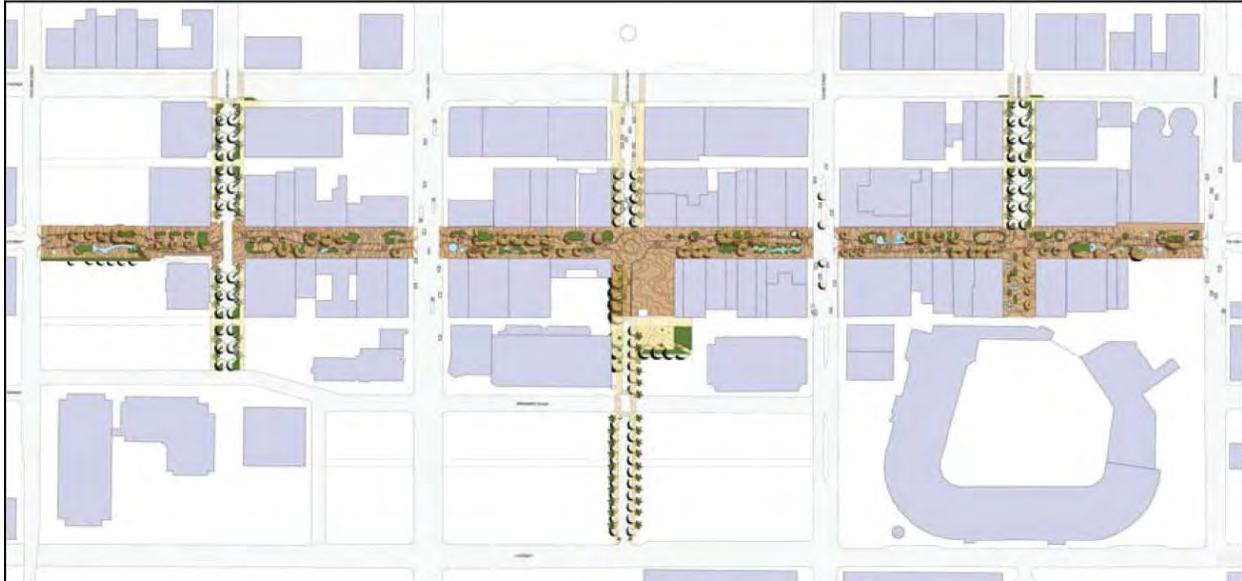
9

This alternative would weave a one-lane, one-way road with parking through the Fulton Mall, keeping as many Eckbo features as possible. It would add traffic to the existing Mall pavement as it exists today. The alternative would maintain six blocks of Fulton Mall but not the Merced, Mariposa, or Kern mall areas. This alternative would alter the pedestrian areas of Merced, Mariposa, and Kern streets by converting them to standard streets. North-south traffic would be routed along the existing Mall pavement. The alternative also would rehabilitate the remaining Eckbo features and restore all existing artwork, moving the art elsewhere within the Fulton corridor where necessary. The Mariposa Plaza would be reconstructed, outdoor dining facilitated, more lighting, new restrooms, better signage, and new streetscape and artwork in selected locations would be introduced.

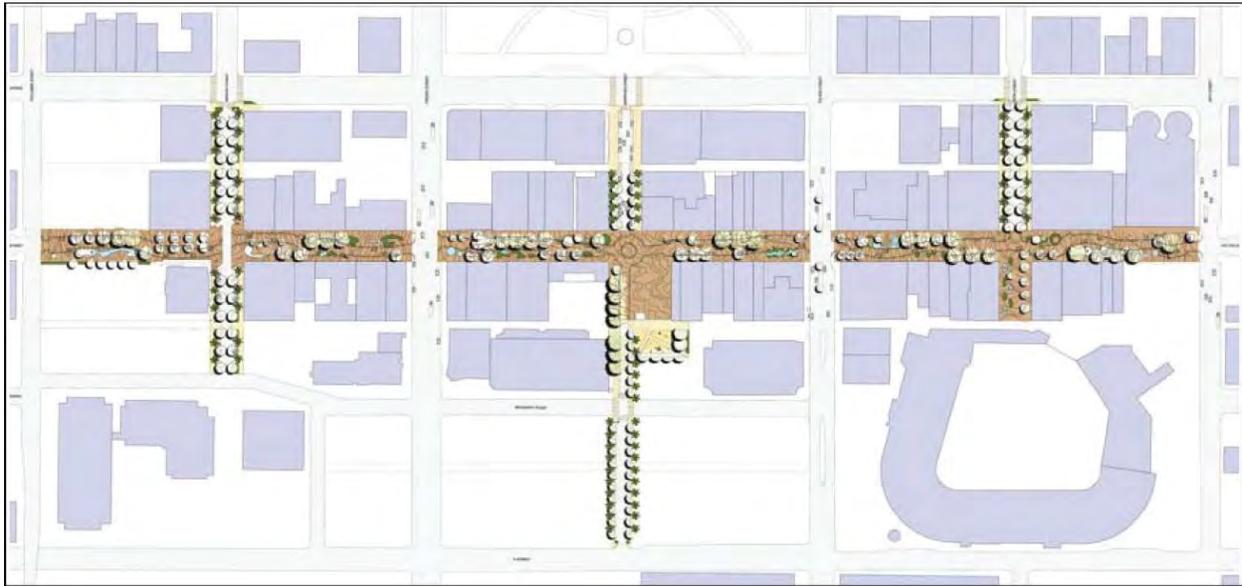
10

This alternative would weave a two lane, two-way road with parking through the Fulton Mall, keeping as many Eckbo features as possible. It would add traffic to the existing Mall pavement as it exists today. It would maintain six blocks of Fulton Mall as a pedestrian-only facility, but not the Merced, Mariposa, or Kern mall areas. It would alter the pedestrian areas of Merced, Mariposa, and Kern by converting them to standard streets. North-south traffic would be routed along the existing Mall pavement. This alternative would rehabilitate the remaining Eckbo features and restore all existing artwork, moving the art elsewhere within the Fulton Corridor where necessary. It would reconstruct the Mariposa Plaza, facilitate outdoor dining and introduce more lighting, new restrooms, better signage, and new streetscape and artwork in selected locations.

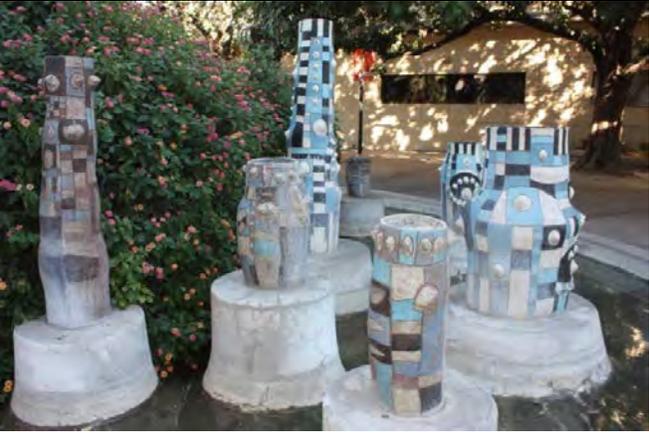
<p>1 (a-d) Sculpted pipes by Stanley C. Bitters Fired clay</p> <p><i>About:</i> In four locations on Merced Mall (a) and Fulton Mall (b, c, d), set within fountains 8 (a), 29 (b), and 38 (c), 7 (d). <i>In NRHP app.:</i> Described as part of contributing objects #1, #10, and #21. <i>Condition:</i> Present. Paint largely faded except in a.</p> <p>In all alternatives all sculptures would be restored and replaces as described below:</p> <p><i>In Alt. 1:</i> c would be returned to current location, a, b, and d would be relocated to new locations on the same block. <i>In Alt. 2:</i> c and d would be returned to their current location, a and b would be relocated to new locations on the same block. <i>In Alt 5:</i> b and d would be returned to current location, a and c would be relocated to new locations on the same block. . <i>In Alt 6:</i> b would be returned to current location, a, c, & d would be relocated to new locations on the same block. <i>In Alt 7:</i> b would be returned to current location, a, c, and d would be relocated to new locations on the same block. <i>In Alt 8:</i> a-d would be relocated to new locations on the same block.</p>

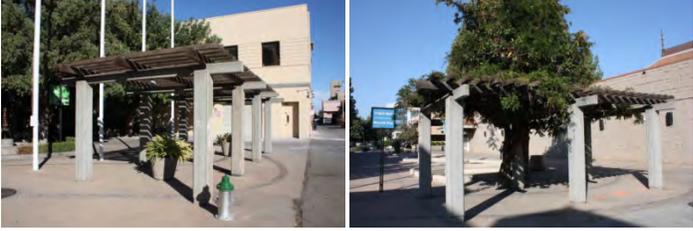
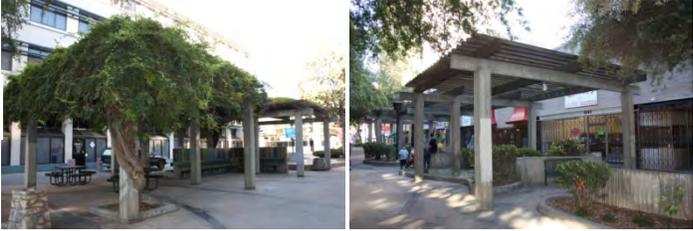
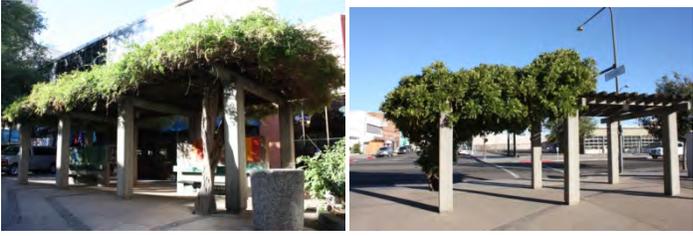
<p>a</p> <p>b</p>	<p>3 (a-b)</p> <p>Playgrounds or tot lots</p> <p><i>About:</i> Combined federally and state-funded recreational area of 1,772 sq. ft. Original to the Fulton Mall landscape, remodeled in 2008 by the City of Fresno.</p> <p><i>In NRHP app.:</i> Mentioned, but not as contributing features.</p> <p><i>Condition:</i> Original equipment removed in favor of contemporary replacements. Some damage to equipment in a.</p> <p><i>In Alt. 1:</i> Both tot lots removed in favor of replacement site at Fresno County EOC property.</p> <p><i>In Alt. 2:</i> Same as Alt. 1.</p> <p><i>In Alt. 5:</i> Both retained in place.</p> <p><i>In Alt. 6:</i> Both retained in place.</p> <p><i>In Alt. 7:</i> 1 retained in place, 1 moved to EOC property.</p> <p><i>In Alt. 8:</i> Both moved to EOC property</p>
-------------------	--

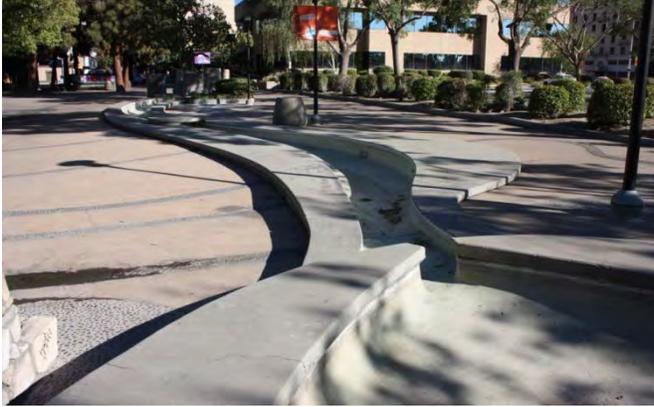
6

Water feature

Condition: Not functioning.

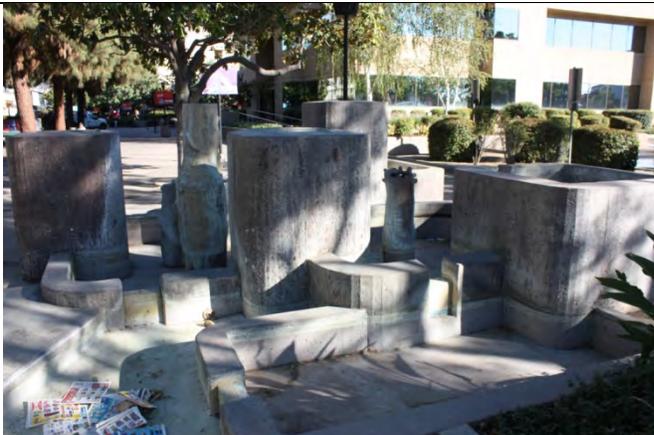
7

Water feature with rounded rectangular concrete structures and sculpted ceramic pipes

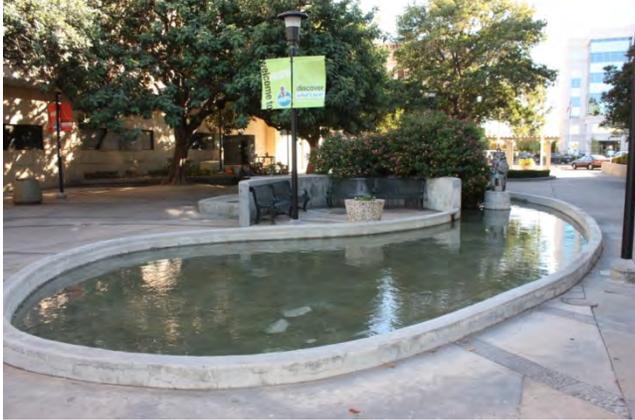
<p>8</p> <p>Pool with fountain spouts</p> <p><i>About:</i> 60 feet long, 32.5 feet wide. Contains work 1(a).</p> <p><i>In NRHP app.:</i> Contributing object #21.</p> <p><i>Condition:</i> Functioning, but with irrigation problems.</p> <p><i>In Alt. 1:</i> Demolished and new feature built to resemble original at smaller scale at new location on the same block</p> <p><i>In Alt. 2:</i> Demolished and new feature built to resemble original at smaller scale at new location on the same block.</p> <p><i>In Alt. 5:</i> Demolished and new feature built to resemble original at smaller scale at new location on the same block.</p> <p><i>In Alt. 6:</i> Demolished and new feature built to resemble original at smaller scale at new location on the same block.</p> <p><i>In Alt. 7:</i> Demolished and new feature built to resemble original at smaller scale at new location on the same block.</p> <p><i>In Alt. 8:</i> Demolished and new feature built to resemble original at smaller scale at new location on the same block.</p>

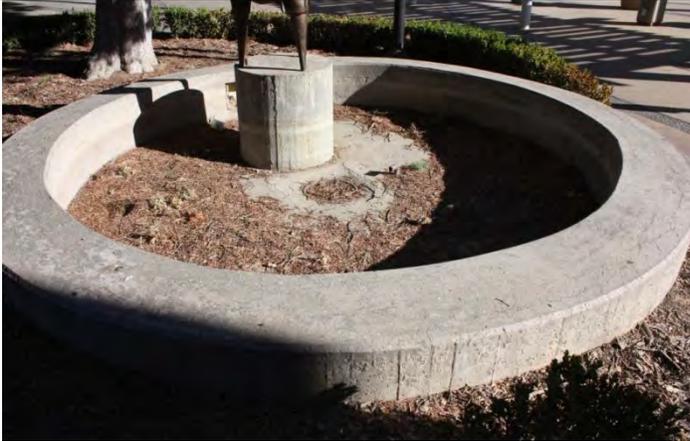
<p>9</p> <p>Pool with fountain spouts</p> <p><i>About:</i> 12 feet in diameter. Contains work 10.</p> <p><i>In NRHP app.:</i> Not described.</p> <p><i>Condition:</i> Not functioning.</p> <p><i>In Alt. 1:</i> Demolished and new feature built to resemble original at new location, same block.</p> <p><i>In Alt. 2:</i> Demolished and new feature built to resemble original at new location on the same block.</p> <p><i>In Alt. 5:</i> Demolished and new feature built to</p>

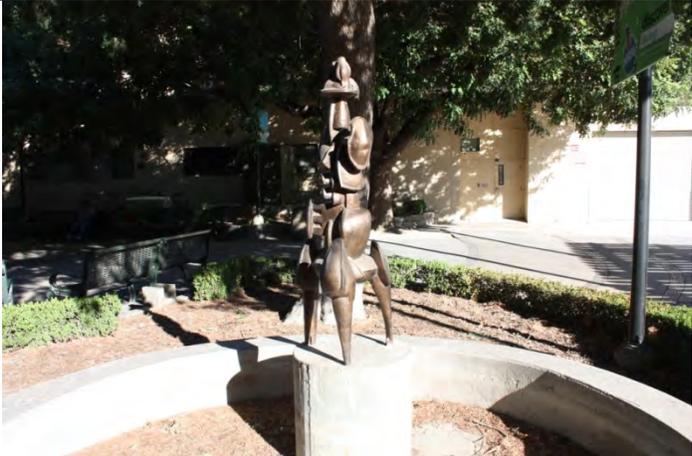
<p>10</p> <p>Talos by James Lee Hansen, 1959 Bronze</p> <p><i>About:</i> 5 feet tall on 2-foot-tall base. Set in pool 9.</p> <p><i>In NRHP app.:</i> Mentioned, but not as a contributing feature.</p> <p><i>Condition:</i> Present and intact after repairs from vandalism completed in 2012.</p> <p><i>In Alt. 1:</i> Restored and relocated, same block.</p> <p><i>In Alt. 2:</i> Restored and relocated, same block</p> <p><i>In Alt. 5:</i> Restored and relocated, same block.</p> <p><i>In Alt. 6:</i> Restored and relocated, same block.</p> <p><i>In Alt. 7:</i> Restored and relocated, same block.</p> <p><i>In Alt. 8:</i> Restored and relocated, same block.</p>

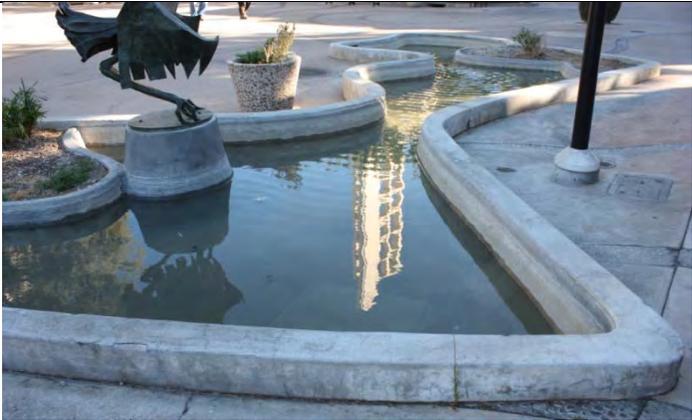
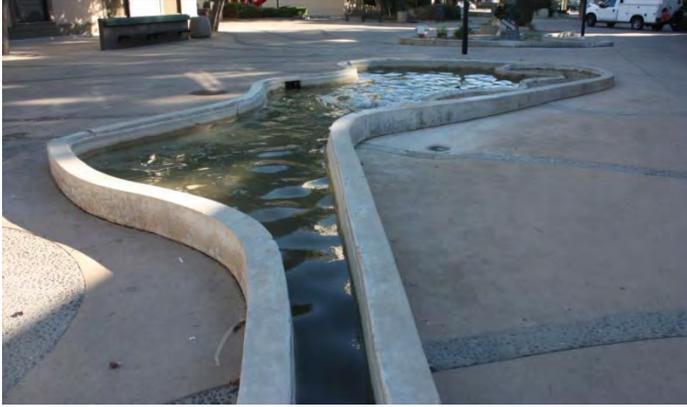
<p>b</p>	<p>11 (a-b)</p> <p>Two pools with fountain spouts</p> <p><i>About:</i> 36 feet long by up to 3.6 feet wide (a) and 71.5 feet long by up to 24 feet wide (b). Pool a contains work 12.</p> <p><i>In NRHP app.:</i> Contributing objects #22 (a) and #24 (b).</p> <p><i>Condition:</i> Functioning after repairs to a from vandalism completed in 2012.</p> <p><i>In Alt. 1:</i> Demolished and new feature built to resemble original, same block.</p> <p><i>In Alt. 2:</i> Demolished and new feature built to resemble original, same block.</p> <p><i>In Alt. 5:</i> Demolished and new feature built to resemble original, same block.</p>

In Alt. 6: Demolished and new feature built to resemble original, same block.
In Alt. 7: Demolished and new feature built to resemble original, same block.
In Alt. 8: Demolished and new feature built to resemble original, same block.

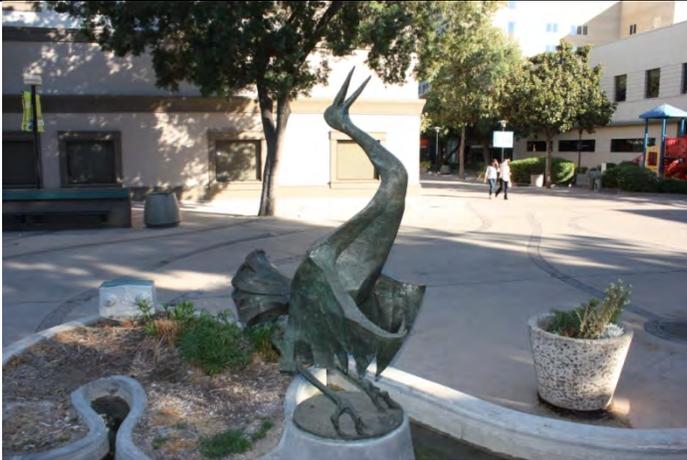
12
Rite of the Crane by Bruno Groth, 1964
 Bronze

About: 6 feet high. Set in pool **11a**.
In NRHP app.: Contributing object #23.
Condition: Present and intact.
In Alt. 1: Restored and relocated, same block.
In Alt. 2: Restored and relocated, same block.
In Alt. 5: Restored and relocated, same block.
In Alt. 6: Restored and relocated, same block.
In Alt. 7: Restored and relocated, same block.
In Alt. 8: Restored and relocated, same block.

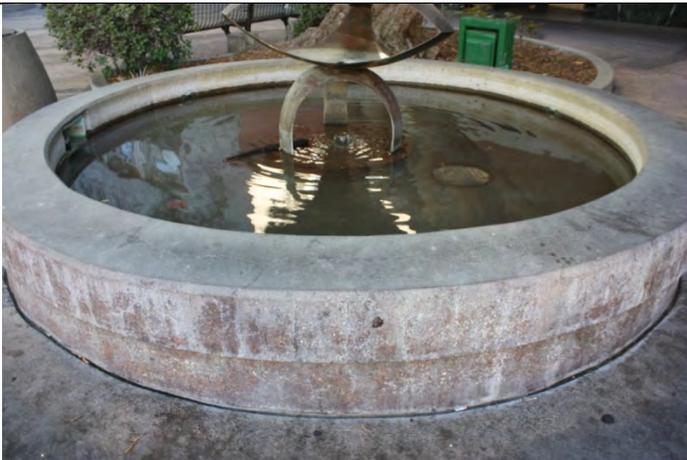
13
Pool

About: 12 feet in diameter. Work **14** functions as the fountain for this pool.
In NRHP app.: Not described.
Condition: Present, functioning.
In Alt. 1: Demolished and new feature built to resemble original, same block.
In Alt. 2: Demolished and new feature built to resemble original in current location.
In Alt. 5: Demolished and new feature built to resemble original in current location.
In Alt. 6: Demolished and new feature built to resemble original in current location.
In Alt. 7: Demolished and new feature built to resemble original, same block.
In Alt. 8: Demolished and new feature built to resemble original, same block.

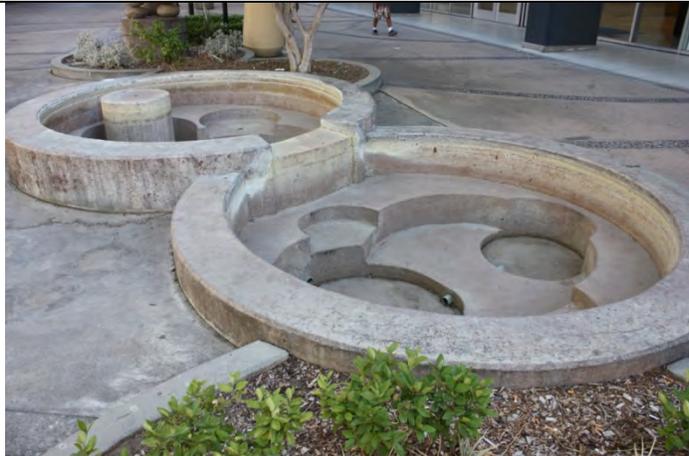
15

Two connecting pools

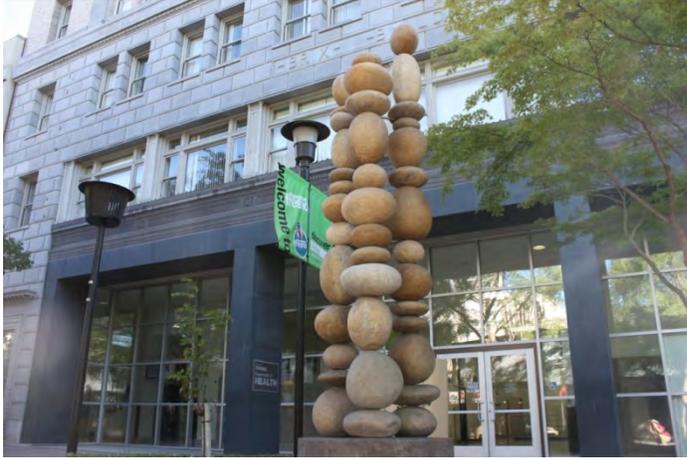
16

Trisem by T. Newton Russell, 1966
Granite boulders on stained concrete podium

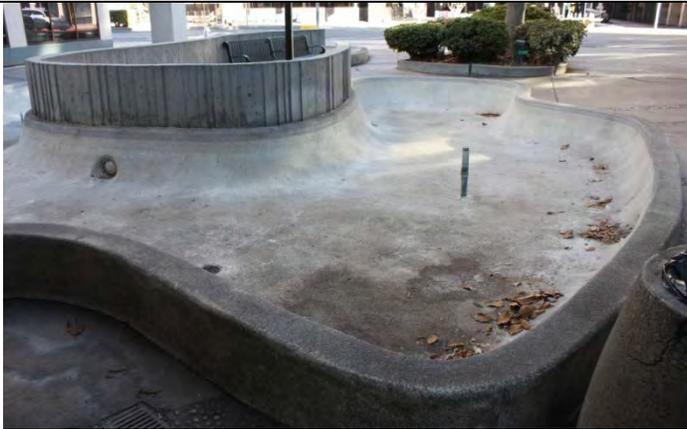
17

Pool with fountain bubblers

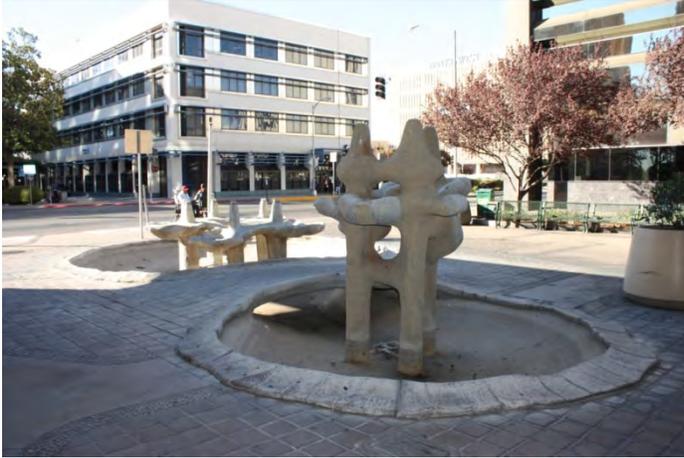
18

Guarantee Fountain or Dancing Waters
by Stanley C. Bitters, 1964

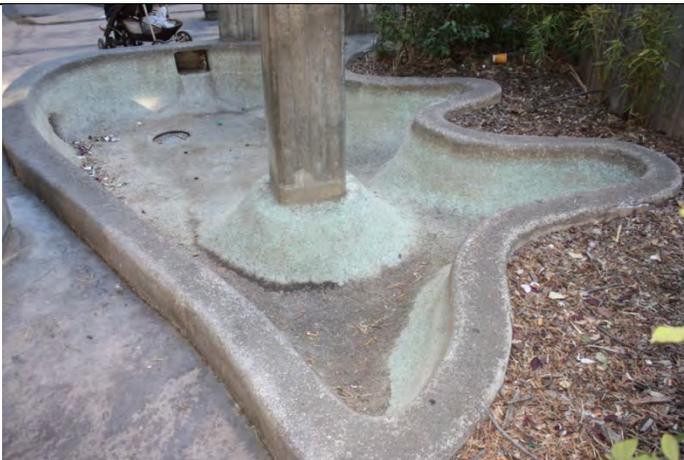
19

Pool

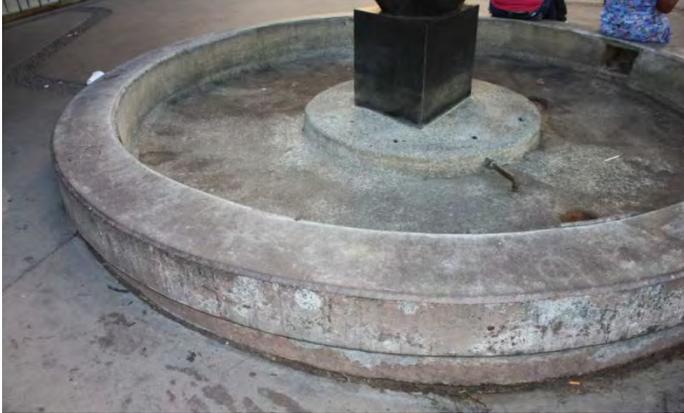
20

Pool with fountain bubblers

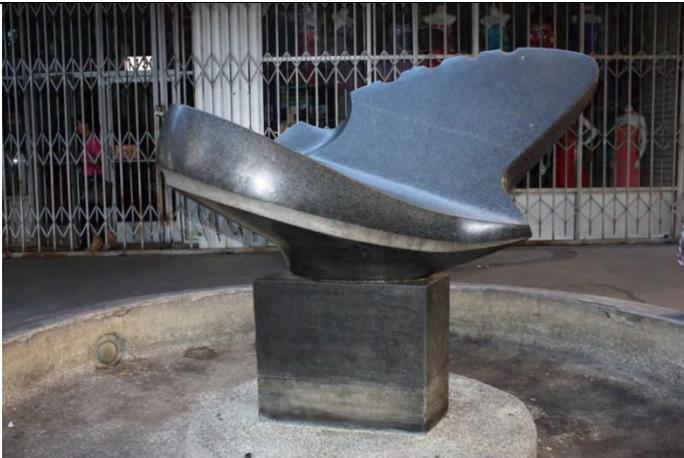
21

Valley Landing by Gordon Newell, 1965
San Joaquin Valley granite

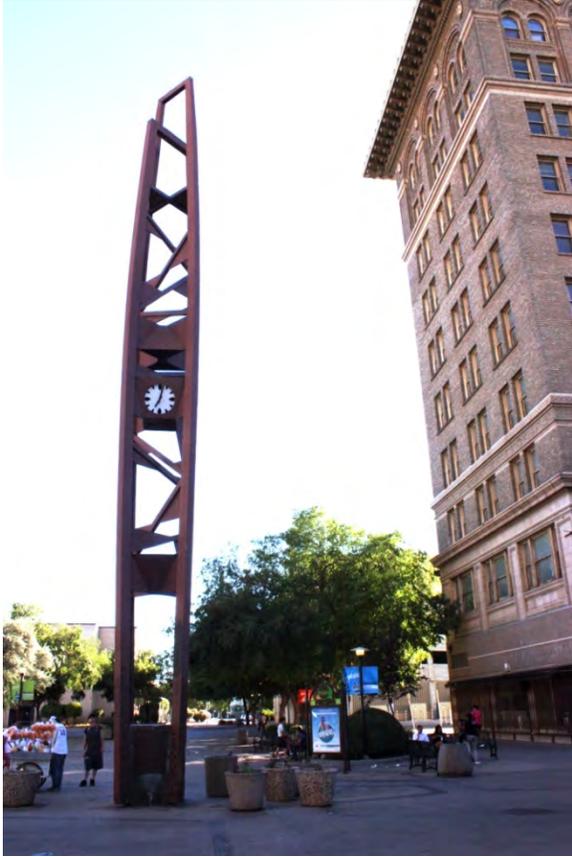
22

Clock Tower by Jan de Swart, 1964
Wood and fiberglass

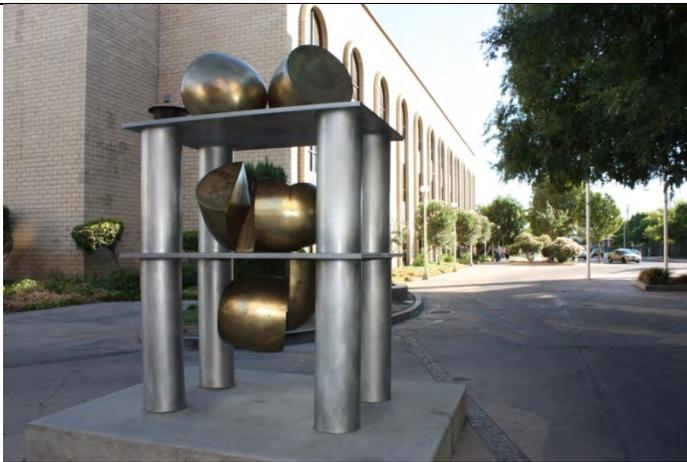
23

Big A by Peter Voulkos, 1965
Aluminum and bronze

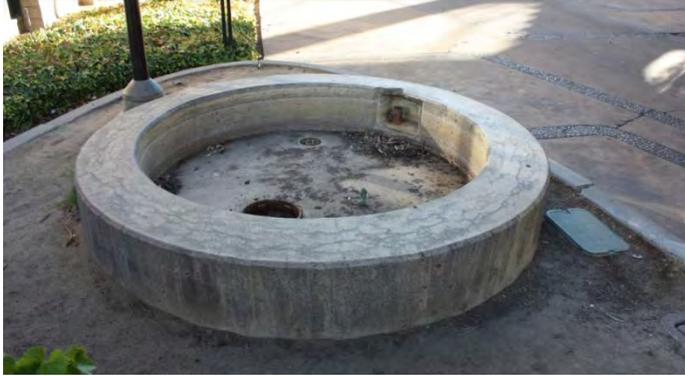
24

Pool with fountain bubblers

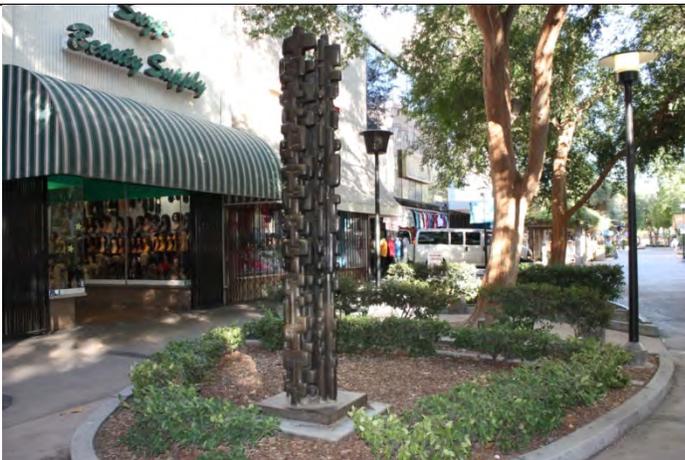
26

***Arbre Échelle* by François Stahly, 1964**

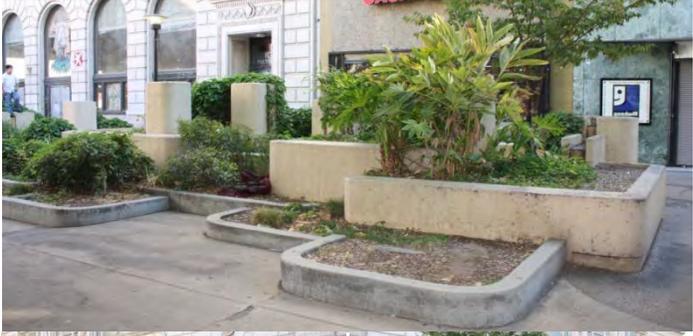
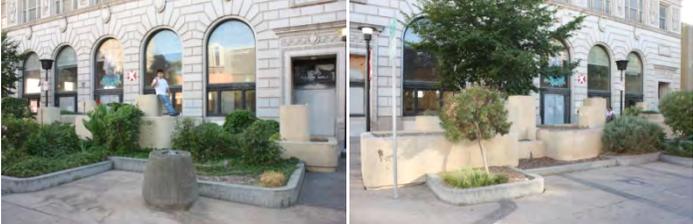
<p>c</p>	<p>27 (a-c) Former fountains (now planters)</p> <p><i>About:</i> Overall 122 feet long, and up to 27 feet wide.</p> <p><i>In NRHP app.:</i> Not contributing features. The fountain conversion is mentioned in the application.</p> <p><i>Condition:</i> These fountains were converted to planters in the 1980s. Planters are intact.</p> <p><i>In Alt. 1:</i> Demolished.</p> <p><i>In Alt. 2:</i> Demolished.</p> <p><i>In Alt. 5:</i> Demolished and new feature built to resemble original in current location.</p> <p><i>In Alt. 6:</i> Demolished and new feature built to resemble original in current location.</p> <p><i>In Alt. 7:</i> Demolished and new feature built to resemble original in current location.</p> <p><i>In Alt. 8:</i> Demolished and new feature built to resemble original in current location.</p>

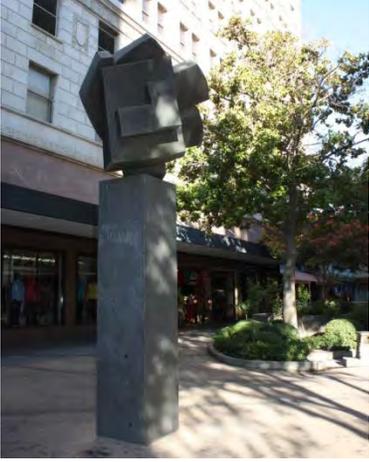
<p>28 Orion by Bernard (Tony) Rosenthal, 1966 Bronze on Academy granite</p> <p><i>About:</i> 5-foot-tall sculpture on 9-foot-tall base.</p> <p><i>In NRHP app.:</i> Contributing object #11.</p> <p><i>Condition:</i> Present, intact.</p> <p><i>In Alt. 1:</i> Restored and relocated, same block.</p> <p><i>In Alt. 2:</i> Restored and Returned to current location.</p> <p><i>In Alt. 2:</i> Restored and returned to current location.</p> <p><i>In Alt. 5:</i> Restored and returned to current location.</p> <p><i>In Alt. 6:</i> Restored and returned to current location.</p> <p><i>In Alt. 7:</i> Restored and returned to current location.</p> <p><i>In Alt. 8:</i> Restored and returned to current location.</p>

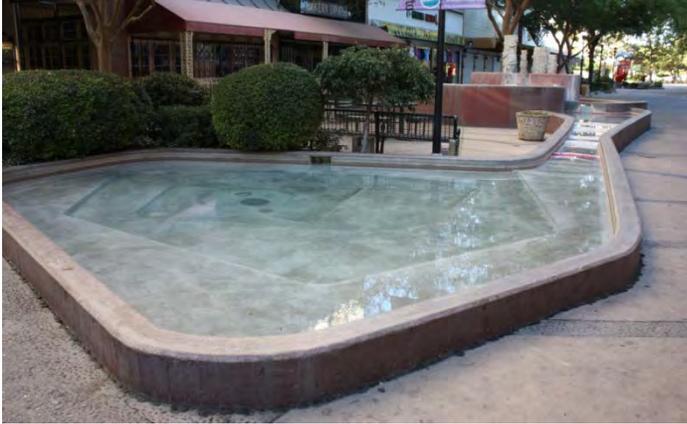
29

Multilevel pool

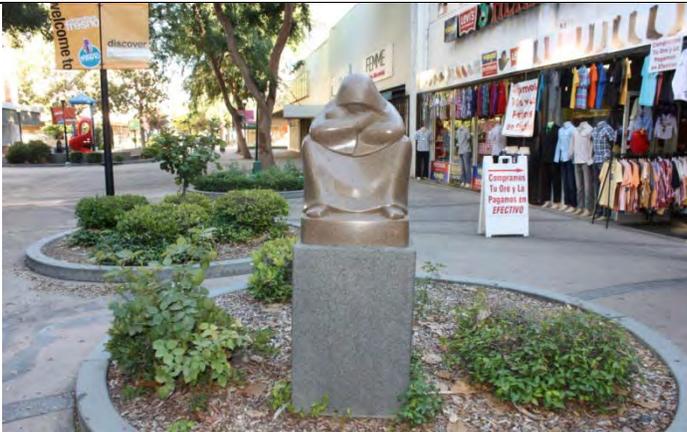
30

Mother and Child by Raimondo Puccinelli, 1940

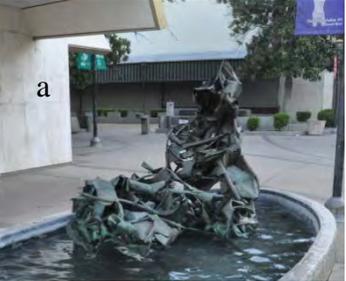
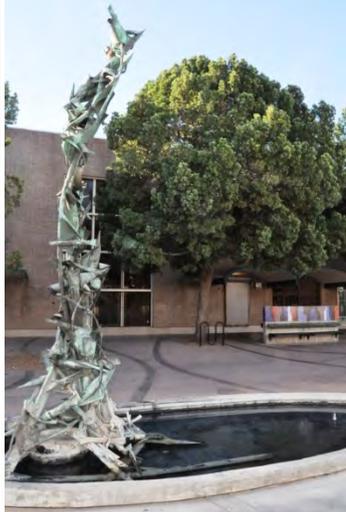
<p>b</p> <p>c</p>	<p>31 (a-c)</p> <p>c Three pools with fountain bubblers</p> <p>About: Each oval approximately 25 feet long. Pools contain works 32a (a), 32b (b), and 32c (c).</p> <p>In NRHP app.: Not described.</p> <p>Condition: Functioning intermittently.</p> <p><i>In Alt. 1:</i> Demolished and new feature built to resemble original in same location.</p> <p><i>In Alt. 2:</i> Demolished and new feature built to resemble original in same location.</p> <p><i>In Alt. 5:</i> Demolished and new feature built to resemble original in current location.</p> <p><i>In Alt. 6:</i> Demolished and new feature built to resemble original in current location.</p> <p><i>In Alt. 7:</i> Demolished and new feature built to resemble original in current location.</p> <p><i>In Alt. 8:</i> Demolished and new feature built to resemble original in current location.</p>
<p>a</p>

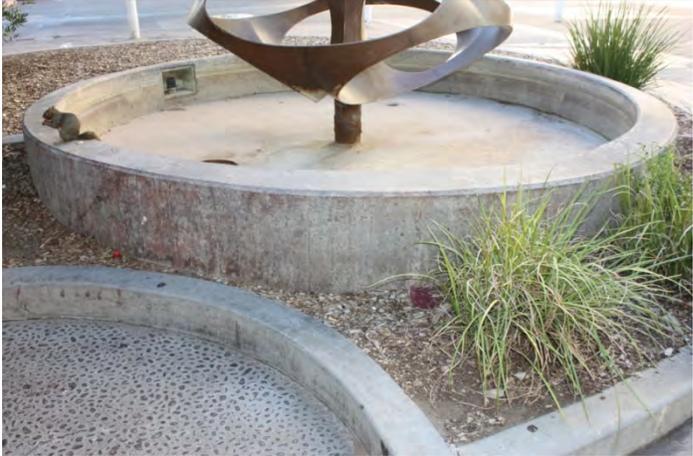
<p>33 Pool</p> <p><i>About:</i> Diameter approx. 8 feet. Work 34 functions as the fountain for this pool.</p> <p><i>In NRHP app.:</i> Included in the description of contributing object #5.</p> <p><i>Condition:</i> Not functioning.</p> <p><i>In Alt. 1:</i> Demolished and new feature built to resemble original, new location, same block.</p> <p><i>In Alt. 2:</i> Demolished and new feature built to resemble original, new location, same block.</p> <p><i>In Alt. 5:</i> Demolished and new feature built to resemble original, new location, same block.</p> <p><i>In Alt. 6:</i> Demolished and new feature built to resemble original, new location, same block.</p> <p><i>In Alt. 7:</i> Demolished and new feature built to resemble original, new location, same block.</p> <p><i>In Alt. 8:</i> Demolished and new feature built to resemble original, new location, same block.</p>

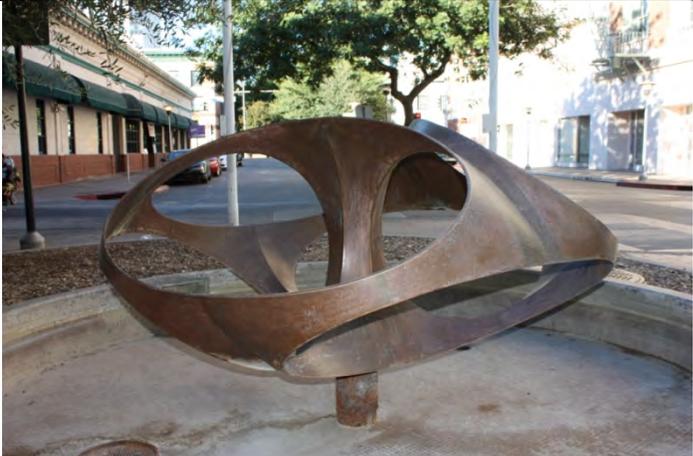
<p>34 <i>Ellipsoid VI</i> by Charles O. Perry, 1964 Bronze</p> <p><i>About:</i> Approximately 4 feet high. Set in pool 33.</p> <p><i>In NRHP app.:</i> Contributing object #5.</p> <p><i>Condition:</i> Present, intact.</p> <p><i>In Alt. 1:</i> Restored and relocated, same block, set in a smaller pool.</p> <p><i>In Alt. 2:</i> Restored and relocated, same block, set in smaller pool.</p> <p><i>In Alt. 5:</i> Restored and relocated, same block, set in a smaller pool.</p> <p><i>In Alt. 6:</i> Restored and relocated, same block, set in a smaller pool.</p> <p><i>In Alt. 7:</i> Restored and relocated, same block,</p>

<p>set in a smaller pool. <i>In Alt. 8:</i> Restored and relocated, same block, set in a smaller pool.</p>

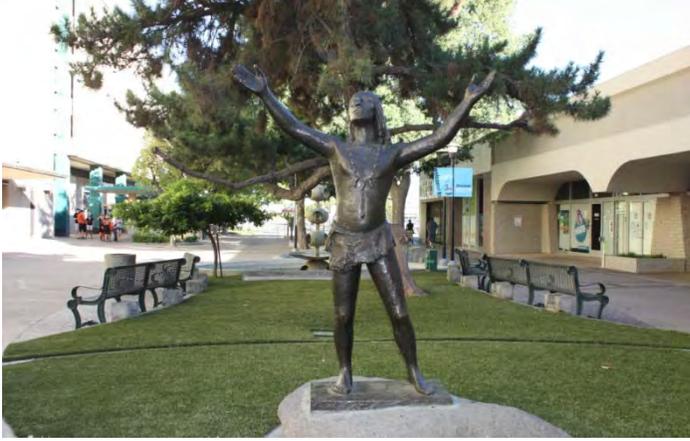
<p>35 <i>The Yokuts Indian</i> by Clement Renzi, 1974 Bronze</p> <p><i>About:</i> 7 feet tall on 1-foot-tall base. <i>In NRHP app.:</i> Contributing object #4. <i>Condition:</i> Present, intact.</p> <p><i>In Alt. 1:</i> Restored and relocated, same block. <i>In Alt. 2:</i> Restored and returned to current location. <i>In Alt. 5:</i> Restored and returned to current location. <i>In Alt. 6:</i> Restored and relocated, same block. <i>In Alt. 7:</i> Restored and relocated, same block. <i>In Alt. 8:</i> Restored and relocated, same block.</p>

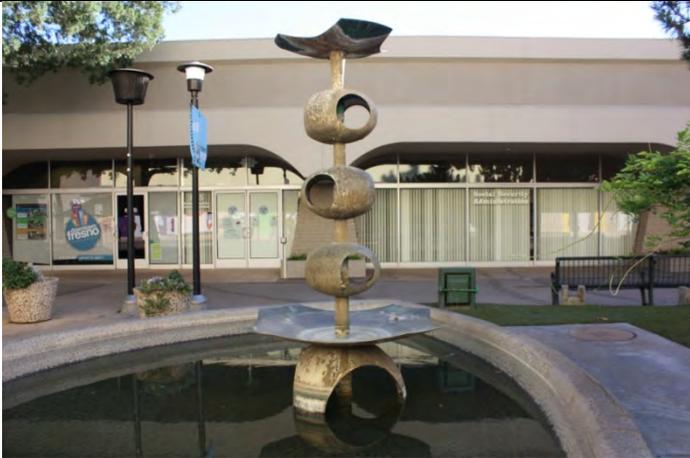
<p>36 <i>Obos</i> by George Tsutakawa, 1964 Bronze</p> <p><i>About:</i> Approximately 10 feet high. Set in pool 37. <i>In NRHP app.:</i> Contributing object #3. <i>Condition:</i> Present, intact.</p> <p><i>In Alt. 1:</i> Restored and relocated same block, set in smaller pool. <i>In Alt. 2:</i> Restored and returned to current location. <i>In Alt. 5:</i> Restored and returned to current location. <i>In Alt. 6:</i> Restored and relocated, same block, set in smaller pool. <i>In Alt. 7:</i> Restored and relocated, same block, set in smaller pool. <i>In Alt. 8:</i> Restored and relocated, same block, set in smaller pool.</p>

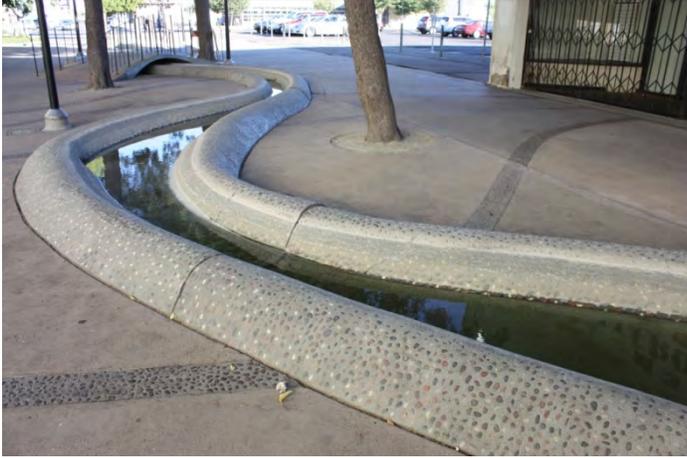
37

Serpentine water feature

Condition: Functioning intermittently.

In Alt. 7: Demolished and new feature built to resemble original in different location, same block, smaller scale.

In Alt. 8: Demolished and new feature built to resemble original in different location, same block, smaller scale.

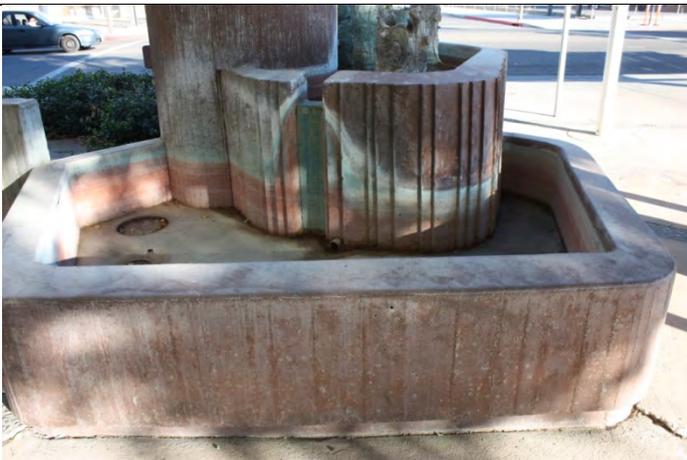
38

Multilevel pool

Condition: Not functioning.

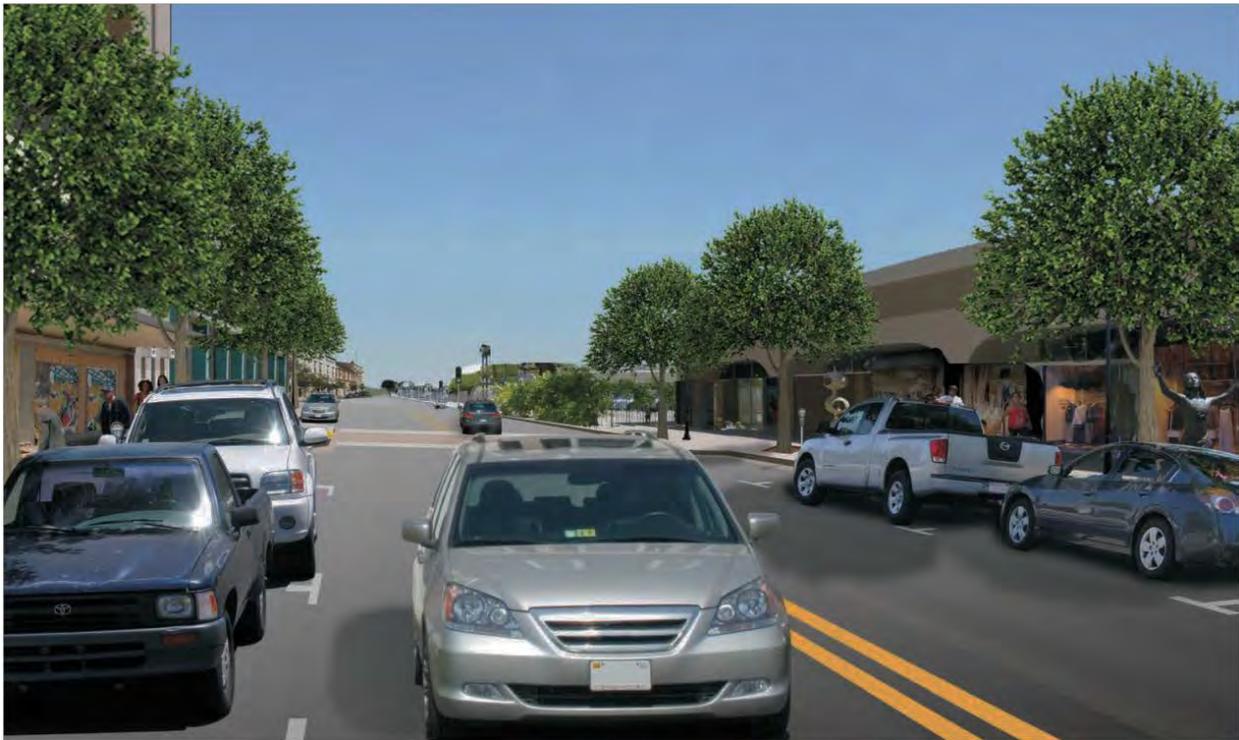
Visual Simulation at Key Observation Point 1 for Alternative 1
