Supplemental Finding of Adverse Effect

Fulton Mall Reconstruction Project

City of Fresno, California

Project ID TCSPL-5060(263)

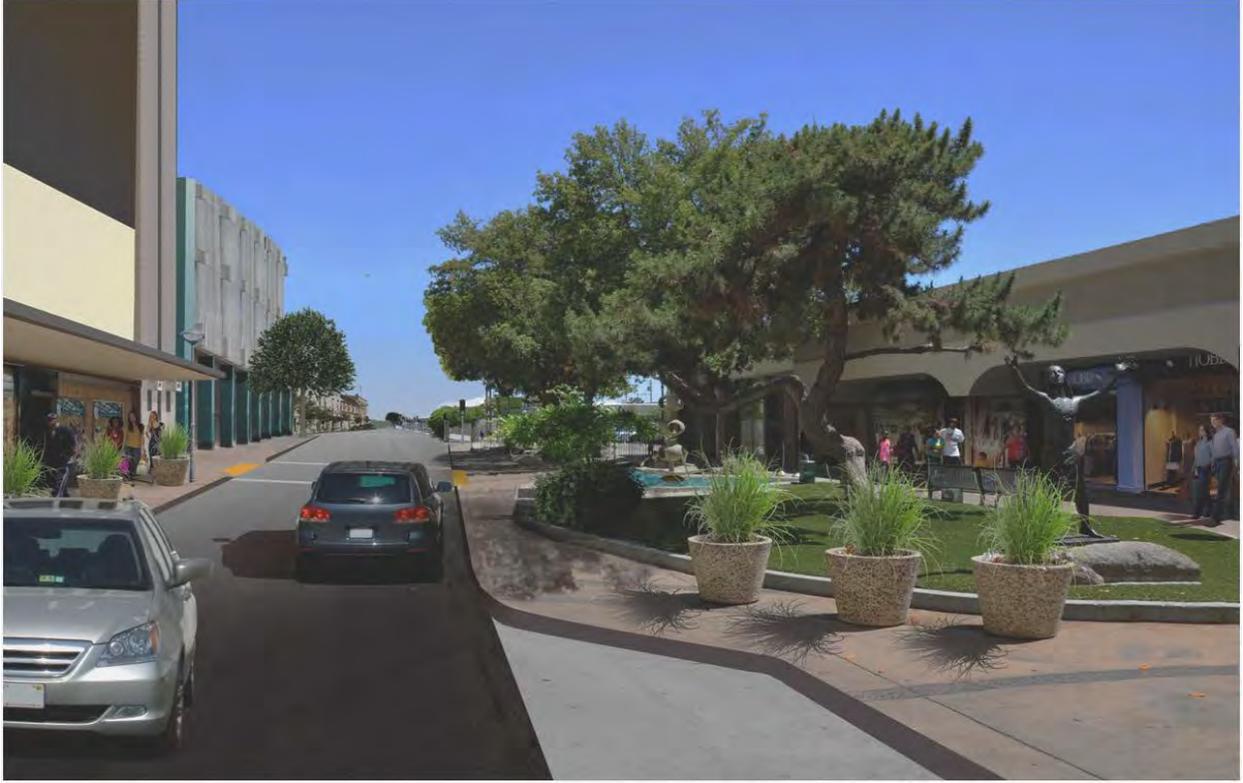
Visual Simulation at Key Observation Point 1 for Alternative 2

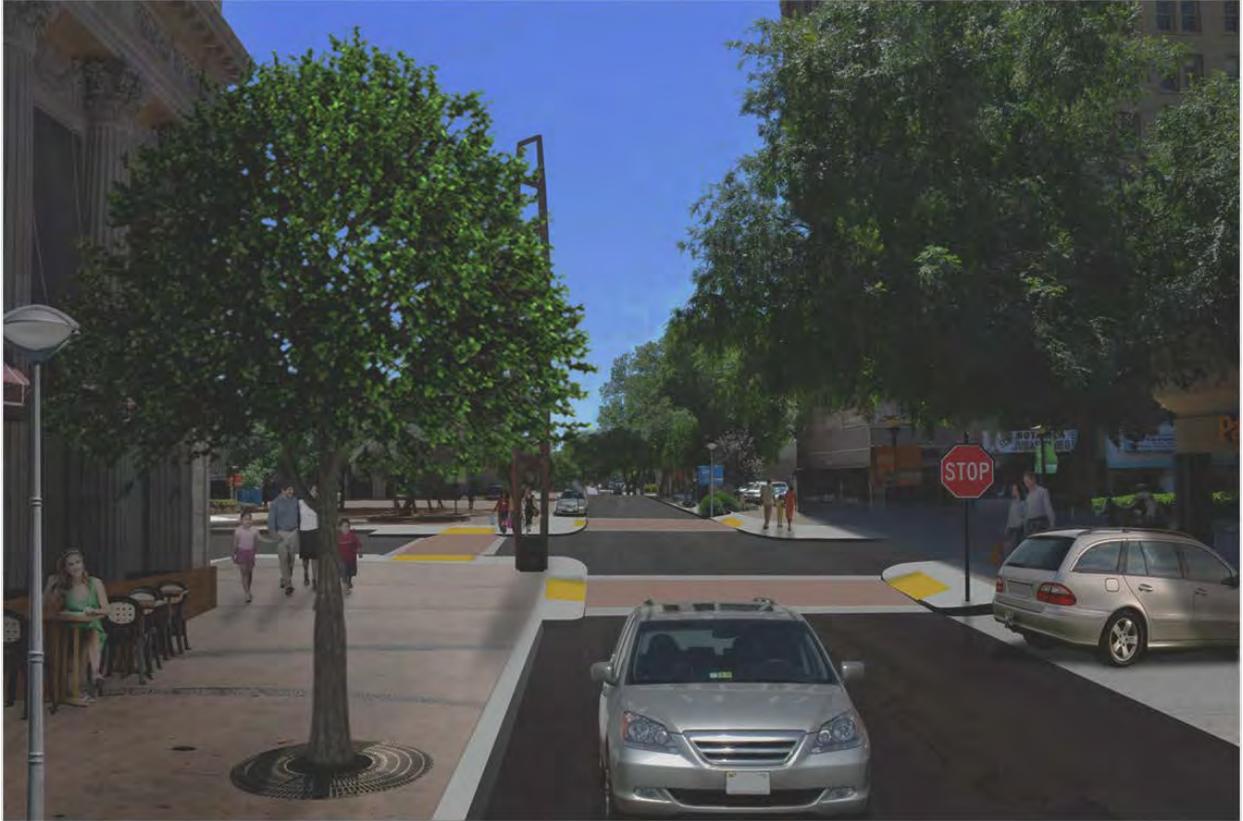
Visual Simulation at Key Observation Point 2 for Alternatives 1 and 2

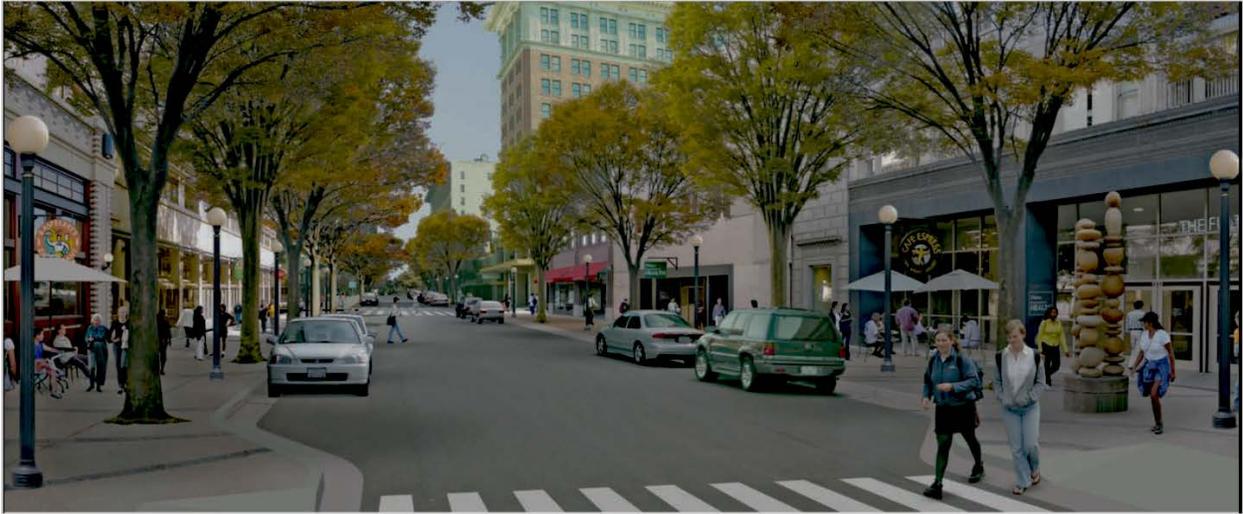
Visual Simulation at Key Observation Point 3 for Alternative 1

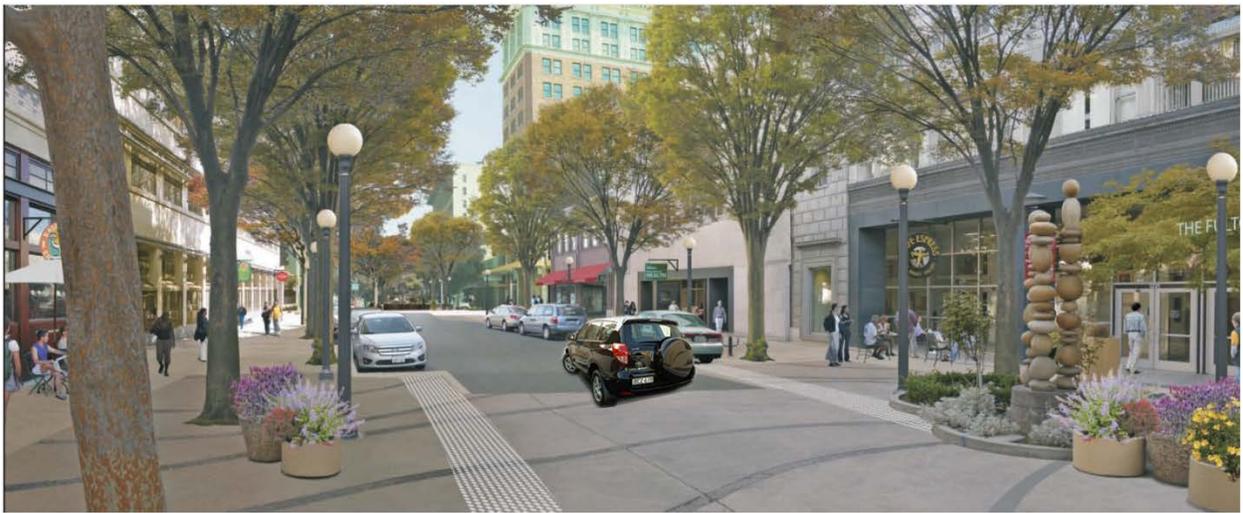
Visual Simulation at Key Observation Point 3 for Alternative 2

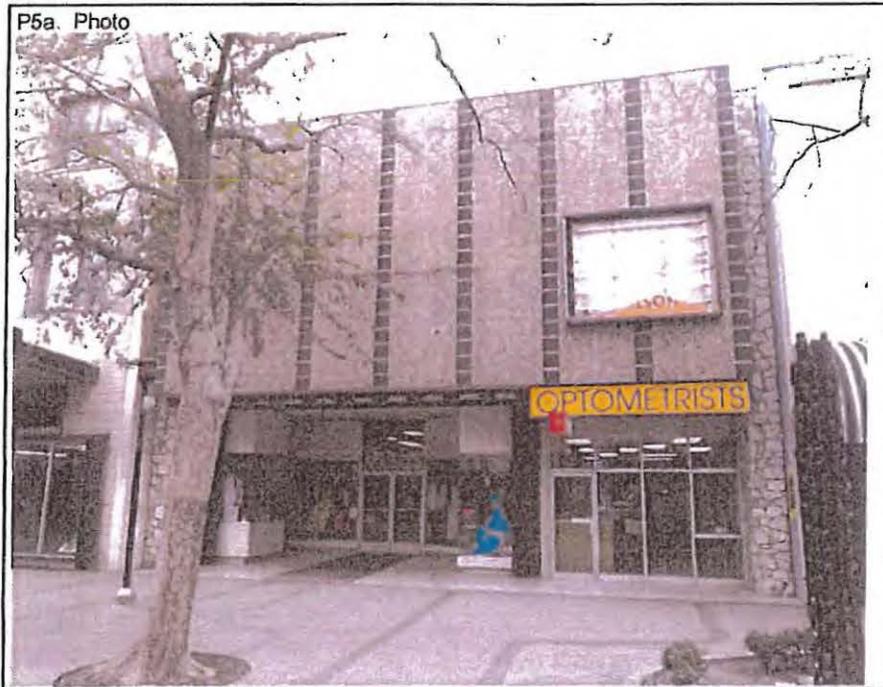
P5a. Photo

Located on the northeast side of Fulton Mall, near Tulare Street, this commercial building is rectangular in plan and capped with a flat, unelaborated roof. Divided into two storefronts, the building displays metal-framed windows and paired glass doors at sidewalk level, with applied stone veneer spanning the façade above. Alterations to the property include the reconfiguration of the original storefronts, as well as the removal of original materials and features, such as wall cladding and doors. In fair condition, the property does not retain a sufficient degree of integrity to convey its period of significance.

P5b. Photo: (view and date)
View from southwest
March 1, 2011

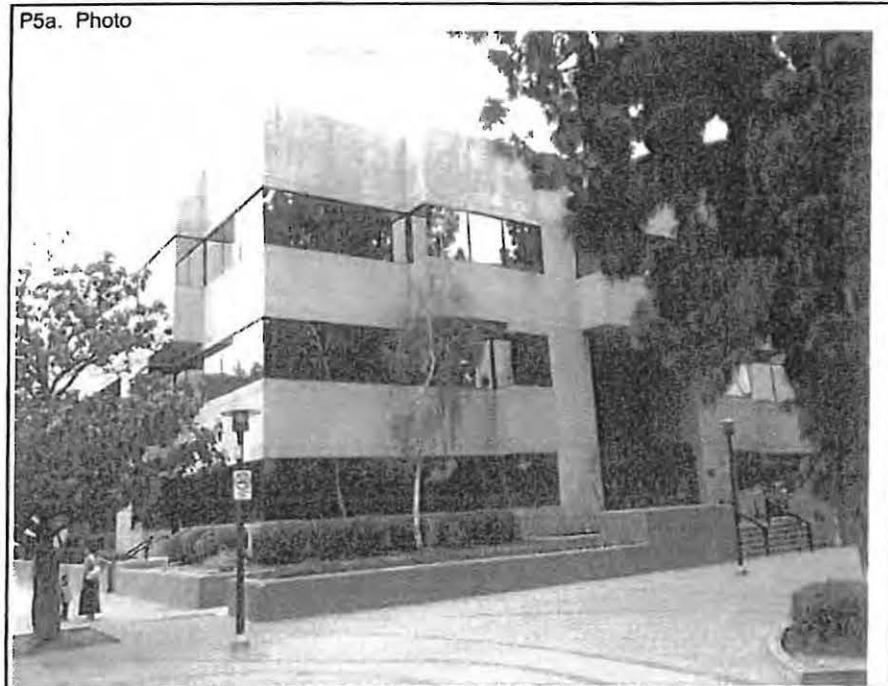
Located on the southwest side of Fulton Mall, near Merced Street, this property is three stories in height and square in plan. The building displays bands of windows, alternating with stucco-clad exterior walls. In good condition, the property exhibits a good degree of integrity.

P5b. Photo: (view and date)
View from east
March 1, 2011

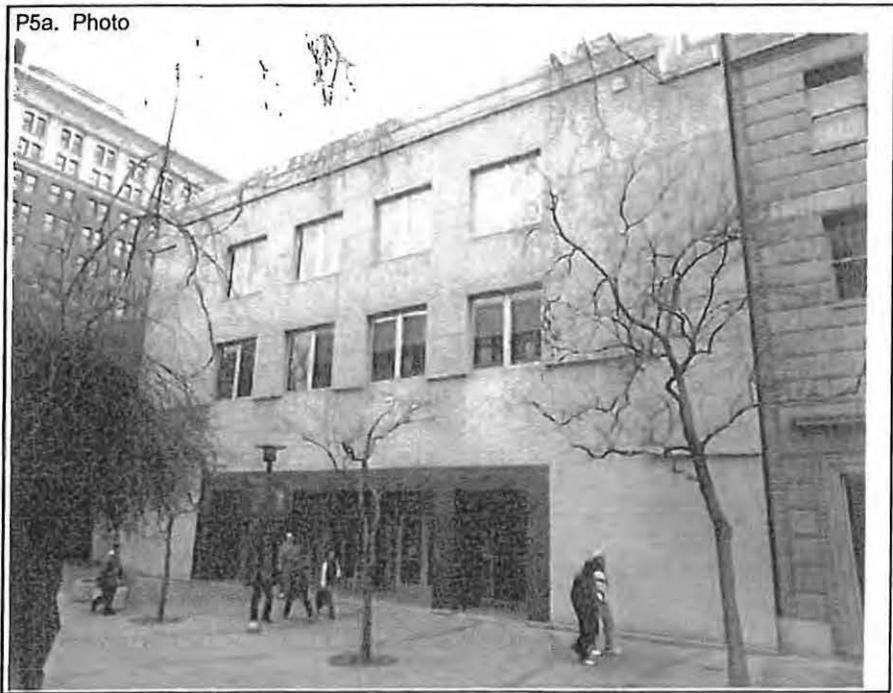
P5a. Photo

Located on the southwest side of Fulton Mall, at the corner of Fresno Street, this three-story building is rectangular in plan and capped with a flat roof. In good condition, the property retains a good degree of integrity.

*P5b. Photo: (view and date)
View from southeast
March 1, 2011

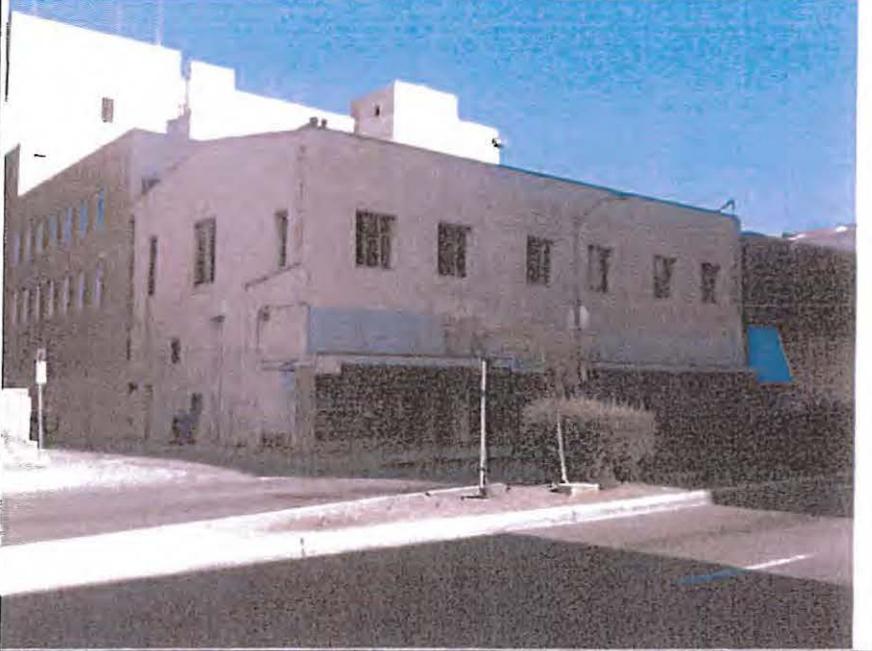
P5a. Photo

Located on the northwest side of Fresno Street, between Broadway Street and Fulton Mall, this property is a two-story, vernacular commercial building. A shallow side-gabled roof caps the building, which is sheathed in stucco. The façade displays a series of storefront windows (which are sheltered beneath a flat canopy) and metal-frame glass and wood entries. On the second story, fenestration consists of thin metal casement windows and, in the rear elevation, wood-framed double-hung sashes. Alterations include the reconfiguration of the original façade and storefronts, as well as replacement of the building's original wall cladding, doors, and windows. In fair condition, the property retains a poor level of integrity and no longer conveys its historic significance.

P5b. Photo: (view and date)
View from south
March 4, 2011

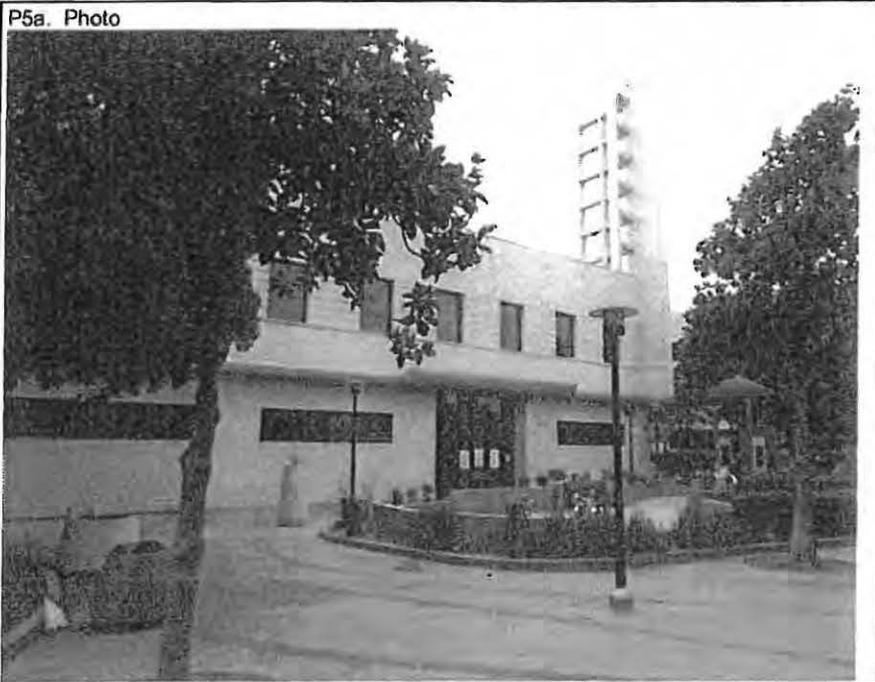
Located on the southwest side of Fulton Mall, near Merced Street, this commercial building is rectangular in plan and capped with a flat roof. The building displays narrow bands of windows and paired metal-framed doors, sheltered beneath a shallow canopy, on the lower facade. The upper façade consists of a row of symmetrically placed windows, with Moderne detailing. Alterations noted during field observations include the removal of original features, such as original signage, windows, and doors. In good condition, the property does not retain a sufficient degree of integrity to convey its period of significance.

P5b. Photo: (view and date)
View from east
March 1, 2011

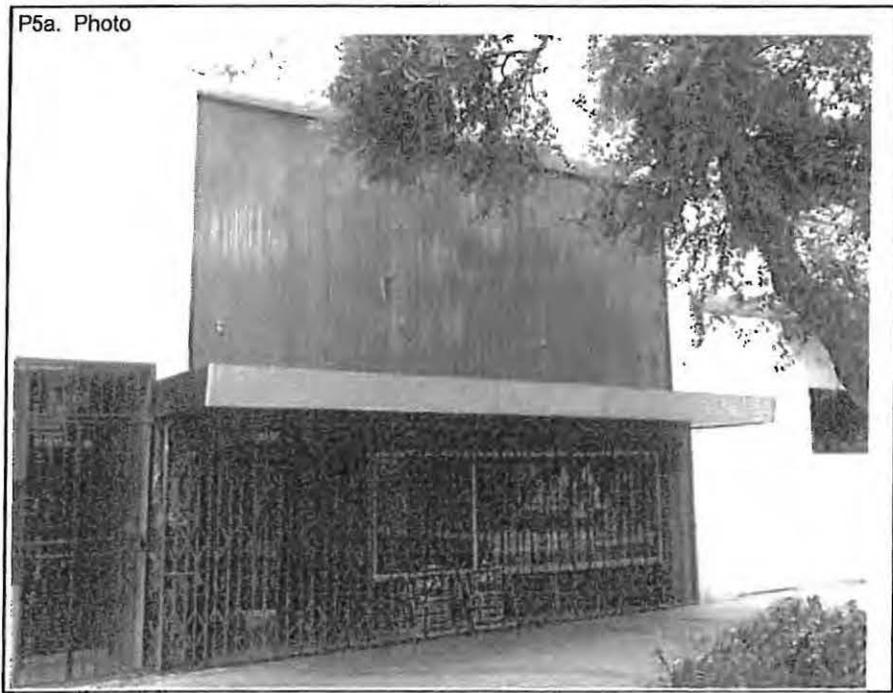
Located on the southwest side of Fulton Mall, between Fresno and Merced Streets, this commercial building is rectangular in plan and capped with a flat roof. The building displays metal-framed glass doors and windows at the street level, with unadorned siding on the exterior walls above. A flat canopy shelters the store windows and doors. Alterations to the property include the reconfiguration of the original storefronts, as well as the removal of original materials and features, such as wall cladding, doors, and windows. In fair condition, this property retains a poor level of integrity.

P5b. Photo: (view and date)
View from northeast
March 1, 2011

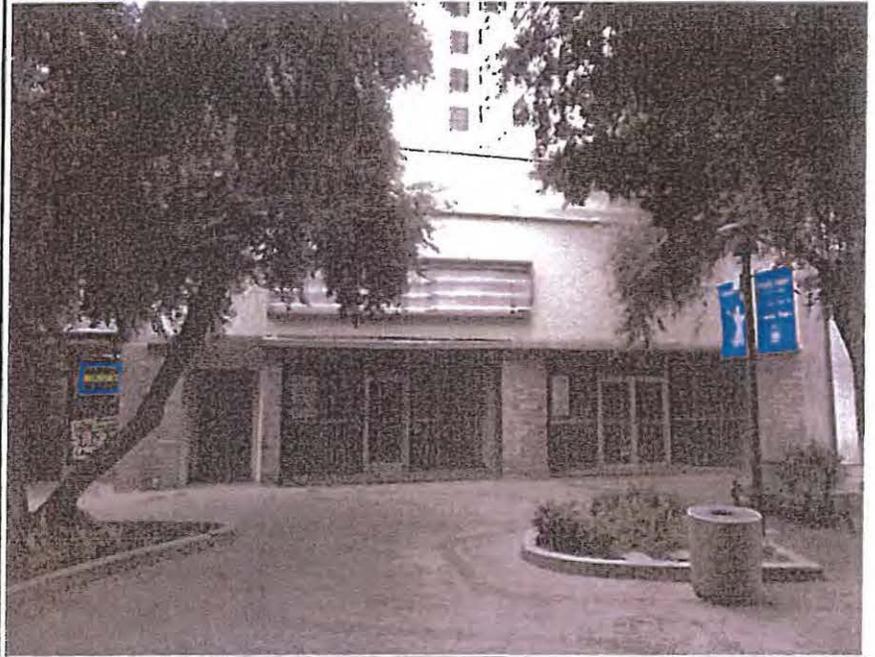
P5a. Photo

Located on the southwest side of Fulton Mall, near Fresno Street, this commercial building is rectangular in plan and capped with a flat roof with no overhanging eaves. The building displays a series of non-original metal-framed windows and glass doors at sidewalk level, and stucco-clad exterior walls above. Alterations include the reconfiguration of the original storefronts, as well as the removal of original materials and features, such as wall cladding, windows, and doors. In fair condition, the property exhibits a poor degree of integrity.

View from northeast
March 1, 2011

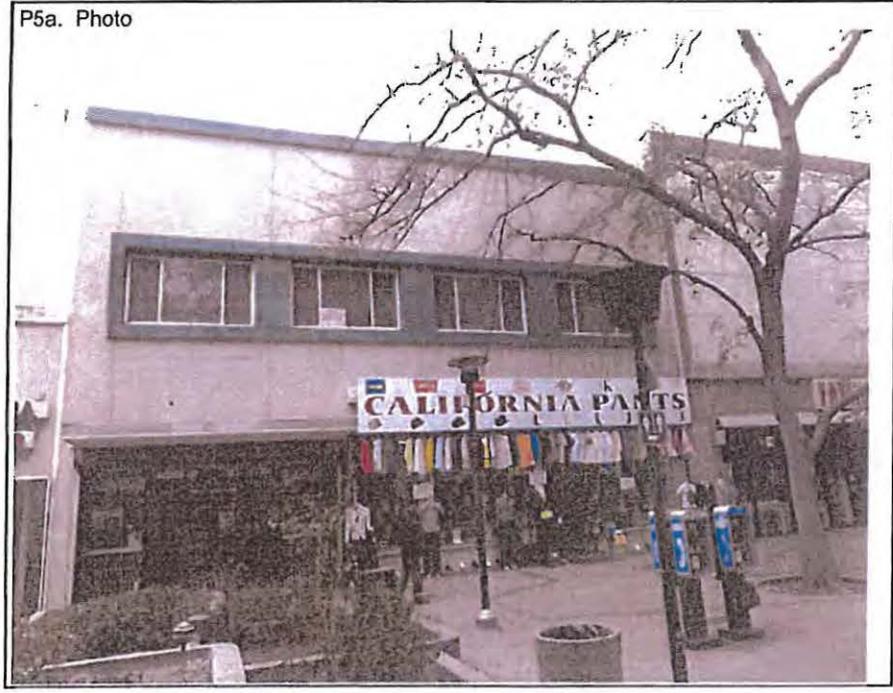
P5a. Photo

Located on the southwest side of Fulton Mall, near Tulare Street, this commercial building is rectangular in plan and capped with a flat, unelaborated roof. The façade consists of a series of metal-framed windows and glass doors at sidewalk level, with a band of metal-framed windows on the second story. A flat, cantilevered canopy shelters the entrance. Alterations to the property include the reconfiguration of the original storefronts, as well as the removal of original materials and features, such as wall cladding and doors. In fair condition, the property exhibits a poor degree of integrity.

P5b. Photo: (view and date)
View from northeast
March 1, 2011

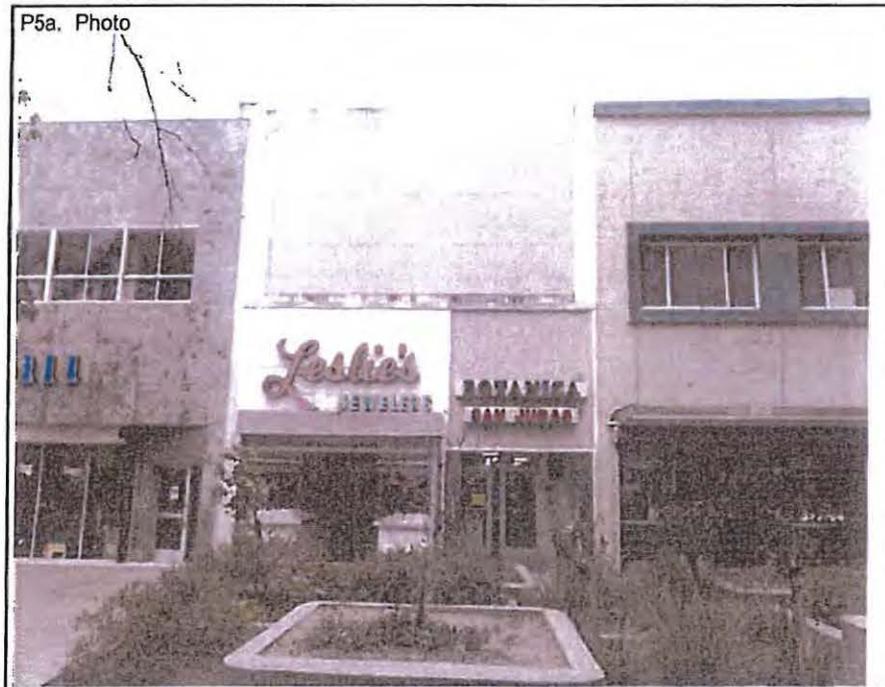
Located on the southwest side of Fulton Mall, near Tulare Street, this commercial building is rectangular in plan and capped with a flat, unelaborated roof. Divided into two storefronts, the building displays metal-framed windows and paired glass doors at sidewalk level. Alterations to the property include the redesign of the façade and storefronts and removal of original materials and features, such as wall cladding and doors. In fair condition, the property exhibits a poor degree of integrity.

*P5b. Photo: (view and date)
View from northeast
March 1, 2011

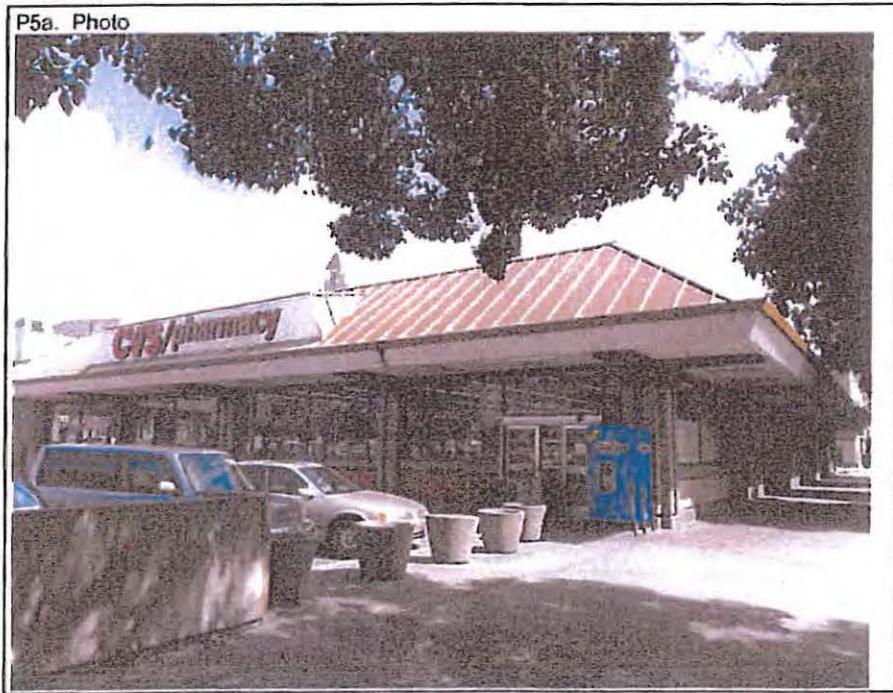
Located on the northeast side of Fulton Mall, near Merced Street, this parcel is improved with a one-story commercial building and adjacent surface parking lot. Rectangular in plan and capped with a hipped roof, the building displays a series of single-pane display windows and metal-framed glass entries, sheltered beneath cantilevered roof eaves. In good condition, the property exhibits a fair degree of integrity.

P5b. Photo: (view and date)
View from

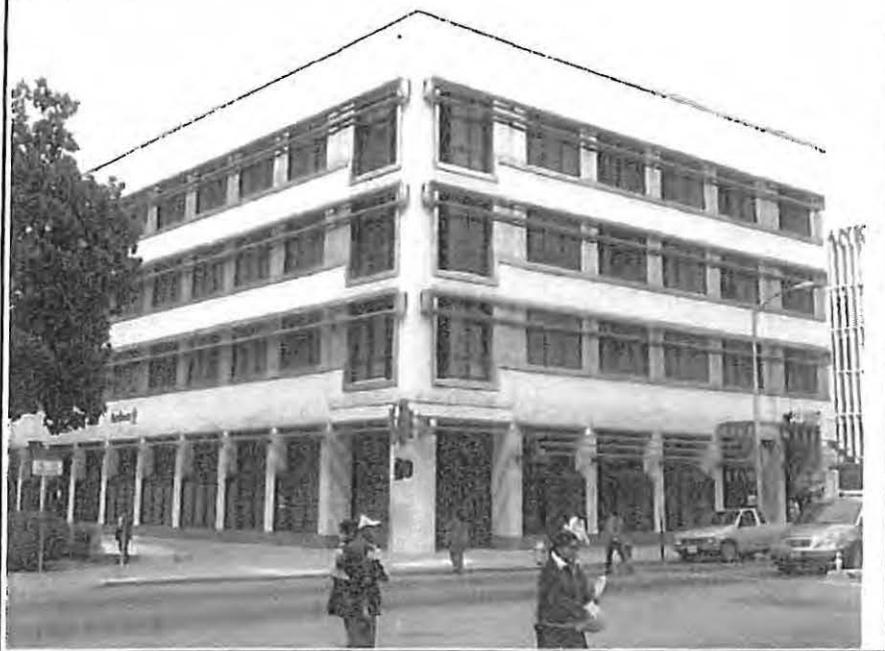
P5a. Photo

Located on the northeast side of Fulton Mall, on the corner of Fresno Street, this commercial building is rectangular in plan and capped with a flat roof with no overhanging eaves. The four-story building displays bands of multi-light windows, with a decorative steel detailing framing the windows and extending across the façade. In good condition, the property exhibits a poor degree of integrity.

- P5b. Photo:** (view and date)
View from northeast
March 1, 2011
- *P6. Date Constructed/Age and Sources:** historic
1970 (County of Fresno Tax Assessor)
- *P7. Owner and Address:**
CENTER MALL COURT INVESTORS
2720 W SHAW AVE
FRESNO CA 93711-3317
- *P8. Recorded by:**
Historic Resources Group
12 S. Fair Oaks Avenue, Suite 200
Pasadena, CA 91105-1915
- *P9. Date Recorded:**
March 16, 2012
- *P10. Survey Type:**
Intensive

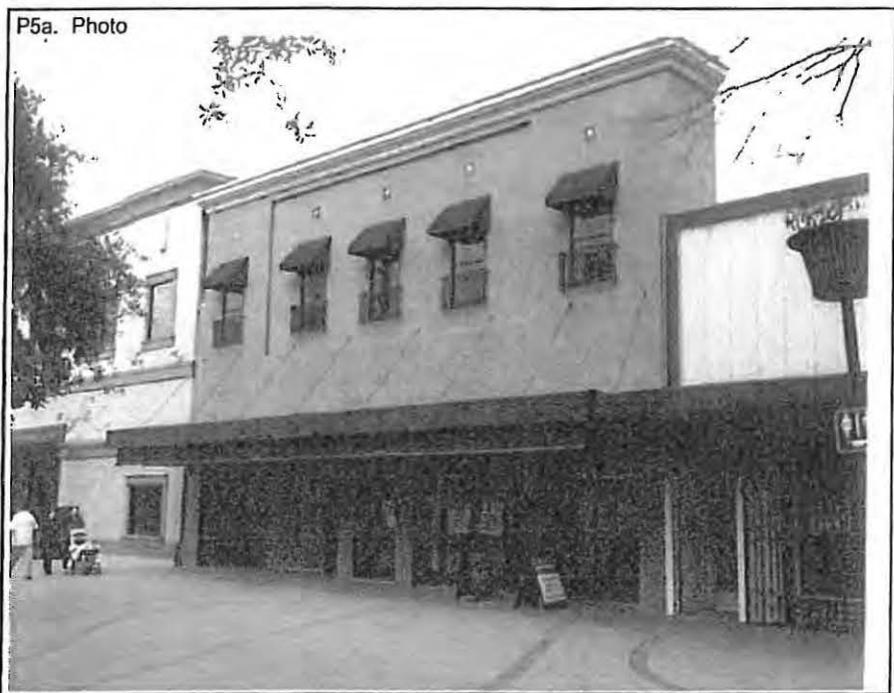
Located on the northeast side of Fulton Mall, near Merced Street, this commercial building is rectangular in plan and capped with a flat roof. The building displays bands of windows and metal-clad exterior walls and corner piers. No major alterations were noted during field observations. In good condition, the property exhibits a good degree of integrity.

- P5b. Photo:** (view and date)
View from southwest
March 1, 2011
- *P6. Date Constructed/Age and Sources:** historic
1970 / c. 2000 (County of Fresno Tax Assessor and Field Estimate)
- *P7. Owner and Address:**
ALAN L & MOIRA L ALLEN
4529 N COLLEGE AVE
FRESNO CA 93704-3808
- *P8. Recorded by:**
Historic Resources Group
12 S. Fair Oaks Avenue, Suite 200
Pasadena, CA 91105-1915
- *P9. Date Recorded:**
April 3, 2012
- *P10. Survey Type:**
Intensive

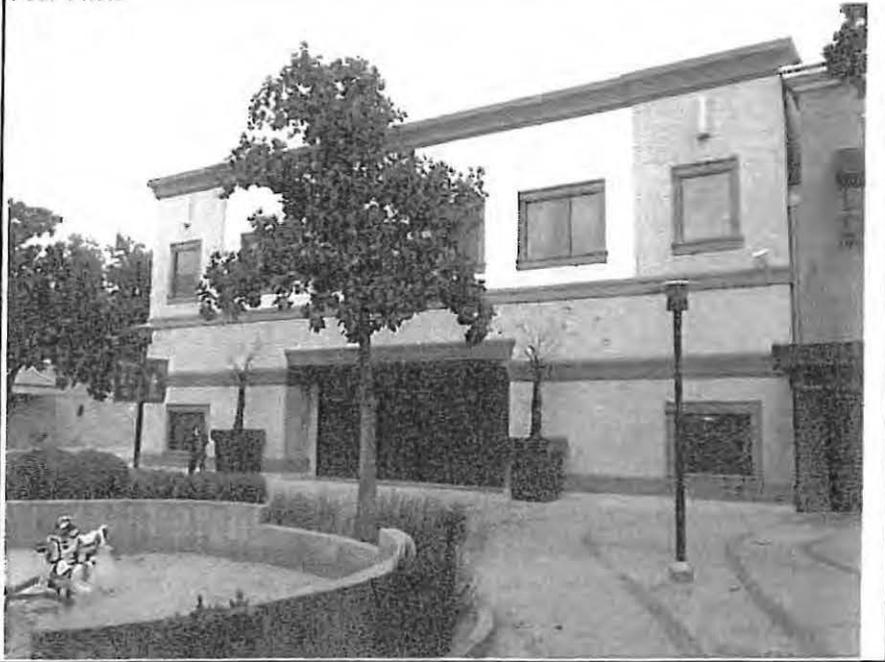
P5a. Photo

Located on the northeast side of Fulton Mall, near Merced Street, this commercial building is rectangular in plan and two stories in height. The façade appears to have been added recently to the building. In good condition, the property exhibits a poor degree of integrity.

P5b. Photo: (view and date)
View from southwest
March 1, 2011

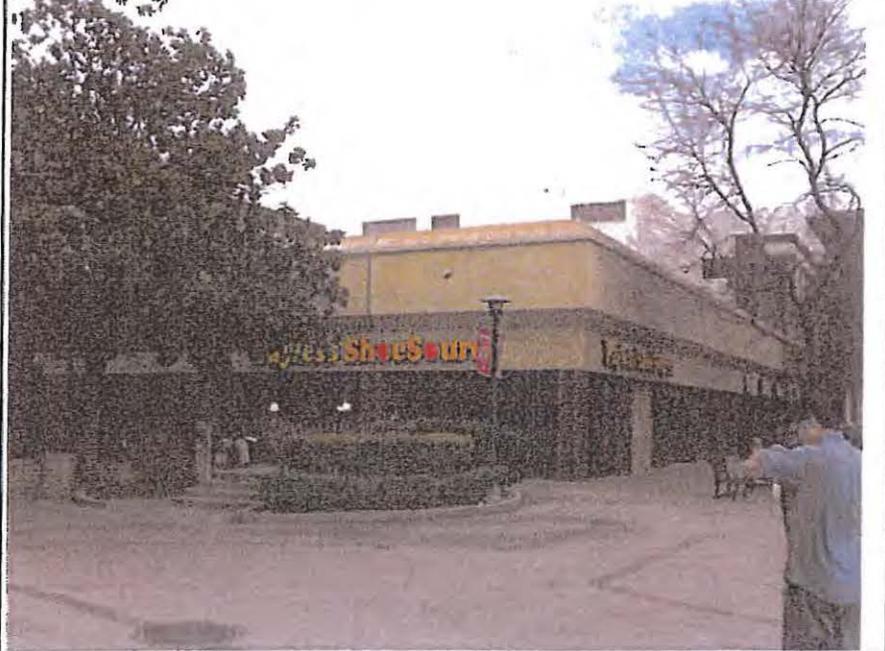
P5a. Photo

Located on the northeast side of Fulton Mall, near Fresno Street, this commercial building is rectangular in plan and capped with a flat roof. The building displays a series of metal-framed windows and paired glass doors along the lower façade, and stucco-clad exterior walls on the upper façade. No major alterations were noted during field observations. In good condition, the property exhibits a fair degree of integrity.

P5b. Photo: (view and date)
View from southwest
March 3, 2011

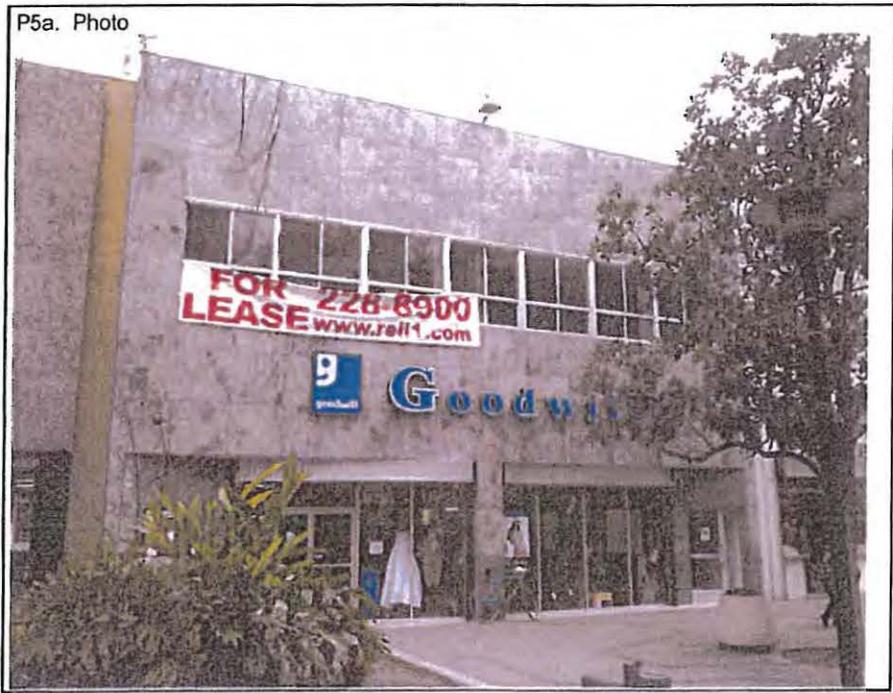
Located on the southwest side of Fulton Mall, near Tulare Street, this two-story commercial building is rectangular in plan and capped with a flat, unelaborated roof. The building displays metal-framed storefront windows and glass doors at sidewalk level. Sided with marble veneer, the façade has a band of multi-light windows on the second story. Alterations to the property include the reconfiguration of the original storefront, as well as the removal of original materials and features, such as wall cladding and doors. Although in good condition, this property does not retain a sufficient level of integrity to convey its significance.

P5b. Photo: (view and date)
View from southeast
March 1, 2011

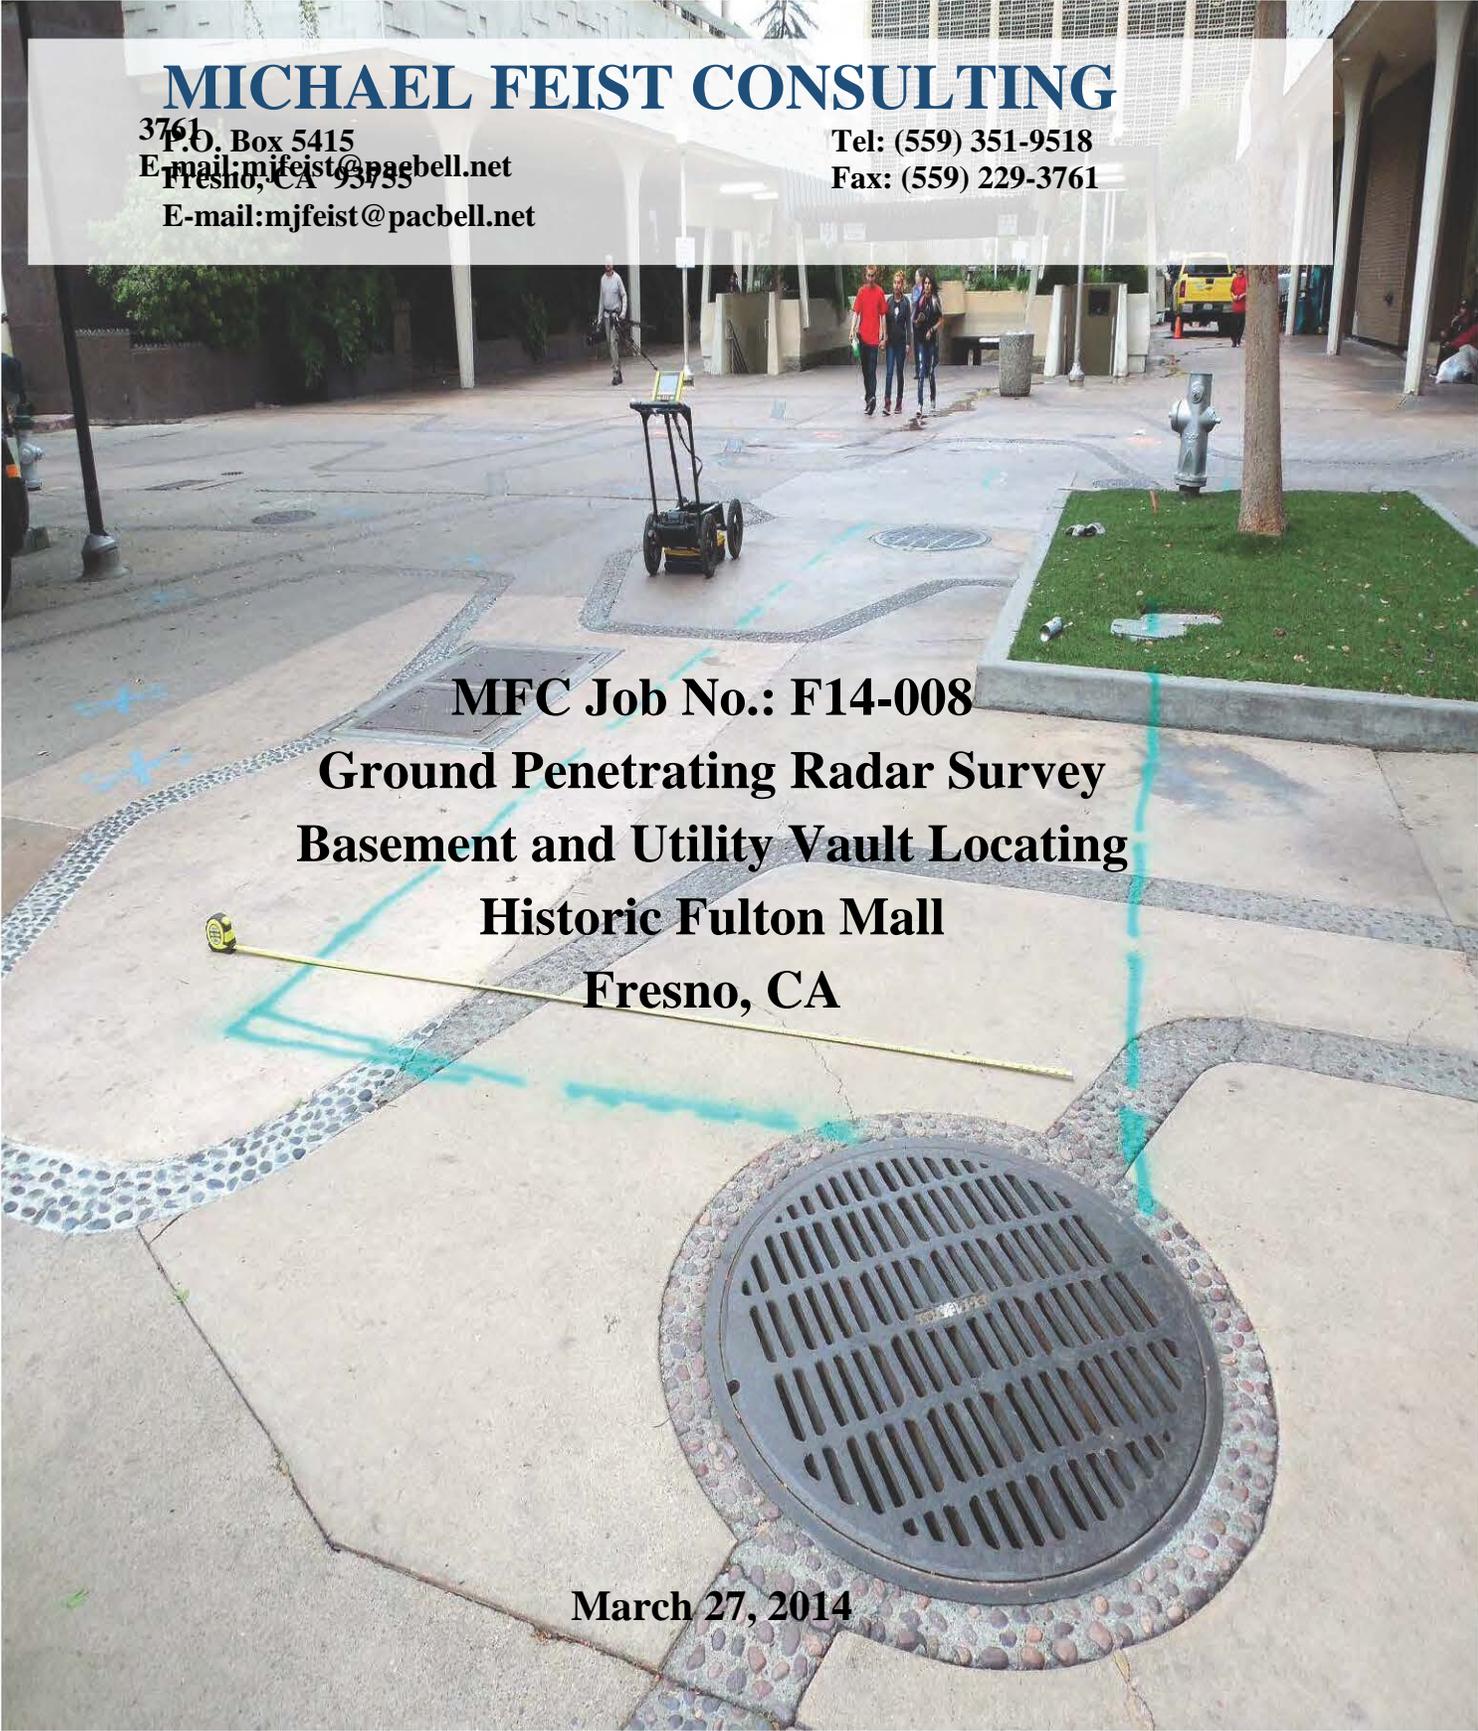
MFC Job No.: F14-008
Ground Penetrating Radar Survey
Basement and Utility Vault Locating
Historic Fulton Mall
Fresno, CA

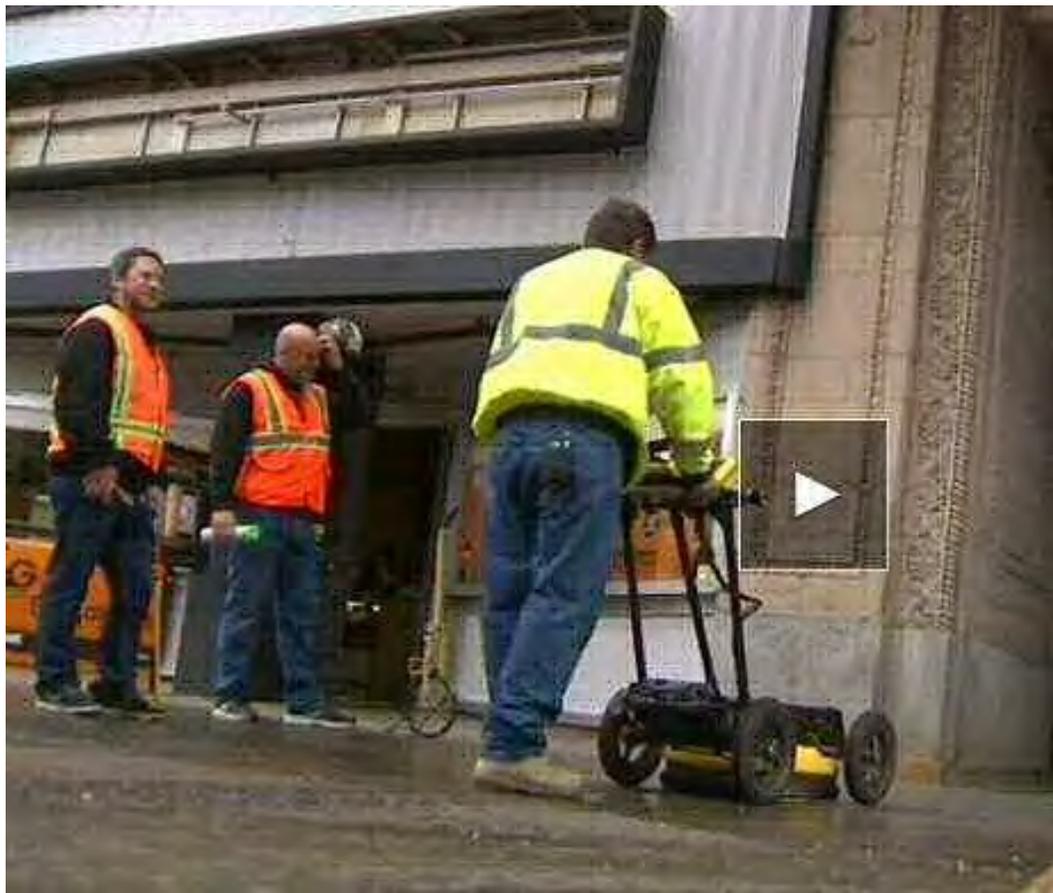
(B)

The basement study consisted of reviewing the prior records for indications of basements. The GPR data was collected using a Sensors & Software NogginPlus GPR system that includes a 250-megahertz transducer and SmartCart acquisition system. A 250 MHz antenna was used during the investigation to provide the greatest possible penetration of the conductive (moist and clayey) near surface sediments. This antenna was selected because it provided the best penetration as well the resolution necessary to meet the project objectives. Figure 3B shows a photograph of the GPR system in use at the site.
