ASBESTOS AND
LEAD-CONTAINING PAINT SURVEY REPORT

ROUTE: 03-SAC-160-L6.98

**Three Mile Slough Bridge (Bridge 24-0121)
Sacramento County, California**

Subject: THREE MILE SLOUGH BRIDGE (BRIDGE 24-0121)
SACRAMENTO COUNTY, CALIFORNIA
CONTRACT NO. 03A1368
TASK ORDER NO. 58, EA NO. 03-4E3801
ASBESTOS AND LEAD-CONTAINING PAINT SURVEY REPORT

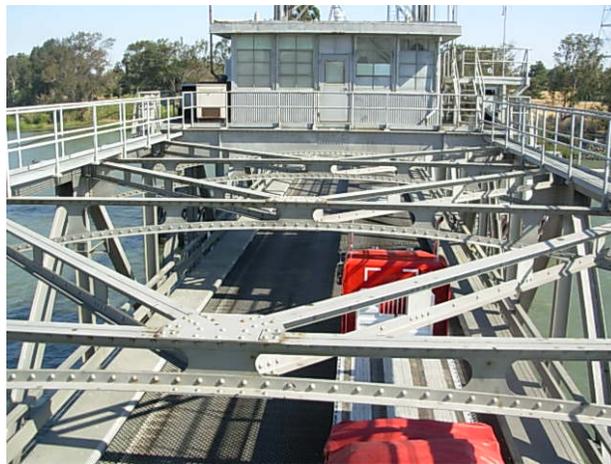
Photo 2 – Bridge house

Chrysotile asbestos at concentrations of 10% and 20% was detected in samples representing approximately 600 square feet of nonfriable cementitious panels used in the bridge house.

Samples representing intact white paint used in the bridge house exhibited total lead concentrations of 73,000 and 87,000 mg/kg and a soluble (TCLP) lead concentration of 110 mg/l.

NESHAP regulations require that asbestos-containing cementitious panels (a Category II nonfriable/nonhazardous material) used in the bridge house be removed and disposed of prior to demolition or other activities that would disturb the material. A licensed and certified asbestos abatement contractor must perform activities that would disturb the panels. For budgetary planning purposes, our opinion of probable abatement costs for the removal, containerization, transportation, and disposal of the asbestos-containing panels is \$10,000.

Geocon also recommends the notification of contractors (that will be conducting demolition, renovation, or related activities) and bridge house employees of the presence of asbestos in their work areas (i.e., provide the bridge house employees and contractor[s] with a copy of this report and a list of asbestos removed during subsequent activities). Contractors and bridge house employees should be instructed not to disturb asbestos during their work.

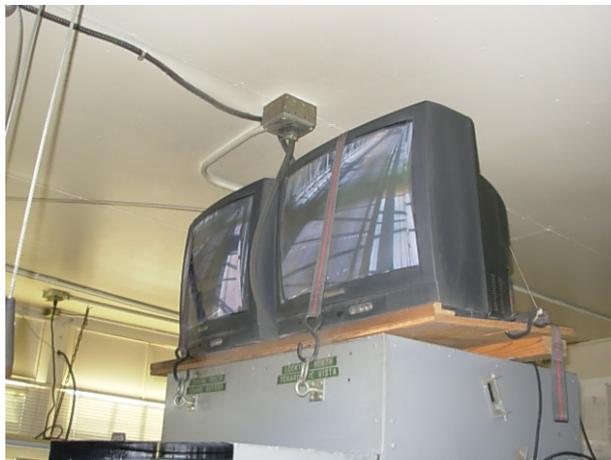
Photo 3 – Bridge house interior

Chrysotile asbestos at a concentration of less than (<) 0.25% was detected in a sample representing nonfriable window putty used on the bridge house. The asbestos content was determined using PLM point count analysis (400 points).

The silver and white bridge LCP and yellow traffic paint LCP identified during our survey would be considered a California hazardous waste if stripped, blasted, or otherwise separated from the substrate. In addition, removed silver and white bridge LCP would be considered a Federal hazardous waste. The white traffic paint would not be considered a California or Federal hazardous waste if stripped, blasted, or otherwise separated from the substrate.

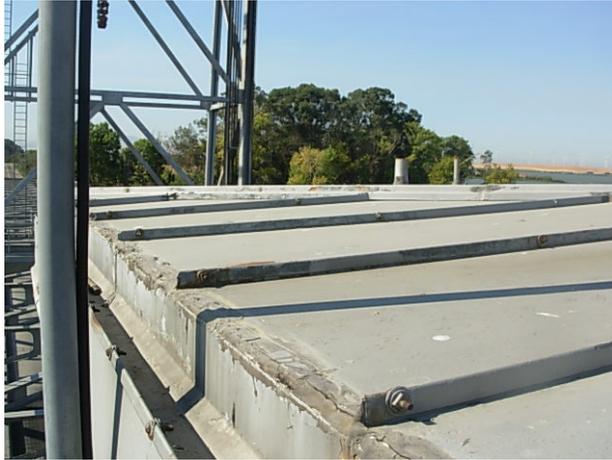
Photo 4 – Bridge house roofing

Chrysotile asbestos at concentrations of 2% and 5% was detected in samples representing approximately 50 square feet of nonfriable roofing mastic used on the bridge house.

NESHAP regulations do not require that asbestos-containing asphalt roofing mastic (a Category I nonfriable/nonhazardous material) or window putty identified during our survey be removed prior to demolition or be treated as hazardous waste. However, the disturbance of these materials is still covered by the Cal/OSHA asbestos standard (Title 8, CCR Section 1529). Contractors are responsible for informing the landfill of the contractor's intent to dispose of asbestos waste. Some landfills may require additional waste characterization. Contractors are responsible for segregating and characterizing waste streams prior to disposal.

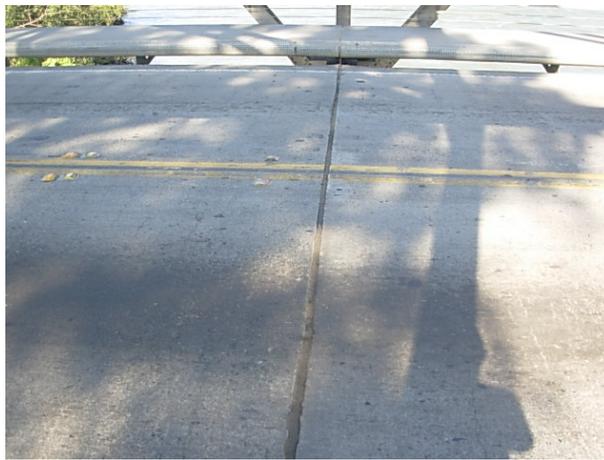
Photo 5 – Bridge deck joint seal (non-suspect)

A sample representing intact white traffic striping on the bridge deck exhibited a total lead concentration of 83 mg/kg and a soluble (WET) lead concentration of 0.38 mg/l.

A sample representing intact yellow traffic striping on the bridge deck exhibited a total lead concentration of 7,300 mg/kg and a soluble (TCLP) lead concentration of 1.7 mg/l.

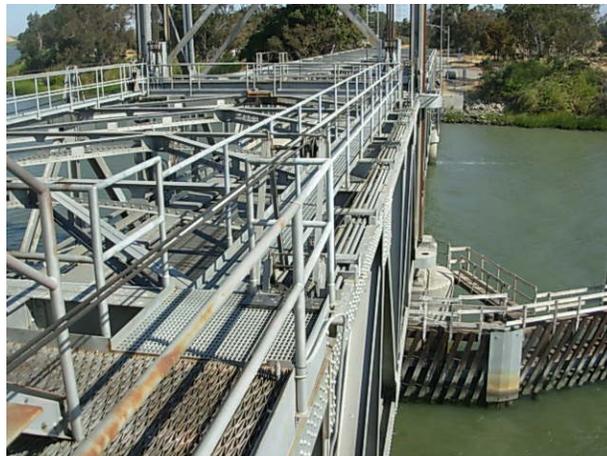
Photo 6 – Superstructure

No asbestos was detected in samples of textured silver paint collected during our survey. A summary of the analytical laboratory test results for asbestos is presented on Table 1. Reproductions of the laboratory reports and chain-of-custody documentation are presented in Appendix A.

Samples representing intact silver paint used on the bridge structural steel exhibited total lead concentrations of 20,000 and 13,000 mg/kg and a soluble (TCLP) lead concentration of 8.3 mg/l.

The Cal/OSHA lead standard will apply to any maintenance, renovation, or demolition activity that disturbs LCP identified during our survey. In accordance with Title 8, CCR, Section 1532.1(p), written notification to the nearest Cal/OSHA district office is required at least 24 hours prior to certain lead-related work.
