U.S. Department of Transportation Federal Highway Administration- California Division- Title 23 Damage Assessment Form (DAF)		DAF No. <input type="text"/> - NAP <input type="text"/> - 0 2 2 - 0	Sheet # 1 of 3 Federal Project # EO ER - ()
		Disaster No. CA <input type="text"/> 1 4 - <input type="text"/> 1 PR ER - ()	
Applicant Napa County Public Works		County Napa Congressional districts 5	Incident Date (mm/dd/yyyy) Inspection 08/24/2014 09/25/2014
Location of Damage: _____ Per Site <input checked="" type="checkbox"/> or <input type="checkbox"/> Per Mile		Federal-aid Highway? Y for yes, if no, ineligible for ER funds <input type="checkbox"/> Y	
Name of Road/Bridge: Silverado Trail Bridge at Taplin Rd		Map No <input type="text"/> 5K13	
PM Begin: 15.35 PM Length: 10.00 PM End: 15.35 (in feet)		Functional Classification Type: MAJOR COLLECTOR	
Road/Bridge Data:	Bridge No _____ Type: Conc Arch & box, stc	Route # _____

SILVERADO TRAIL AT TAPLIN ROAD (REF: District 3, Structure 2) LOP 214; DAF 22 **2/4/2015**

Damage Assessment and Recommendations Report
Silverado Trail at Taplin Rd MP 15.35 Bridge
03/09/15

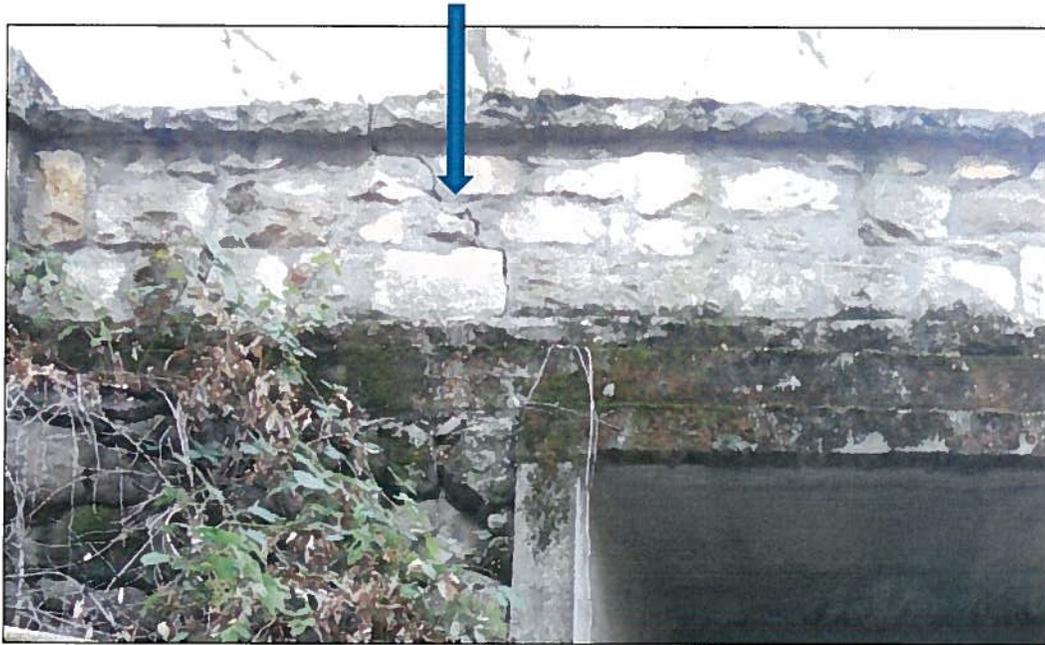
Crack at Stone masonry Barrier

Silverado Trail Bridge consists of 3 different segments. The segments include concrete arch, stone masonry arch, and rectangular concrete box segment. No damage is observed at the bridge structure, other than cracks and missing mortar/stone at the stone masonry barrier at the North side of the structure.

Bridge repair includes replacing the existing stone masonry barrier with concrete barrier slab and concrete barrier. Stone architectural treatment will be applied to the concrete barrier to match the existing stone masonry look.

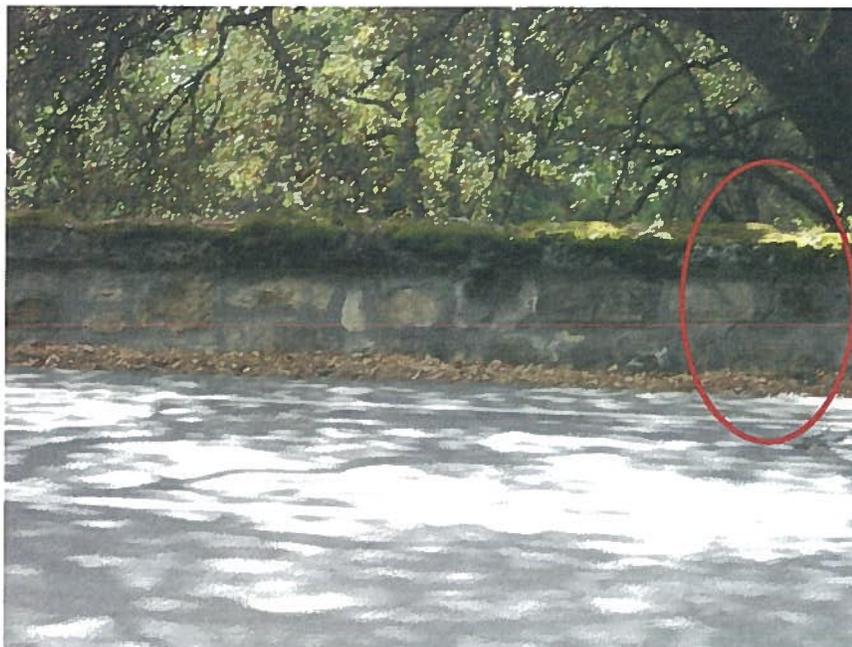
Crack at Stone masonry Barrier
