Phase III Gross Solids Removal Devices Pilot Study: 2002 - 2005

**Final Report
December 2005**

State of California
Department of Transportation

CTSW-RT-05-130-03.1

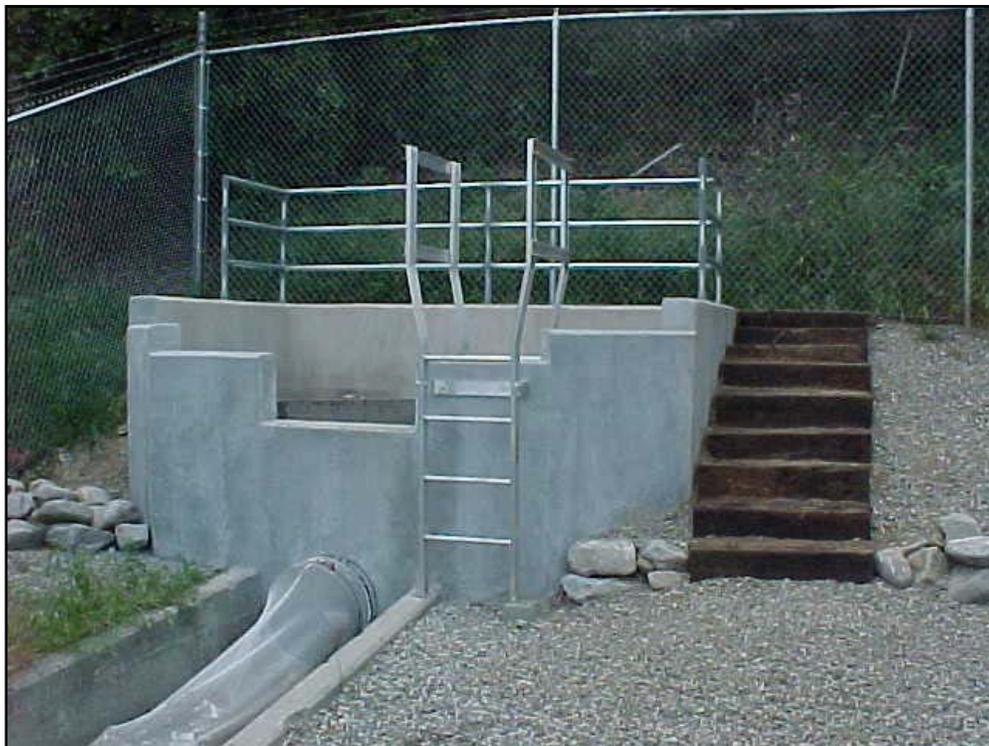
Figure 3-2
VS1 I-405 After Installation

- Two inlets located along the freeway shoulder and 1 inlet along the freeway centerline
- One outlet, 450 mm (18 in) in diameter
- Drainage area of approximately 1.2 ha (3.0 ac)

The site is a grassy parcel in the Caltrans right-of-way below the sound wall along southbound Interstate 405. An existing Baffle Box was demolished and removed for the installation of the Phase III GSRD.

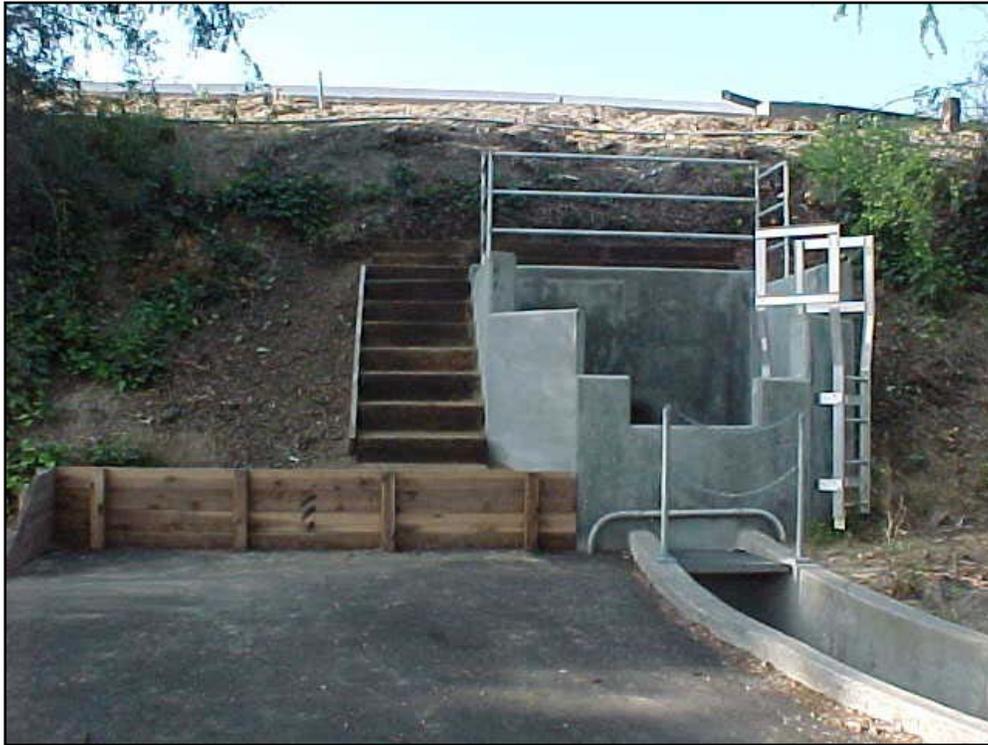
Figure 3-3
VS2 SR-91 After Installation

- Drainage area of approximately 0.8 ha (2.0 ac)

The site is a sloped, ivy-covered parcel in the Caltrans right-of-way below the edge of traveled way on westbound SR-91. The site was selected due to: (1) adequate space available within the ROW; and (2) convenient access from secondary streets.

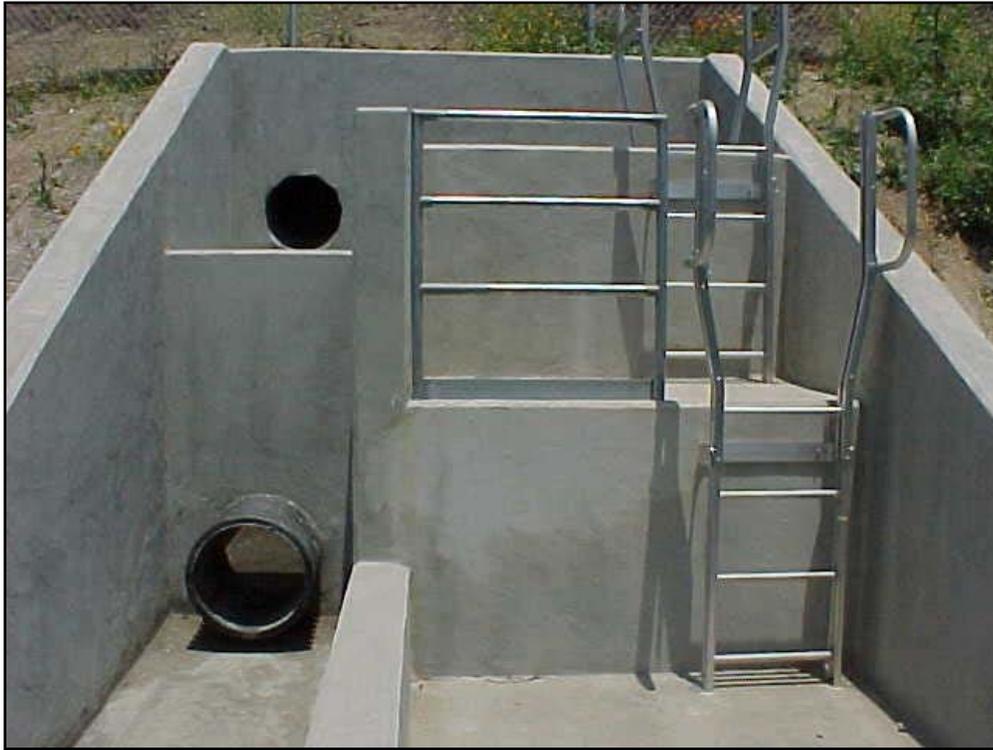
**Figure 3-4
IS4 I-210 After Installation**

- Three inlets located along the freeway shoulder
- One outlet, 450 mm (18 in) in diameter
- Drainage area of approximately 1 ha (2.5 ac)

The site is a sloped, grassy parcel in the Caltrans right-of-way below the sound wall on eastbound Interstate 210. An existing Baffle Box was demolished and removed for the installation of the Phase III GSRD.

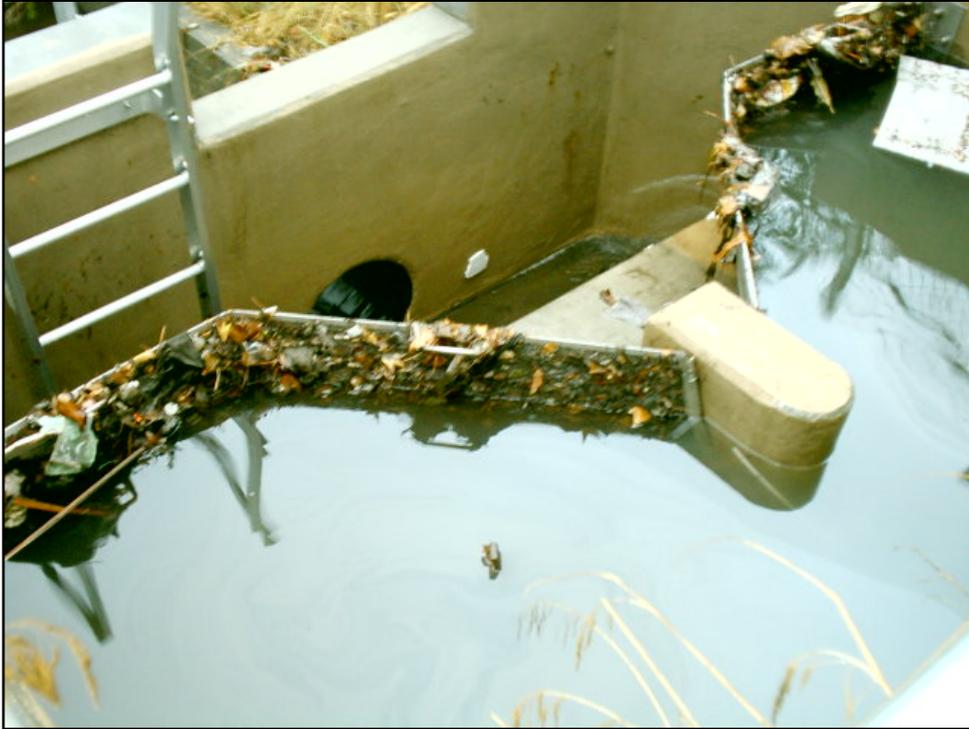
Figure 4-1
VS1 I-405 During Monitoring

During the 2004-05 storm season, the VS1 I-405 was inspected eight times and cleaned once when the screen modules were removed. During the first two storms of the season, the screens were observed to be completely blinded by a layer of solids, resulting in storm water overflowing the top of the screens (see Figure 4-1). As a result, large amounts of gross solids filled the bypass bag, causing it to become detached from the downstream pipe. The 4-foot bypass bag was replaced with an 8-foot bag. The gross solids from the 4-foot bag were transferred to the 8-foot bag. The second storm of the season resulted in the 8-foot bypass bag being full of gross solids (Figure 4-2). The screen modules were cleaned after the first two storm events to remove solids and allow normal flow of water. The solids removed from the screens were placed in the solids storage portion of the GSRD.

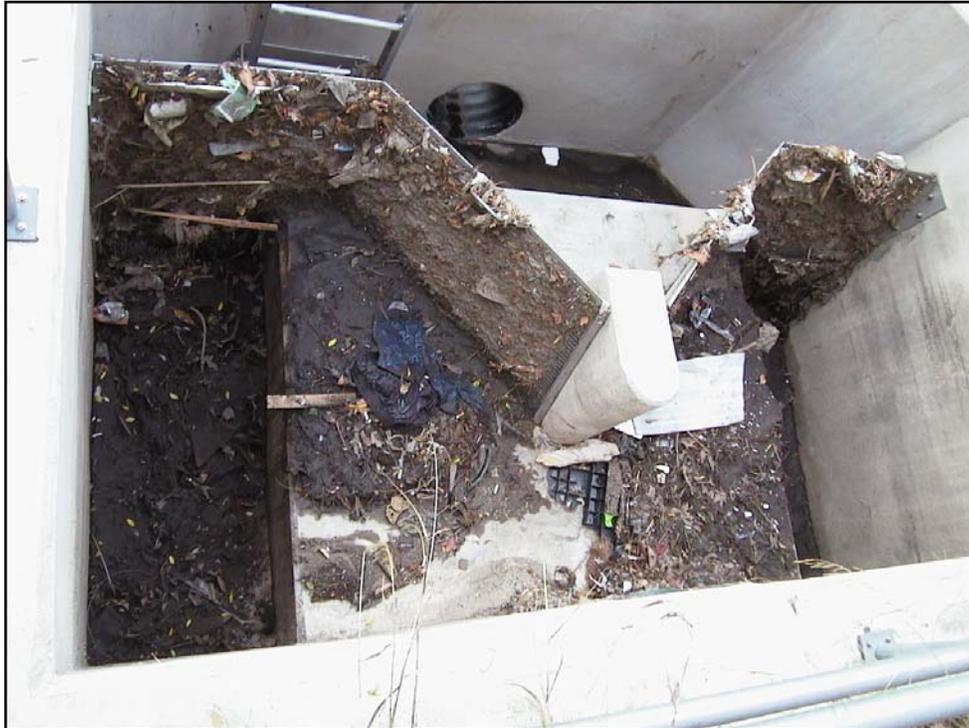
Figure 4-3
VS1 I-405 Before Cleaning and Removal of Screens

Despite the complete blinding of the screens (Figure 4-3) and overflow of storm water, standing water did not appear to be a problem as the device was observed to drain in less than 24 hours.

As discussed in section 4.3.3, IS4 I-210 had no observable problems with clogging or blinding. As discussed in Section 4.3.1 and 4.3.2, the VS1 I-405 and VS2 SR-91 GSRDs experienced observable problems with clogging and blinding of the screen modules. The screen in the VS1 I-405 became completely blinded by a layer of gross solids, which caused storm water to flow over the top of the screen. At VS2 SR-91, the lower portion of the screen became partially clogged, resulting in slow drainage of water through the screen.

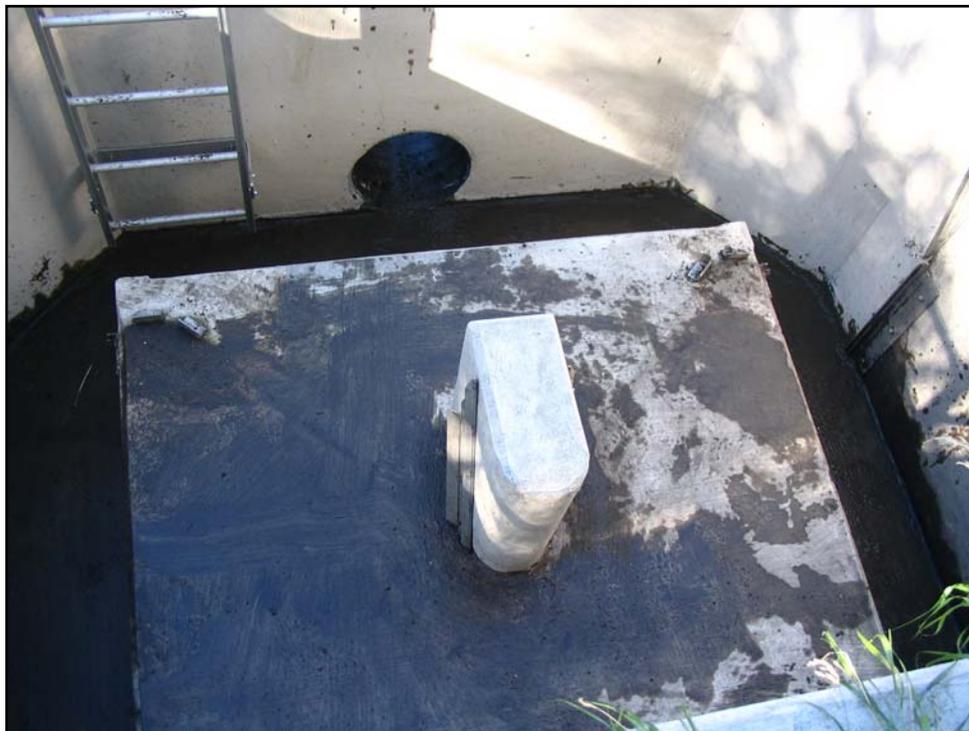
Figure 4-4
VS1 I-405 After Cleaning and Removal of Screens

On November 30, 2004, the screen modules were removed, the device was cleaned (Figure 4-4).

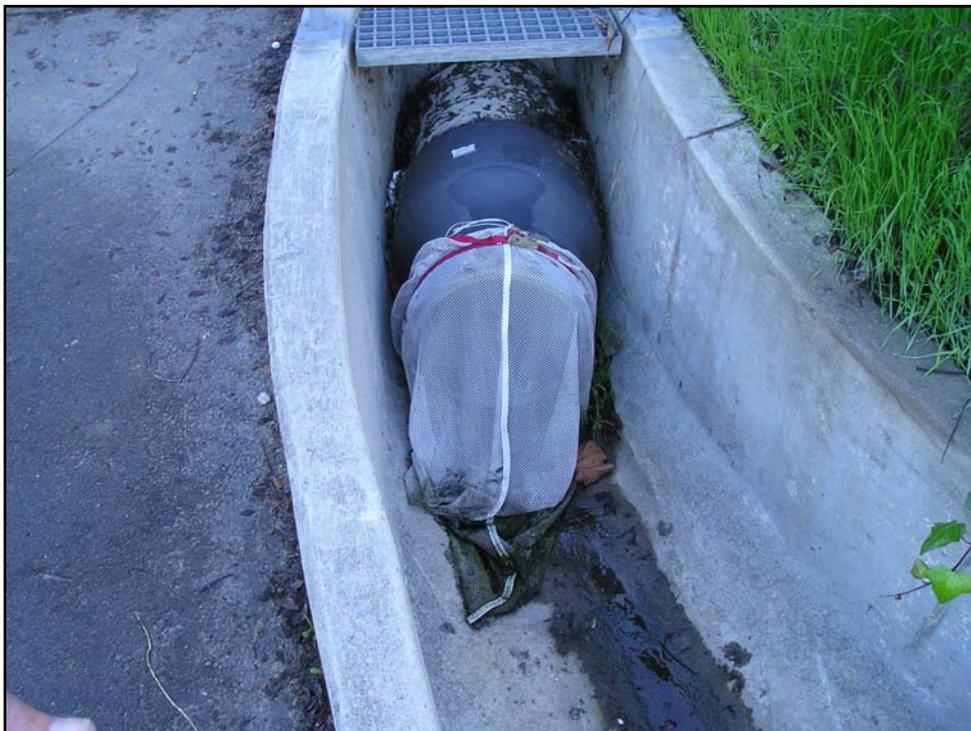
Figure 4-6
VS2 SR-91 During Monitoring

During the 2004-05 storm season, the VS2 SR-91 was inspected 12 times and cleaned once at the end of the season. No interim cleanings were required for this site. The lower portion of the screen module became clogged with gross solids, causing water to drain slowly through the GSRD (see Figure 4-5). Standing water behind the screen generally took more than 72 hours to drain from the GSRD following storm events. There was no evidence that water or gross solids larger than 5 mm (0.2 in.) overflowed the screen. Figures 4-7 and 4-8 show the site before and after the end of season cleaning.

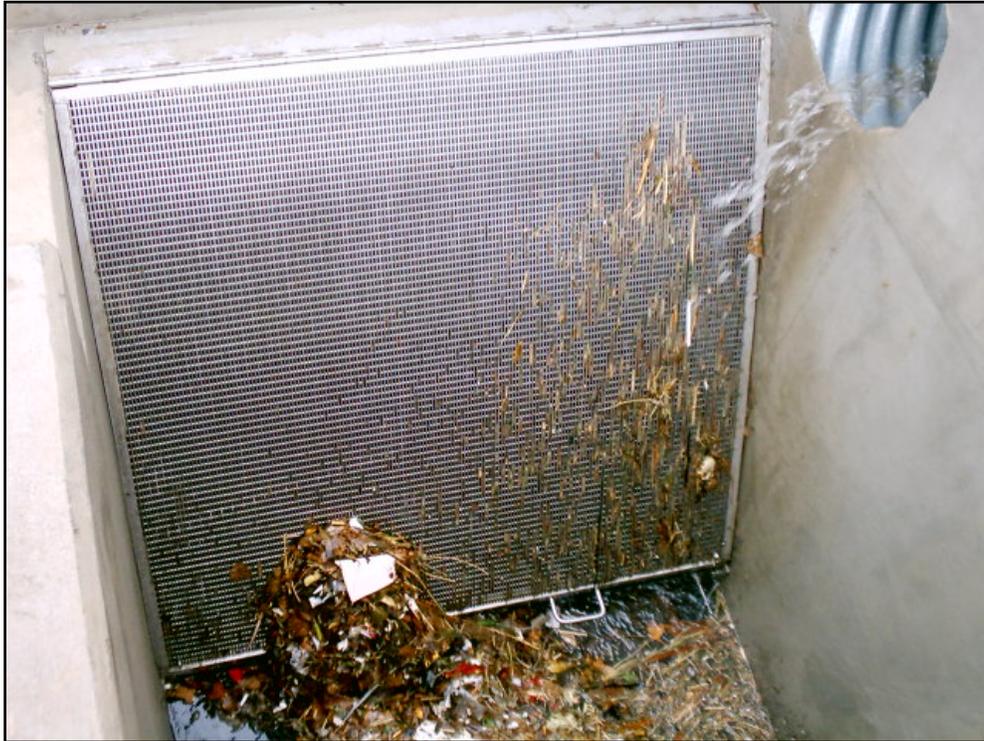
Figure 4-9
IS4 I-210 Screen During Monitoring

During the 2004-05 storm season, the IS4 I-210 was inspected 12 times and cleaned once at the end of the season. No interim cleanings were required for this site. There was no evidence that water or gross solids larger than 5 mm (0.2 in.) escaped the GSRD. The bypass bag trapped gross solids smaller than 5 mm (0.2 in.), while the lower portion of the inclined screen was observed to have vegetation caught on it (see Figure 4-9). However, the screen did not appear to be clogged, and the device appeared to be performing as designed. The IS4 I-210 did not encounter any other operational or performance problems. However, due to the large amount of sediment at this site, weed seeds sprouted and began growing in the sediment in the gross solids capture area and in the bypass bag (see Figure 4-10). During the end of season cleaning, on May 25, 2004, the bypass bag contained sediment, but no gross solids. Figures 4-11 and 4-12 shows the site during and after the end of season cleaning. There was a small quantity of sediment (< 1 cu.ft.) located beneath the screen which was subsequently removed during the end of season cleaning.

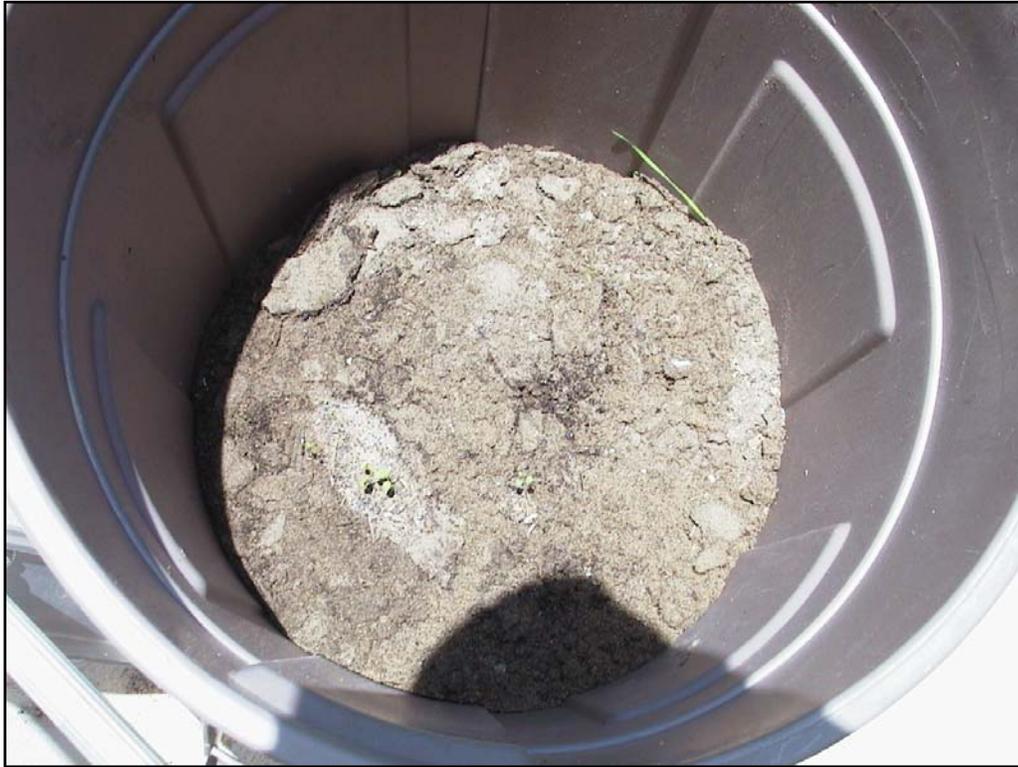
Figure 5-1
IS4 I-210 Bypass Material

For the 2004-05 season, the reported capture efficiency for the IS4 I-210 is 46 percent by weight and 67 percent by volume. However, the material collected in the bypass bag was completely sediment, as seen in Figure 5-1. Since sediment is not a target constituent of the Trash TMDLs, the IS4 I-210 capture efficiency should be 100 percent by weight and volume.
