Route 58 - Westbound  
KP R189.9 to KP R207.6

## NEW CONCRETE PAVEMENT

**DISTRICT 6**  
Kern County  
Route 58

**CONTRACT NUMBER:**  
06-396704

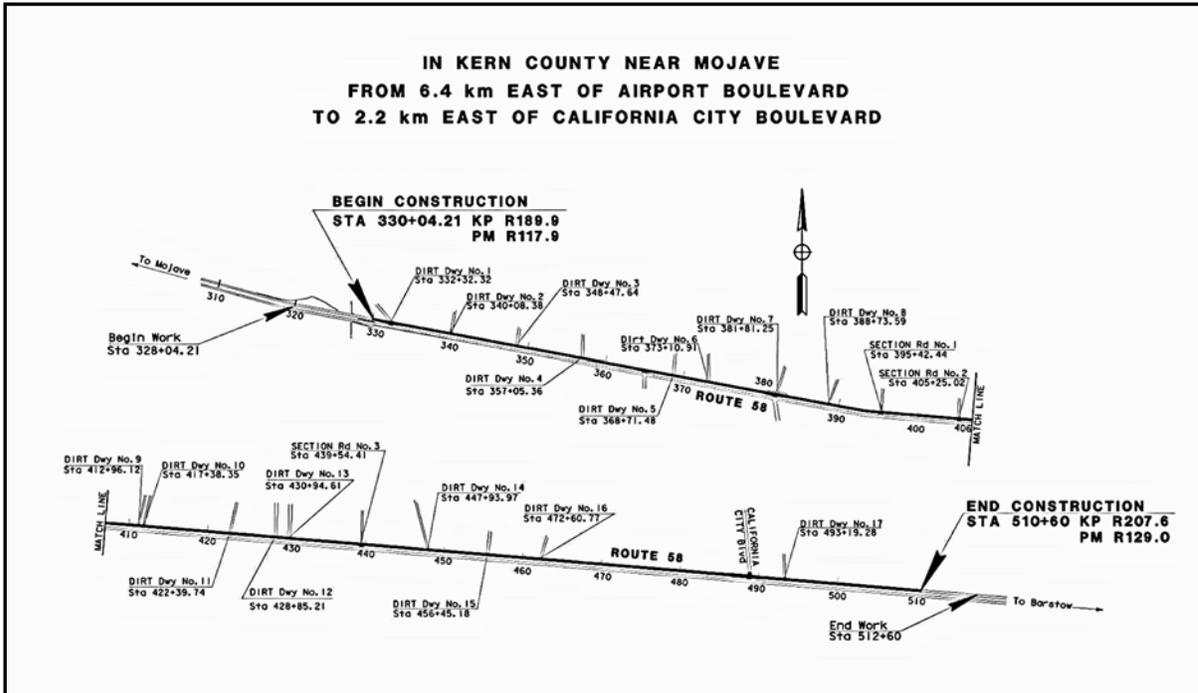
Figure 2. Project Limits

This project is reconstructing a 18.1-km long segment of Route 58 by removing the asphalt concrete (AC) pavement in the existing westbound travel way, lanes 1 and 2, and replacing it with portland cement concrete (PCC) pavement. The project limits extended from 6.4 km east of Airport Boulevard (Station 330+04.21) to 2.2 km east of California City Boulevard (Station 510+60) (Station 510+60).

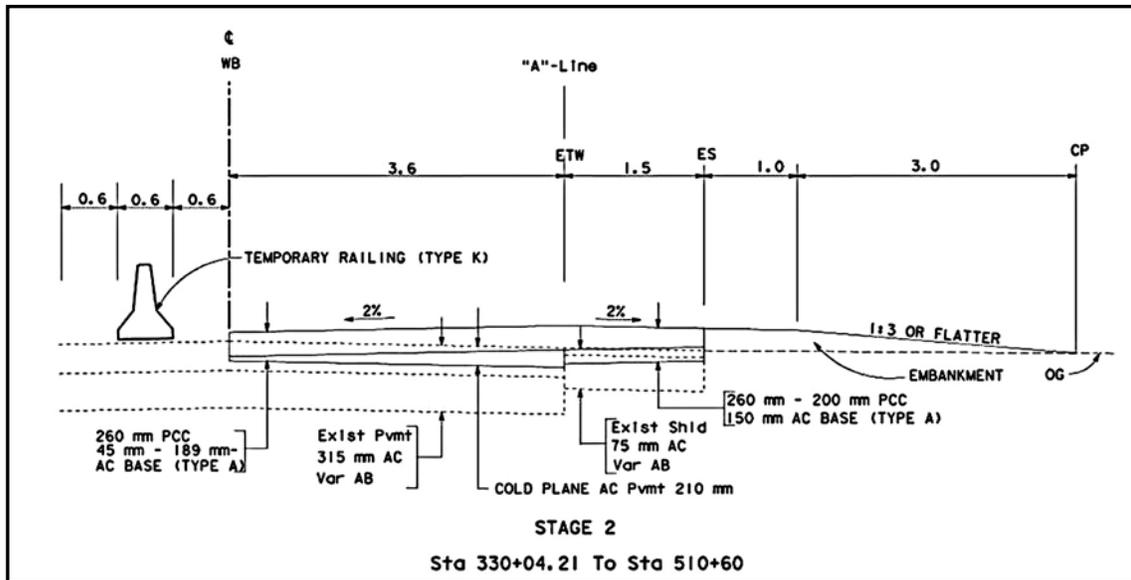
**Figure 3.** Stage 2 – Pavement Structural Section

Stage 2 is the reconstruction of lane 1 and the inside shoulder with PCC pavement from station 330+04.21 to Station 510+60 (Figure 3). The existing structural section for lane 1 and the shoulder consisted of AC pavement on an aggregate base (AB). The AC pavement was 315-mm thick in lane 1 and 75-mm thick in the shoulder. The new section for lane 1 is PCC, 260-mm thick, and an AC base (Type A) varying in thickness from 45 to 189-mm over the cold-planed AC. The inside shoulder has PCC with a thickness that varies from 260 to 200-mm with an AC base (Type A), 150-mm thick, over the cold-planed AC. All construction work is behind k-rail.

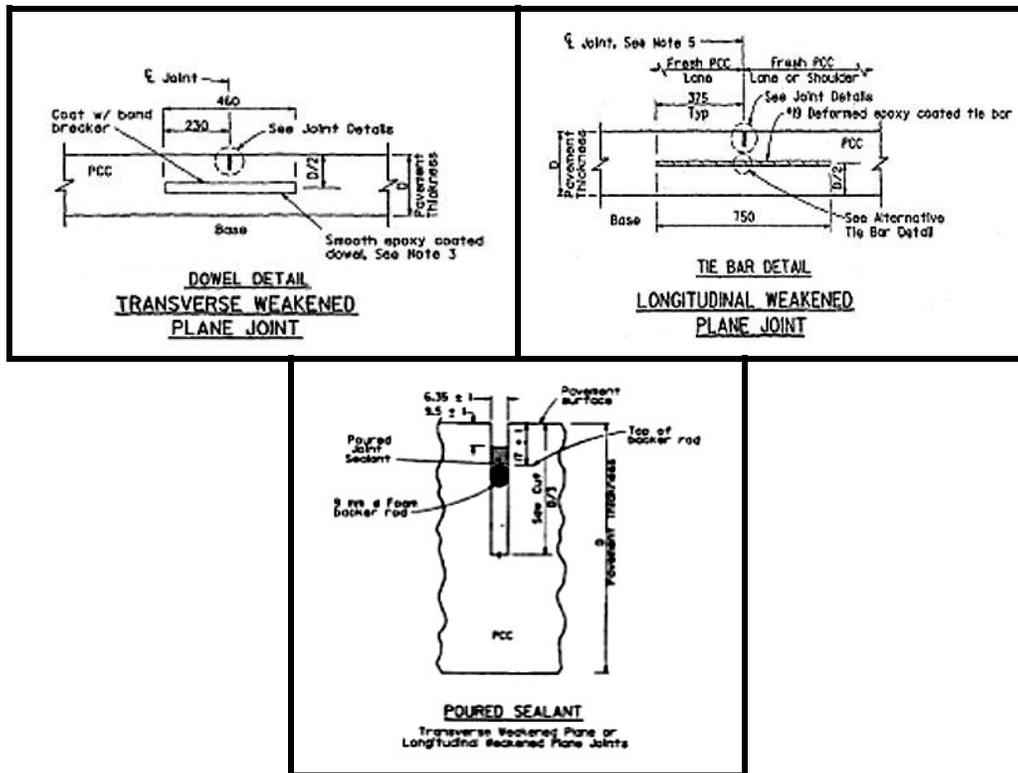
**Figure 4.** Miscellaneous Joint Details

The longitudinal joint between lane 1 and the shoulder is required to have tie bars and be constructed by the sawing method. The tie bars specified are epoxy-coated #19 deformed bars, 750 mm long. Tie bars are spaced at 710-mm intervals, on center, and at least 380-mm from transverse joints (Figure 4).

The transverse joints are also to be constructed by the sawing method, except at the contact joints. Only the transverse joints in lane 1 are required to have dowel bars, those in the shoulder do not. The dowel bars specified are 460-mm long, 38-mm diameter epoxy-coated smooth bars evenly spaced at 300-mm intervals, on center.

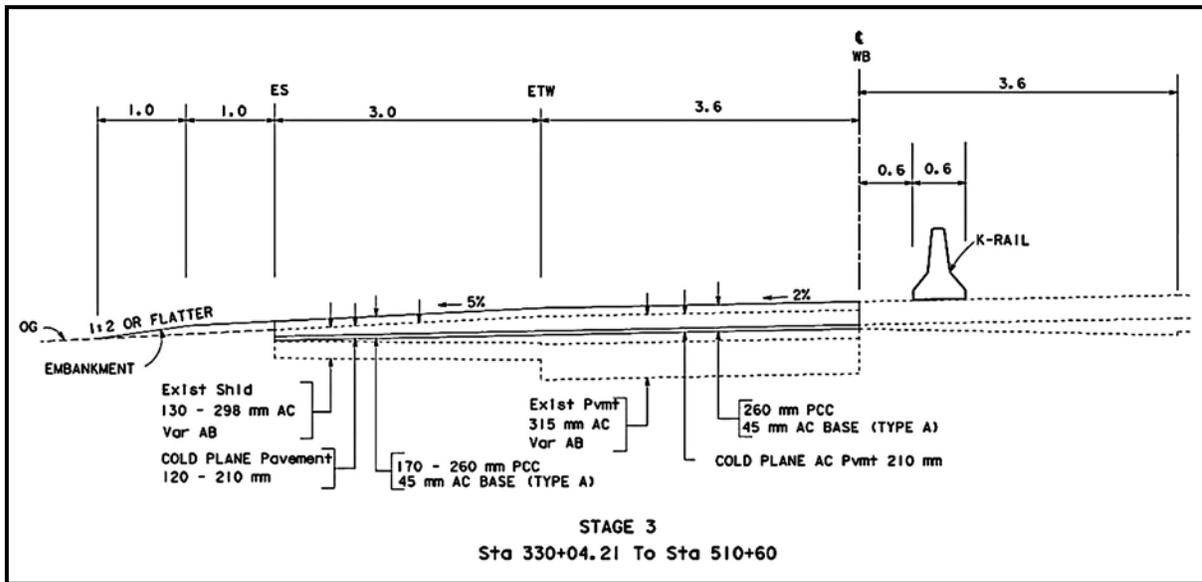
**Figure 5.** Stage 3 – Pavement Structural Section

Stage 3 is the reconstruction of lane 2 and the outside shoulder with PCC pavement from station 330+04.21 to Station 510+60 (see Figure 5). The existing structural section for lane 2 and the shoulder consisted of AC pavement on an AB. The AC pavement was 315-mm thick in lane 2 and varying from 130 to 289-mm thick in the shoulder. The new section for lane 2 is also PCC, 260-mm thick, with an AC base (Type A), 45-mm thick, over the cold-planned AC. The outside shoulder is PCC with a thickness that varies from 260 to 170-mm with an AC base (Type A), 45-mm thick, over the cold-planned AC. All construction work is behind k-rail.

Tie bars are required in the longitudinal joint between lanes 1 and 2, and between lane 2 and the outside shoulder. The longitudinal joint between lane 2 and the outside shoulder is to be constructed by the sawing method. The tie bars between the lanes are drilled and bonded into the pavement of lane 1 prior to placing the concrete for lane 2. Only the transverse joints in lane 2 are required to have dowel bars, those in the shoulder do not.

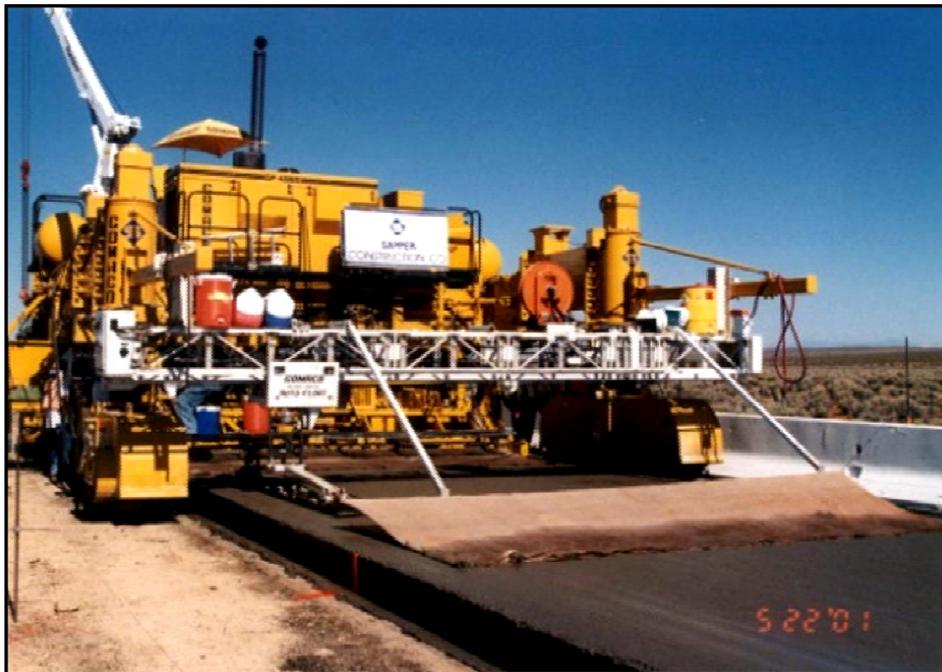
**Figure 6.** Concrete Placement

The test strip for Stage 2 was placed on Tuesday, May 22, 2001. Paving operations began at approximately 8:45 a.m. The concrete was placed monolithically at a width of 5.1-m (3.6 m for lane 1 and 1.5 m for the shoulder) in the direction of travel (Figure 6).

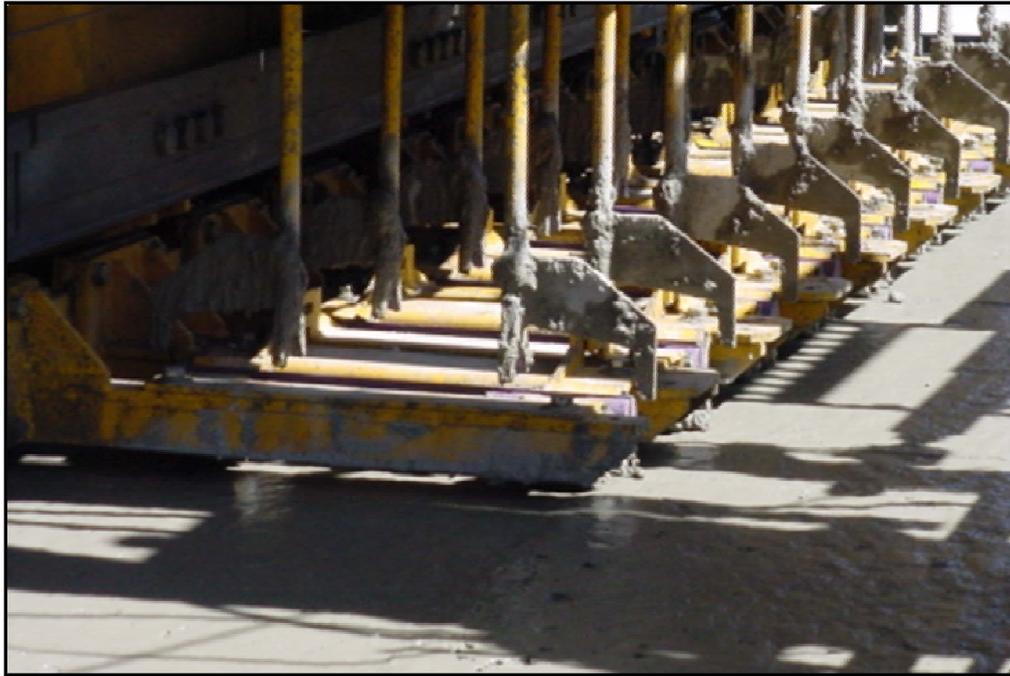
**Figure 7.** Dowel Bar Inserter

Tie bars and dowel bars were placed using inserters (Figure 7). The dowel bar inserter was computer controlled and programmed to insert the dowels automatically at the required joint spacing of 3.6, 4.0, 4.3, and 4.6-m. The insertion of the tie bars between the inside shoulder and lane 1 was similarly controlled.

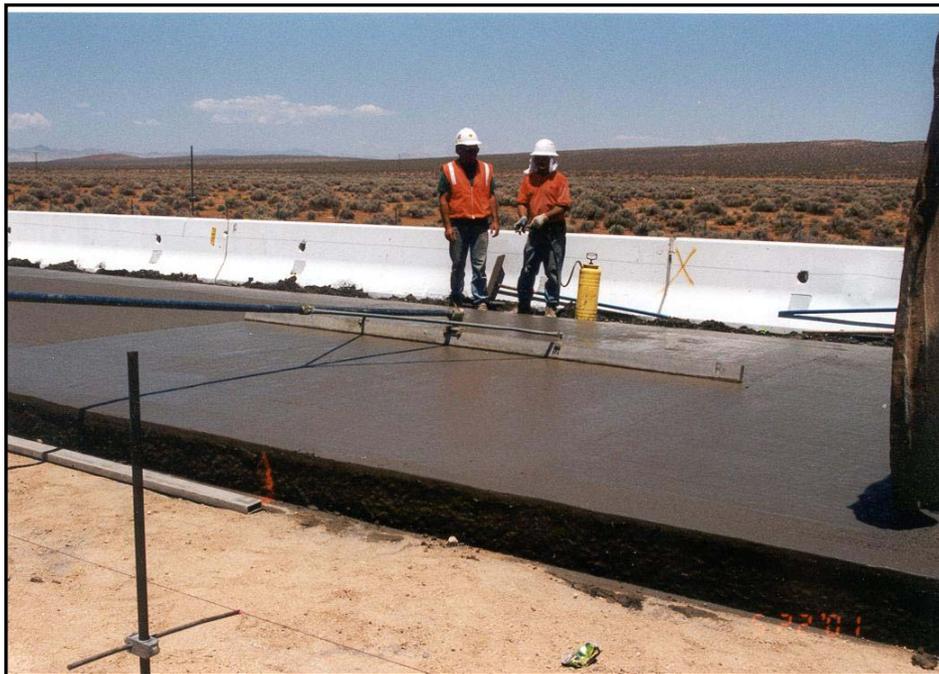
**Figure 8.** Finished Concrete

The paving crew and foreman were favorably impressed with the workability of the concrete and ease with which it could be finished (Figure 8).

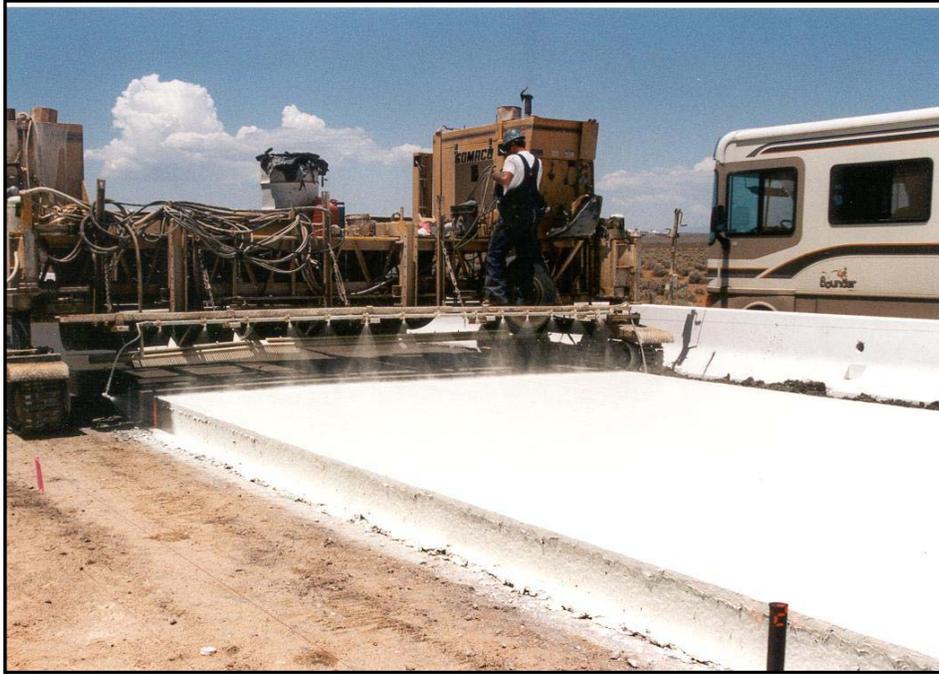
**Figure 9.** Curing Compound Application

Shortly after finishing and tine texturing the pavement, the curing compound was applied. The application was even and thoroughly covered the concrete surface (Figure 9). The standard specifications require the curing compound application rate to be  $3.7 \pm 0.5$  square meters per liter. The application rate, measured in accordance with California Test 535, was determined to be within this range.

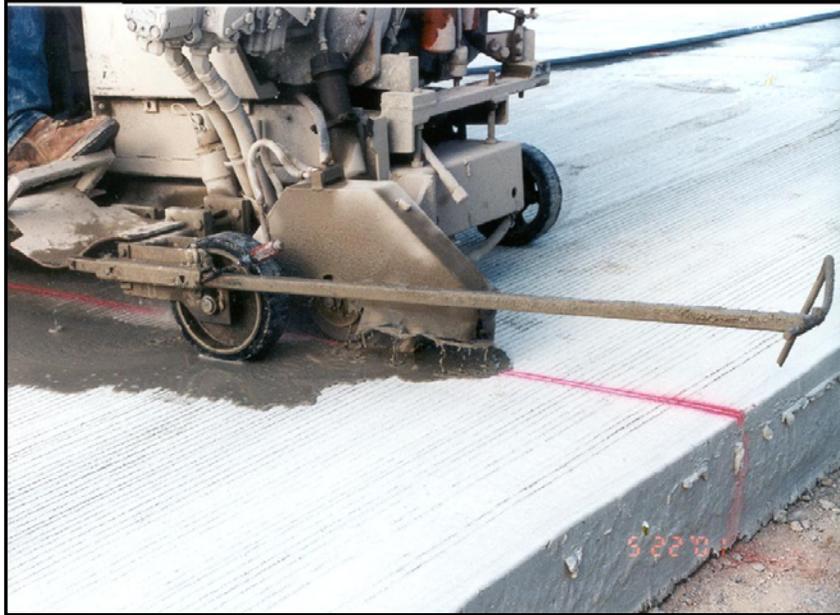
**Figure 11.** Saw Cutting Joints

Eight to twelve hours after placement, the transverse joints were initially saw cut using a 3-mm wide, single blade to prevent unnecessary spalling (Figure 11). Longitudinal joints were usually cut within 15 hours. The joints were later saw cut again to required shape and to widen the joint opening to 6 mm.

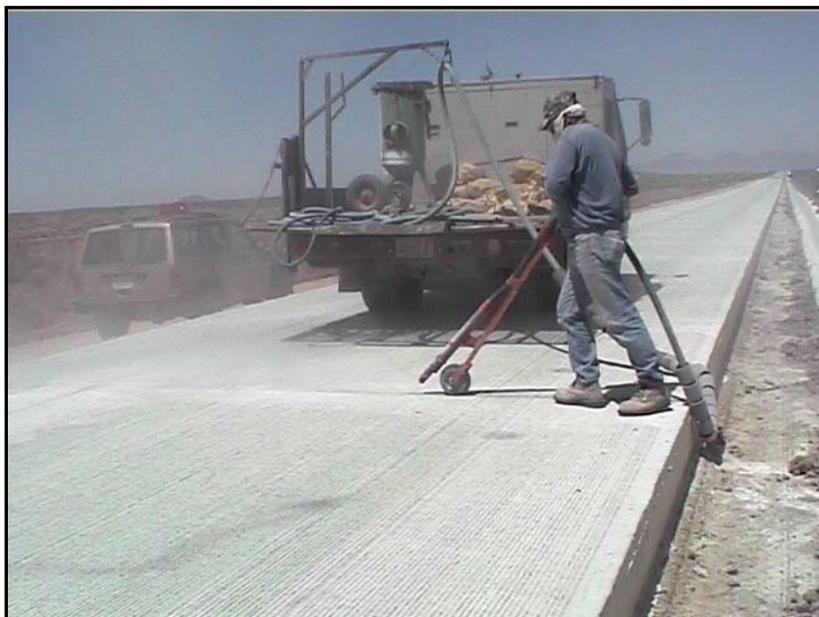
**Figure 12.** Sand Blasting Joints

The slurry was washed away to minimize buildup of unwanted contaminants in the joint. After the widened joints had dried, they were simultaneously sand blasted and air blasted to remove any remaining residue and clean the inside of the joint.

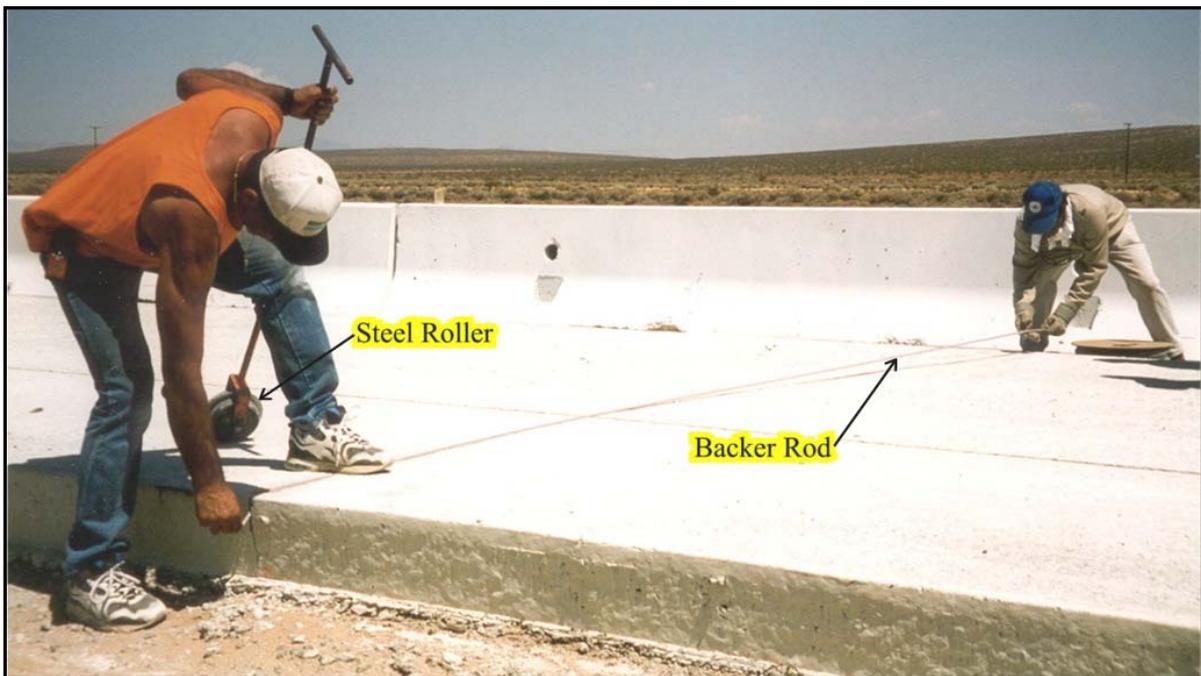
**Figure 14.** Backer Rod Installation

After the joint has been cleaned and prepared, the backer rod was installed. A double-wheeled steel roller was used to push the backer rod into the joint and place it at the desired depth.

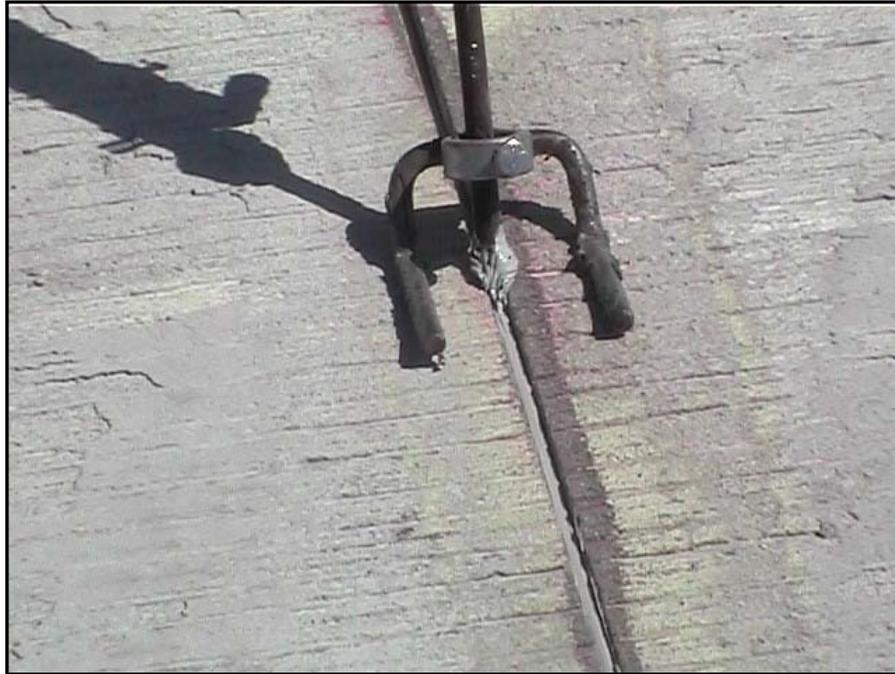
**Figure 15.** Applying Joint Sealant

Once the backer rod was securely placed in the joint, the silicone sealant was applied. Sealant was applied into the joint with a nozzle to ensure the joint is filled uniformly

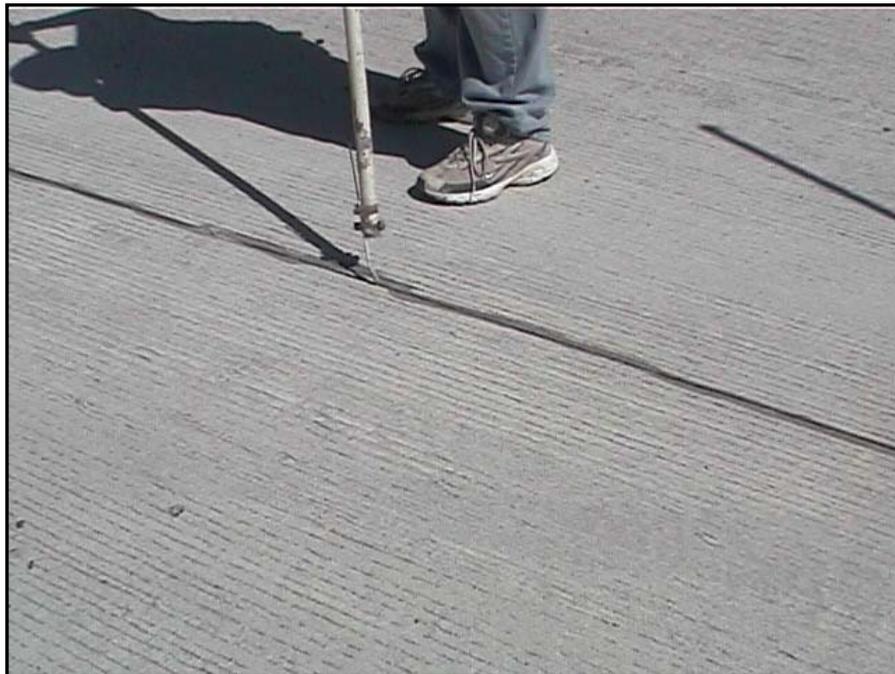
**Figure 16.** Tooling the Joint Sealant

The sealant was also tooled to make sure contact is made with the sides of the joint and the desired shape is obtained.

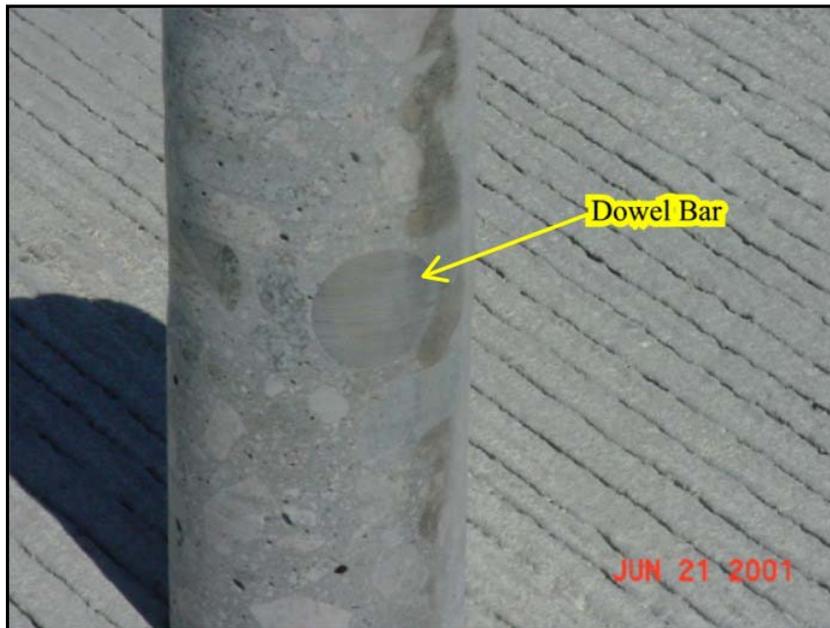
**Figure 17.** Core Sample by Contractor

On Thursday, June 21, 2001, a second site visit was made. The resident engineer made available some core samples taken by the contractor. The cores showed that the concrete was well consolidated throughout.

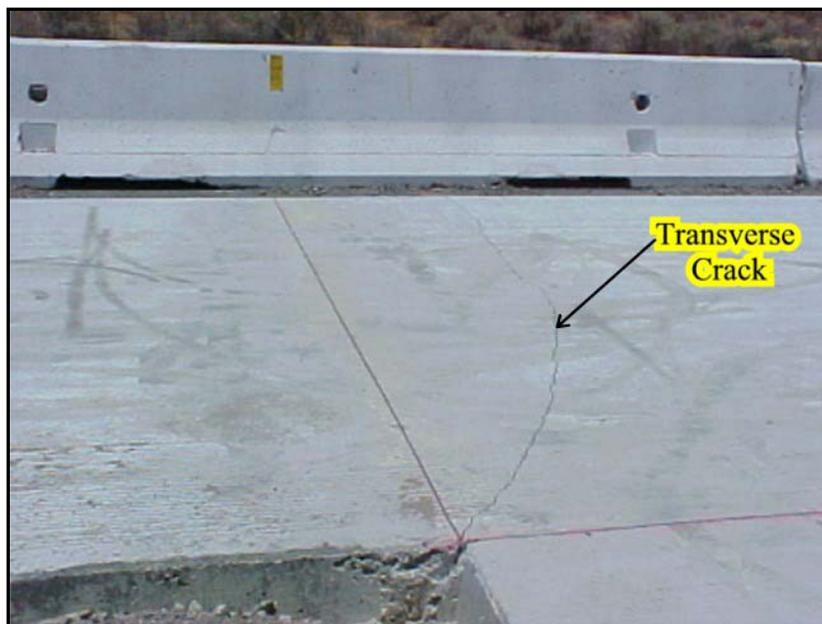
**Figure 18.** Transverse Crack at Formed Corner

A total of 18,000 linear meters of concrete pavement were placed during Stage 2, only minor distresses developed. Two transverse cracks were observed. The cracks developed as a result of late saw cutting. Also, some limited plastic shrinkage cracks developed.

The crack shown in Figure 18 is due to the stress raising effect of the formed inside corner. It began at the formed corner and extended the entire width of the concrete panel. The crack was measured to be about 5 mm wide. At formed corners, the timing of the saw cut is very critical. The repair strategy was to remove the damaged section of the concrete and replace it with a new panel, including dowel bars.

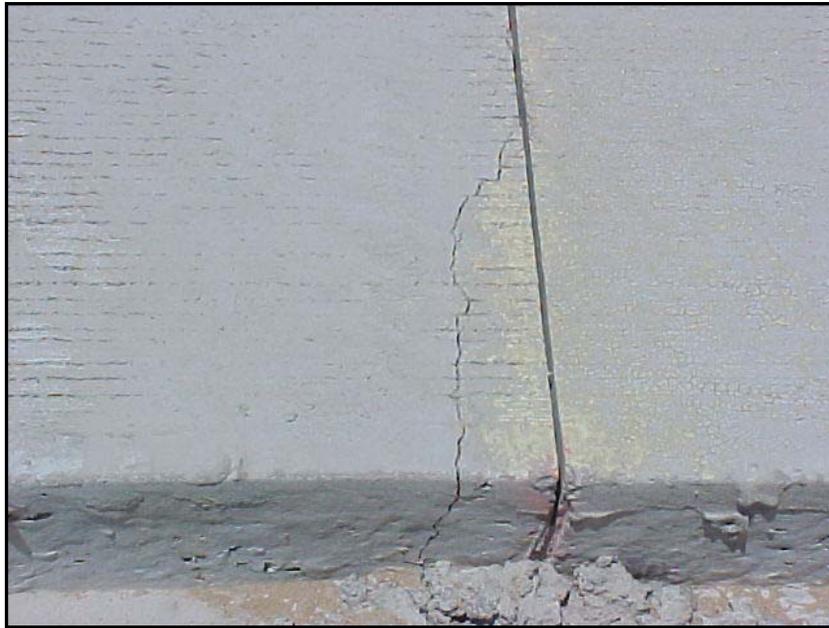
**Figure 19.** Runaway Transverse Crack

The other crack developed along a transverse joint approximately 300 mm from the edge of the inside shoulder (Figure 19). This crack was routed, cleaned and sealed.

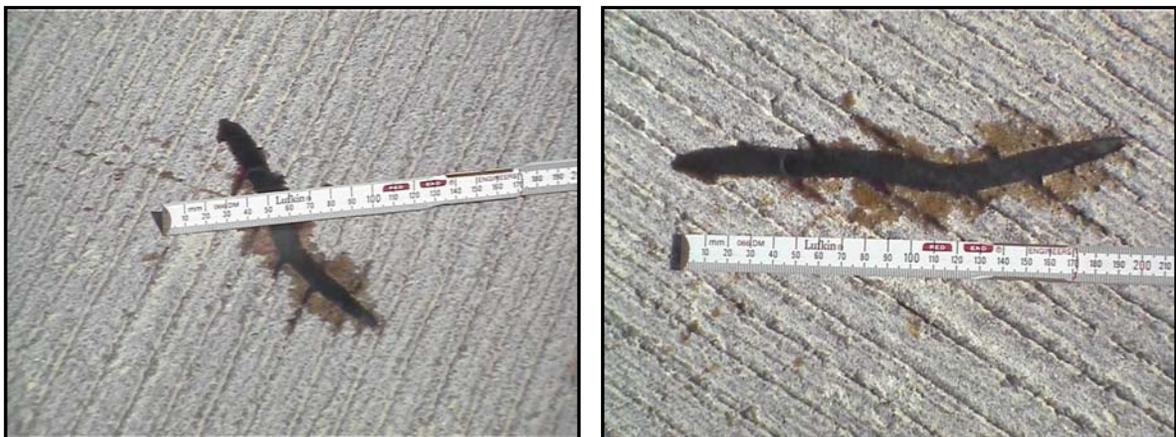
**Figure 20.** Repaired Plastic Shrinkage Crack

Near the western end of the project, some isolated areas developed plastic shrinkage cracks. The cracking may be related to weather conditions, unintentional variations in the batching of the placed concrete, or a combination of both. These areas were paved on June 25.

The recorded high temperature on this day was 35.5°C; the relative humidity was 30%; and the wind ranged from 18 to 32 km/h. According to inspection records, the paving mix varied from wet to dry. The cracks were routed, cleaned and filled with epoxy (Figure 20).
