Report No.
SSRP-2001/27
FINAL

**SEISMIC PERFORMANCE OF
HOLLOW RECTANGULAR
REINFORCED CONCRETE PIERS
WITH HIGHLY-CONFINED
BOUNDARY ELEMENTS PHASE III:
WEB CRUSHING TESTS**

Final Report Submitted to Caltrans under Contract No. 59A0051

June 2002

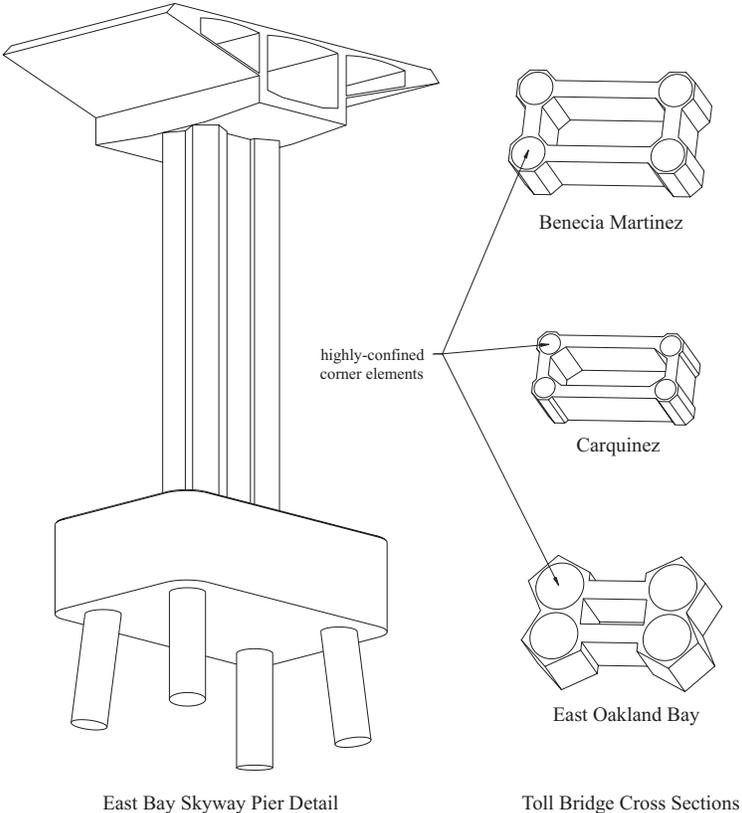
Figure 1.1: Schematic representation of proposed Bay Area bridge piers.

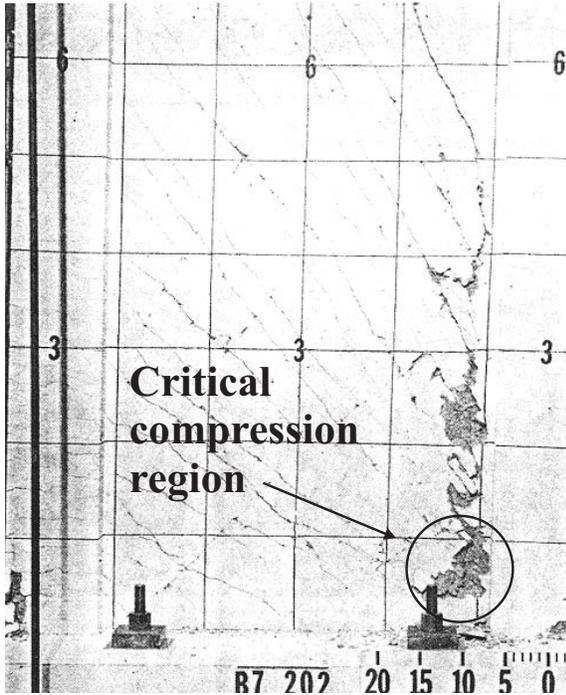
Figure 1.3: Detail of web crushing in a structural wall with confined boundary elements [4].

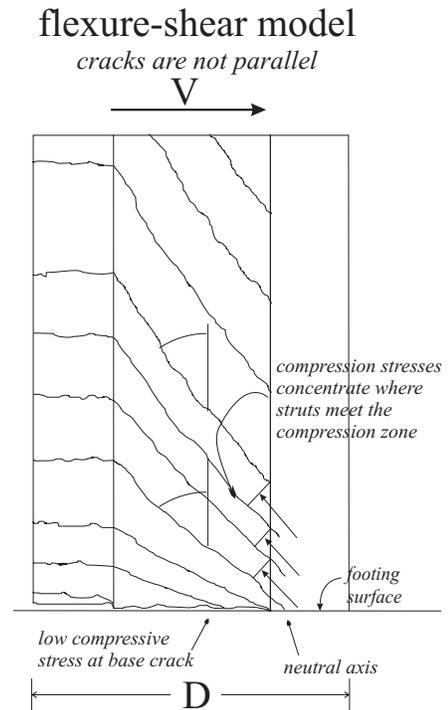
Figure 1.4: Critical compression struts take shear directly into the compression toe.

Contrary to the assumption of pure shear behavior, upon which pure shear web crushing models are based, the actual phenomenon of web crushing in structural walls with highly-confined boundary elements under seismic loading occurs in a concentrated region of the wall where the struts converge at the compression toe of the column [5, 6] as shown in Figure 1.3. This suggests that the web crushing behavior in a plastic hinge zone does not follow the pure shear model in Figure ?? but rather follows a flexure-shear model (see Figure 1.4).

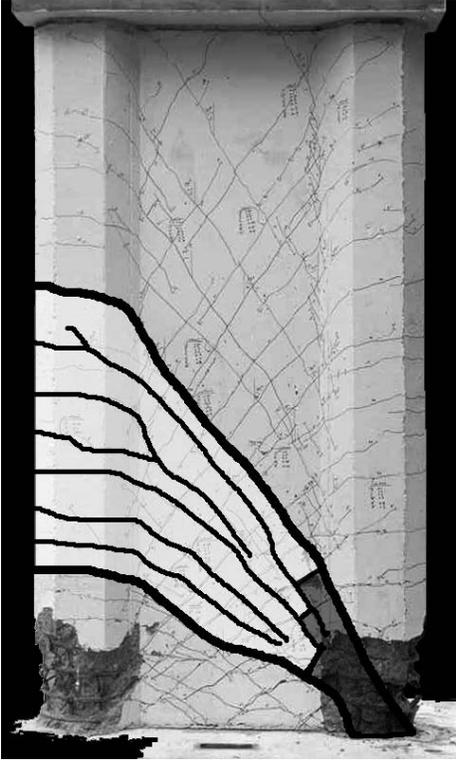
Figure 1.5: Crack pattern and compression struts in the plastic hinge region of UCSD Test Unit 2C.

Typically the critical region crushes just outside of the compression toe and then neighboring struts crush successively either above or to the side of the initial failed struts. Crack patterns for such walls confirm that the diagonal compression stresses are concentrated in this region where the individual struts become thinner and converge in the compression toe (see Figure 1.5).

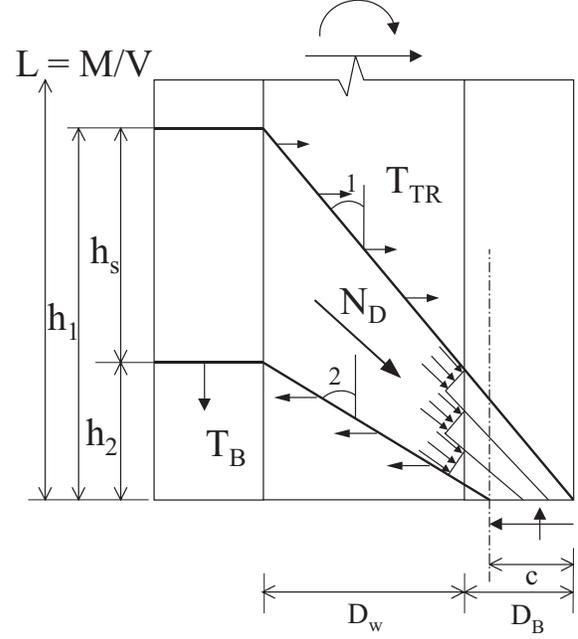
Figure 1.6: Free body diagram for critical compression strut region.

An alternative expression for web crushing strength can be derived based on the free body diagram pictured in Figure 1.6. Cracks are assumed to be horizontal in the tension boundary element and the longitudinal steel is assumed to behave elastically above a height of h_2 .

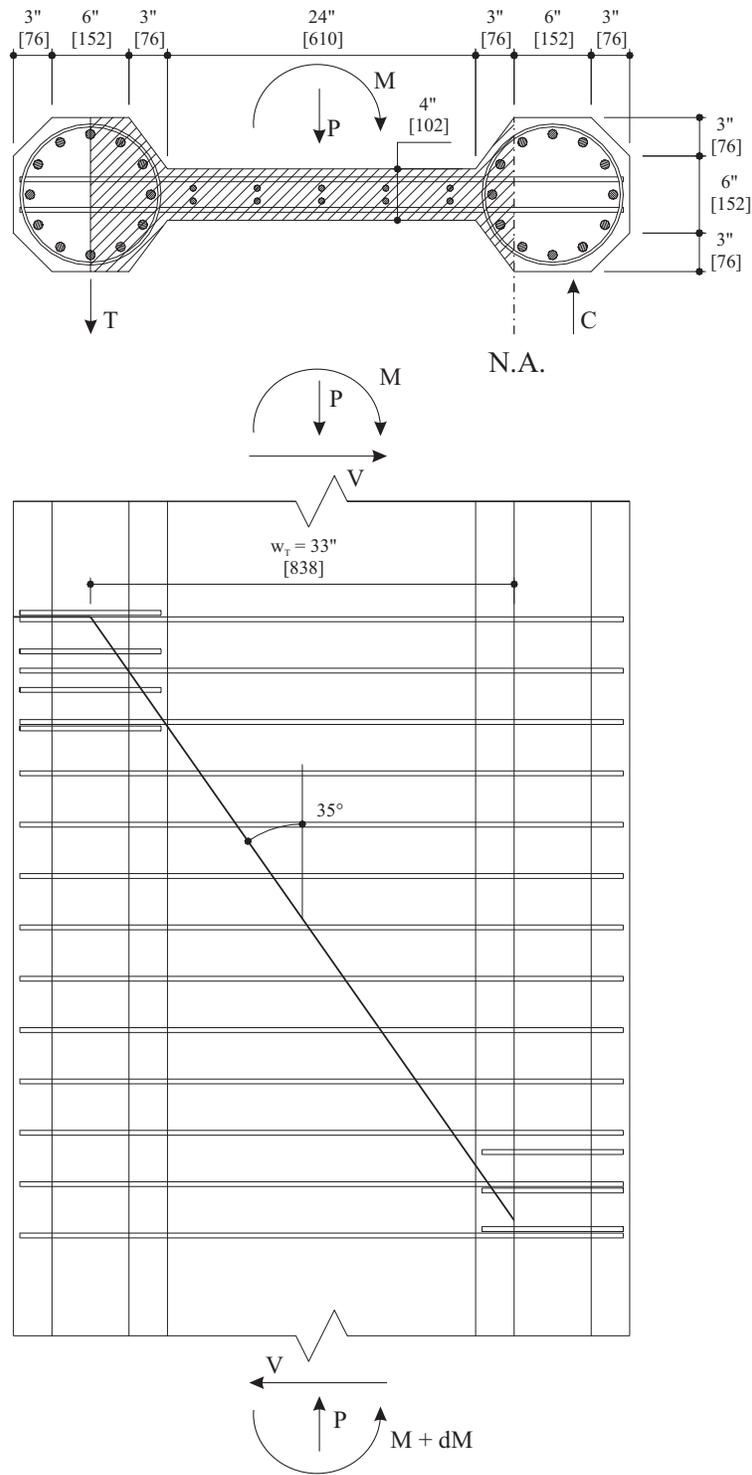
Figure 2.5: Cross section and partial elevation for Test Unit 3A, with the assumed shear crack relevant to the V_s component of shear resistance.

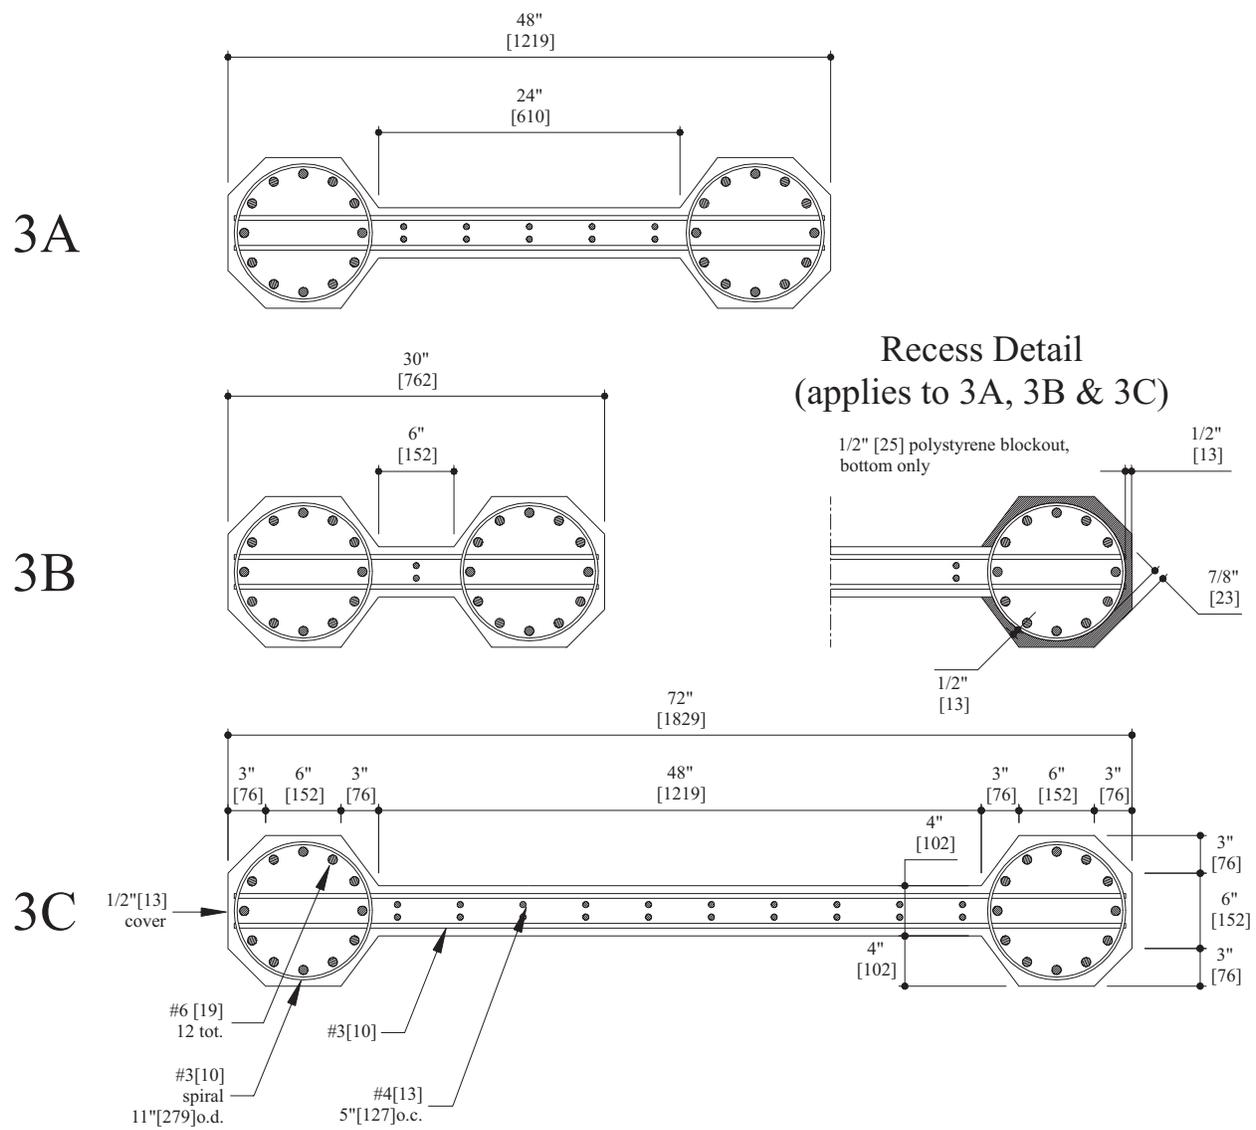
Figure 2.6: Cross section of Test Units 3A, 3B and 3C with reinforcement.

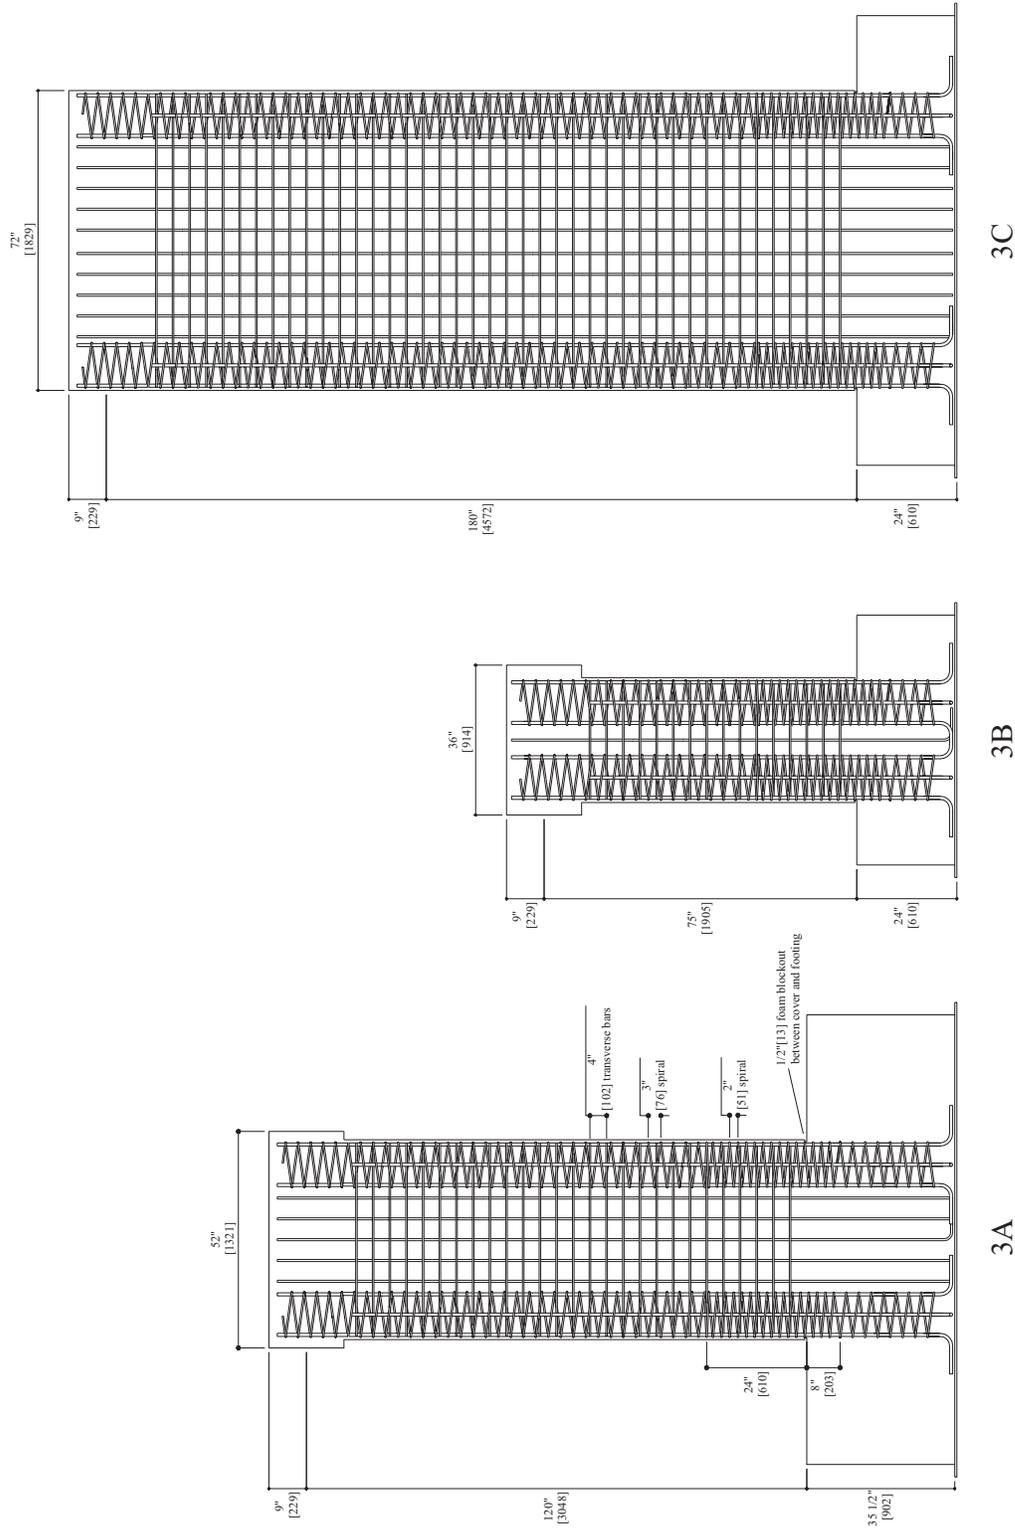
Figure 2.7: West elevations of Test Units 3A, 3B and 3C (Footing reinforcement and some boundary element longitudinal bars not shown).

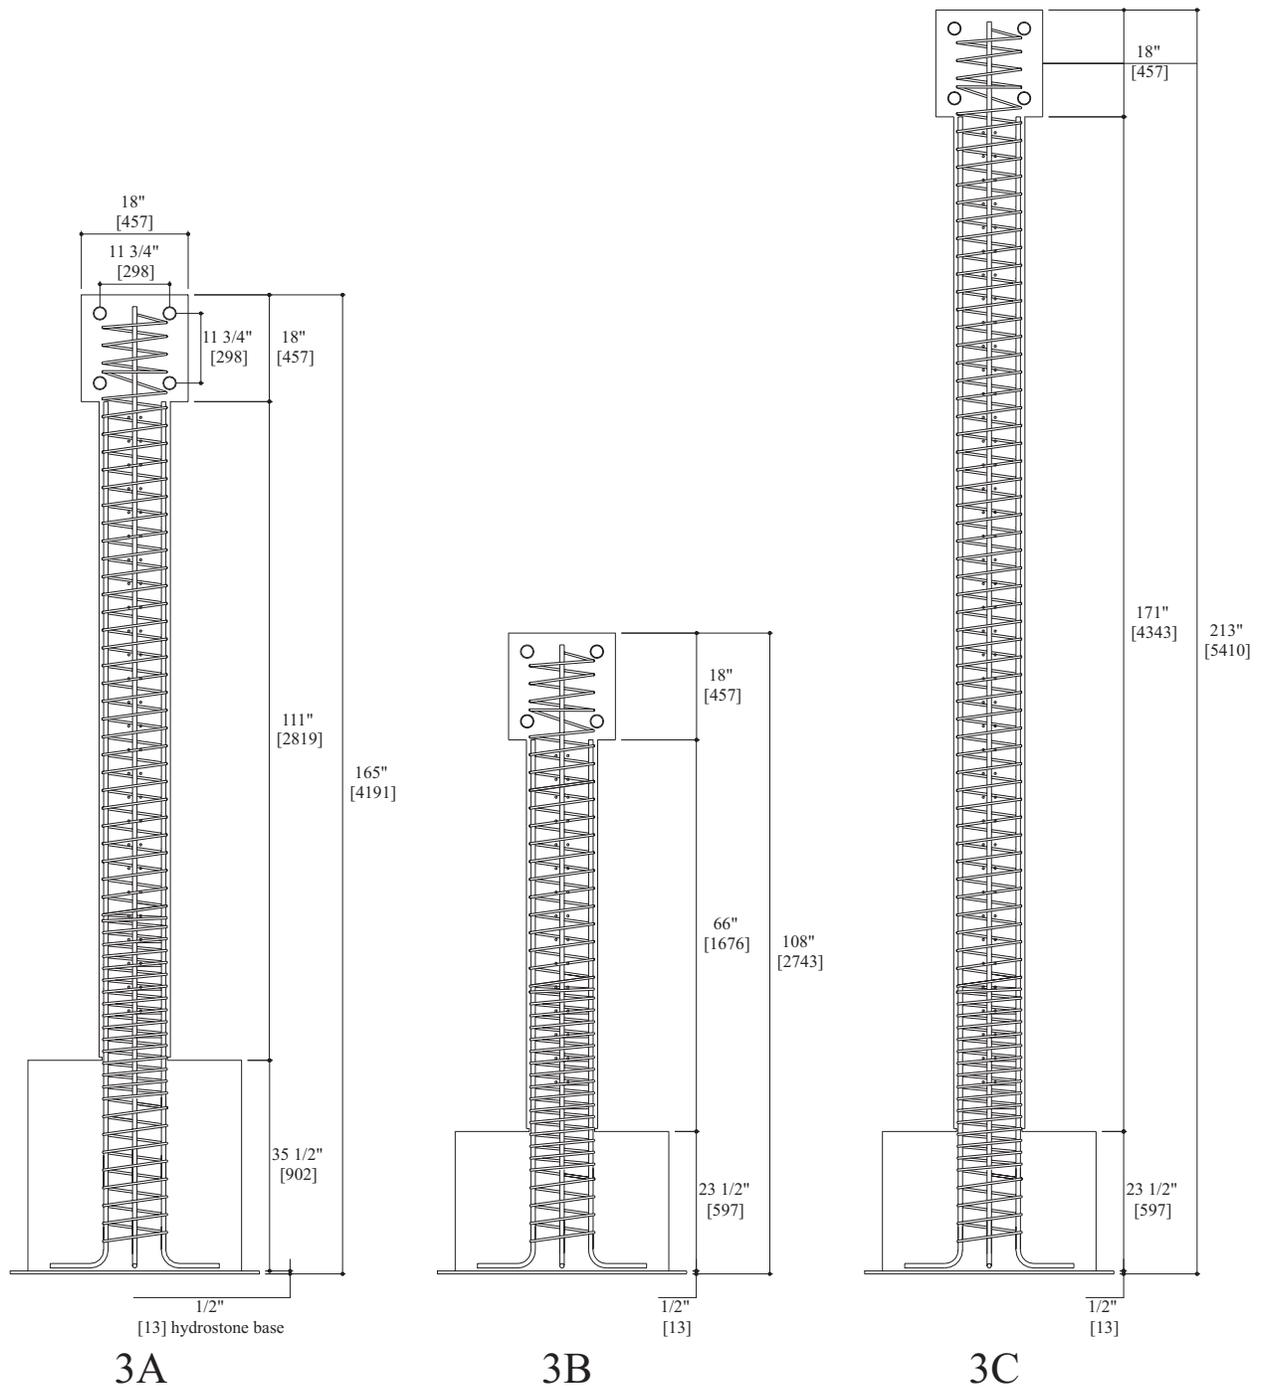
Figure 2.8: South elevations of Test Units 3A, 3B and 3C with reinforcement (Footing reinforcement and some boundary element longitudinal bars not shown).

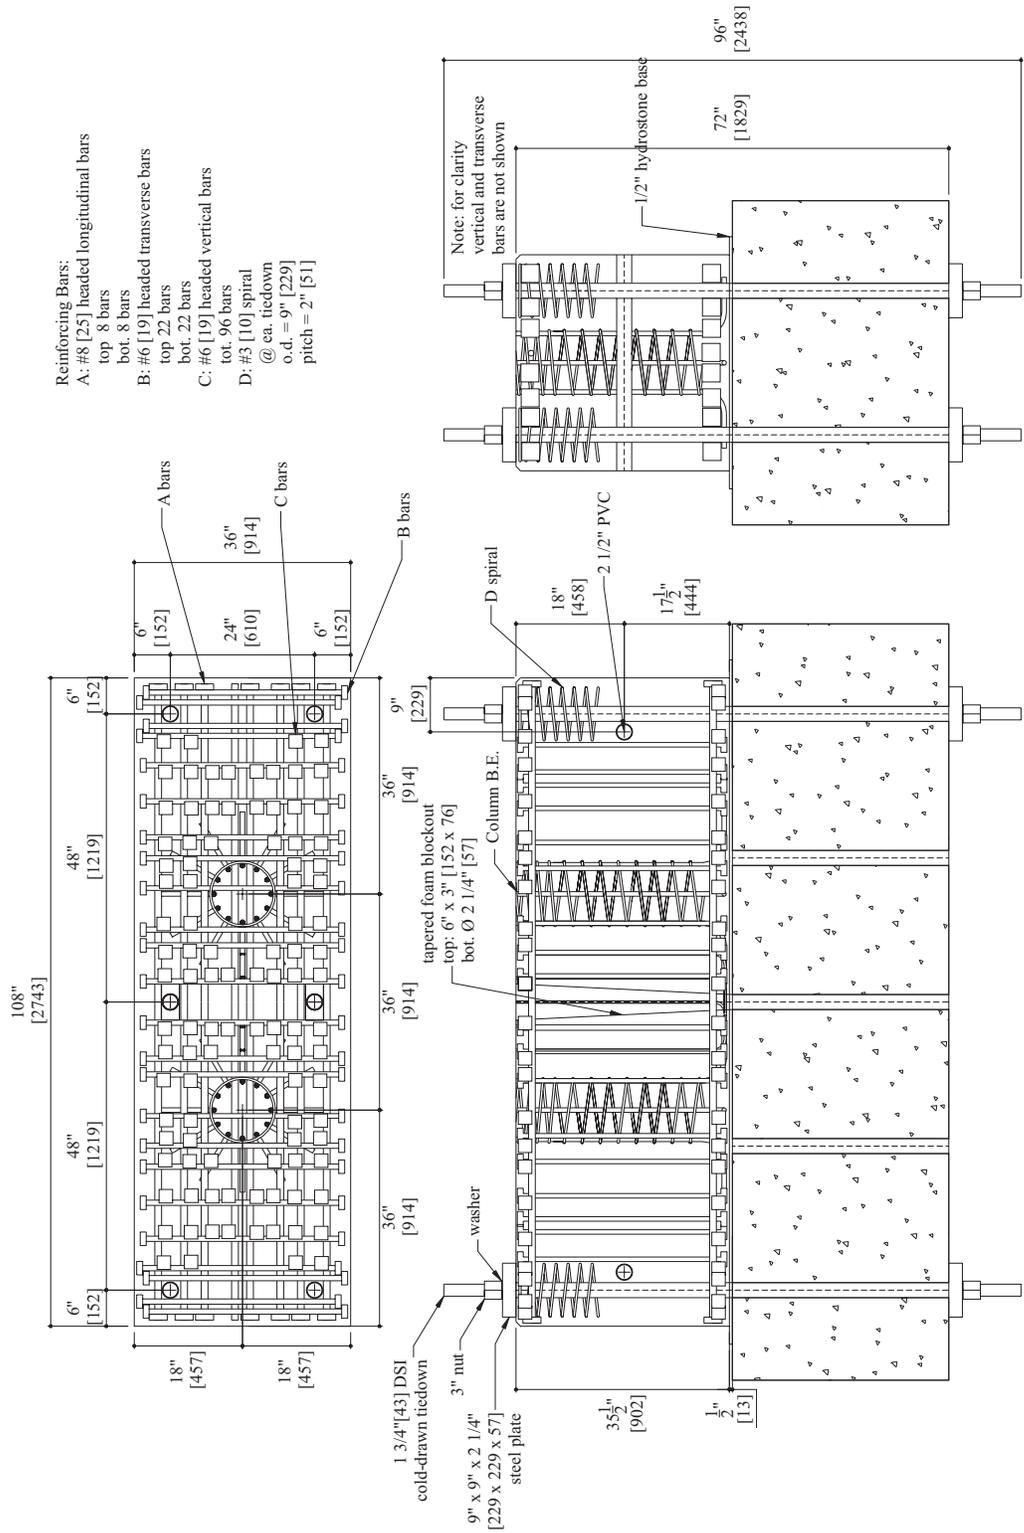
Figure 2.9: Test Unit 3A footing reinforcement plan.

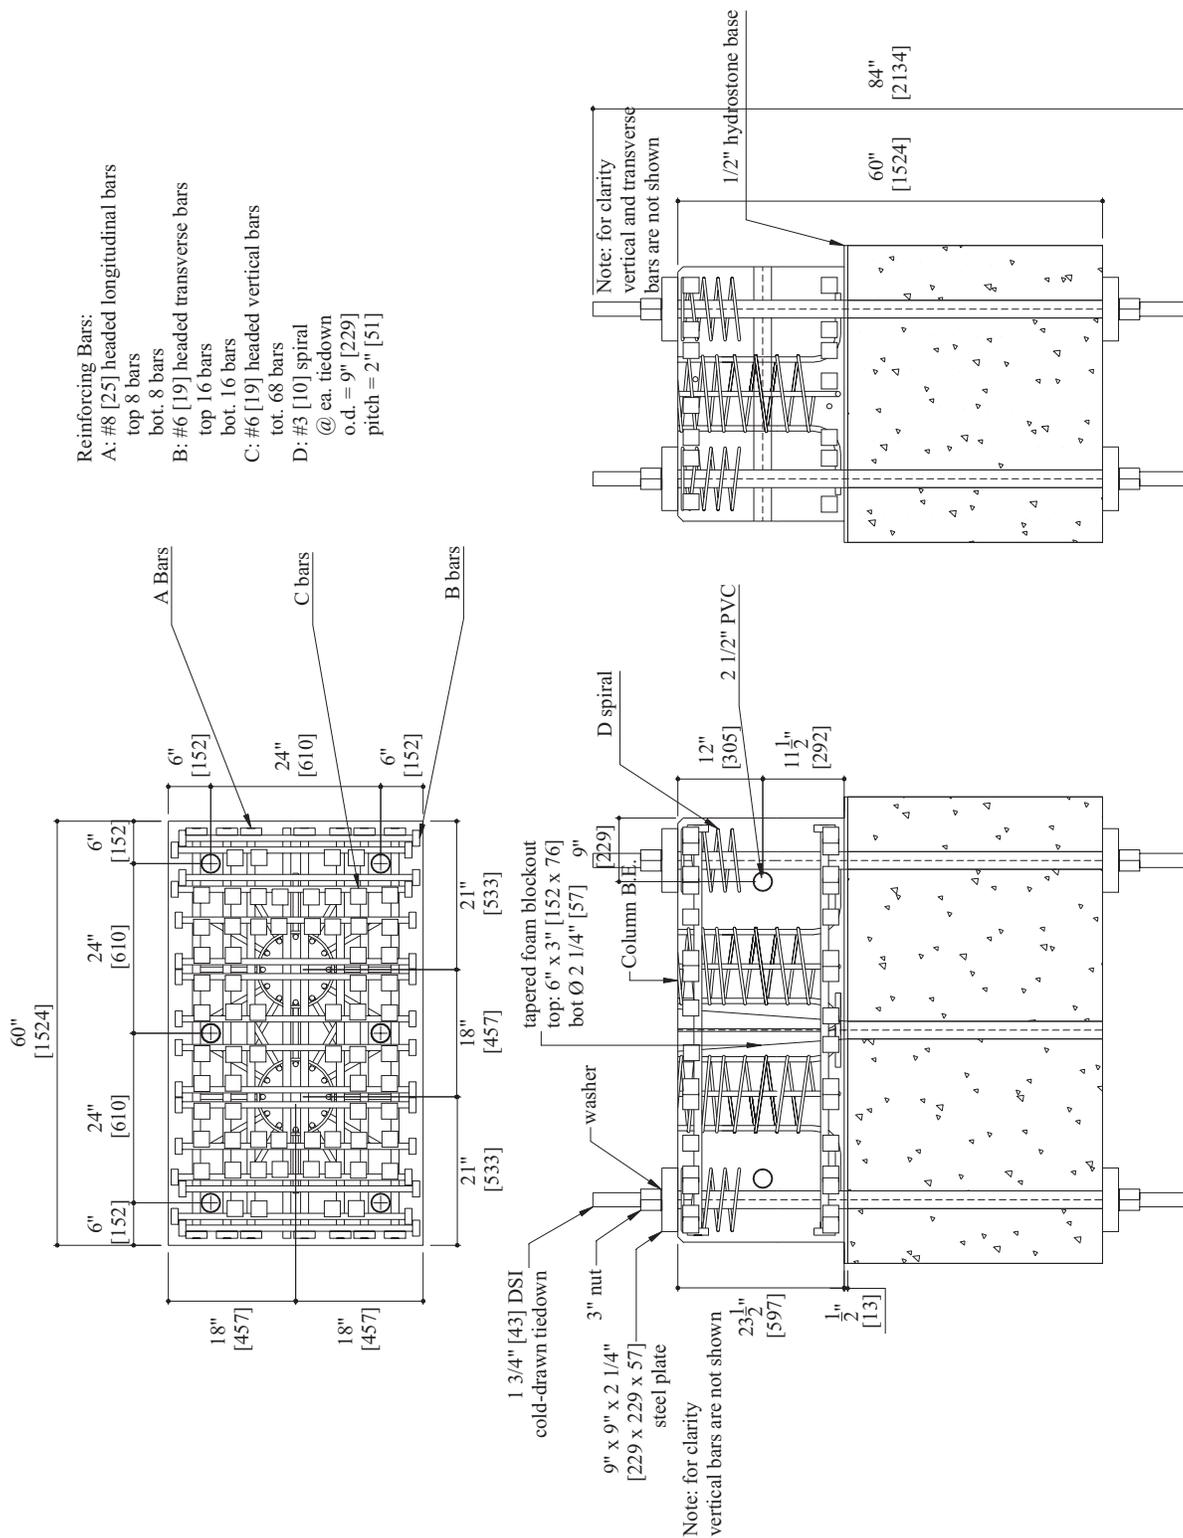
Figure 2.10: Test Unit 3B footing reinforcement plan.

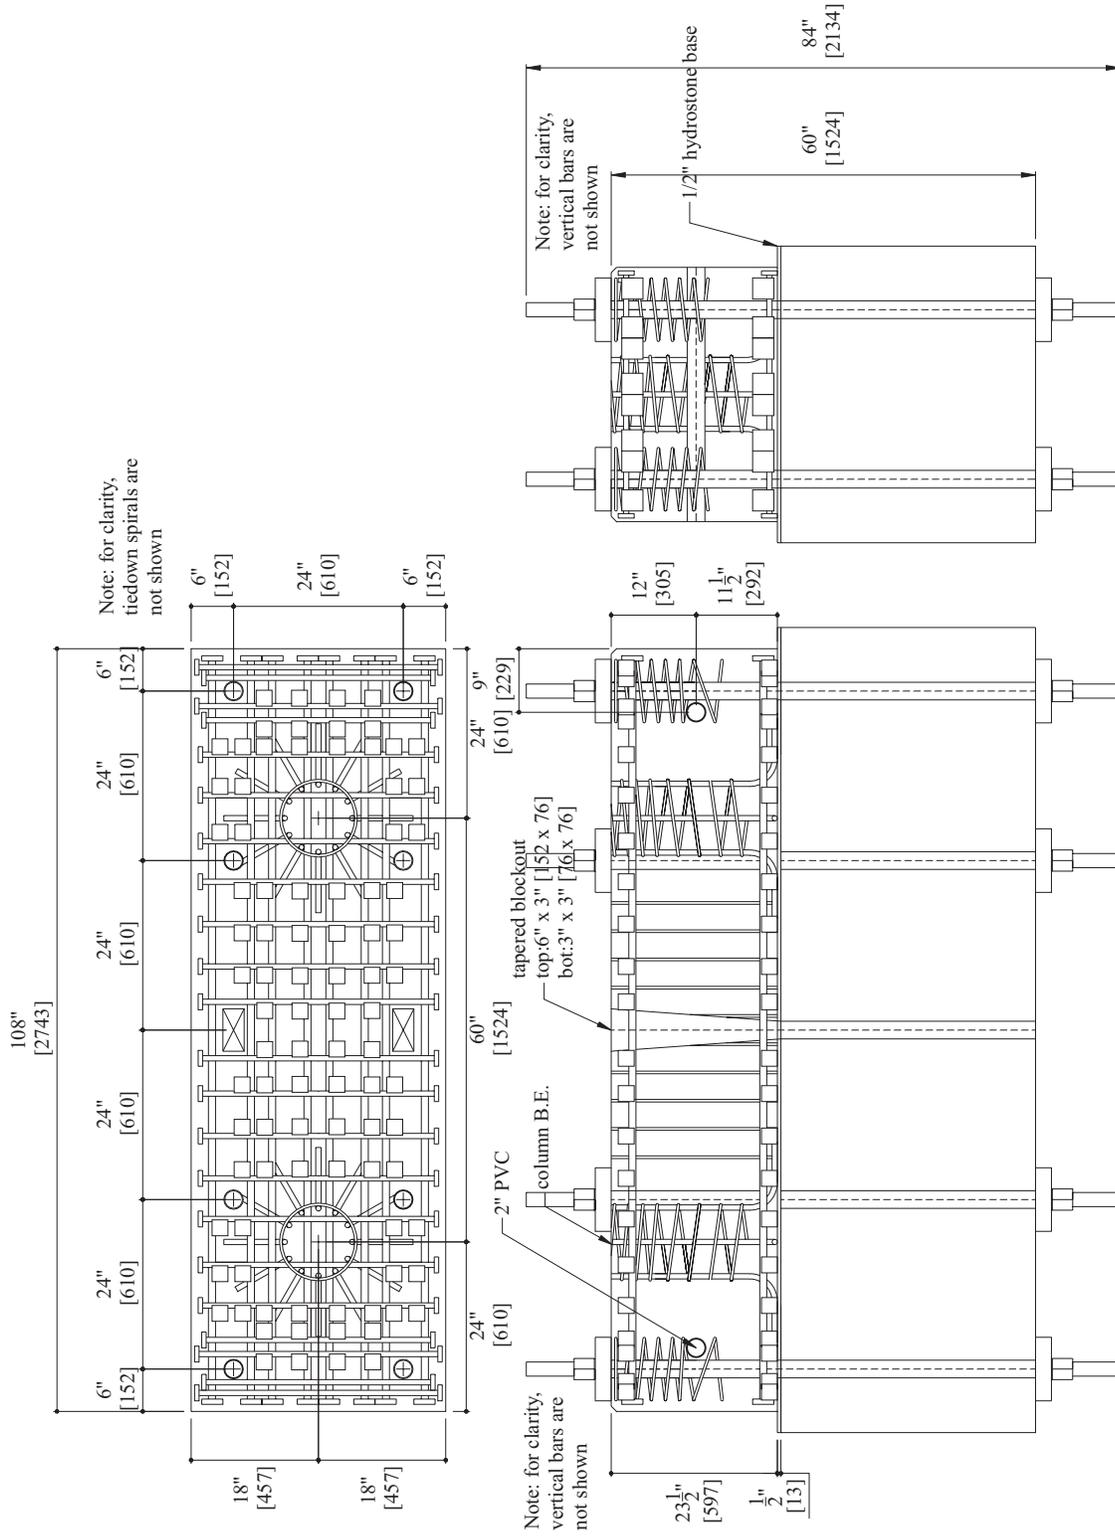
Figure 2.11: Test Unit 3C footing reinforcement plan.

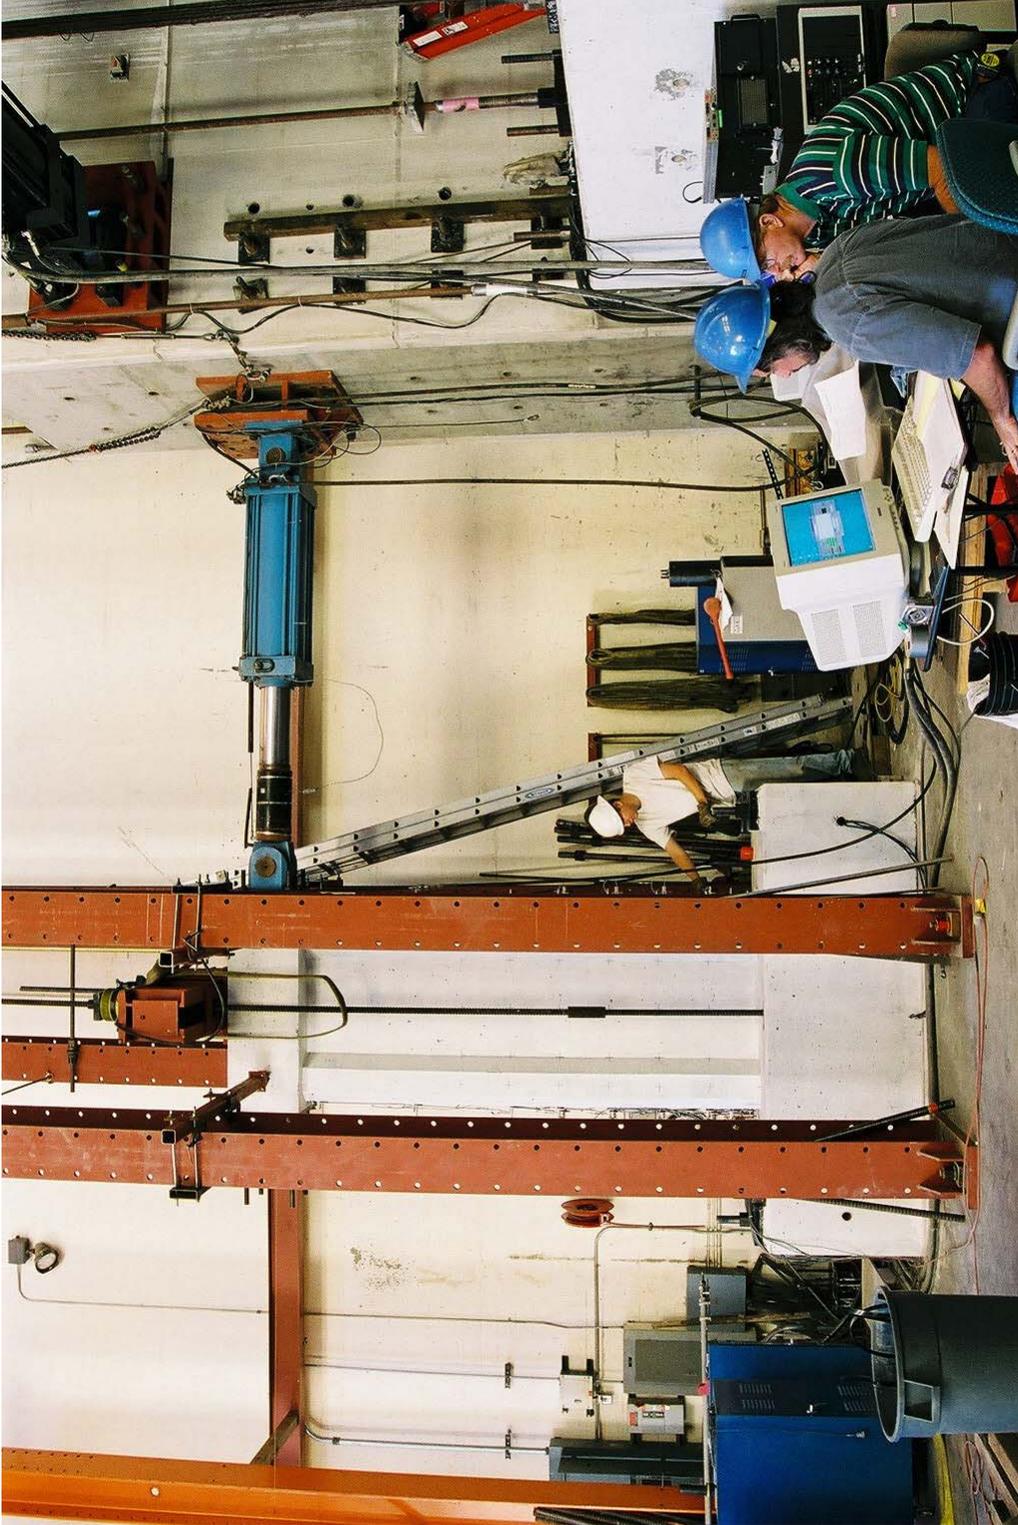
Figure 4.1: Completed test setup for Test Unit 3A with instrumentation, a few hours before testing. East elevation.

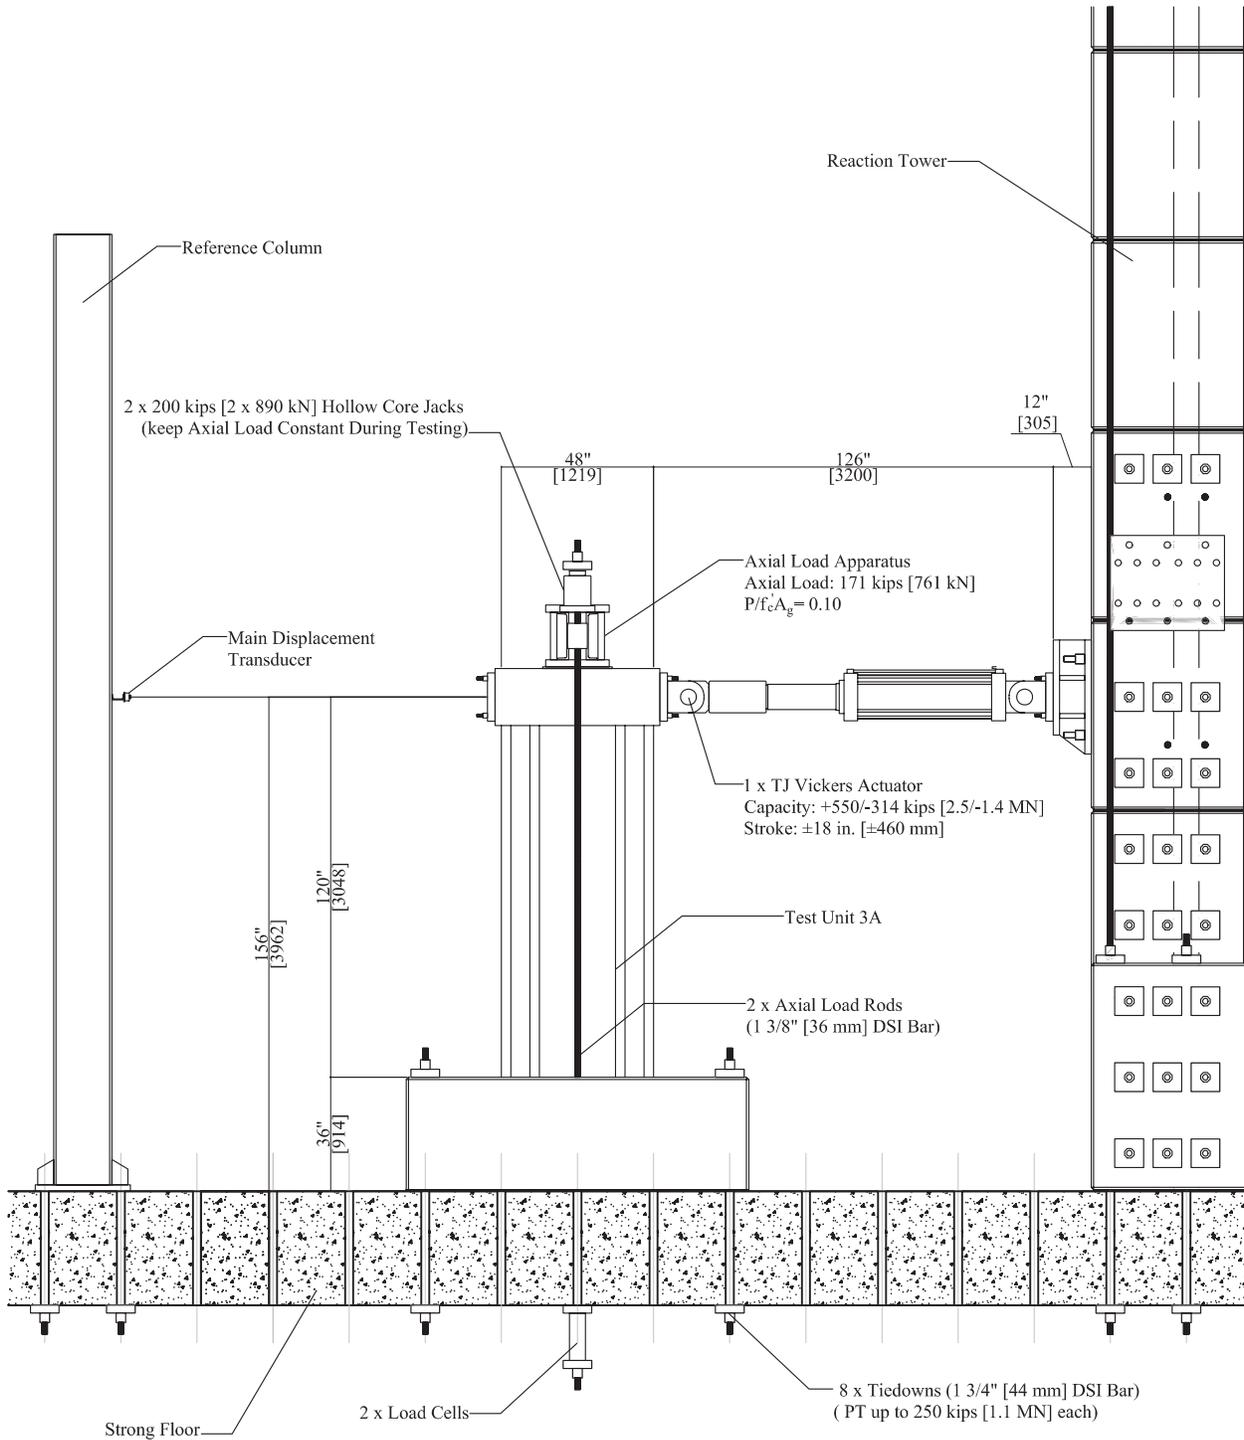
Figure 4.2: Test Unit 3A setup, east elevation.

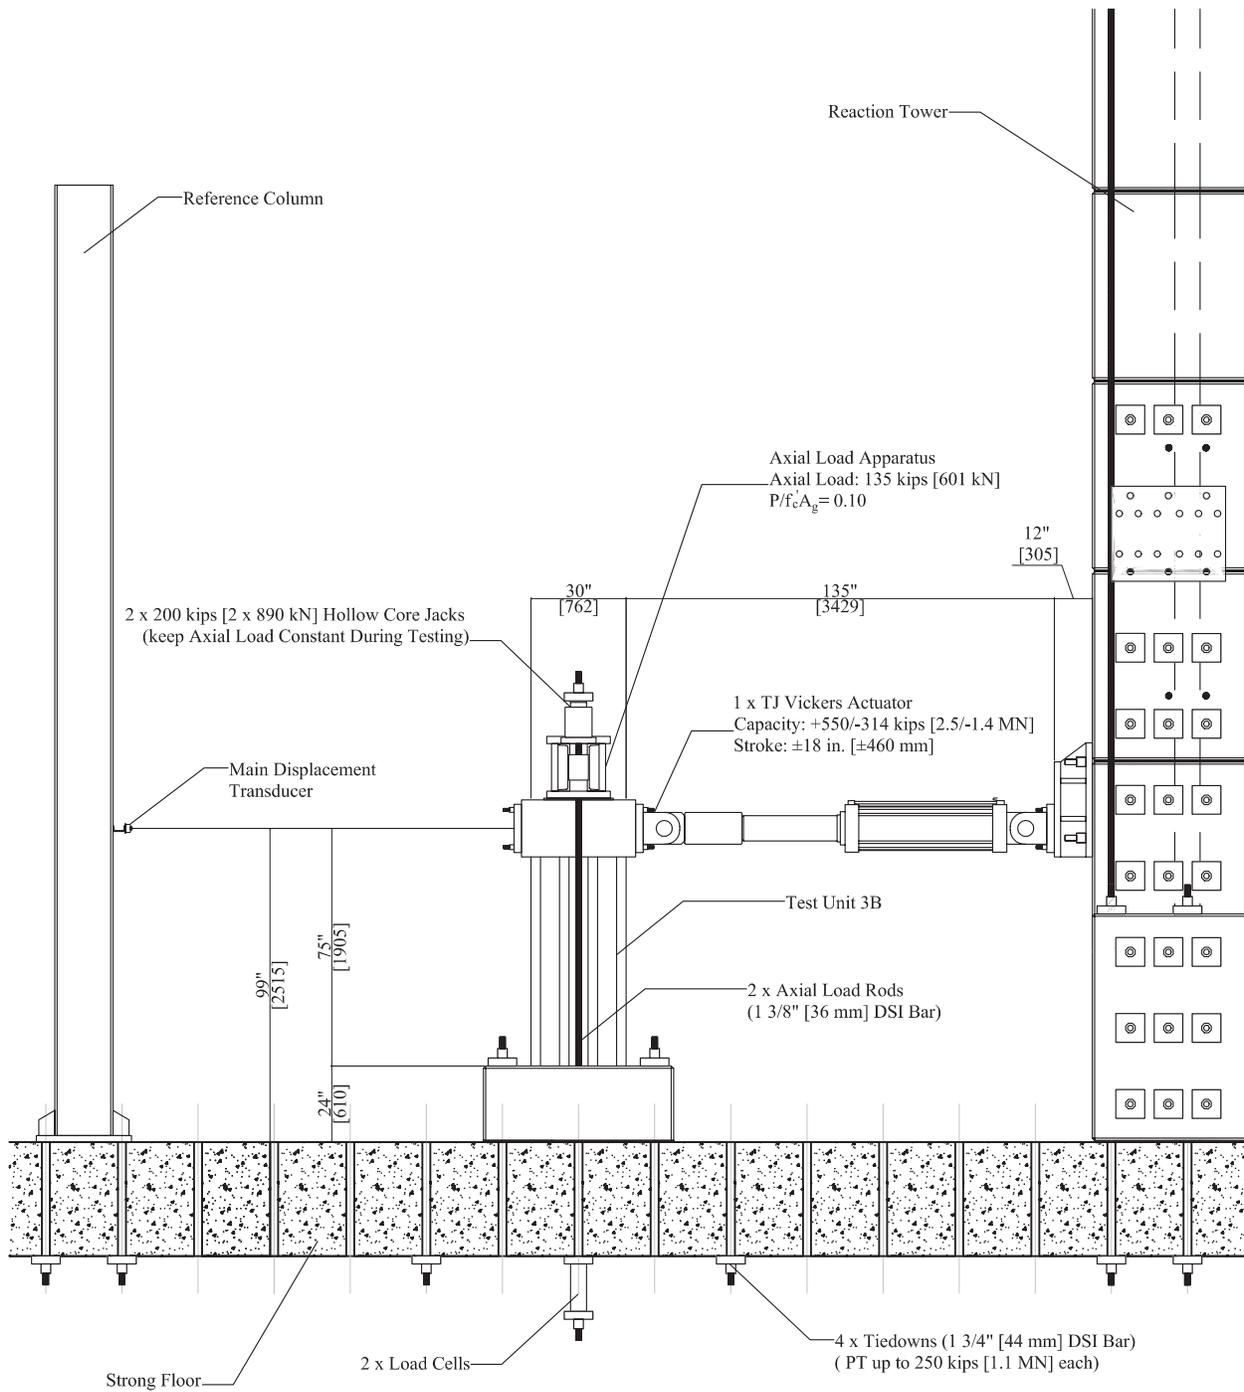
Figure 4.3: Test Unit 3B setup, east elevation.

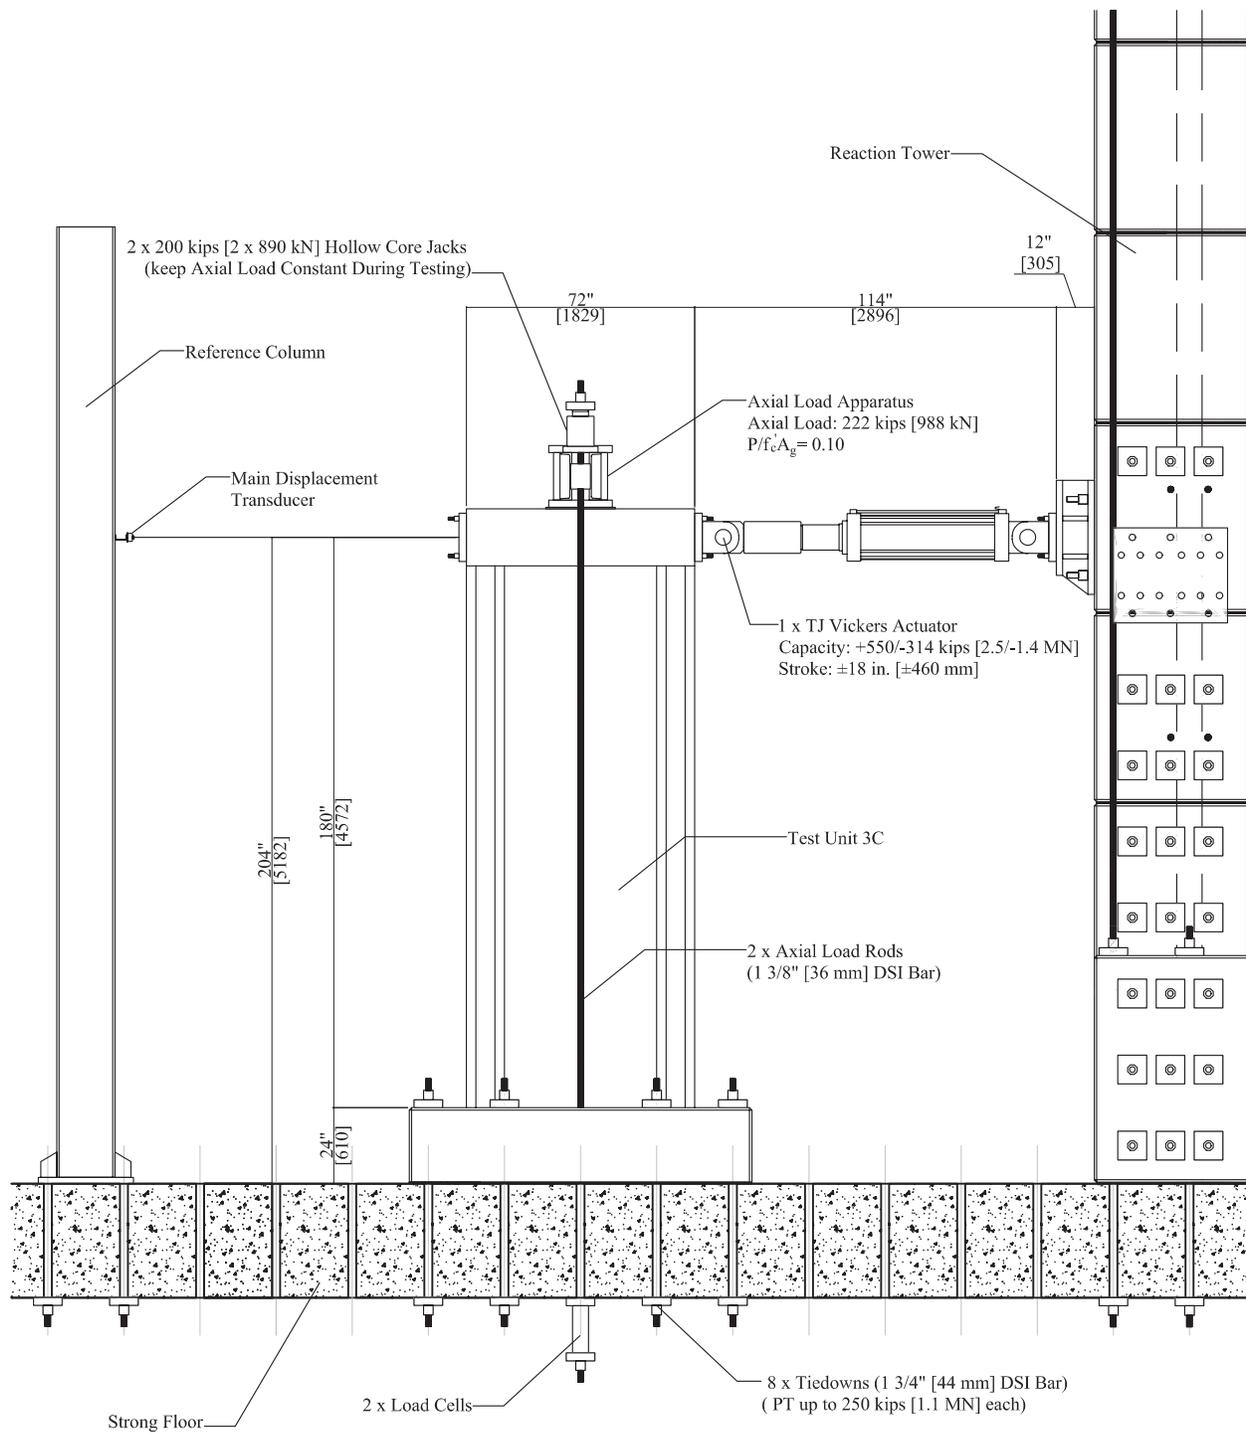
Figure 4.4: Test Unit 3C setup, east elevation.

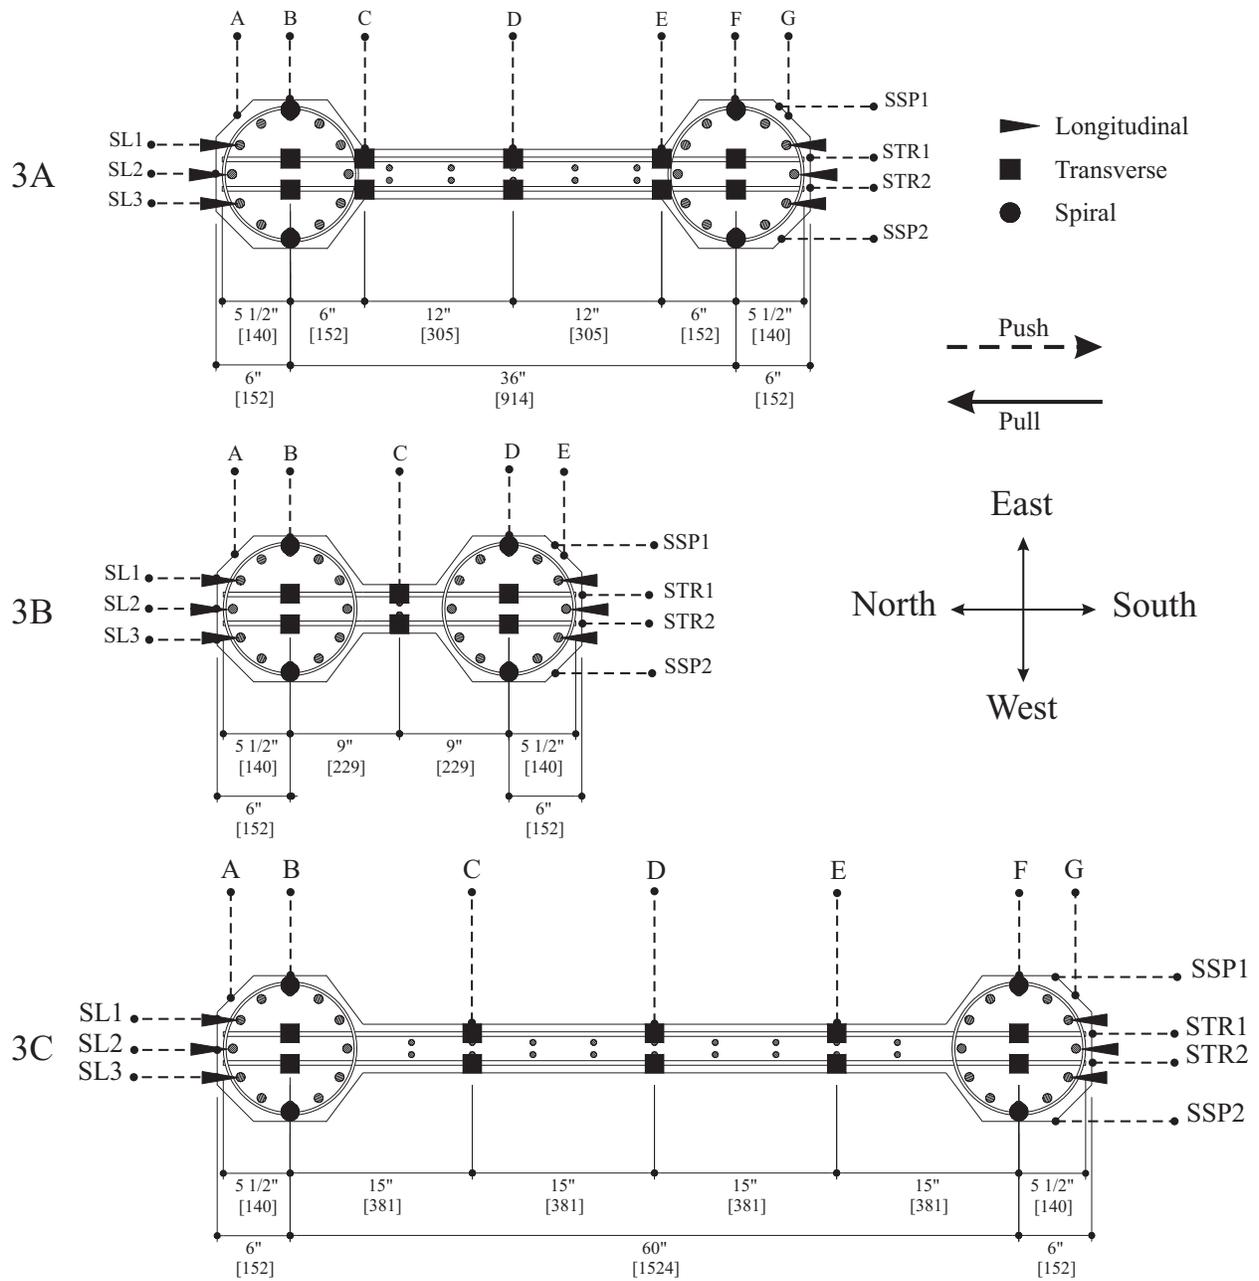
Figure 4.5: Test Units 3A, 3B and 3C, strain gage layout, sections.
