Report No.
SSRP-2001/27
FINAL

**SEISMIC PERFORMANCE OF
HOLLOW RECTANGULAR
REINFORCED CONCRETE PIERS
WITH HIGHLY-CONFINED
BOUNDARY ELEMENTS PHASE III:
WEB CRUSHING TESTS**

Final Report Submitted to Caltrans under Contract No. 59A0051

June 2002

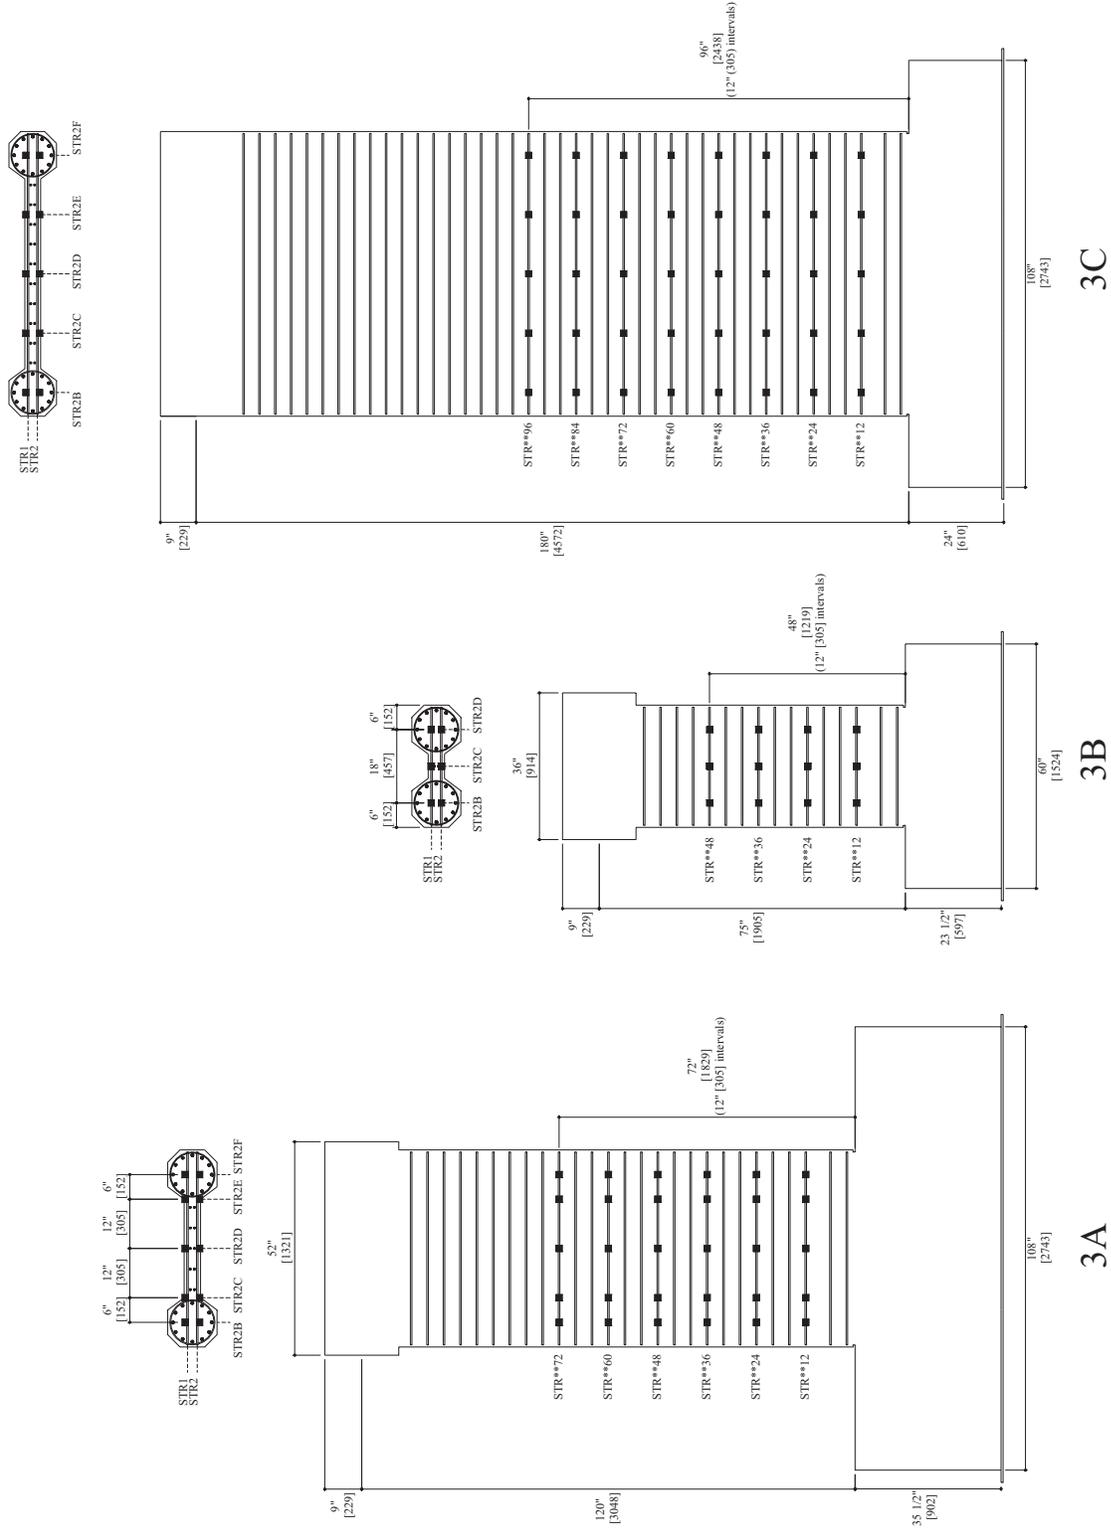
Figure 4.7: Test Units 3A, 3B and 3C, transverse bar strain gage layout, west elevations.

Figure 4.7 shows the transverse bar and spiral gages distributed along all three column heights. Transverse bar gages were placed at five locations on transverse bars in Test Units 3A and 3C and placed at three locations on transverse bars in Test Units 3B. The center gages were expected to give an adequate distribution of strain along the bar while the two extreme gages were expected to give insight into the development length of the transverse bars anchored into the tension boundary element.

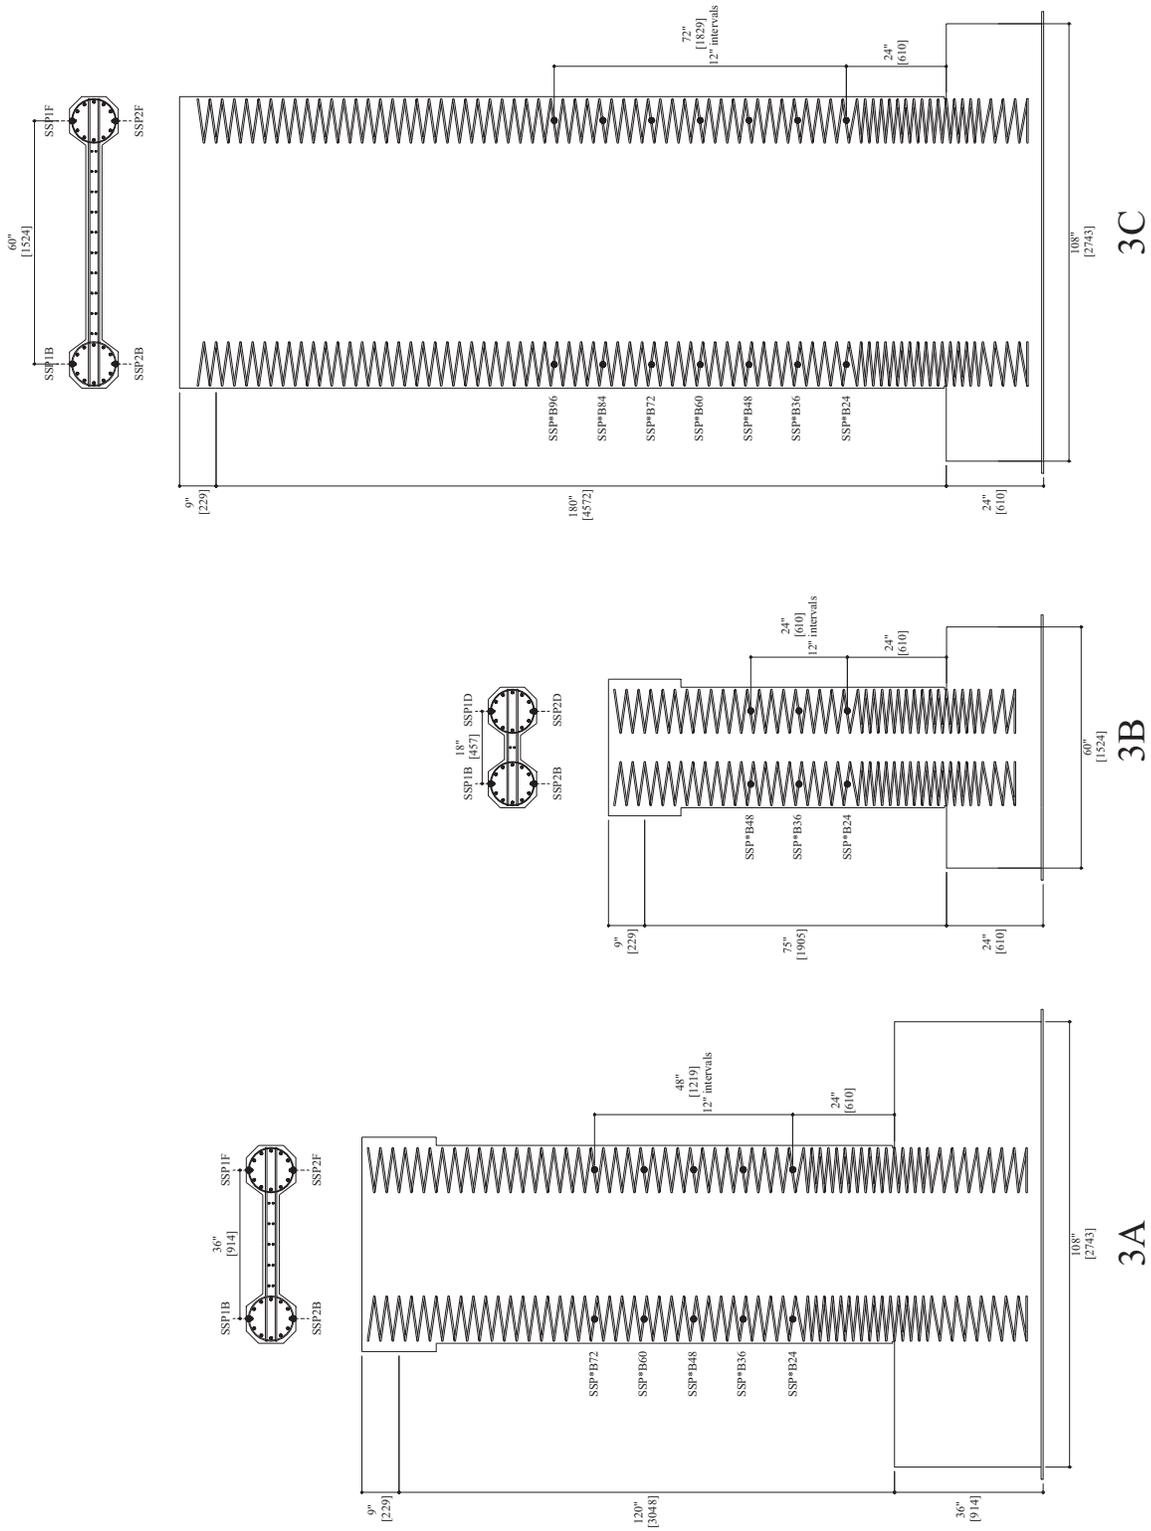
Figure 4.8: Test Units 3A, 3B and 3C, spiral strain gage layout, west elevations.

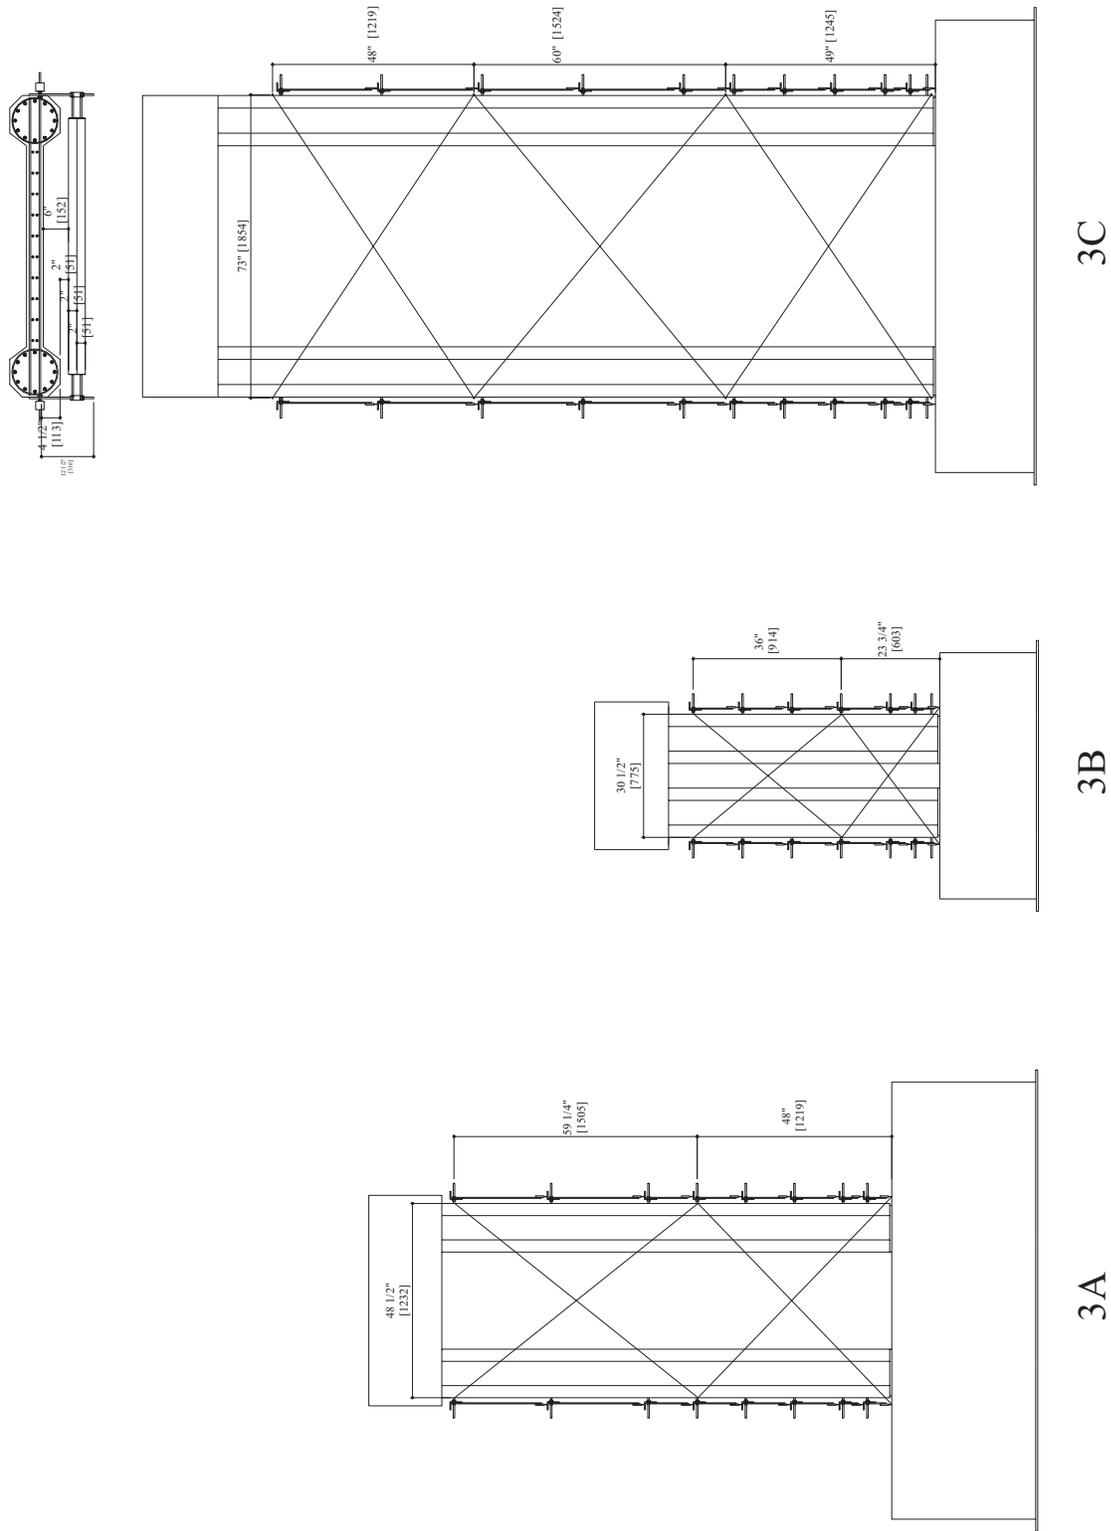
Figure 4.13: Test Units 3A, 3B and 3C, shear instrumentation layout, west elevations.

which characterizes the average shear deformation over a given region with height h , and depth D^* . Figure 4.13 shows the panel deformation instrumentation in elevation and section. Figure 4.15 D shows a typical mounting bracket for the shear panel instrumentation. These brackets consisted of 3/8 in. [10] high-precision cold-rolled steel rod, welded to a steel plate that was in turn bolted with 3/8 in. [10] anchors into a given boundary element.

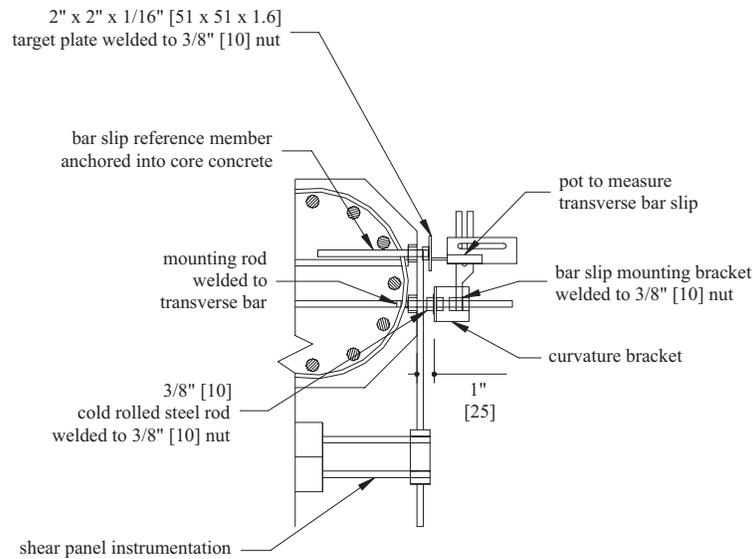
Figure 4.14: Bar slippage, shear and curvature instrumentation detail.

The Phase III Test Units were instrumented to measure the slippage of the transverse bars on 12 in [305] vertical intervals up to a height of 48 in. [1219] above the footing. The ends of the bars were expected to slip when the bars themselves were engaged to hold the column together in shear. At higher displacement levels, this slippage was expected to become significant because of the increasing flexural crack width. Figure 4.14 shows the slippage instrumentation in detail as it was mounted to the curvature bracketry. If slippage occurred, the bars were expected to slip into the column and compress the displacement potentiometer mounted on an aluminum angle bracket, giving a negative reading. The slippage potentiometers were targeted on plates that extended directly out of the confined core concrete, so that no slippage readings would result from expansion of the cover concrete as had been the result on earlier tests [1, 11]. Figures 4.15 and 4.16 show photographic details of the transverse bars slippage instrumentation.

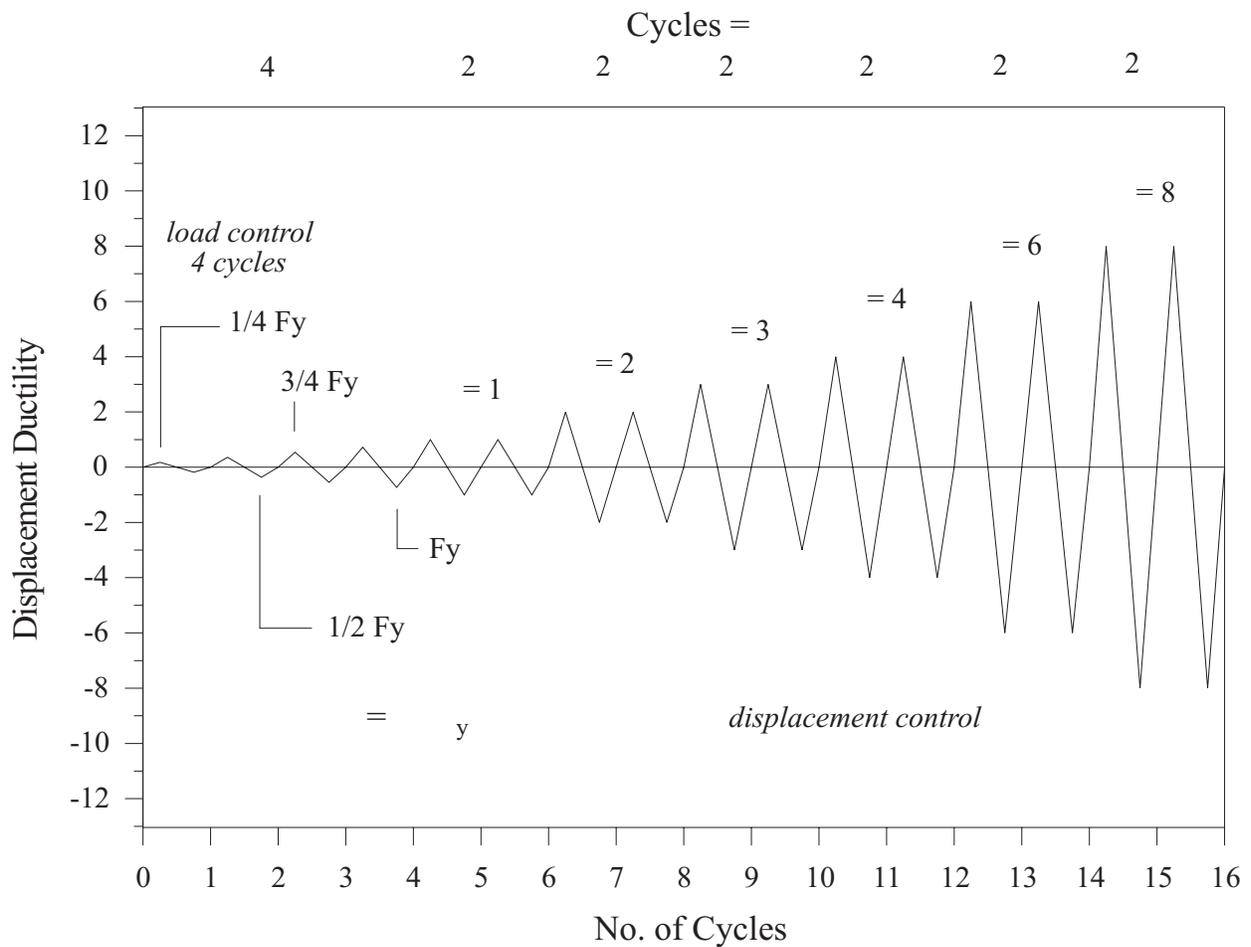
Figure 4.17: Loading history for the Phase III Web Crushing Test Units.

The test unit was subjected to the modified UCSD cyclic loading history shown in Figure 4.17. This particular loading history, in its simplicity, allows for comparison of damage and performance at specified displacement ductility levels. It is less severe in terms of energy demand on the test units than the standard UCSD loading history which cycles three times at each displacement ductility level.

Four initial cycles were run in load control up to theoretical first yield of the extreme longitudinal reinforcing bars. The remainder of the test was conducted in displacement control until failure of the test unit.

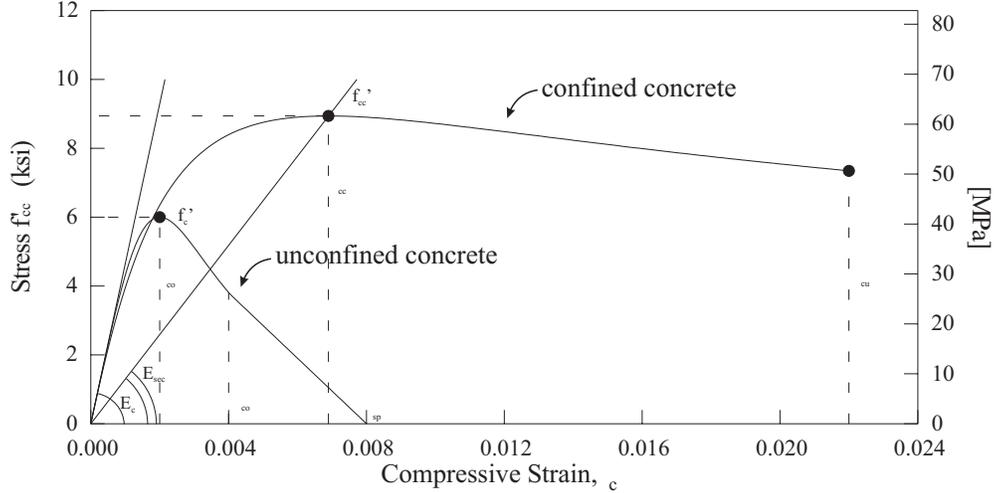
Figure 5.1: Concrete stress-strain curves used in the moment-curvature analysis.

The stress-strain curve for unconfined concrete is pictured in Figure 5.1. Typical concrete spalling strains range between $0.003 \leq \varepsilon_{sp} \leq 0.008$. Therefore ε_{sp} was set at the maximum 0.008 because the boundary element cover concrete was blocked out at the column base. The unconfined concrete stress-strain curve shown in Figure 5.1 peaks at a strain of $\varepsilon_{co} = 0.002$ and follows the Popovics curve until $\varepsilon_c = 2\varepsilon_{co} = 0.004$. At higher strains, the stress decreases linearly to zero.

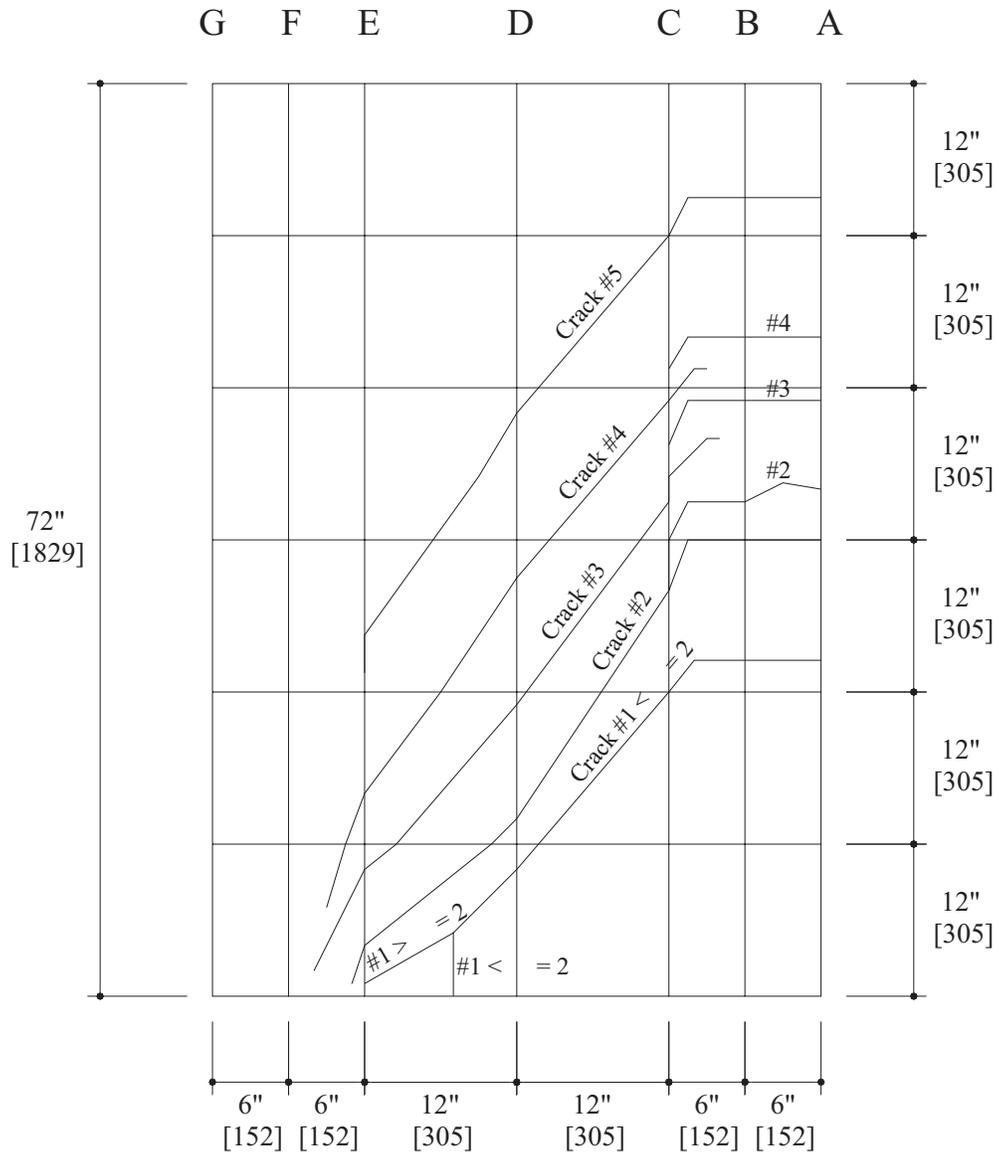
Figure 6.1: Test Unit 3A, Cracks 1 - 5.

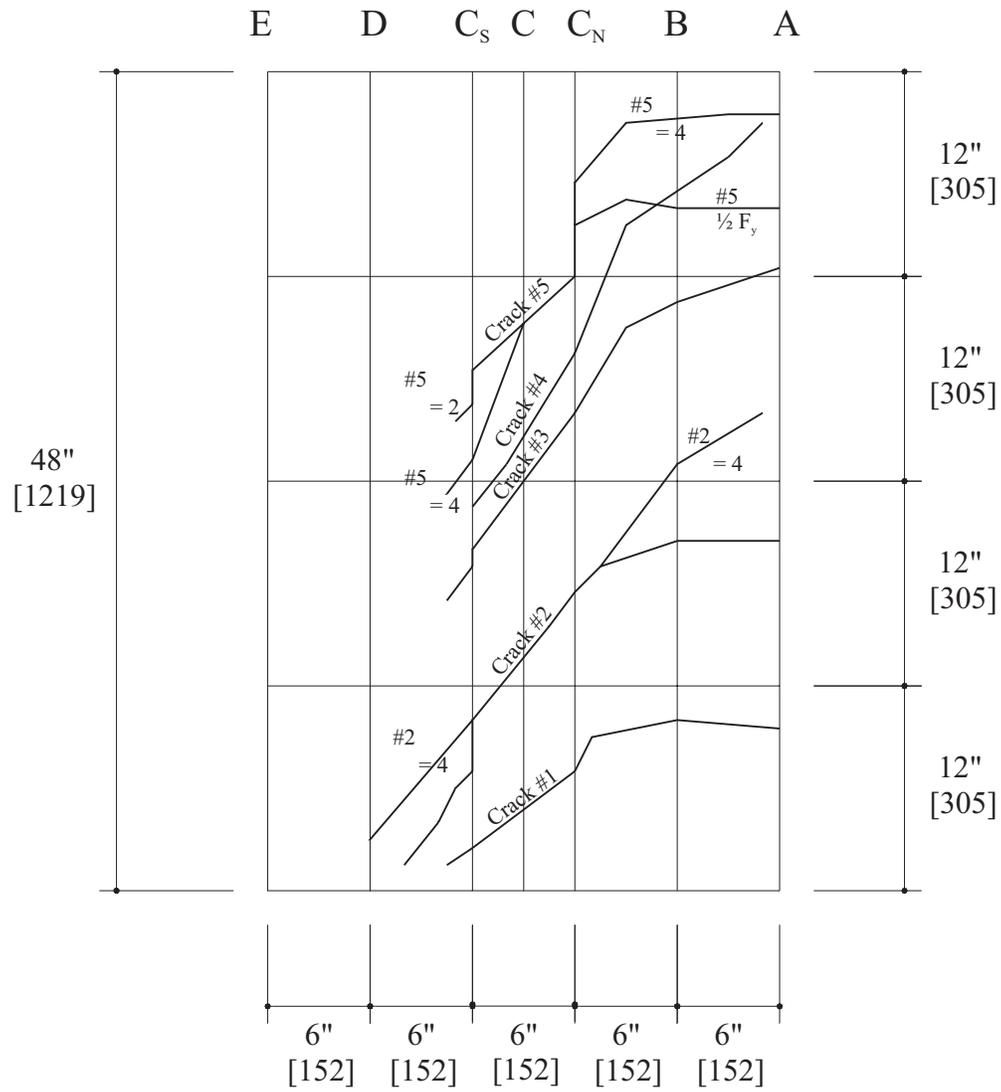
Figure 6.2: Test Unit 3B, Cracks 1 - 5.

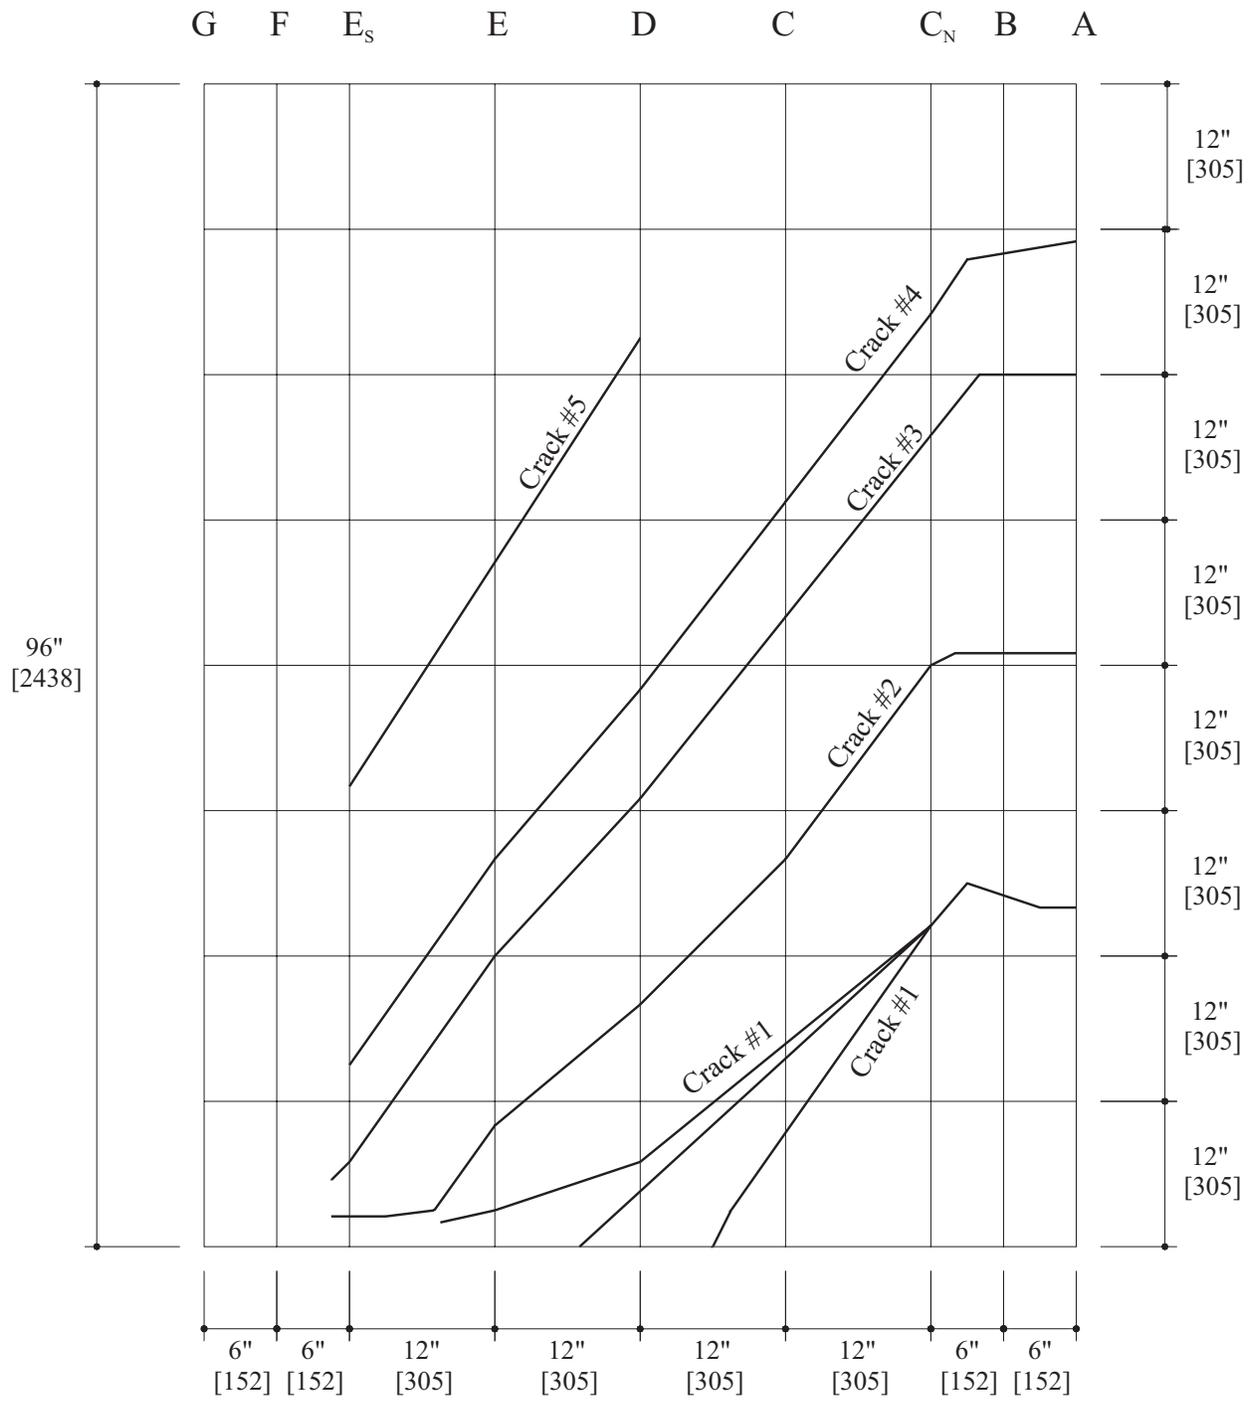
Figure 6.3: Test Unit 3C, Cracks 1 - 5.

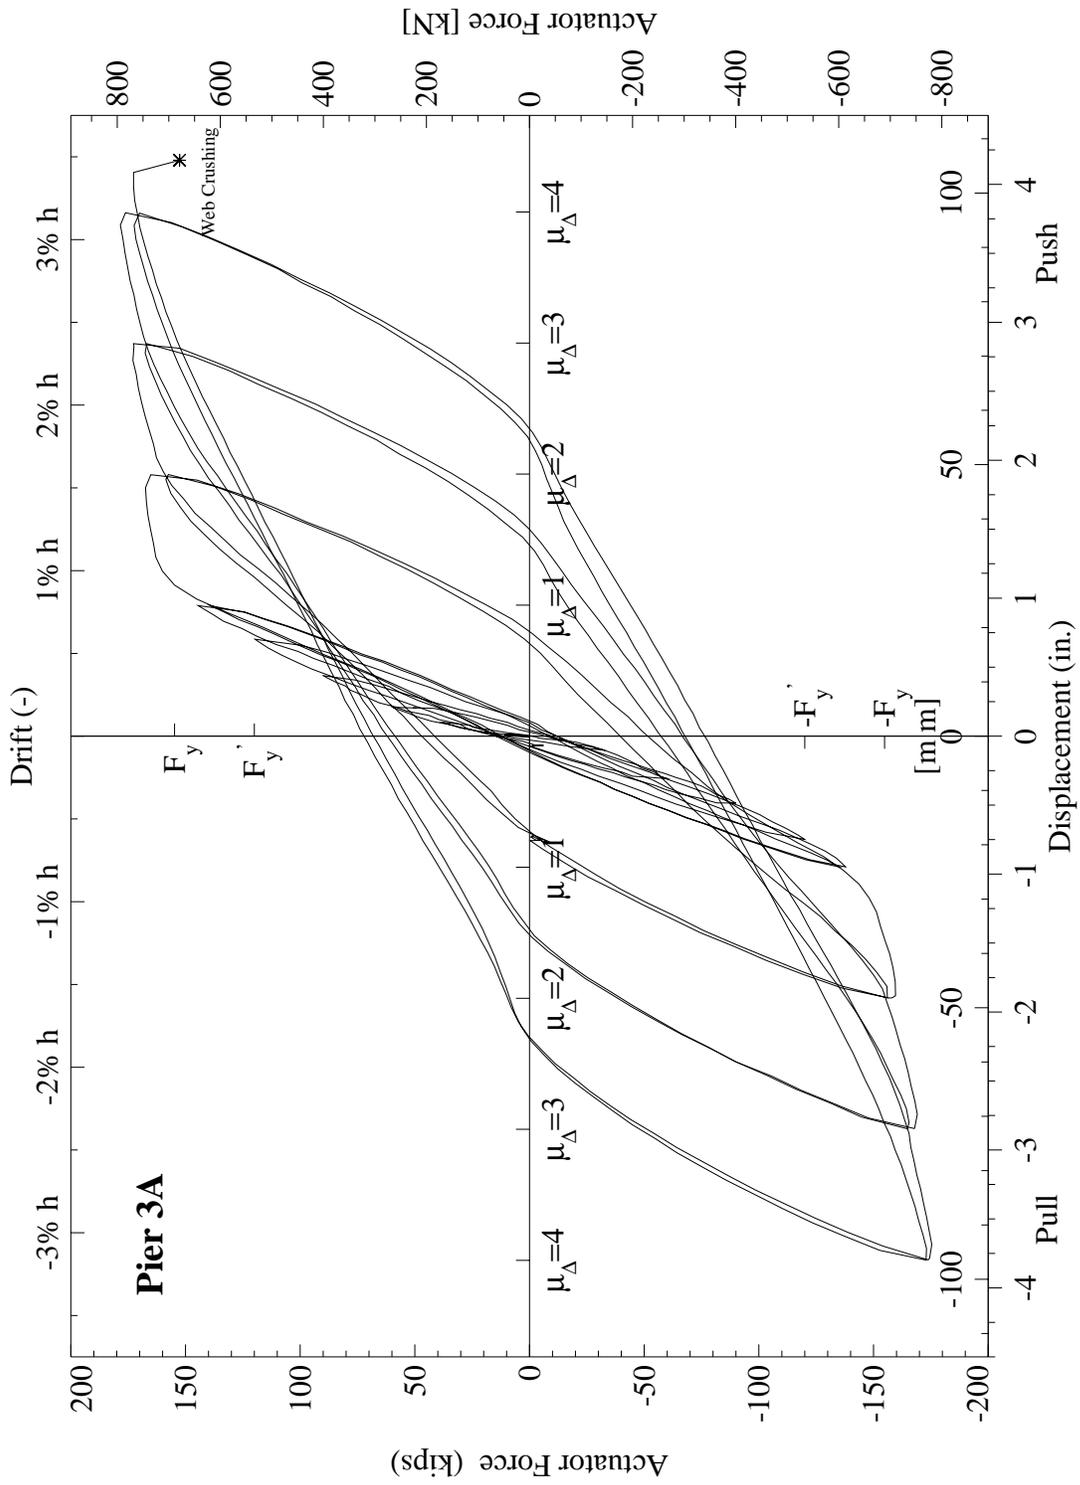
Figure 7.1: Test Unit 3A, measured experimental hysteretic response.

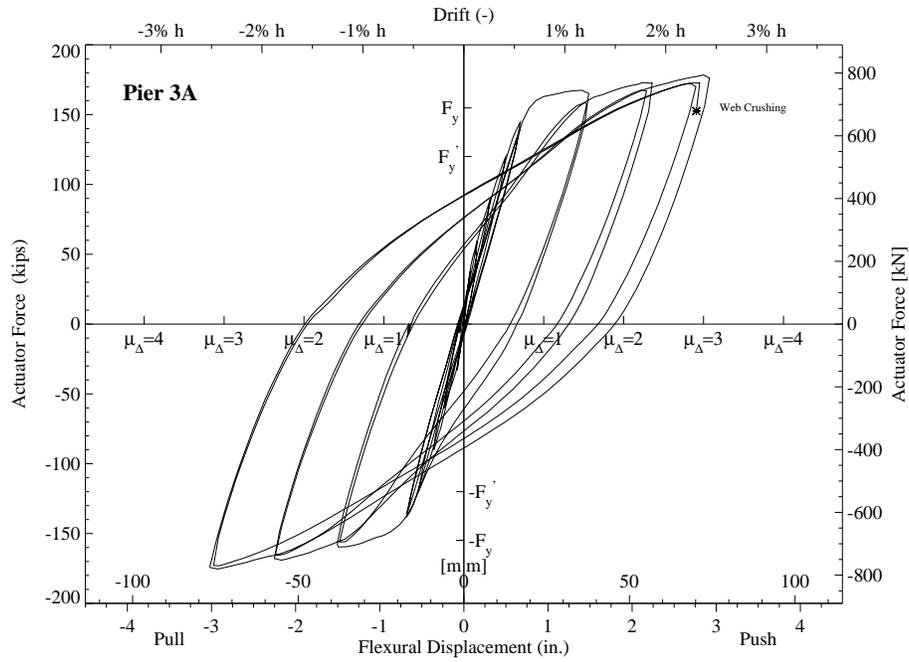
Figure 7.3: Test Unit 3A, calculated experimental flexural hysteretic response.

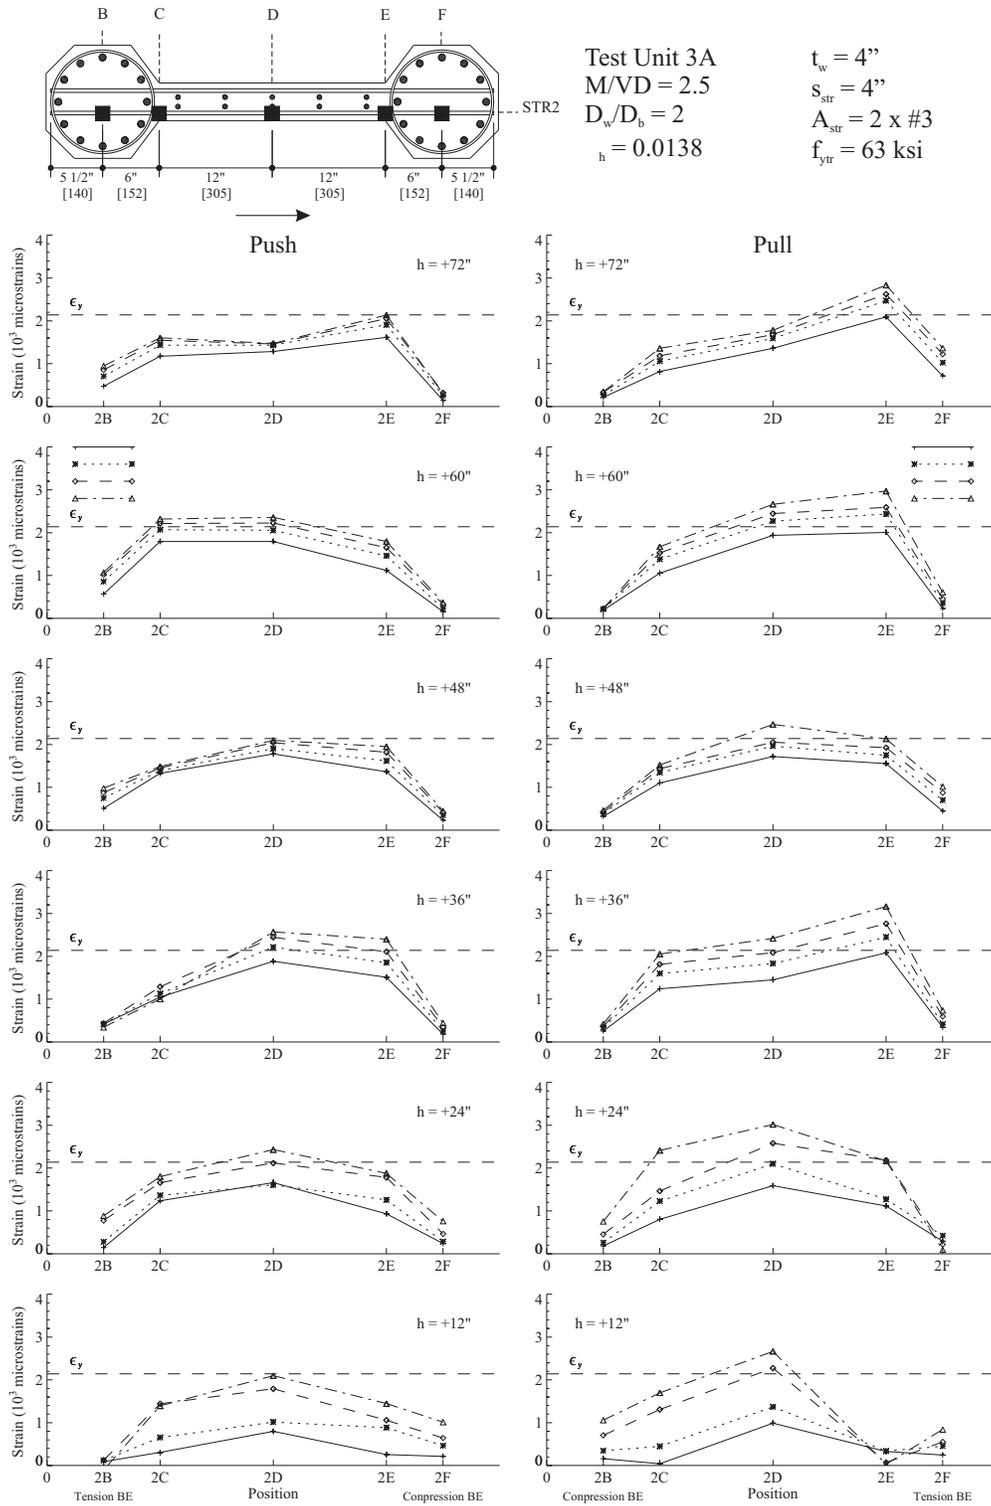
Figure 7.8: Test Unit 3A, transverse bar strain profiles.

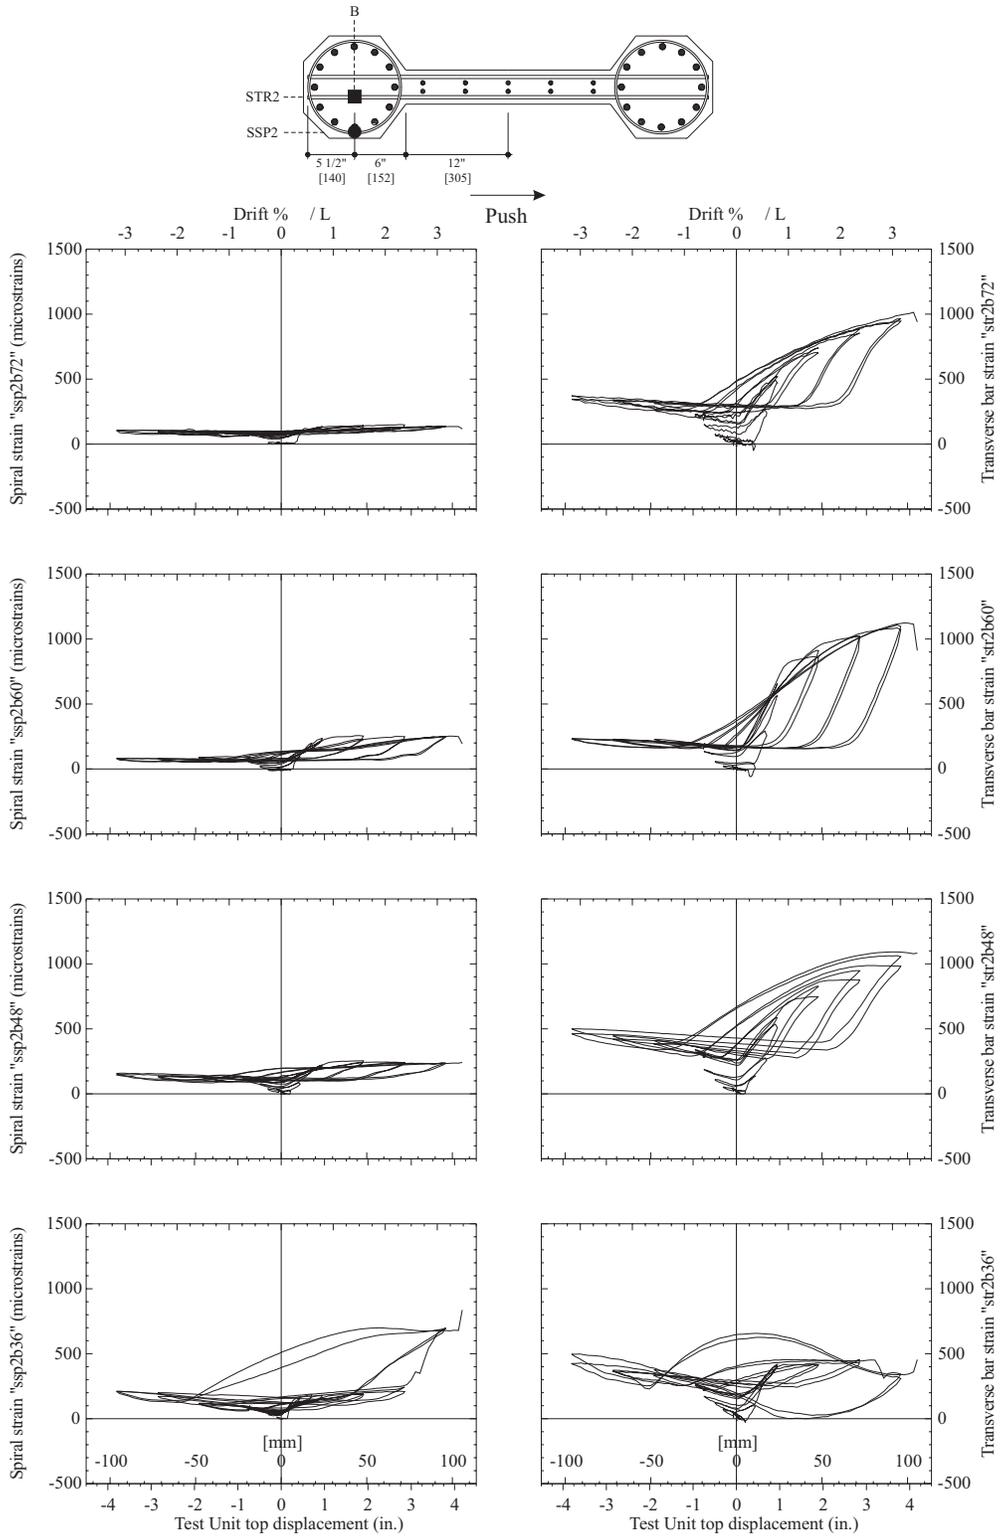
Figure 7.9: Test Unit 3A, spiral strains and transverse bar strains at Position B, for heights 36 in. [914], 48 in. [1219], 60 in. [1524] and 72 in. [1829] above the footing.

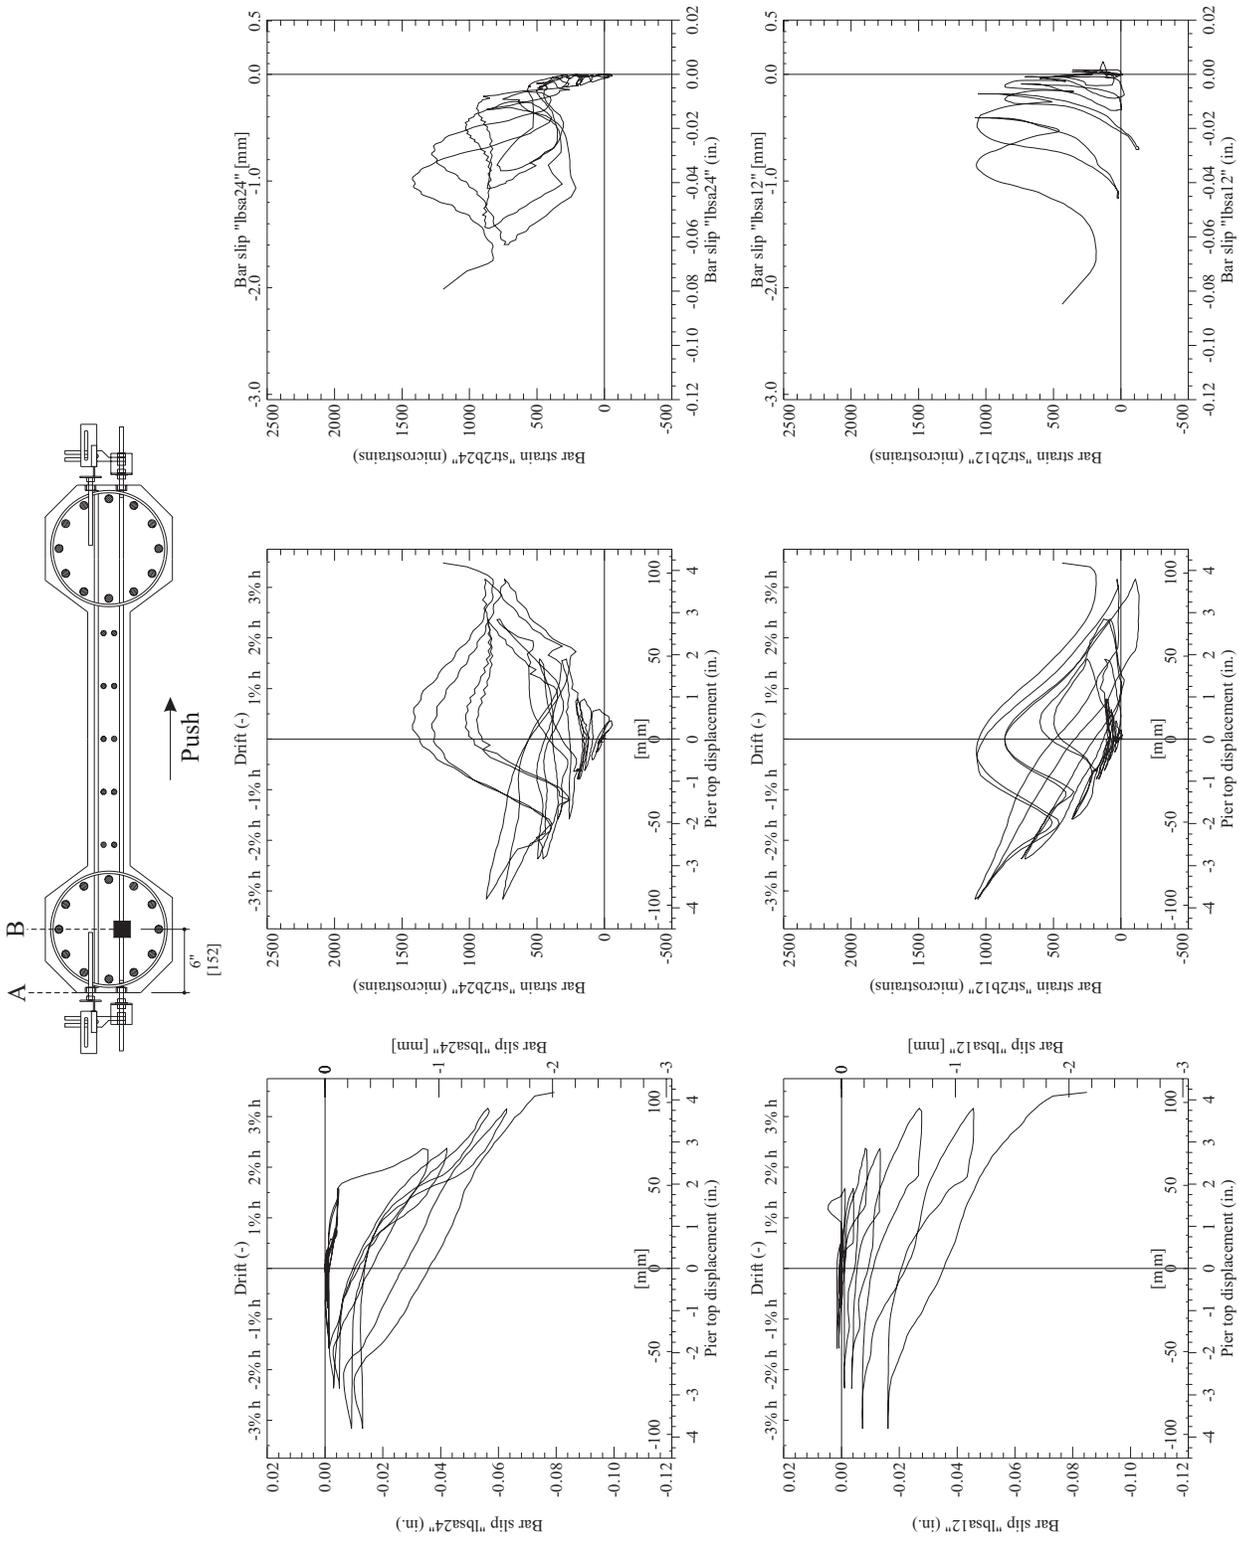
Figure 7.10: Test Unit 3A bar slip and transverse bar strain histories at positions A and B, 12 in. [305] and 24 in. [610] above the footing. Push (positive) direction is south.

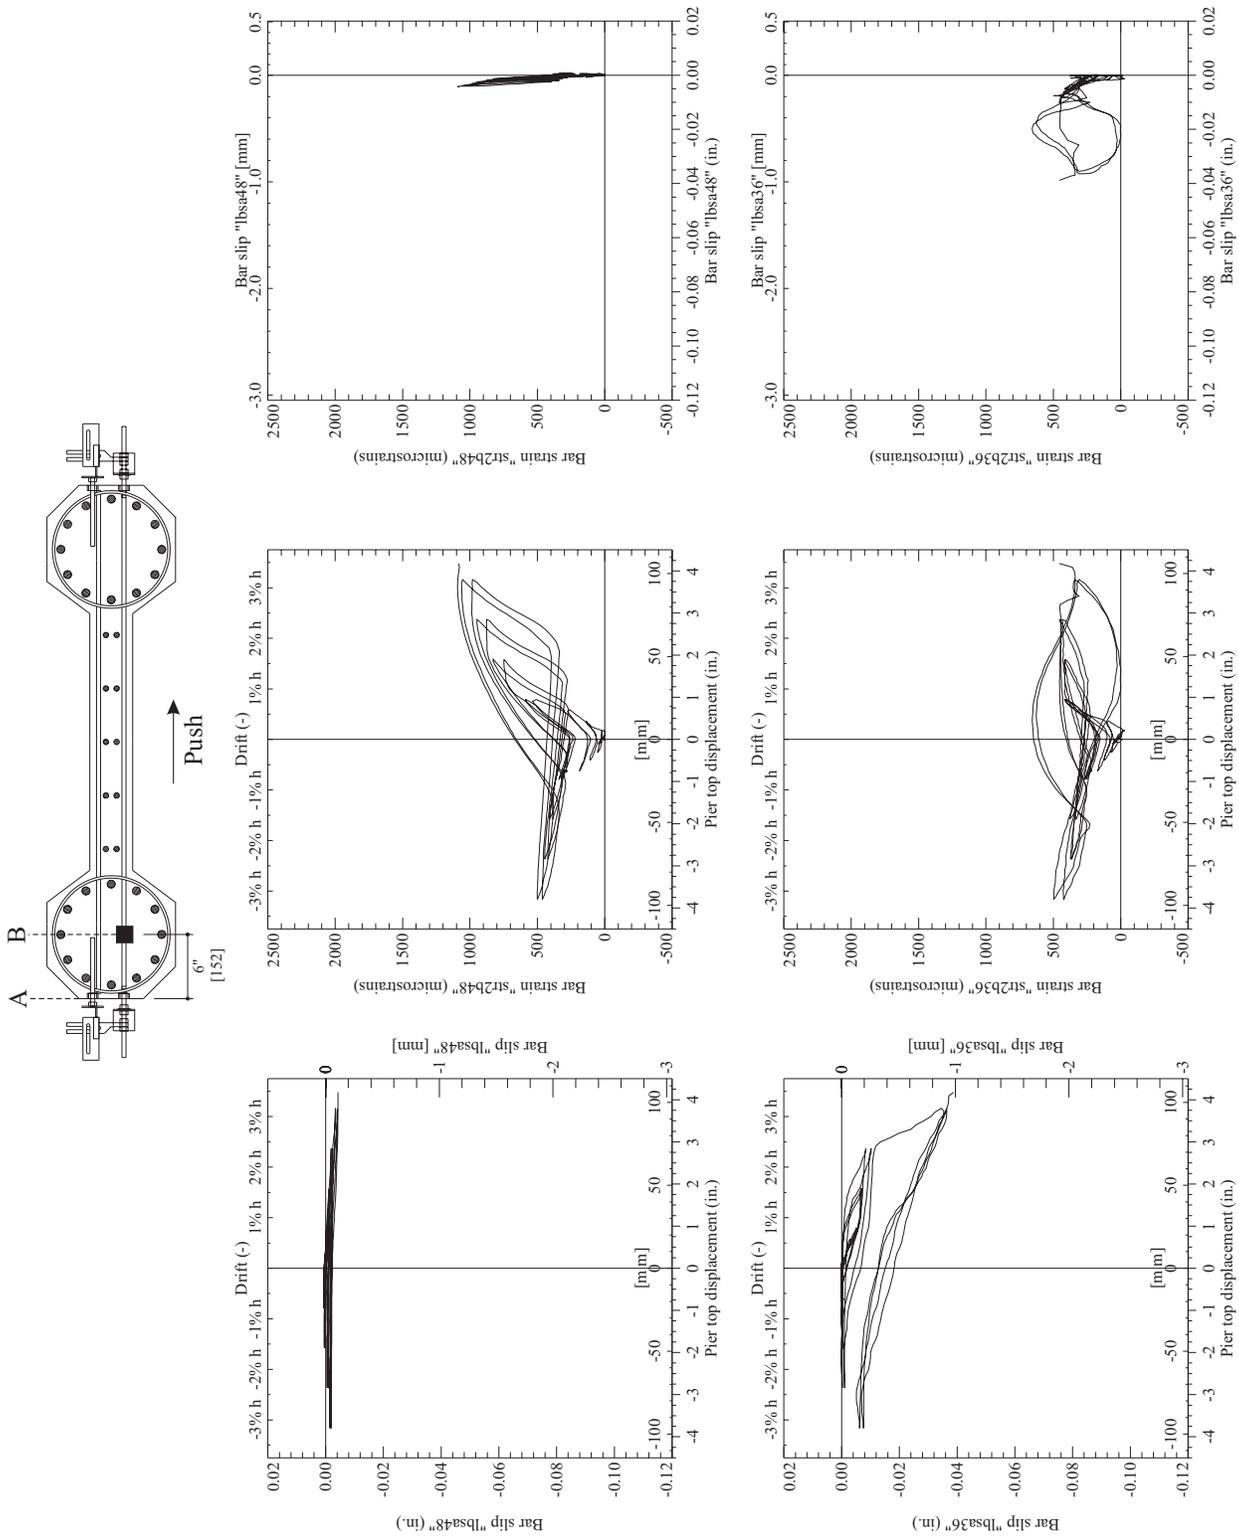
Figure 7.11: Test Unit 3A bar slip and transverse bar strain histories at positions A and B, 36 in. [914] and 48 in. [1219] above the footing. Push (positive) direction is south.

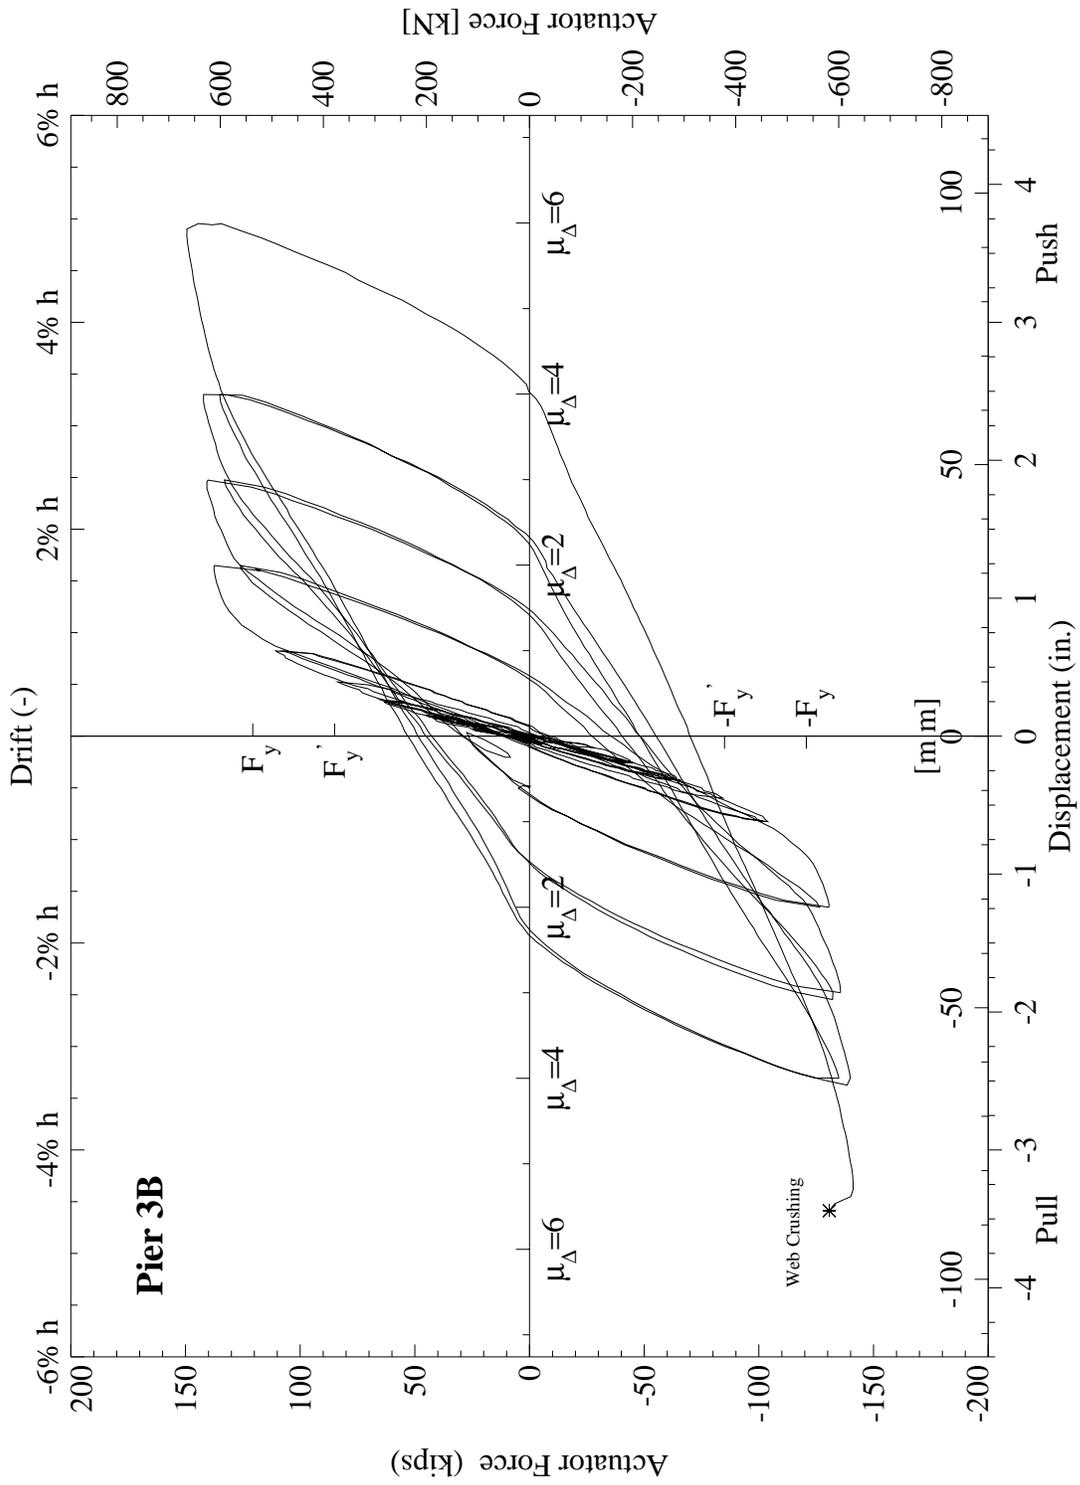
Figure 7.12: Test Unit 3B, measured experimental hysteretic response.
