Report No.
SSRP-2001/27
FINAL

**SEISMIC PERFORMANCE OF
HOLLOW RECTANGULAR
REINFORCED CONCRETE PIERS
WITH HIGHLY-CONFINED
BOUNDARY ELEMENTS PHASE III:
WEB CRUSHING TESTS**

Final Report Submitted to Caltrans under Contract No. 59A0051

June 2002

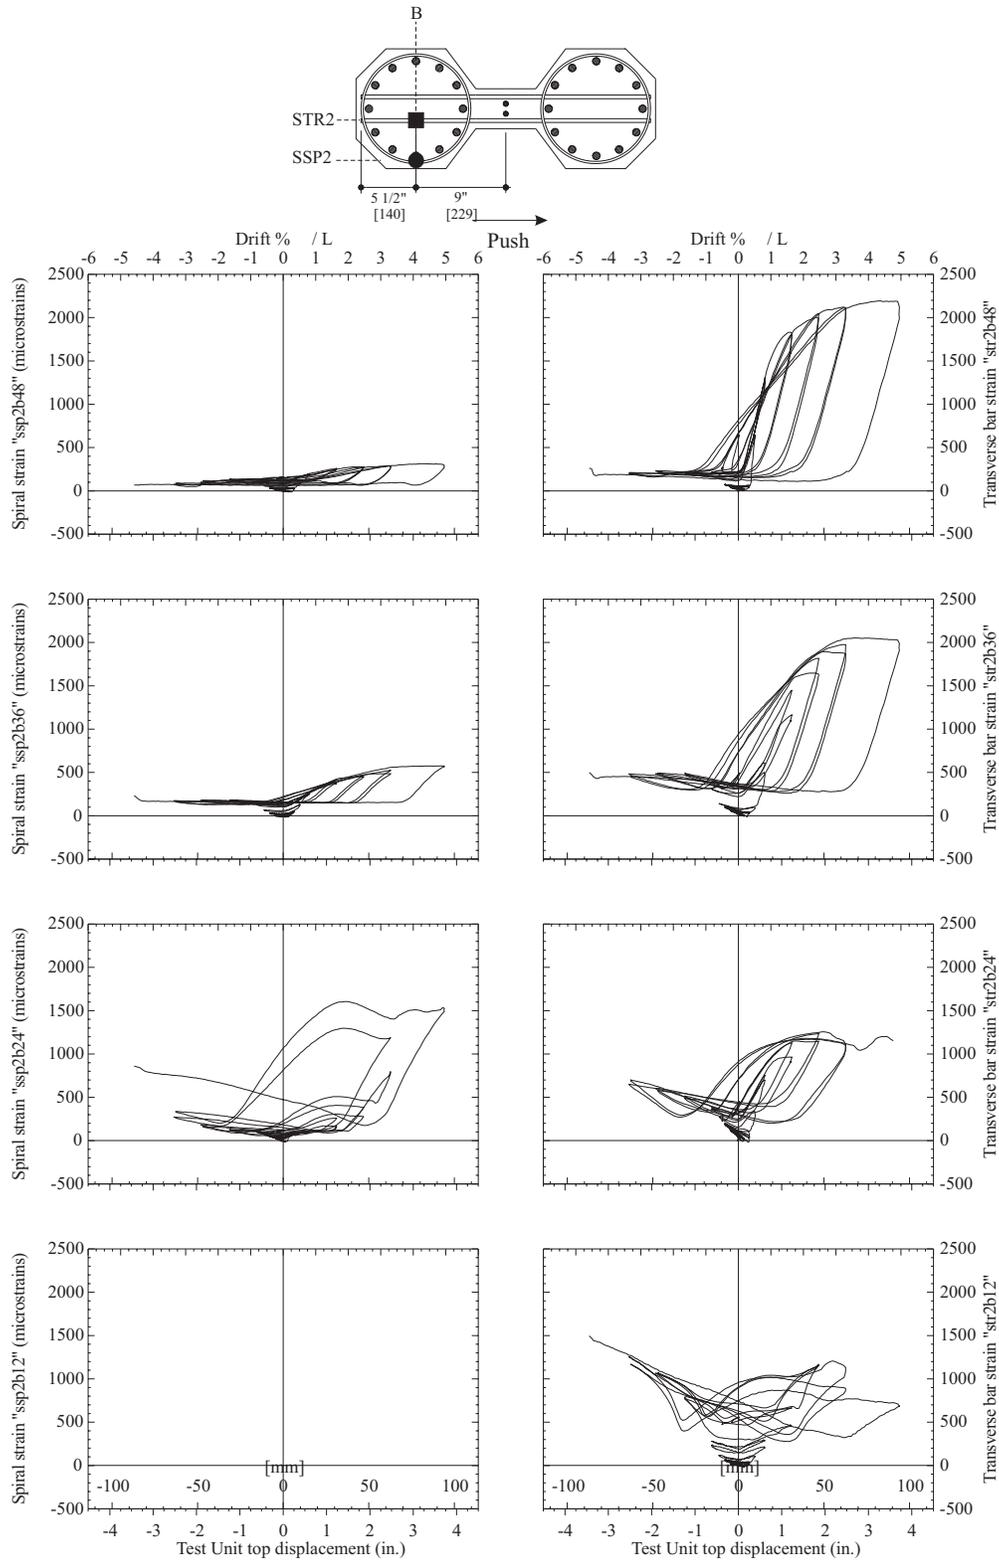
Figure 7.20: Test Unit 3B, spiral strains and transverse bar strains at Position B, for heights 12 in. [305], 24 in. [610], 36 in. [914] and 48 in. [1219] above the footing.

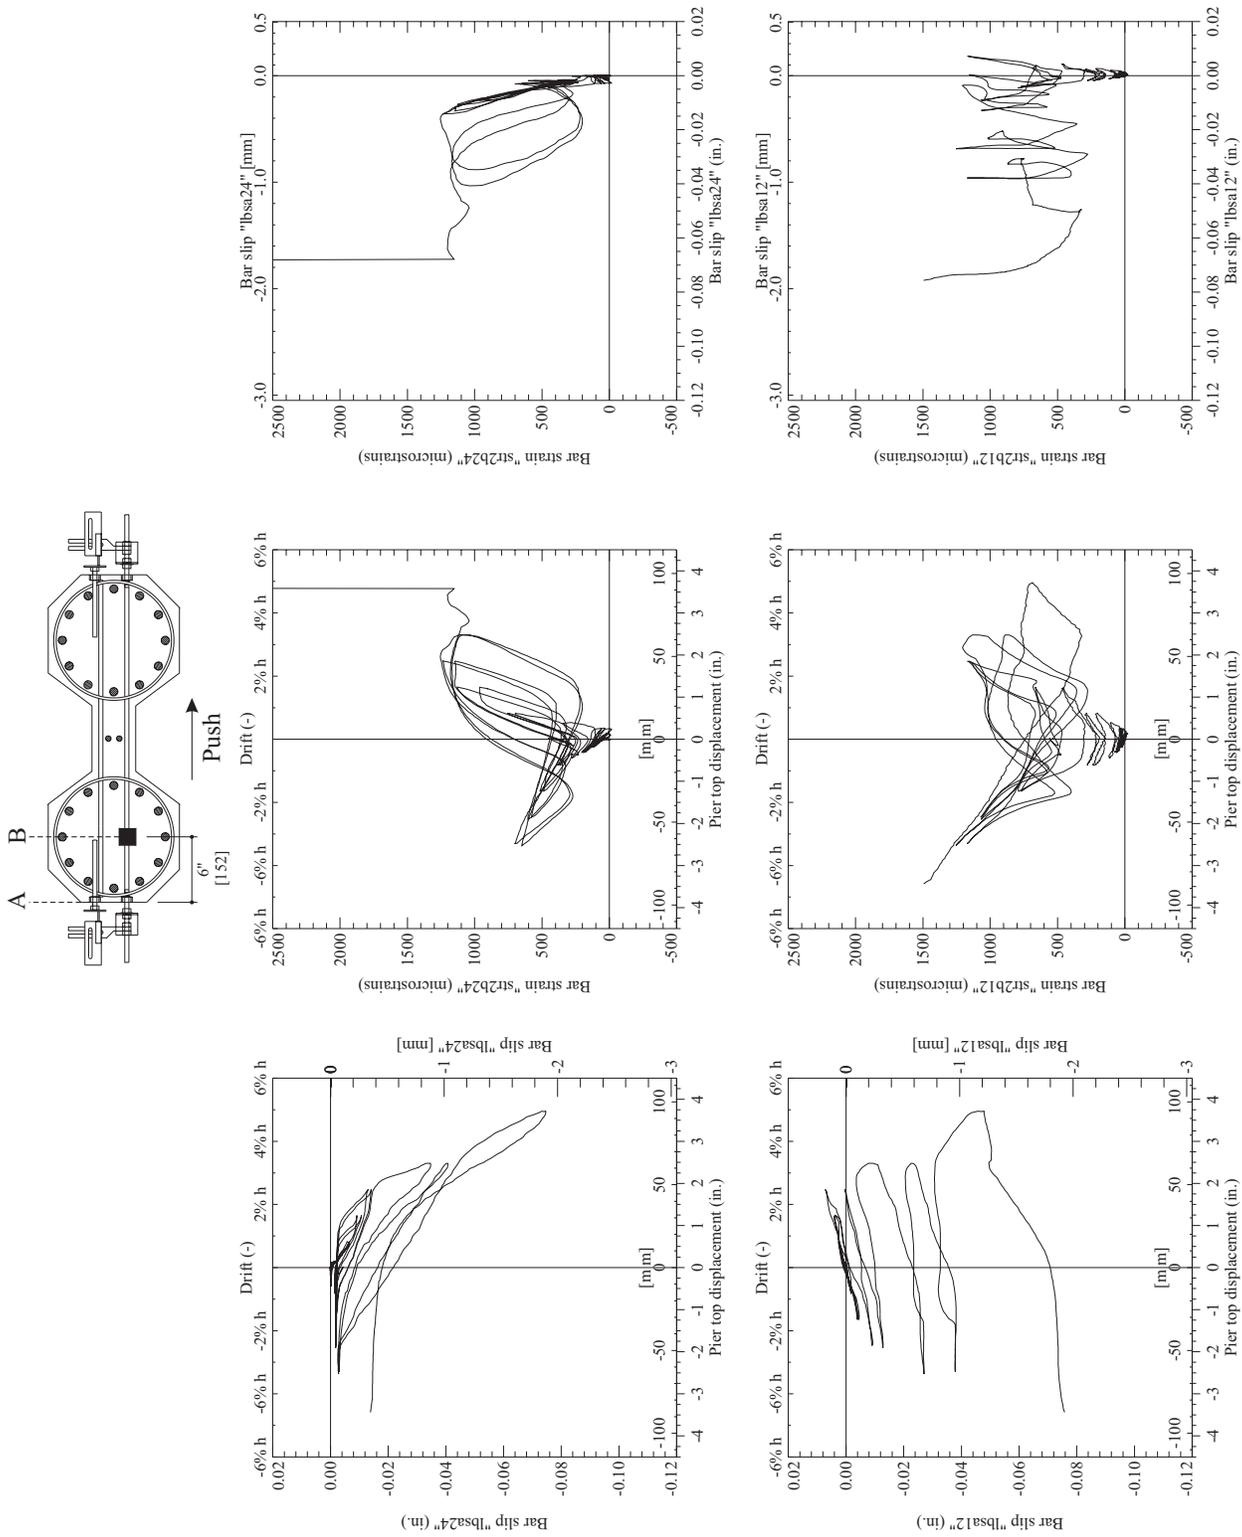
Figure 7.21: Test Unit 3B bar slip and transverse bar strain histories at positions A and B, 12 in. [305] and 24 in. [610] above the footing. Push (positive) direction is south.

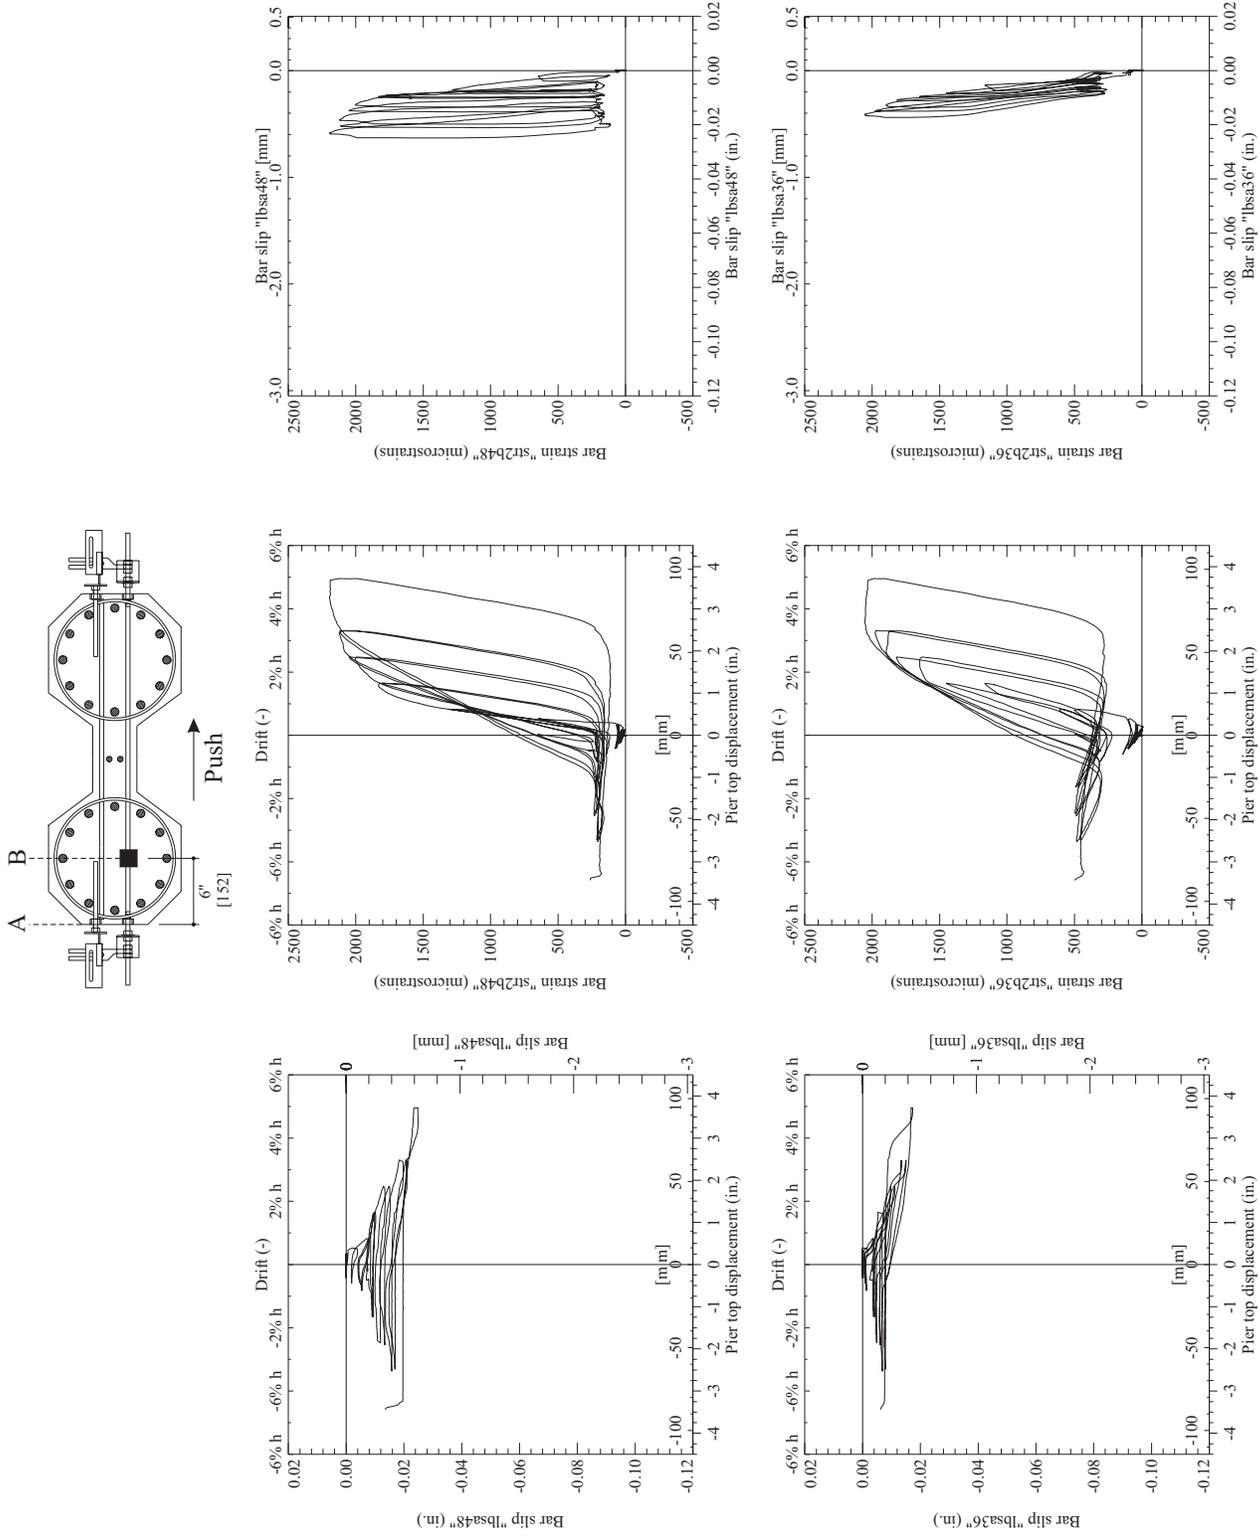
Figure 7.22: Test Unit 3B bar slip and transverse bar strain histories at positions A and B, 36 in. [914] and 48 in. [1219] above the footing. Push (positive) direction is south.

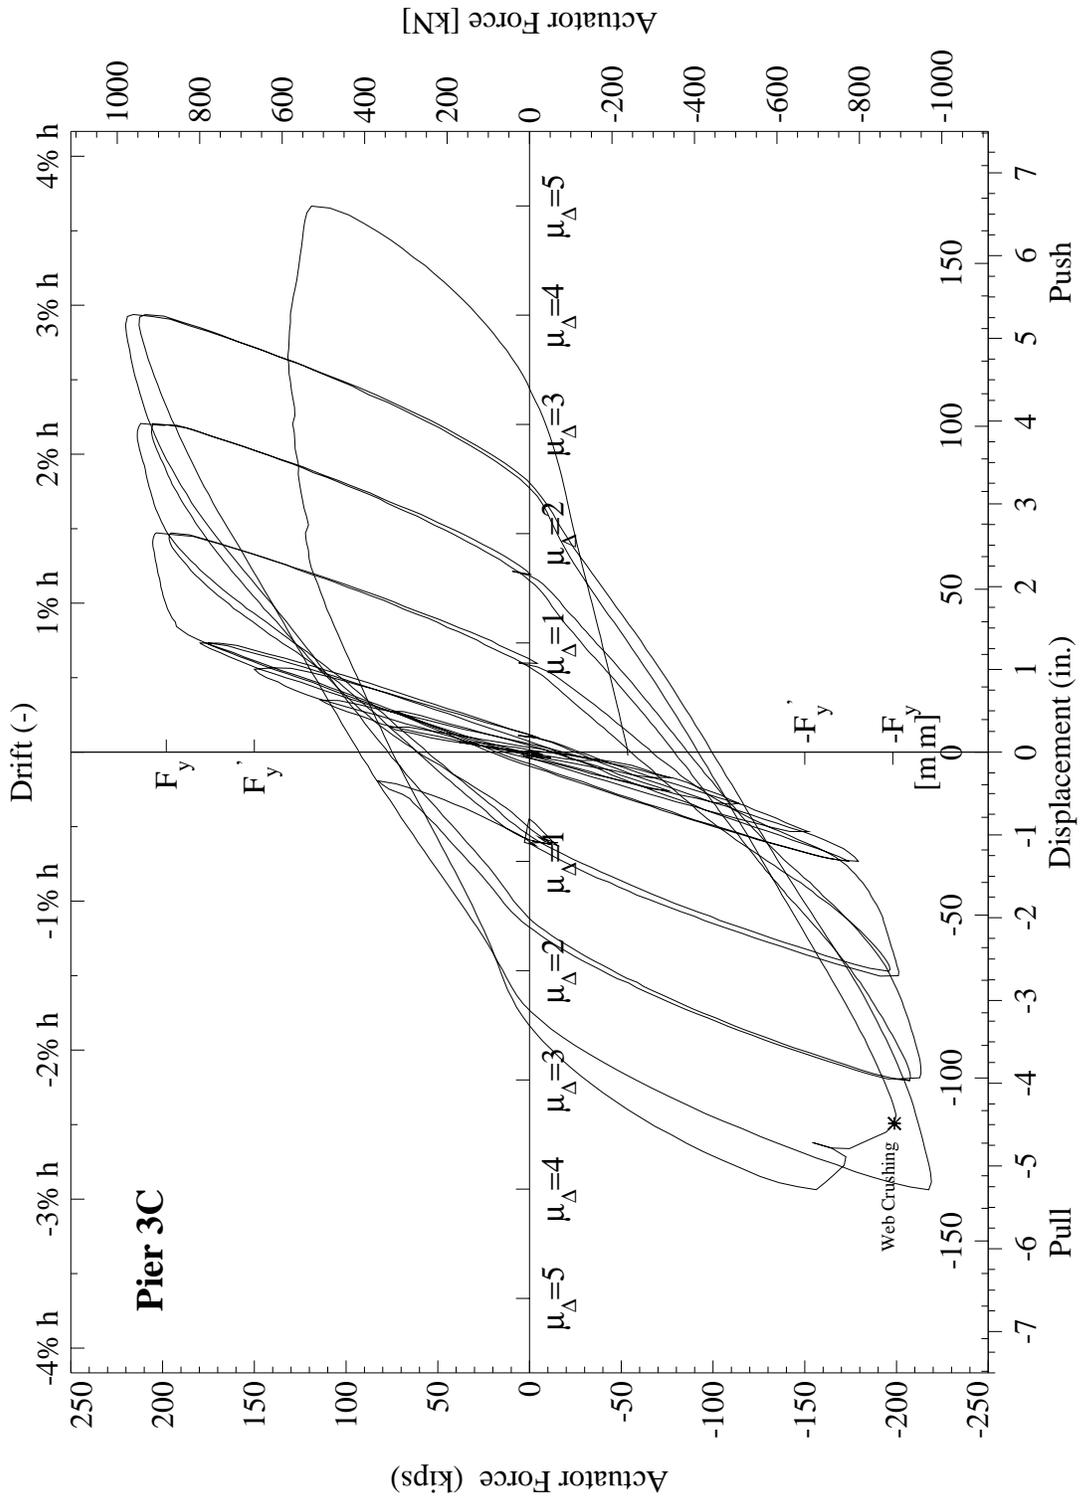
Figure 7.23: Test Unit 3C, measured experimental hysteretic response.

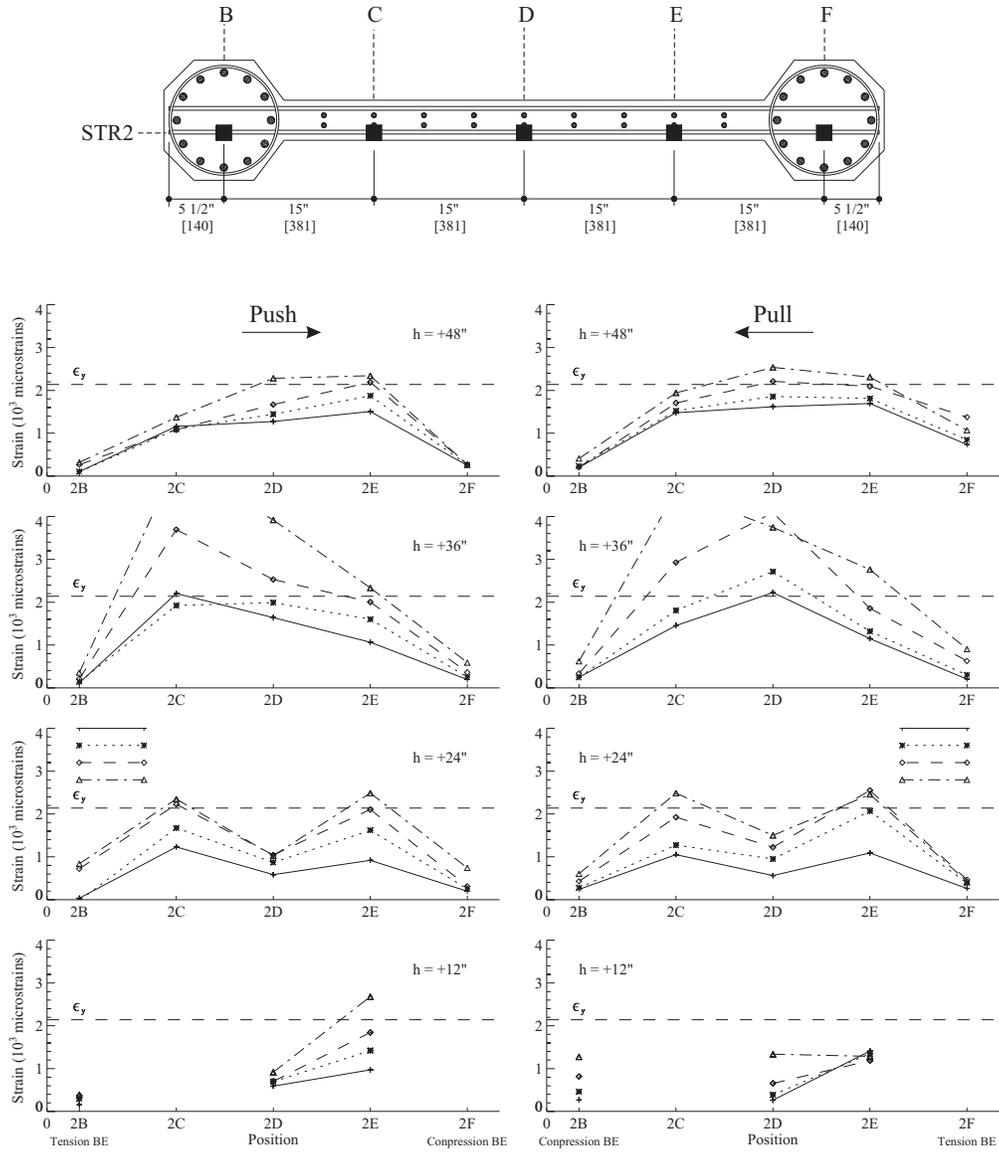
Figure 7.30: Test Unit 3C, lower transverse bar strain profiles.

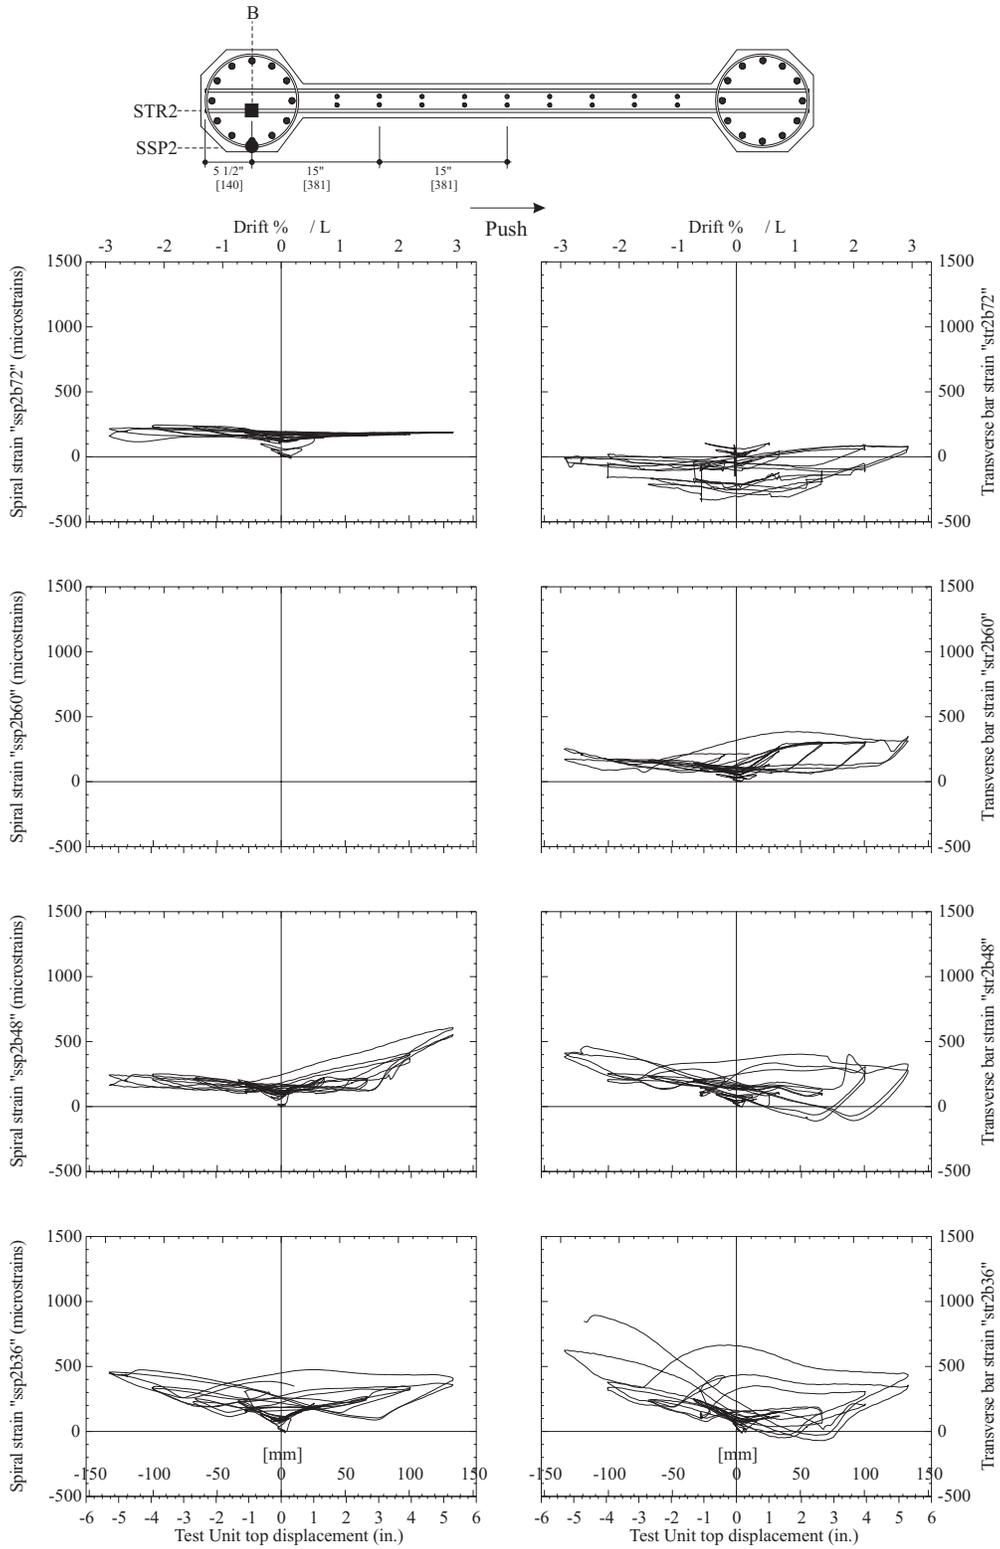
Figure 7.32: Test Unit 3C, spiral strains and transverse bar strains at Position B, for heights 36 in. [914], 48 in. [1219], 60 in. [1524] and 72 in. [1829] above the footing.

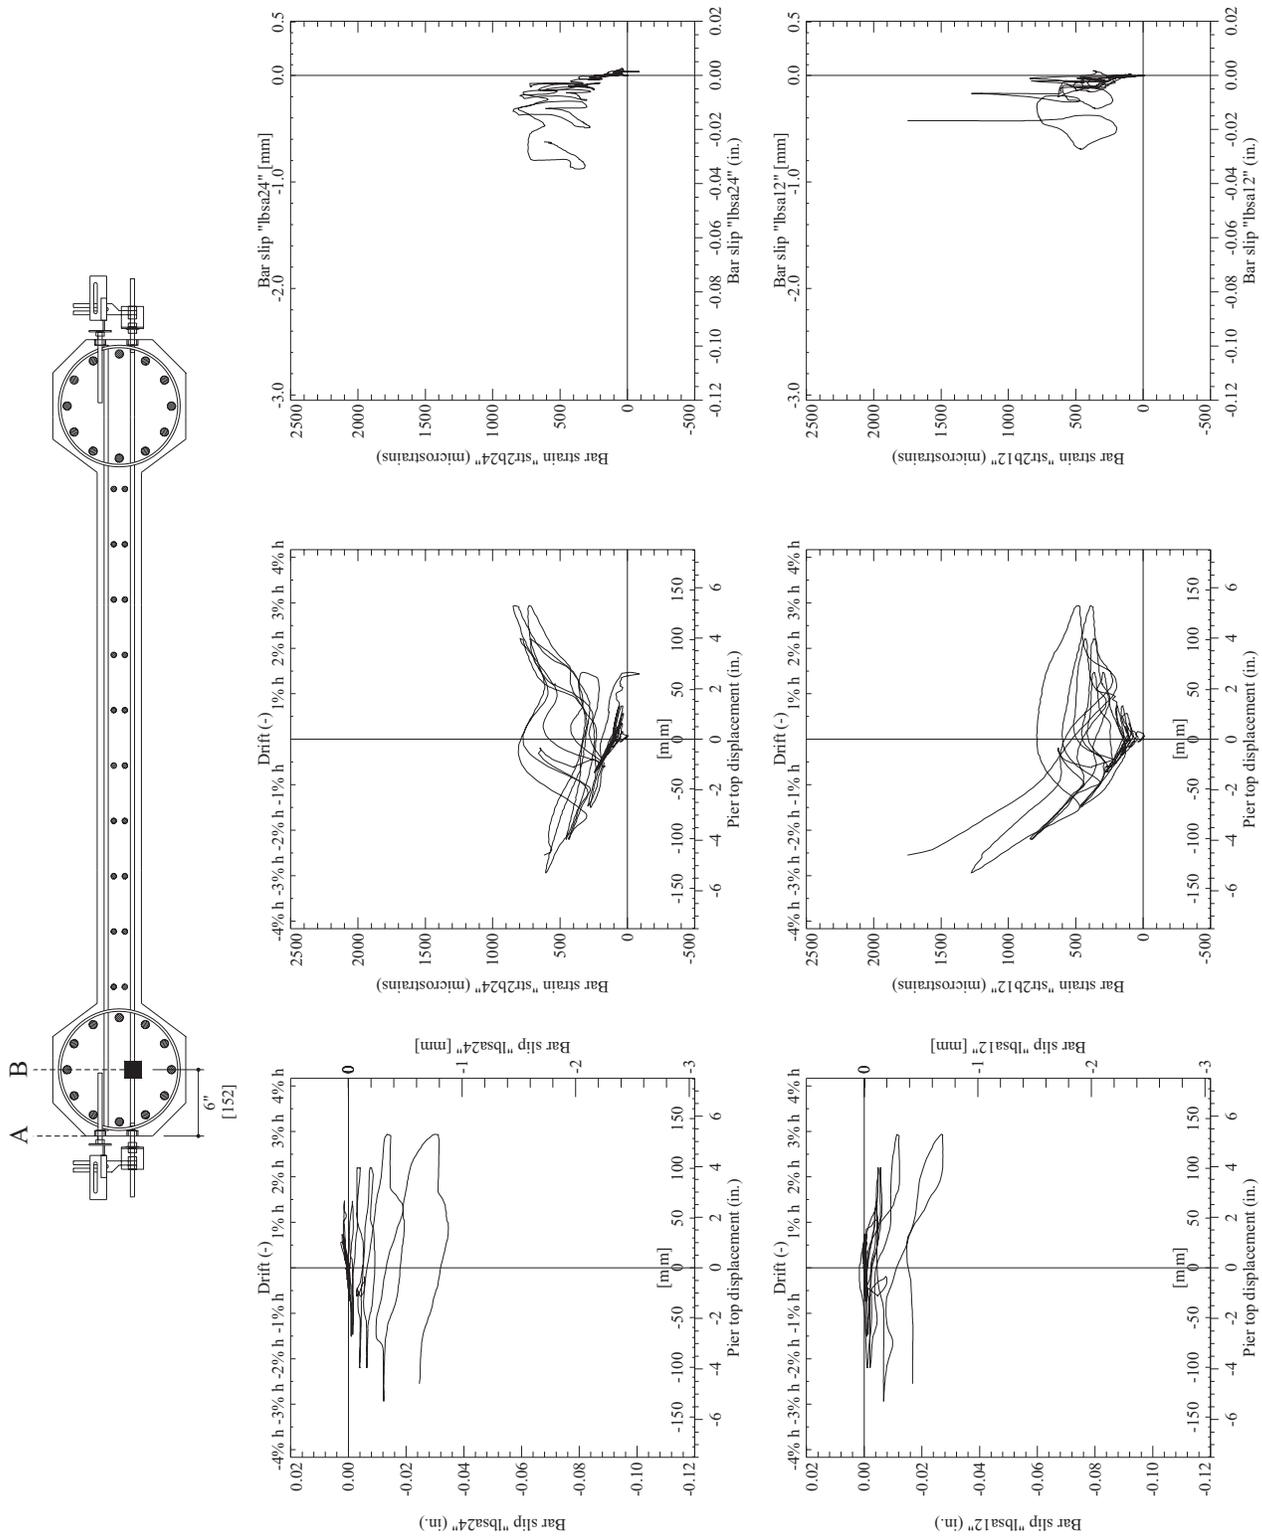
Figure 7.33: Test Unit 3C bar slip and transverse bar strain histories at positions A and B, 12 in. [305] and 24 in. [610] above the footing. Push (positive) direction is south.

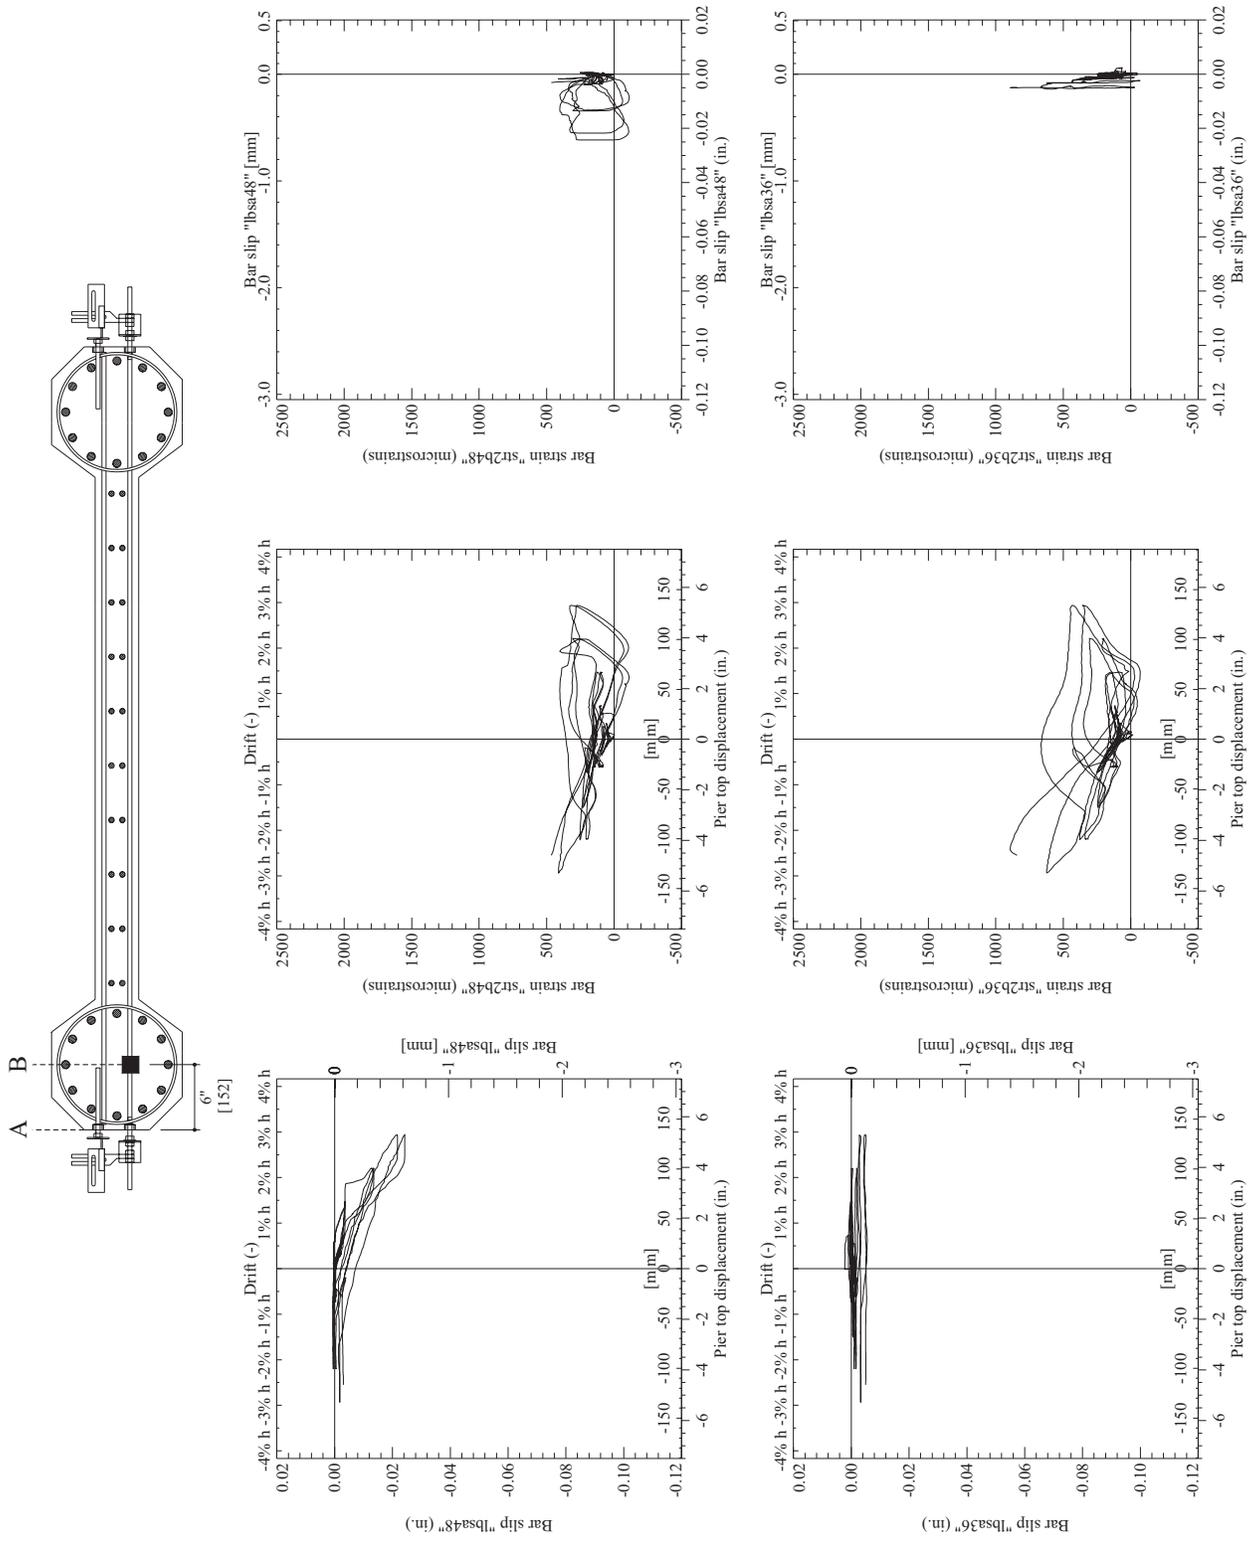
Figure 7.34: Test Unit 3C bar slip and transverse bar strain histories at positions A and B, 36 in. [914] and 48 in. [1219] above the footing. Push (positive) direction is south.

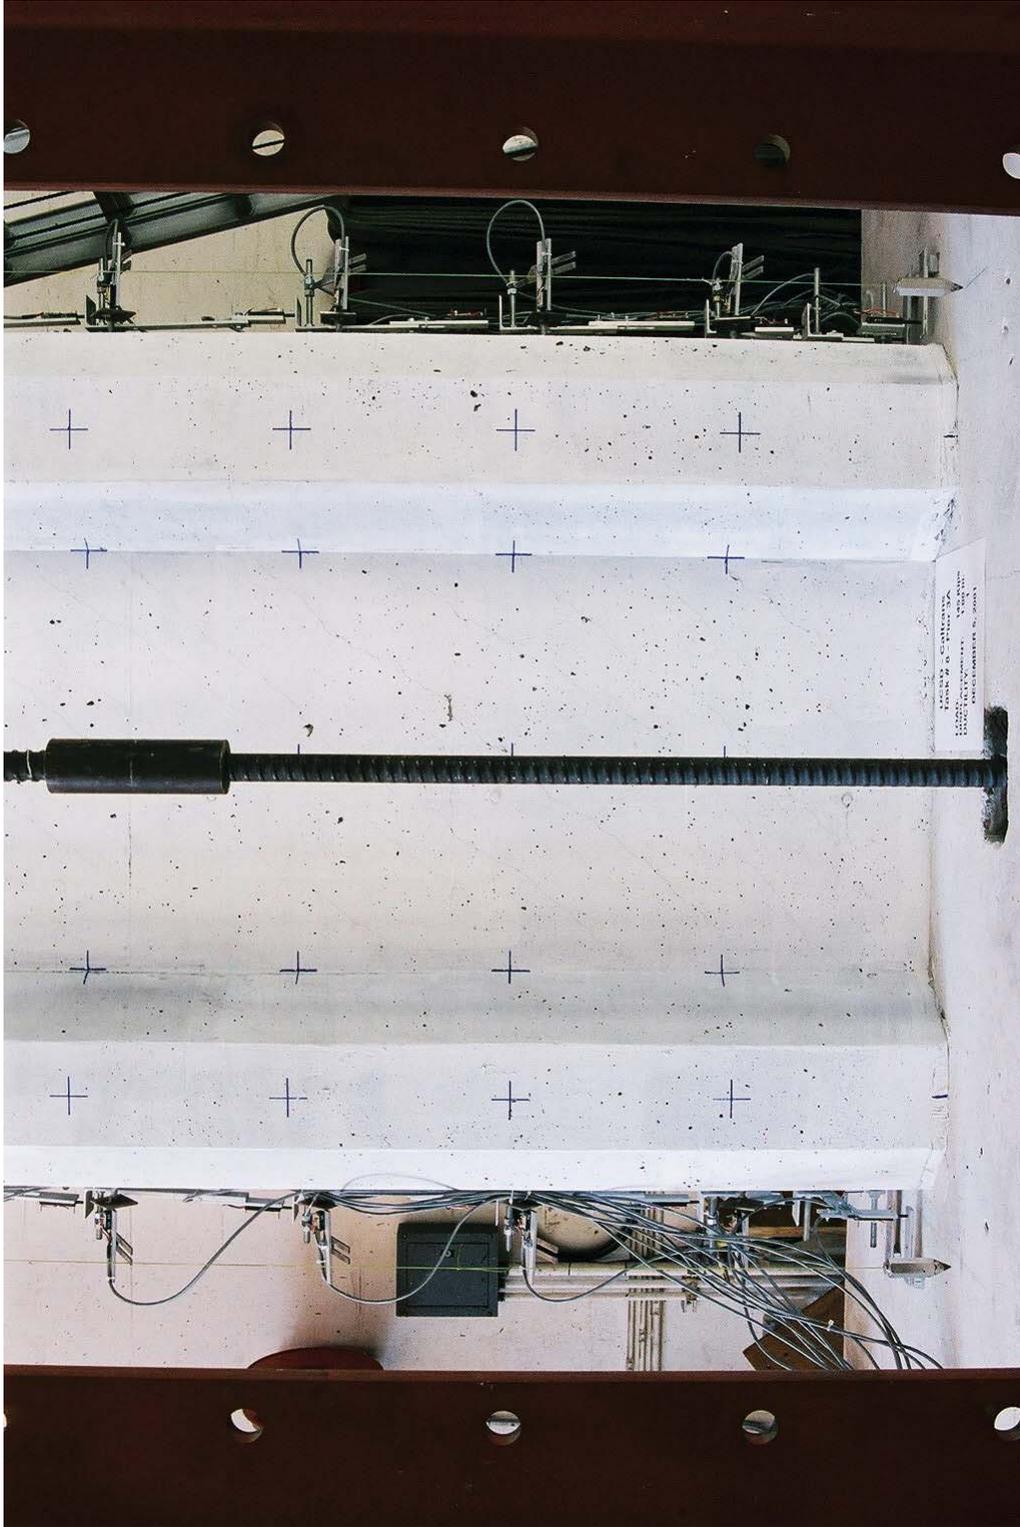
Figure B.1: $\mu_{\Delta} = 1 \times +1$; Test Unit 3A, east face. Push (positive) direction is south.

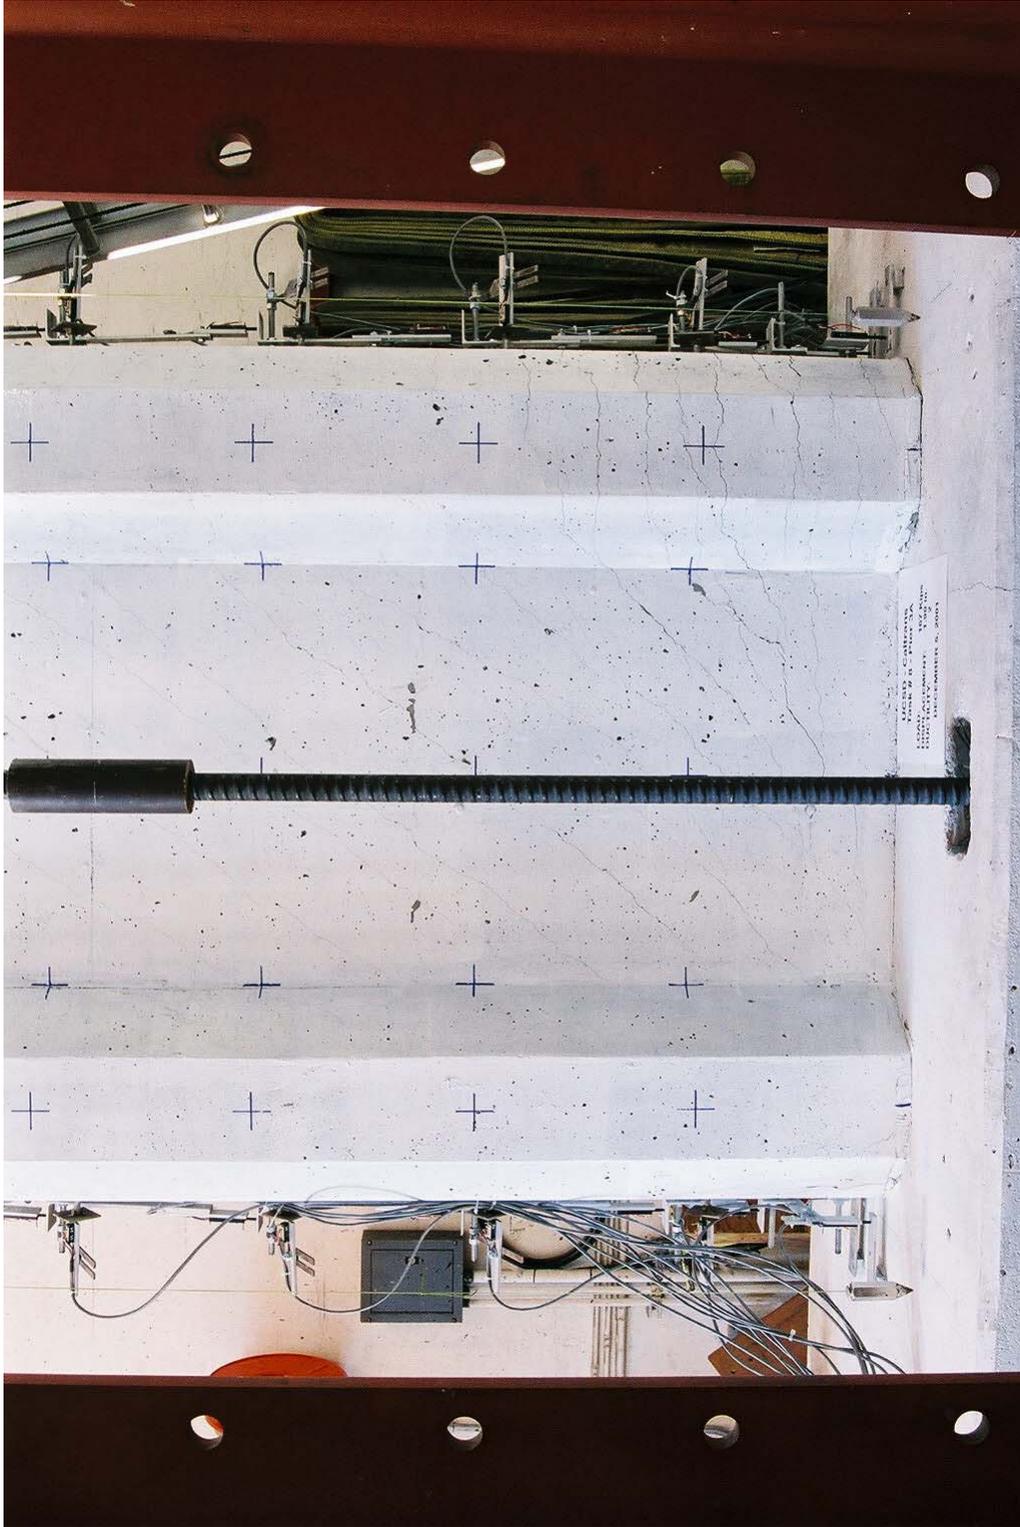
Figure B.2: $\mu_{\Delta} = 2 \times +1$; Test Unit 3A, east face. Push (positive) direction is south.

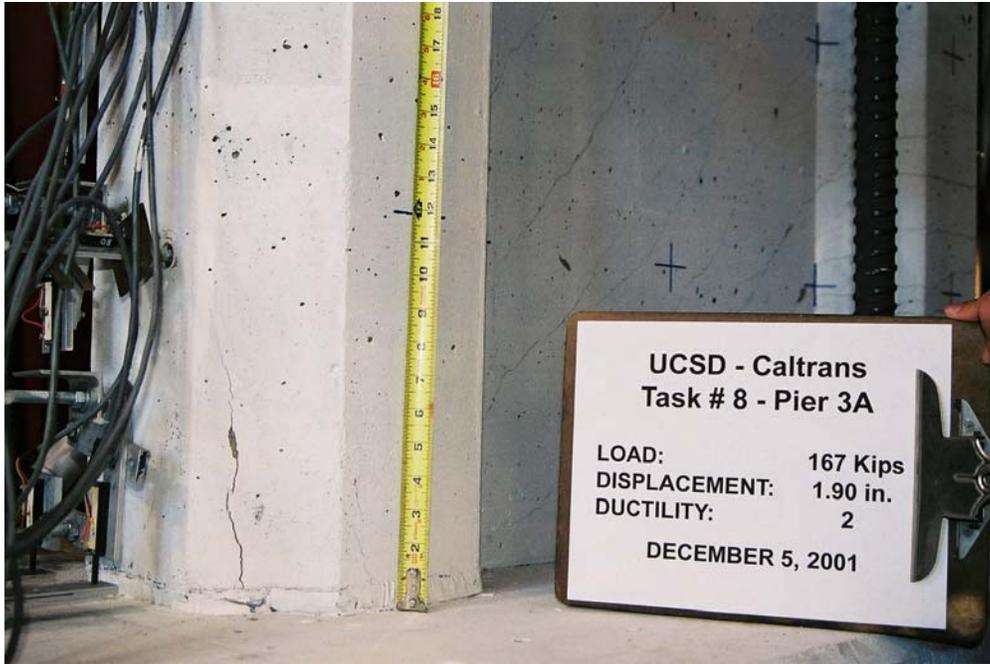
Figure B.3: $\mu_{\Delta} = 2 \times +1$; Test Unit 3A, splitting cracks on compression (south) boundary element.

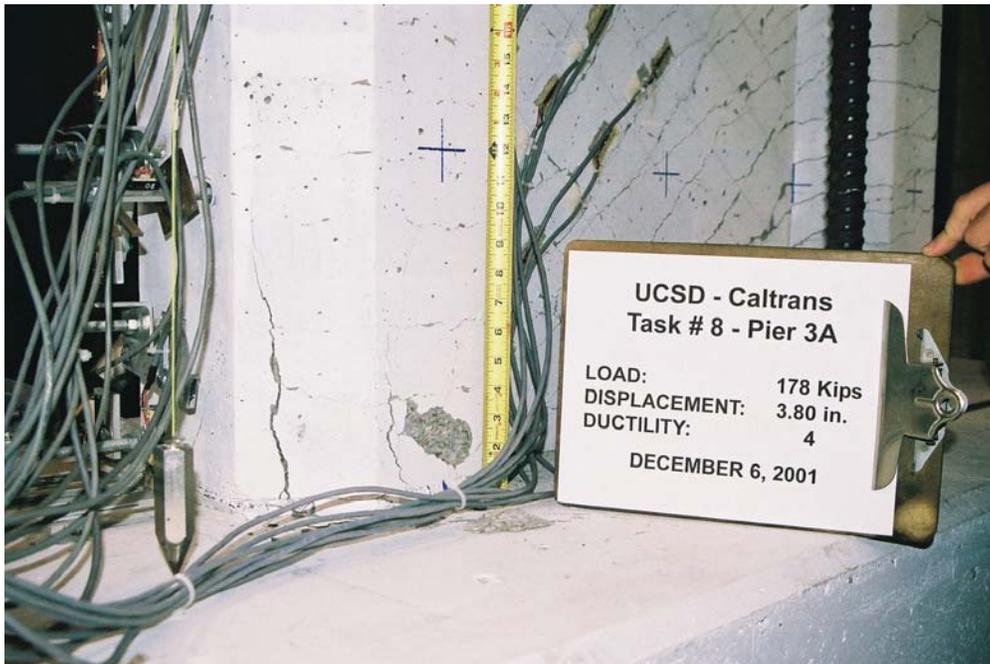
Figure B.4: $\mu_{\Delta} = 4 \times +1$; Test Unit 3A, splitting cracks and spalling on compression (south) boundary element.

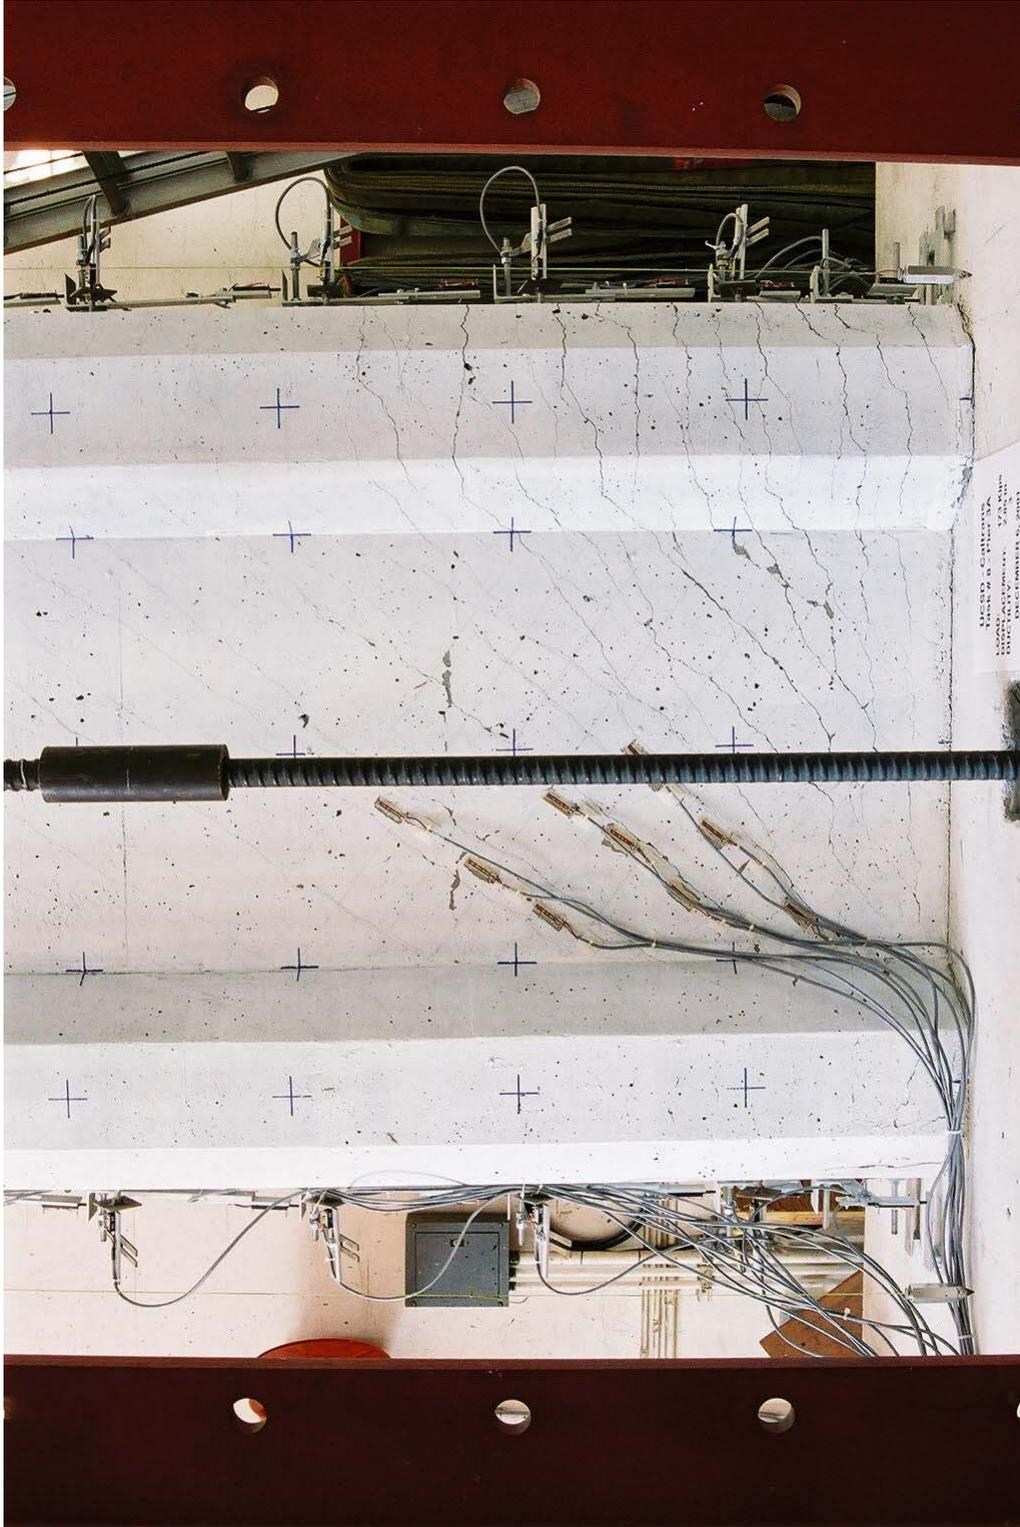
Figure B.5: $\mu_{\Delta} = 3 \times +1$; Test Unit 3A, east face. Push (positive) direction is south.

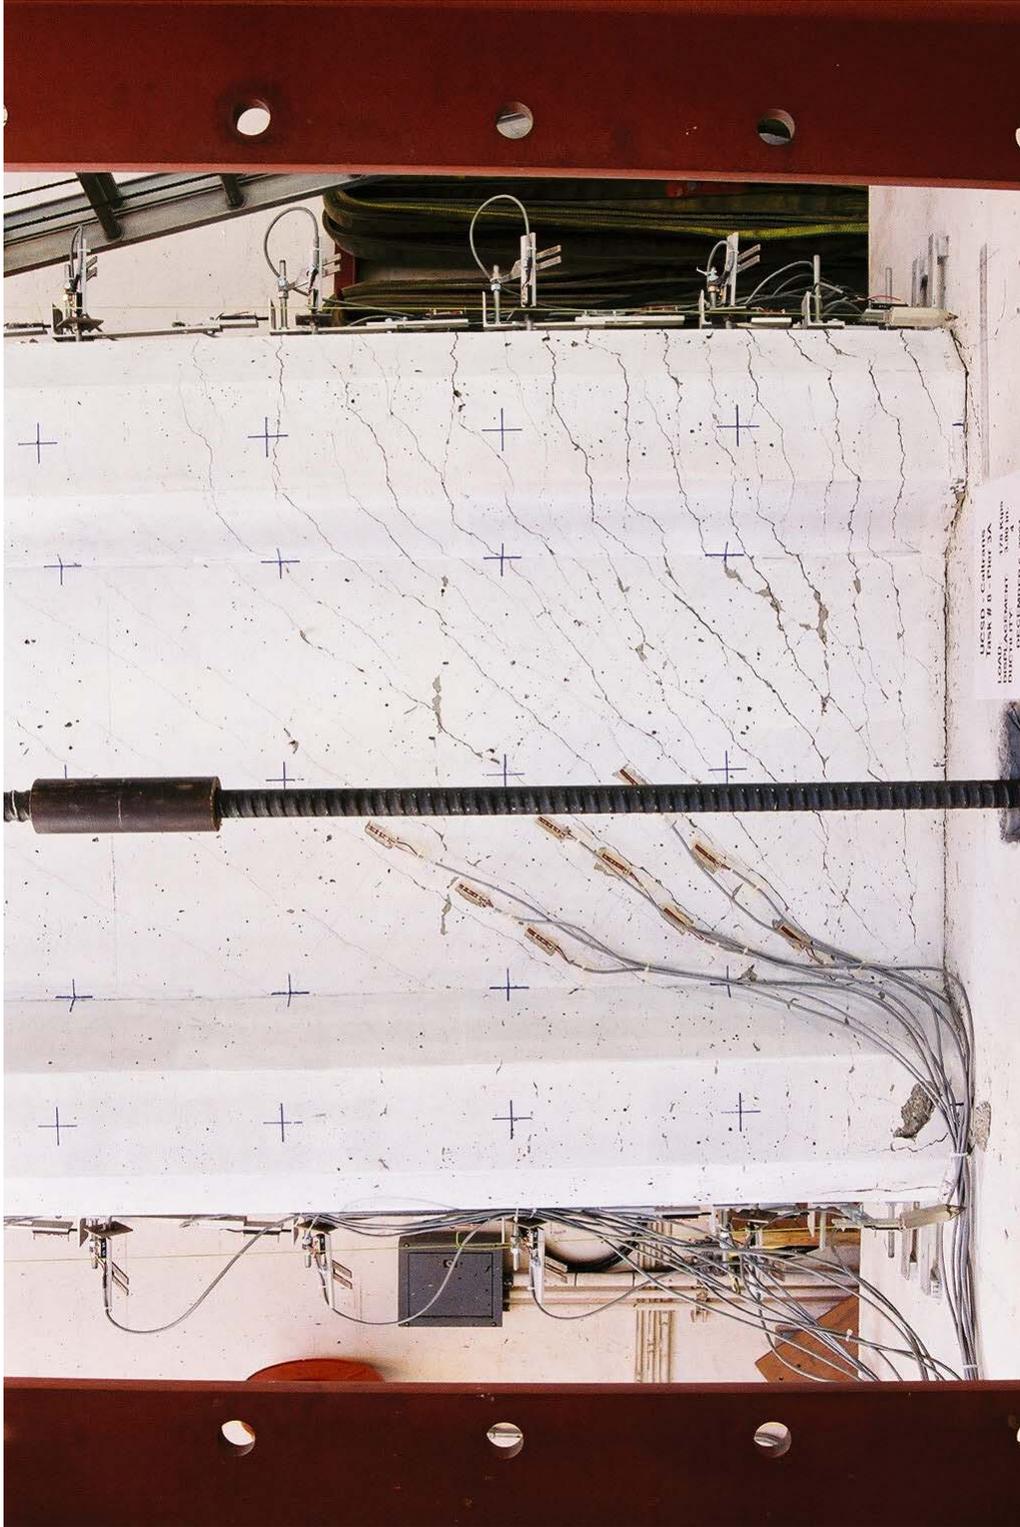
Figure B.6: $\mu_{\Delta} = 4 \times +1$; Test Unit 3A, east face. Push (positive) direction is south.

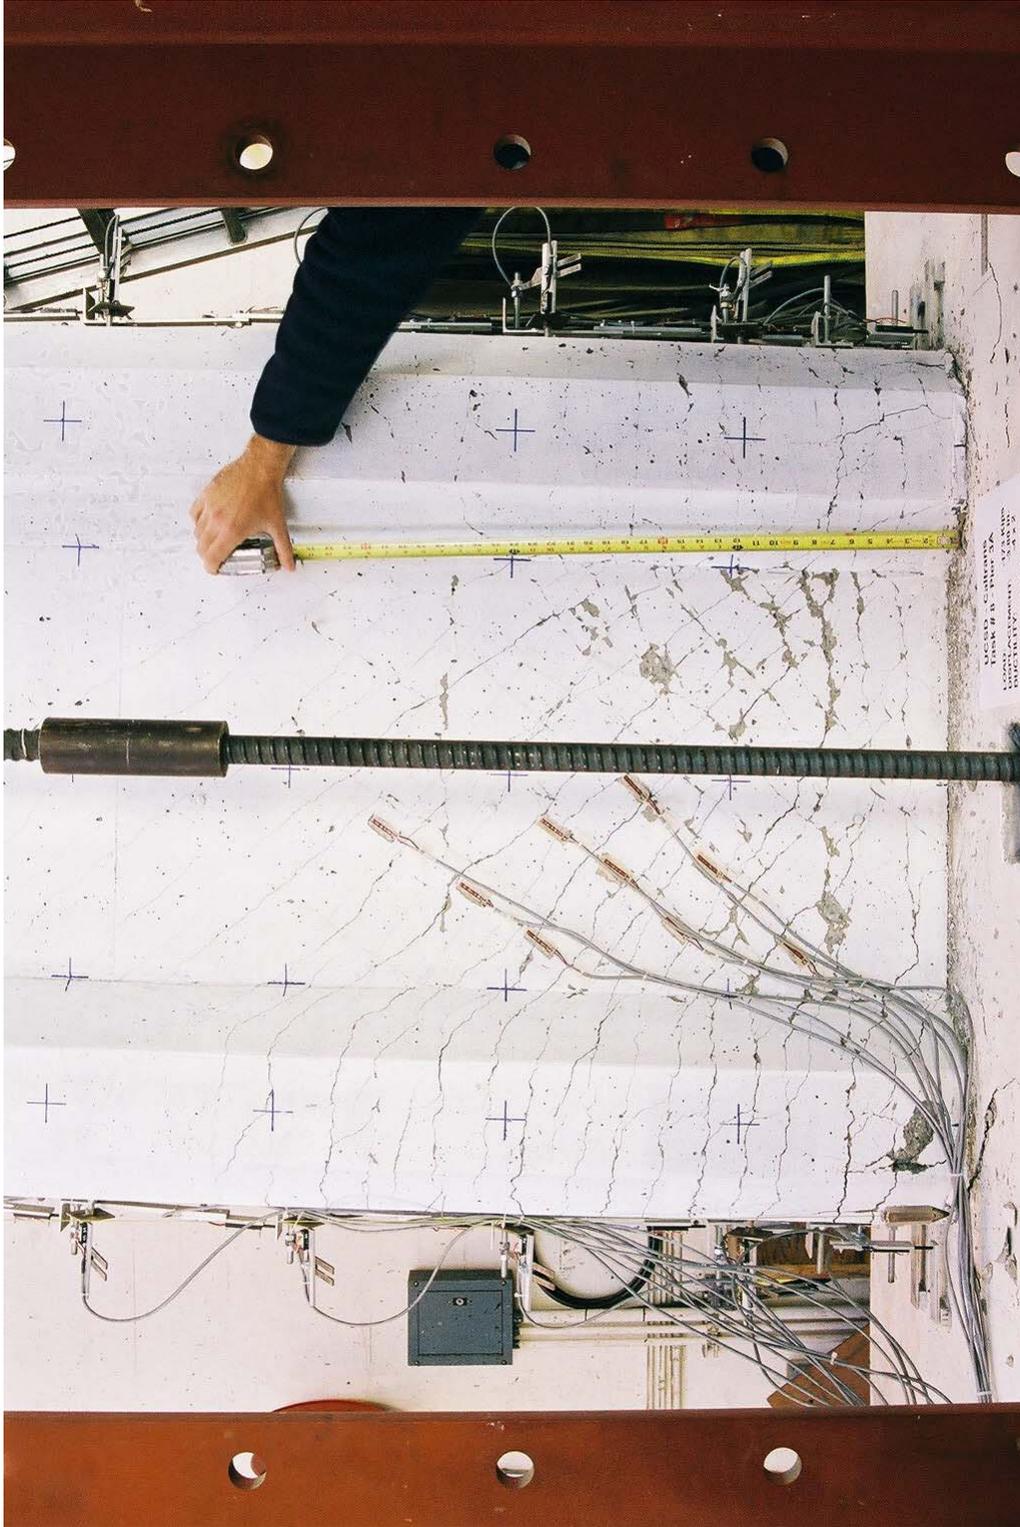
Figure B.7: $\mu_{\Delta} = 4 \times -2$; Test Unit 3A, east face. Push (positive) direction is south.
