Report No.
SSRP-2001/27
FINAL

**SEISMIC PERFORMANCE OF
HOLLOW RECTANGULAR
REINFORCED CONCRETE PIERS
WITH HIGHLY-CONFINED
BOUNDARY ELEMENTS PHASE III:
WEB CRUSHING TESTS**

Final Report Submitted to Caltrans under Contract No. 59A0051

June 2002

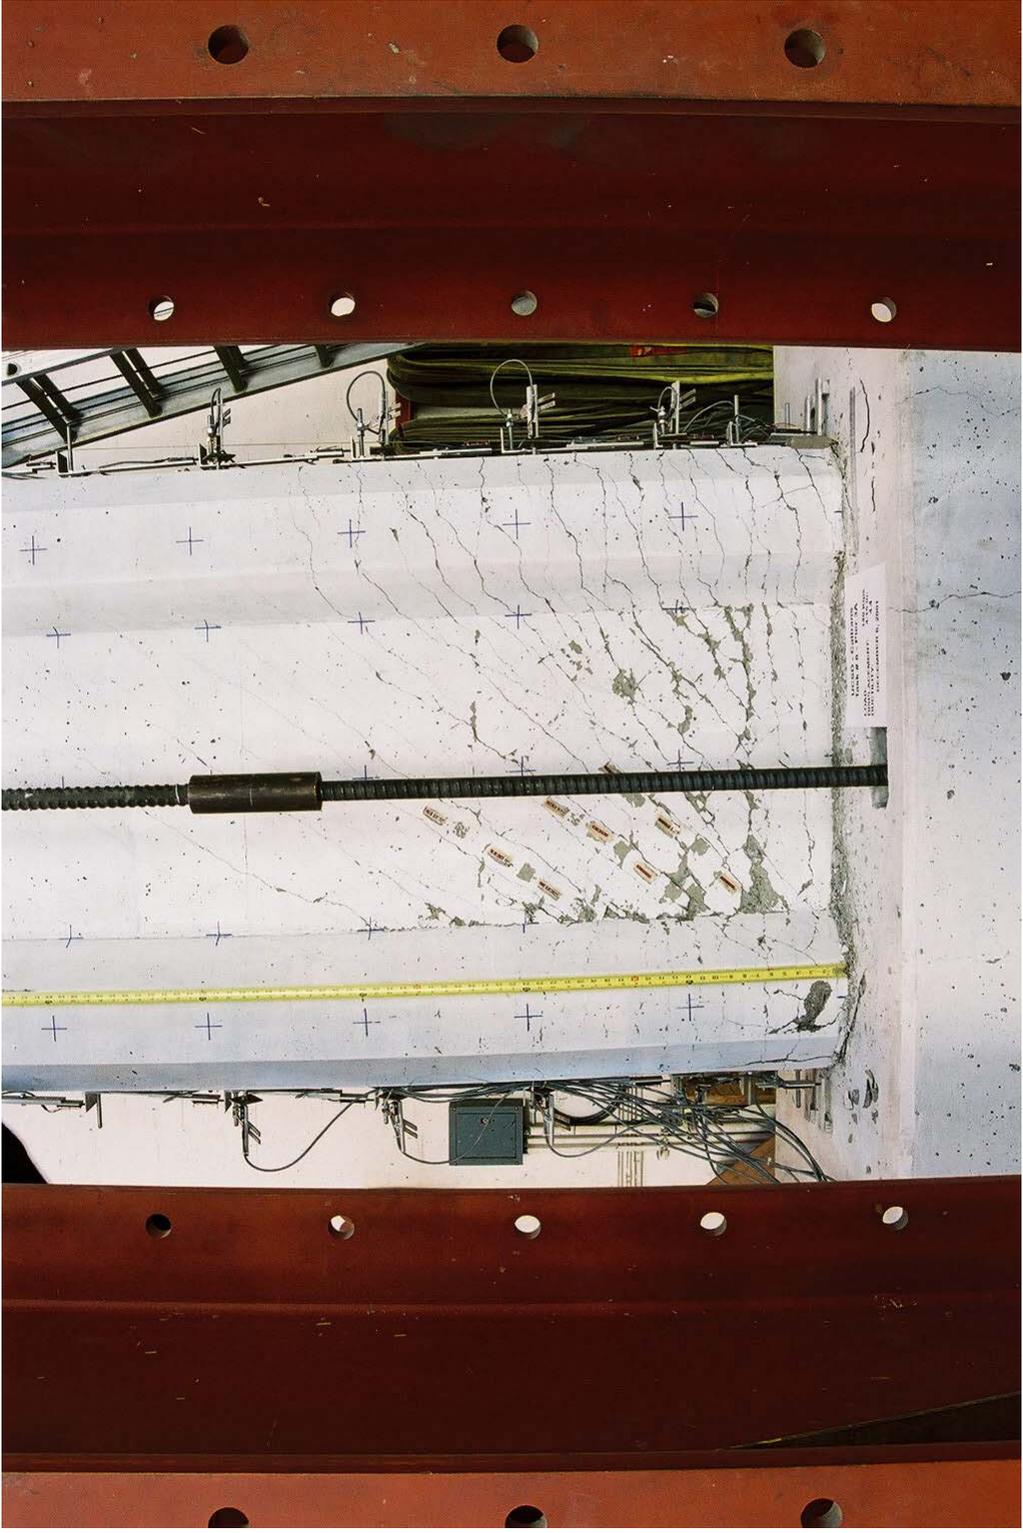
Figure B.8: $\mu_{\Delta} = 4.4 \times +1$; Test Unit 3A, east face. Push (positive) direction is south.

The test unit finally failed on the first positive excursion to $\mu_{\Delta} = 5$ at a displacement ductility level of approximately $\mu_{\Delta} = 4.4$. Critical compression struts were first observed to crush in the wall next to the compression (south) boundary element between heights of 6 - 12 in. [152 - 305] above the footing. After these initial two struts crushed, the struts just above them began to slide downward along the interface between the compression boundary element and the wall, creating a vertical failure plane up to a height of roughly 36 in. [914] above the footing. Loading was halted as soon as the first struts were observed to crush, but under a constant displacement at this level, the sliding failure occurred in the higher struts until the load dropped by roughly 20%. At this point, the test unit was brought back to zero load and the test was ended.

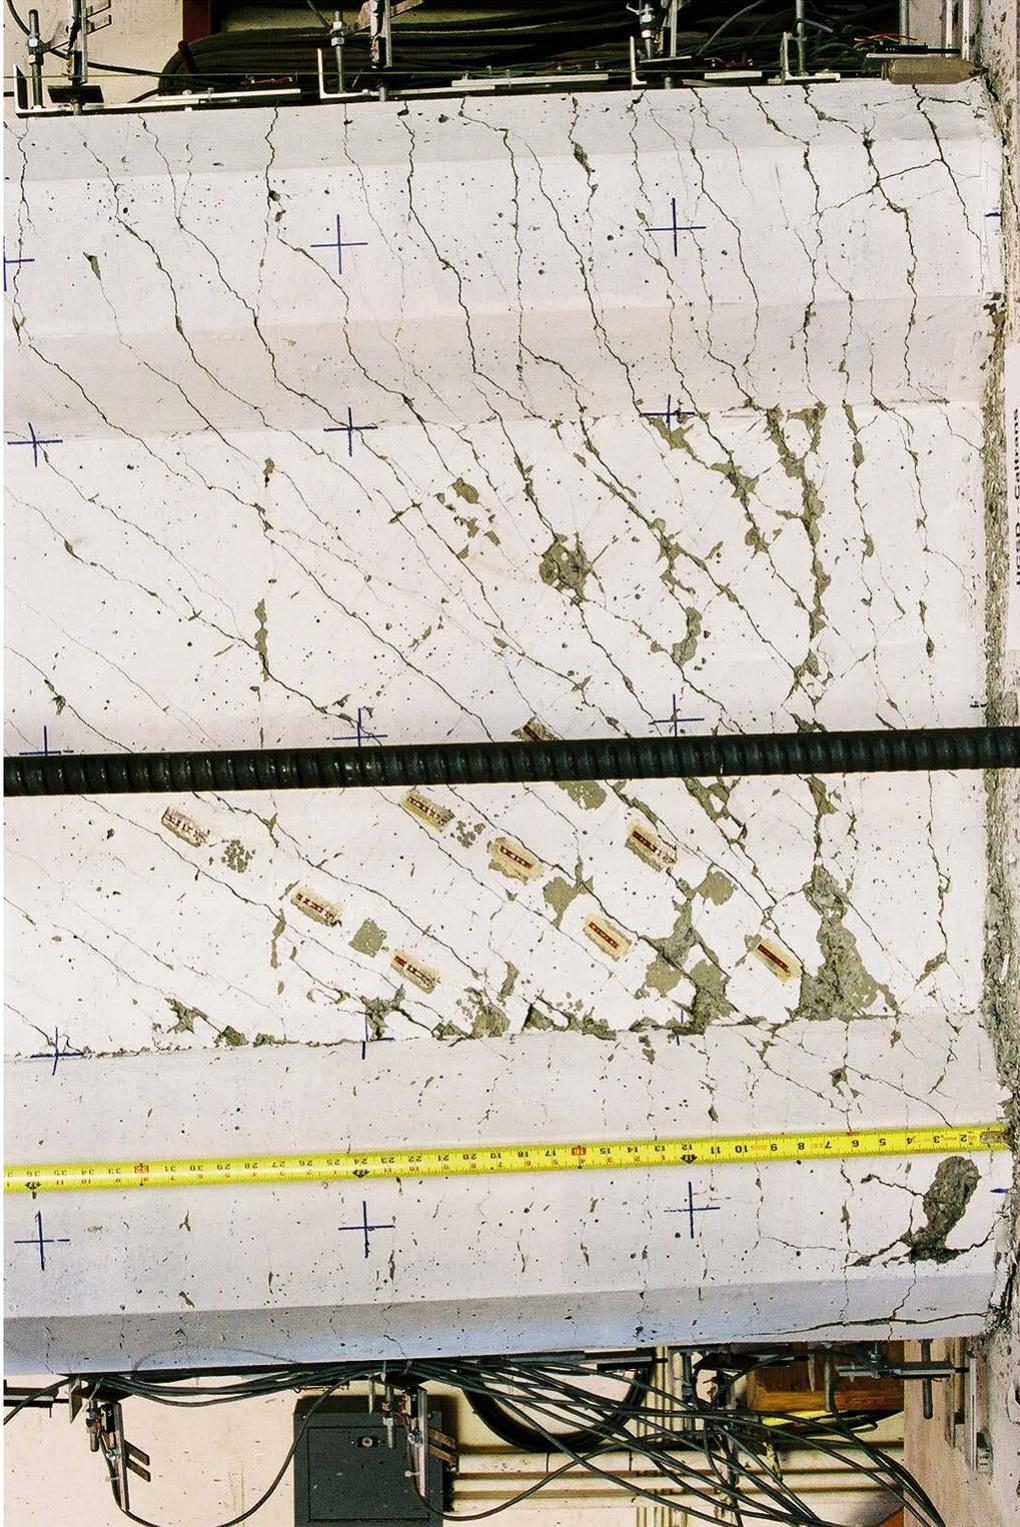
Figure B.9: $\mu_{\Delta} = 4.4 \times +1$; Test Unit 3A, closeup of east face. Push (positive) direction is south.

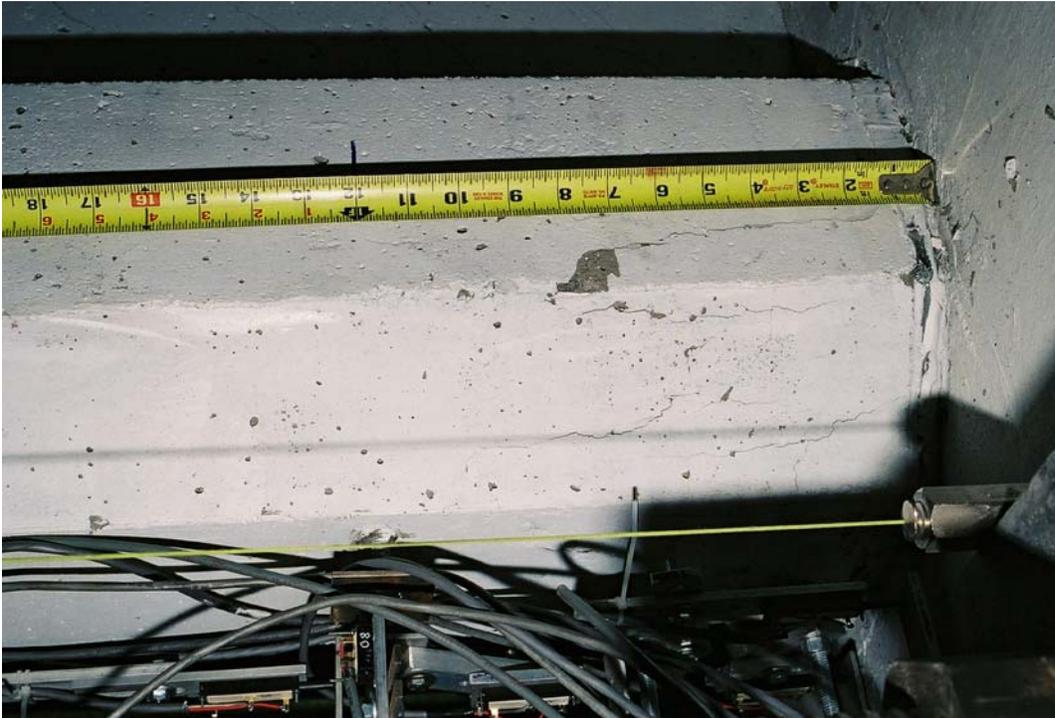
Figure B.12: $\mu_{\Delta} = 2 \times +1$; Test Unit 3B, vertical splitting crack on west face of compression (south) boundary element. Push (positive) direction is south.

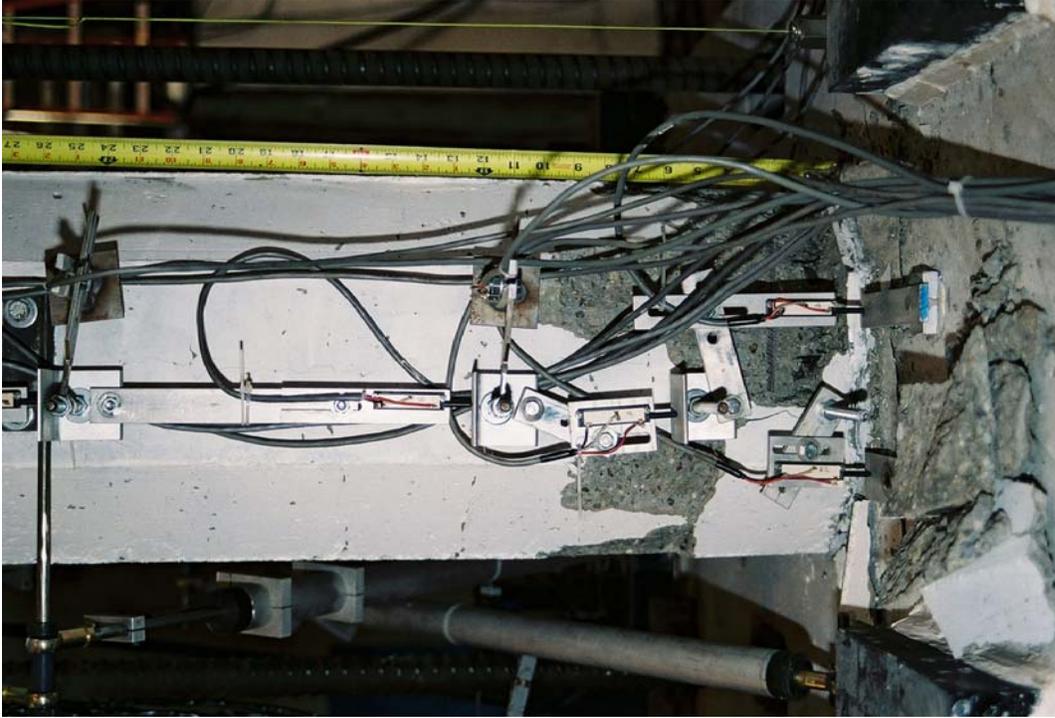
Figure B.13: $\mu_{\Delta} = 4 \times 1$; Test Unit 3B, spalled region on west face of tension (south) boundary element. Push (positive) direction is south.

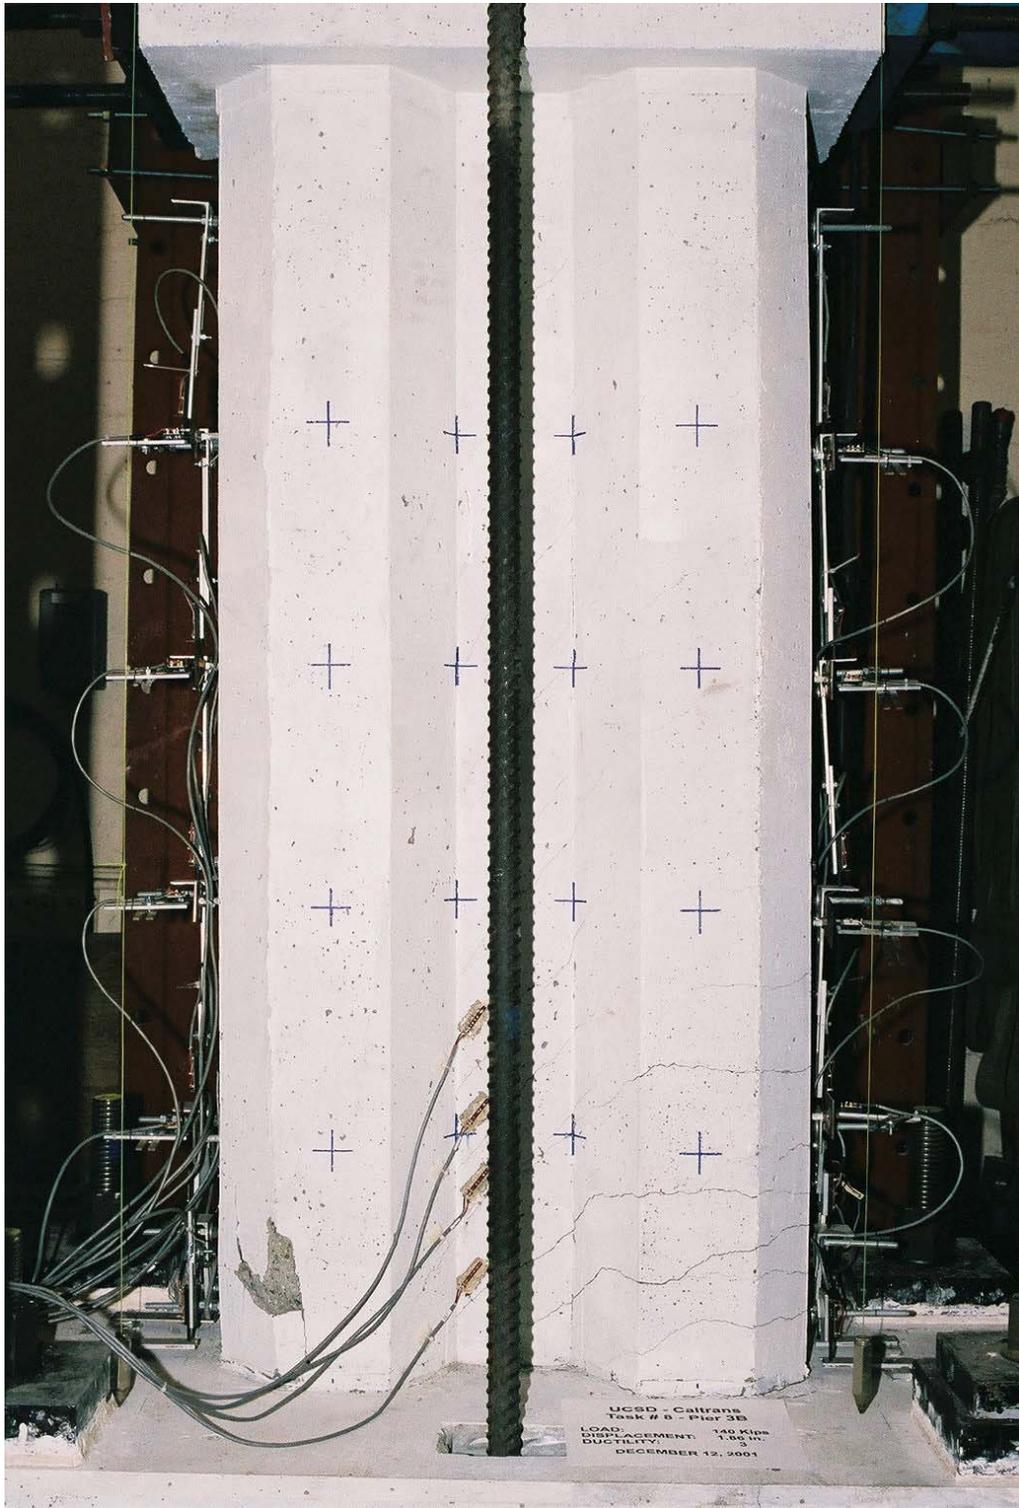
Figure B.14: $\mu_{\Delta} = 3 \times +1$; Test Unit 3B, east face. Push (positive) direction is south.

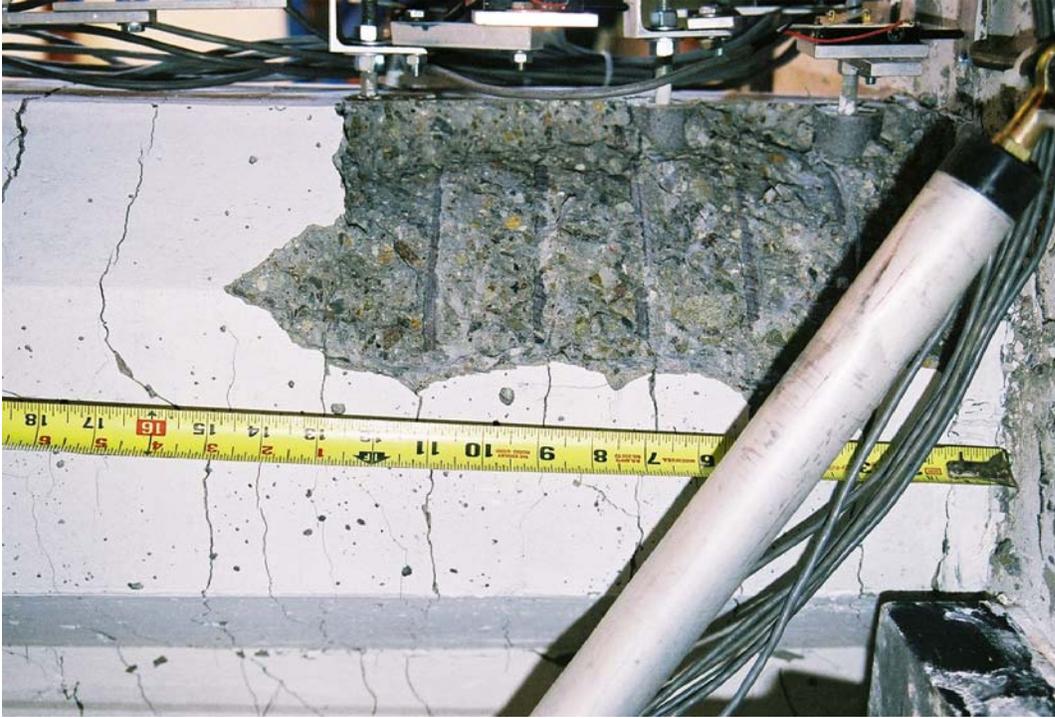
Figure B.22: $\mu_{\Delta} = 3 \times -1$; Test Unit 3C, spalled region on west face of tension (south) boundary element. Push (positive) direction is south.

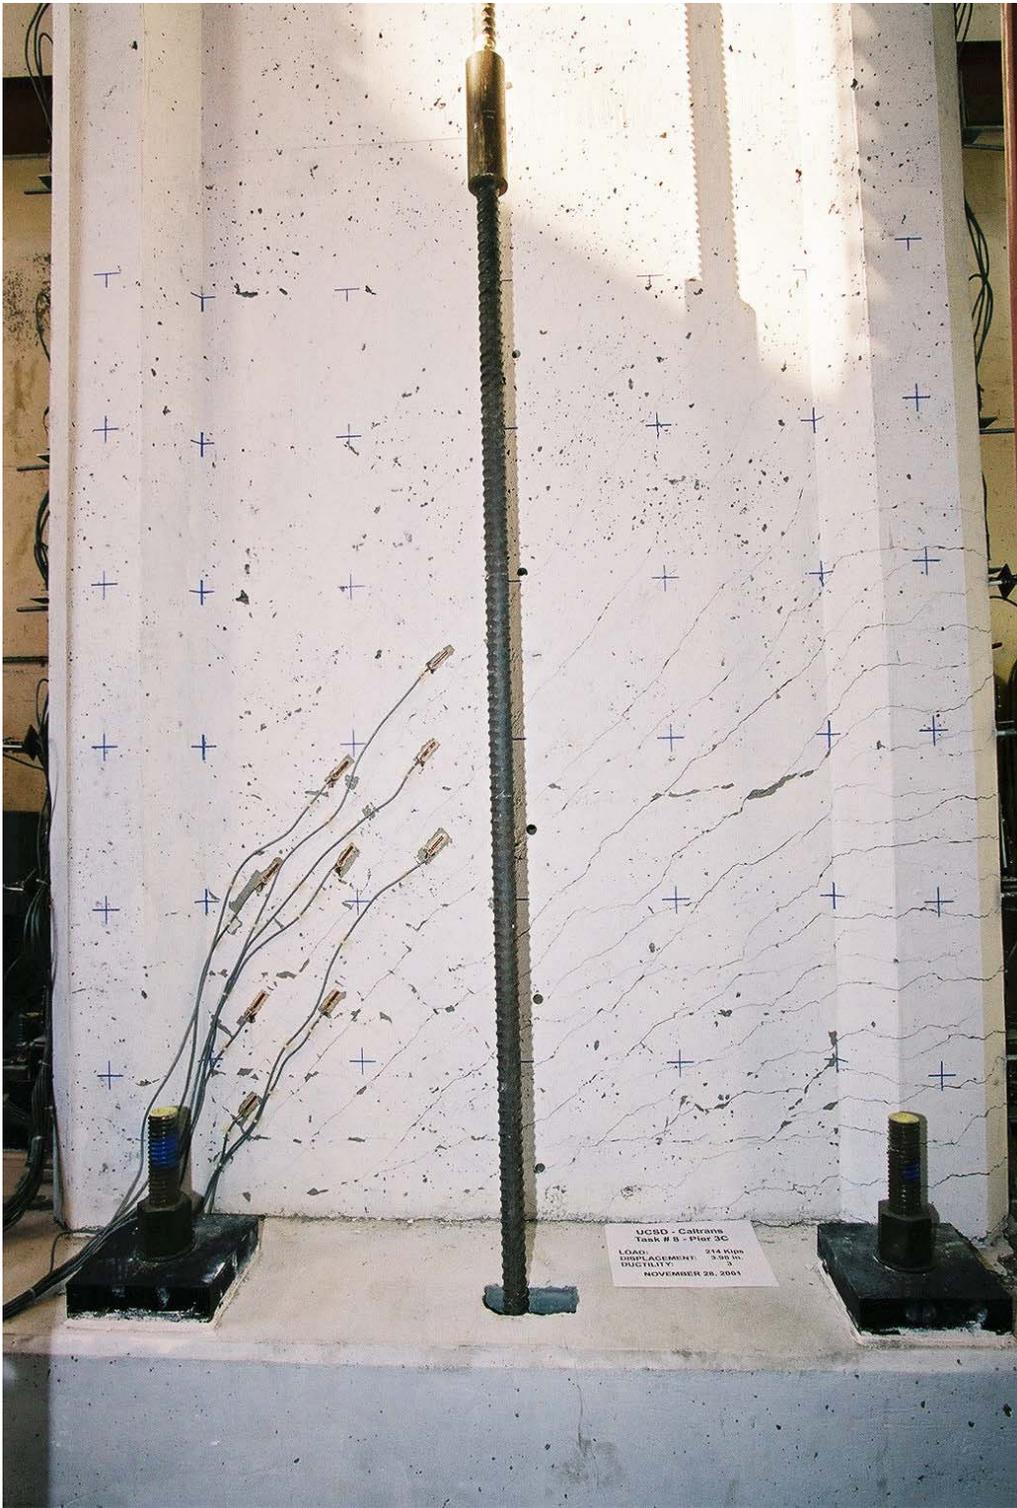
Figure B.23: $\mu_{\Delta} = 3 \times +1$; Test Unit 3C, east face. Push (positive) direction is south.

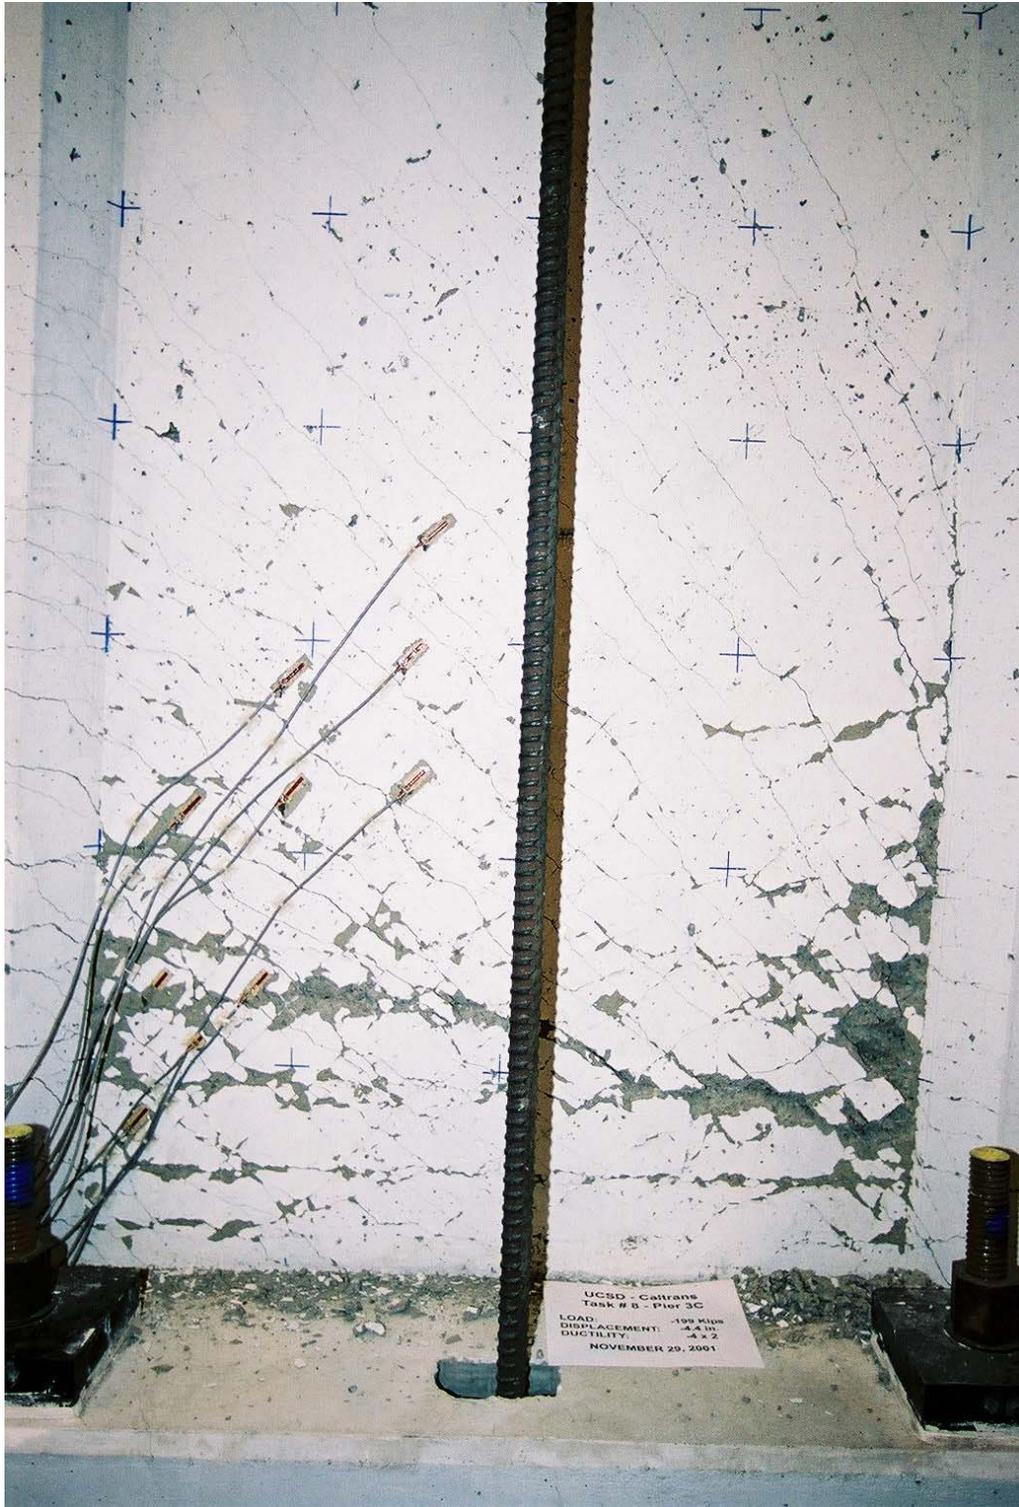
Figure B.25: Cycling to $\mu_{\Delta} = 4 \times -2$; Test Unit 3C,web crushing failure, east face. Push (positive) direction is south.

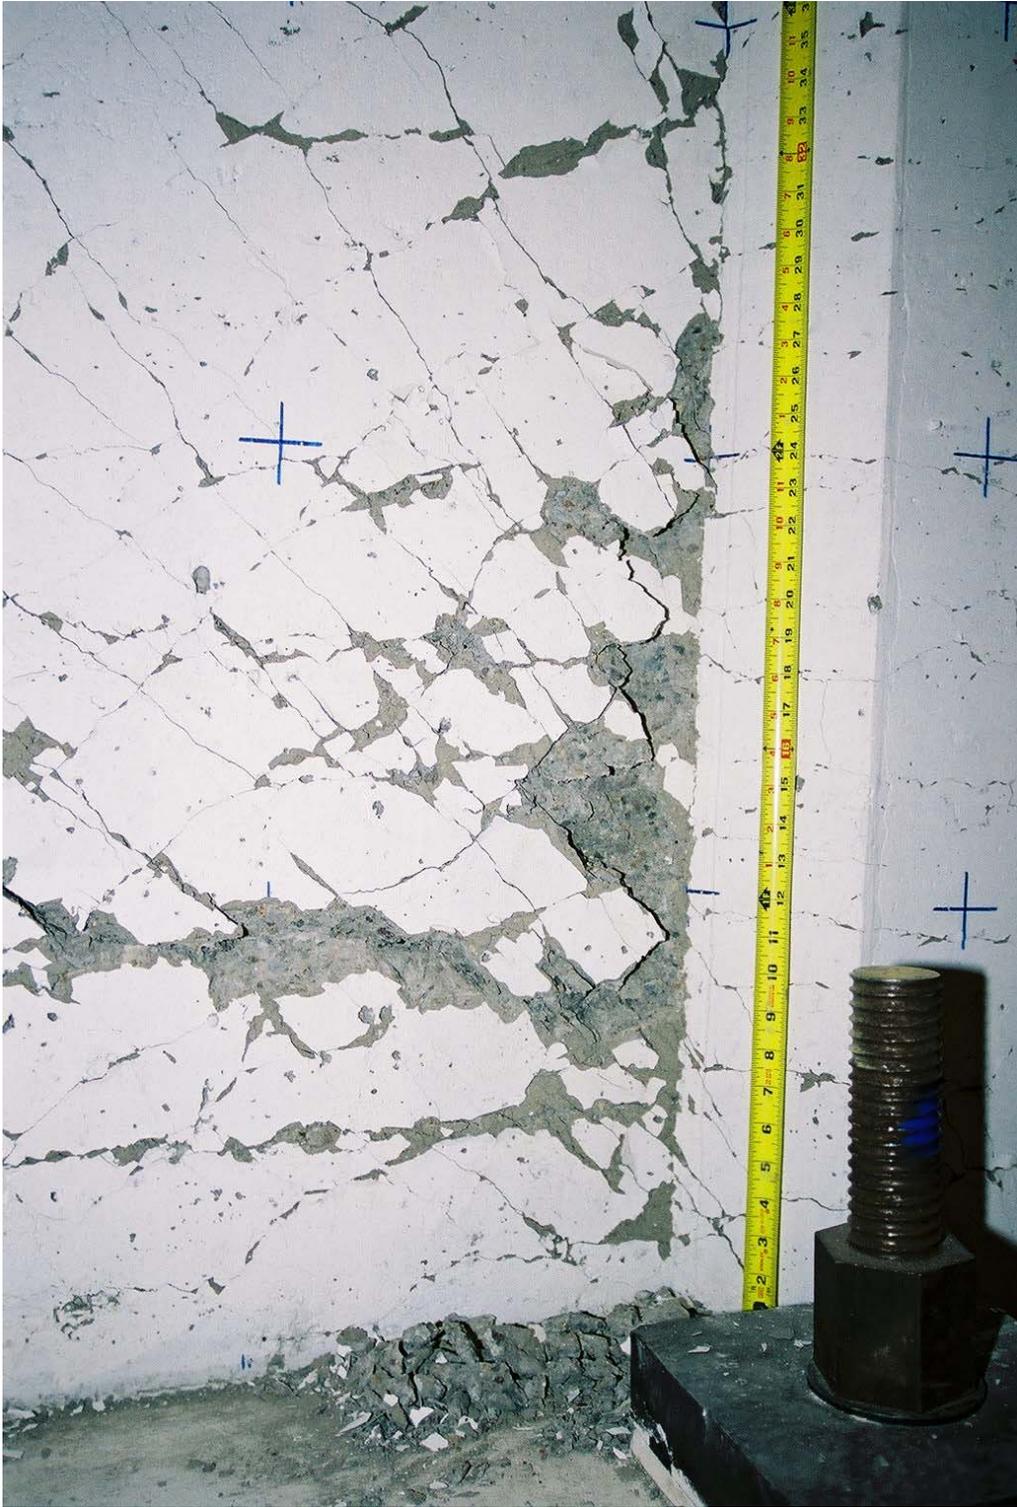
Figure B.26: Cycling to $\mu_{\Delta} = 4 \times -2$; Test Unit 3C, closeup of the web crushing failure on the the interface between the wall and the compression (north) boundary element, east face . Push (positive) direction is south.

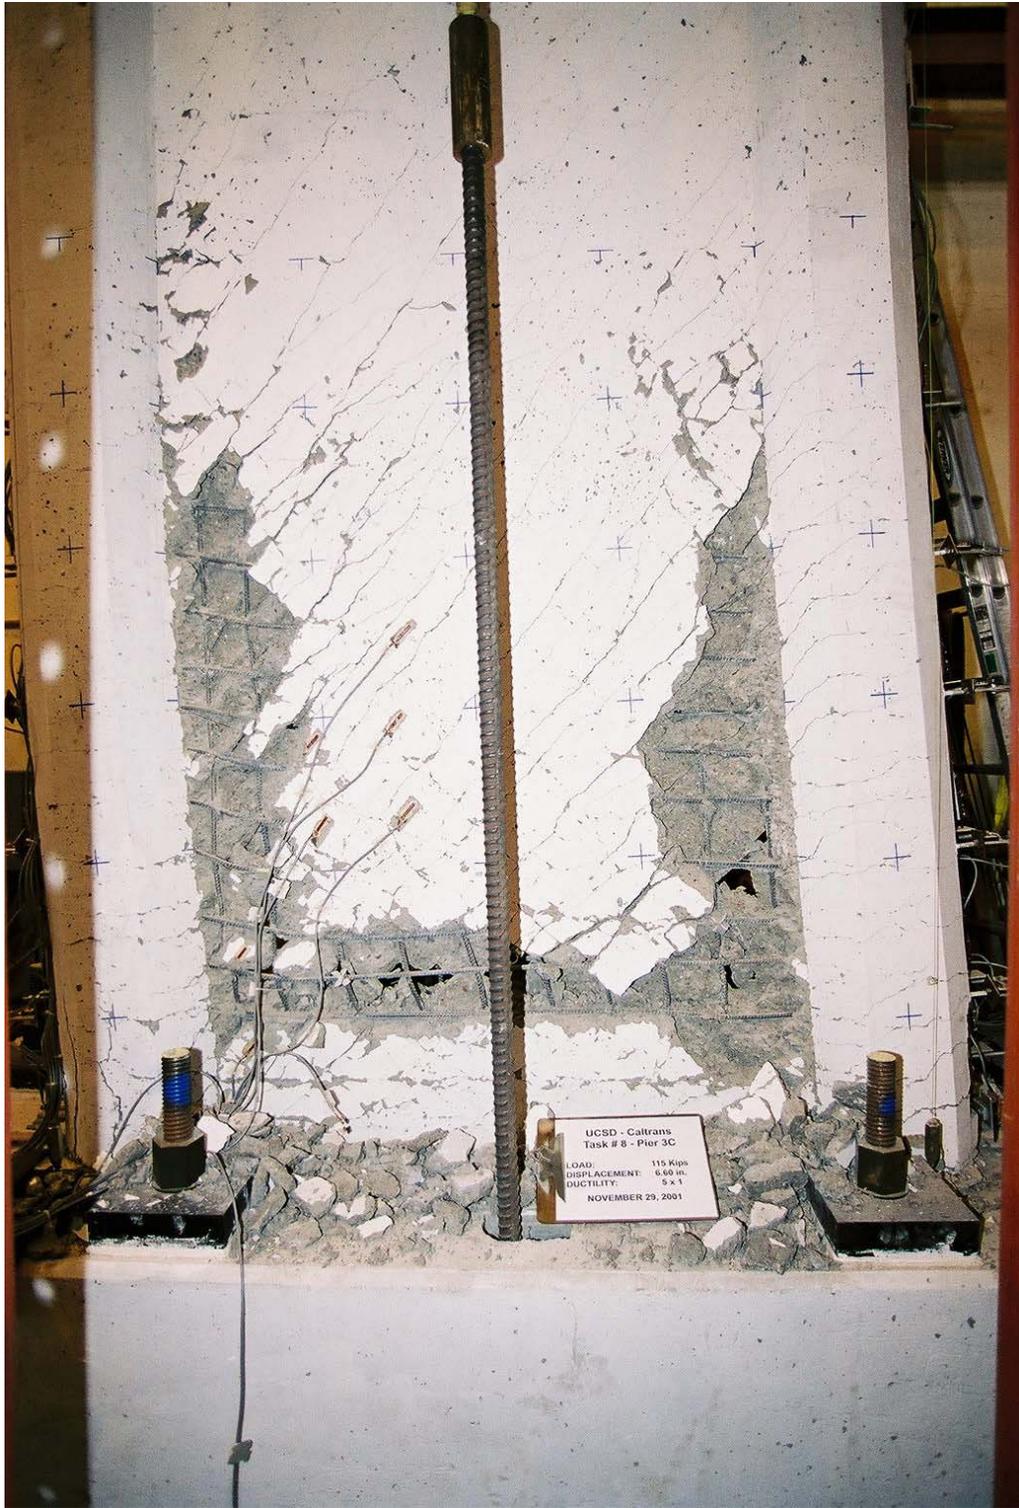
Figure B.27: $\mu_{\Delta} = 5 \times +1$; Test Unit 3C, end of test, east face. Push (positive) direction is south.

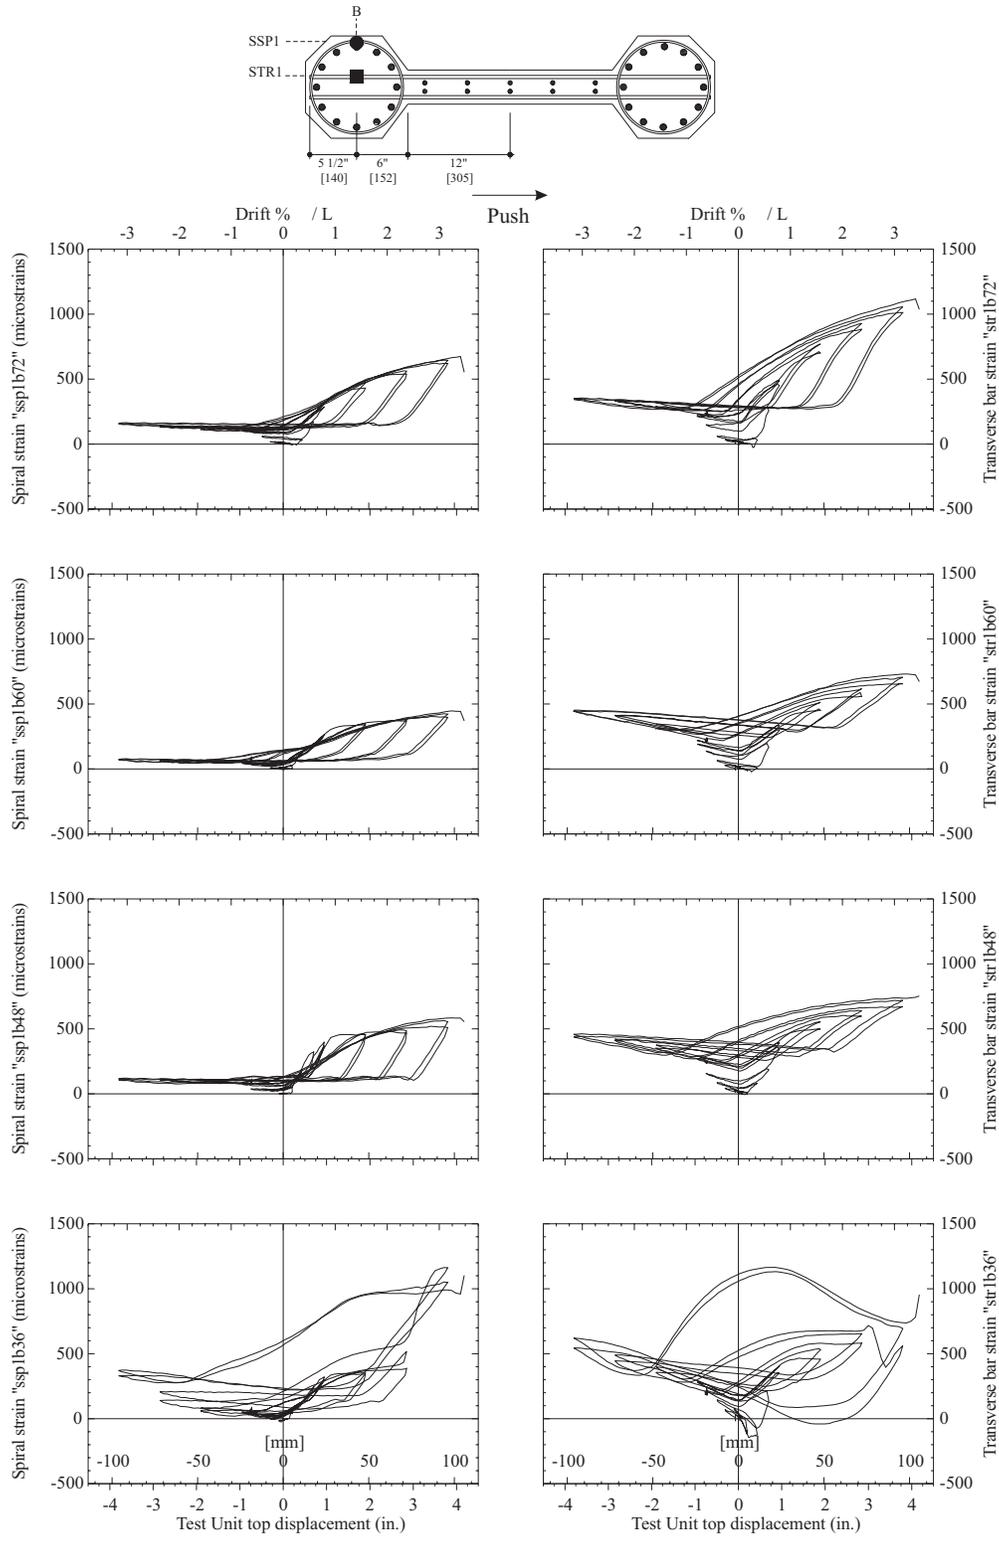
Figure C.7: Test Unit 3A, spiral strains and transverse bar strains at Position 1B, for heights 36 in. [914], 48 in. [1219], 60 in. [1524] and 72 in. [1829] above the footing.

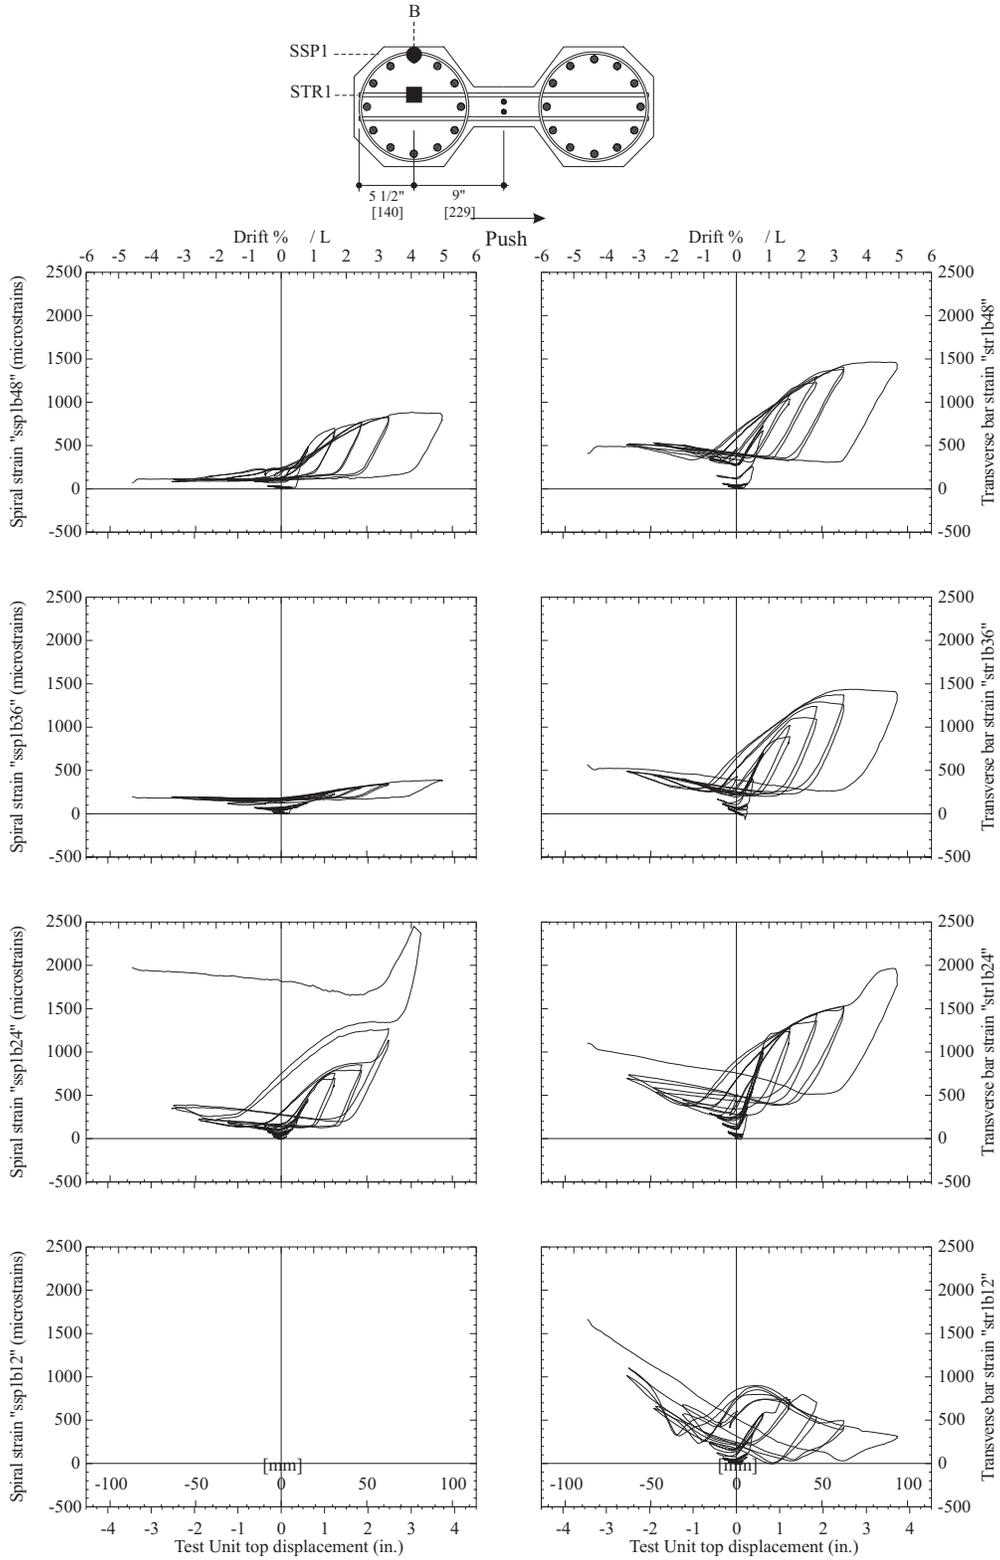
Figure C.21: Test Unit 3B, spiral strains and transverse bar strains at Position 1B, for heights 12 in. [305], 24 in. [610], 36 in. [914] and 48 in. [1219] above the footing.

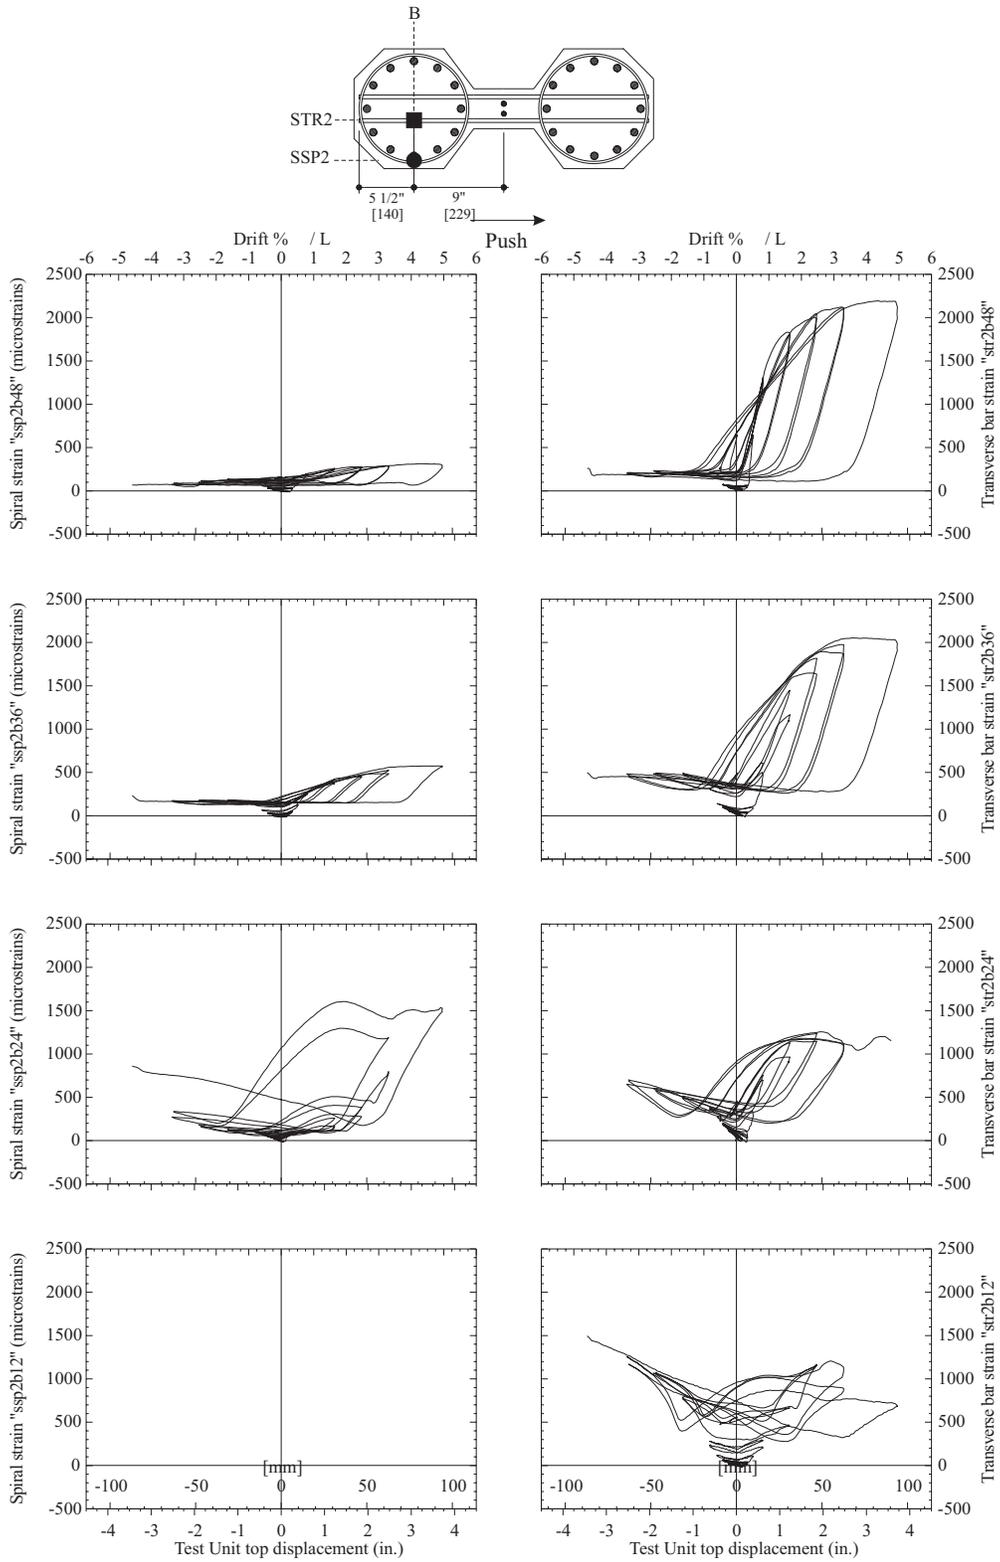
Figure C.22: Test Unit 3B, spiral strains and transverse bar strains at Position 2B, for heights 12 in. [305], 24 in. [610], 36 in. [914] and 48 in. [1219] above the footing.

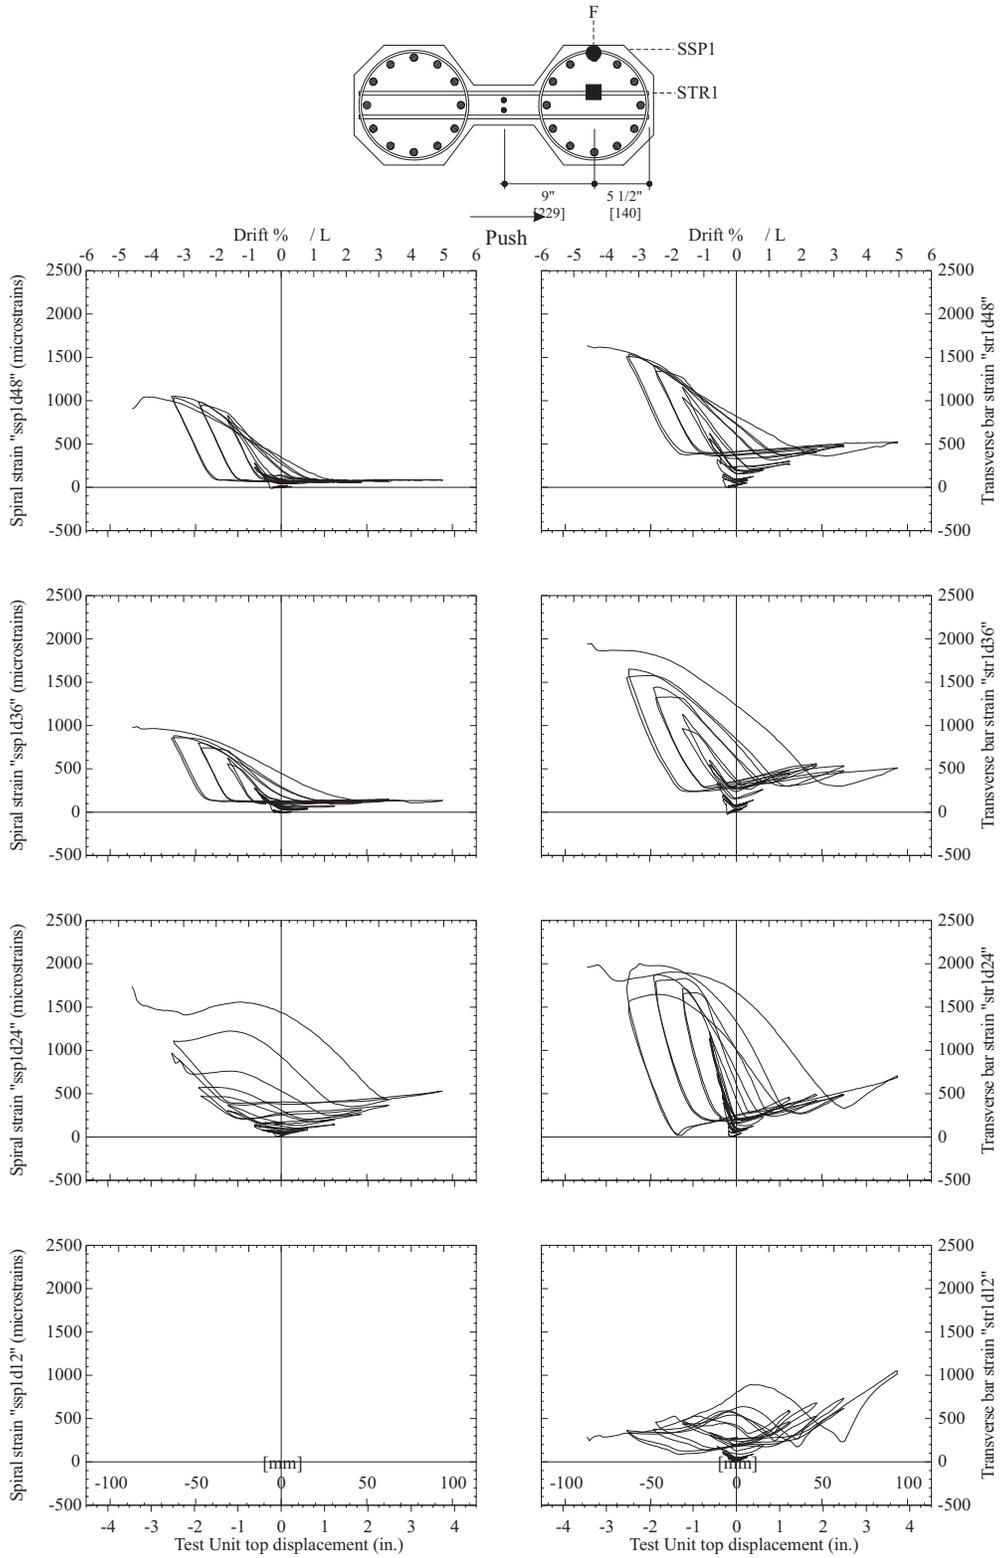
Figure C.23: Test Unit 3B, spiral strains and transverse bar strains at Position 1D, for heights 12 in. [305], 24 in. [610], 36 in. [914] and 48 in. [1219] above the footing.

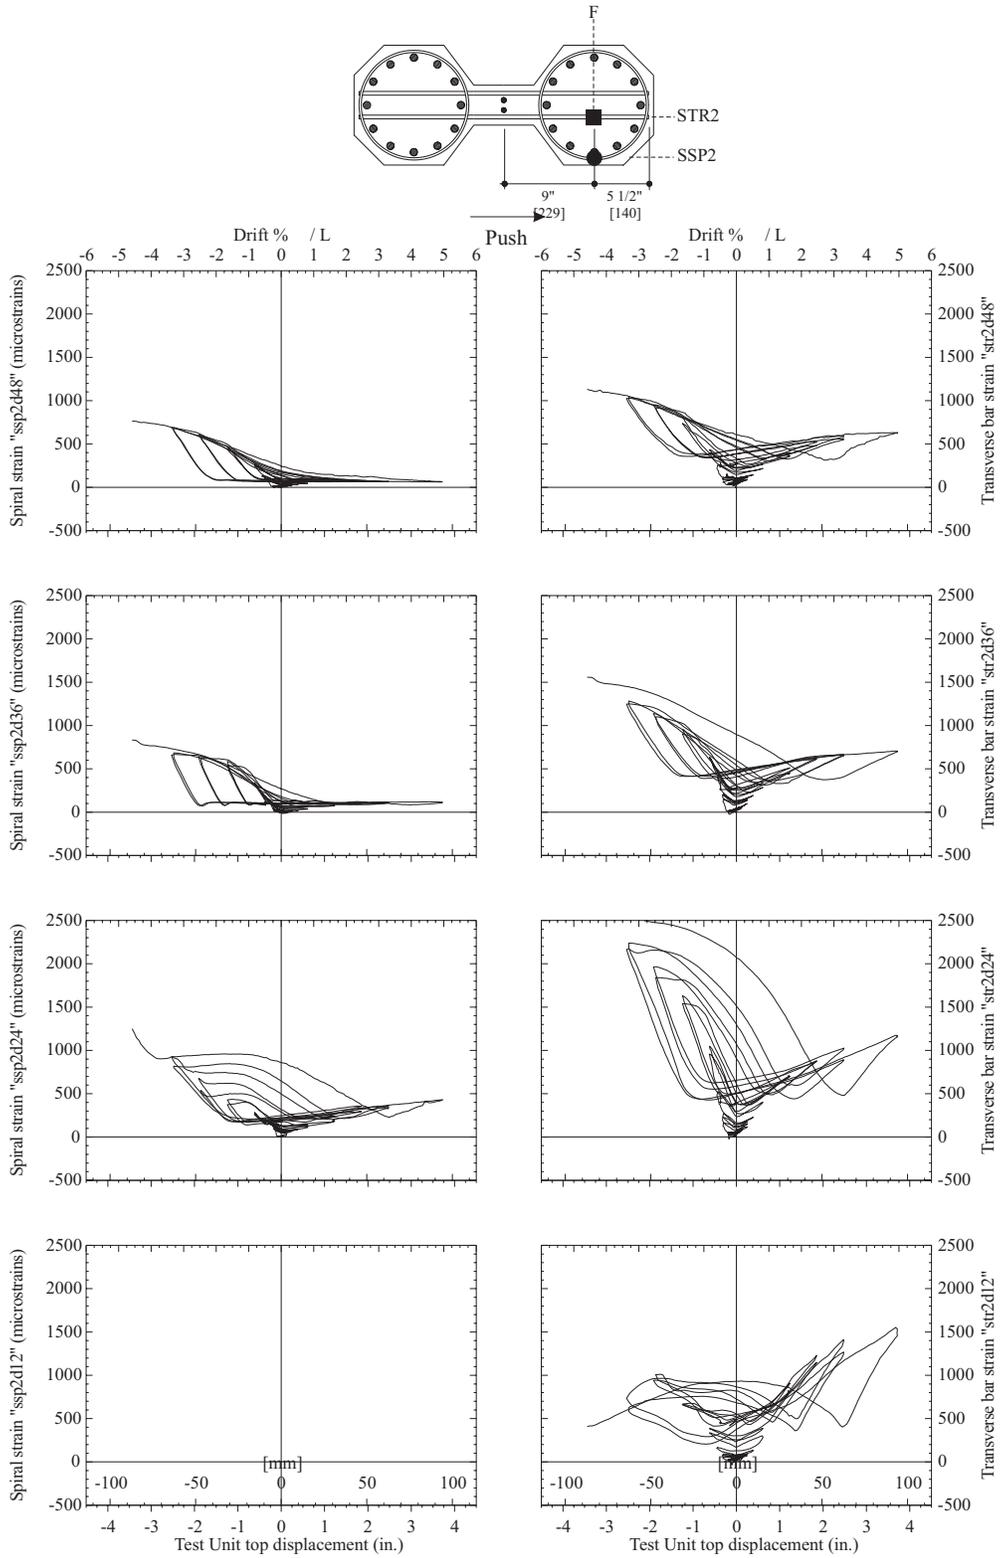
Figure C.24: Test Unit 3B, spiral strains and transverse bar strains at Position 2D, for heights 12 in. [305], 24 in. [610], 36 in. [914] and 48 in. [1219] above the footing.
