Report No.
SSRP-2001/27
FINAL

**SEISMIC PERFORMANCE OF
HOLLOW RECTANGULAR
REINFORCED CONCRETE PIERS
WITH HIGHLY-CONFINED
BOUNDARY ELEMENTS PHASE III:
WEB CRUSHING TESTS**

Final Report Submitted to Caltrans under Contract No. 59A0051

June 2002

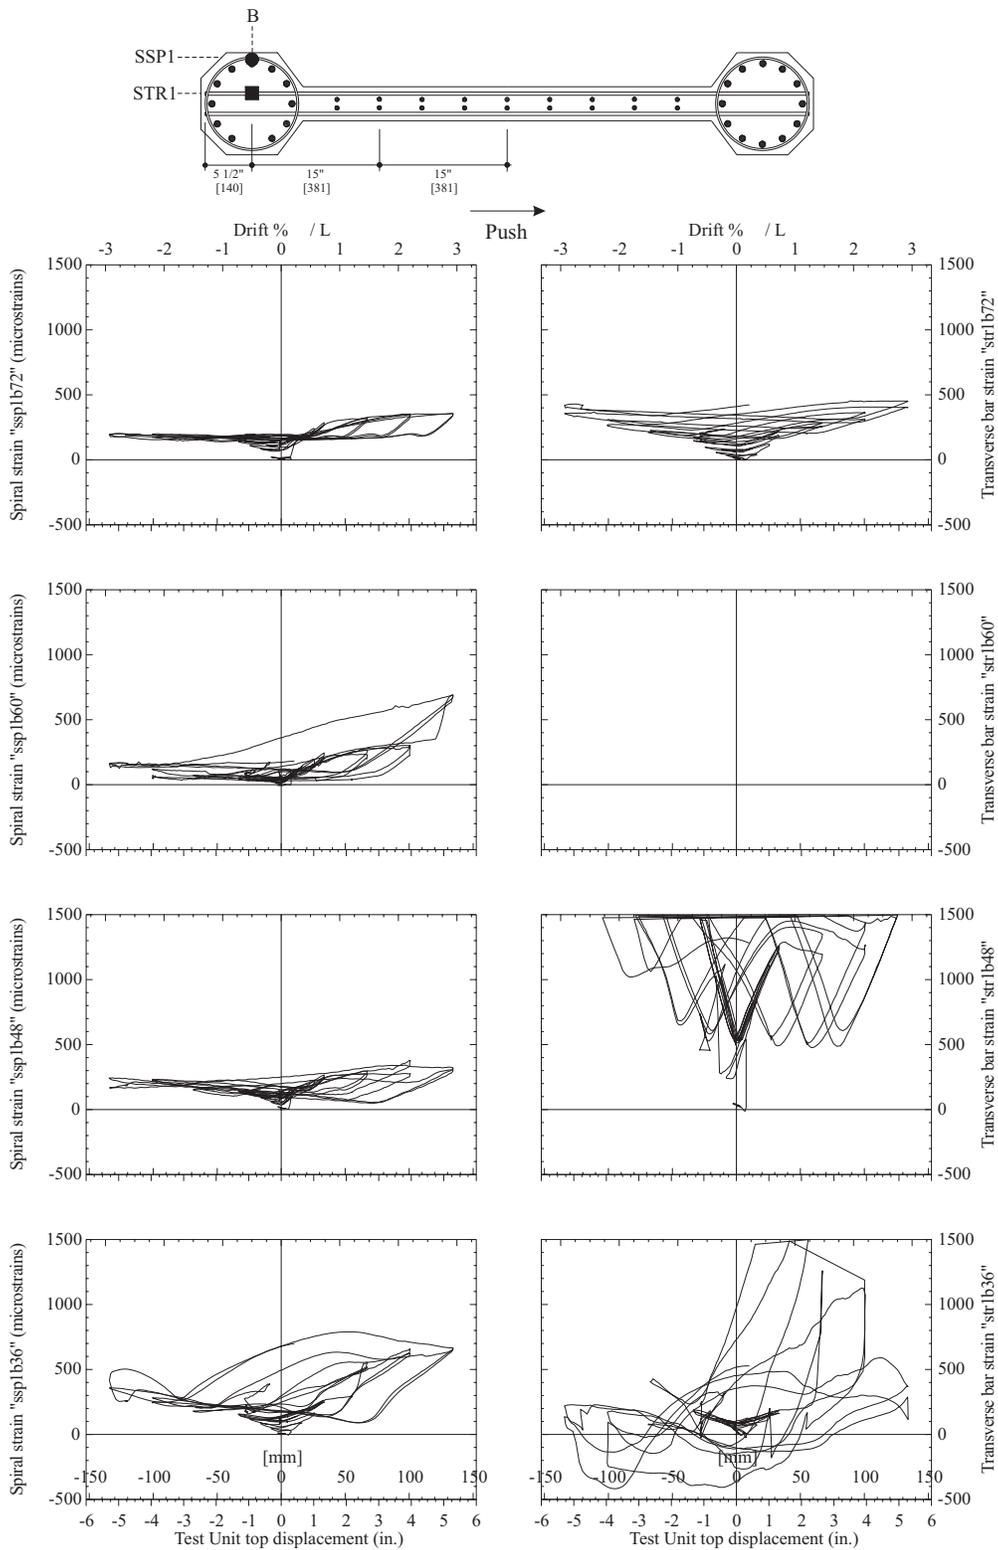
Figure C.36: Test Unit 3C, spiral strains and transverse bar strains at Position 1B, for heights 36 in. [914], 48 in. [1219], 60 in. [1524] and 72 in. [1829] above the footing.

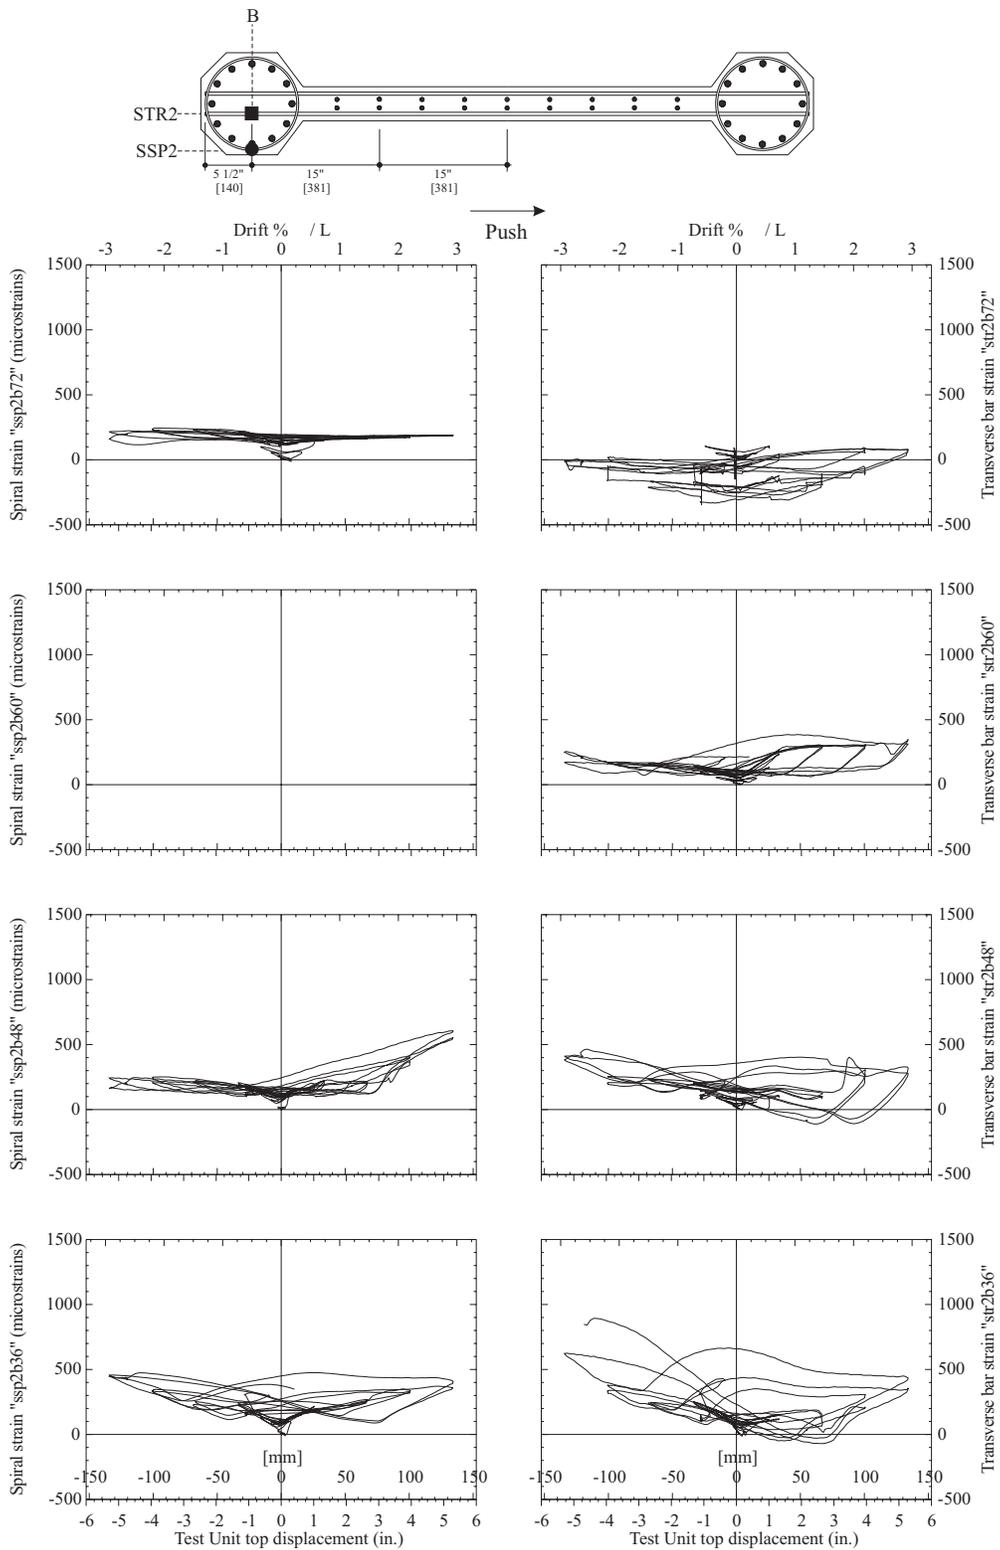
Figure C.37: Test Unit 3C, spiral strains and transverse bar strains at Position 2B, for heights 36 in. [914], 48 in. [1219], 60 in. [1524] and 72 in. [1829] above the footing.

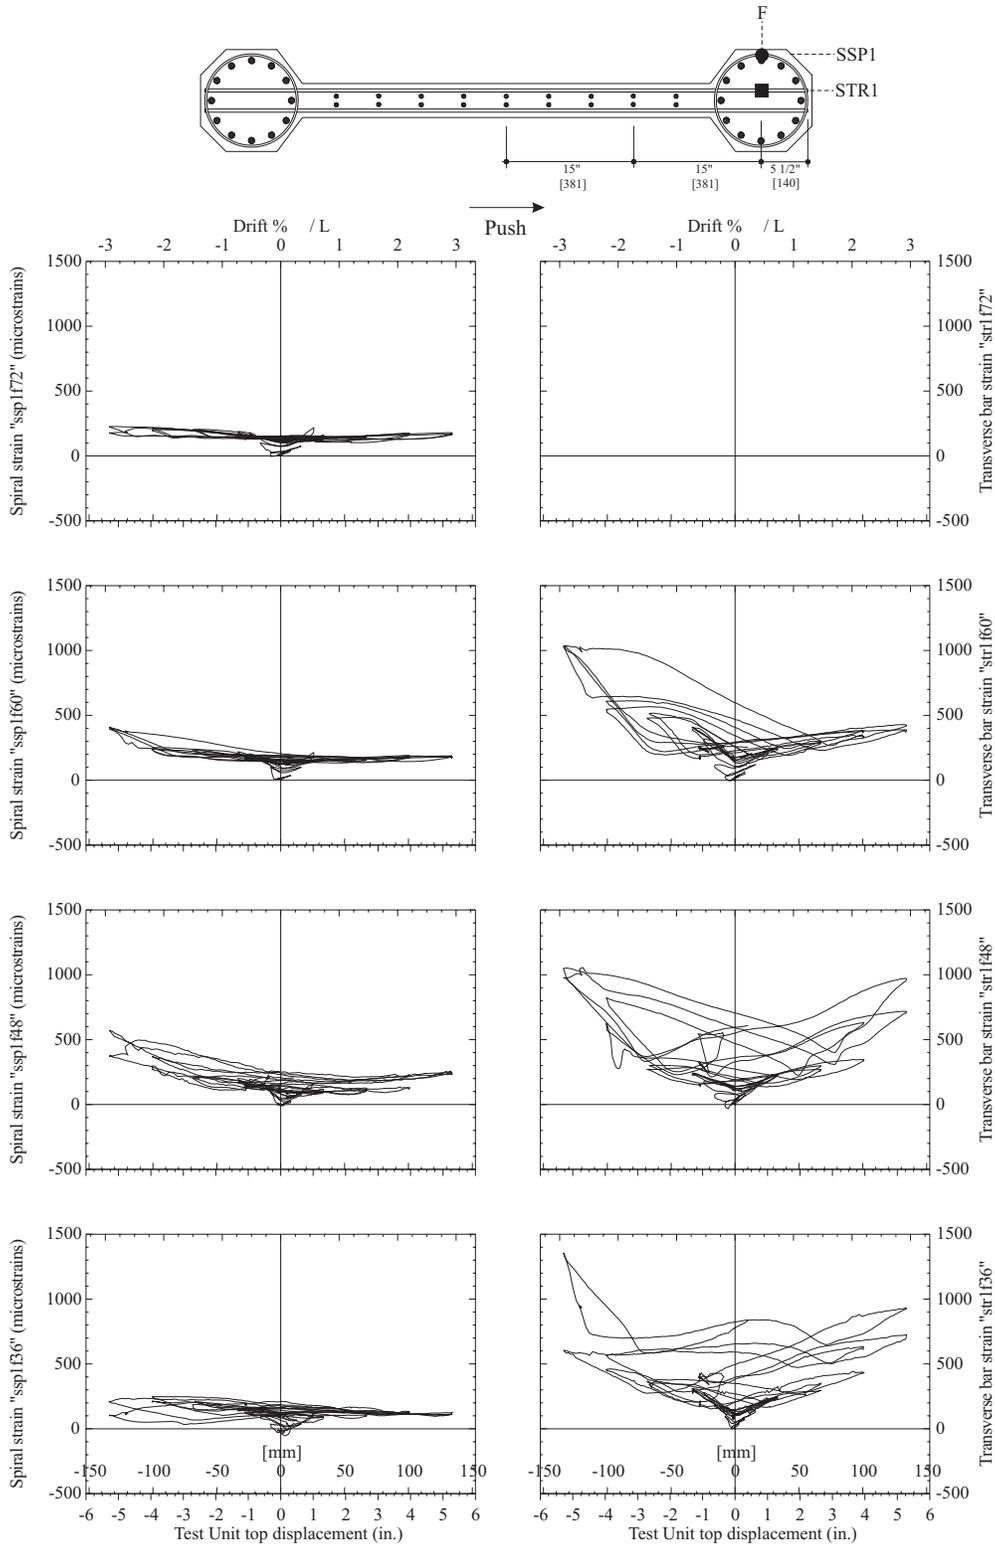
Figure C.38: Test Unit 3C, spiral strains and transverse bar strains at Position 1F, for heights 36 in. [914], 48 in. [1219], 60 in. [1524] and 72 in. [1829] above the footing.

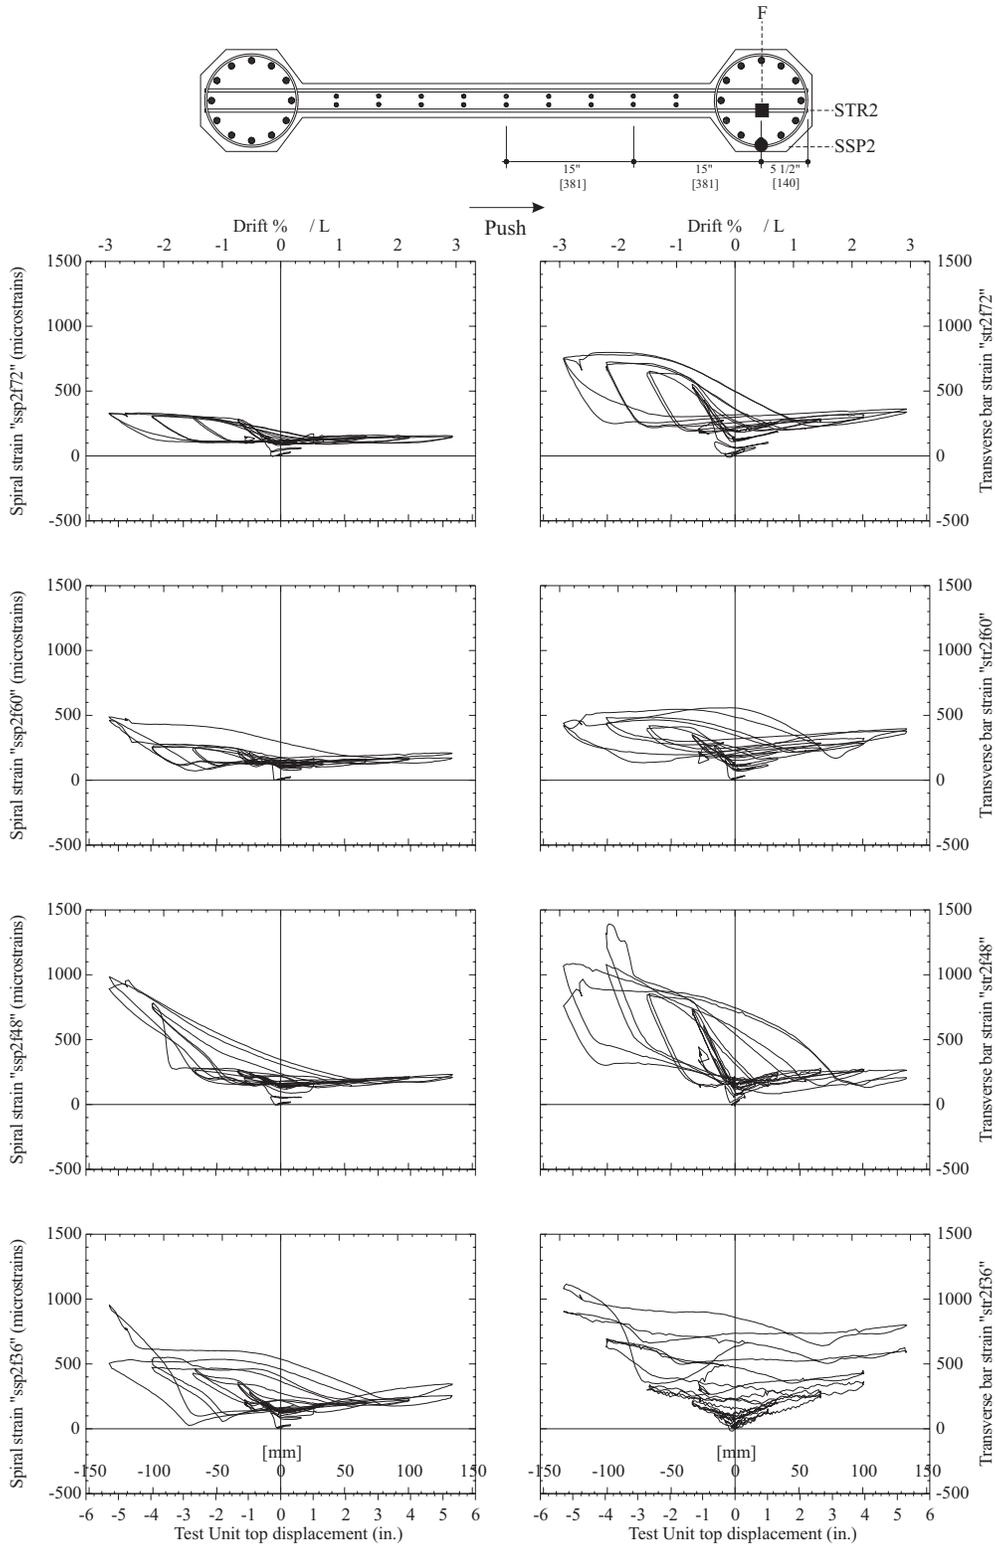
Figure C.39: Test Unit 3C, spiral strains and transverse bar strains at Position 2F, for heights 36 in. [914], 48 in. [1219], 60 in. [1524] and 72 in. [1829] above the footing.
