At 03-Sac-5-23.3

Asbestos and Lead-Containing Paint Survey Report dated January 2014

ASBESTOS AND LEAD-CONTAINING PAINT SURVEY REPORT

**O Street Pumping Plant
03-SAC-5 PM 23.26
Sacramento County, California**

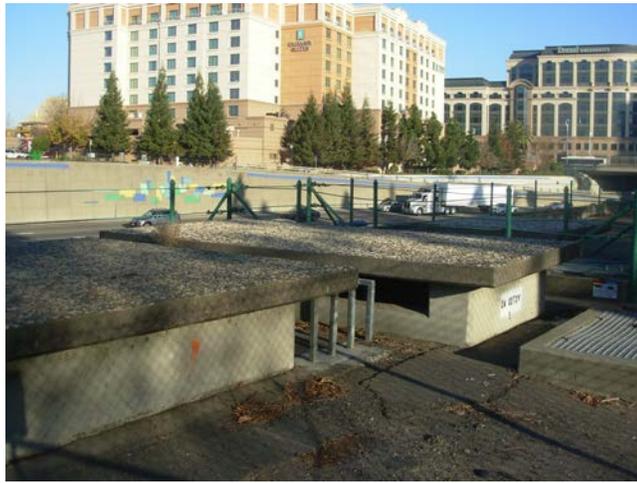
A sample representing intact green exterior paint used on the barrier rails exhibited a total lead concentration of 24 mg/kg.

Photo 1 – O Street Pumping Plant at PM 23.26 on Interstate 5 in Sacramento County, California

We recommend that all paints at the project location be treated as lead-containing for purpose of determining the applicability of the Cal/OSHA lead standard during maintenance, renovation, and demolition activities. This recommendation is based on LCP sample results and the fact that lead was a common ingredient of paints manufactured before 1978 and is still an ingredient of some paints. In accordance with Title 8, CCR, §1532.1(p), written notification to the nearest Cal/OSHA district office is required at least 24 hours prior to certain lead-related work. Compliance and training requirements regarding construction activities where workers may be exposed to lead are presented in Title 8, CCR, §1532.1, subsections (e) and (l), respectively.

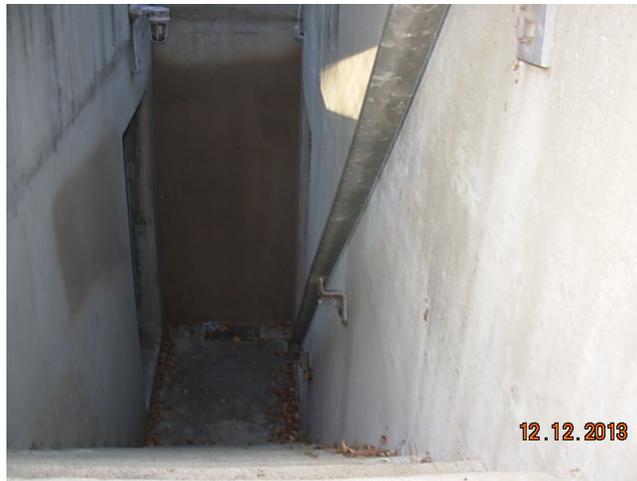
Photo 2 – Stairwell between street level and diesel generator control room

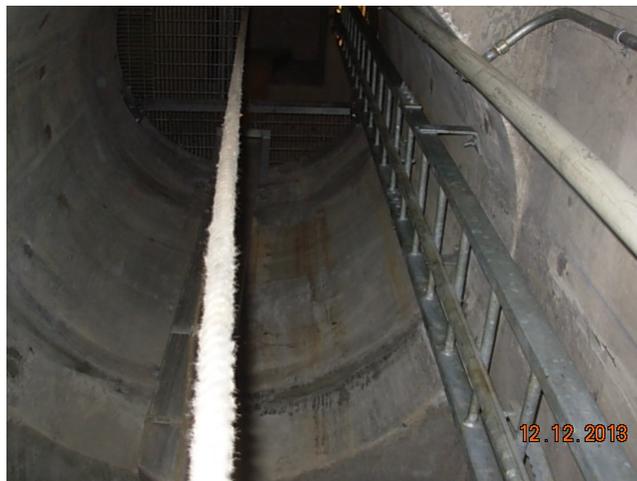
Photo 3 – Ladder between pump vault and diesel generator control room

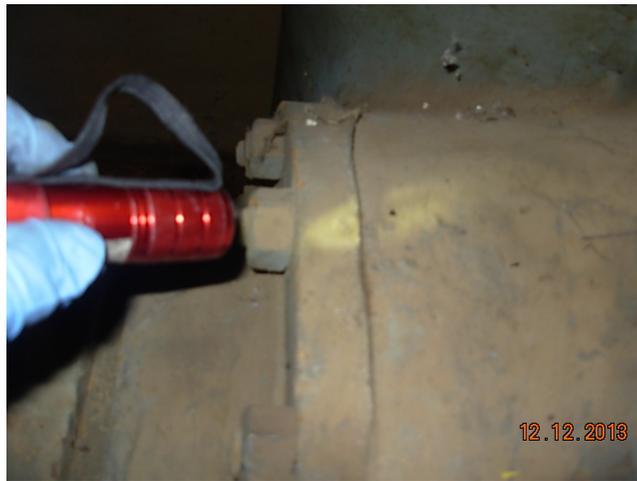
No asbestos was detected in samples of the suspect materials collected during our survey. A summary of the analytical laboratory test results for asbestos is presented on Table 1. Reproductions of the laboratory report and chain-of-custody documentation are presented in Appendix A.

Photo 4 – Gaskets (pumping system)

Since no asbestos was detected in the samples collected during our survey, the Cal/OSHA asbestos standard does not apply for planned activities. In addition, renovation debris would not be considered a California hazardous waste based on asbestos content. In accordance with Sacramento Metropolitan Air Quality Management District (SMAQMD) Rule 902, written notification to SMAQMD is required ten working days prior to commencement of *any* demolition activity (whether asbestos is present or not).

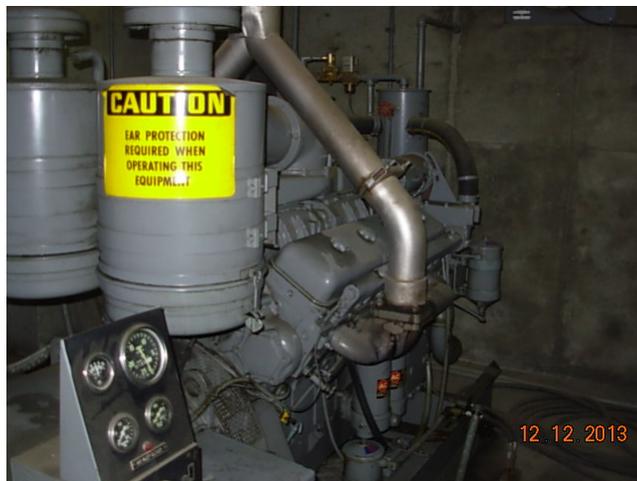
A sample representing intact gray interior paint used on the mechanical and electrical equipment exhibited a total lead concentration of 2,300 mg/kg.

A sample representing intact silver interior paint used on the diesel engine exhaust line exhibited a total lead concentration of 1,300 mg/kg.

Further analysis of the interior paints indicated a composite TCLP lead concentration of 2.8 mg/l.

Photo 5 – Diesel generator

Interior paints sampled during our survey would be classified as California hazardous based on lead content if stripped, blasted, or otherwise separated from the substrate.

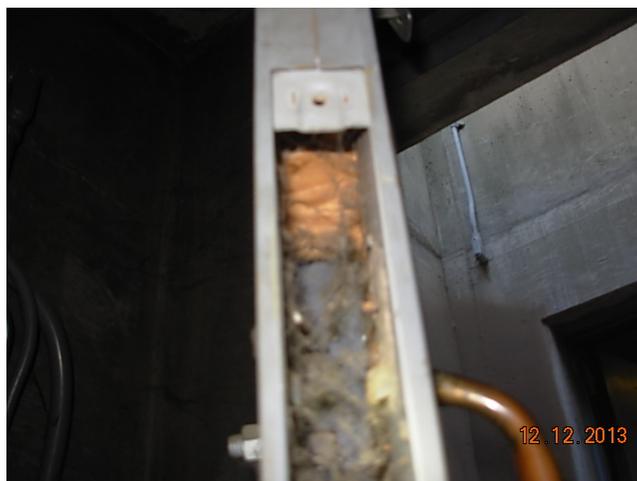
Photo 6 – Door core insulation
