**FOR CONTRACT NO.: 02-2E0004**

# **INFORMATION HANDOUT**

**AERIALY DEPOSITED LEAD AND NATURALLY OCCURRING ASBESTOS  
SITE INVESTIGATION REPORT**

**GEOTECHNICAL DESIGN REPORT**

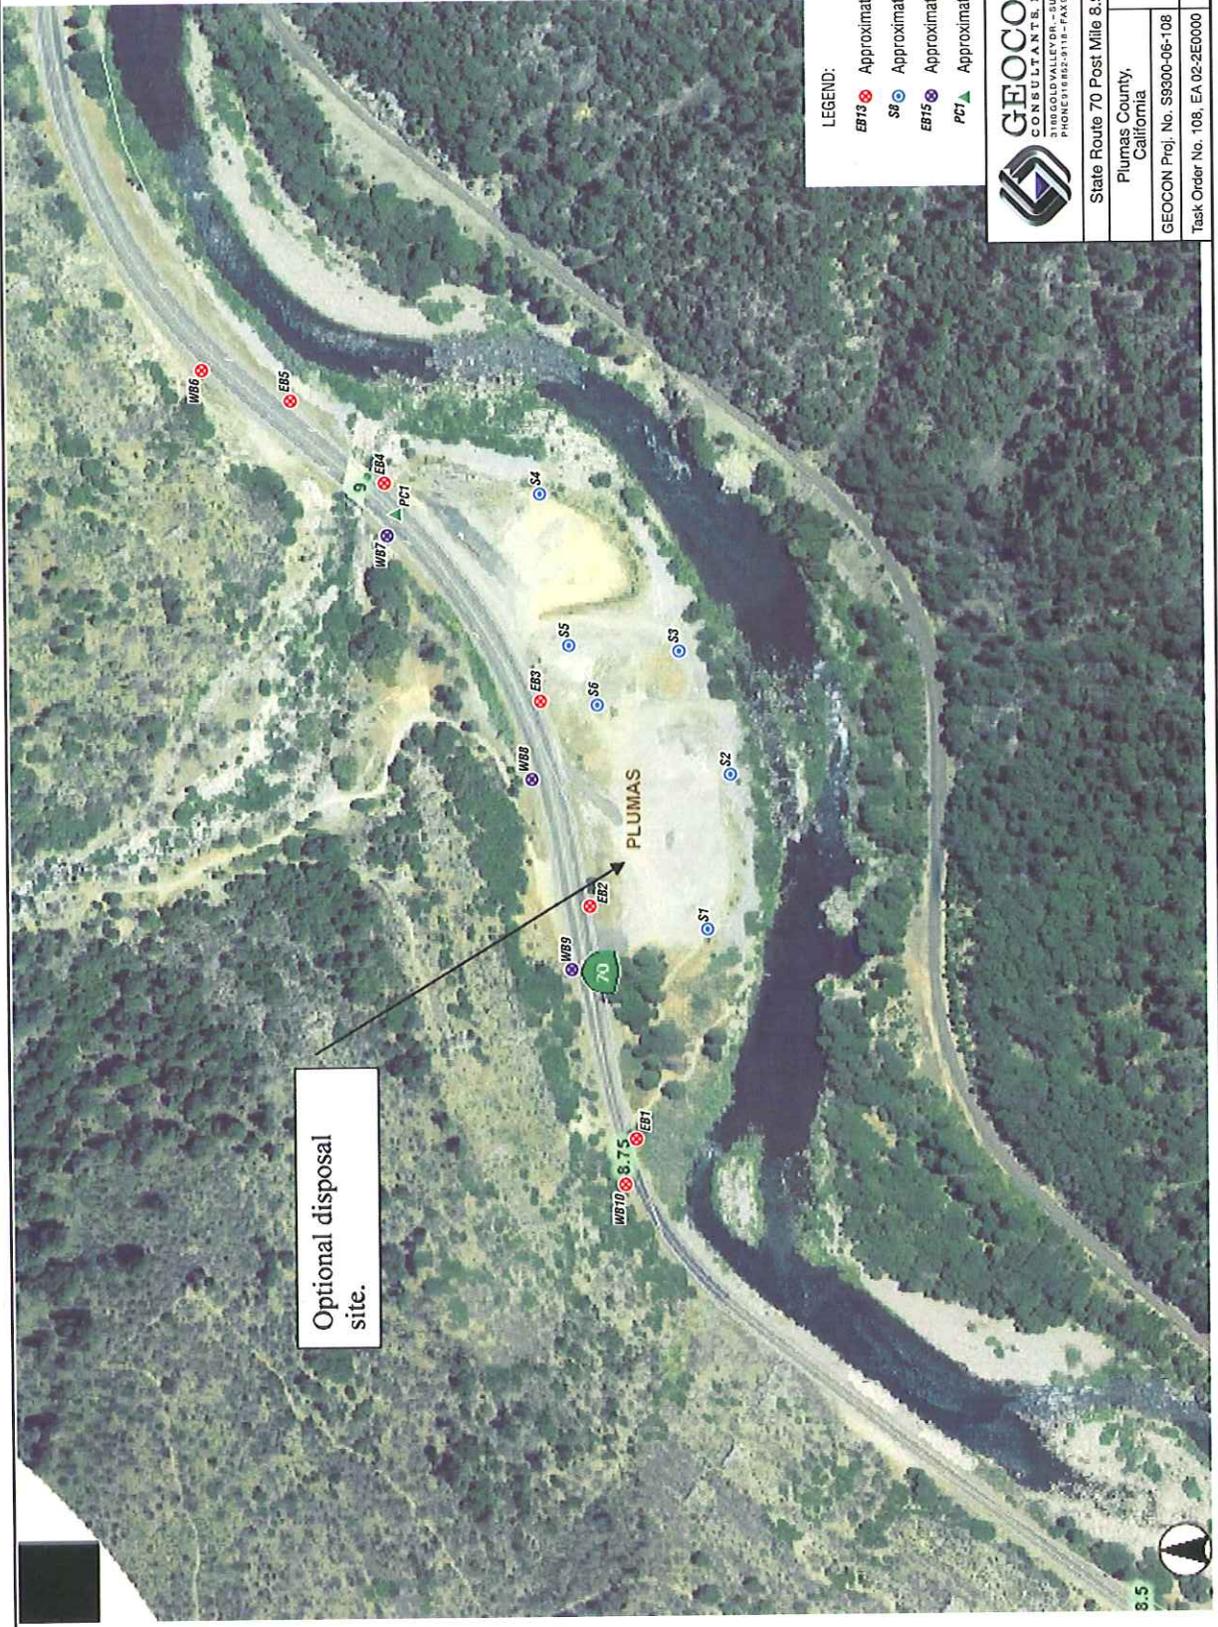
Figure 1

Optional disposal site.

The project area consists of the Caltrans right-of-way from Post Mile (PM) 8.9 to 9.2 and PM 17.1 to 17.5 (the Site) in Plumas County, California. The approximate project location is depicted on the attached Vicinity Map, Figure 1. The Site and major roadway features are depicted on the Site Plans, Figures 2-1 and 2-2. Caltrans proposes to re-align the roadway and construct 8-foot-wide shoulders on SR-70. The project area also included a disposal area on the south side of SR-70 between PM 8.9 and 9.2 and a stockpiled soil area on the north side of SR-70 between PM 17.1 and 17.5.

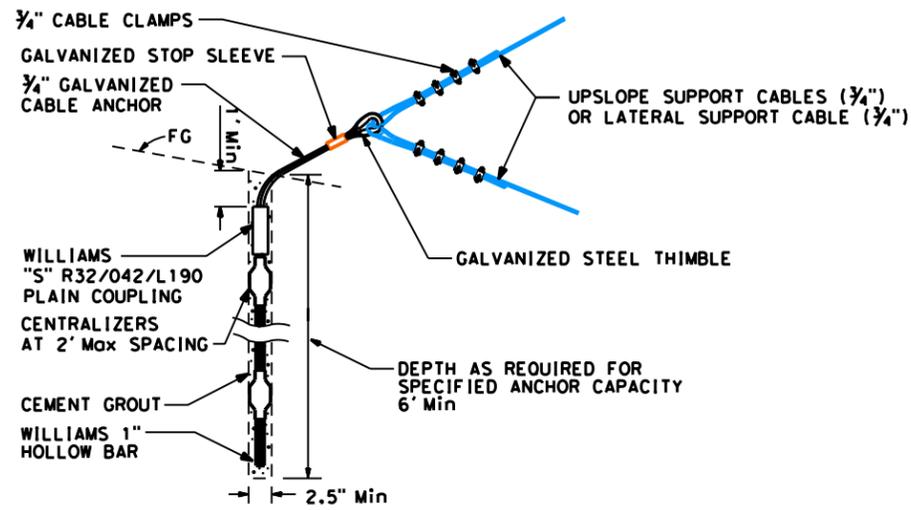
**ALTERNATE B  
GROUND ANCHOR  
(HOLLOW BAR ANCHOR)**

- NOTES:
- EXACT LOCATION OF ANCHORS TO BE DETERMINED IN THE FIELD BY THE ENGINEER.
  - DESIGN LOAD OF ANCHORS SHALL BE 10 TONS.

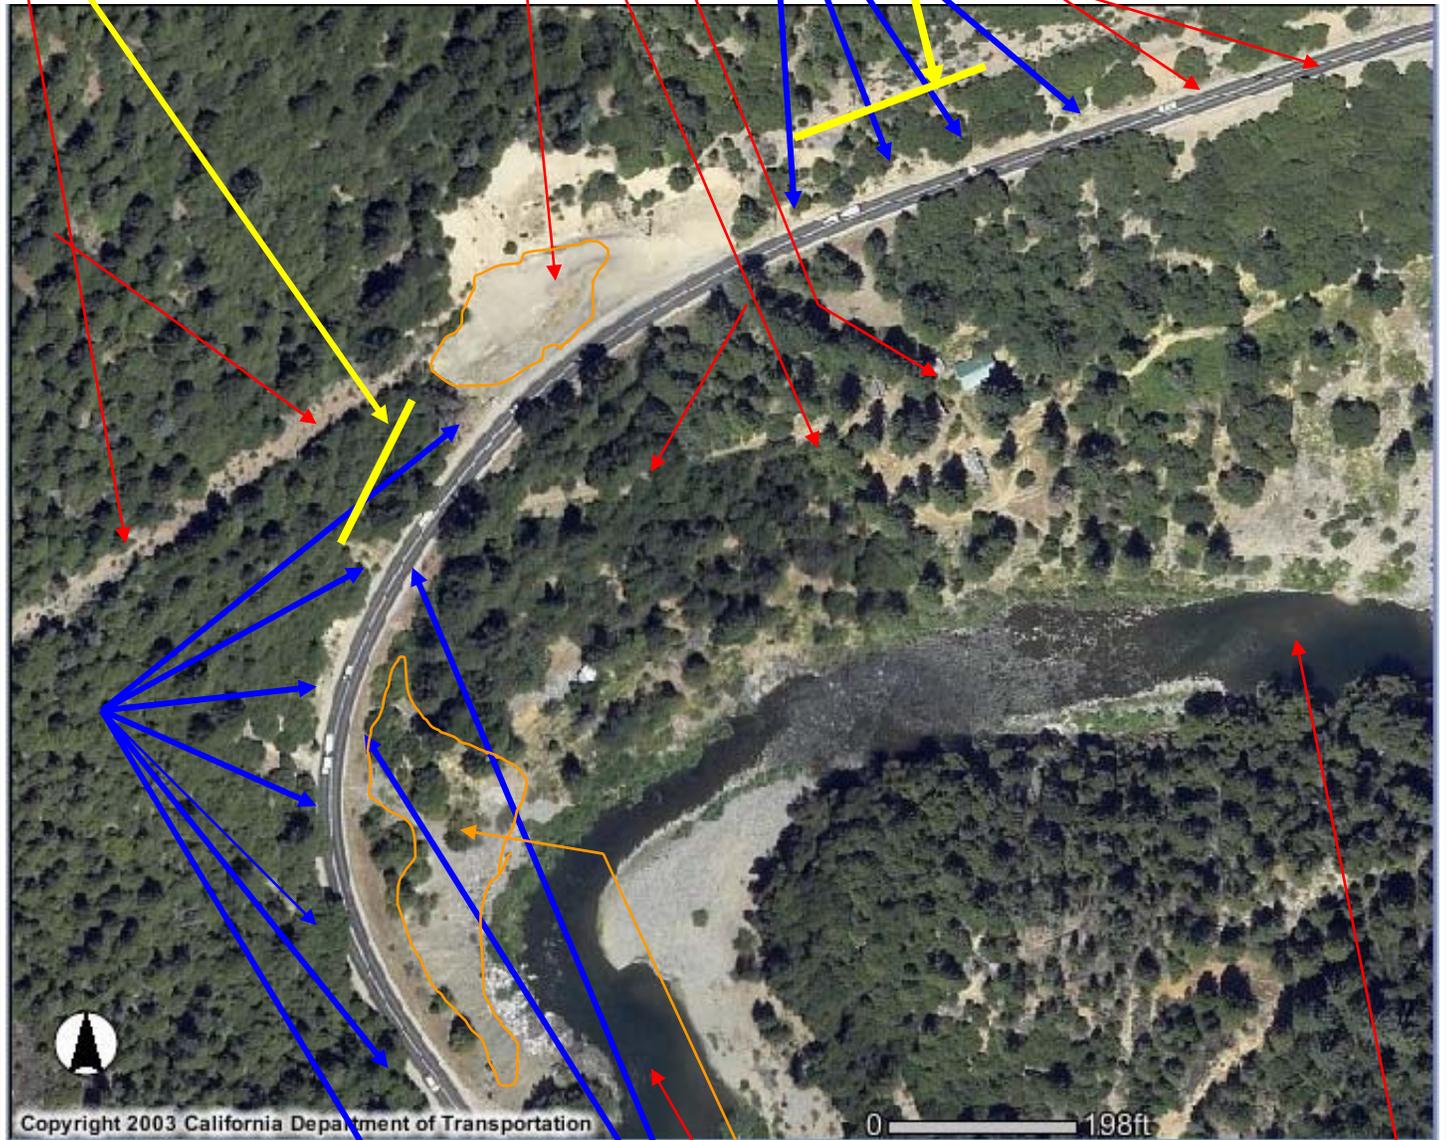
Plate  
No. 2

Proposed Slope Cuts

Fill containing serpentinite outlined in orange

Two areas within the project location were observed to contain serpentine rock that was placed there by maintenance forces and construction forces (during construction of the present highway). The disposal area north of the road near the eastern end of the project has been a repository for slide material for many years and was observed to hold significant amounts of serpentine rock. The fills below the roadway in the middle and western end of the project also were observed to contain serpentine rock. These deposits may contain asbestos. These areas are roughly delineated on the aerial photo shown on Plate 2.

A private driveway that enters the highway from below the roadway at about station 120+00 has undergone episodes of surface water inundation caused when high amounts of surface water flowing in the paved ditch on the south side of the highway carry debris that plugs the ditch and/or the DI just to the west of the driveway. When this occurs the water quickly builds up enough depth and tops the dike, sending a high flow down the driveway. This flow rapidly induces a significant amount of erosion in the private driveway a short distance below the roadway where the pavement gives way to an unpaved surface. Design should consider this problem when redesigning the roadway geometrics and surface flow paths. Plate 2 presents an aerial photo of the site with the location of this driveway shown.

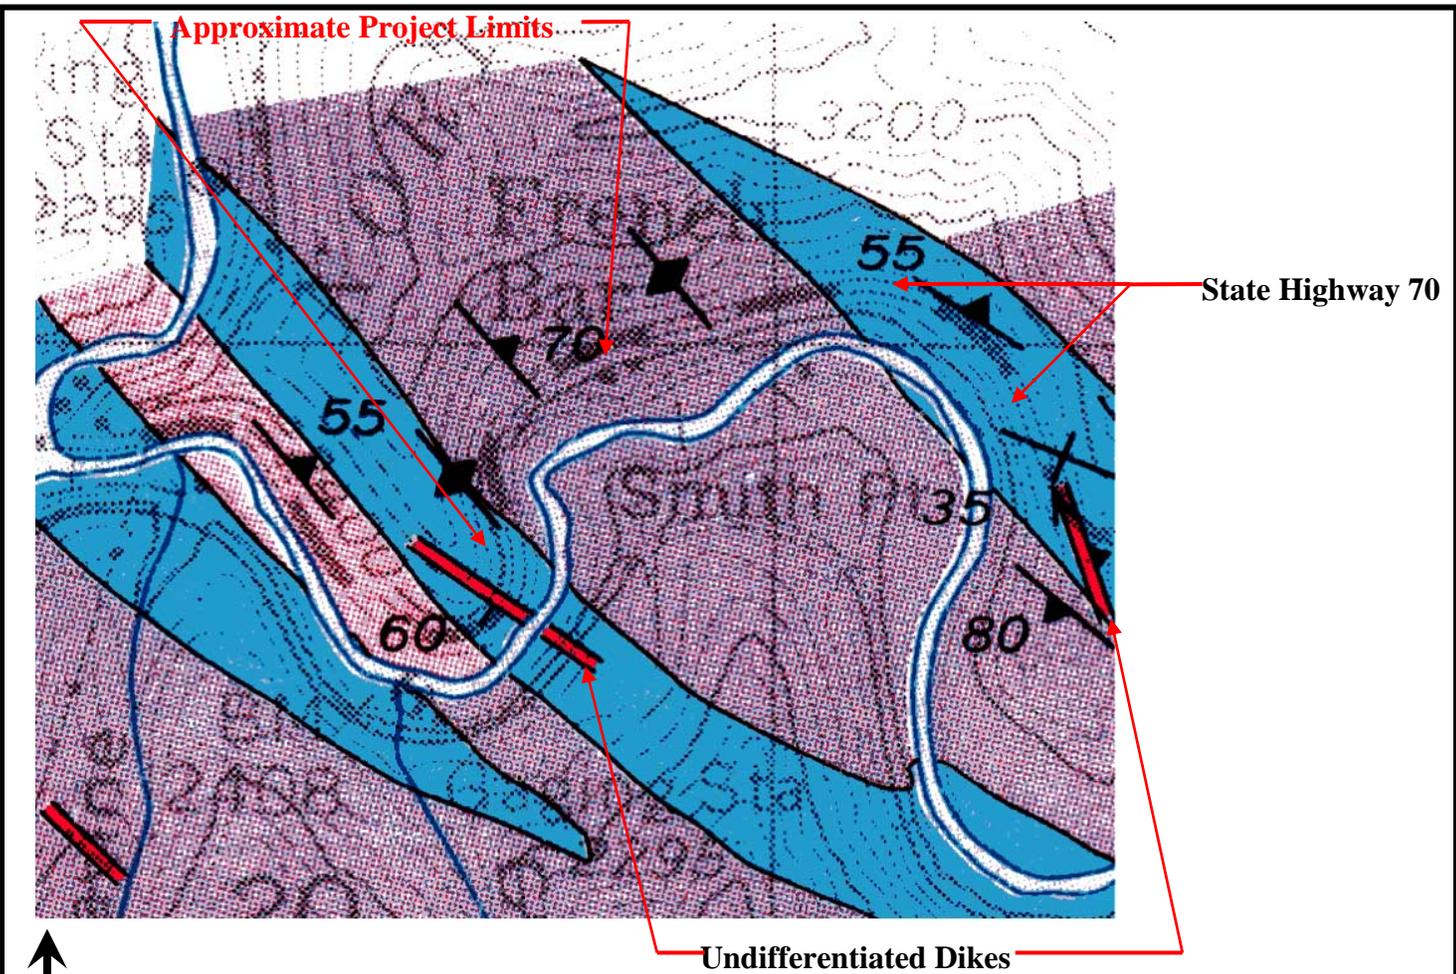
Plate  
 No. 3

(Geological map from Hiatanen, 1973)

There are primarily two rock units and colluvial overburden in the project area. The first rock unit is a very thickly-bedded to mostly massive metachert (quartzite) that varies from hard to extremely hard, and varies from slightly weathered to fresh. It is observed at the very western end of the project from about station 115+10 (at the road) to the western end of the project and beyond, where it forms vertical to near-vertical cut slopes over 100 ft high.

In contrast to the metachert, the phyllite demonstrates scattered to local relict bedding, periodic and localized foliation, localized fractures, and local smaller scale folding (warping) within the project area. Large-scale folds occur rhythmically in the region (Hiatenan, 1973), but are not observed in the phyllite within the scale of the project area. Foliations from these large-scale folds, however, are common. According to Hiatenan's (1973) map these foliations are roughly vertical to steeply dipping with strikes between  $319^{\circ}$  and  $328^{\circ}$ . Mapping by OGDN found the foliations to be similarly vertical to steeply dipping, but with a significantly wider range of strike orientations than Hiatenan's, with azimuths varying between  $287^{\circ}$  and  $330^{\circ}$ . While Hiatenan's foliation orientations align tightly with the known structural grain of the Nevadan Orogeny, a tectonic event that is well-documented as having left its imprint in the ancient Sierran rocks during mid-Jurassic time (about 170 million years ago), the field measurements taken by OGDN may be the result of localized forces (and consequent folding and foliation) induced by the rising emplacement of the nearby Buck's Lake Pluton. It is also possible that these planar features are actually tight fractures, not foliations as interpreted by Mr. Lewis of OGDN, that have been created by the intersection of foliations and relict bedding, or some other cause. Their true structural nature, however, is fairly irrelevant to the kinematic analysis and stability of the slope, while their presence and orientation as structural discontinuities, which has been recorded by OGDN, is completely relevant. These 'foliation' discontinuities are observed typically in clusters, and are spaced from one-quarter in. to roughly one foot apart within these groupings. No infilling is observed within these discontinuities. They are almost always closed, with the exception of a few locations where they have widths up to one half in. It is believed that these openings are strictly the result of being exposed at a cut surface where localized movement and unloading can and has occurred. These discontinuities generally have slightly rough surfaces, while second-order asperities (larger scale) are mildly undulating to planar.

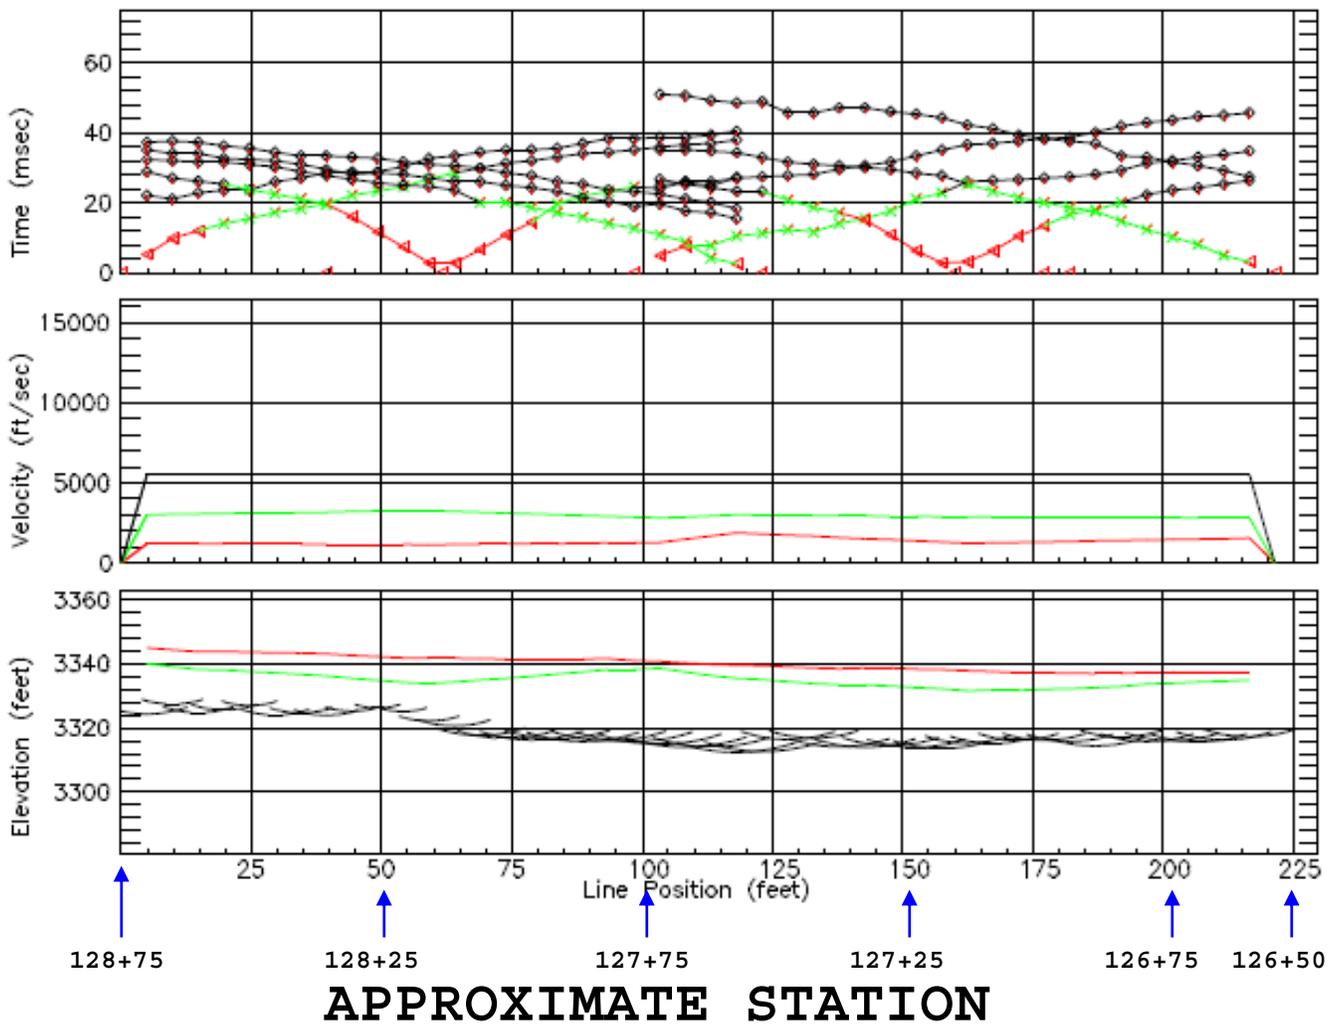
**Seismic Refraction Line 1- Results.** Travel-time curves (top), velocity model (middle), and depth section for seismic refraction line 1. The left side of the above displays is oriented approximately to the east with line position '0' being located at approximately station 128+75, about 110 feet north of present center line, while line position 225 feet is located at approximately station 126+50 about 80 feet north of the present center line. The approximate location of seismic line 1 is shown on Plate 2.

The upper portion of the phyllite beneath the seismic lines, which varies by station in thickness from about 10 to 24 ft, has an average observed compressional wave (p-wave) velocity of about 3000 ft/second (ft/s) in its anisotropically slow direction. This velocity is atypically slow for phyllite, but is best (though not perfectly) explained as a combination of weathering and anisotropy. This upper phyllite portion is believed to have a moderately higher average seismic velocity parallel to the strike of the structure (which is generally perpendicular to the slopes), but seismic data to prove such an hypothesis was not obtained in this direction due to steepness, rough topography, conditions requiring traffic control (that run up support costs and create additional logistical problems), and time limitations. The possibility also exists that this low velocity material is not composed of phyllite in some locations, but rather is made up of clay deposits, a scenario that is further discussed in section 8.1.1 below on cut slopes.

Below this slower material the phyllite is harder and apparently (not observed by touch or sight; sampled only by refracted seismic waves) less weathered. This material continues downward to below the road grade. Seismic velocities of this lower phyllite portion are about 8500 ft/s west of the disposal site and about 5500 ft/s east of the disposal site. Again, these velocities are considered to be generally minimal values due to the structurally based anisotropy of the rocks. The distinct velocity difference between the western and eastern slopes is thought to result primarily from the difference in the amount of silicification of the rocks.

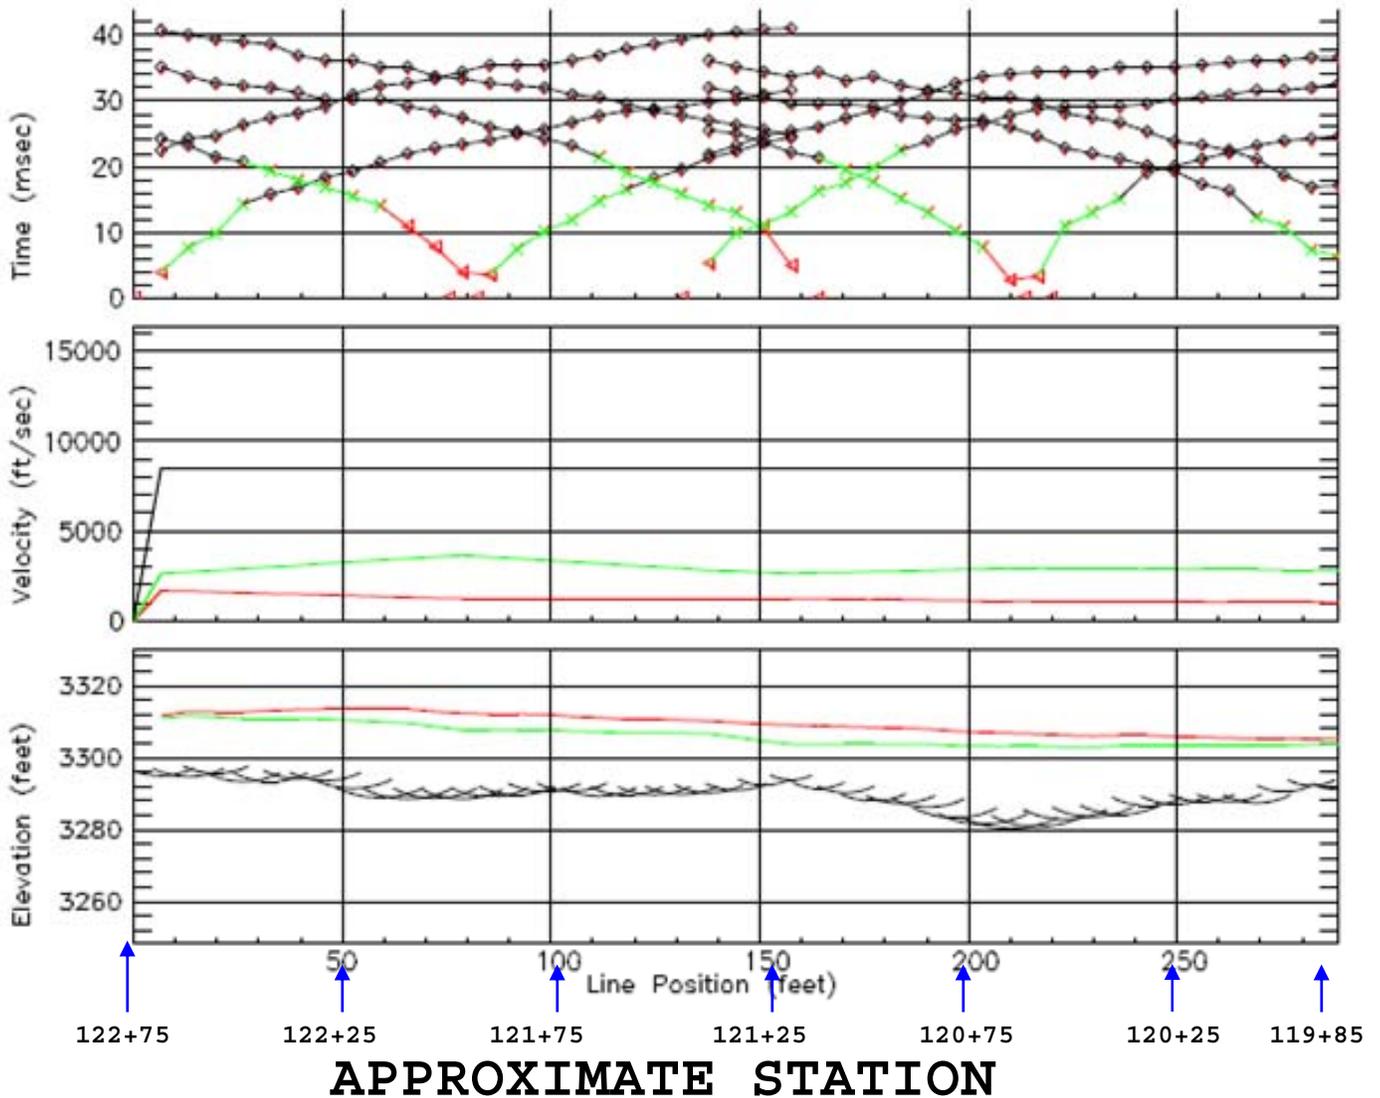
**Seismic Refraction Line 2- Results.** Travel-time curves (top), velocity model (middle), and depth section for seismic refraction line 2. The left side of the above displays is oriented approximately to the east with line position '0' being located at approximately station 122+75, about 80 feet north of present center line, while line position 290 feet is located at approximately station 119+85 about 70 feet north of the present center line. The approximate location of seismic line 1 is shown on Plate 2.

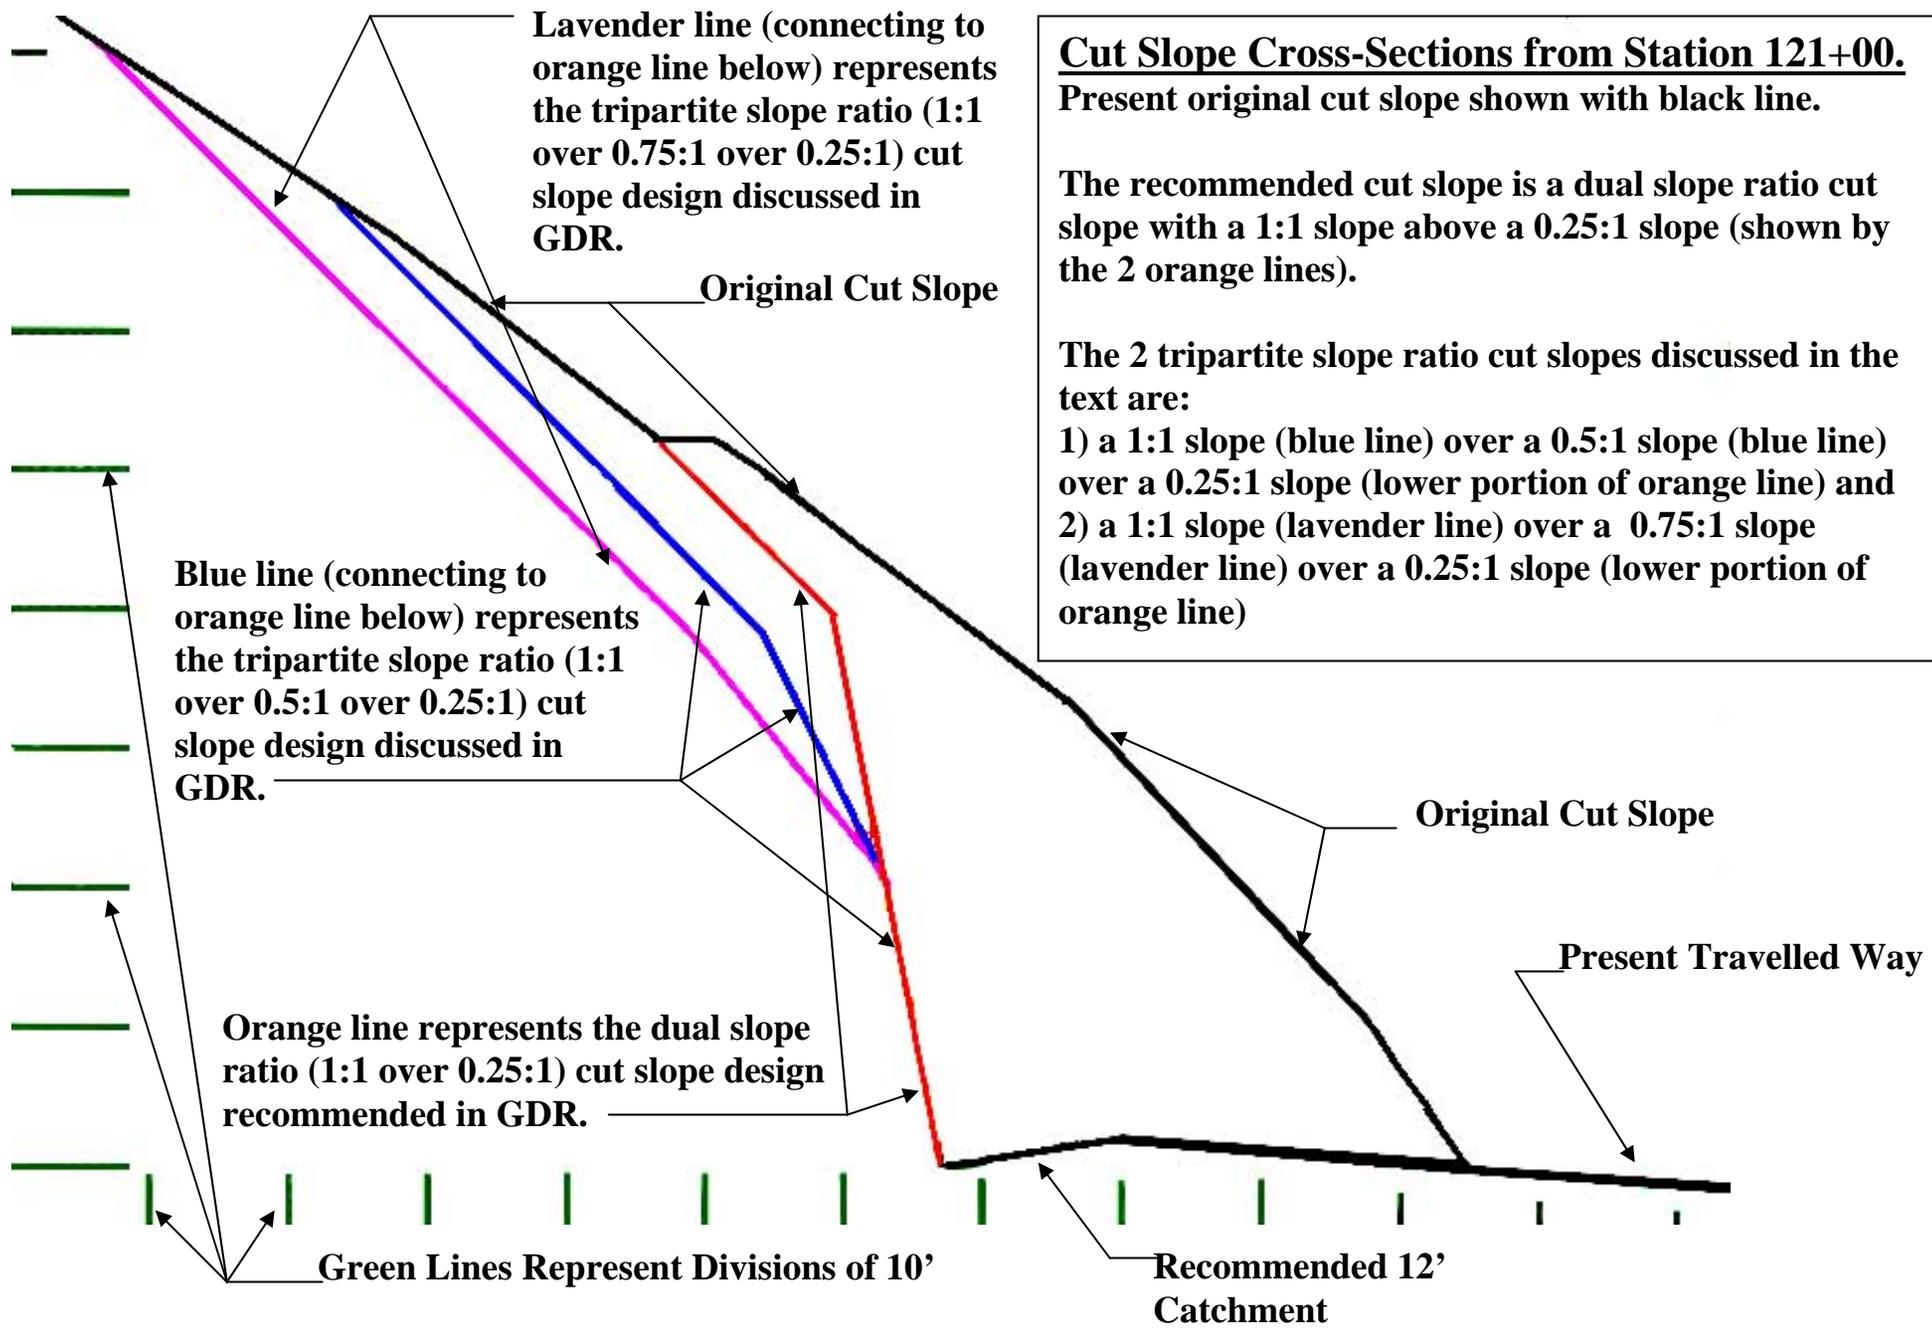
The 2 tripartite slope ratio cut slopes discussed in the text are:

- 1) a 1:1 slope (blue line) over a 0.5:1 slope (blue line) over a 0.25:1 slope (lower portion of orange line) and
- 2) a 1:1 slope (lavender line) over a 0.75:1 slope (lavender line) over a 0.25:1 slope (lower portion of orange line)

A compromise for the phyllite slopes east of station 120+00 that carries some risk was reached with the design team and project engineer that hopefully represents an optimum balance between stability concerns, rockfall creation, rockfall mitigation, increasing or reducing excavation quantities, increasing or eliminating the need for additional right-of-way, and the risks of slope failure with different cut slope ratio scenarios. This compromise involves a dual-slope ratio cut slope design with a slightly thicker section cut at 1:1 overlying a 0.25:1 section that then extends to the bottom of the slope. The thickness of the 1:1 cut portion is increased up to the limit where the upslope catch point begins to run up the slope excessively. This results in the uppermost reaches of the moderately weathered phyllite, together with the overburden, being cut at 1:1. The 0.25:1 portion of the cut section extends up from the strong relatively unweathered phyllite into the

lower portion of the moderately weathered phyllite. It is this steep (0.25:1) portion of the moderately weathered phyllite (or sandy gravelly clay?), a portion that varies from about 5 to 12 ft in vertical thickness, that represents the risk involved in this design and which carries with it the possibility of some slope failure in these sections. Plate 7 shows a typical cross-section of this dual-slope ratio cut slope (the orange line). Should failures occur during construction in these cut slope sections, it may become necessary to modify the cut design to either the tripartite design discussed above or to a dual slope ratio design that incorporates the stable 0.25:1 portion of the lower cut slope with a modified flatter upper slope ratio between 0.75:1 and 1:1.

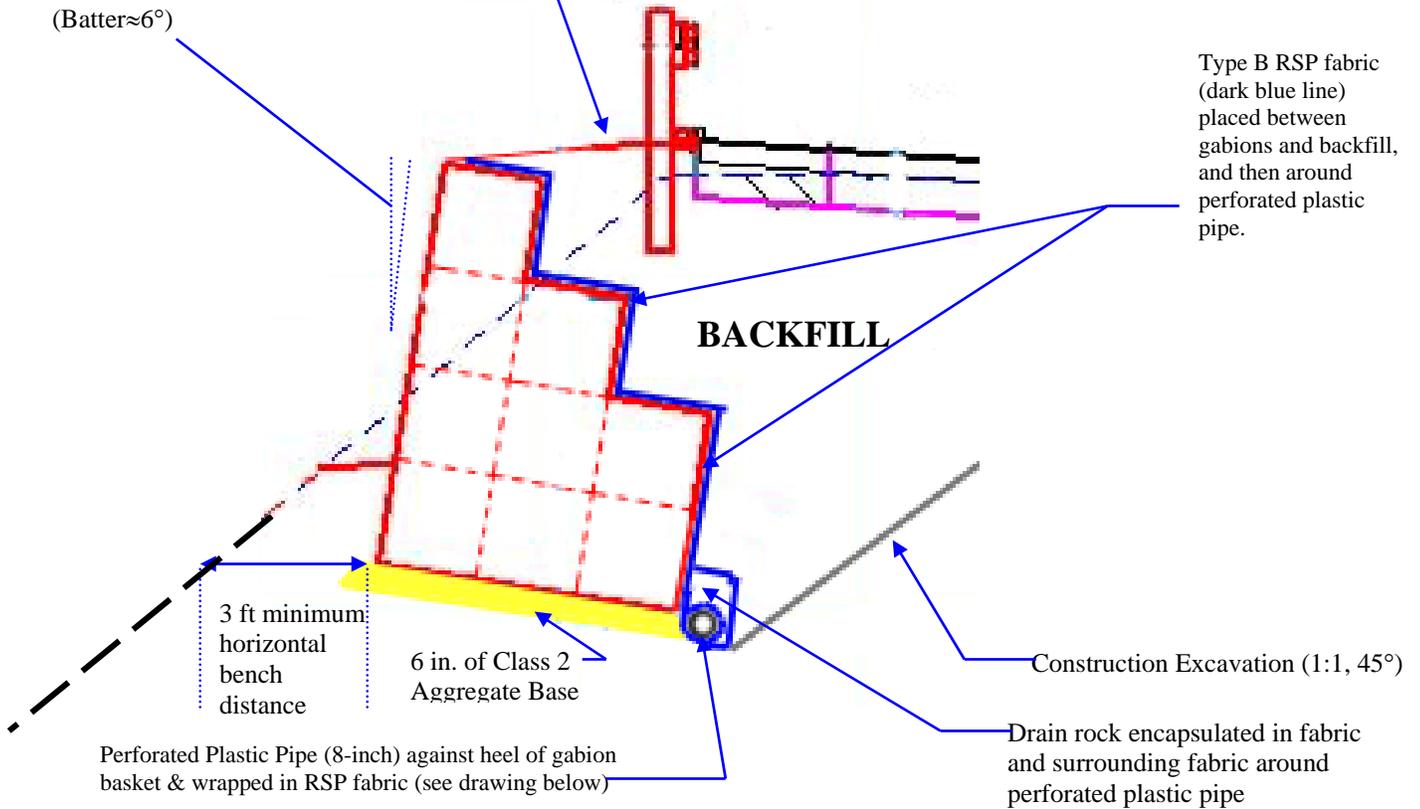
**Gabion Basket Dimensions:** 3 ft x 3 ft  
**Top:** Length x 3 ft x 3 ft  
**Middle:** Length x 3 ft x (3 ft x 2 baskets)  
**2 Bottom Rows:** Length x 3 ft x (3 ft x 3 baskets)

Surface should be coated with AC to protect shape, prevent loss of backfill material, and to exclude water

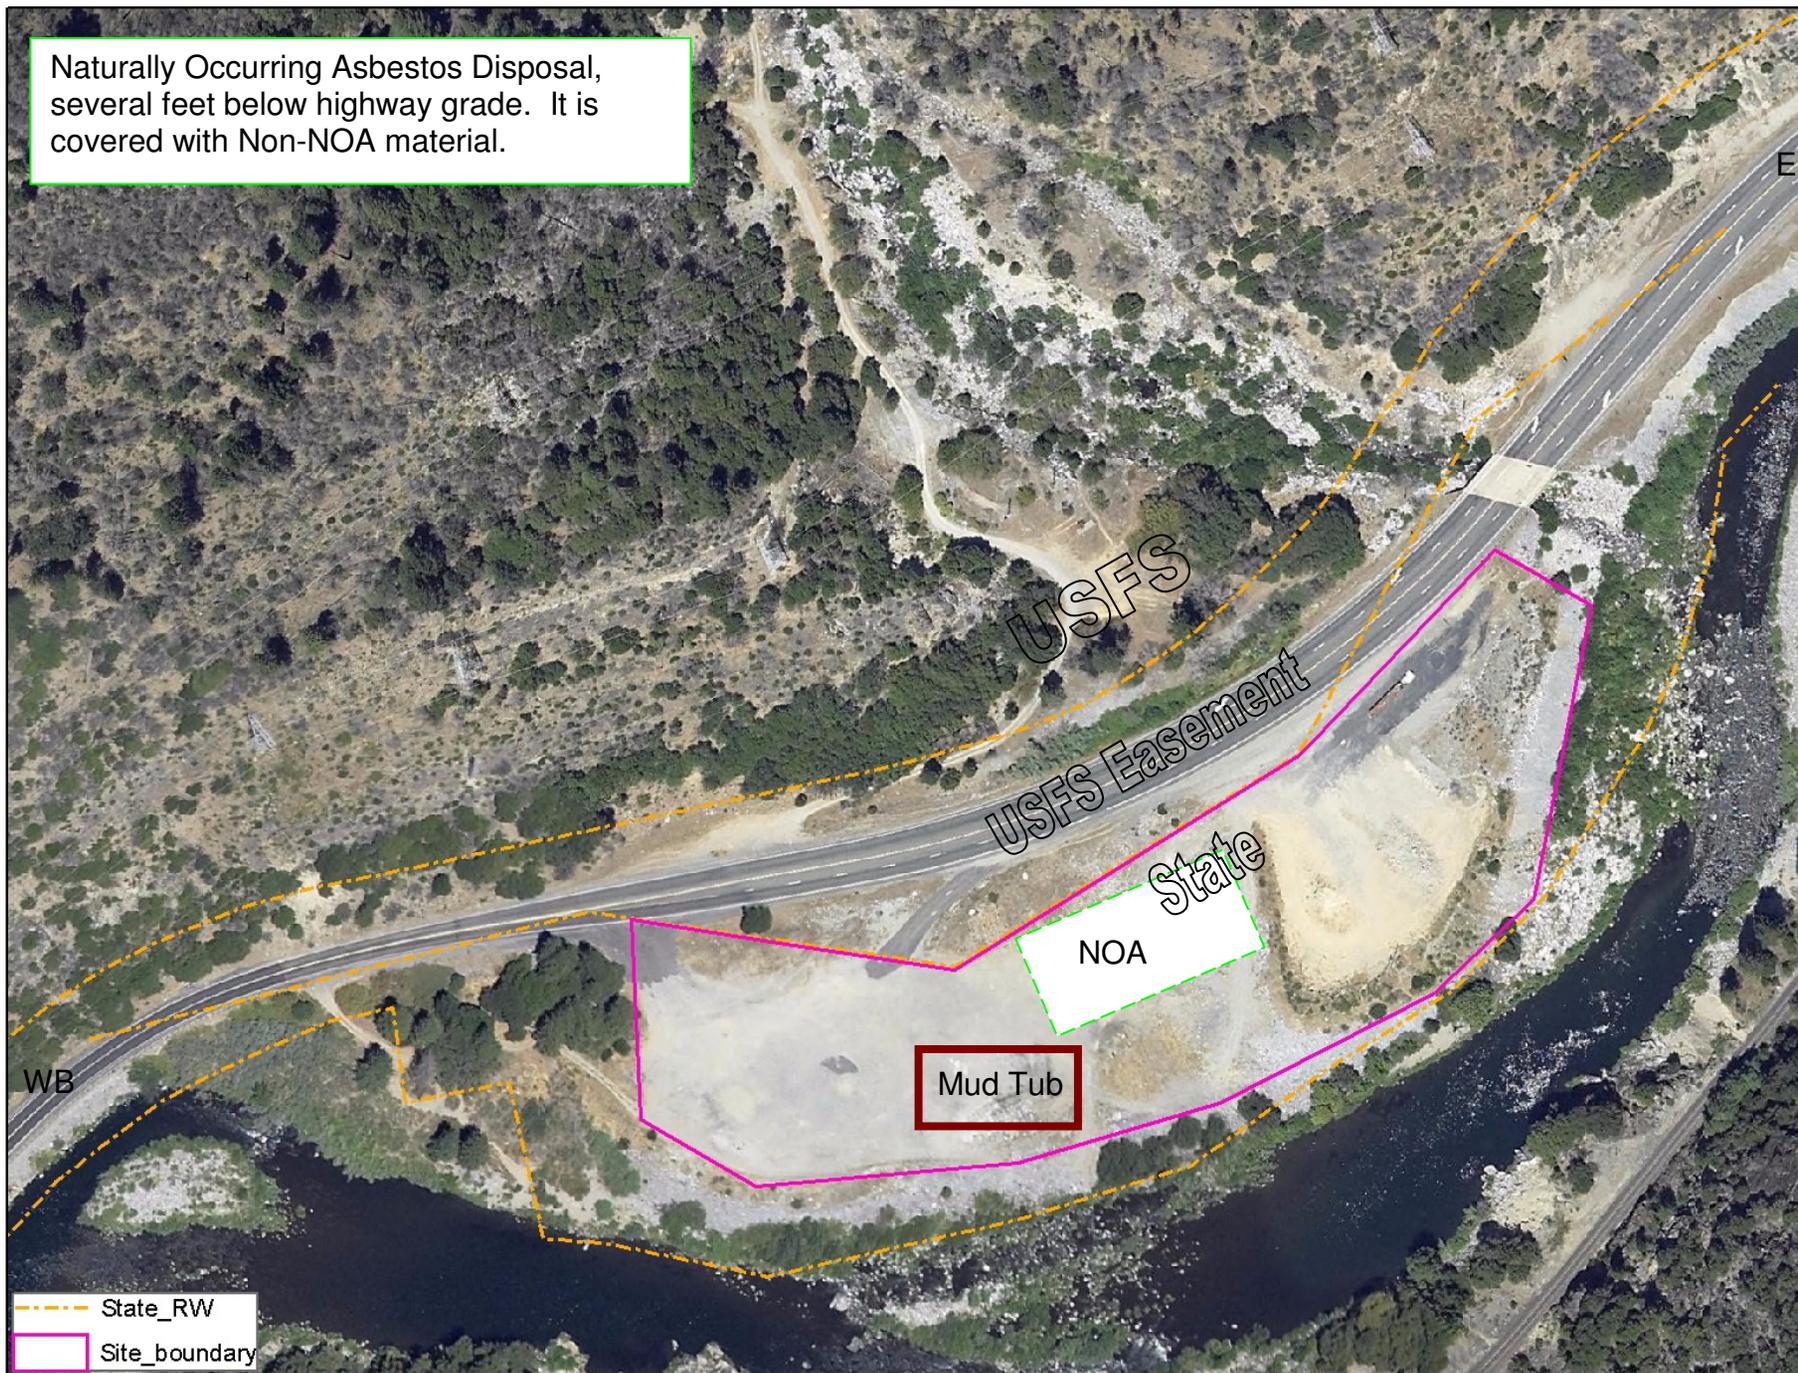
# Disposal Site Plu-070-009.0 Chambers Creek

Naturally Occurring Asbestos Disposal, several feet below highway grade. It is covered with Non-NOA material.
