**AERIALY DEPOSITED LEAD,
PETROLEUM HYDROCARBON AND
VOLATILE ORGANIC COMPOUND
SITE INVESTIGATION REPORT**

**Tahoe Y at State Highway 89 and
US 50 Between Tahoe Y and Trout Creek
South Lake Tahoe,
El Dorado County, California**

**GEOCON PROJECT NO. S9300-06-48
CONTRACT NO. 03A1368
TASK ORDER NO. 48, EAs 03-1A7320 AND 3C3800**

JANUARY 2009

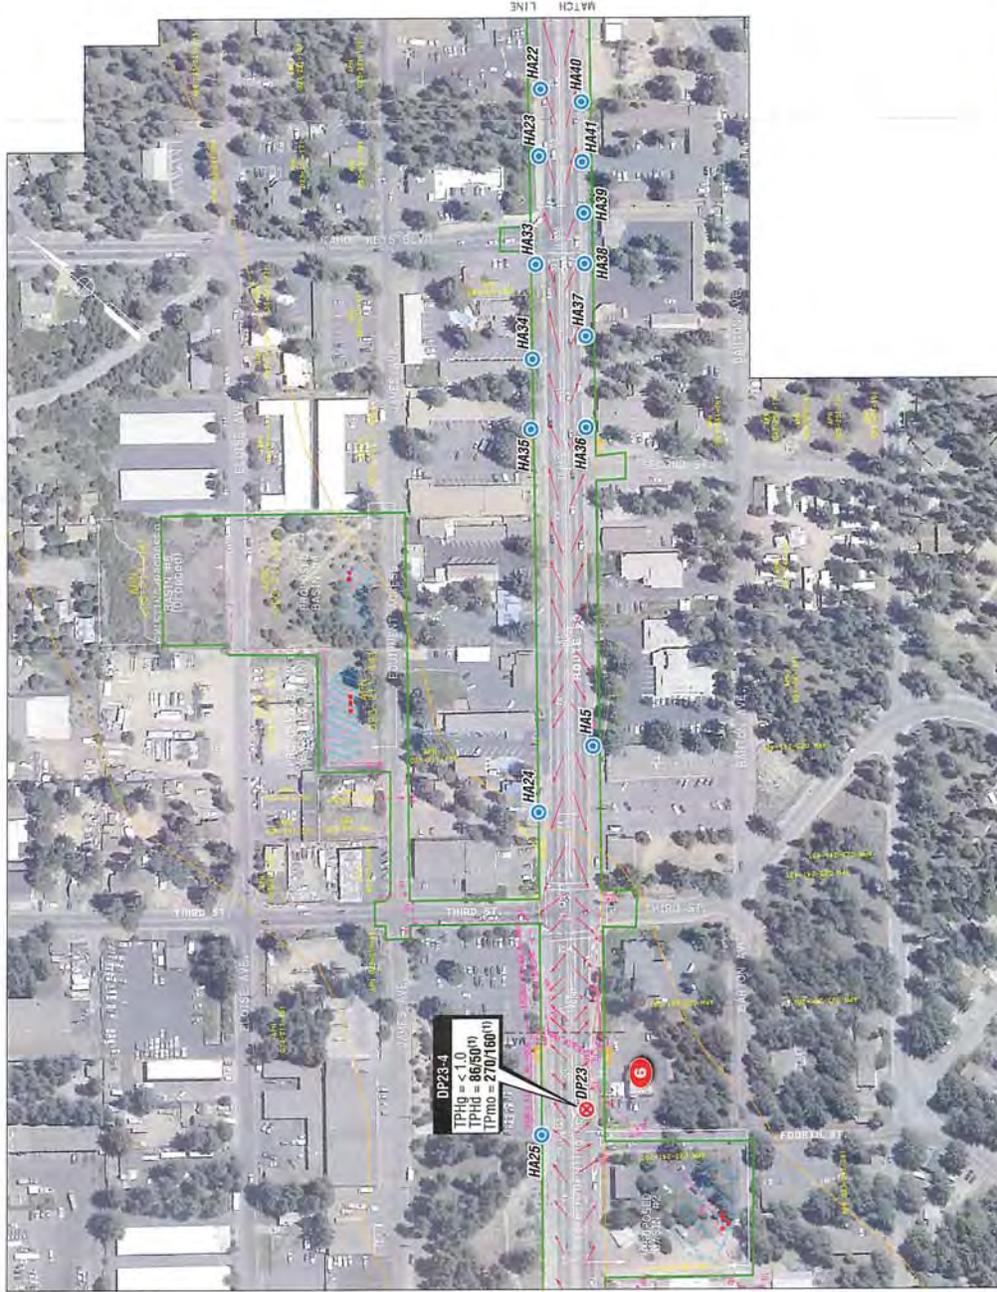
Tahoe Y at State Highway 89
 and US 50 Between Tahoe Y and Trout Creek
 South Lake Tahoe, California
 GEOCON Proj. No. S9300-06-48
 Task Order No. 48
 January 2009
SITE PLAN
 Figure 2-5

2. TPHd and TPHmo at concentrations of 86 and 270 mg/kg (50 and 160 mg/kg using silica gel cleanup), respectively, in soil sample DP23-4 obtained adjacent to the Brothers Burrito House located at 2136 Lake Tahoe Boulevard, a former service station (Map ID 6, Figure 2-5). Slight odor and staining were noted for boring DP23.

The elevated petroleum hydrocarbon soil concentrations for each of the identified four locations are depicted on the Site Plans, Figures, 2-1, 2-5, 2-8 and 2-9. Soil excavated from these areas may require disposal at a licensed recycling/disposal facility. For preliminary planning purposes, estimated costs to transport and dispose (excluding excavation, stockpile and loading costs) of petroleum hydrocarbon-impacted soil from the project site to a Class II non-hazardous waste landfill facility (Hay Road Landfill in Vacaville, California) are estimated at \$67 per ton.

We recommend that a soil management plan (SMP) be prepared for use during construction activities. The SMP would present contingencies for handling, transportation, and disposal of petroleum hydrocarbon-impacted soil, if encountered during roadway excavation activities. It may be necessary for the contractor(s) to stockpile excavated soils and obtain representative soil samples for analytical testing to determine appropriate and economical disposal options. Asphalt debris and grindings should not be incorporated into soil stockpiles that require disposal evaluation.

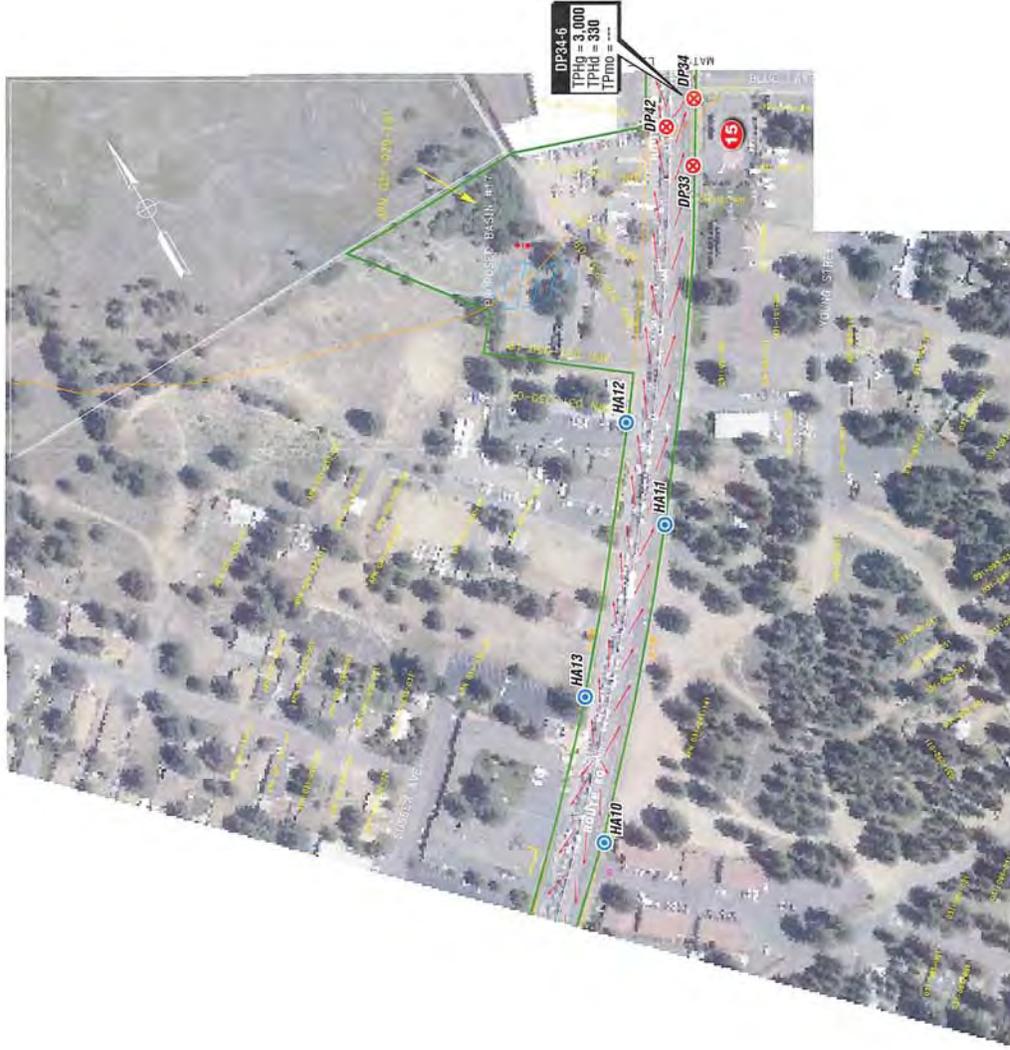
Figure 2-8

3. TPHg and TPHd at concentrations of 3,000 and 330 mg/kg, respectively, in soil sample DP34-6 obtained adjacent to the active American Gas service station located at 2762 Lake Tahoe Boulevard (Map ID 15, Figure 2-8). Slight to strong odor, staining and positive PID readings were noted for boring DP34.

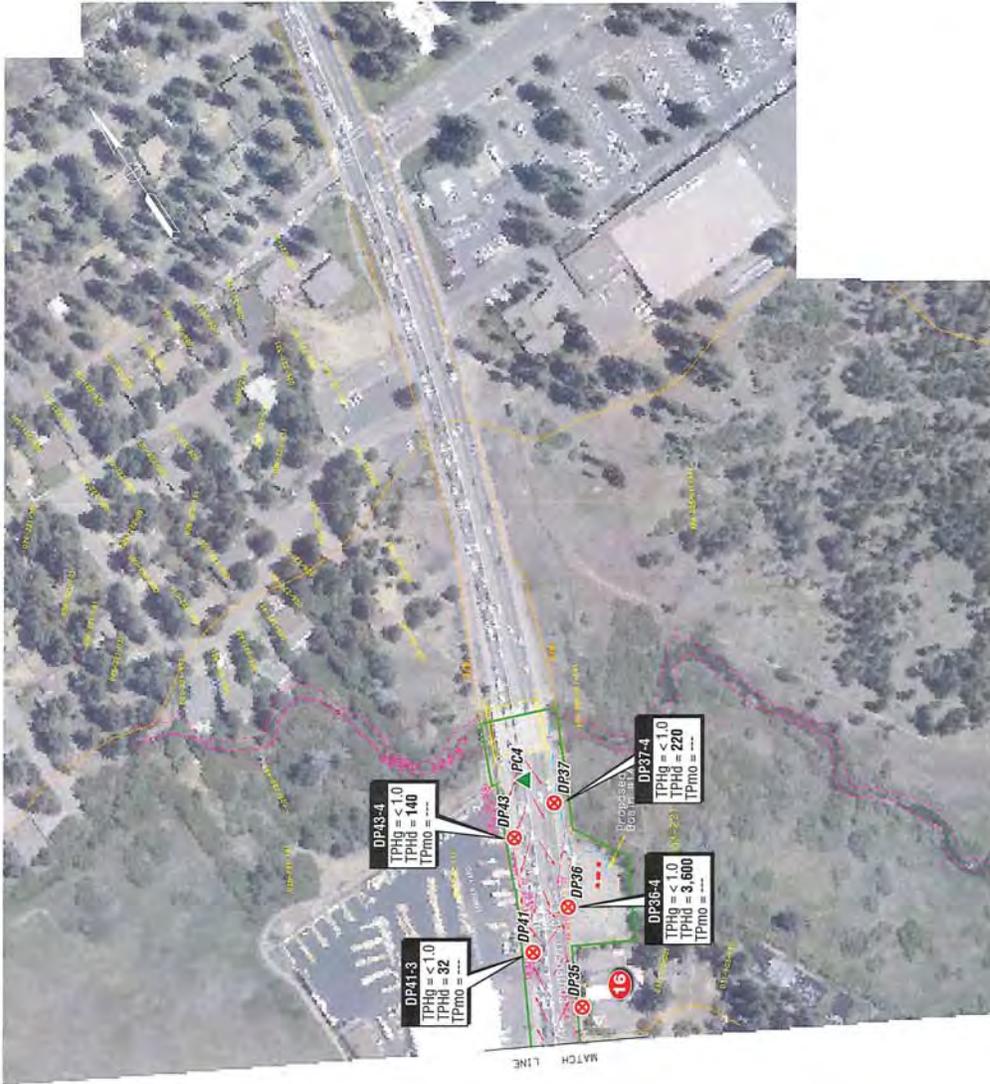
4. TPHd at concentrations ranging from 32 to 3,600 in soil samples obtained from borings DP36, DP37, DP41 and DP43 in the vicinity of a former Muffler Palace service station located at 2774 Lake Tahoe Boulevard (Map ID 16, Figure 2-9). Odor, staining and/or positive PID readings were noted for each of these borings.
