INFORMATION HANDOUT

NESTING BIRD DETERRENCE MEASURES: MATERIALS AND APPLICATIONS

EA 04-013521

**Supplement to the 2003 Final (Revised) Bird Monitoring and
Management Plan**

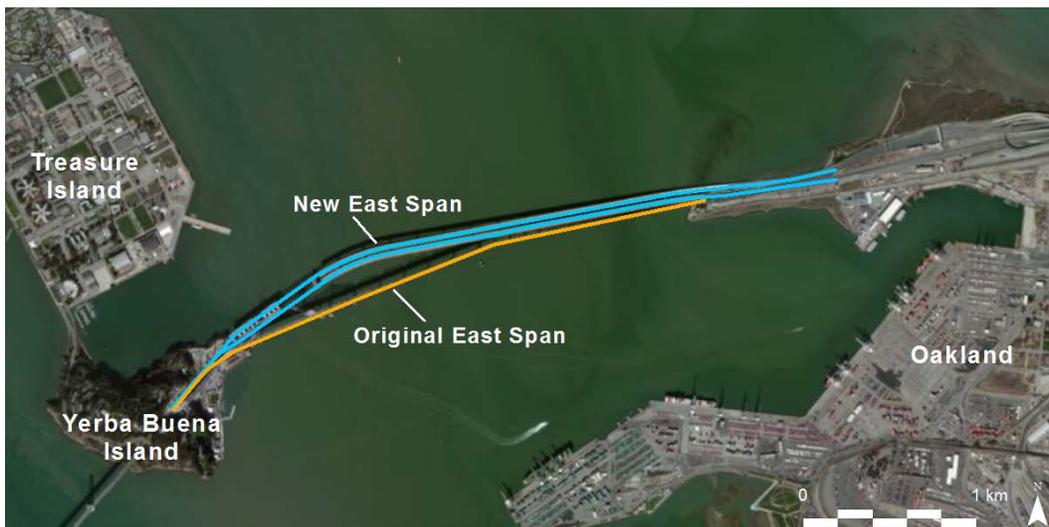
Figure 1.2 SFOBB new and original east spans

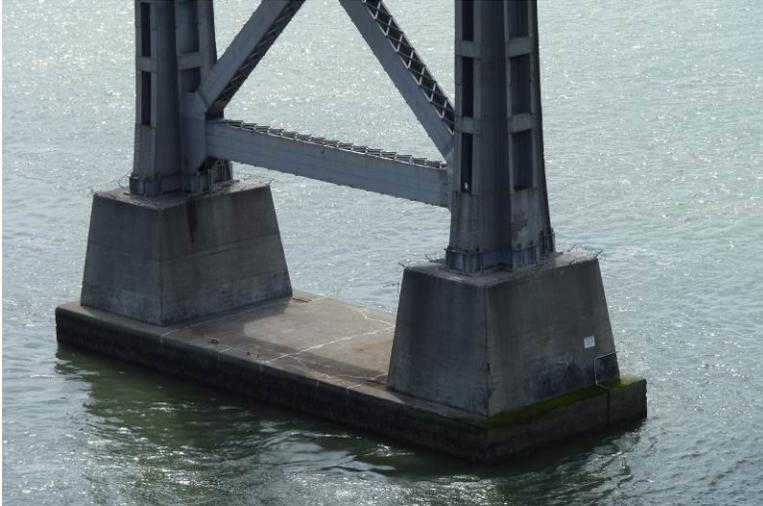
Figure 2.1 Marine foundation at Pier E7 with raised pedestals, ledge areas around pedestals, and large open area between pedestals.

Description: Flat, open areas between concrete pedestals defined by tops of concrete foundations (Figure 2.1).

Deterrence measure(s): Large, flat surfaces are not feasibly covered by exclusionary deterrence measures and may need to be left open for access to construction area. These areas shall be managed by contractor biologist(s) to prevent or remove nest starts. Management strategies for these areas may include, but are not limited to monitoring, bird-hazing, and removal of nest starts

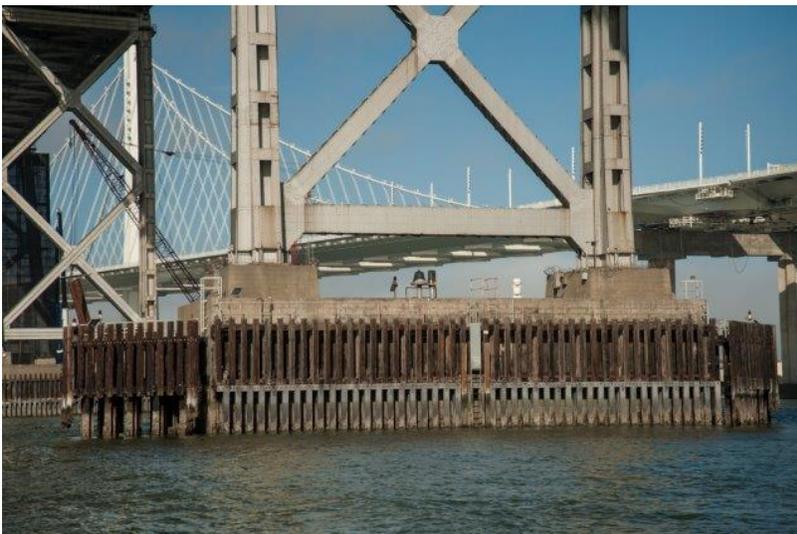
Figure 2.2 Wooden fender at Pier E5

Description: Complex lattice of vertical and horizontal wooden beams, constructed around marine foundations as protection against potential collision from vessels and debris (Figure 2.2)

Deterrence measure(s): Remove, or cover entire fender with netting to block access. To avoid creating flat horizontal surfaces with netting, extend netting at a diagonal from top of bumper to wall of concrete foundation and secure tightly. Slope panels may be used in areas where it is not feasible to attach netting to avoid creating a flat surface. Any remaining flat surfaces must be filled with bird spikes, or blocked to prevent access by nesting birds

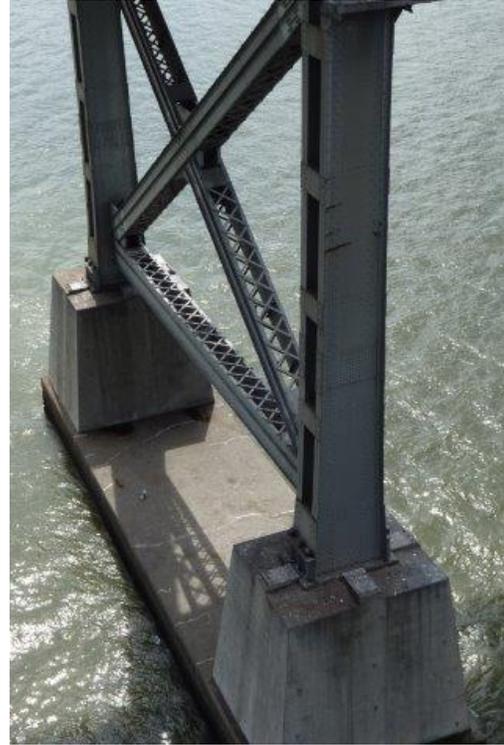
Figure 2.5 Pedestal top and tower typical for Piers E4-E8 and E10-E16

The 504/288 spans are supported by 13 steel towers (Piers E4-E16) anchored to concrete marine foundations. Towers E4-E8 and E10-E16 (Figure 2.5) each have 2 legs, connected by horizontal and diagonal truss-beams. Pier E9 (Figure 2.6) is composed of four tower legs, also connected by horizontal and diagonal truss-beams. For the purposes of bird management, the support towers are addressed by member type. Support tower member types include: legs, diagonal braces, and lateral top beams. Within each steel support tower member type are nesting bird habitat areas, for which specific deterrence measures are required. Deterrence measure requirements are presented below.

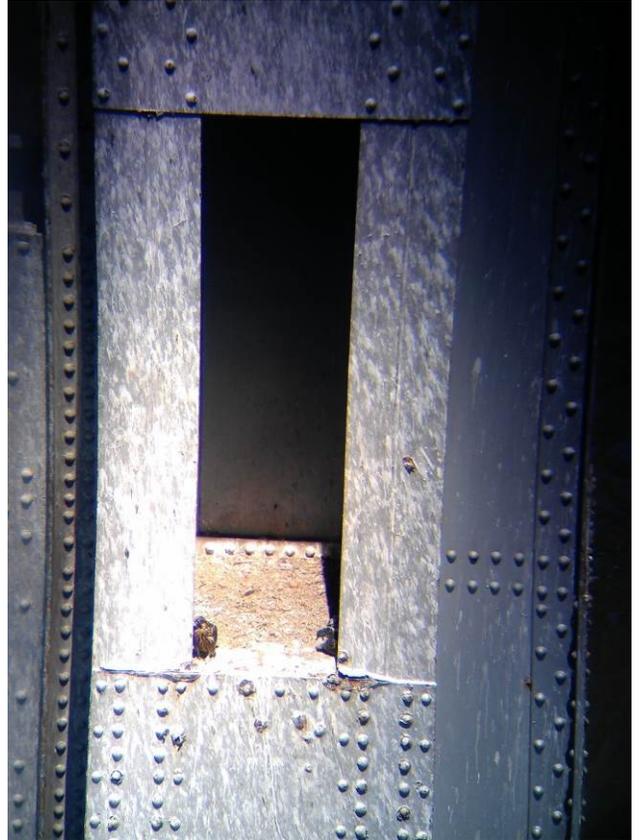
Figure 2.7 West-facing recess (with peregrine falcon nestlings) in Pier E8 tower leg

Description: Vertical, steel, truss-members with tower legs have a number of vertically elongated, rectangular, recessed alcoves along the vertical length of their east and west faces (Figure 2.7) Piers 5-8 also have additional alcoves along the vertical length of the north and south faces of each leg

Nesting habitat: Horizontal areas within each recess (Figure 2.7) and at base of steel support tower legs (Figure 2.8)

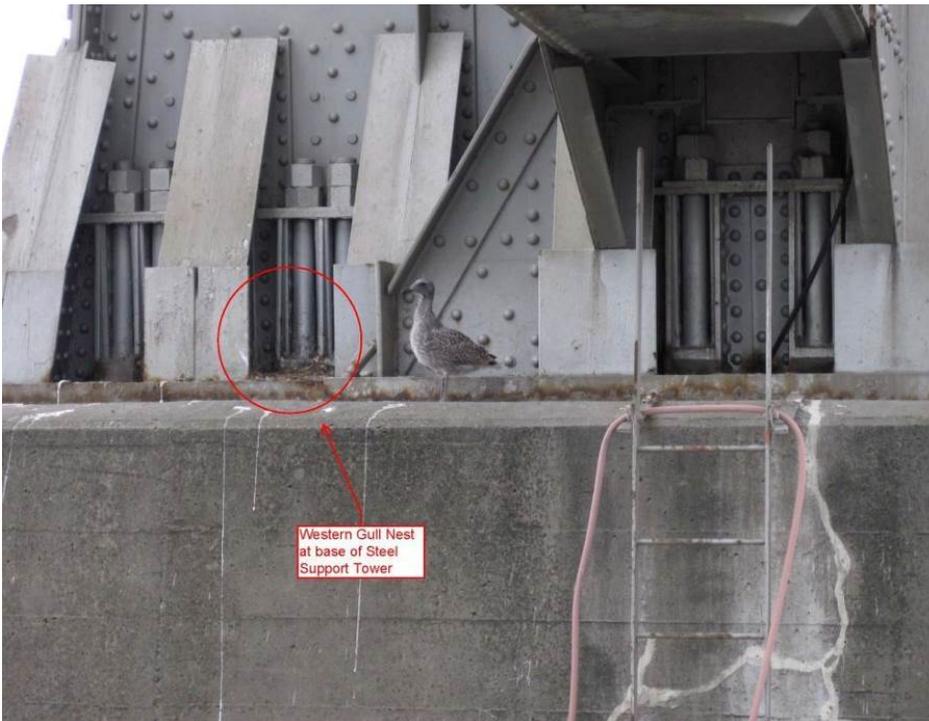
Figure 2.8 Western gull nest at base of steel support tower

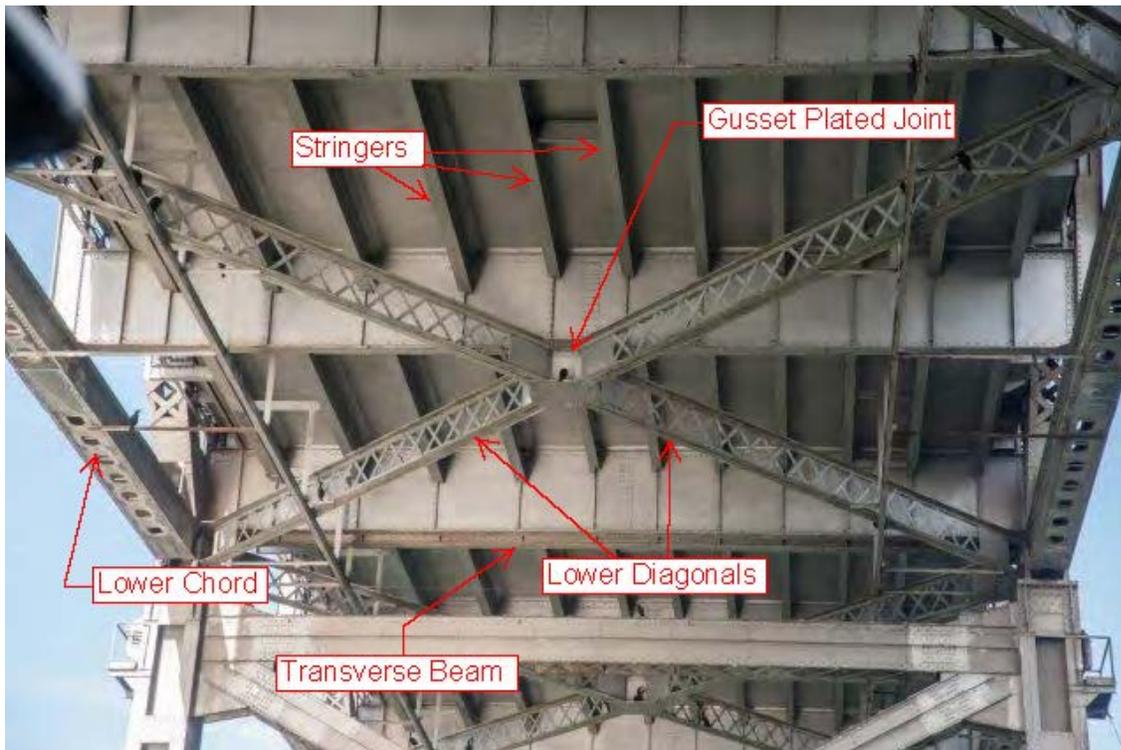
Figure 2.9 288-ft span, lower members

The structural members below the lower deck of the 504-ft and 288-ft spans of the SFOBB Original East Span include a network of stringers, transverse beams, lower diagonal, eye bars, and lower chords. Between Pier E4 and Pier E9 there are five 504-ft bridge sections. Between Pier E9 and Pier E23 there are fourteen 288-ft sections (Figure 2.9).

A double-crested cormorant colony is located primarily within the lower members of the bridge, therefore nesting bird deterrence measures for the bottom of the bridge will require complete exclusion. Use of a suspended scaffolding system netted at all open ends and scaffolding deck openings will provide bird exclusion from these areas. If a scaffolding system fails to provide exclusion, wrap all diagonals with netting, clean and spike all flat surfaces at joints and install bird-wire system on top surfaces of all lateral members that are accessible to birds. The suspended scaffolding system will also provide nesting bird monitoring and deterrence monitoring access to the below-deck structural members.

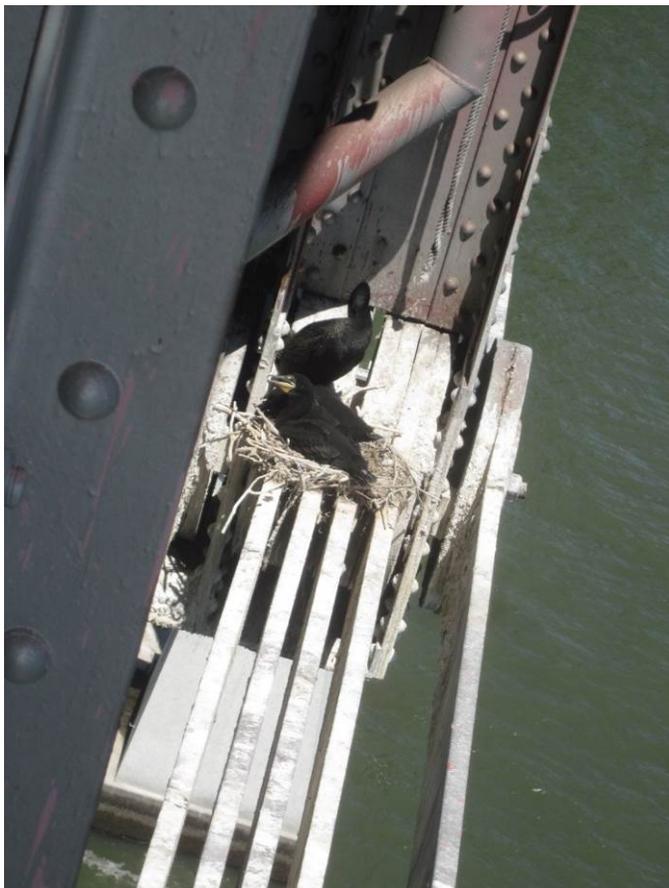
Figure 2.10 Double-crested cormorant nest on eye-bars

Nesting habitat: Eye-bars in groups of six spaced less than 5 inches apart from each other present potential nesting surfaces (Figure 2.10)

Deterrence measure(s): Install a suspended scaffolding system below the lower deck. Such a system shall extend beyond the north and south side of the bridge. The side-space between the suspended scaffolding system platform and the bridge shall be sealed with netting to exclude birds from nesting areas. Securely attach netting to the side of the lower deck. Seal all openings between the suspended scaffolding system and the lower deck with netting

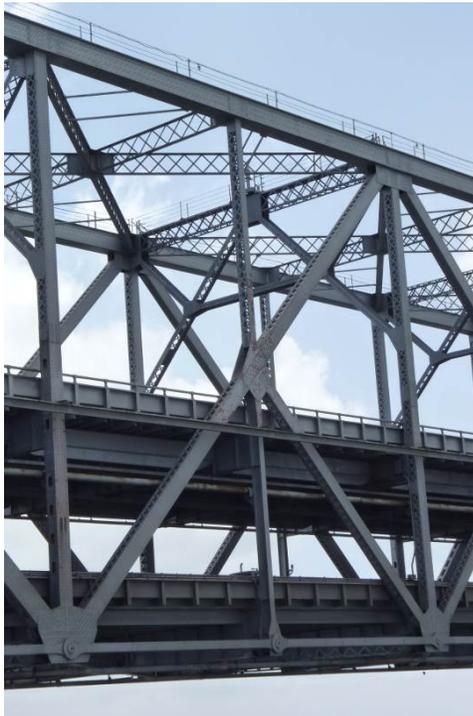
Figure 2.11 Typical superstructure for 504-ft span

For this technical report, the upper superstructure refers to the bridge members extending above the bottom lateral structures, including the lower deck, the upper deck, and upper laterals (Figure 2.11, Appendix B). Most locations in these structures will be highly accessible during the dismantling process. Based on this accessibility as well as low incidence of historical nesting locations in upper superstructure locations, deterrence measure requirements for these areas emphasize daily monitoring, hazing, nest-start removal, supplemental deterrents and installation of deterrents as shown in Contract plans.

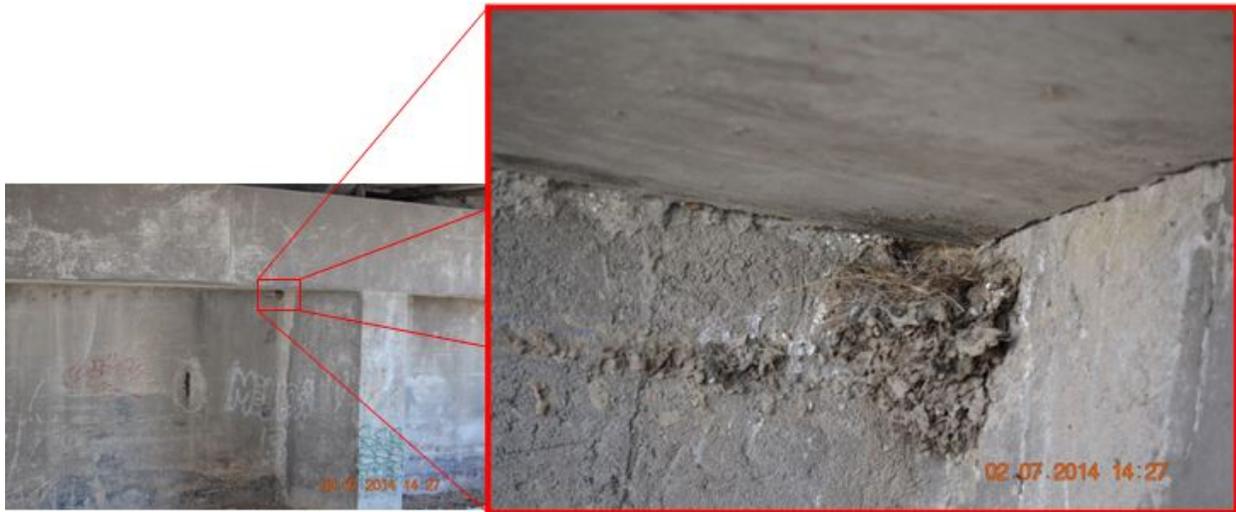
Figure 2.14 Black phoebe nest on OTD concrete bent

Additional SFOBB Original East Span land-based foundations occur east of Pier E22, on which the Oakland Touchdown (OTD) is built. Within this structure are multiple protected overhangs located on several concrete bents (Pier E23, Bents E24-E28). Protected overhangs provide nesting habitat for some bird species (Figure 2.14). Deterrence measures are given below.

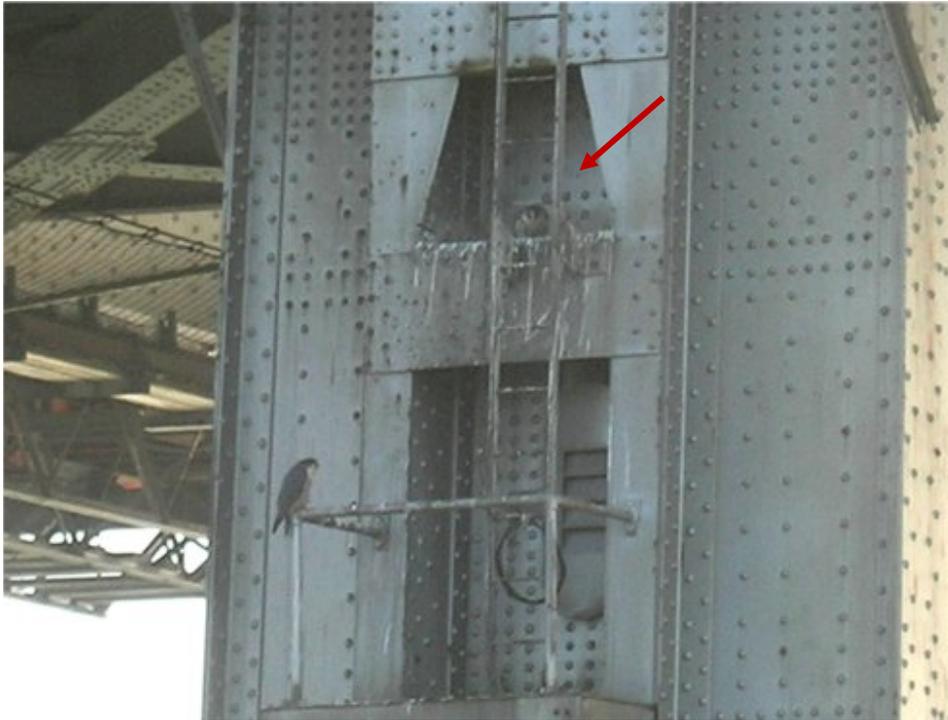
Figure 3.1. Peregrine falcon pair at 2009-2013 nest site, located in a trapezoidal alcove on the north side of Pier E2.

During monitoring conducted for the SFOBB Project from 2003 to 2013, the nest site for this territory has been in multiple locations on the Cantilever portion of the original east span, below the lower deck of the bridge (Table 3.2). From 2009 to 2013, the nest site was located in a trapezoid-shaped alcove below the lower deck, on the north side of Pier E2 (Figure 3.1). In response to deterrence measures installed during dismantling of the Cantilever section of the original east span, the SFOBB peregrines initiated nesting in 2014 at a new unknown location beneath the lower deck, between Piers E5 and E6. This initial nesting attempt failed. The pair then re-nested in a west-facing alcove at the base of Pier E8 (Figure 3.2).

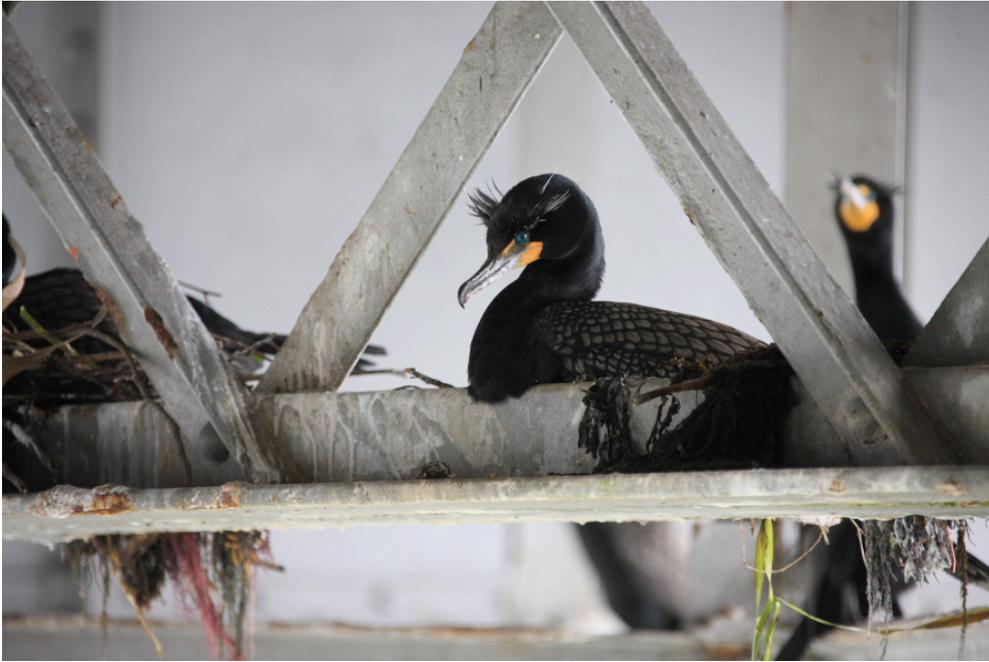
Figure 3.6. Double-crested cormorant nests on the steel crossbeams under the original SFOBB east span.

Double-crested cormorants were first documented nesting on the original SFOBB east span in the early 1980s. This species nests colonially on the steel crossbeams below the lower deck (Figures 3.6, 3.7). The colony occupies an area that varies laterally each year, expanding and contracting around the colony's core between Piers E7 and E10. In the past decade, the number of nests has fluctuated from a high of 814 in 2007 to a low of 83 in 2009 (Table 3.3). Nest count data from 2003 to 2014 shows that the SFOBB colony can extend from Pier E3 to Pier E18 of the original east span.

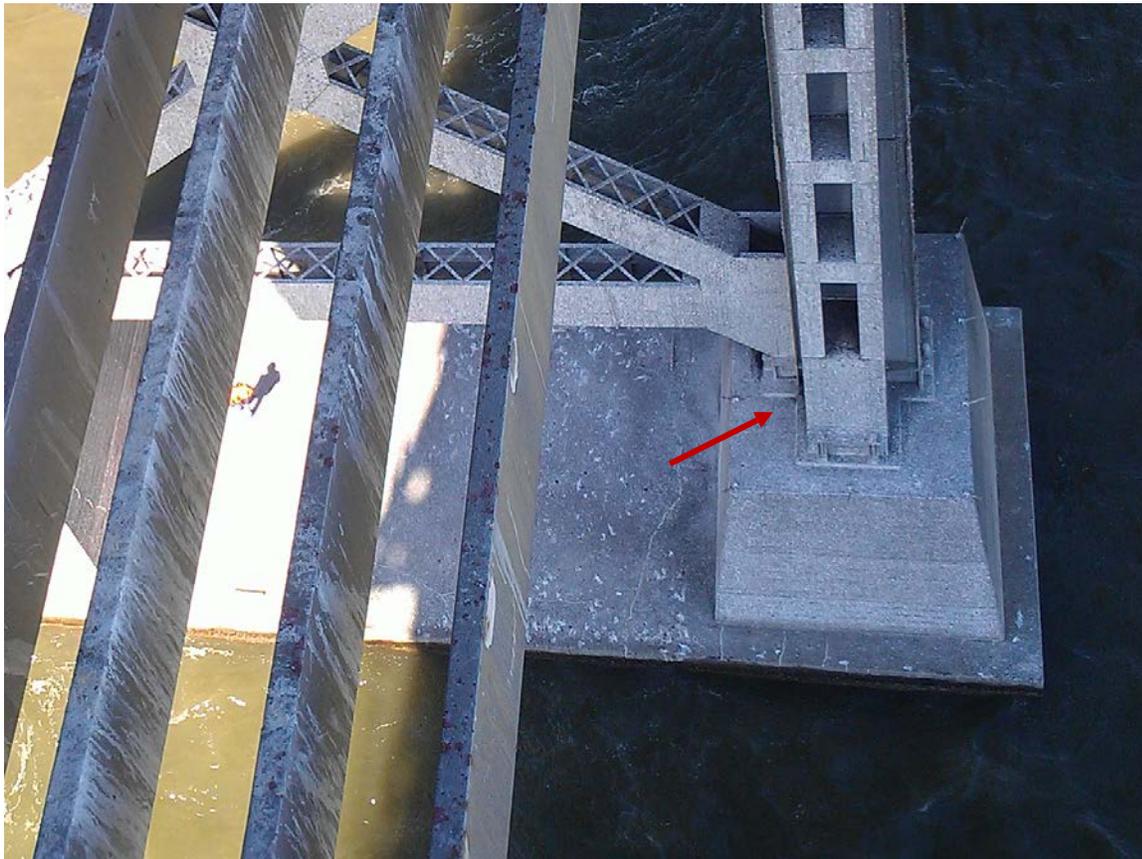
Figure 3.8. Western gull 2014 nest location at the base of the Pier E8 south tower leg.

Western gulls are present within the 504/288 contract area year-round. Individuals may be extremely persistent in their attempts to nest on the bridge. In some cases eggs may be laid without the presence of any nest or nesting material. Nests are constructed on ledges or other flat surfaces including the marine foundations (Figure 3.8), on pilings, tower legs, and other locations where they are protected from terrestrial predators. Western gulls have been observed nesting throughout the 504/288 bridge structure, on falsework structures, on footings of the new east span, and at the base of the T1 foundation (Figure 3.9). Occasional pairings between western gull and glaucous-winged gull (*Larus glaucescens*) have also been observed within the 504/288 contract area. For management purposes, these species are treated equally. No other gull species has been documented nesting or is likely to nest within the 504/288 contract area.

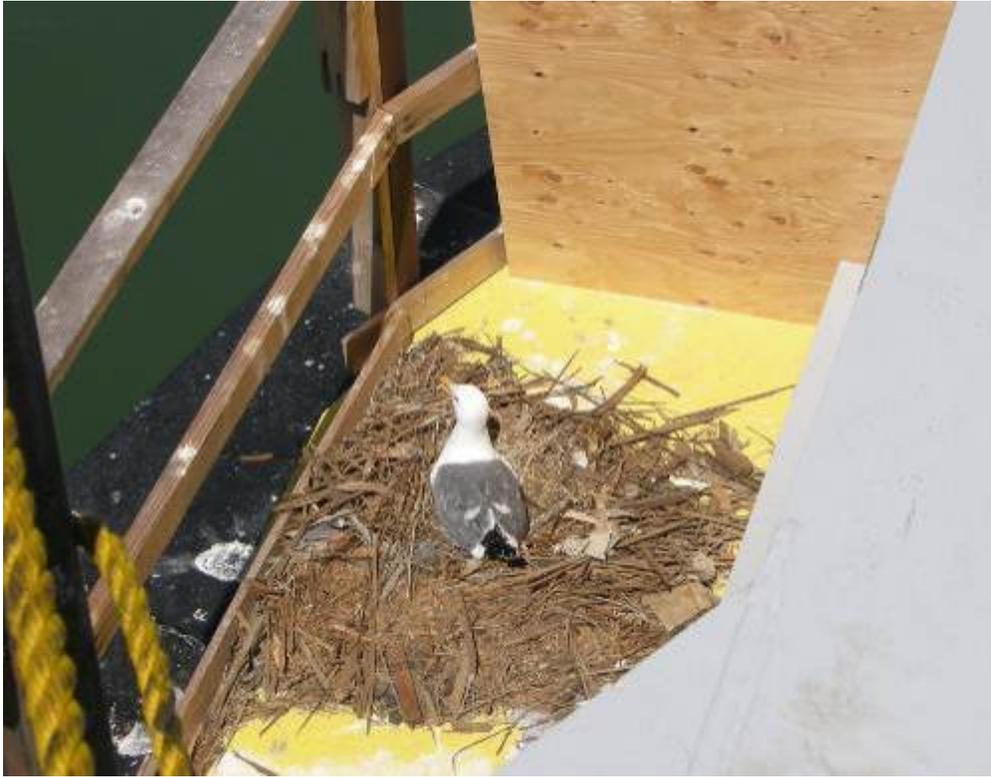
Figure 3.9. Western gull nest on the T1 foundation, within active construction area.

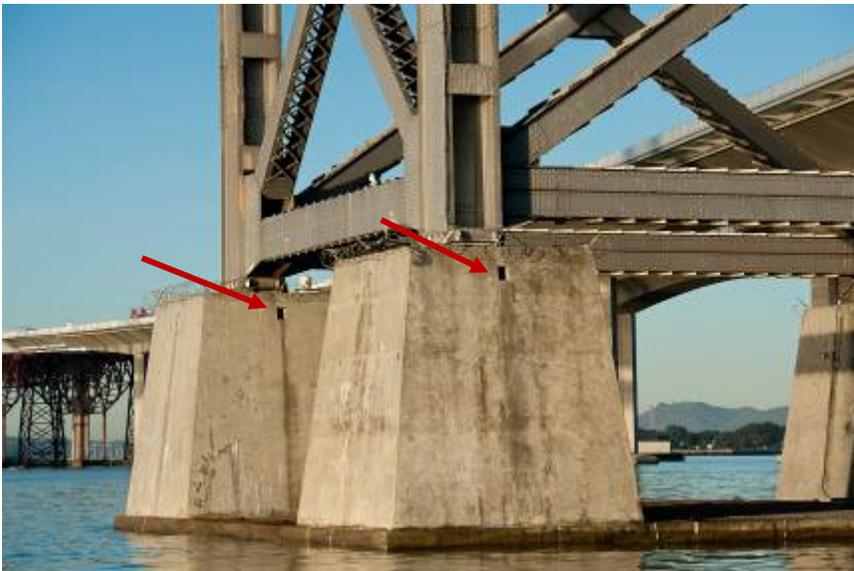
Figure 3.11. Pigeon guillemot nest locations in weep holes at base of Pier E9.

Since 2010 pigeon guillemots have been observed during the nesting season and entering weep holes in the concrete pedestals at Piers E9, and E20 to E22 (Figure 3.11). This increase in nesting season observations, and observations of pigeon guillemots entering weep holes with fish in their bill, indicate that nesting numbers may be increasing within the 504/288 contract area.

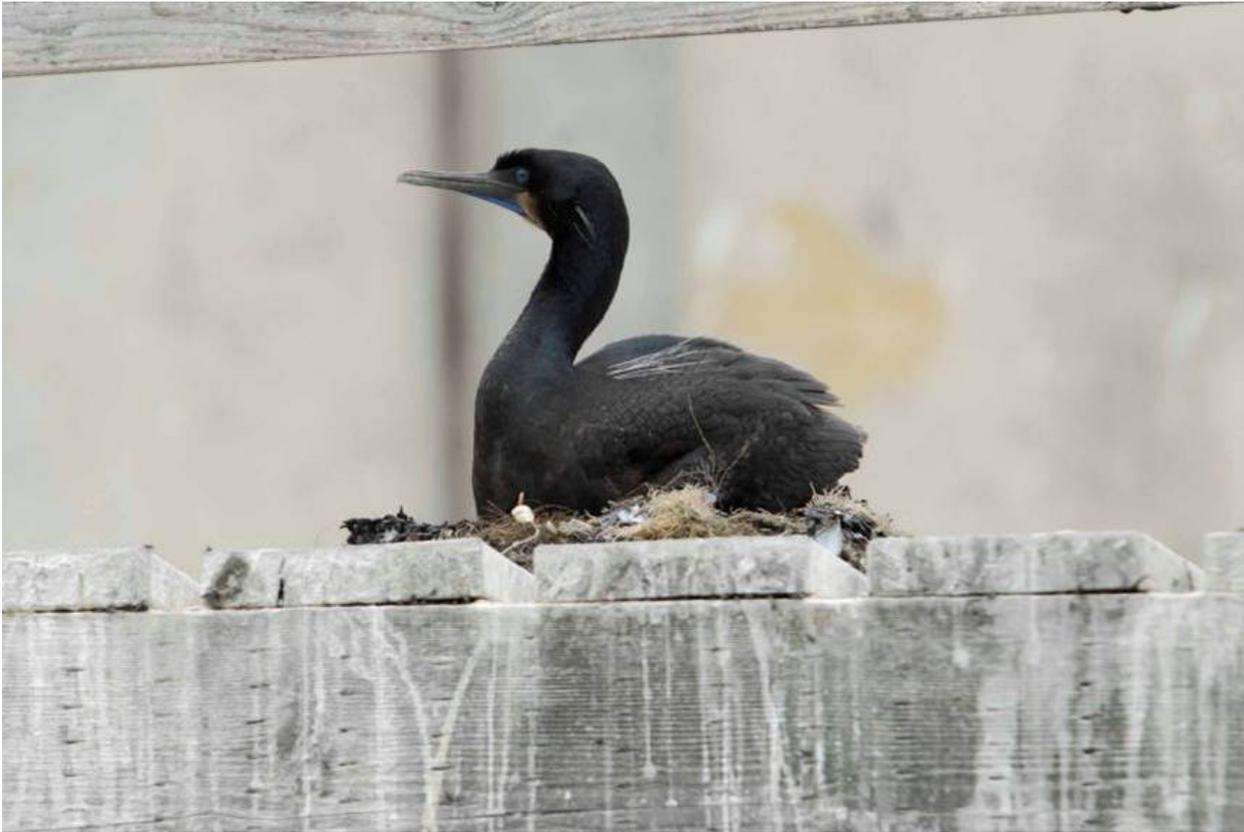
Figure 3.14. Brandt's cormorant nest adjacent to cable crossing structure, south of the SFOBB original east span.

Brandt's cormorants are regularly observed in the 504/288 contract area, but nesting has not been documented on the original east span. A single Brandt's cormorant nest was observed on the cable-crossing structure directly south of the original east span in 2011 (E. Lichtwardt, pers. comm. 2011) (Figure 3.14). Two nests have been observed on the west side of YBI and there is a significant and increasing breeding colony on Alcatraz Island (San Francisco Field Ornithologists 2003). Nests may also occur within the double-crested cormorant colony between Piers E3 and E16. The nesting season is from March through August. Nests are constructed from grass, seaweed, and driftwood, and may take between two and ten days to complete. Clutch size averages between one and four eggs. Eggs hatch in 28 to 32 days. Fledging date is variable (33 to 42 days) and dependent on food availability. Fledging may also be gradual, with the young initially left alone by adults, then later forming "crèches" (groups of young birds) within the nesting area. Like the double-crested cormorant, Brandt's cormorant also nests colonially and is sensitive to human presence within the colony (Wallace and Wallace 1998).

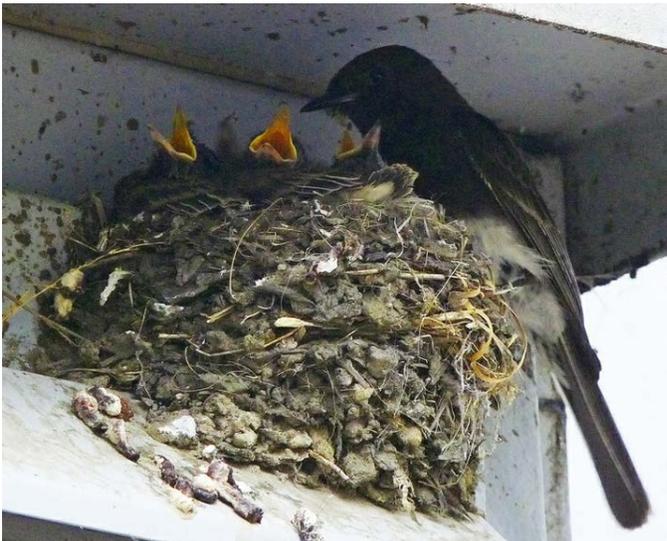
Figure 5.3. Black phoebe nest.

Paint ball guns were used successfully to remove cliff swallow nest starts on the Antioch Bridge during seismic retrofitting (A. Arakozie, pers. comm. 2011). They could be equally effective for species such as black phoebe, which can nest on vertical surfaces that are difficult to access (Figure 5.3). Clear training paint balls would be used. These paint balls are composed of biodegradable colorless gelatin liquids and shells made of vegetable oil that is designed to dissolve in water. Paint balls can knock down targets up to 30 meters (100 feet) distant, although they are likely to be more effective at closer range. Paint ball guns would be particularly effective for use when a nest start is encountered that is difficult to remove using other means. Paint balls containing vegetable oil may also be effective in preventing nesting in certain locations by leaving an oil-residue on the substrate, thereby reducing the adherence nesting materials. The use of a paint ball gun, both over land and over water, will require approval by the RWQCB and a Storm Water Pollution Prevention Plan (SWPPP) amendment may be required.

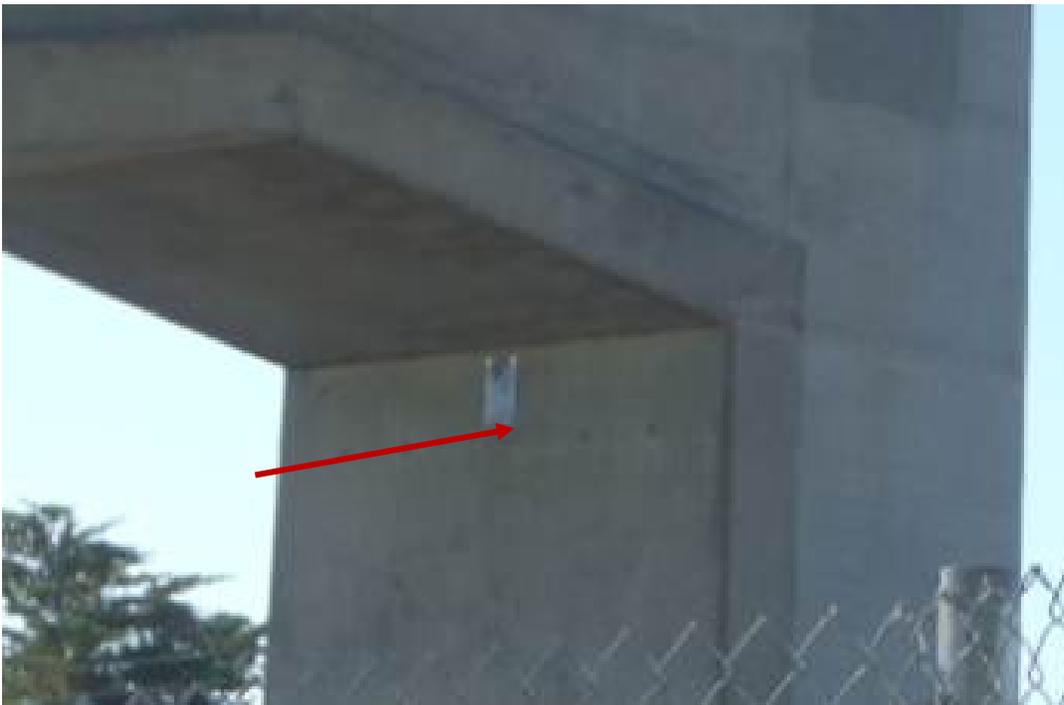
Figure 5.4. Blocked weep hole in concrete footing for the seismic retrofit of the Antioch Bridge.

There will be other structures on the piers that provide suitable nesting habitat for birds. Weep holes and other cavities could be blocked by screens (Figure 5.4), if it can be determined they are not being actively used by nesting birds through the use of a fiber-optic camera or careful observation. Unless cavities are known to be unoccupied, one-way doors should be installed to block the entrances; these doors allow birds to exit but not re-enter the cavity. One-way doors are not to be installed if there is an occupied nest within the cavity. Filling or blocking of potential nest cavities may be accomplished from a hydraulic lift (for lower holes or crevices), snooper truck, or by rappelling to the pertinent locations on the bridge.

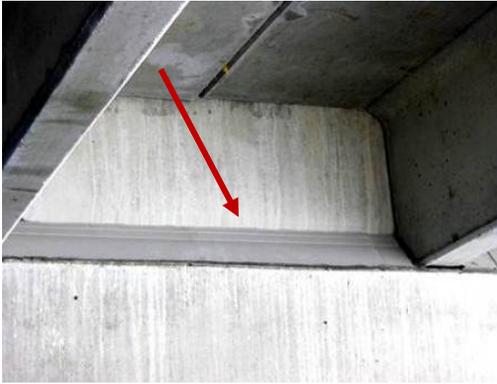
Figure 5.6. A slope panel installed on a concrete ledge under a bridge.

Slope panels made of various materials (polycarbonate polymers (i.e., Lexan), PVC plastic, or clear acrylic surfaced slope panels (Figure 5.5) are to be used to exclude birds (Figure 5.6). These panels create a slippery and/or angled surface to which small to medium-sized birds cannot attach nest material. Panels may be attached to either vertical or horizontal surfaces. Large slope panels constructed of plywood or equivalent material may be fabricated on-site to block large bird access to large platform areas, such as the base of marine foundation pedestals. The panels are typically fastened to concrete using a power-actuated tool. They also may be attached to steel beams with outdoor polyurethane adhesives (BirdBGone 2011).

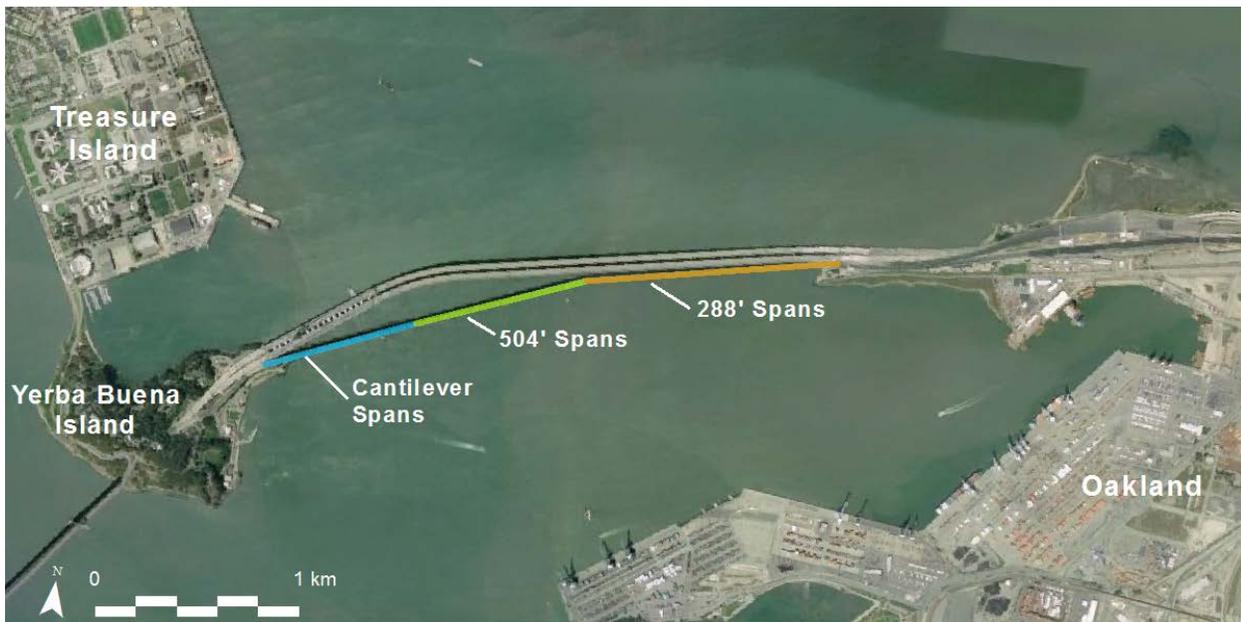
Figure 6.1. The original east span of the San Francisco-Oakland Bay Bridge, including spans to be removed under the 504/288 contract.

The SFOBB original east span is composed of three main sections (Figure 6.1): the Cantilever spans (Piers E1-E4), the 504-foot spans (Piers E4-E9), and the 288-foot spans (Piers E9-E23). The 504-foot segment of the bridge is comprised of five 154-meter (504-foot) long steel truss spans (Figure 6.1). The vertical clearance beneath the 504-foot spans (504's) is approximately 50 meters (165 feet) above the mean high water level. The 288-foot segment is comprised of fourteen 88-meter (288 feet) long steel truss spans (Figure 6.2). The vertical clearance beneath the 288-foot spans (288's) decreases as the structure extends towards the Oakland shoreline. The superstructure of both segments includes the trusses, road deck and steel and/or concrete support towers.

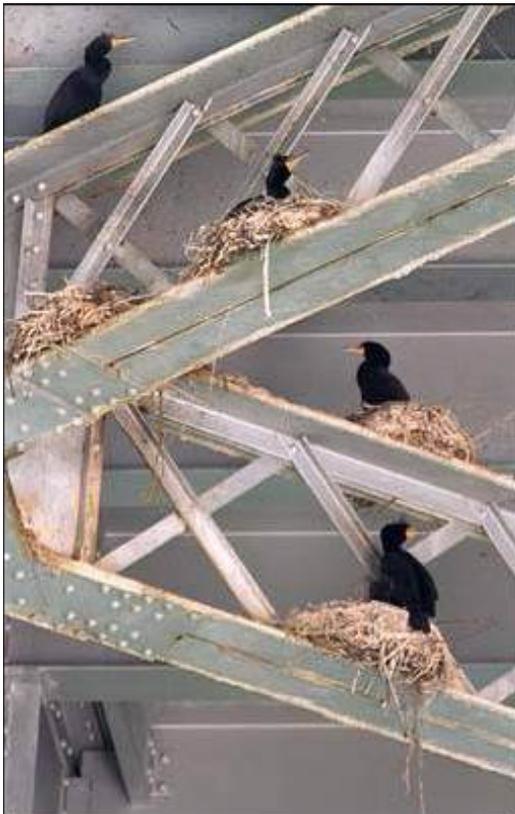
Figure 6.9. Typical double-crested cormorant nests on diagonal bracing below the lower deck of the SFOBB original east span.

The core of the SFOBB double-crested cormorant nesting colony is located on crossbeams below the lower deck of the original bridge, between Piers E7 and E10 (Figures 6.8- 6.11). Nest count data from 2003 to 2014 shows that the SFOBB colony can extend from Pier E3 to Pier E18 of the original east span (Table 3.3). The colony has the highest number of nests in the vicinity of Pier E9, which is at the junction of the 504-foot and the 288-foot segments. SFOBB dismantling work will ultimately displace this colony. As dismantling work progresses eastward, double-crested cormorants may establish new nesting areas east of Pier E18. Falsework construction and trestle installation may also impact breeding cormorants. Whether double-crested cormorants will attempt to nest on temporary supports is unknown, but could reasonably be expected to occur when the species is excluded from the historic colony by suspended decking that will be installed to deter nesting within areas to be dismantled during the breeding season.

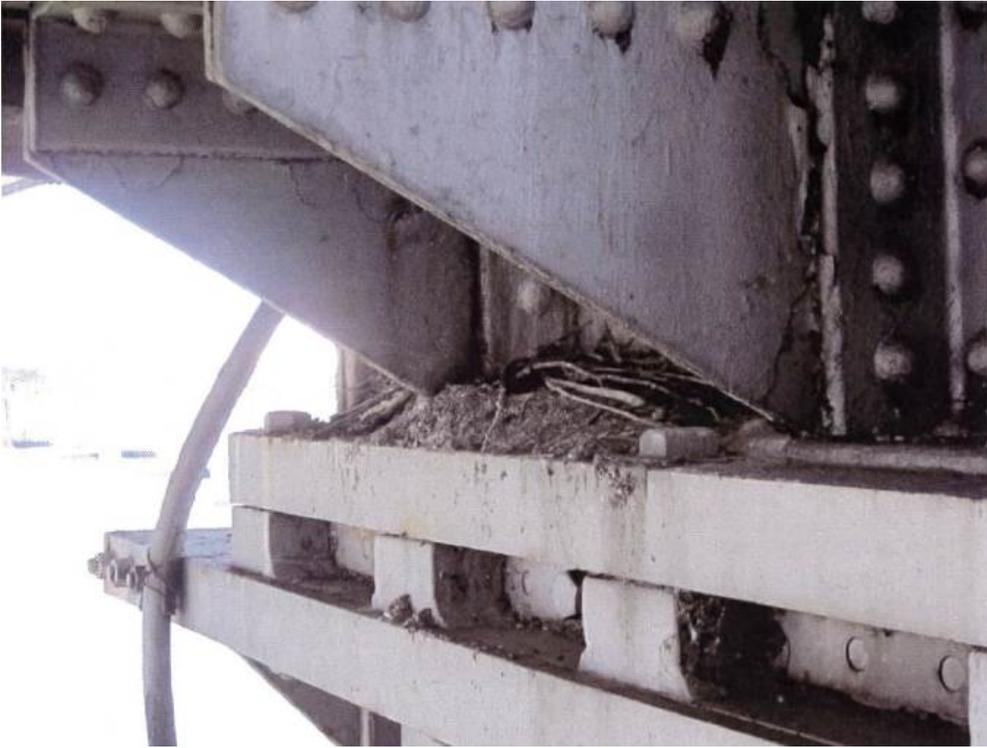
Figure 6.10. Double-crested cormorant nest on a protected ledge at the top of Pier E9 support tower.

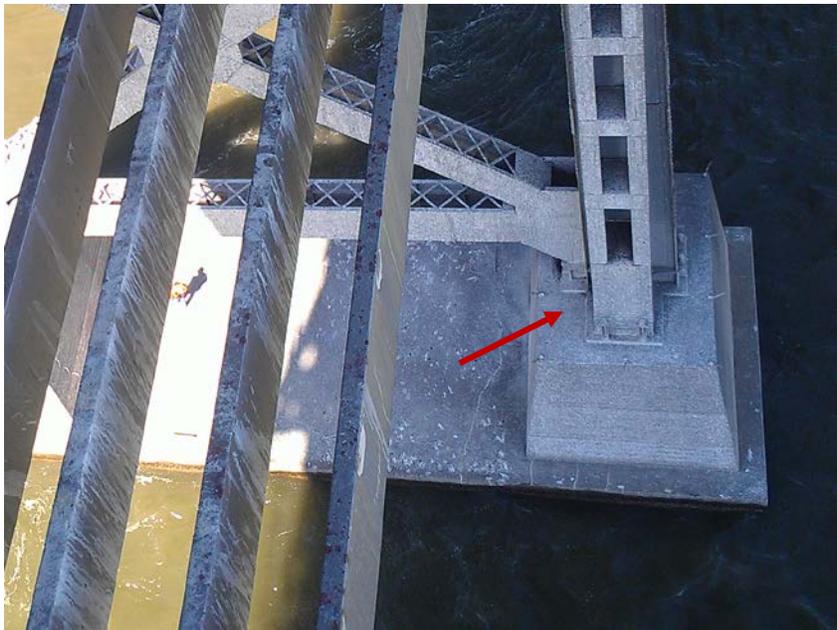
Figure 6.13. Western gull 2014 nest location at the base of the Pier E8 south tower leg.

Western gulls nest throughout the steel superstructure of the 504/288 work area and on the associated marine foundations (Figure 6.12). Western gull nests have also been observed on the tops of marine piles, temporary bridge support structures, and recesses on buildings on land. Nesting density within the 504/288 contract area has historically remained low, with one to two nesting pair per bridge pier. Nests tend to occur at locations where one or more 90-degree angle in the bridge structure provides a protected horizontal surface on which to build. Typical historic nest locations include, but are not limited to: the base of marine foundation concrete pedestals, recesses at the base of support towers, alcoves within support towers, horizontal surfaces at the top of support towers, access platforms, and protected alcoves with horizontal surfaces within truss joints (Figures 6.13-6.18).

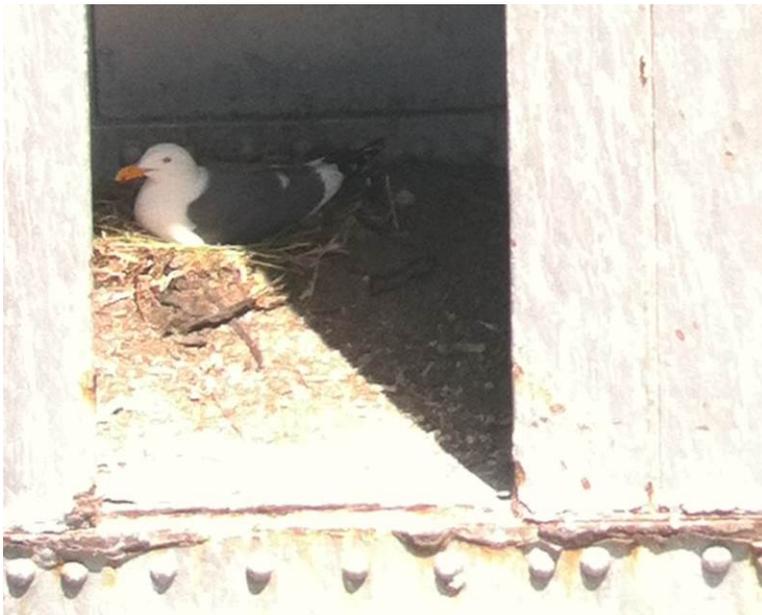
Figure 6.15. Adult western gull in incubation posture on 2014 nest in west-facing alcove at base of south leg of Pier E7 support tower.

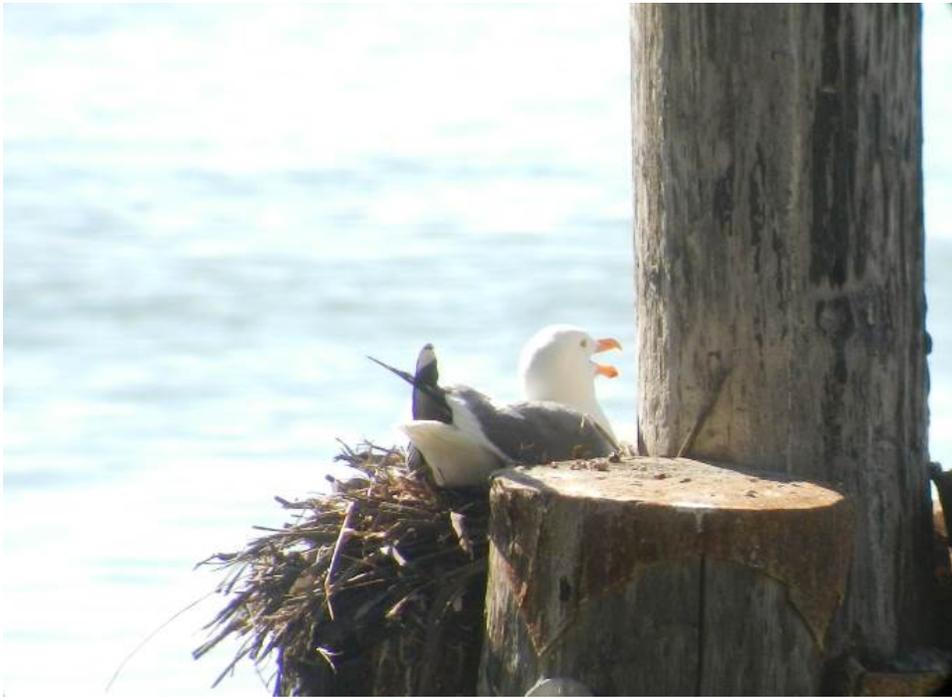
Figure 6.16. Adult western gull in incubation posture on 2013 nest on top of wooden pile, west of Pier E2.

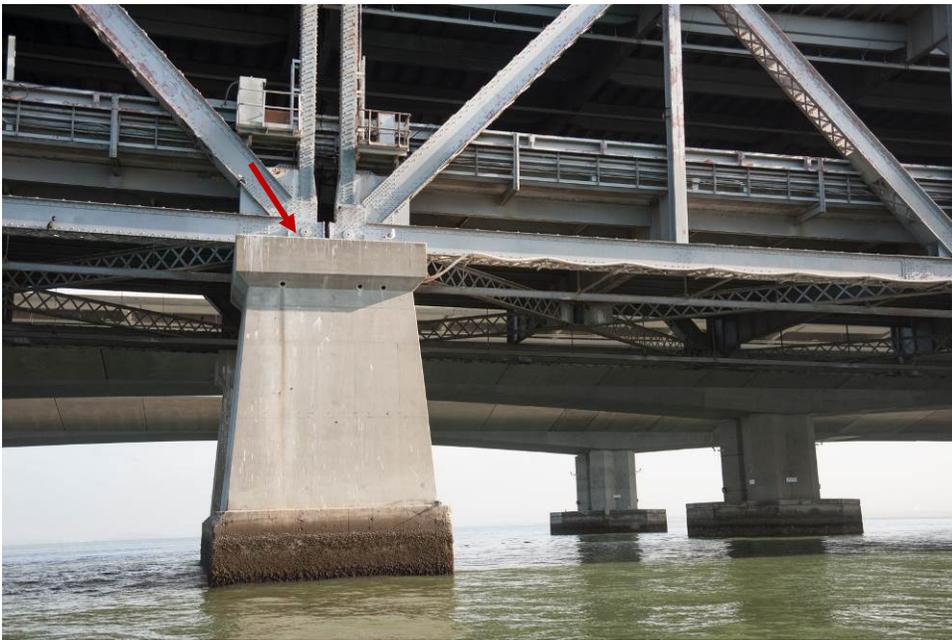
Figure 6.17. Typical western gull nest location, at top of concrete pedestal (note attending adult).

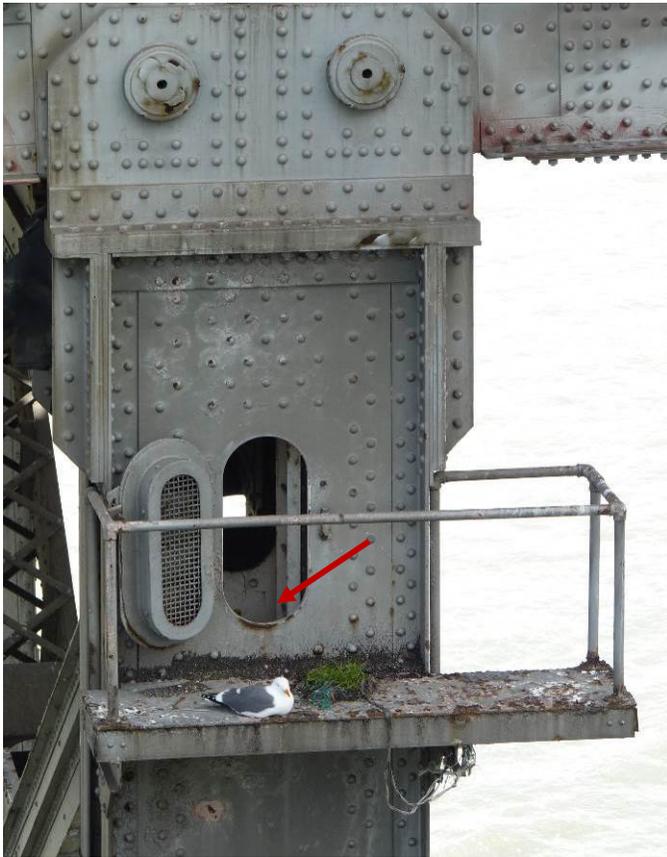
Figure 6.18. Adult western gull roosting on access platform adjacent to a historic nest site within the open porthole on north side of the Pier E16 support tower.

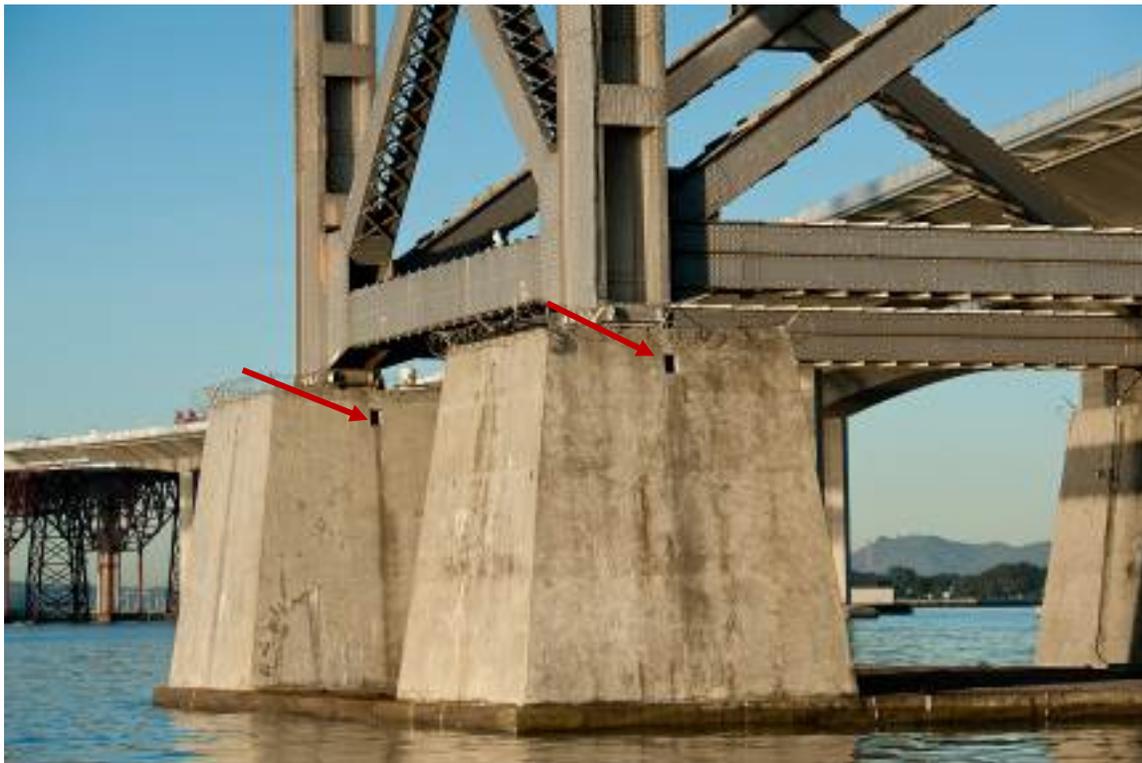
Figure 6.21. Pigeon guillemot nest locations in weep holes in concrete pedestals at the base of Pier E9.

Small numbers of pigeon guillemots have been observed nesting within marine foundation weep holes at Piers E9 and E20. This species may also utilize weep holes in additional marine foundations at Piers 17 through 22 (Figure 6.20). Since 2011, flocks of up to 12 individuals have been observed flying and swimming in the vicinity of Piers E9 and E20 through 22 (Figure 6.21-6.22).

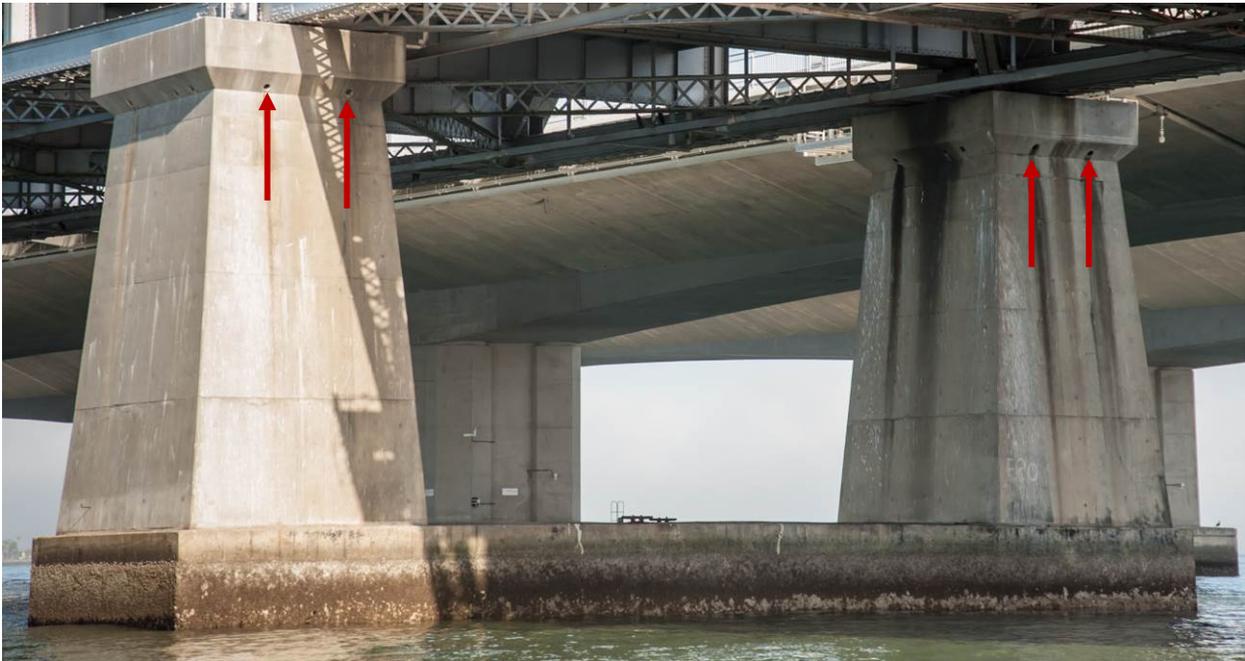
Figure 6.22. Pigeon guillemot nesting habitat occurs in weep holes in the concrete pedestals at Pier E20.
