INFORMATION HANDOUT

NESTING BIRD DETERRENCE MEASURES: MATERIALS AND APPLICATIONS

EA 04-013521

**Supplement to the 2003 Final (Revised) Bird Monitoring and
Management Plan**

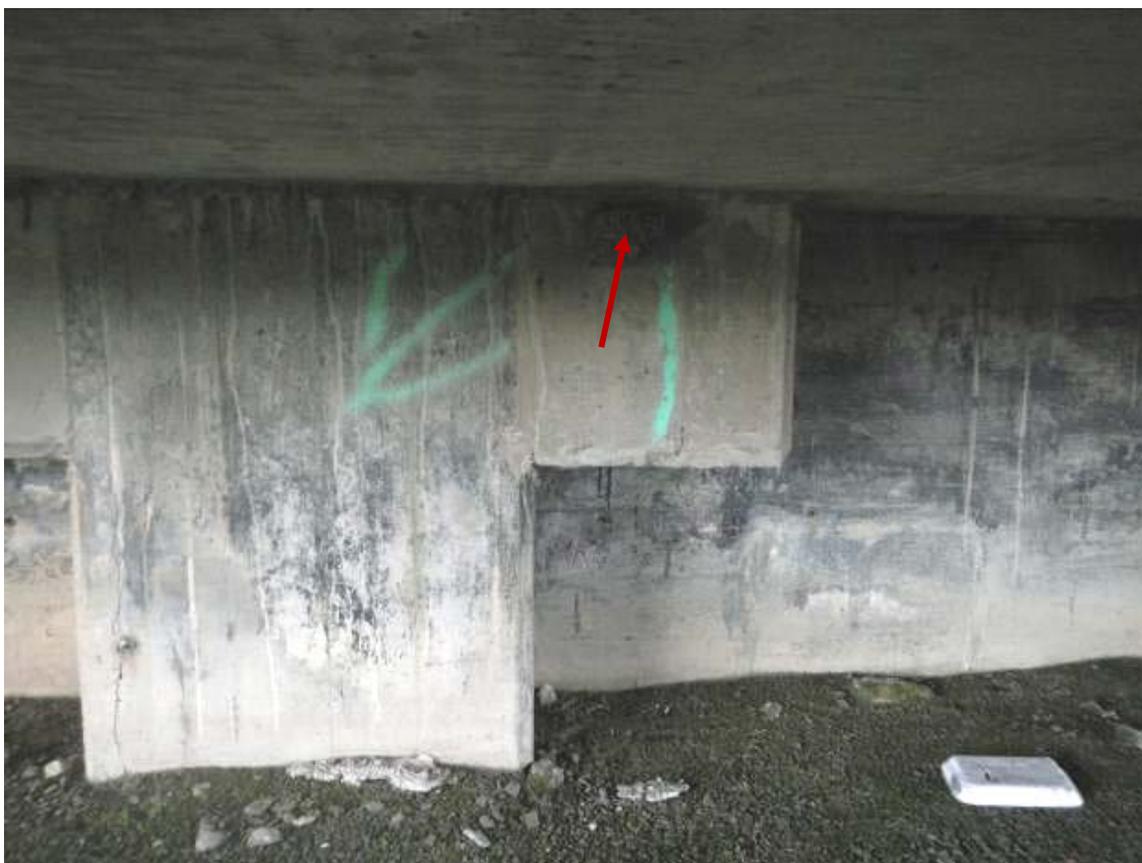
Figure 6.24. Black phoebe nest under a protected overhang on the southeast side of Bent E27.

There are a few past observations of black phoebes nesting in the 504/288 contract area. From 2012 through 2014 black phoebes have been observed nesting or attempting to nest under the protected concrete overhangs east of Pier E23 (Figure 6.23). At these locations, the black phoebe has built its nest against the 90-degree angle formed by the concrete pier and the roadway (Figure 6.24). Black phoebes may also nest under overhangs on various permanent and temporary structures adjacent to and within the OTD.

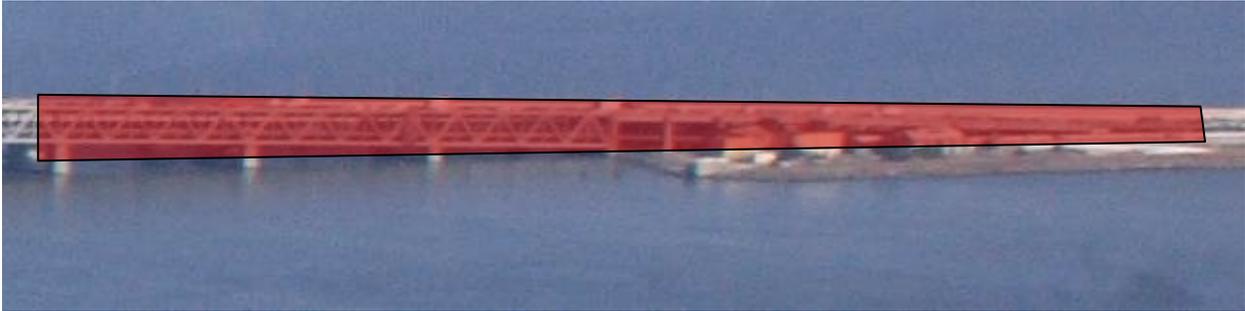
Figure 6.25. House finch nesting habitat in the eastern portion of the 504/288 contract area, east of Pier E20 and at the OTD.

House finches have nested on the bridge structures near the OTD within the 504/288 contract area. In 2014 house finch nests were observed in the vicinity of Bent E24, on crossbeams below the temporary bicycle path and at Bent E24, on pipes below the lower deck. Small flocks of house finches have also been observed flying from perch to perch along the bridge structure as far west as Pier E20. Nesting habitat for house finches occurs on the myriad protected ledges within the bridge structure (Figure 6.25). House finches may also nest within construction equipment and temporary structures within the 504/288 contract area (Figure 6.26).
