INFORMATION HANDOUT

For Contract No. 04-4A5104

At 04-SF-280-R5.2/R6.0

ASBESTOS AND LEAD-CONTAINING PAINT SURVEY REPORT

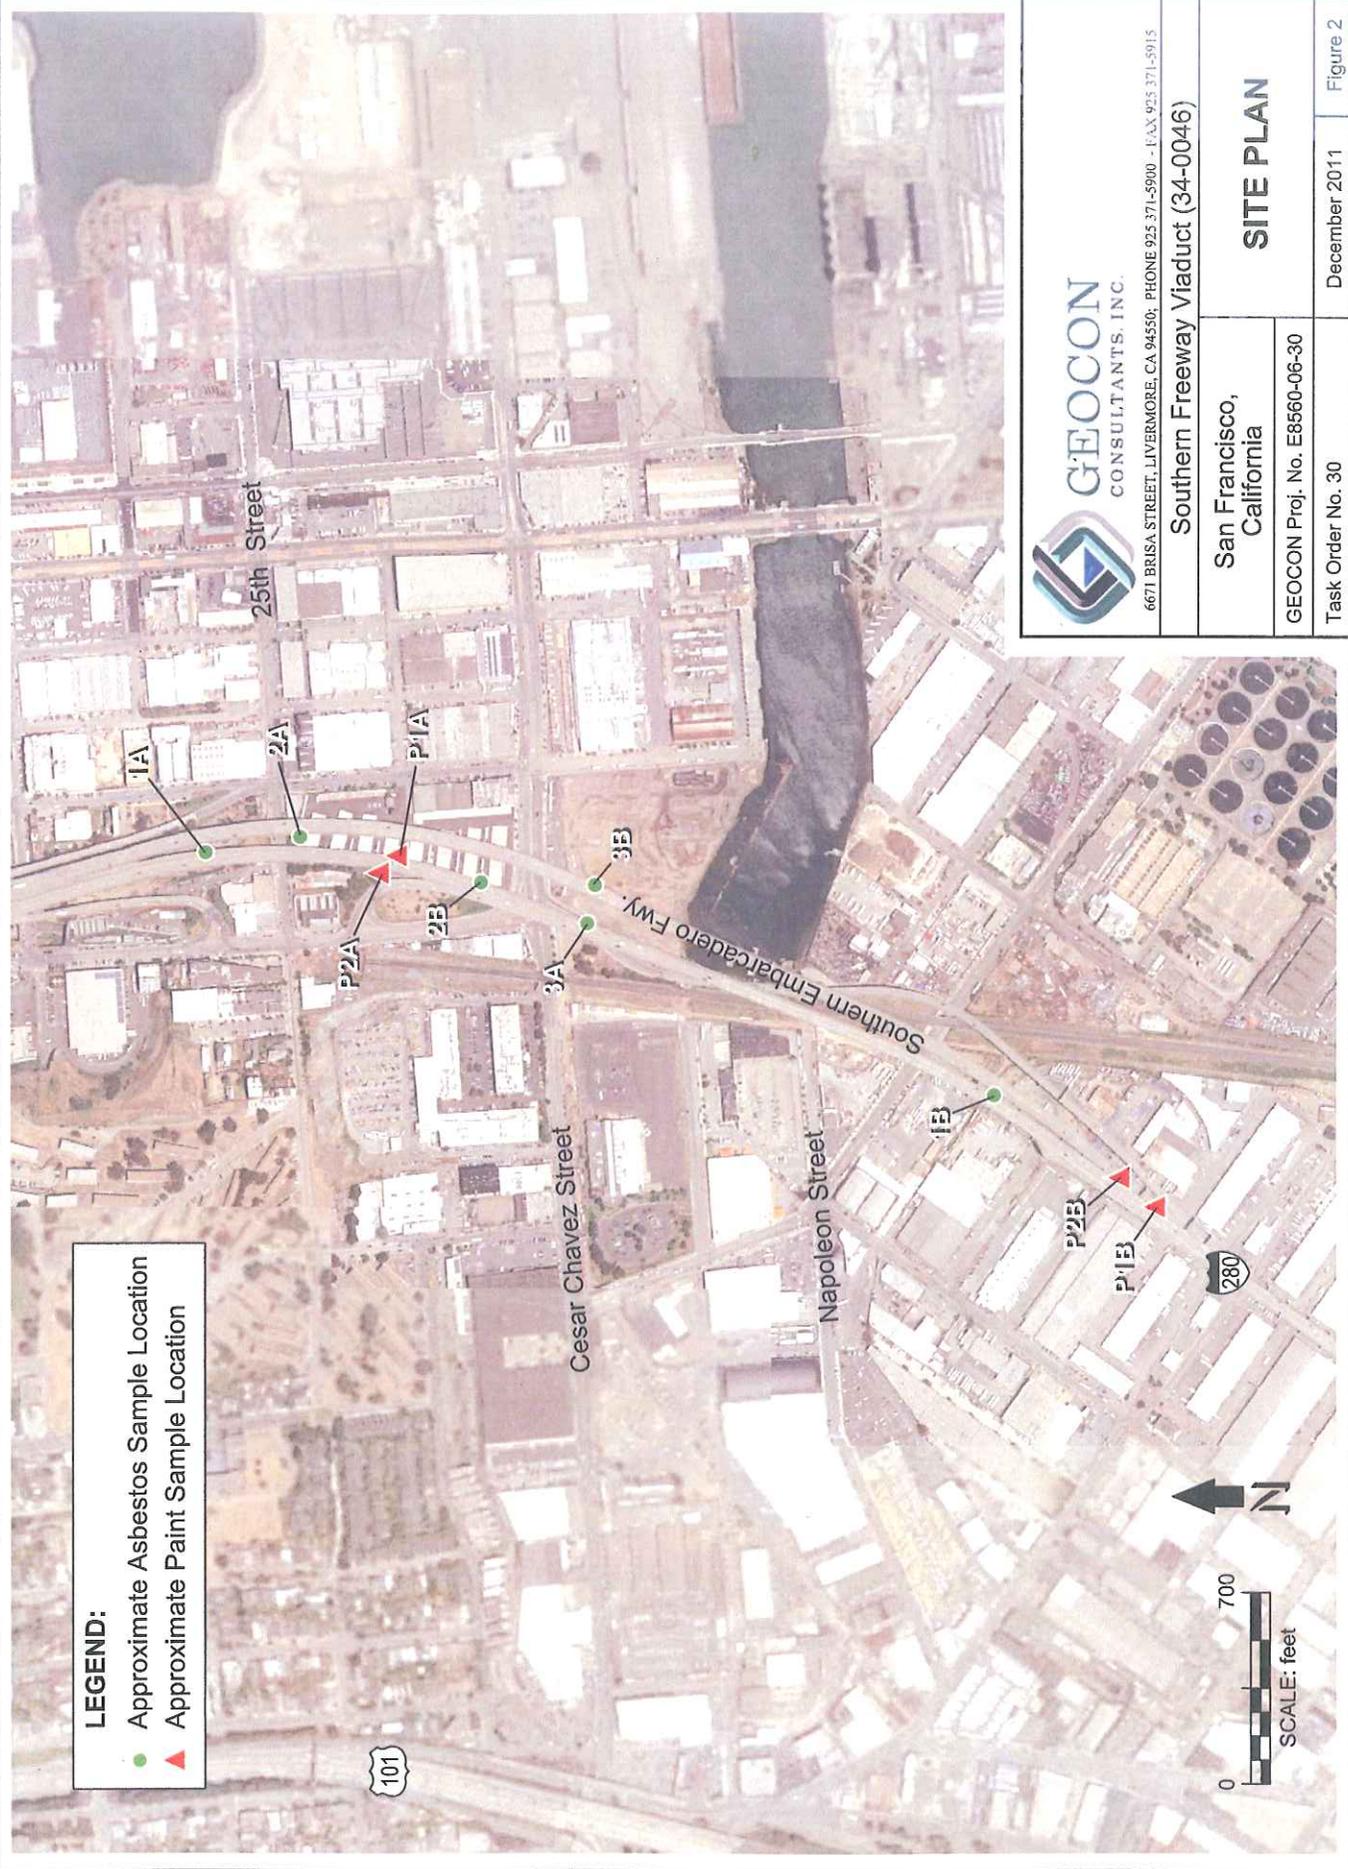
SITE PLAN

Samples were collected from locations as shown in the Site Plan (Figure 2). Suspect asbestos and LCP sample identification numbers are presented in Tables 1 and 2, respectively. Materials represented by the samples collected are presented in the Site Photographs.

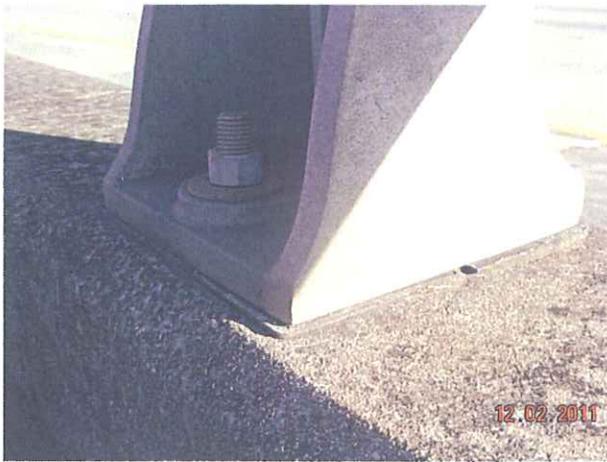
- Chrysotile asbestos at a concentration of 75% was detected in samples representing nonfriable sheet packing used as shims on the bridge barrier rail system. We were not able to quantify the shims due to safety concerns (i.e., traffic).
- No asbestos was detected in samples of the remaining suspect materials collected during our survey.

Photo 2 – Barrier rail system (shims are asbestos-containing)

NESHAP regulations do not require that asbestos-containing sheet piling (a Category 1 nonfriable/nonhazardous material) identified during our survey be removed prior to demolition or treated as hazardous waste. However, the disturbance of the material is still covered by the Cal/OSHA asbestos standard contained in Title 8, CCR Section 1529. We recommend that a licensed contractor registered with Cal/OSHA for asbestos-related work perform activities that would disturb the sheet piling. Contractors are responsible for informing landfills and recycling facilities of the contractor's intent to dispose of asbestos-containing waste. Some landfills and recycling facilities may require additional waste characterization. Contractors are responsible for segregating and characterizing waste streams prior to disposal.

We also recommend written notification to contractors that will be conducting related activities of the presence of asbestos (i.e., provide the contractor[s] with a copy of this report and a list of asbestos removed by a licensed contractor[s] during subsequent abatement activities). Contractors not trained for asbestos work should be instructed not to disturb asbestos.

In accordance with Bay Area Air Quality Management District (BAAQMD) Regulation 11, Rule 2, written notification is required ten working days prior to commencement of *any* demolition activity (whether asbestos is present or not). In accordance with Title 8, CCR 341.9, written notification to the nearest Cal/OSHA district office is required at least 24 hours prior to certain asbestos-related work.

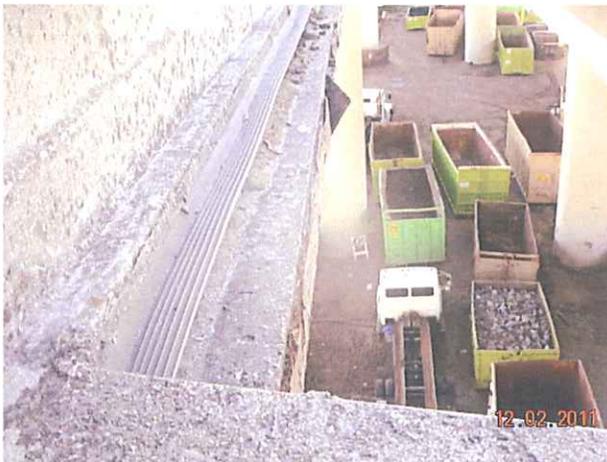
Photo 3 – Joint fill material on northbound span

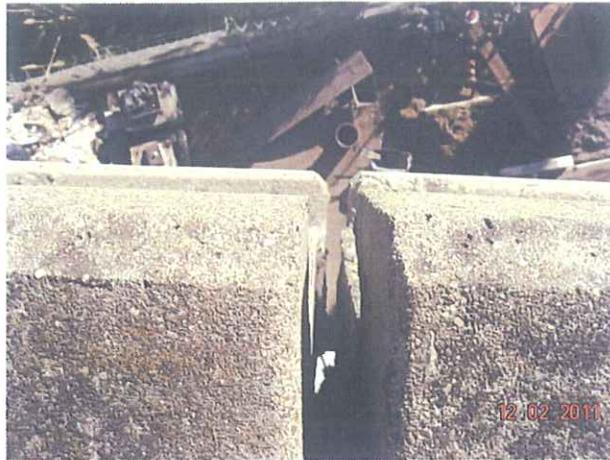
Photo 4 – Joint fill material on southbound span

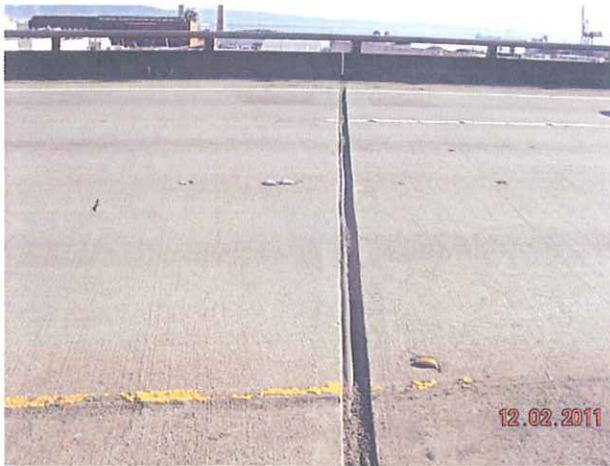
- Bulk samples representing intact yellow traffic striping exhibited total lead concentrations of 120 and 96 mg/kg and a composite WET lead concentration of 0.91mg/l.
- Bulk samples representing intact white traffic striping exhibited total lead concentrations of 6.8 and 2.9 mg/kg.

Photo 5 – Bridge deck

We recommend that all paints at the project location (graffiti, graffiti abatement, signage, etc.) be treated as lead-containing for purposes of determining the applicability of the Cal/OSHA lead standard during maintenance, renovation, and demolition activities. This recommendation is based on LCP sample results and the fact that lead was a common ingredient of paints manufactured before 1978 and is still an ingredient of some paints. In accordance with Title 8, CCR, Section 1532.1(p), written notification to the nearest Cal/OSHA district office is required at least 24 hours prior to certain lead-related work. Compliance and training requirements regarding construction activities where workers may be exposed to lead are presented in Title 8, CCR, Section 1532.1, subsections (e) and (l), respectively. Contractors are responsible for segregating and characterizing waste streams prior to disposal.

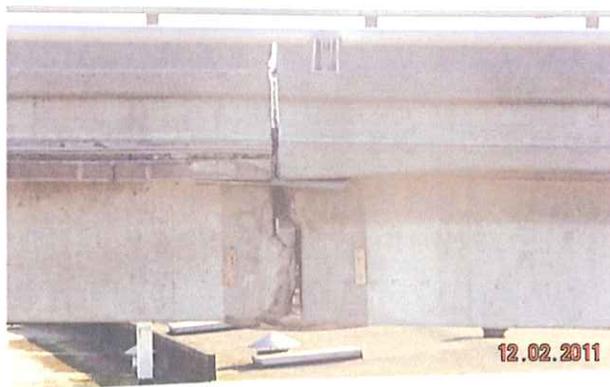
Photo 6 – Damaged hinge near 25th Street
