# **INFORMATION HANDOUT**

UPDATED GEOTECHNICAL REPORT Dated January 4, 2013

**File:** 06-Ker-178  
PM 13.8/15.8  
06-0N3801  
Major Damage Restoration

**Subject:** Updated Geotechnical Report

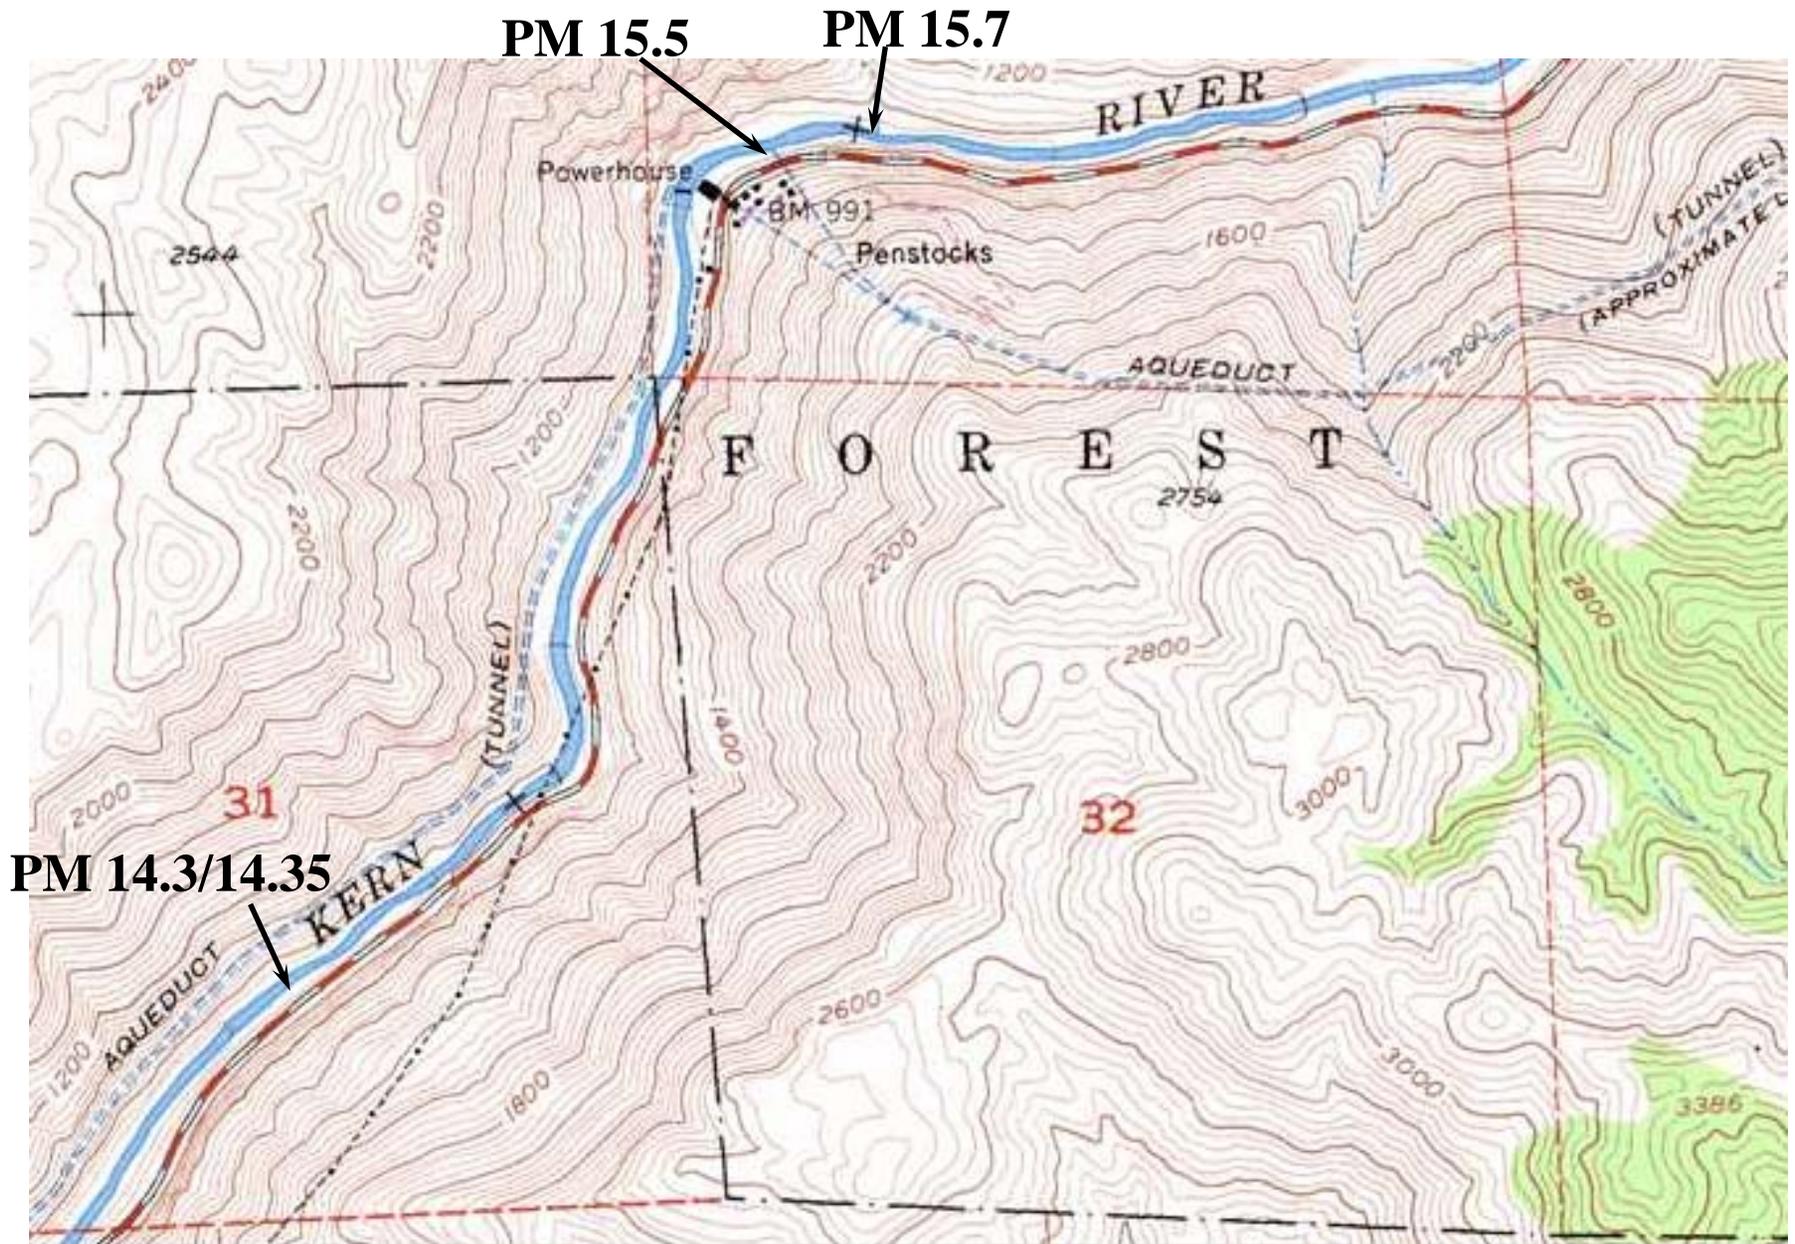
Figure 3

## Topographic Map

Based on the United States Geological Survey (USGS) topographic map of the Rio Bravo Ranch quadrangle (1968, Figure 3), the overall topography of the area ranges from about 950-feet at road level to over 3000-feet above mean sea level at the adjacent peaks. The map indicates the Kern River lies adjacent to the west side of the roadway. The map also indicated that aqueducts lie to the east and west of the Kern River tying into a powerhouse situated on the Kern River at about PM 15.4.

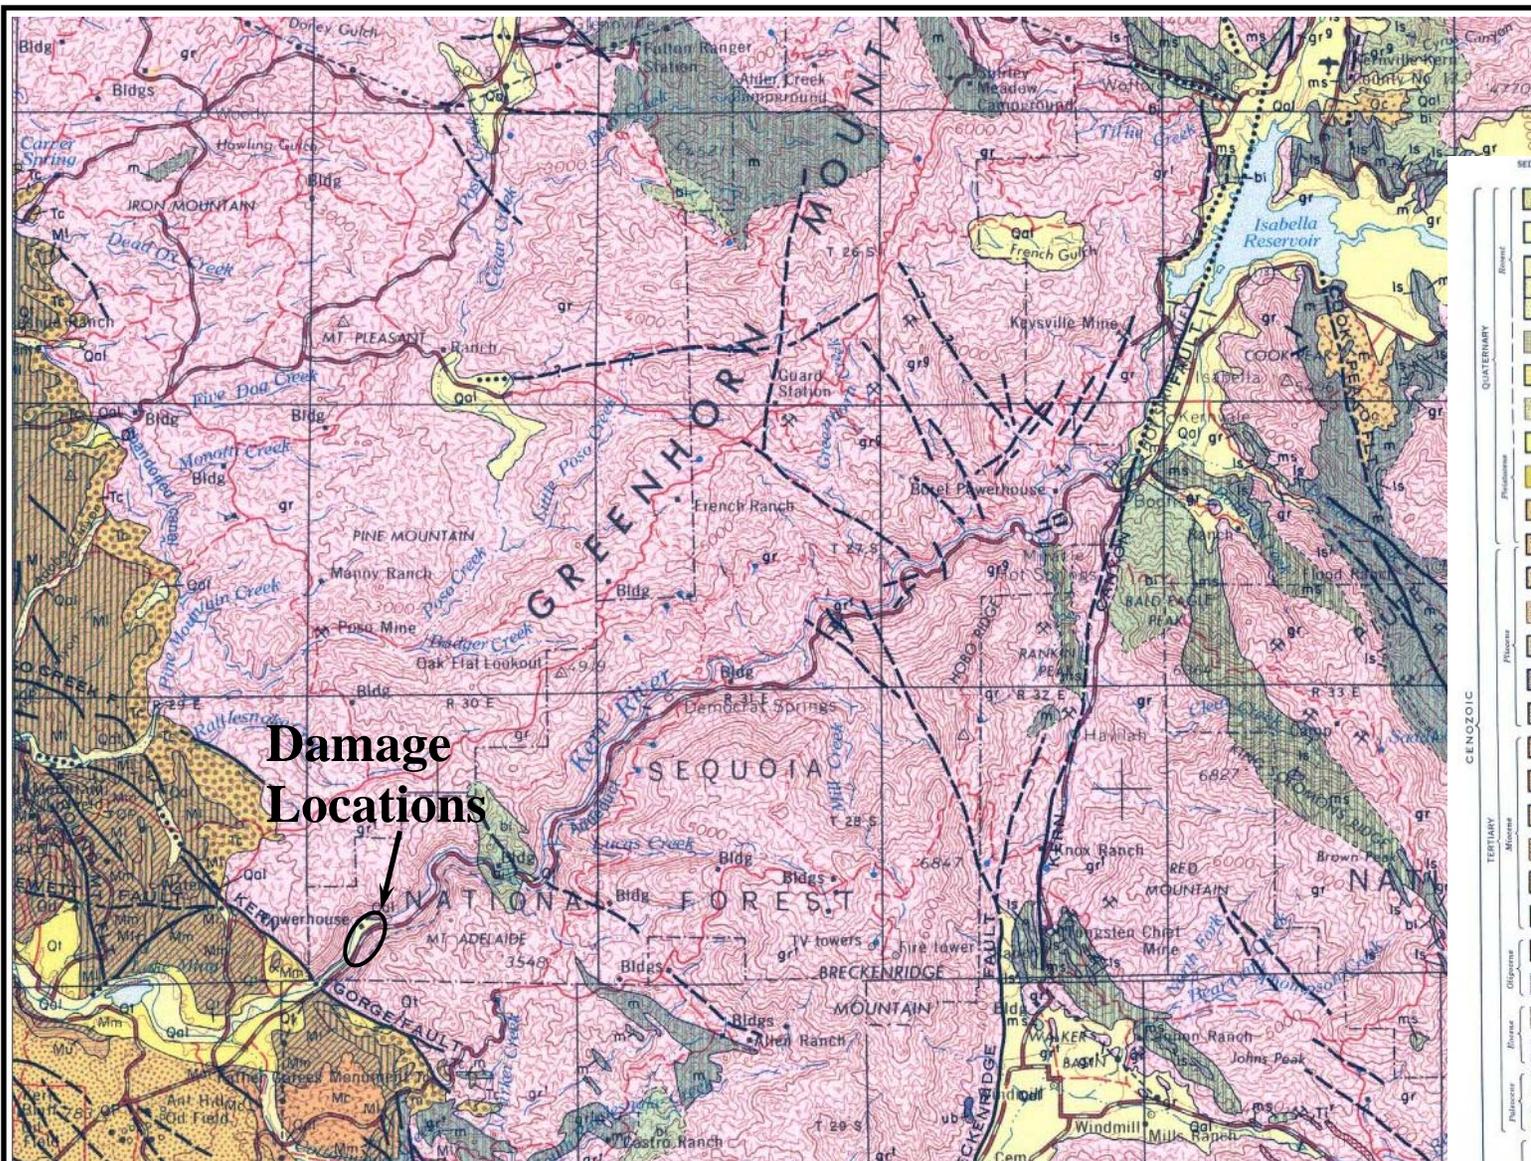
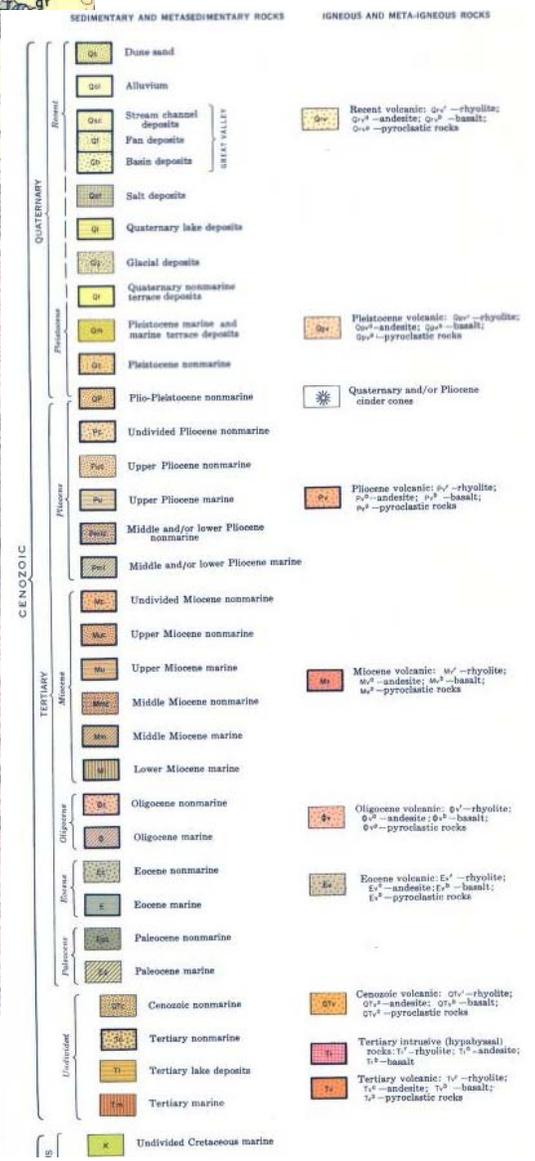
# Geologic Map

According to the Geologic Map of California: Bakersfield Sheet (CGS, 1964), the bedrock observed outcropping in the cutslope and in the Kern River consists of Pre-Cretaceous granitic rocks (gr). Figure 4 depicts the geology of the area.

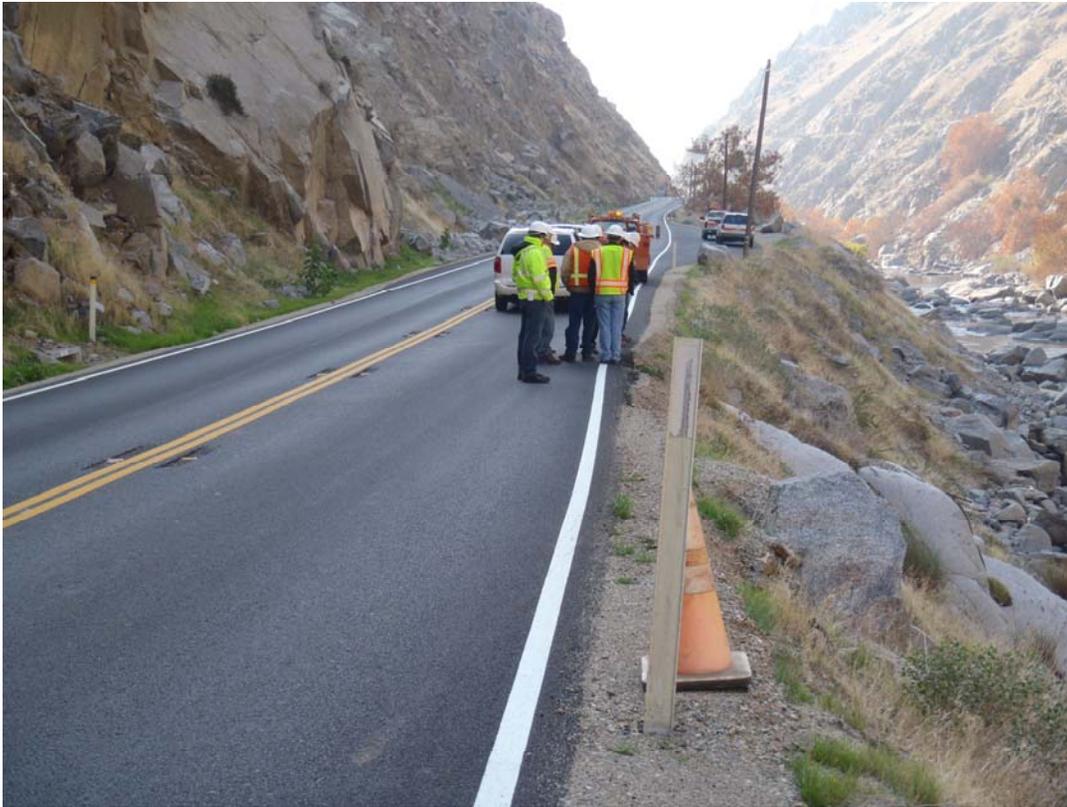
Figure 5

Photograph showing the roadway at PM 14.35. Note the granitic bedrock in the cutslope as well as embankment.

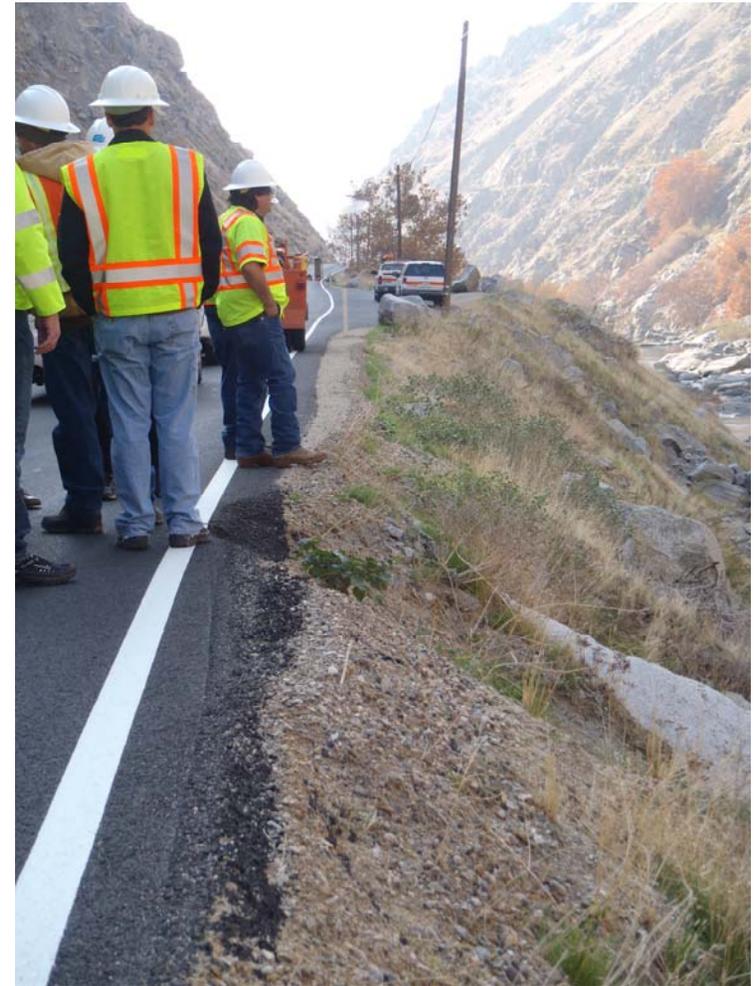
Photograph showing the major damage at PM 14.35. Note the outcrop of granitic bedrock ore extremely large boulder in the embankment fill.
