INFORMATION HANDOUT

For Contract No. 07-2W6604

At 07-LA-10-PM 26.8/30.8

Asbestos Containing Materials Survey Report

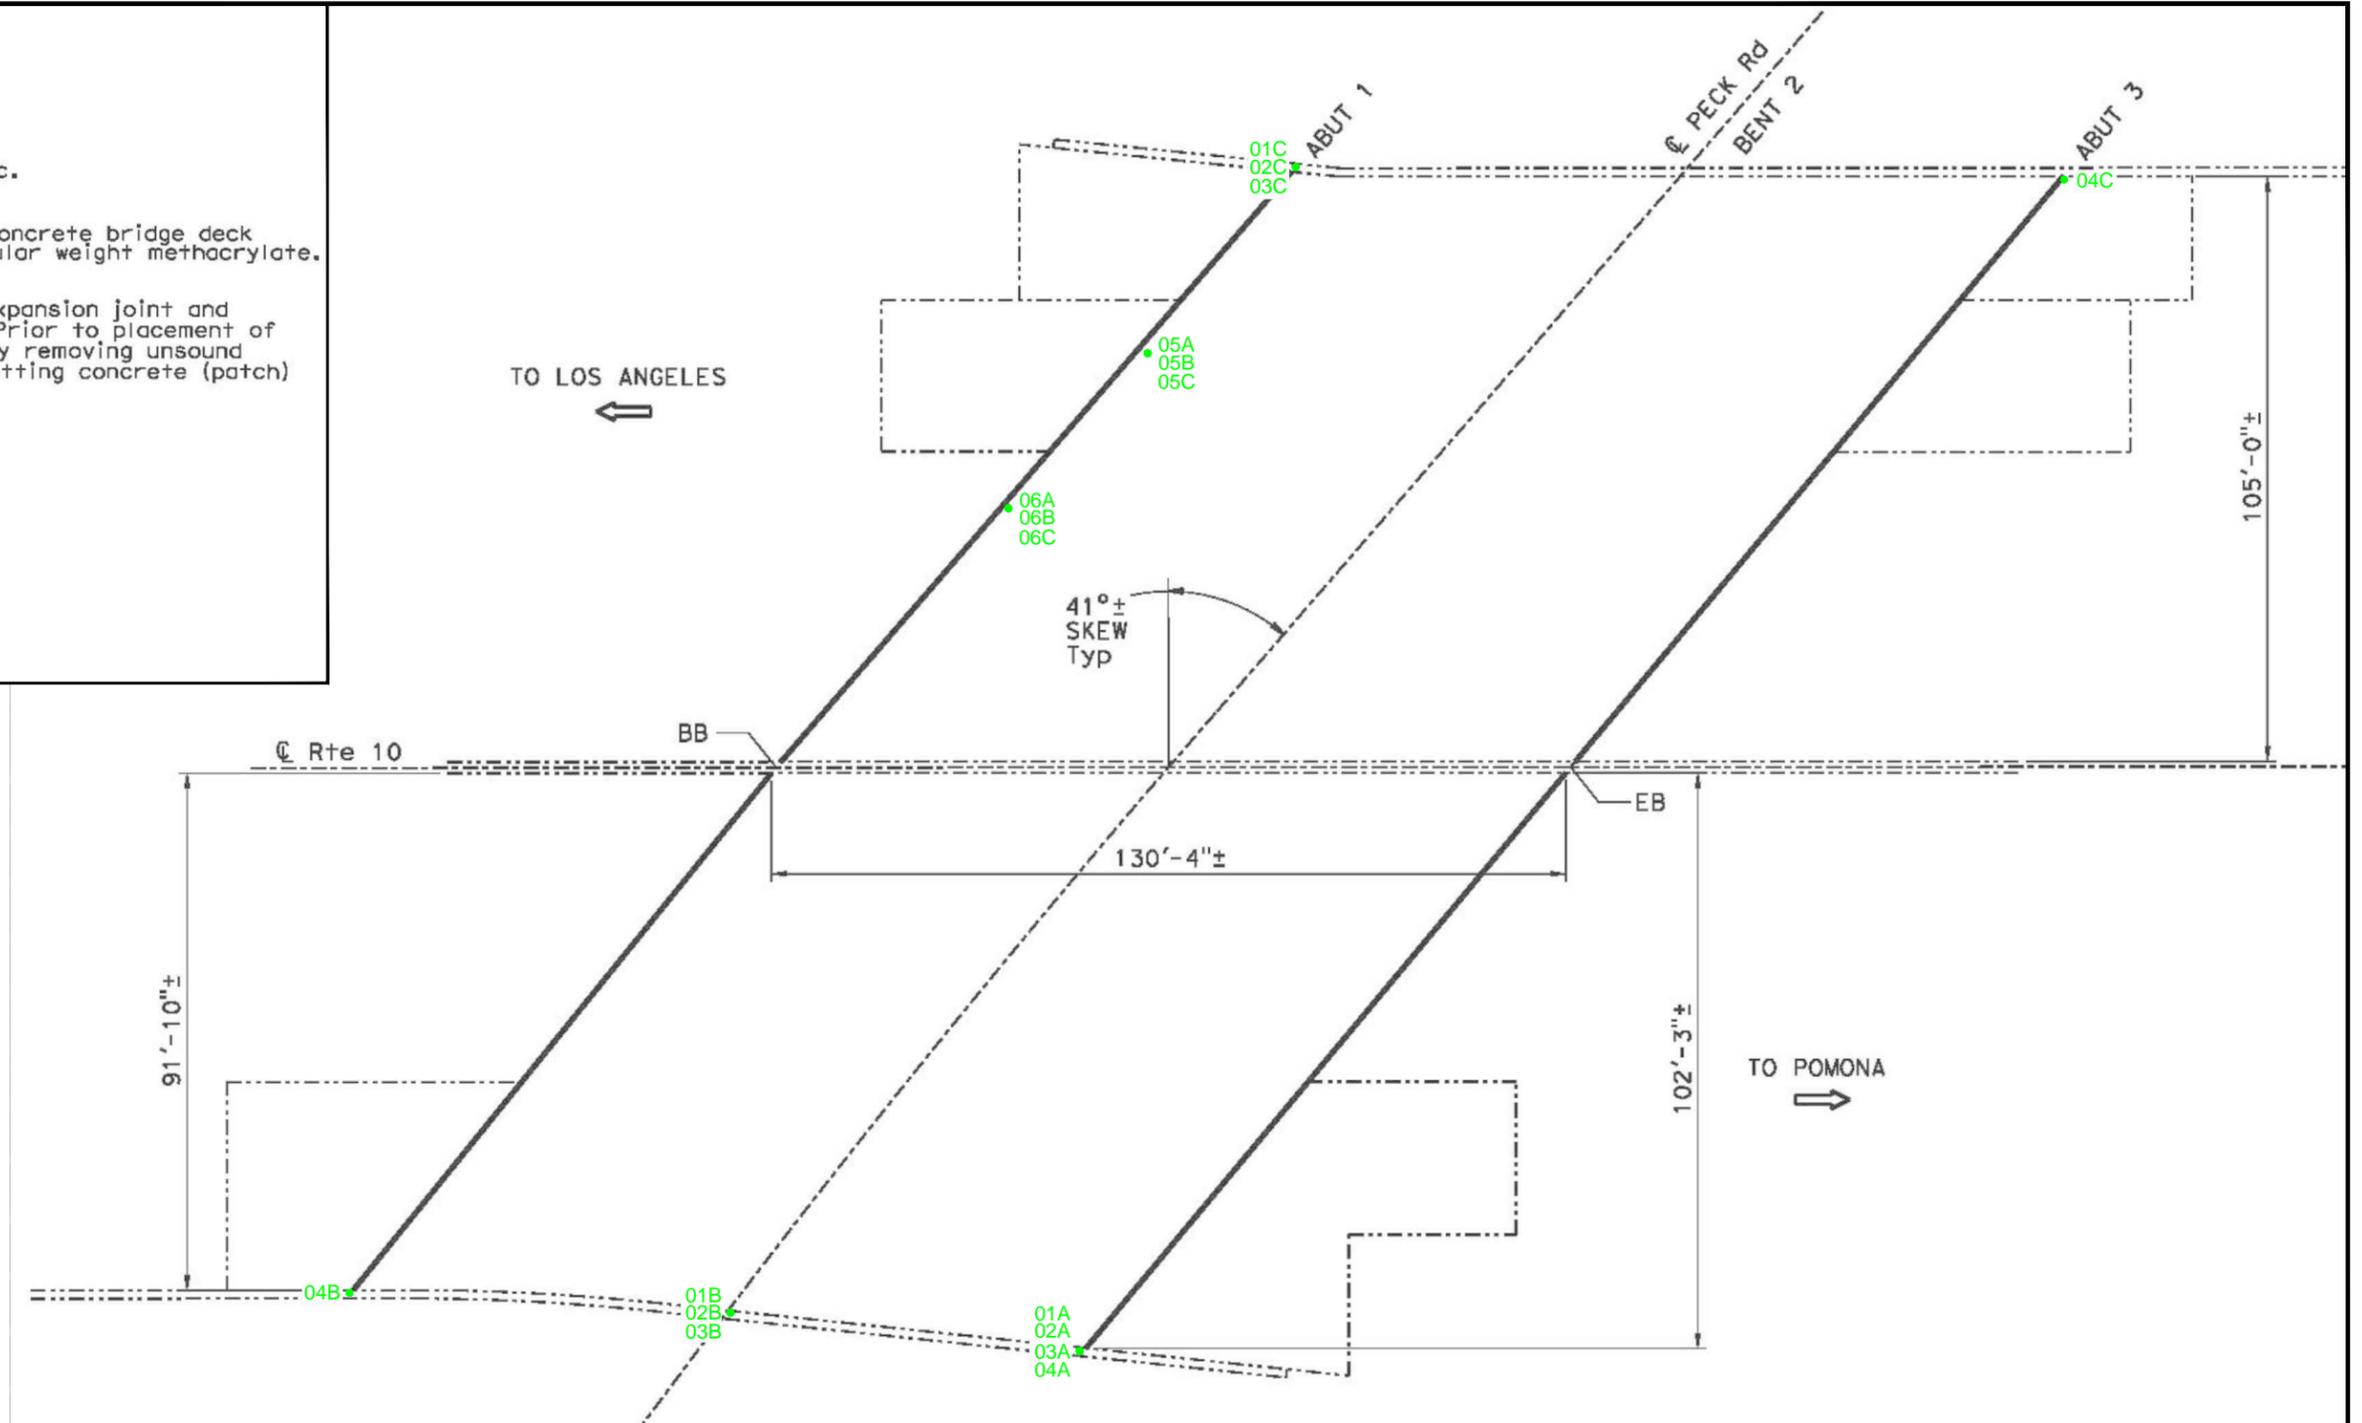
PECK ROAD UC
 Br No. 53-0661, Rte 10, PM 29.43
 NO SCALE

- SAMPLE LOCATION
- 01 GUARDRAIL
- 02 DECK
- 03 DECK SEALANT
- 04 FELT
- 05 PRESS BOARD (HINGE)
- 06 PRESS BOARD (VERTICAL-BENEATH)

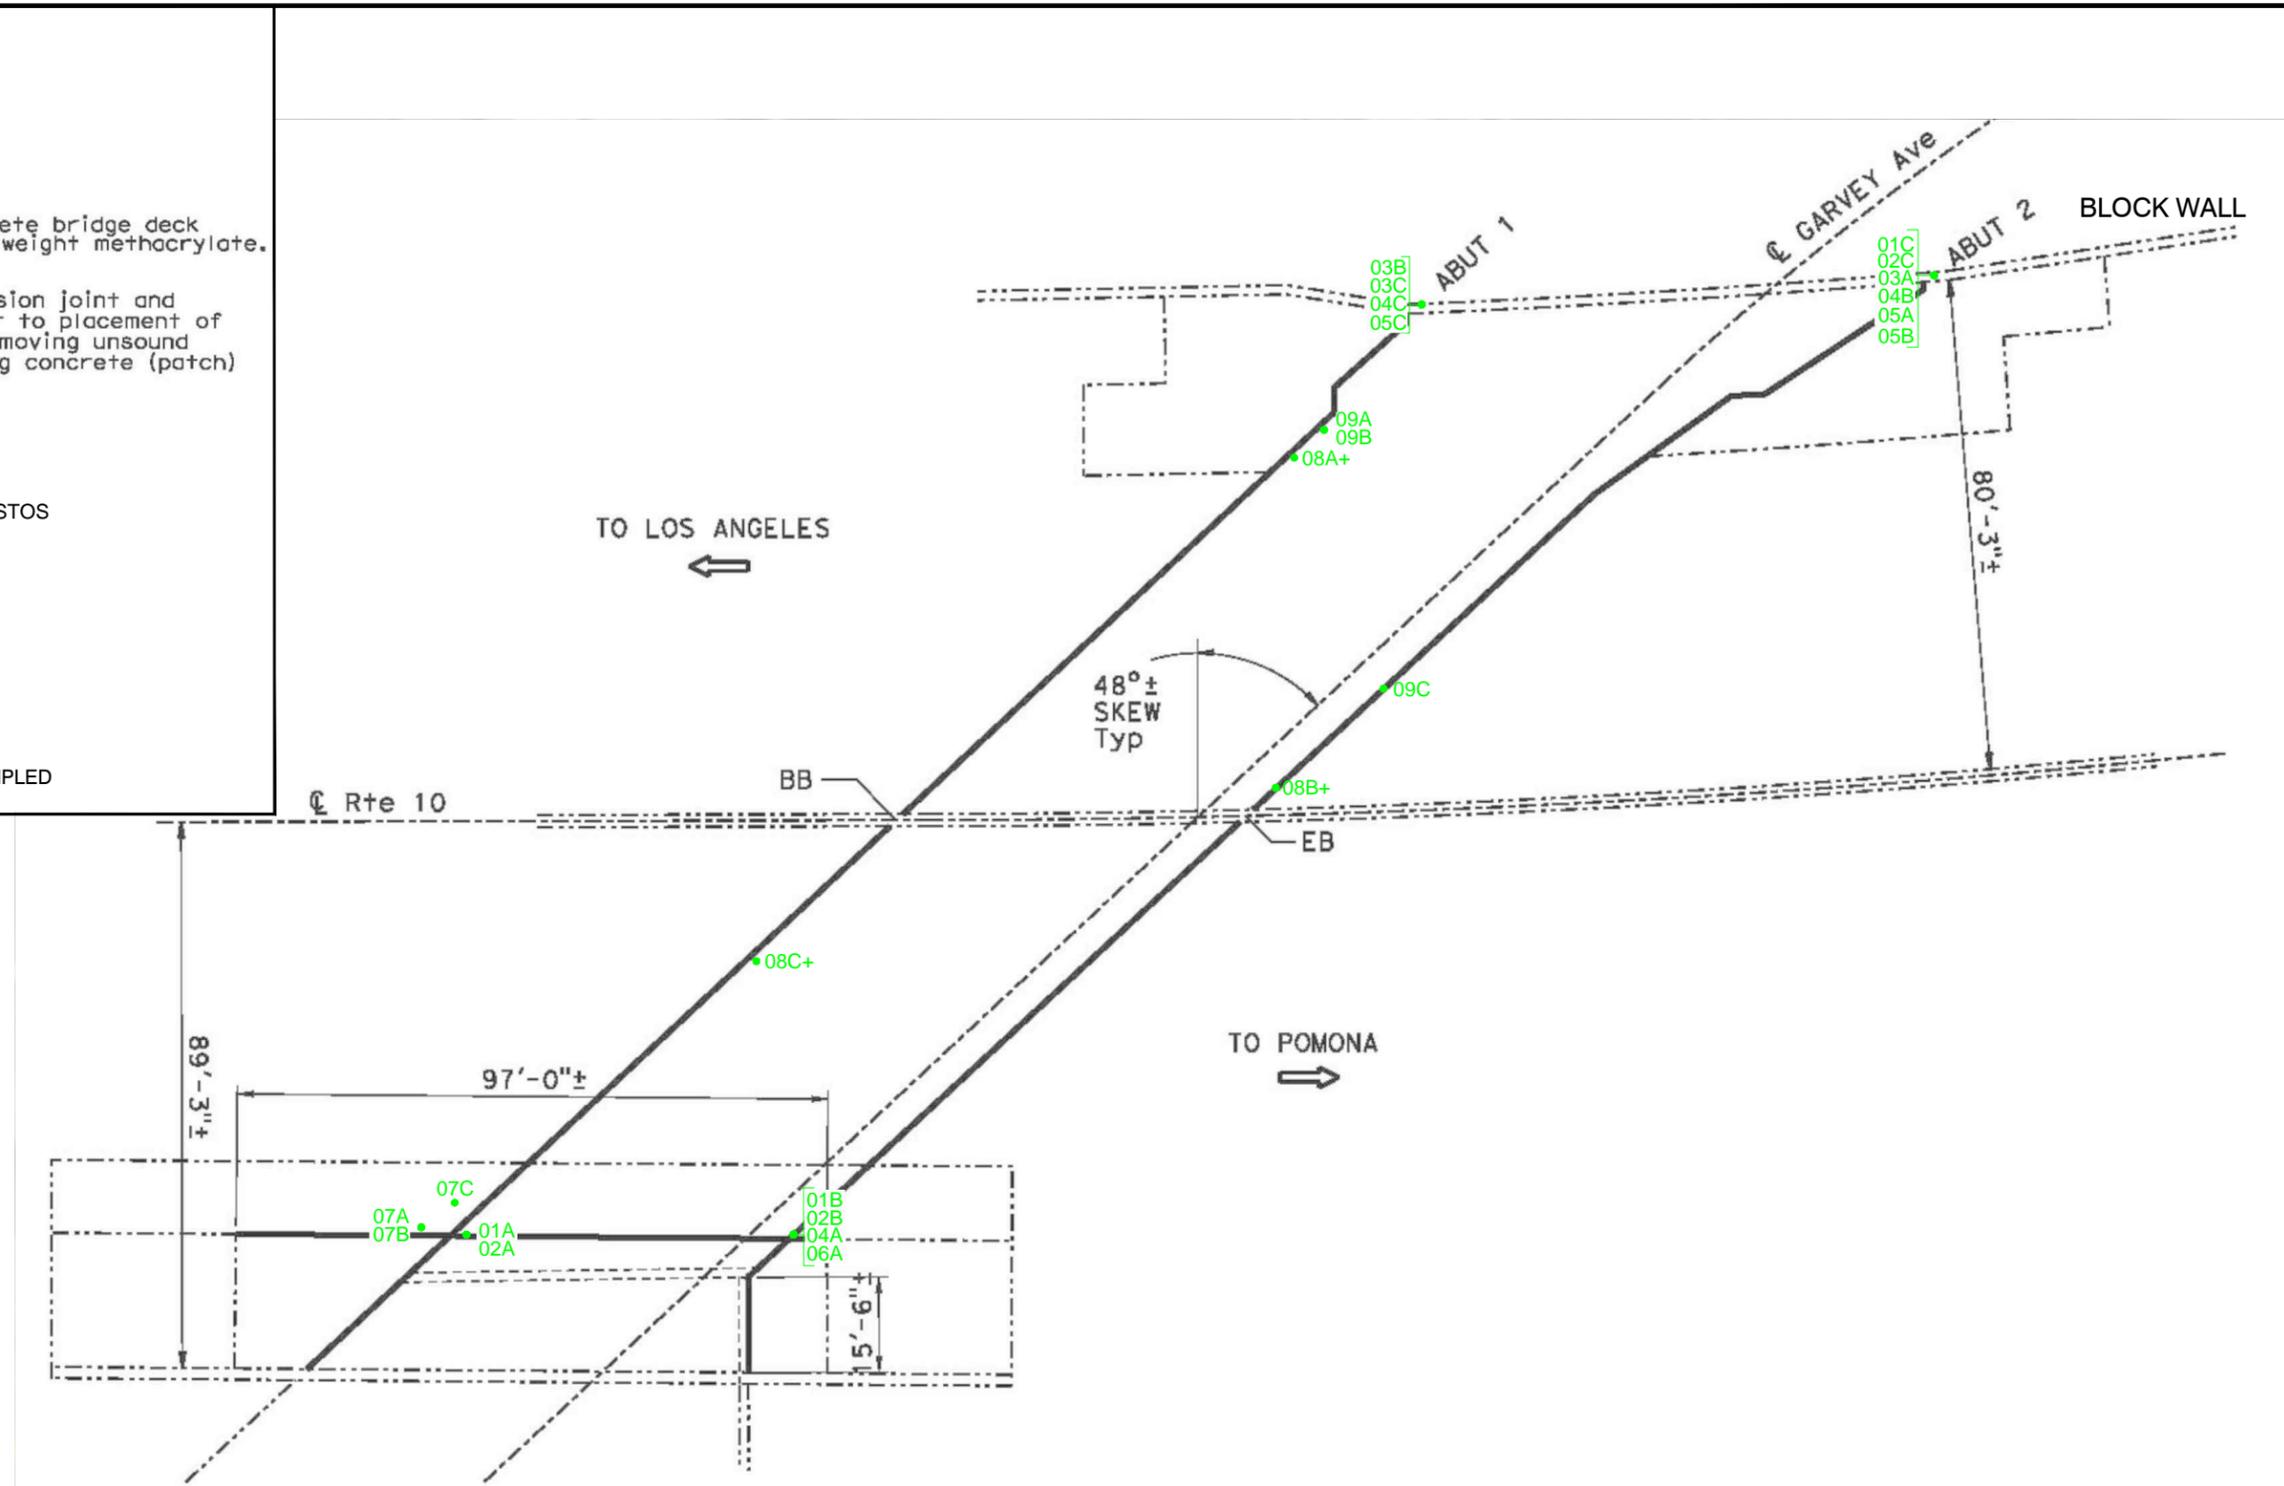
Br No. 53-1032, Rte 10, PM 30.58
NO SCALE

- SAMPLE LOCATION
- (+) INDICATES SAMPLE POSITIVE FOR ASBESTOS
- 01 GUARDRAIL
- 02 DECK
- 03 BLOCK
- 04 FELT
- 05 MORTAR
- 06 GUARDRAIL REFLECTOR MASTIC
- 07 CONCRETE WEEP HOLE
- 08 WEEP HOLE (BENEATH)
- 09 VERTICAL PRESS BOARD (BENEATH)
- * DECK SEAL WAS RUBBER STRIP - NOT SAMPLED

GARVEY AVENUE OFF-RAMP UC

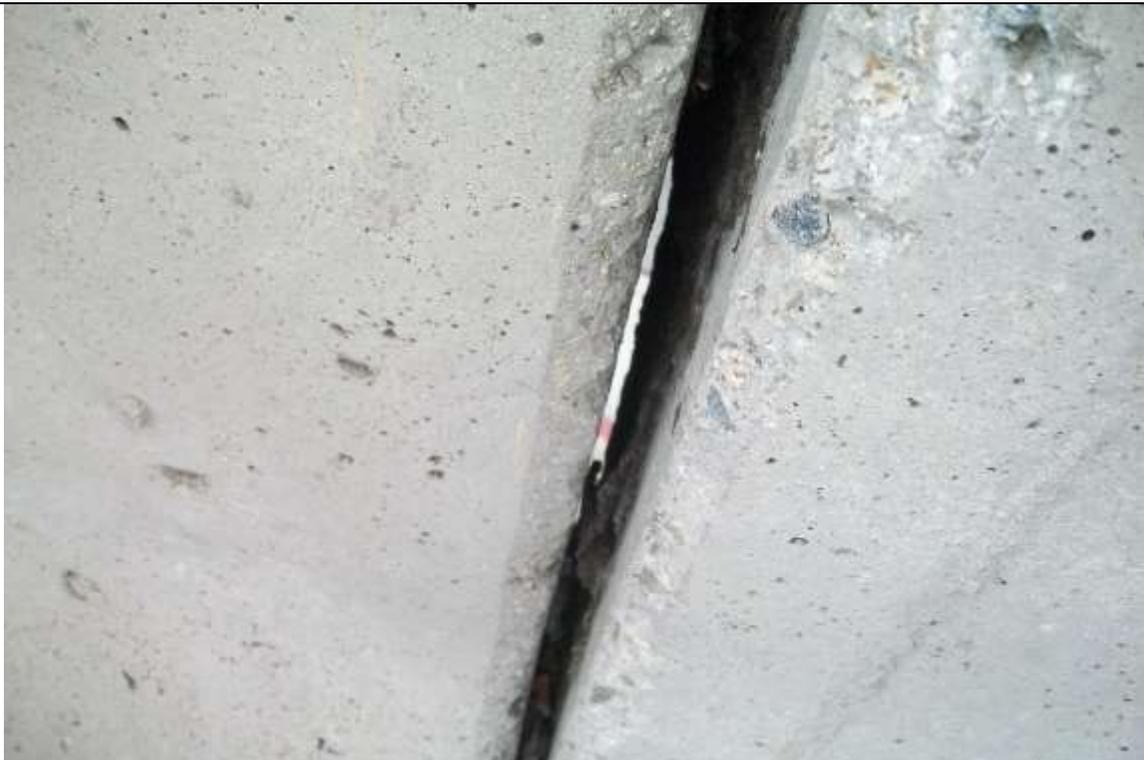
Photograph No. 4

SANTA ANITE UC BRIDGE (53-0685): VIEW OF SEAM CONTAINING EXPANSION JOINT FELT. SAMPLED AND NOT FOUND TO CONTAIN ASBESTOS.

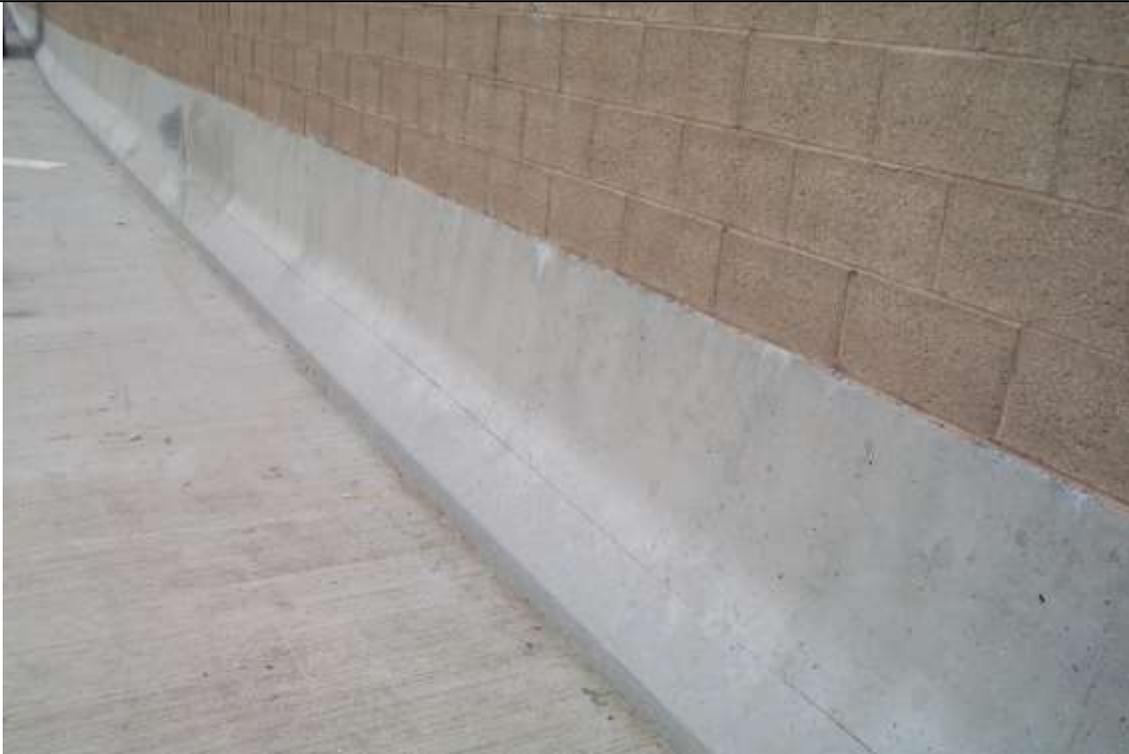
Photograph No. 7

TYLER AVENUE UC BRIDGE (53-0659): VIEW OF GUARD RAIL AND BLOCK WALL ALONG SOUTH SIDE OF BRIDGE. SAMPLED AND NOT FOUND TO CONTAIN ASBESTOS.

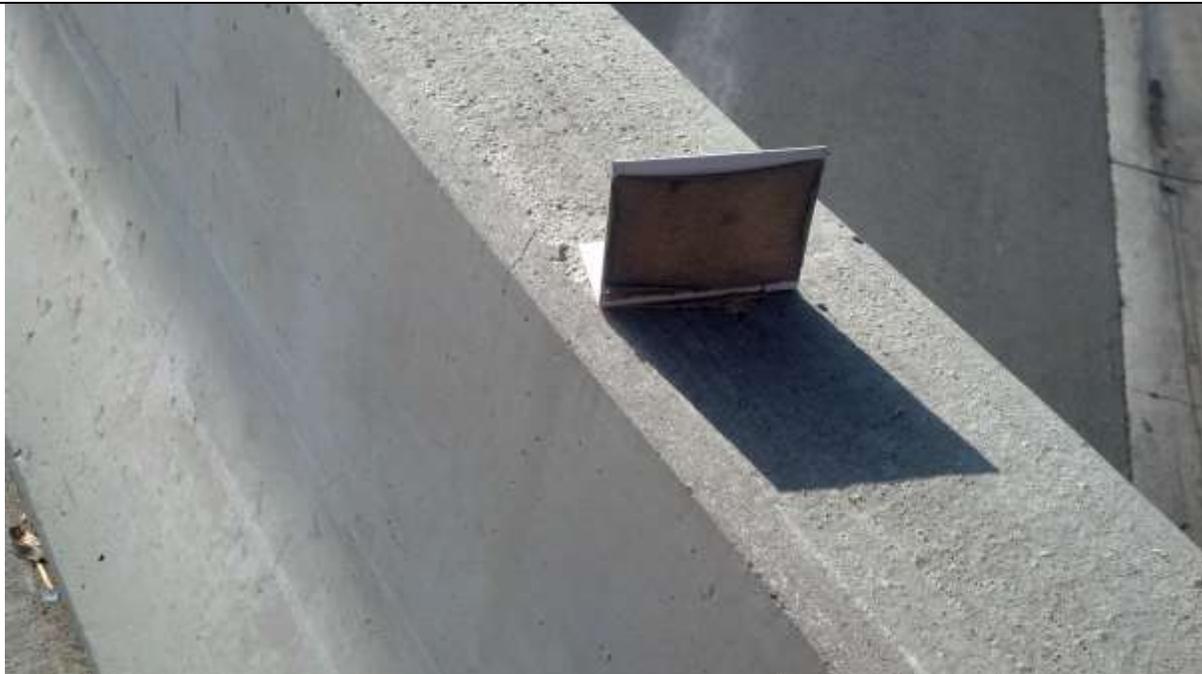
Photograph No. 10

VALLEY BOULEVARD UC BRIDGE (53-0660): VIEW OF GUARD RAIL REFLECTOR WITH MASTIC. SAMPLED AND NOT FOUND TO CONTAIN ASBESTOS.

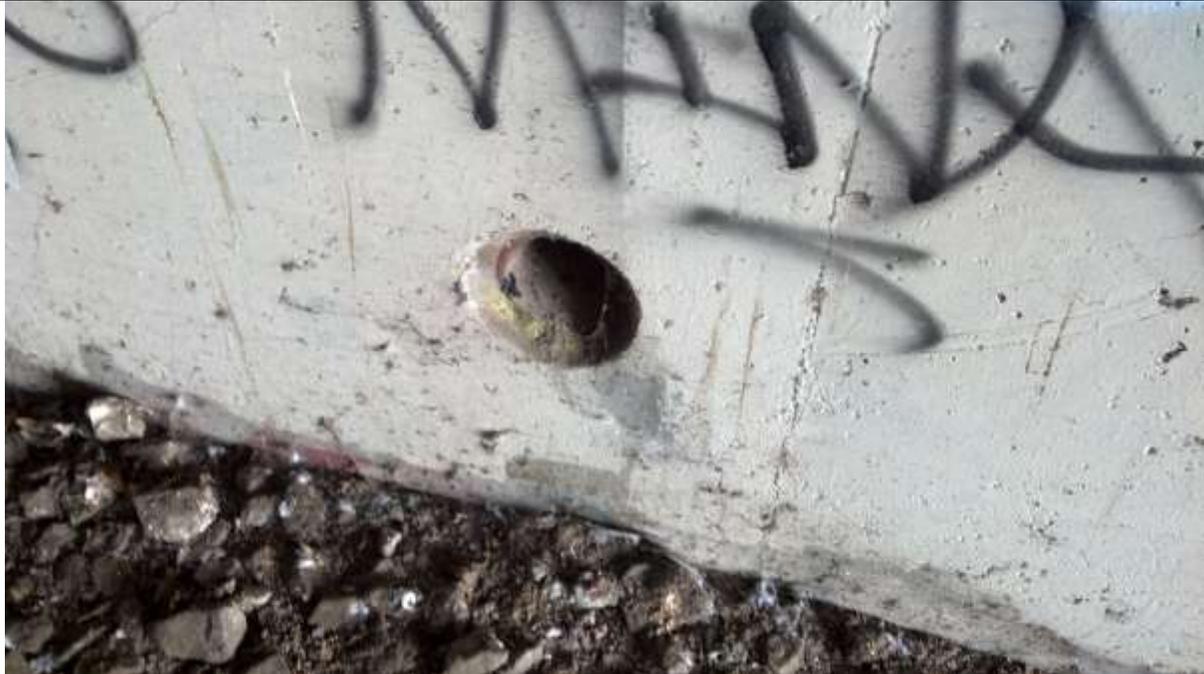
Photograph No. 11

EAST EL MONTE OH UC BRIDGE (53-0867): VIEW OF BLACK DRAIN LINES SAMPLED AND NOT FOUND TO CONTAIN ASBESTOS.

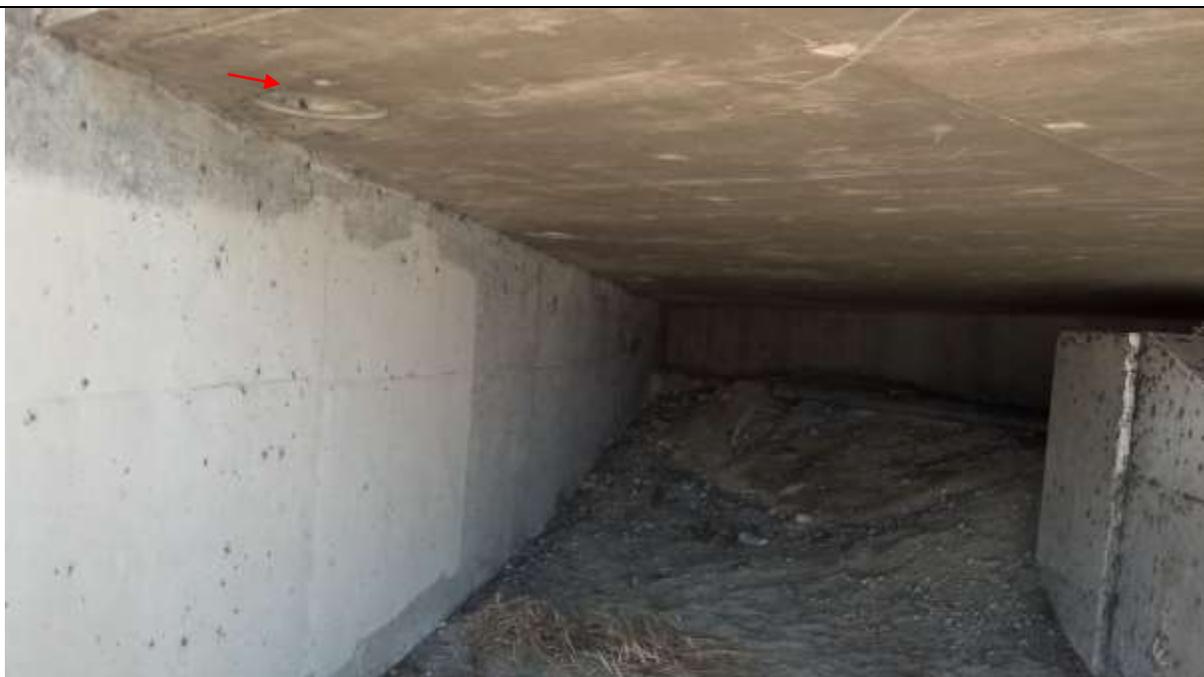
Photograph No. 12

STEWART STREET ON-RAMP UC BRIDGE (53-1030): VIEW OF CONCRETE WEEP HOLES (SEE RED ARROW) SAMPLED AND NOT FOUND TO CONTAIN ASBESTOS.

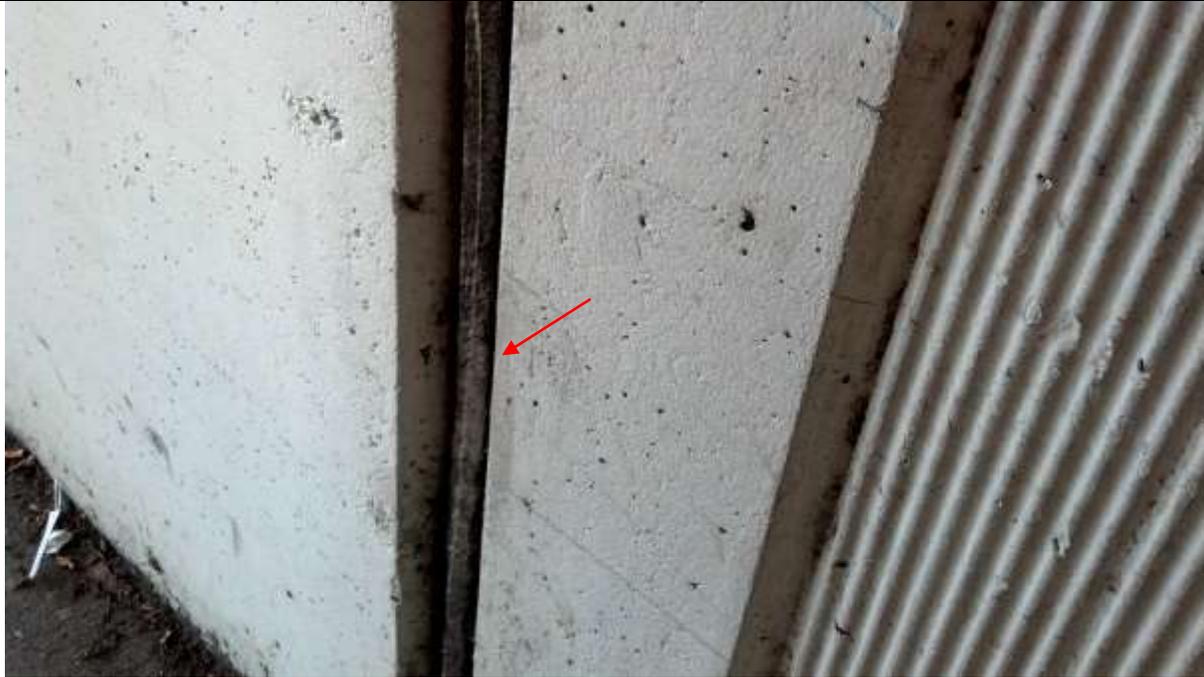
Photograph No. 13

COGSWELL ROAD UC BRIDGE (53-0662): VIEW OF TYPICAL SEAM CONTAINING EXPANSION FELT (SEE RED ARROW), LOCATED BENEATH BRIDGE.

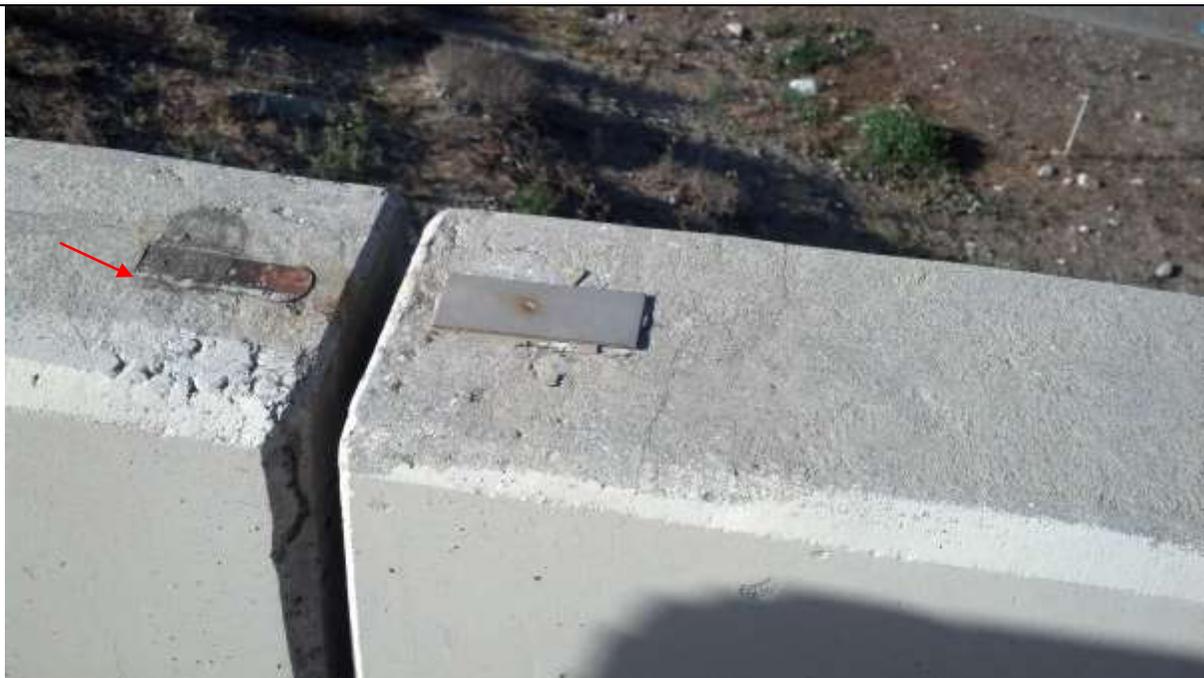
Photograph No. 14

DURFEE ROAD UC BRIDGE (53-1031): VIEW OF GUARD RAIL REFLECTOR MASTIC (SEE RED ARROW). SAMPLED AND NOT FOUND TO CONTAIN ASBESTOS.

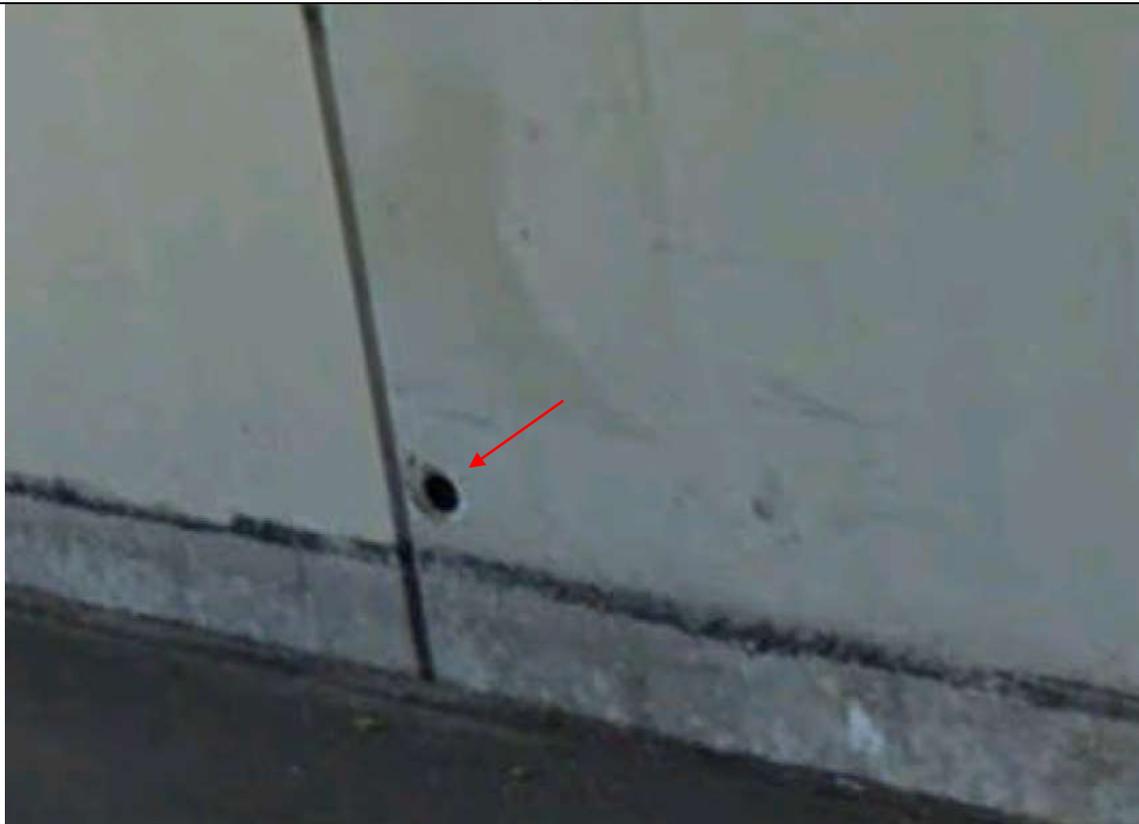
Photograph No. 15

The black pipes appeared to be in good condition at the time of the survey, and if left undisturbed are considered a Category I non-friable ACM. However, if the black piping, or any other currently undiscovered suspect materials are disturbed during construction, they should be classified and handled as a RACM due to the high probability of becoming crumbled, pulverized, or reduced to a powder by the forces expected to act on the material in the course of demolition or construction. If disturbance of these materials is required for bridge preservation, the following should be considered:

GARVEY OFF-RAMP UC BRIDGE (53-1032): VIEW OF A BLACK DRAIN LINE (SEE RED ARROW) SAMPLED AND FOUND TO CONTAIN ASBESTOS.

- Any generated ACM wastes should be disposed as hazardous asbestos waste.
- ACM abatement is required by a licensed ACM abatement contractor prior to renovation, refurbishing, or demolition activities. The abatement contractor's responsibilities include,
