**ROUTE 5 AND BAY MARINA DRIVE
BURN ASH STUDY REPORT
NATIONAL CITY, CALIFORNIA
CALTRANS CONTRACT NO. 11A1638
EA 297610**

March 23, 2012

Kleinfelder Project No. 125347

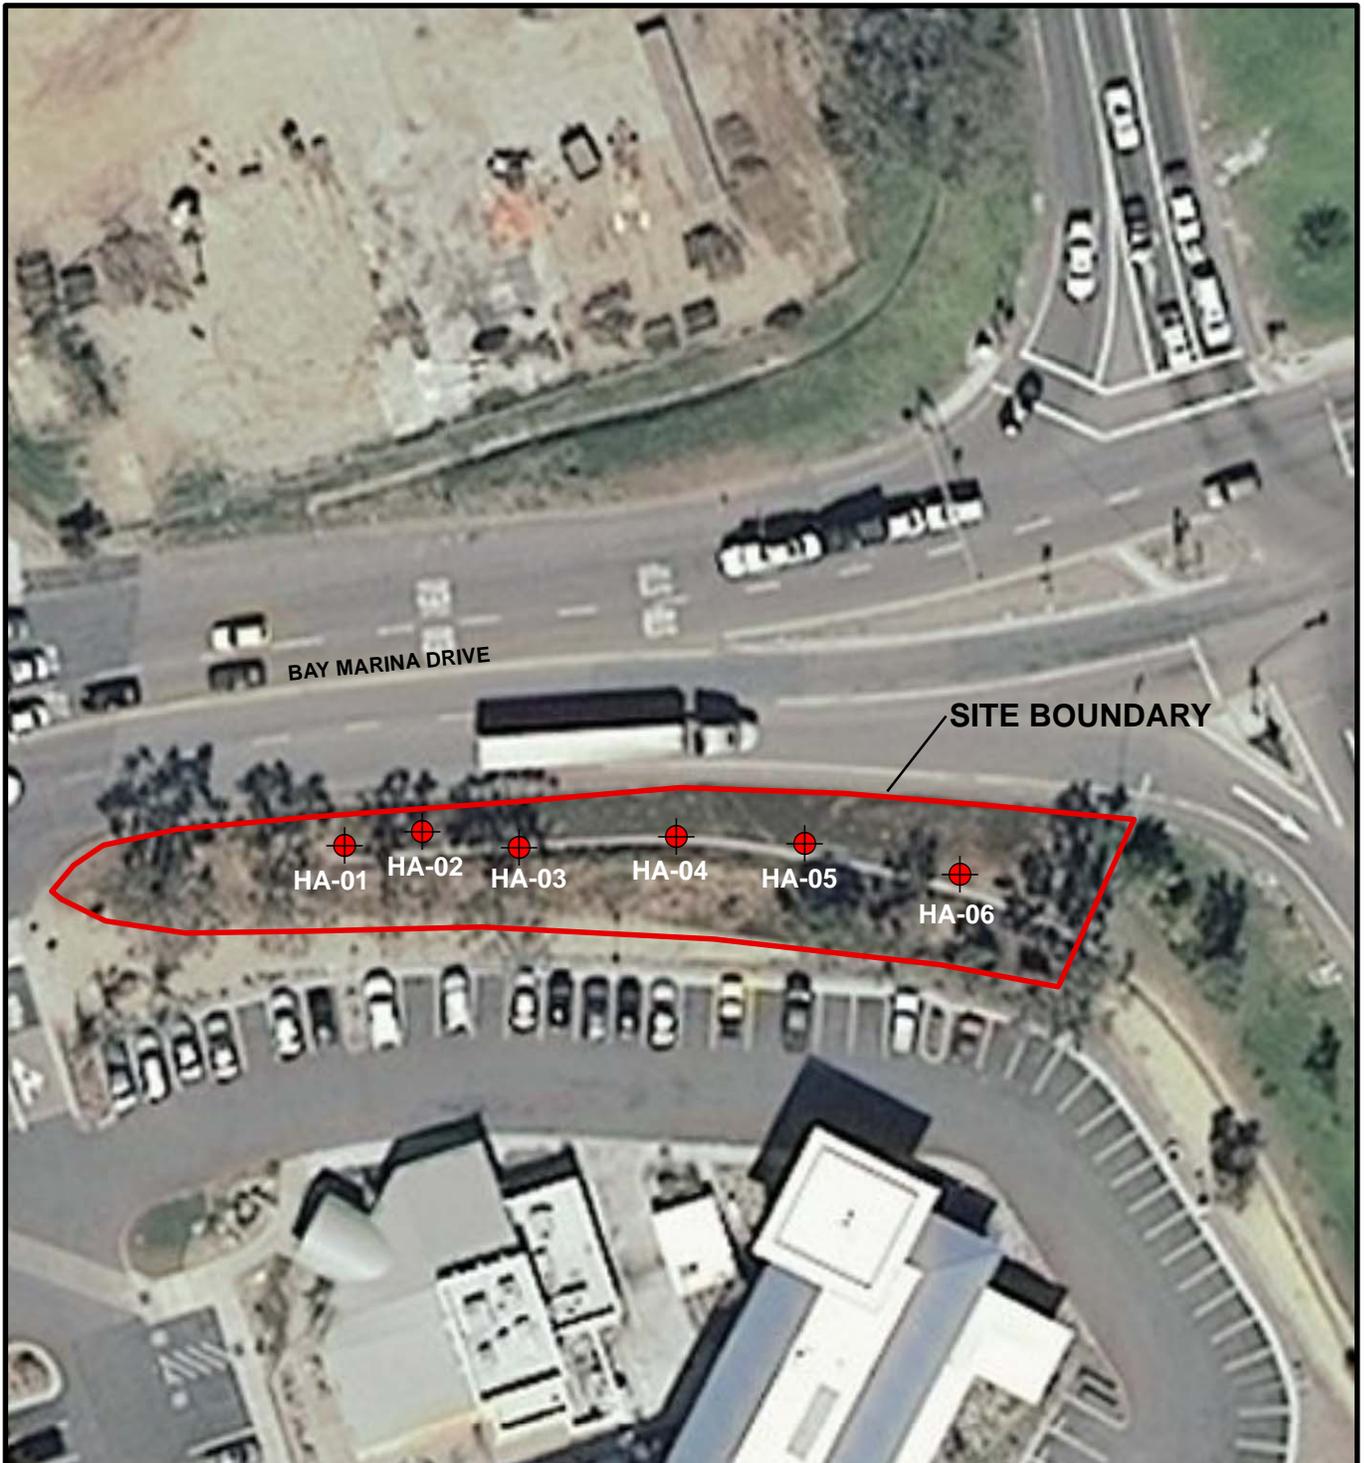
<p>KLEINFELDER Bright People. Right Solutions. www.kleinfelder.com</p>	PROJECT NO. 125347	SAMPLE LOCATION MAP	PLATE 2
	DRAWN: 03/20/2012		
	DRAWN BY: SC	BAY MARINA DRIVE SAN DIEGO, CALIFORNIA	
	CHECKED BY: MH		
FILE NAME: SLC12A021.MXD

BORING LOCATION
-

SITE BOUNDARY

Soil sampling was conducted to investigate whether chemicals of concern related to burn ash were present in soils anticipated to be excavated at the Site. The location and depth for each soil sample location is provided in Table 1 and the locations are shown on Plate 2. Soil analytical results are presented on Plate 3.

Hand auger borings were advanced to depths up to 4 feet bgs on February 10, 2012, at locations shown on Plates 2 and 3. Borings were advanced using a manually-operated, pre-cleaned, stainless steel hand auger. Work was performed in the unpaved shoulder.

The sample locations were recorded during utility location using a hand-held Trimble GPS unit and coordinates are provided in Table A-1 (Appendix A). The approximate locations of these borings are shown on Plates 2 and 3.
