# 101 Unpainted Steel Elements

Element Number	Description
101	<b>Steel Closed Web/Box Girder, Unpainted (m)</b> This element defines only those steel closed web/box girder units that are not painted or are constructed of weathering steel or galvanized.
106	<b>Steel Open Girder, Unpainted (m)</b> This element defines only those steel open girder units that are not painted or are constructed of weathering steel.
112	<b>Steel Stringer, Unpainted (m)</b> This element defines all unpainted steel stringers which support the deck in a stringer-floor beam system.
120	<b>Steel Bottom Chord of Truss, Unpainted (m)</b> This element defines the bottom chord of unpainted steel trusses or those constructed of weathering steel. This element includes through trusses and Pony trusses.
125	<b>Steel Truss excluding bottom chord, Unpainted (m)</b> This element defines all truss elements except the bottom chord of unpainted steel trusses or those constructed of weathering steel. This element includes through trusses and Pony trusses.

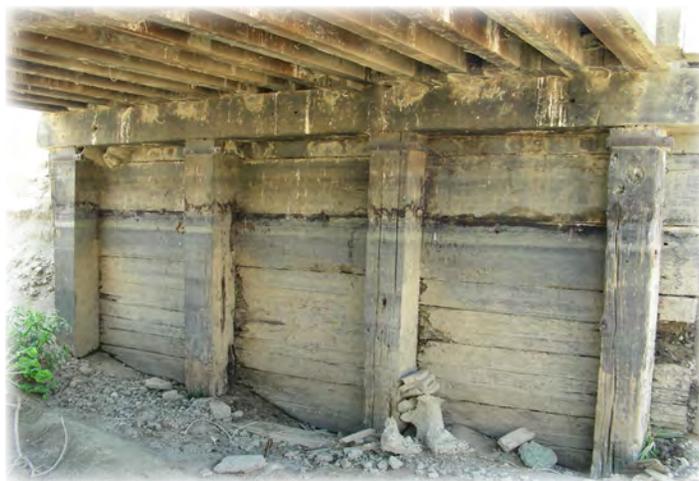
Example: Use Elements 235 (cap), 206 (columns), and 216 (abutment) for the bridge abutment shown above.

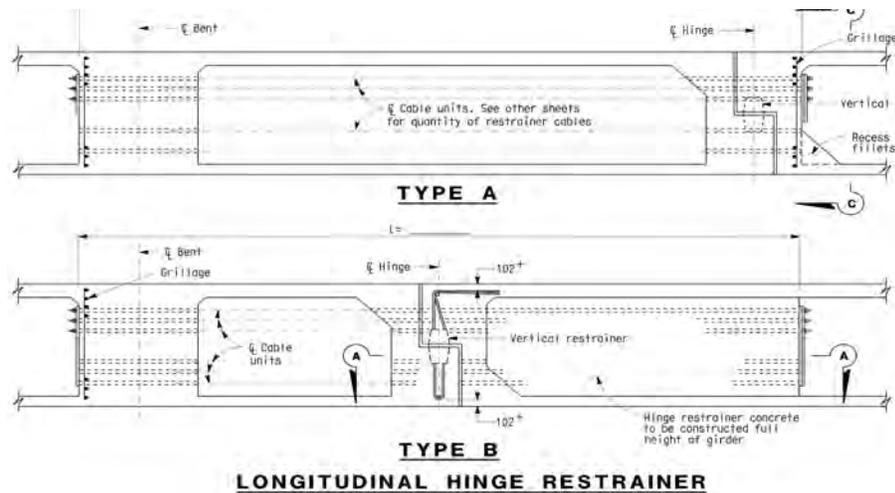
Details of Type II Restrainer Cable System:

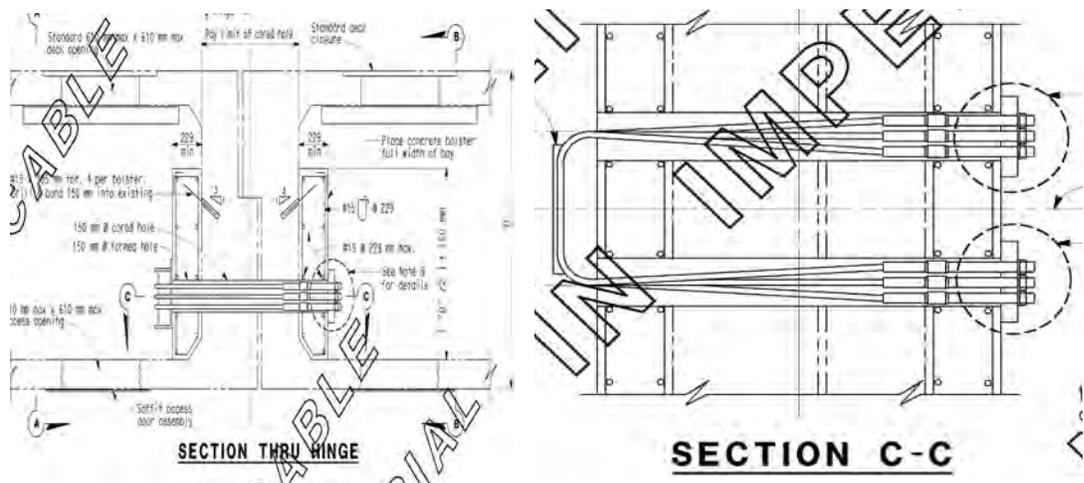
Details of C-1 Restrainer Cable System:

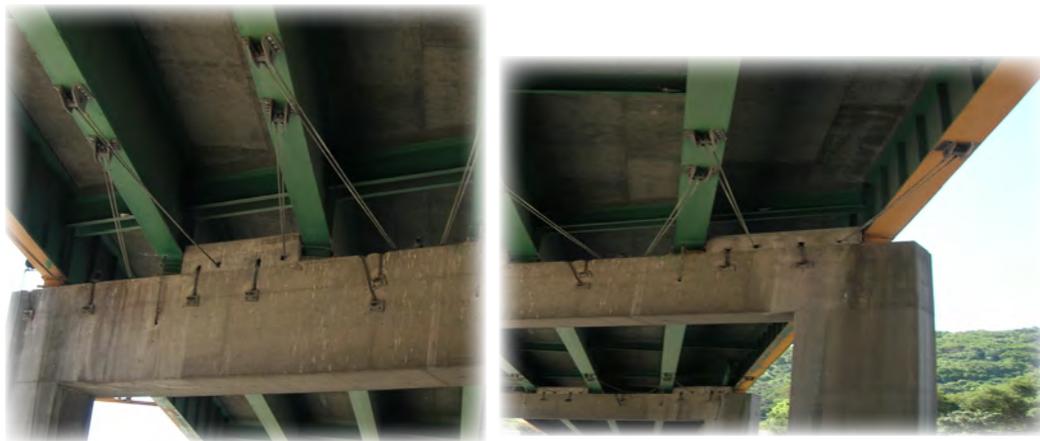
Examples of other Seismic Restrainer Cable System

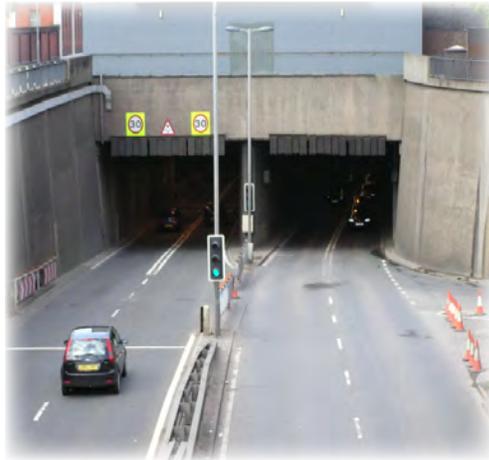
Do not use Tunnel element for cut-and-cover type tunnels

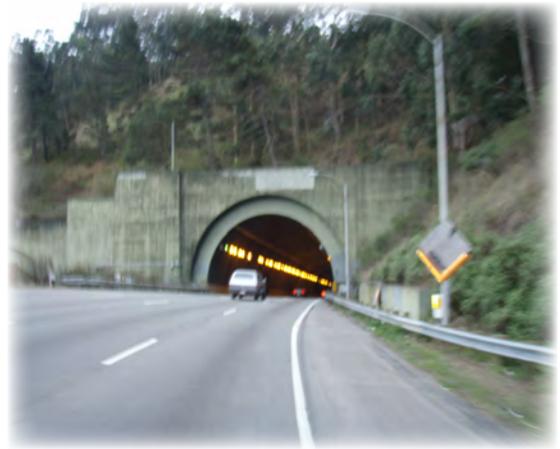
Use this Tunnel element only for bored and lined type tunnels

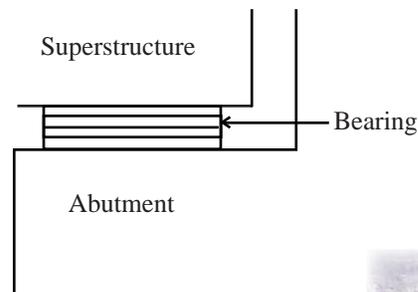
*Typical elastomeric pad at an Abutment*

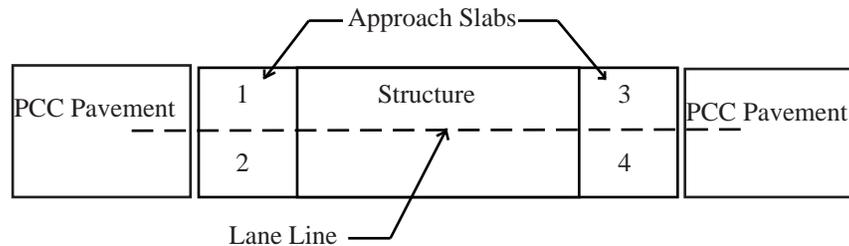
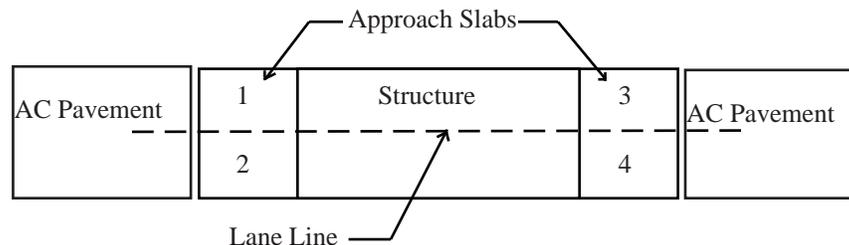
- Each approach slab element should consist of the portion from the bridge to the 1st joint, not to exceed a distance of 30 feet.
- The examples below shows four approach slab units to be recorded.
- If overlays are placed w/out repairs maintain the prior condition state of an approach slab.

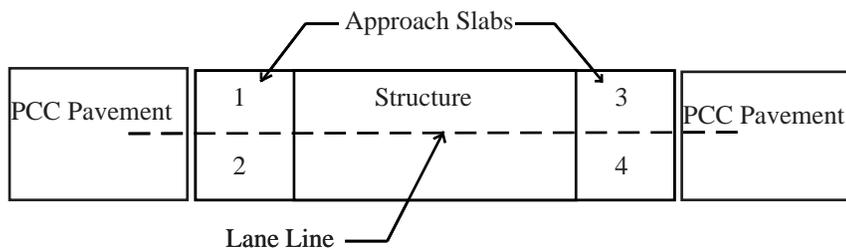
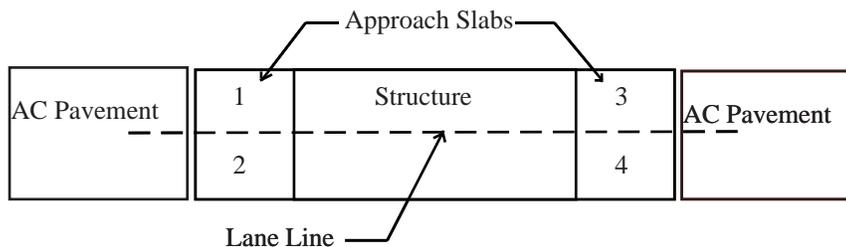
- Each approach slab element should consist of the portion from the bridge to the 1st joint, not to exceed a distance of 30 feet.
- The examples below shows four approach slab units to be recorded.
- If overlays are placed w/out repairs maintain the prior condition state of an approach slab.

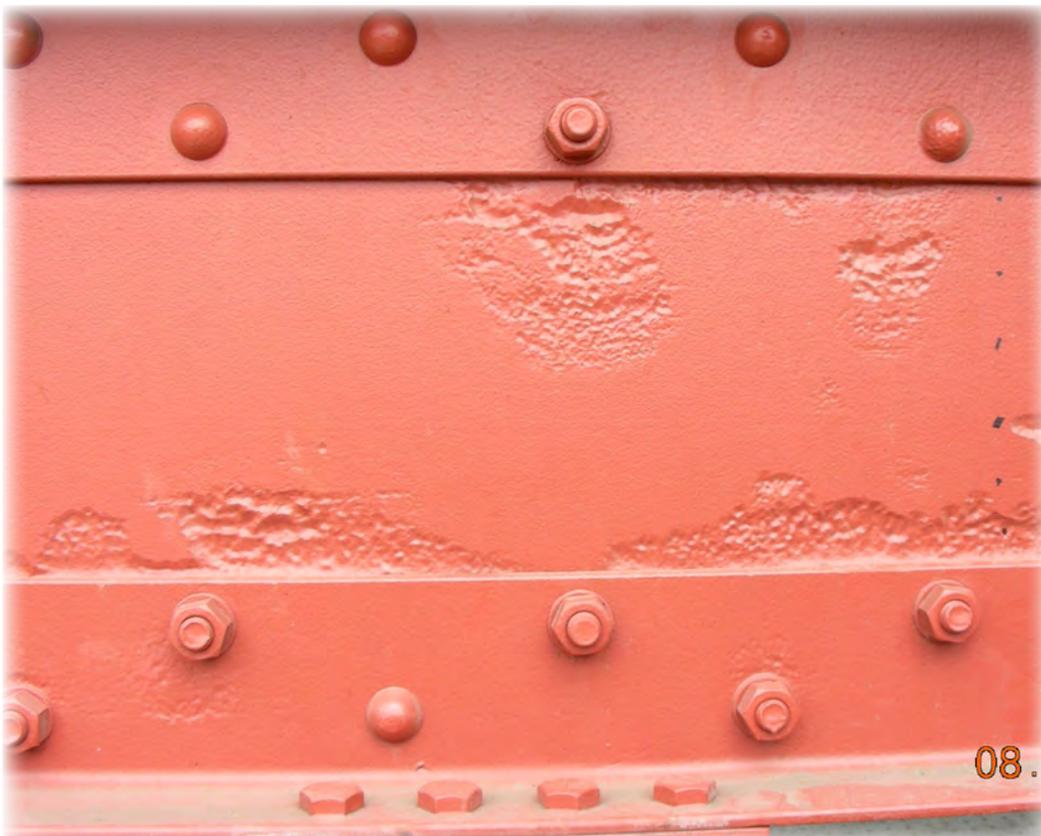
- *This Smart Flag should be used for a steel element that is currently or previously in Condition State 3 (unpainted steel), Condition State 4 (painted steel), or has been repaired and/or cleaned and painted, as shown in photo below.*
