CHAPTER 1 INTRODUCTION

1.1 PURPOSE OF PAVEMENT PRESERVATION

1.2 PCC PAVEMENT DESIGN AND PERFORMANCE IN CALIFORNIA

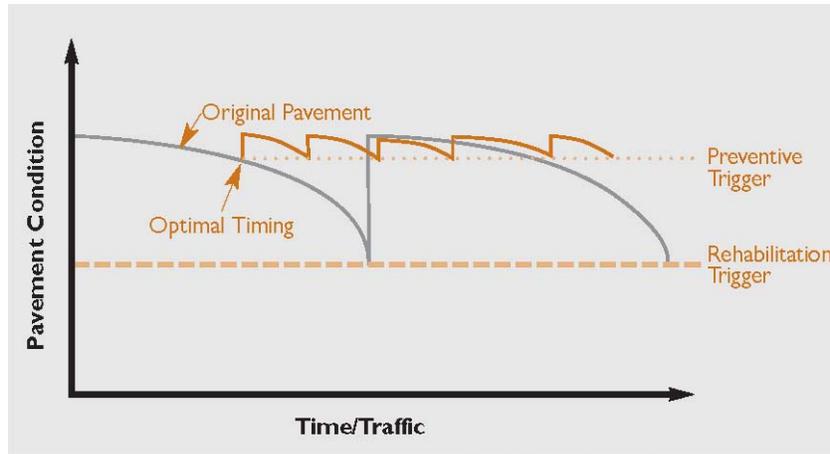
The timing of the application of the treatment has a significant influence on the effectiveness of the treatment in prolonging the performance of the pavement; therefore, applying the right treatment to the right pavement at the right time is the core of pavement preservation. As indicated earlier, by applying cost-effective preservation treatments at the right time, the pavement can be maintained close to its original condition for a longer period of time. Timely application of a successive treatment can maintain the pavement in good condition and prolong the need for more expensive roadway rehabilitation and reconstruction strategies, as shown in Figure 1-2. This figure illustrates the concept

of timely application of a treatment is important to maintain the existing pavement condition. The frequency of applying treatment will depend on the type of treatment that has been used and their life expectancy.

Figure 1-2 Concept of optimal timing for pavement preservation (Galehouse et al, 2003)

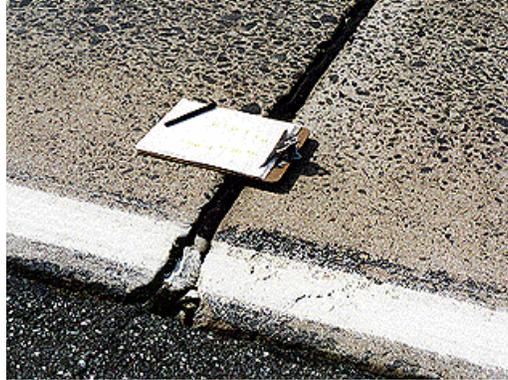
Faulting – Faulting is the difference of elevation across a joint or crack (see Figure 1-5). Faulting is caused in part by a buildup of loose materials under the approach slab near the joint or crack as well as depression of the leave slab. The buildup of eroded or infiltrated materials is caused by pumping from under the leave slab and shoulder (free moisture under pressure) due to heavy loadings. The warp and/or curl upward of the slab near the joint or crack due to moisture and/or temperature gradient contributes to the pumping condition. Lack of load transfer devices like dowel bars contributes greatly to faulting. Faulting is most prominent failure type in California because Caltrans did not build doweled pavement until 1998. A detailed discussion on the faulting mechanism is provided in Section 1.2.3.

Figure 1-5 Faulting (FHWA, 2003)

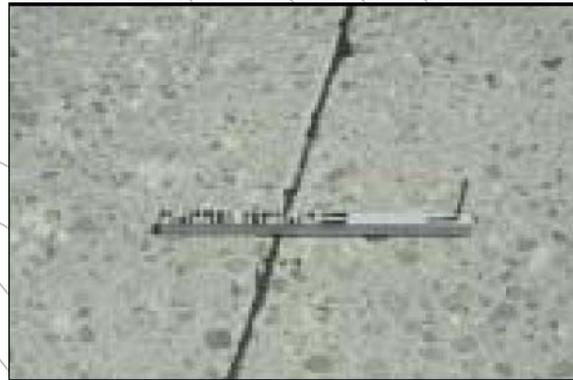
Joint seal damage – Joint seal damage exists when incompressible materials and/or water can infiltrate into the joints (Figure 1-6). This infiltration can result in pumping, spalling, and blow-ups. A joint sealant bonded to the edges of the slabs protects the joints from accumulation of incompressible materials and also reduces the amount of water seeping into the pavement structure. Typical types of joint seal damage are: stripping of joint sealant, extrusion of joint sealant, weed growth, hardening of the filler (oxidation), loss of bond to the slab edges, and lack or absence of sealant in the joint. Poor construction of the joint seal can be a factor in the extent of joint seal damage.

Figure 1-6 Example of joint seal damage (FHWA, 2003)

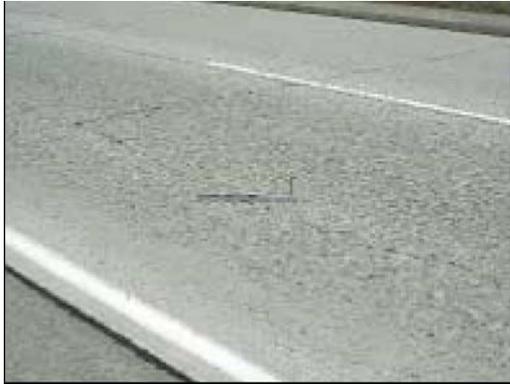
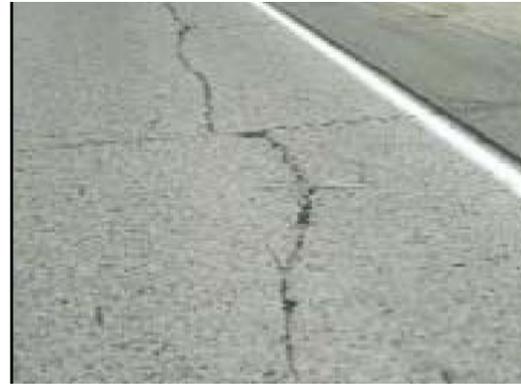
Longitudinal cracks – longitudinal cracks occur generally parallel to the centerline of the pavement (Figure 1-7). They are often caused by a combination of heavy load repetitions, loss of foundation support, and thermal and moisture gradient stresses. Longitudinal cracking is more prevalent in western States which have a drier climate than it is in the more humid eastern States. Early longitudinal cracks can be caused by improper construction of longitudinal joints, inadequate saw-cut depth, late sawing of longitudinal joints, and/or opening the pavement to traffic before the concrete has achieved adequate strength.

Figure 1-7 Examples of longitudinal joint crack (FHWA, 2003)

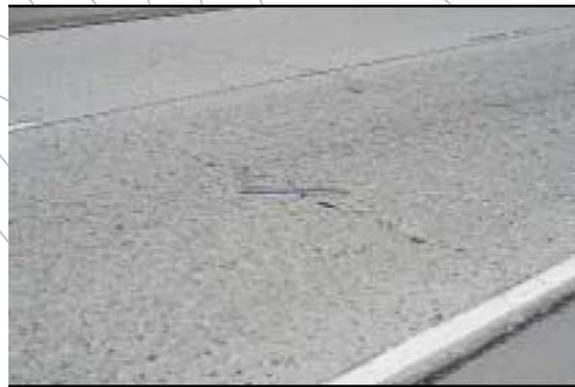
Transverse cracking – transverse cracks are predominantly perpendicular to the pavement centerline and the direction of traffic (Figure 1-8). Typically, JPCP slabs crack when tensile stresses within the slab exceed the slab's tensile strength. Early-age cracking may occur from a combination of restraining forces due to temperature changes, shrinkage, thermal curling, base constraint, and moisture warping, combined with traffic loads imposed on the concrete before it has gained sufficient strength. Transverse cracks that occur in the years following construction are primarily the result of fatigue of the concrete slab caused by repeated heavy axle loads and temperature curling. The cracks develop when the accumulated fatigue damage approaches or exceeds the fatigue life of the JPCP. Note that the potential for transverse cracking increases with increased joint spacing. Old JPCP designs used 18 ft (5.5 m) and 19 ft (5.8 m) spacing which historically has cracked over twice as often as shorter 12 ft (3.7 m) and 13 ft (4 m) spacing. Caltrans now limits joint spacing to 15 ft (4.6 m).

Figure 1-8 Transverse cracking (FHWA, 2003)

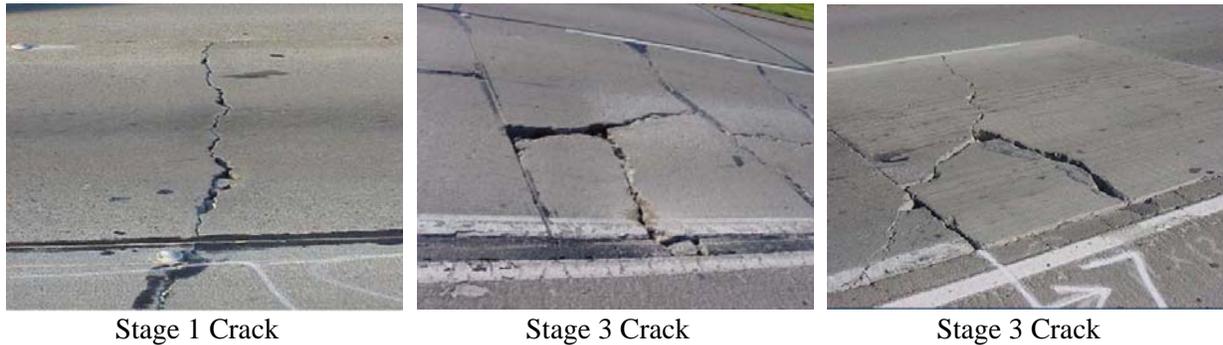
Slab cracking - Caltrans classifies slab cracking by stages based on the severity of the cracks (Caltrans, 2004). Figure 1-9 shows examples of cracks at stage 1 and stage 3. The first stage cracking is defined as transverse, longitudinal, or diagonal cracks that do not intersect and that divide the slab into two or more large pieces. Third stage cracks are interconnected cracks that divide the slab into three or more large pieces. Fragmented slabs are characterized by interconnected irregular multiple cracks which divide the slab into several small pieces. Fragmented slabs are a severe form of third stage cracking. Third stage cracking and first stage cracking cannot co-exist in the same slab. However, corner cracking may co-exist with both first stage and third stage cracking. Slab cracking is

usually caused by a combination of heavy load repetitions on pavement with weak roadbed support, thermal curling, faulting, shrinkage, or moisture-induced stress.

Figure 1-9 Examples of cracks at different stages (Caltrans, 2004a)

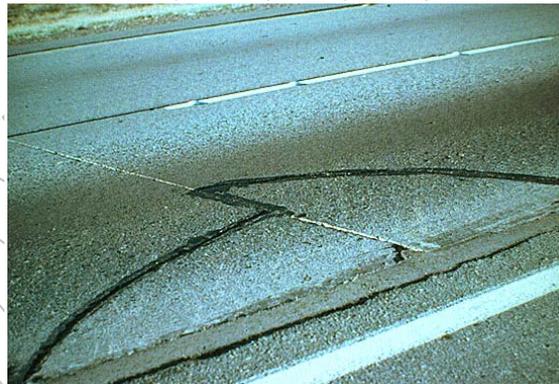
Corner break (or cracking) – A corner break is a crack that occurs in JPCP at the joints a distance less than 6 ft (1.8 m) on each side measured from the corner of the slab. A corner break extends vertically through the entire slab thickness. Corner breaks result from heavy repeated loads combined with pumping, poor load transfer across the joint and thermal curling and moisture warping stresses as shown in Figure 1-10. Corner breaks can also result from a weak or a thin concrete section constructed on a weak base.

Figure 1-10 Corner break/cracking (Caltrans, 2004a)

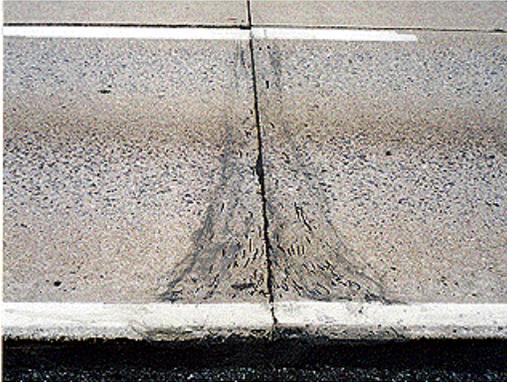
Durability (“D”) cracking – “D” cracking is a series of closely spaced crescent-shaped hairline cracks that appear at a JPCP pavement slab surface adjacent and roughly parallel to transverse and longitudinal joints, transverse and longitudinal cracks, and the free edges of pavement slab. The fine surface cracks often curve around the intersection of longitudinal joints/cracks and transverse joints/cracks (Figure 1-11). These surface cracks often contain calcium hydroxide residue which causes a dark coloring of the crack and immediate surrounding area. “D” cracking is caused by freeze-thaw expansive pressures of certain types of coarse aggregates and typically begins at the bottom of the slab which disintegrates first.

Figure 1-11 D-Cracking (Caltrans, 2004b)

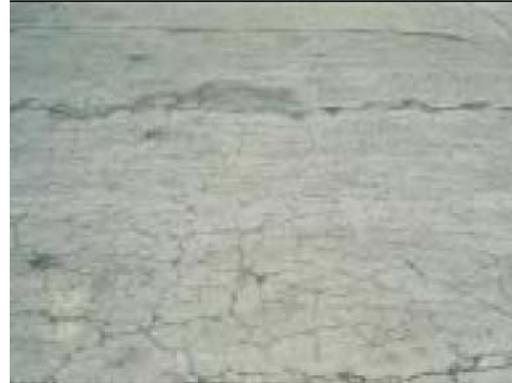
In California, alkali-silica reactivity (ASR) related distress is more prominent. ASR is another durability-related distress which typically produces a “map-cracking” type cracks as shown in Figure 1-12. ASR is caused by a chemical reaction that occurs when free alkalis in the concrete combine with

certain siliceous aggregates to form an alkali-silica gel. As the gel forms, it absorbs water and expands, which cracks the surrounding concrete (ACPA, 1998)

Figure 1-12 Map-cracking (FHWA, 2003)

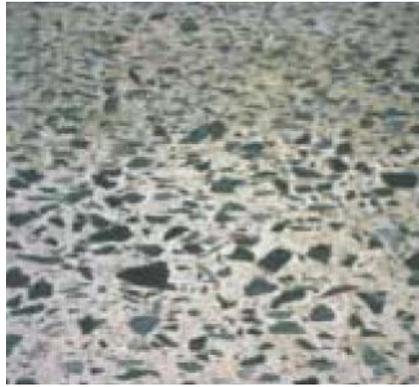
Surface polish/Polished aggregate – Surface polish is the loss of the original surface texture due to traffic wear. Aggregate polishing occurs when surface mortar and texturing have been worn away to expose coarse aggregate and is caused by repeated traffic applications. An example is shown in Figure 1-14.

Figure 1-14 Example of surface polish/polished aggregate (FHWA, 2003)

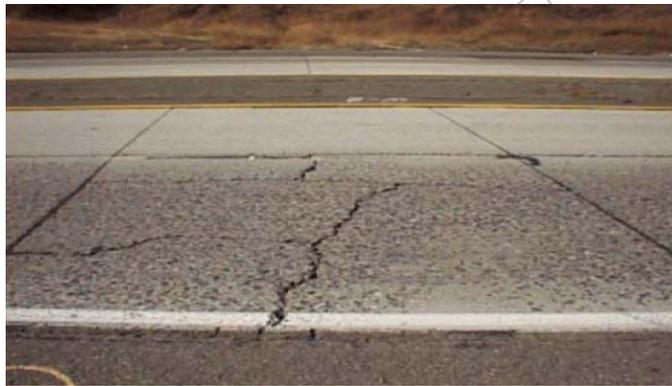
Surface attrition – Surface attrition or surface abrasion is abnormal wear of the concrete pavement (Figure 1-15). It can result from either a poor quality surface material, coarse aggregate, or by the action of tire chains and studded tires. Excessive wear in wheel paths may cause “rutting”, a condition which typically occurs in high mountain and high desert climate regions because of the use of chain during the snow storms.

Figure 1-15 Severe surface abrasion with third stage cracking (Caltrans, 2004b)

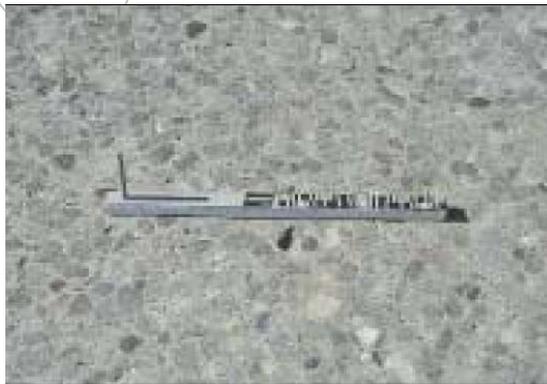
Popouts – A popout is a small piece of concrete that breaks loose from the surface due to freeze-thaw action, expansive aggregates, and/or nondurable materials. Popouts may be indicative of unsound aggregates and “D” cracking (Figure 1-16). Popouts typically range from approximately 1 inch (25 mm) to 4 inches (100 mm) in diameter and from 1/2 inch to 2-inches (13-51 mm).

Figure 1-16 Example of popouts (FHWA, 2003)

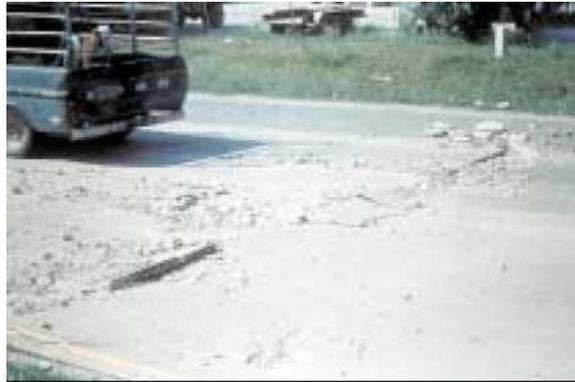
Blow-ups – The mechanism for blow-ups is excessive compressive pressure at joints or cracks. Infiltration of incompressible materials into the joint or crack during cold period results in high compressive stresses in hot periods when slabs expand (Figure 1-17). When this compressive pressure becomes too great, a localized upward movement of the slab or shattering occurs at the joint or crack. Blow-ups are accelerated due to a spalling away of the slab at the bottom creating reduced joint contact area. The presence of “D” cracking (although they do not exist in California’s rigid pavements) or freeze-thaw damage also weakens the concrete near the joint resulting in increased spalling and blow-up potential.

Figure 1-17 Example of blow-ups (FHWA, 2003)

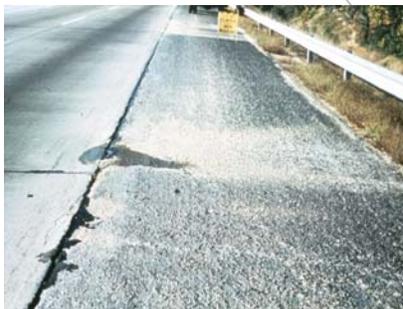
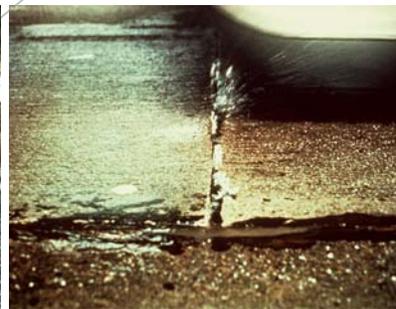
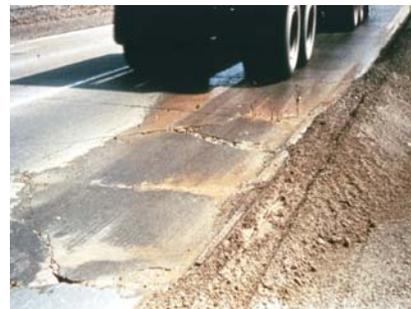
Pumping and water seepage – Pumping is the movement of material by water pressure beneath the slab when it is deflected under a heavy moving wheel load (Figure 1-18). Sometimes the pumped material moves around beneath the slab, but often it is ejected through joints and/or cracks (particularly along the longitudinal lane/shoulder joint with an asphalt shoulder). Beneath the slab there is typically particle movement counter to the direction of traffic across a joint or crack that results in a buildup of loose materials under the approach slab near the joint or crack. Pumping occurs even in pavement sections containing stabilized subbases. Pumping can often increase faulting. Water seepage occurs when water seeps out of joints and/or cracks. Many times it drains out over the shoulder in low areas.

Figure 1-18 Examples of pumping and water seepage (Caltrans, 2004a)

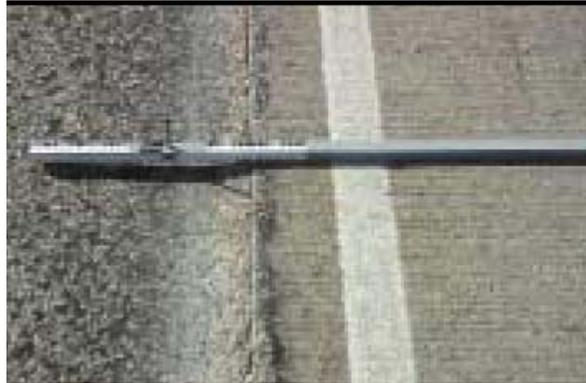
Lane/shoulder drop-off – Lane/shoulder drop-off occurs when there is a difference in elevation between the traffic lane and shoulder (Figure 1-19). Typically, the outside shoulder settles due to a

settlement of the underlying granular or subgrade material or pumping of the underlying material. This is found only with asphalt shoulder. This can also be a result of pumping.

Figure 1-19 Lane/shoulder drop-off (FHWA, 2003)

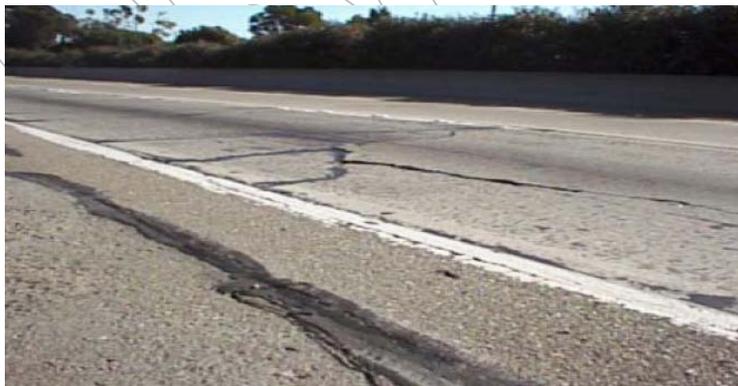
Settlement – Settlement is a local sag in the pavement structural section due to differential settlement, consolidation, or movement of the underlying layer material (Figure 1-20). Sag most commonly occurs above culverts due to the settlement or densification of backfill or at grade points between cut and fill sections. Pavement slippage could also contribute to differential settlement of the pavement and longitudinal cracking.

Figure 1-20 Settlement (Caltrans, 2004b)
