**GAMDAT CASES**  
**STRUCTURAL EVALUATION REPORT**  
**January 31, 2013**

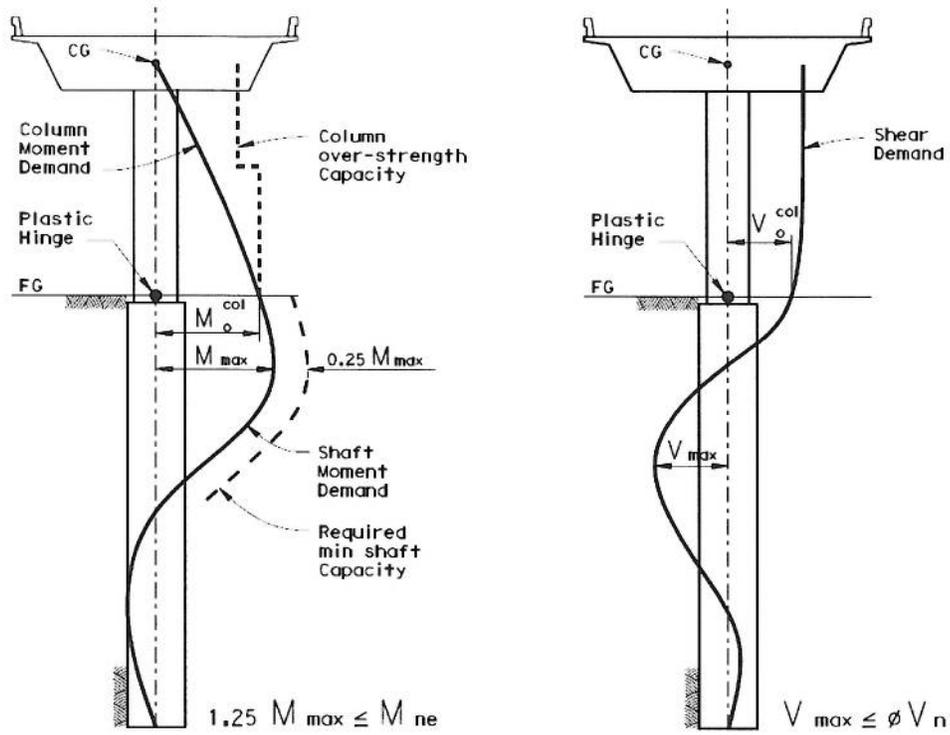
**Figure 1 Typical Moment and Shear Diagrams for Type II Shafts**

For other specially designed piles as in case ID-11 for the Lake Hodges Bridge, the site conditions were such that the pile foundation was susceptible to liquefaction and lateral spreading. The lateral spreading loadings were generated from a geotechnical study done for the site and combined with other loads that the pile is subjected to. The lateral load analysis was done with "Lpile", a computer program where the pile is modeled with p-y springs, which are used to model the soil stiffness along the length of the pile (provided by the geotechnical designer). The lateral EQ loads are added to the other applied loadings such as dead load, earth pressure and inertia loads, to generate maximum moment and shear demands in the pile.

of 1.25 when designing for the maximum moment in the pile (see Section 5.1, Figure 1). In addition to this the column “overstrength” moment, which is defined as  $1.2 \times M_p$ , is applied at the base of column when generating the maximum moment in the shaft. This is done to ensure that the plastic hinge forms at the base of the column and the shaft remains essentially elastic.

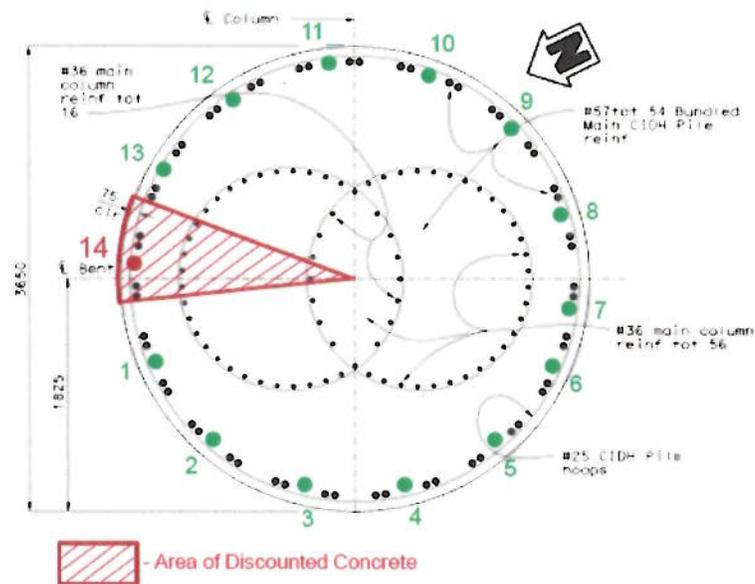
**Figure 2 - SE Connector Bent 15 Pile Cross Section**

As a result of this conservatism built into the design criteria for this type of pile, the conclusion of the structural evaluation was that even with the test data irregularities the pile in question is still structurally adequate.

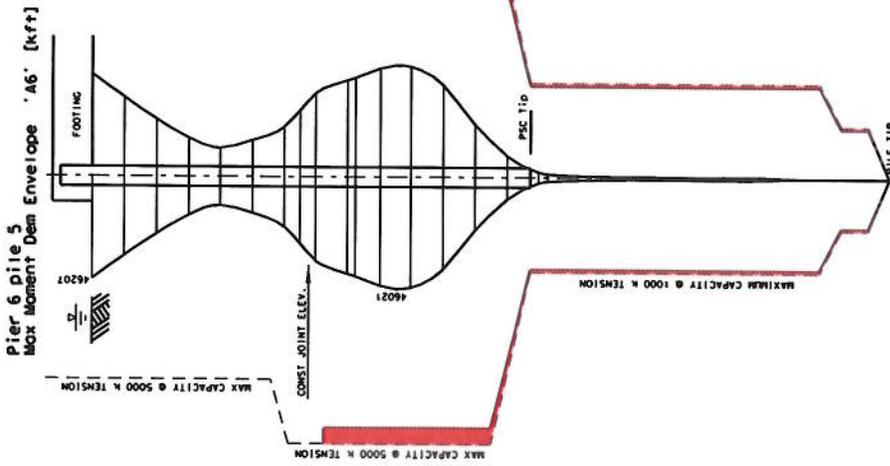
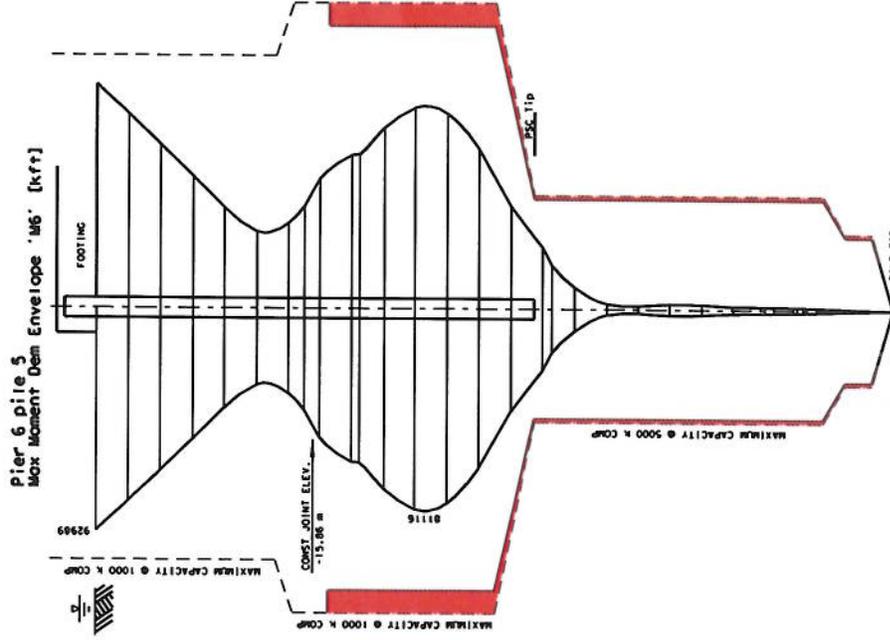
Benicia Main Span Anomaly Review  
 Pier 6, pile 5  
 Max of 3 time history Pile Moment Demands (A6 & M6)

CAPACITY REDUCTION CREATED BY POSSIBLE ANOMALY

Analysis showed that only minor reductions in capacity are possible with anomalies in place. For example, for the location depicted in Figure 6 the analysis showed that in the cased region of the pile with the anomaly in place there was a total reduction in bending capacity of 8.7%, and in the non-cased rock socket region there was generally less than a 5% reduction in capacity. Possible reductions in capacity are mapped on drawings D6, D12, and D14 and are far less than demands.

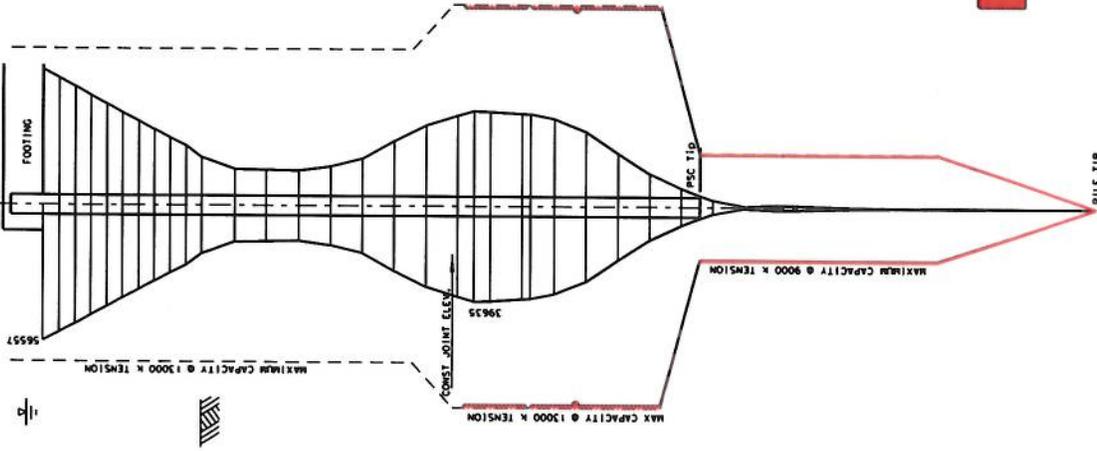
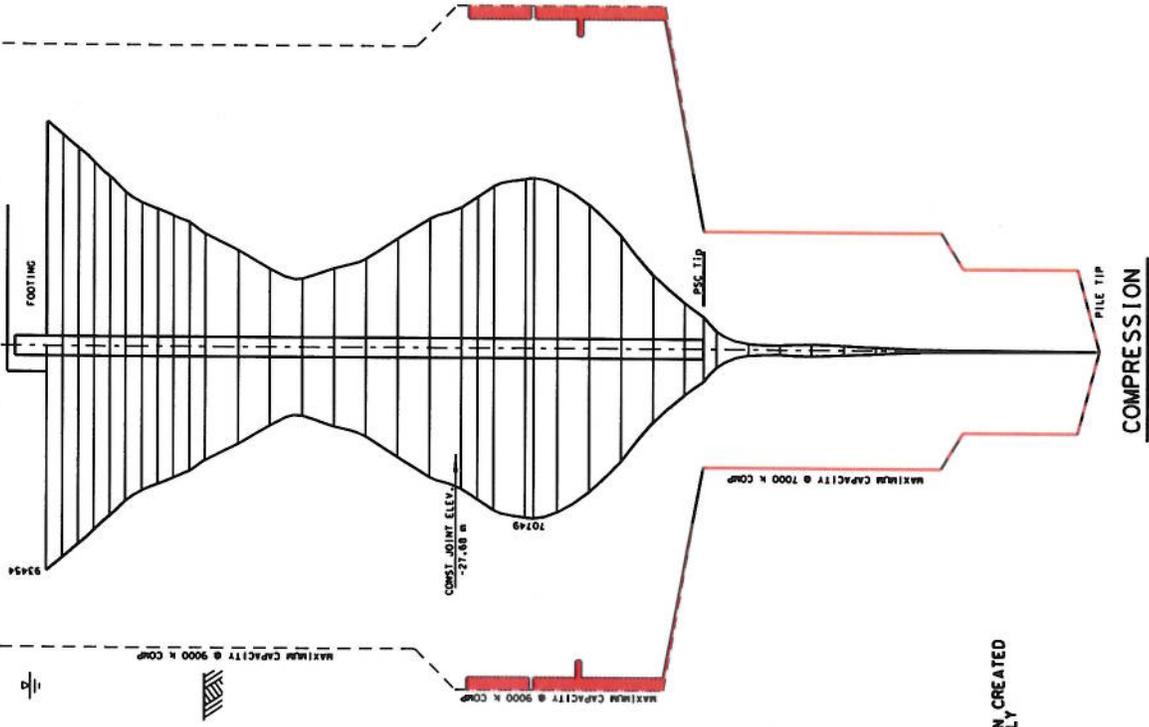
Benicia Main Span Anomaly Review  
Pier 14, pile 8  
Max of 3 time history Pile Moment Demands (A14 & M14)

CAPACITY REDUCTION, CREATED BY POSSIBLE ANOMALY

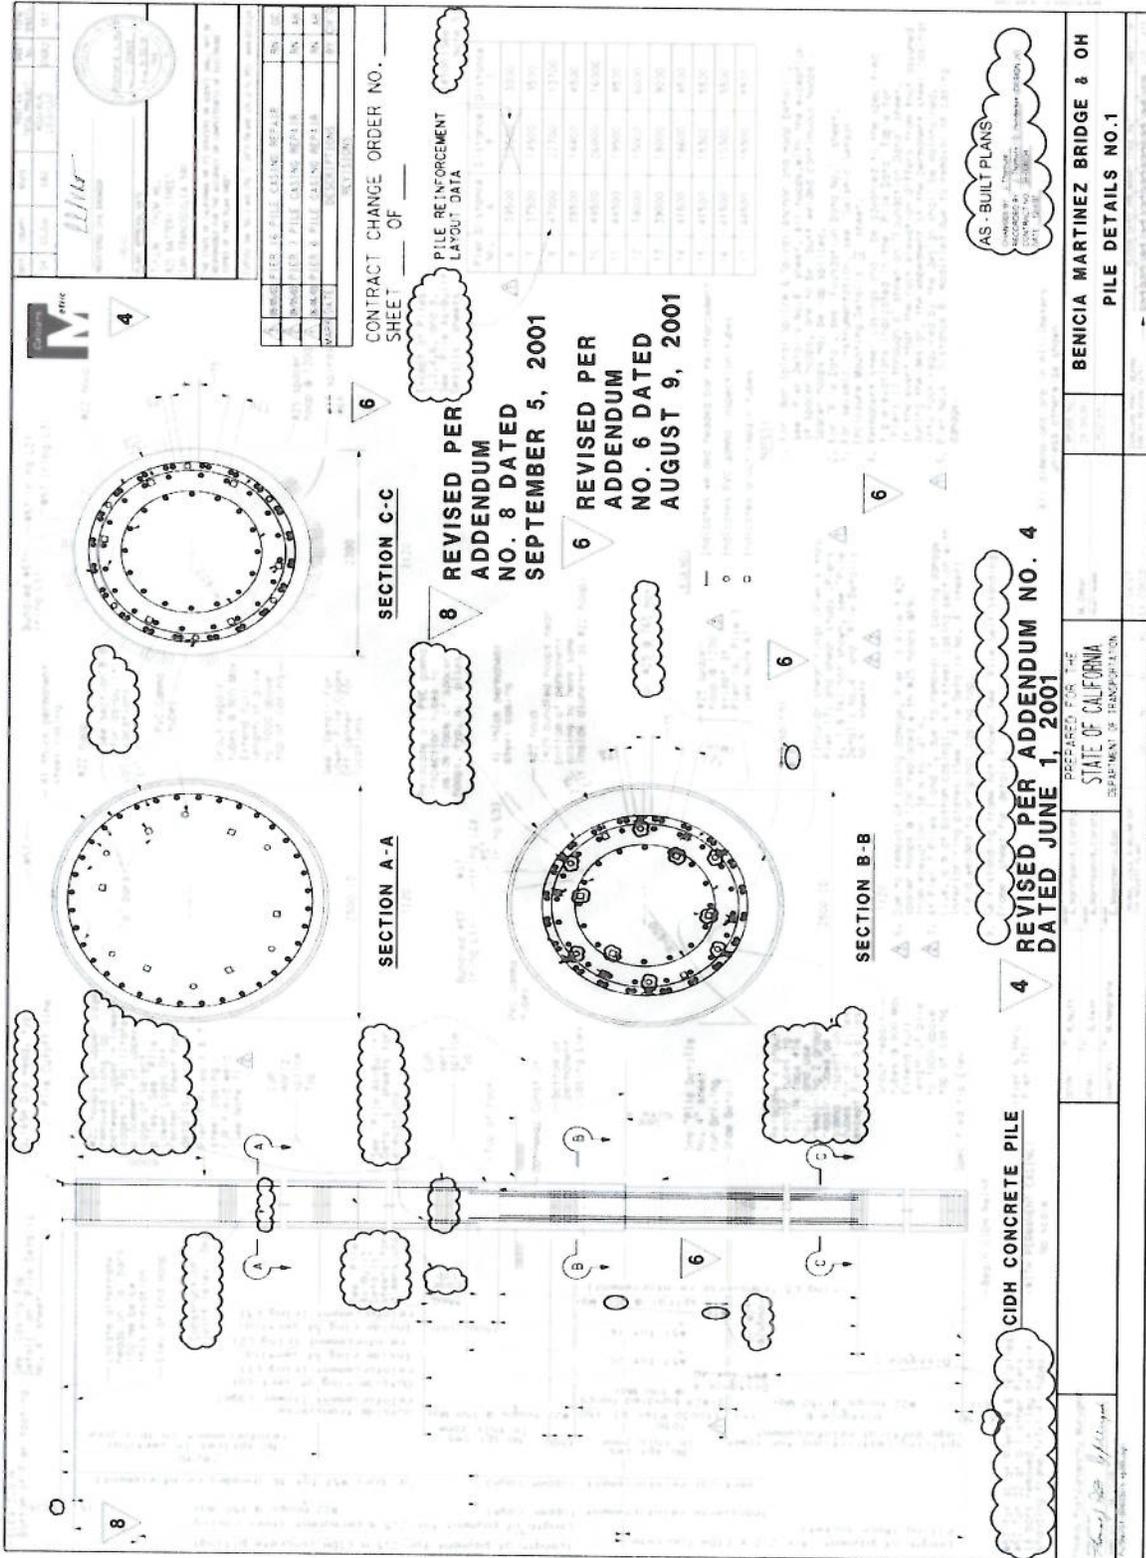
# Attachment 14 As-Built Pile Details

The lower two regions of the pile are not cased and have a diameter of 2.2 meters (7.2 ft). Main reinforcement for these regions is the reverse of the cased region, as #18 bars are much less plentiful near the bottom of the pile where bending demands are minimal. Shear capacity is enhanced along all four regions of the pile by use of reinforcement hoops.

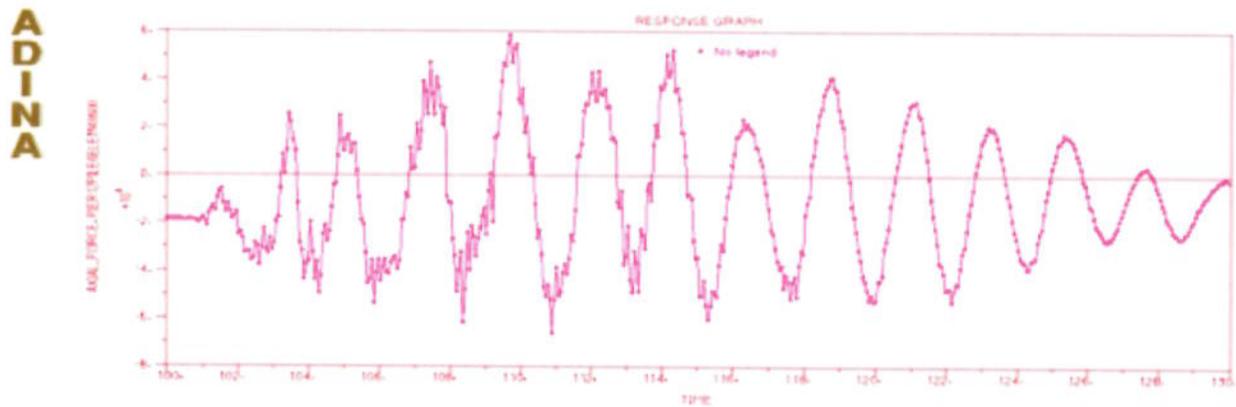
Figure 3: Pier 12 pile 6 axial load vs time plot for top of pile element, time-history set 1

Data extraction from the three time-history ADINA finite element model runs showed great variations in both the bending moment and axial load demands for each element along the piles. For example, Figure 3 shows variations in axial load demand with respect to time for the top element of pile 6 at Pier 12.

ADINA reports compression loads as negative. Note the peak uplift spike of +58561 KN (13164 kips) near time 110. Figure 4 shows variations in resultant bending moment demand with respect to time for the same top of pile element.

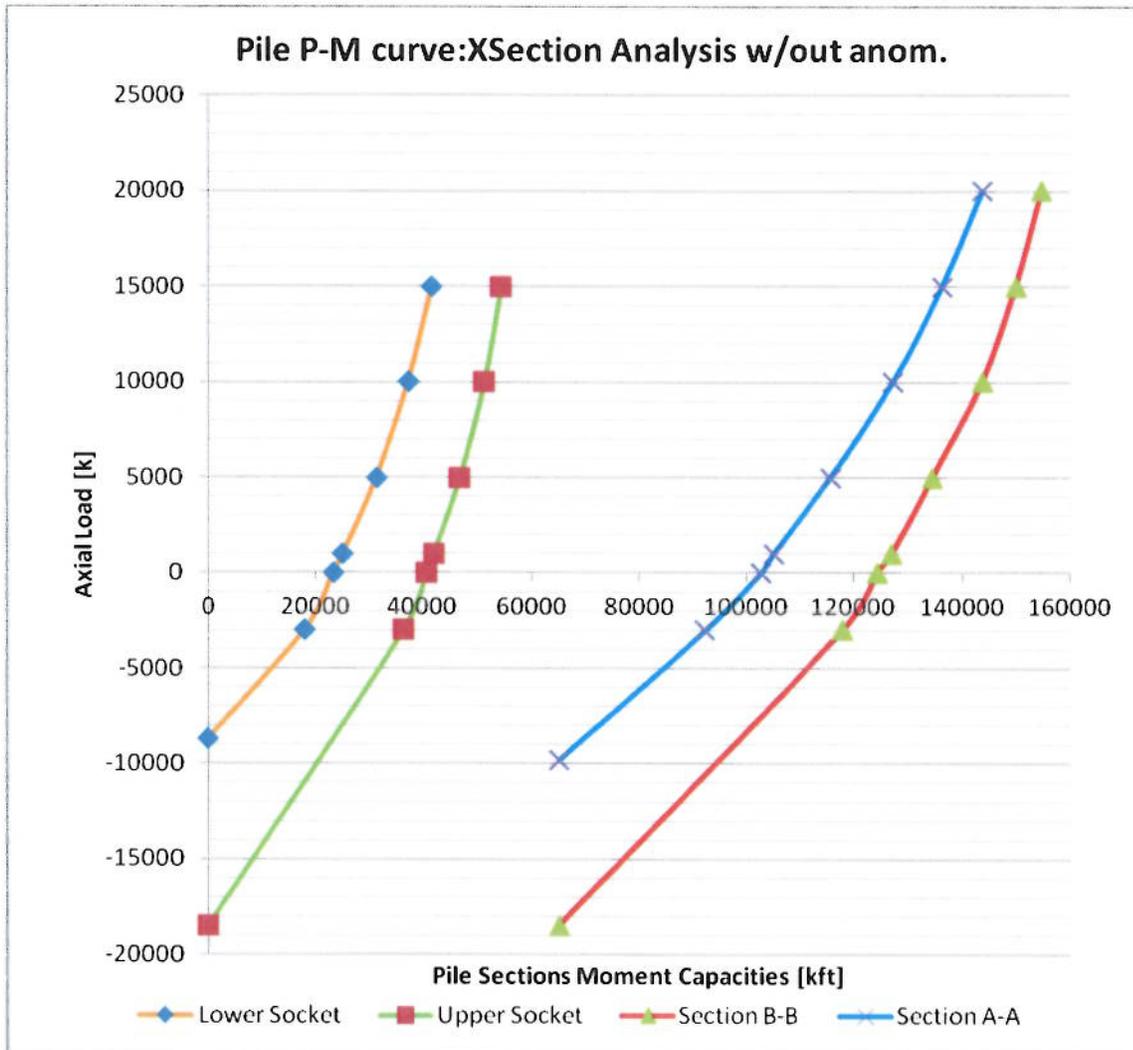
Figure 5: Interaction curves for each region of pile

The bending capacity of each pile was evaluated by using the X-Section analysis tool. The original bending capacity along each pile was recreated before reevaluating suspected anomaly locations. ADINA data was reviewed to assign appropriate axial loads by location so that proper interaction could be followed. Figure 5 graphs interaction curves for all four pile regions prior to anomaly evaluation.

These curves provide bending moment capacity values for the expected range of axial load demands in any region of the pile. Upper sections of pile have much higher capacity due to the presence of the steel casing.

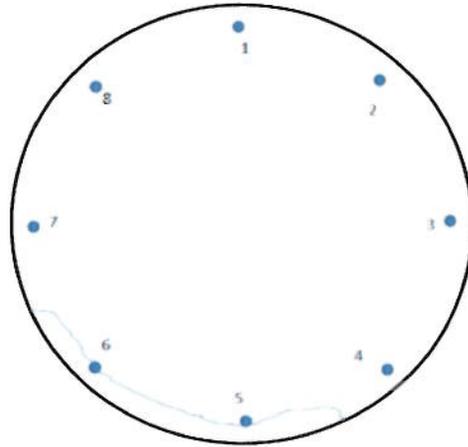
**Figure 6: Typical Anomalous Pile Cross Section**

Bending moment capacity reductions produced by anomalies were also modeled with the XSection analysis tool and compared to demand moments. Areas of suspected anomalies were modeled as low grade (500 psi) concrete. These areas were restricted to portions of the pile outside the core since CSL data showed that the inner portion of the piles was sound. Figure 6 depicts a typical anomalous pile cross section, and Figure 7 shows a typical XSection analysis result.

Section: 1.0m – 1.3m  
 All sections from  
 Top of Construction Joint

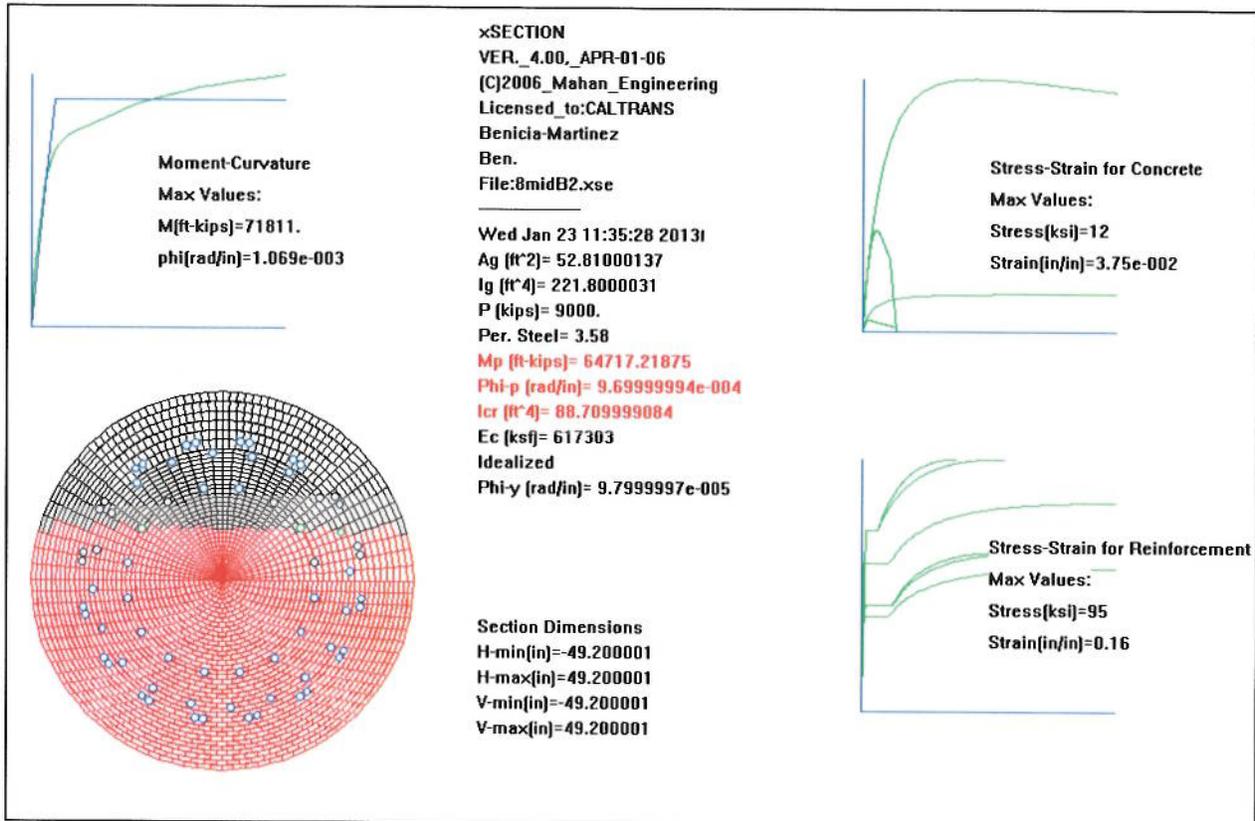
**Figure 7: Typical XSection Evaluation**

Note: Rotated for Minimum Capacity
