A Report on the Corrosion of the Underground Sprinkler System at the Pacific State Hospital

February 1959

R.F. Stratfull

State of California  
Department of Public Works  
Division of Highways  
Materials and Research Department

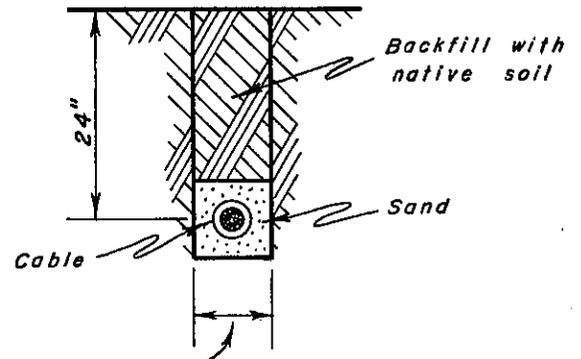
## CABLE DETAIL

Cable trench width equals 3" plus O.D. of cable.

Cable shall have a min. of 1 1/2" sand blanket all around in expansive clay soils. In sandy soils, omit sand blanket and trench width to be minimum of 1" plus O.D. of cable.

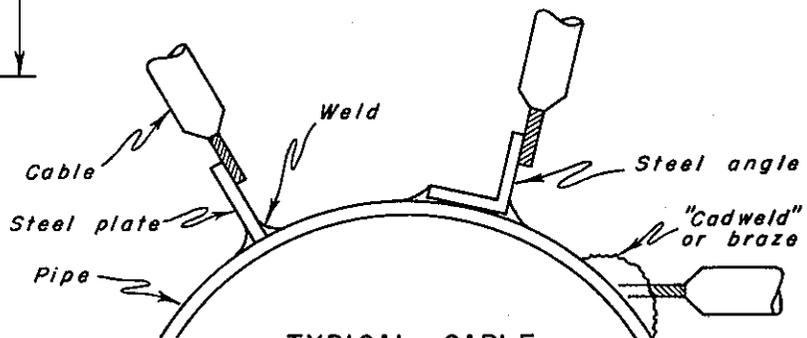
### TYPICAL CABLE CONNECTIONS TO PIPE

Minimum dimensions of steel connector to be 3/8" thick and 2" in other directions. Cable to have a min. of 1" length brazed or otherwise connected to steel connector or pipe. The steel connector is to be welded all around. Pro-Seal EP-711, or equal, shall be spread a min. of 1/2" thick 3" beyond all exposed metals used for connecting the cable to the pipe. A sand blanket shall be placed 6" in all directions from the cable connection prior to backfilling with native soil.

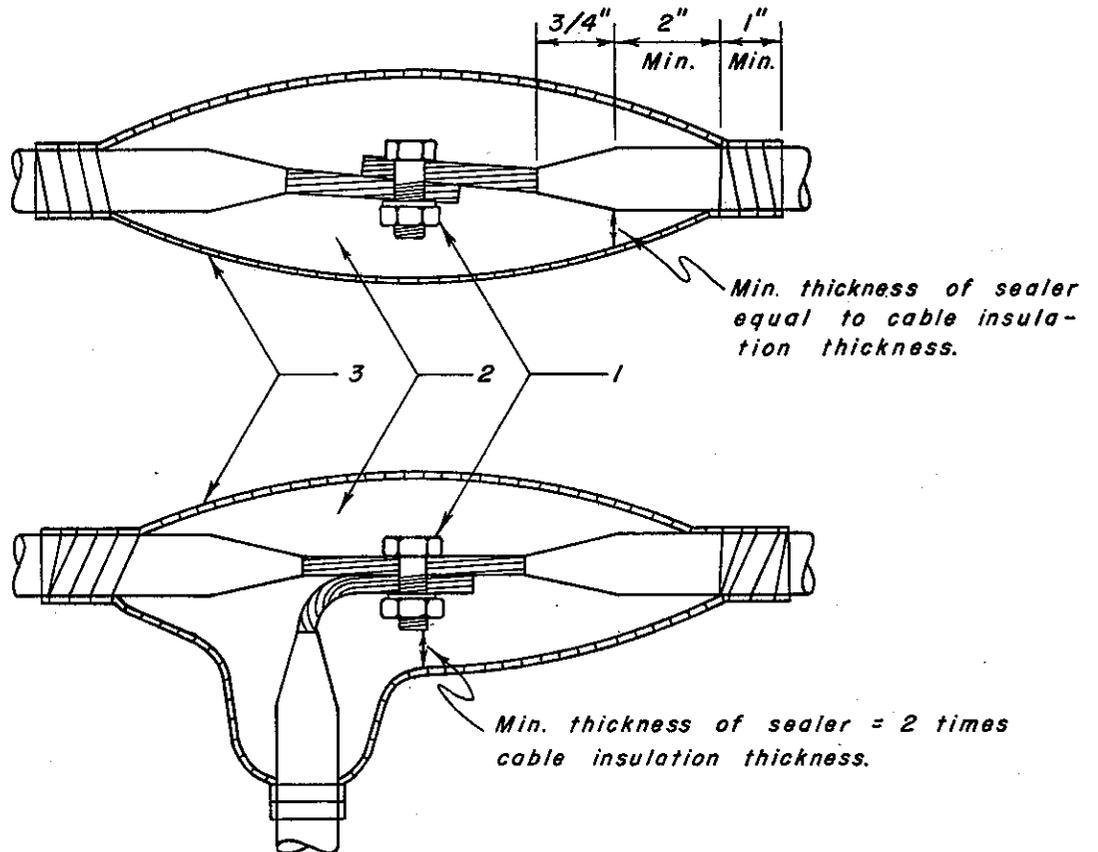
## CATHODIC PROTECTION CABLE SPLICING DETAIL

1. Split bolt connector or equal.
2. Sealer - Use Pro-Seal EP 711 or equal. (Coast Pro-Seal & Mfg. Co., Los Angeles.)
3. Minimum of three layers half lapped of "Scotch" No. 33 Electrical tape or equal.

Cable at the splice shall be free of dirt, grease, or other foreign matter prior to the application of sealing materials.

2. All splices of the anode lead wires to the main feeder lines shall be made by split bolt connector, brazing, or the Cadweld process, or equal.
3. All underground wire splices shall be adequately protected from current leakage through the soil by using a Scotch-cast Splicing Kit containing No. 4 resin or equal.
