Expansion and Contraction of Asphalt Concrete Mixes

EXPANSION AND CONTRACTION
OF
ASPHALT CONCRETE MIXES

Presented at the 44th Annual Meeting of the
Highway Research Board
January 1965

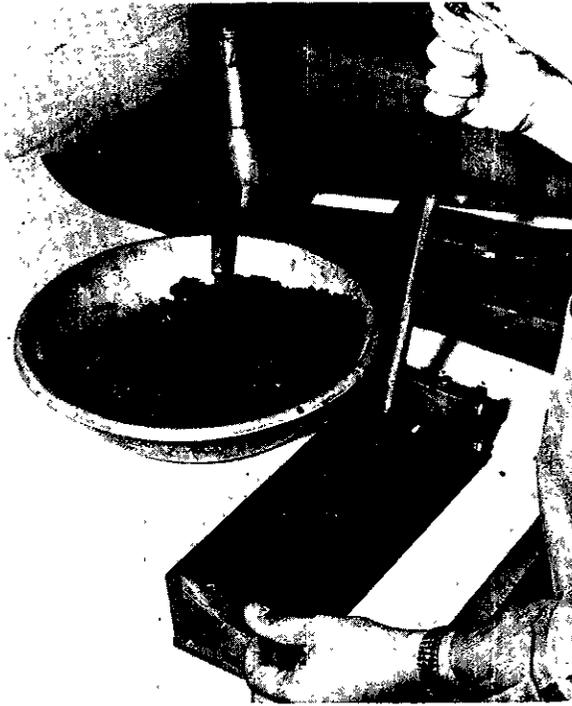
Fig. A - AC mix being rodded with 3/8" bullet nose rod.

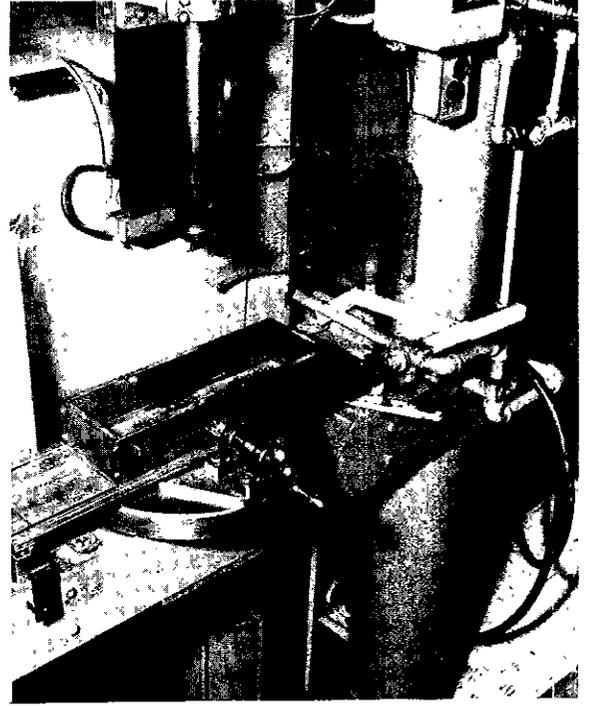
Fig. B - Mold carriage which holds steel mold during compaction.

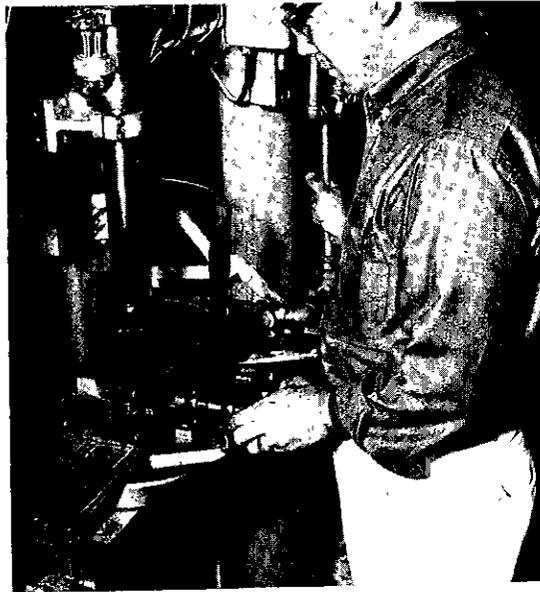
Fig. C - AC mix ready to be compacted. Note rectangular compacting foot (2" x 3")

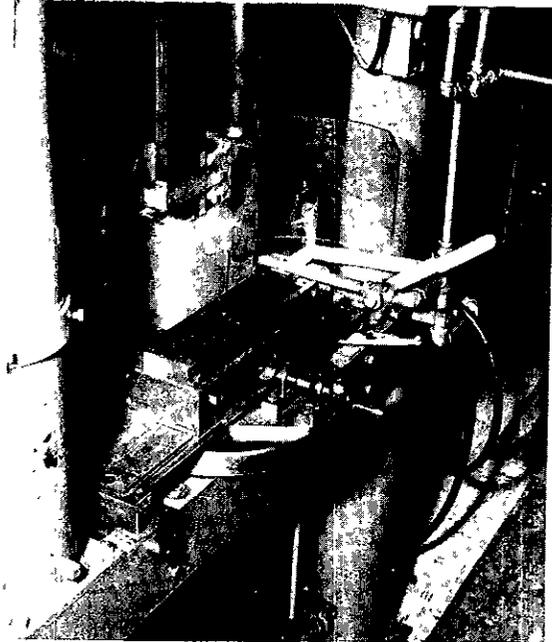
Fig. D - AC bar being fabricated. Crank is turned 1/4 revolution after each stroke of compactor foot.

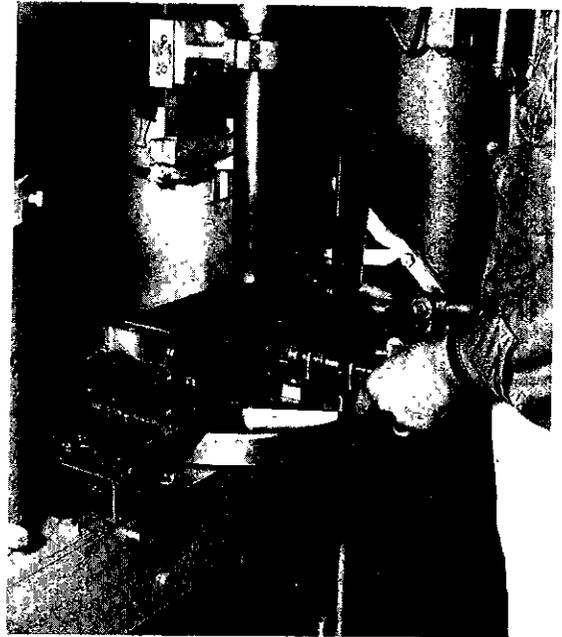
Fig. E - AC bar receiving leveling off load.

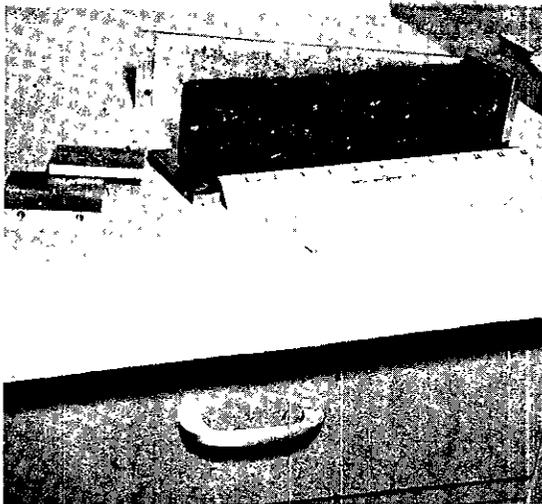
Fig. F - Metal mold being stripped from AC bar. Note steel pins used for measurement.

Briefly, the method consists of heating the AC mixture to 230°F, rodding it into 2 layers in the preheated mold, and compacting it with our kneading compactor. Upon cooling, the mold is stripped and the steel pins at the end of the specimen are fastened into place with epoxy. The bar is then placed in a 100°F oven for 3 days for curing. It is then subjected to the weathering cycles, one cycle consisting of 7 days in a moist room and 7 days in a 100°F oven. Daily measurements are made and any cracks or unusual

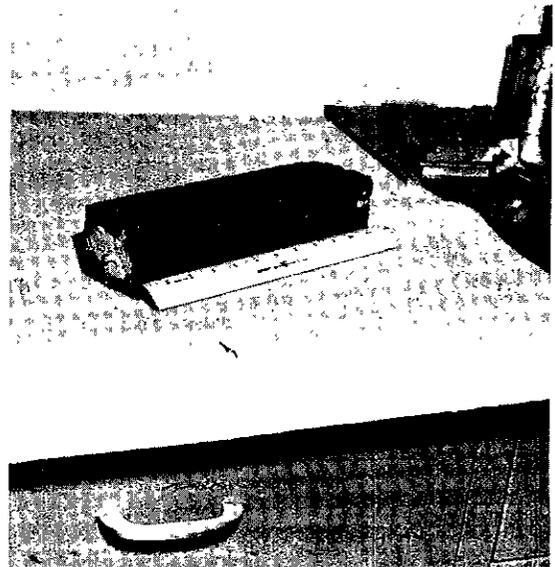
Fig. G - Finished AC bar showing steel pins secured into bar with epoxy.

10. Secure steel end pins to test specimen with epoxy resin.
11. Leave specimen in 100°F oven for approximately 63 hours.

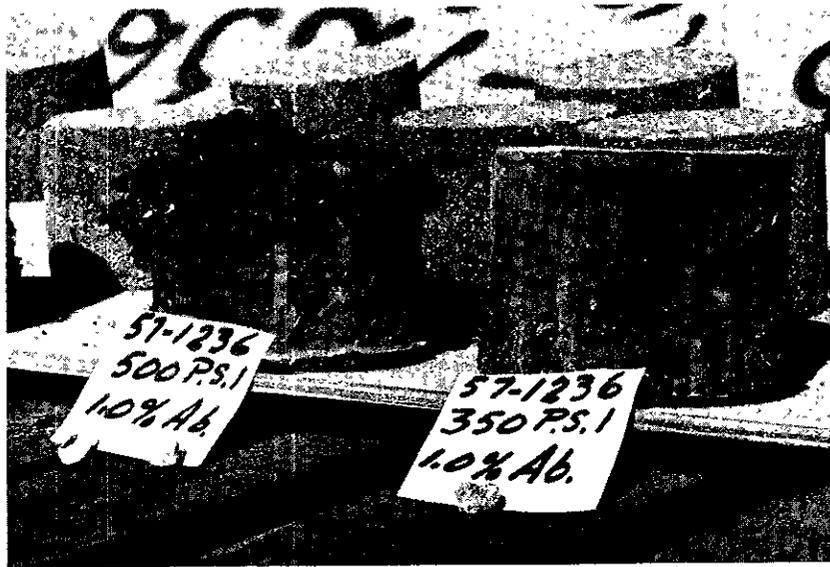
Fig. 1 - Epoxy coated specimen exposed on roof at end of 6 months. Both specimens fabricated from absorptive aggregates.
Left - Specimen compacted at 500 psi.
Right - Specimen compacted at 350 psi.

highly absorptive aggregates and compacted at 500 psi were showing signs of expanding. Hairline cracking and stretch marks were visible in the epoxy coating. About three months from the time the specimens were placed on the roof, the first signs of cracking appeared in the epoxy coating. The other briquettes, nonabsorptive and uncoated, under the same environment showed no signs of stress. This also includes the highly absorptive specimens compacted at 350 psi. However, at the end of six months, signs of distress were visible in the coating of the absorptive specimens compacted at 350 psi. (Figure 1) We believe the reason the highly absorptive specimens compacted at 500 psi ruptured their epoxy coating, before the identical AC samples compacted at 350 psi, is primarily due to insufficient void space. The samples compacted at 350 psi, obviously possessed a greater percentage of air voids than the briquettes compacted at 500 psi. This additional void space permitted the absorptive aggregates to expand without bursting their epoxy coating. However, when the aggregate's volume increase became greater than the available voids in the compacted briquette, the specimens compacted at a lower pressure also ruptured.

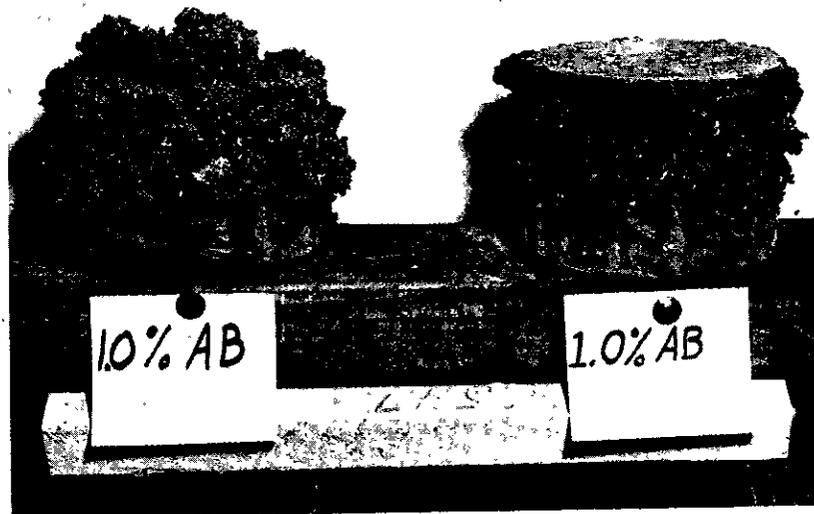
Fig. 2 - Same specimen as in Fig. 1 after 1 year.

At the end of one year, the highly absorptive specimens compacted at 350 and 500 psi had completely ruptured their epoxy coating. (Figure 2) However, for the same

In answer to the first question, we might state that there probably were microscopic holes in the epoxy coating and asphalt binder. These small openings allowed the moisture to pass through the epoxy and asphalt protective coatings. The absorption of moisture by the aggregates caused a sufficient increase in volume to crack the epoxy coating.

This destructive cycle of moisture absorption and expansion continued until the AC briquettes were completely ruptured. (Figure 2)

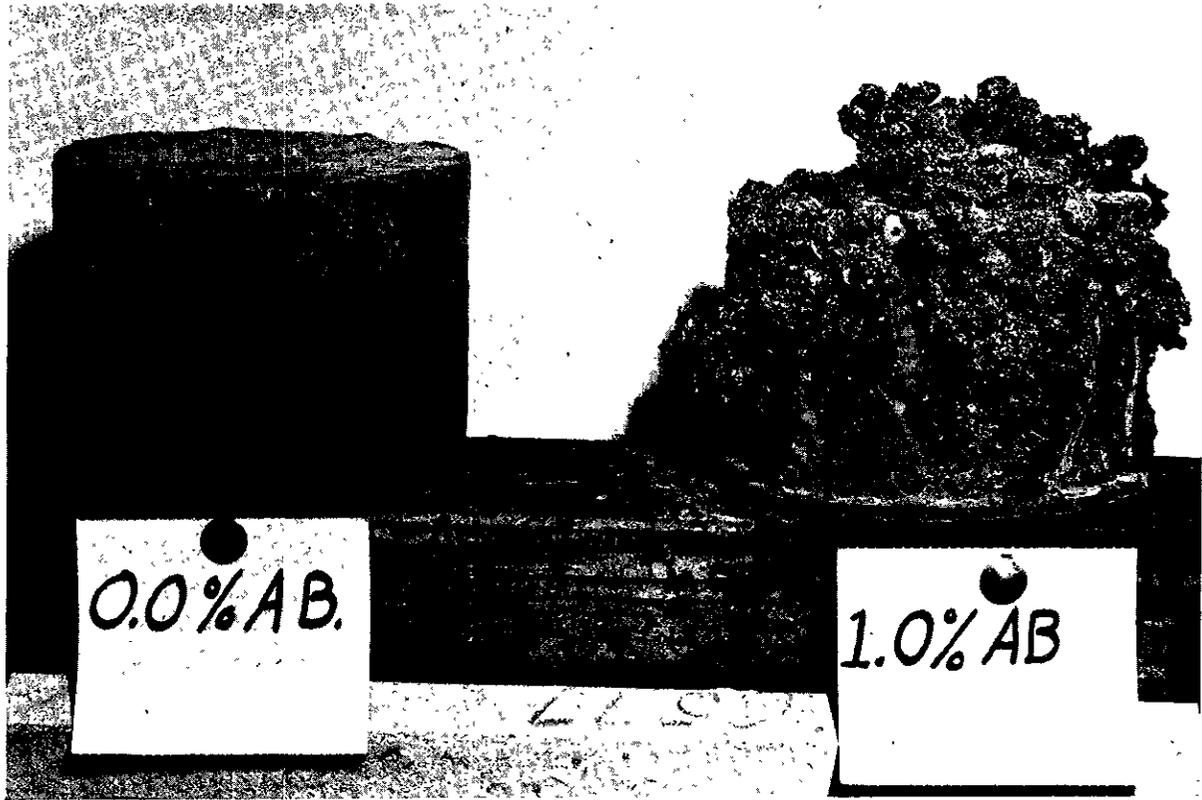
Fig. 3 - Epoxy coated specimen after 1 year.
Left - Nonabsorptive aggregate.
Right - Absorptive aggregate.

period of time, the nonabsorptive capsulated specimens remained in excellent condition. (Figure 3)

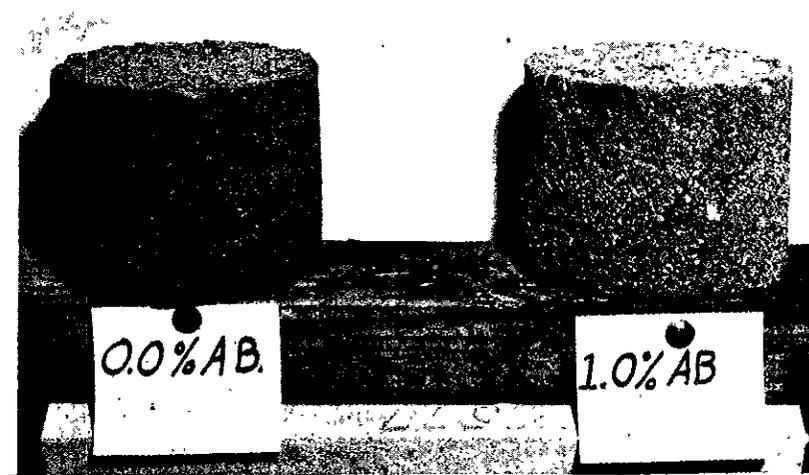
Fig. 4 - Noncapsulated specimen exposed on roof after 6 months.
Left - Nonabsorptive aggregate.
Right - Absorptive aggregate.

The specimens that were not capsulated showed the same trend. The absorptive briquettes had cracks over the entire surface, while the nonabsorptive briquettes showed no signs of cracking. Figure 4 shows their appearance after 6 months. After 6 years the diameter of the absorptive (1.0%) specimen increased from 4.0 inches to an average of 4.25 inches. The height increased from 3.0 inches to 3.15 inches. This is an increase of 18.8% in volume. No expansion in volume occurred in the nonabsorptive briquette. (Figure 5)

The absorptive briquettes which were not capsulated, (Figure 4), had noticeable cracks over their entire surface. Their movements were not confined, allowing expansion and contraction to occur without complete rupture, which was not the case with the capsulated briquettes.

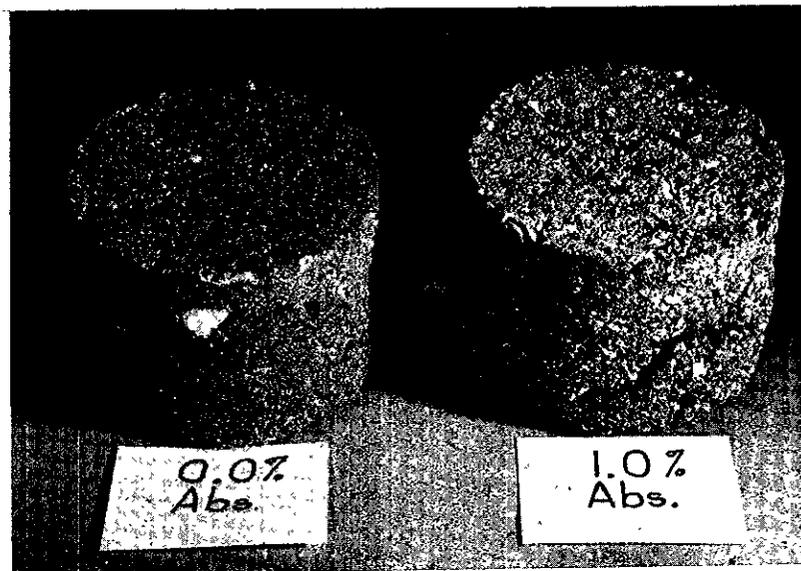
Fig. 5 - Same briquette as shown in Fig. 4. After 6 years.
The briquette made from absorptive aggregates (1.0%) had an increase in volume of 18.8%. No increase in volume was noticed in the briquette fabricated from the nonabsorptive (0.0%) aggregate.

Both absorptive and nonabsorptive briquettes which were stored in a cabinet free from sunlight and moisture remained in excellent condition. Figure 7 shows the appearance of these specimens after 6 years. For comparison, identical specimens stored on the roof for 6 years (Figure 5) are shown.

volume had occurred. We believe the moisture that did enter the briquettes was adsorbed and retained in the void spaces. The hard nonabsorptive aggregates did not absorb moisture; therefore, no over-all expansion was noticed.

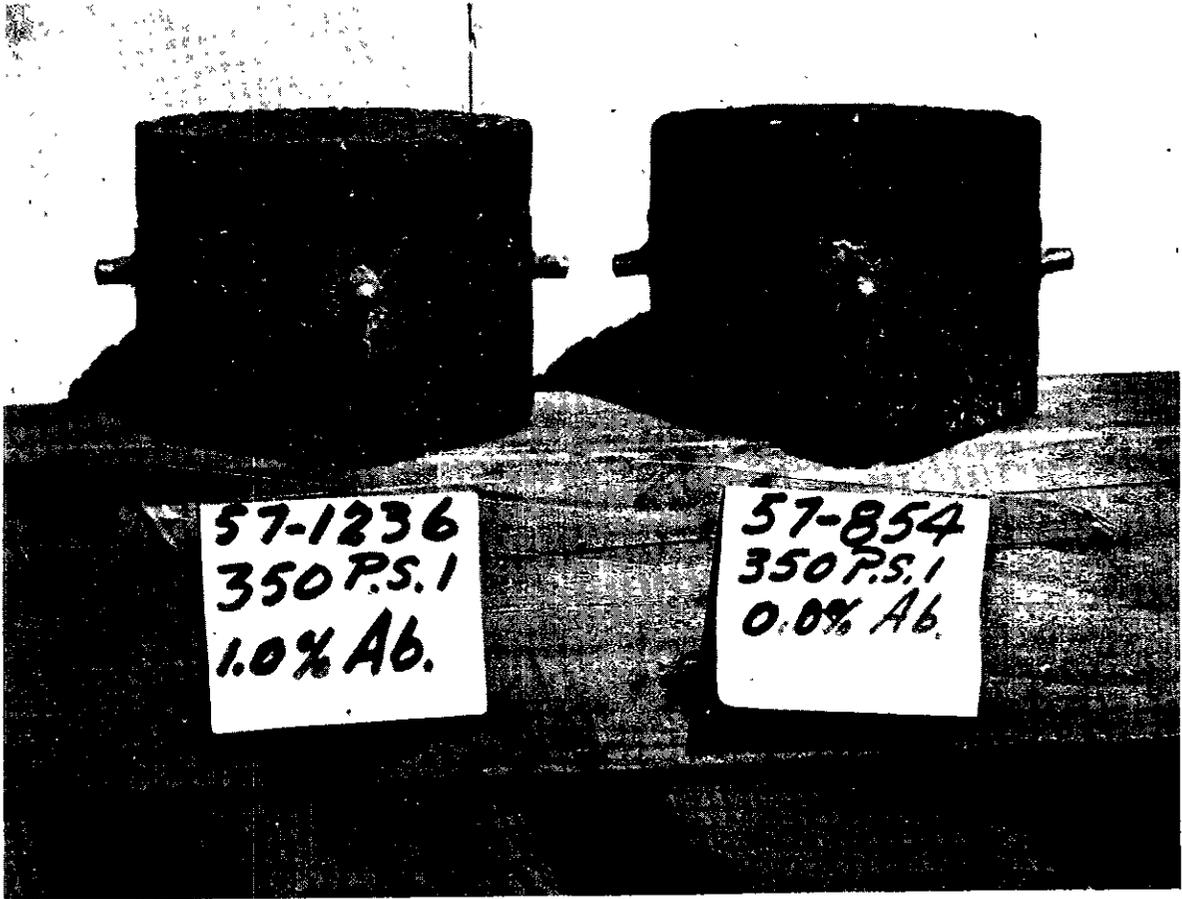
Fig. 6 - Stainless steel pins cemented to sides of specimen to measure volume changes.

After noticing this volume change in the absorptive AC specimen, we made our first attempt to measure the amount of expansion. To the vertical sides of the test specimen made from absorptive and nonabsorptive mixes, $\frac{1}{2}$ " long stainless steel reference pins were cemented with epoxy resin. (Figure 6) The specimens were then placed on the roof and expansion measurements were made. However, after about one week, the weight of the pins and the ambient temperature caused the mix around the pins to soften and disintegrate. As will be mentioned later, this problem was overcome by measuring the volume change of a slab and test beam specimen.

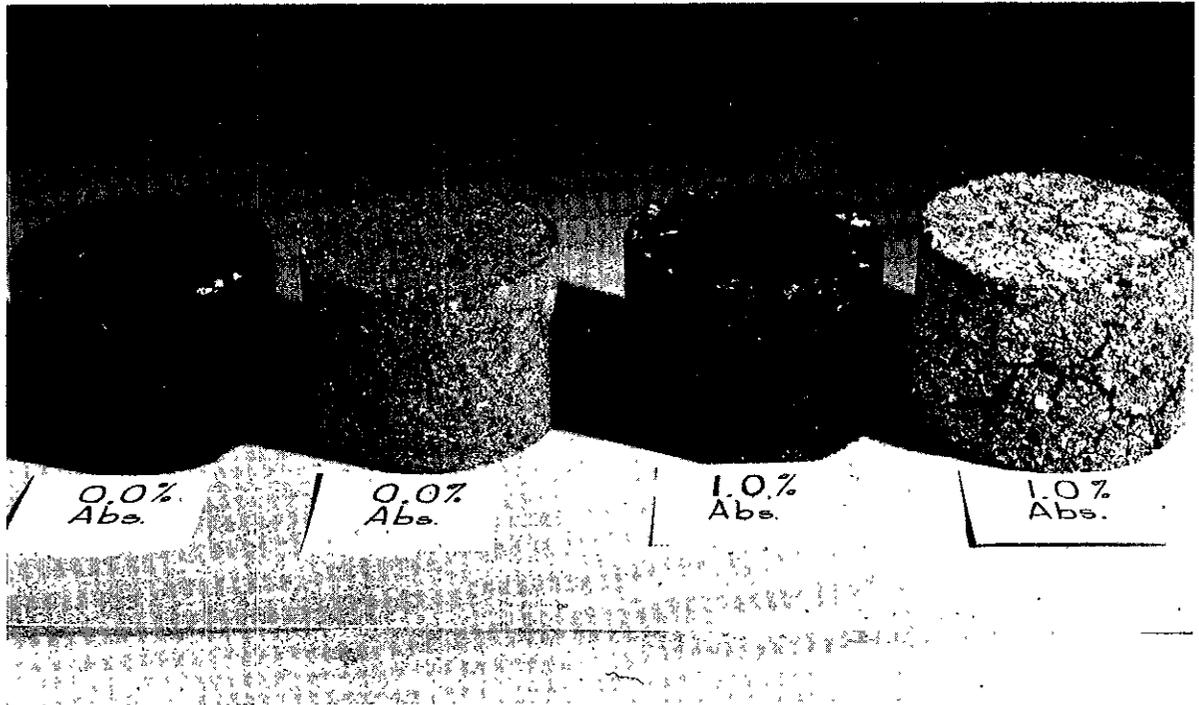
Fig. 7 - Absorptive and nonabsorptive AC briquettes.
Dark colored specimen stored in cabinet for 6 years.
Light colored specimen exposed on roof for 6 years.

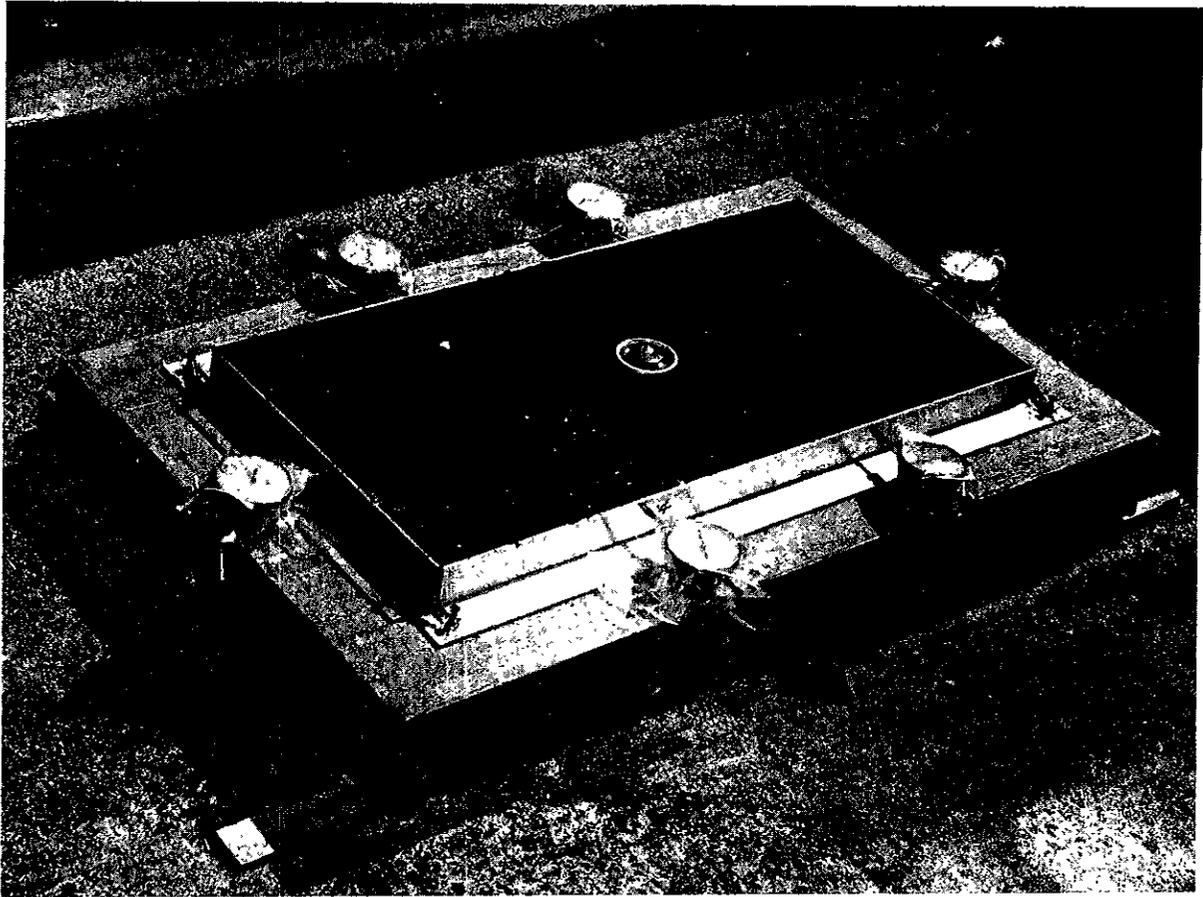
Fig. 8 - Slab specimen 1' x 2' x 3". Note springs holding aluminum sides surrounding surface course.

In order to obtain better measurements, we decided to fabricate a test slab 1' x 2' x 3" thick. A sample of absorptive aggregate (Table 1) was obtained and mixed with 6.3% of 85/100 penetration paving asphalt. The aggregates and asphalt were mixed under controlled conditions in a Hobart Mixer. This procedure for mixing had been calibrated previously for studies on asphalt hardening against field pugmill mixing. The slab was fabricated in two layers and a syntron hammer used for compaction. The specimen required about 65 lbs. of aggregate and was compacted to a density of 126 lbs/cu.ft.

The test slab was compacted in a heavy wooden split frame and, after compaction, the top portion was removed and replaced with aluminum sides which permitted free expansion and contraction. The unrestrained movement was recorded by six dial indicators, reading to the nearest 0.001", and located around the surface course, see Figure 8.

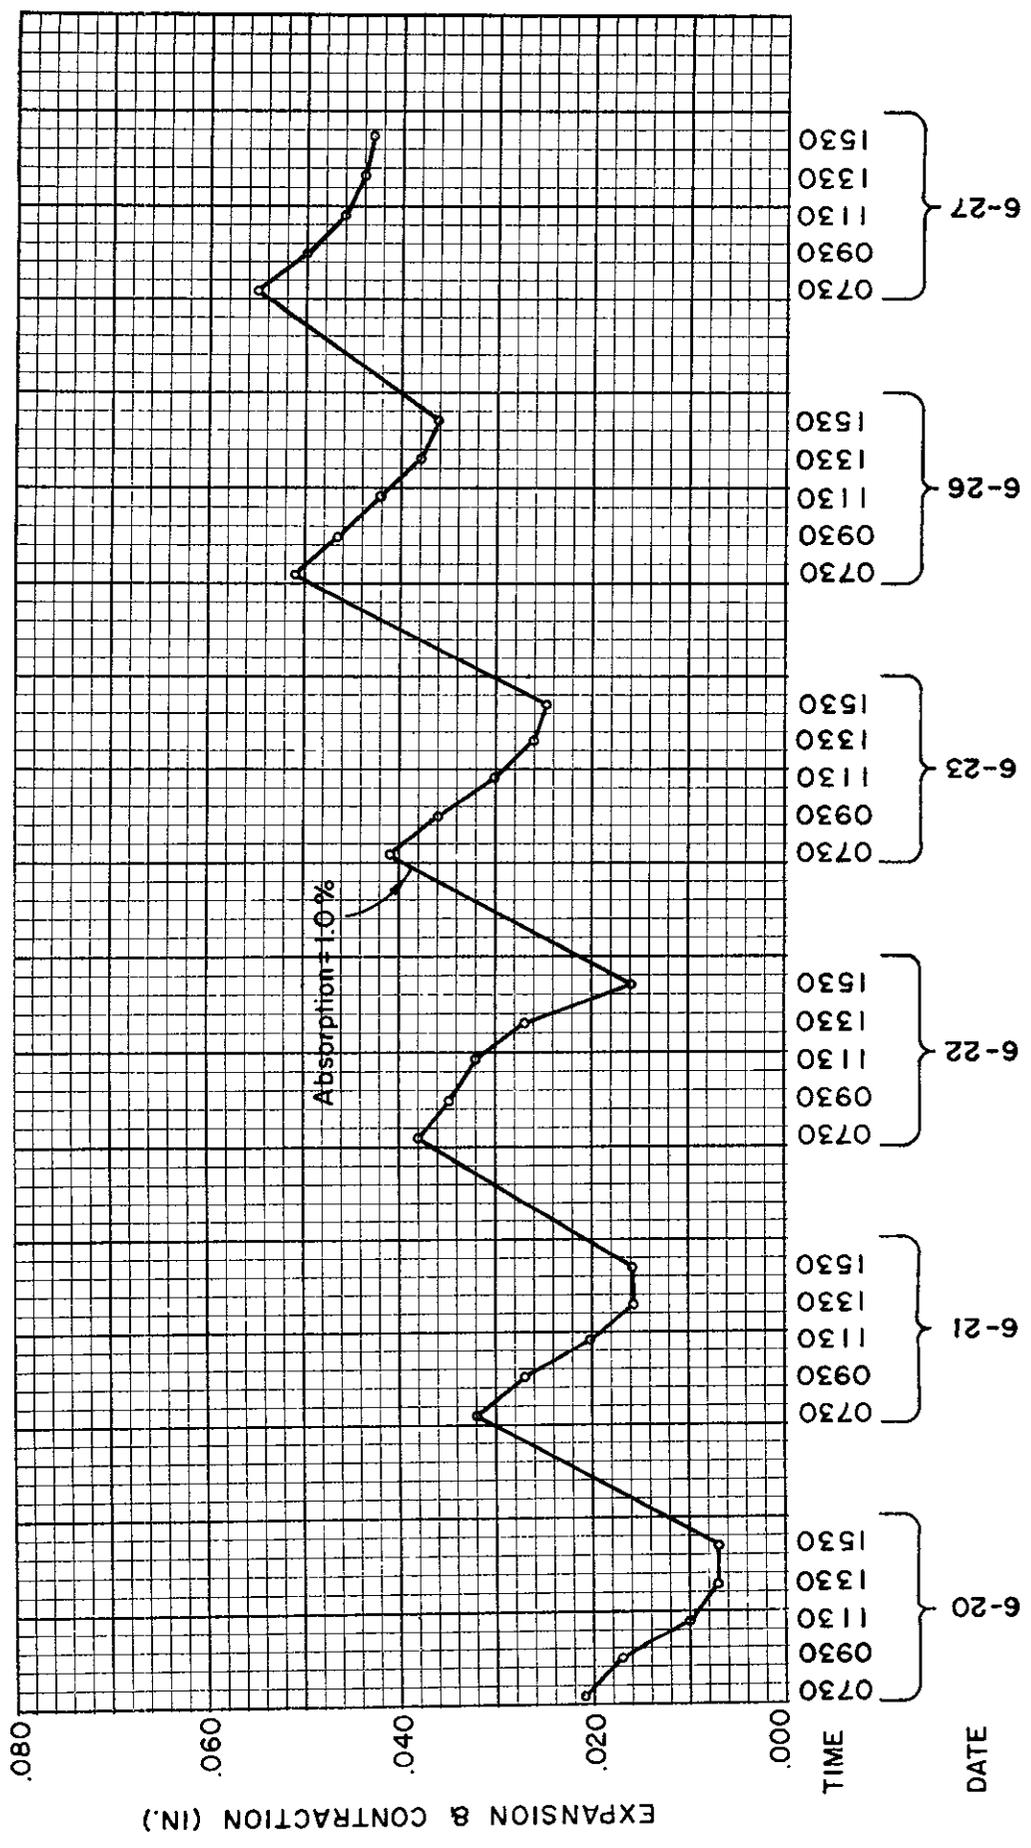
FIGURE 9

TEST NO. 57-1236

Figure 9 represents the expansion and contraction that occurred in a one-week period during the study, which lasted about three months. Figure 10 shows the expansion that occurred during the entire length of test. The cyclic pattern illustrates that maximum expansion for this AC mix occurs during the early morning hours when a considerable amount of moisture is in the atmosphere, while maximum contraction occurs during the warmest hours of the day. It is interesting to note that the test specimen failed to return to its original dimensions during the contraction period. Failure to return to its original size is probably due to structural breakdown of individual aggregates exposed to moisture during the wet cycle. The maximum expansion in width of 0.142" occurred on a day following a rainstorm. The excessive expansion was recorded in September about 3 months after starting date of test. The expansion of 0.142" would have been considerably higher if the lower wooden form had not broken due to the tremendous forces created by the expanding asphalt concrete.

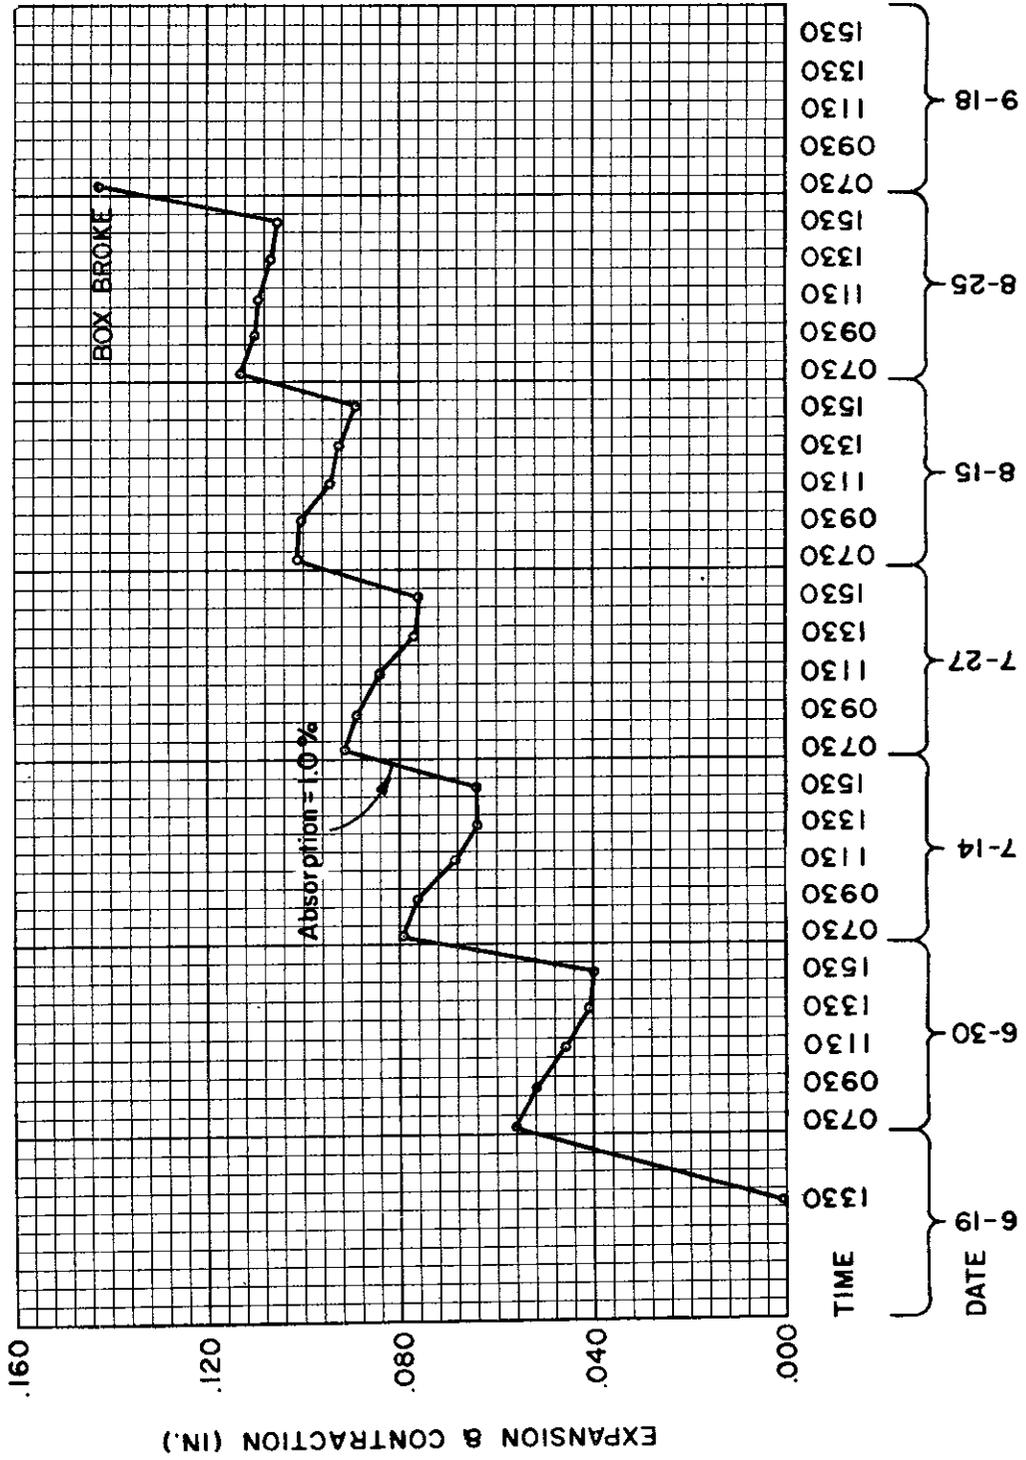
FIGURE 10

TEST NO. 57-1236

higher if the box had not broken and if we had arranged to determine the increase in thickness of the test specimen.

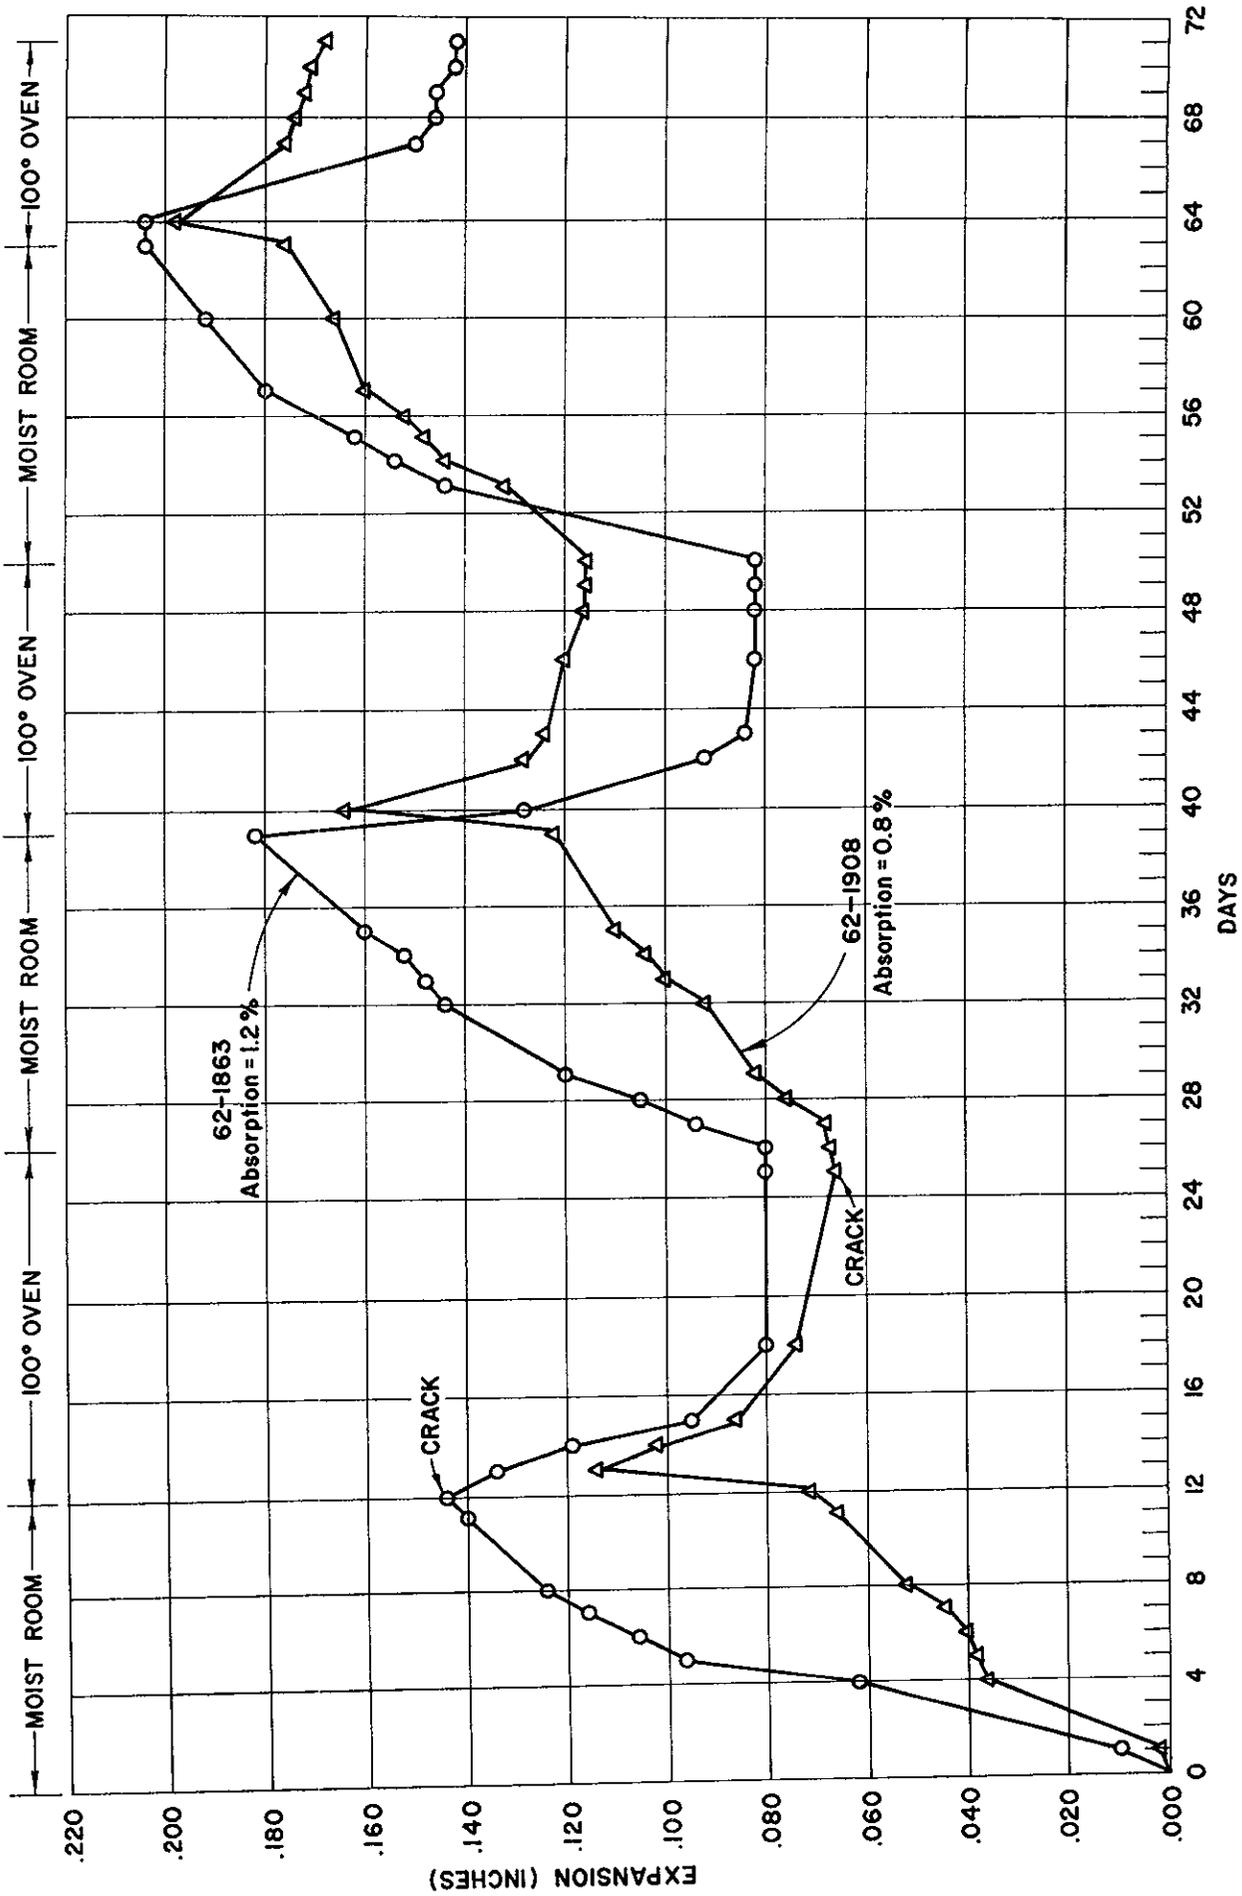
FIGURE 12

TEST NO'S. 62-1863 & 62-1908

Cracks appeared in Sample #62-1863 during the drying period of the first cycle. During the third cycle the sample had expanded over 0.2" with block cracking throughout the entire sample. This expansion of more than 0.2" in a 11.25" bar (1.8% expansion) is the maximum longitudinal increase recorded to date for AC bars.

Transverse cracks were visible on Sample #62-1908 at the end of first cycle. (Figure 13) Rapid expansion (0.045") at the beginning of the drying cycle suggests this specimen is susceptible to moisture in the vapor state. This sample also exhibited several transverse cracks at the

Results show Sample #62-1908 required 13 days in 100°F oven before contraction remained constant. This unusually long period was probably due to the sample's susceptibility to moisture vapor. Sample #62-1863 stopped contracting at the end of six days.

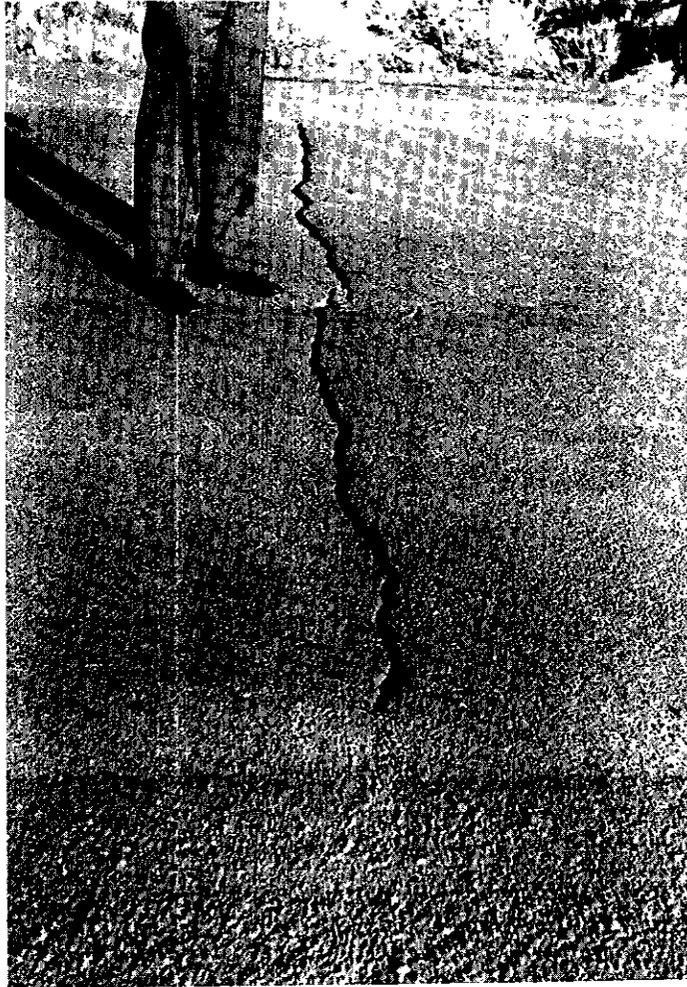
Fig. 15 - Transverse cracks ranging from $3/4$ " to $1-1/2$ " in width.

In 1962 we were asked to investigate an AC pavement failure in one of our districts. This failure (Figure 15) consists of transverse cracks from 3/4" to 1½" wide in the surfacing at irregular intervals ranging from 10 to 20 feet apart throughout the entire project. The pavement was constructed from aggregates obtained from a local pit.

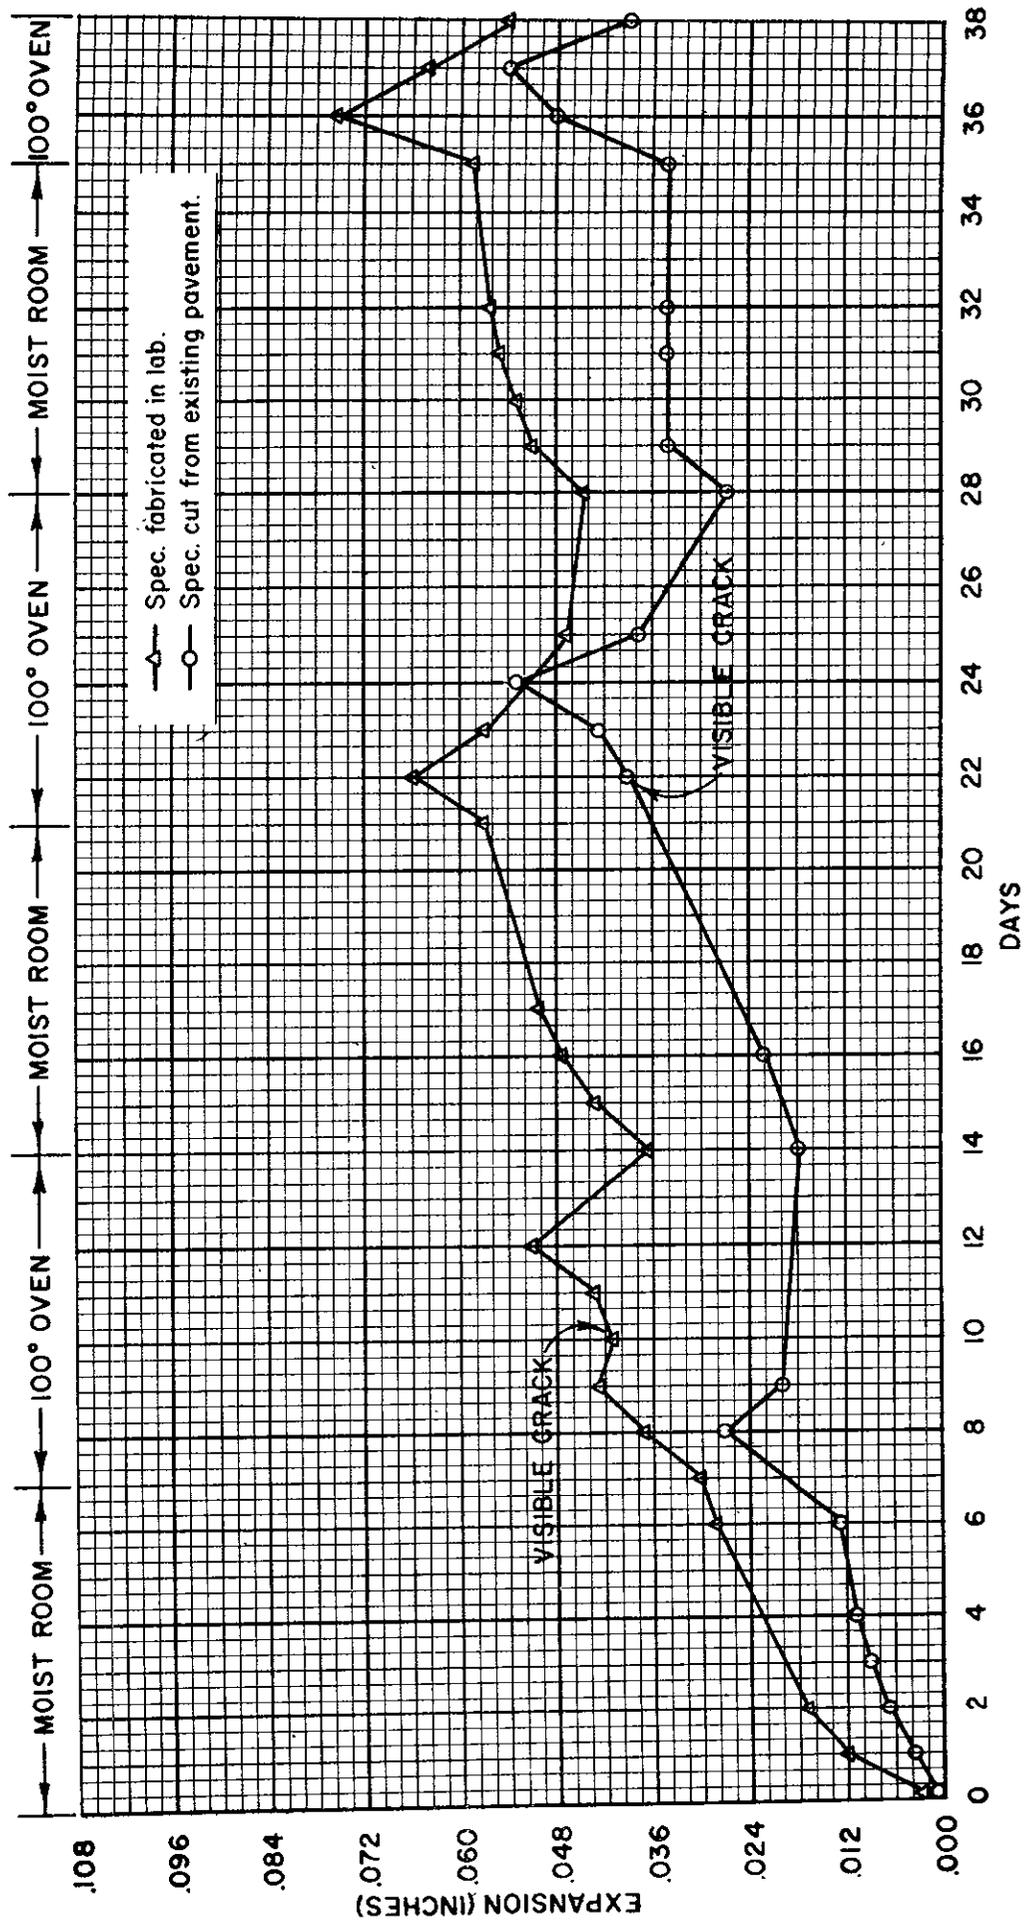
FIGURE 16

TEST NO. 62-5748

To duplicate the field mix design, laboratory specimen were mixed in the Hobart mixer using 6.3% of 85/100 paving asphalt. After mixing, the samples were compacted (see Appendix A) into test bars and placed in the 100^oF oven. After the specified period, the bars were placed in the moist room for the beginning of the test.

Also a test bar 3" x 3" x 11.25" was sawed from a slab sample removed from the existing pavement. The sawed bar was dried in a 100^oF oven to constant weight and then placed in the moist room for the beginning of the test.

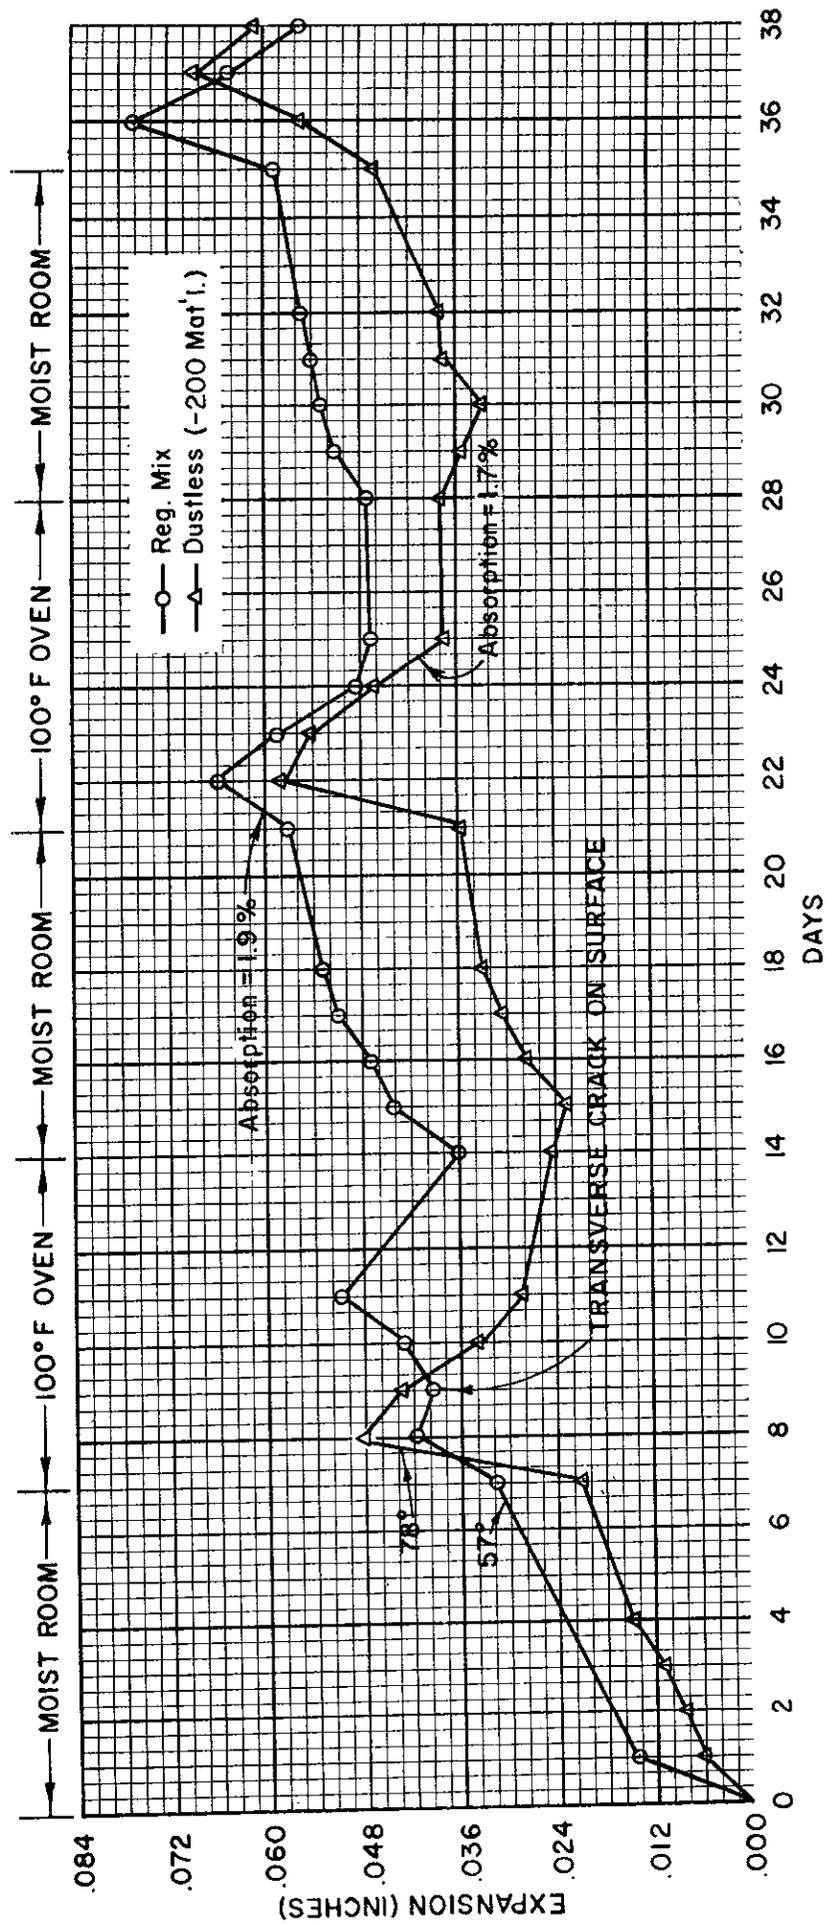
FIGURE 17

TEST NO. 62-5748

2. By wasting the minus 200 material, the natural barrier for keeping the moisture away from the larger absorptive aggregates is removed. Removal of this natural water barrier offers the larger aggregates a constant supply of available water during the wet cycle. When the "dustless" (minus 200 material) mix test bar was placed in the 100^oF oven, the absorbed moisture entrapped in the larger aggregates attempted to escape immediately by evaporation. However, all the moisture could not escape at once through the minute interstices, resulting in vapor pressure rapidly building up during the first few hours of the dry cycle, causing a sharp increase in expansion.
