Expansion and Contraction of Asphalt Concrete Mixes

EXPANSION AND CONTRACTION
OF
ASPHALT CONCRETE MIXES

Presented at the 44th Annual Meeting of the
Highway Research Board
January 1965

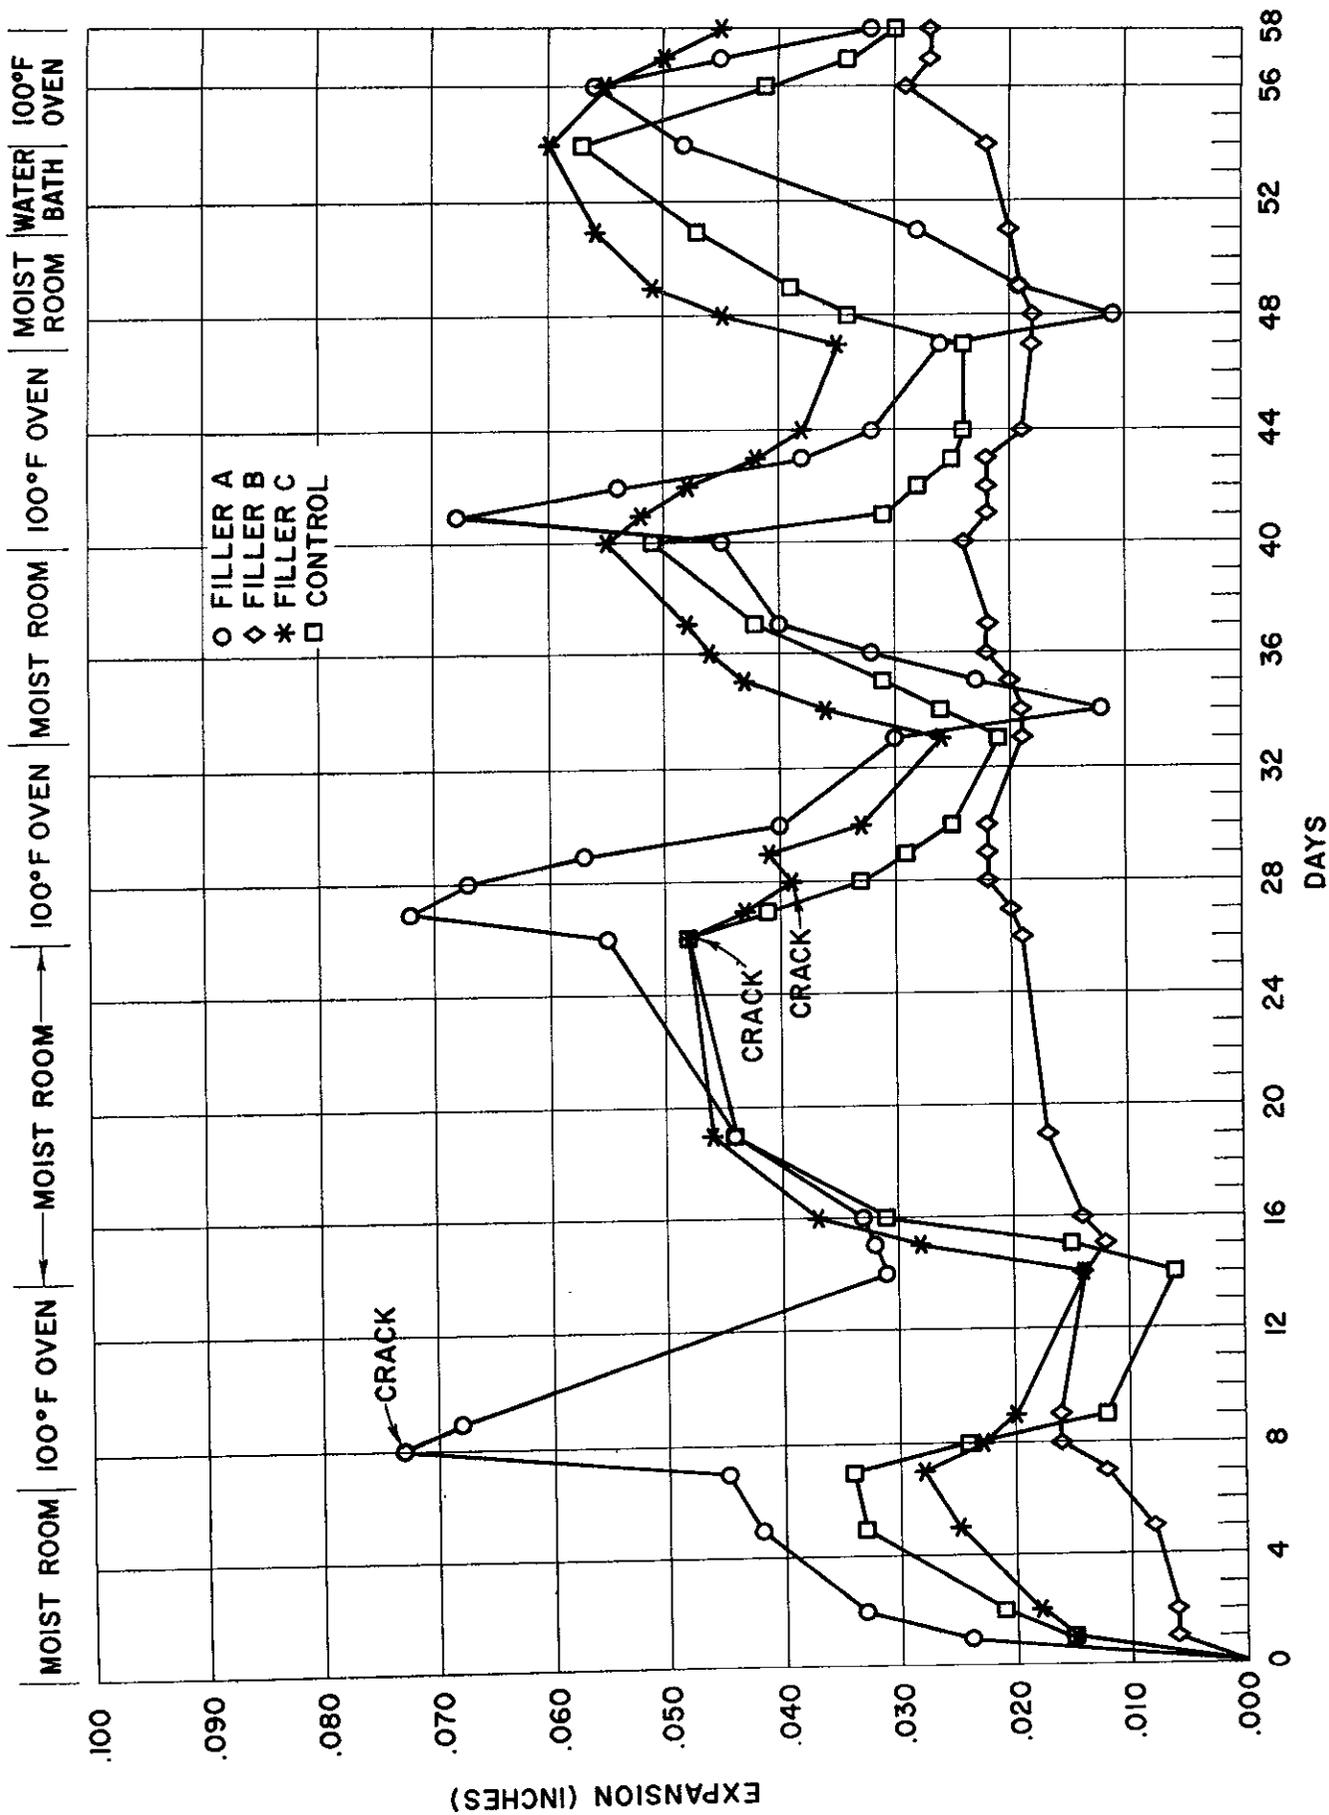
FIGURE 18

EFFECT OF VARIOUS FILLERS

As shown in Figure 18, Filler A expanded excessively during the first hours of the dry cycle. This phenomenon did not occur in the AC control bar or the other AC bars with different fillers added. From results obtained, we assumed that Filler A was the contributing factor which caused this high expansion during the dry cycle. Transverse cracks appeared during the dry period of the first cycle. After cracking, the amount of expansion decreased. This usually occurs when the cracks have progressed through the test bar.

This mineral filler reduced the maximum expansion from 0.057" to 0.029", or 51%, in comparison with the control bar. No cracks were visible on the test bar after four complete cycles.

This filler did suppress expansion during the first cycle. However, the succeeding cycles showed this additive ineffective in decreasing expansion. Cracking appeared during the drying period of the second cycle.

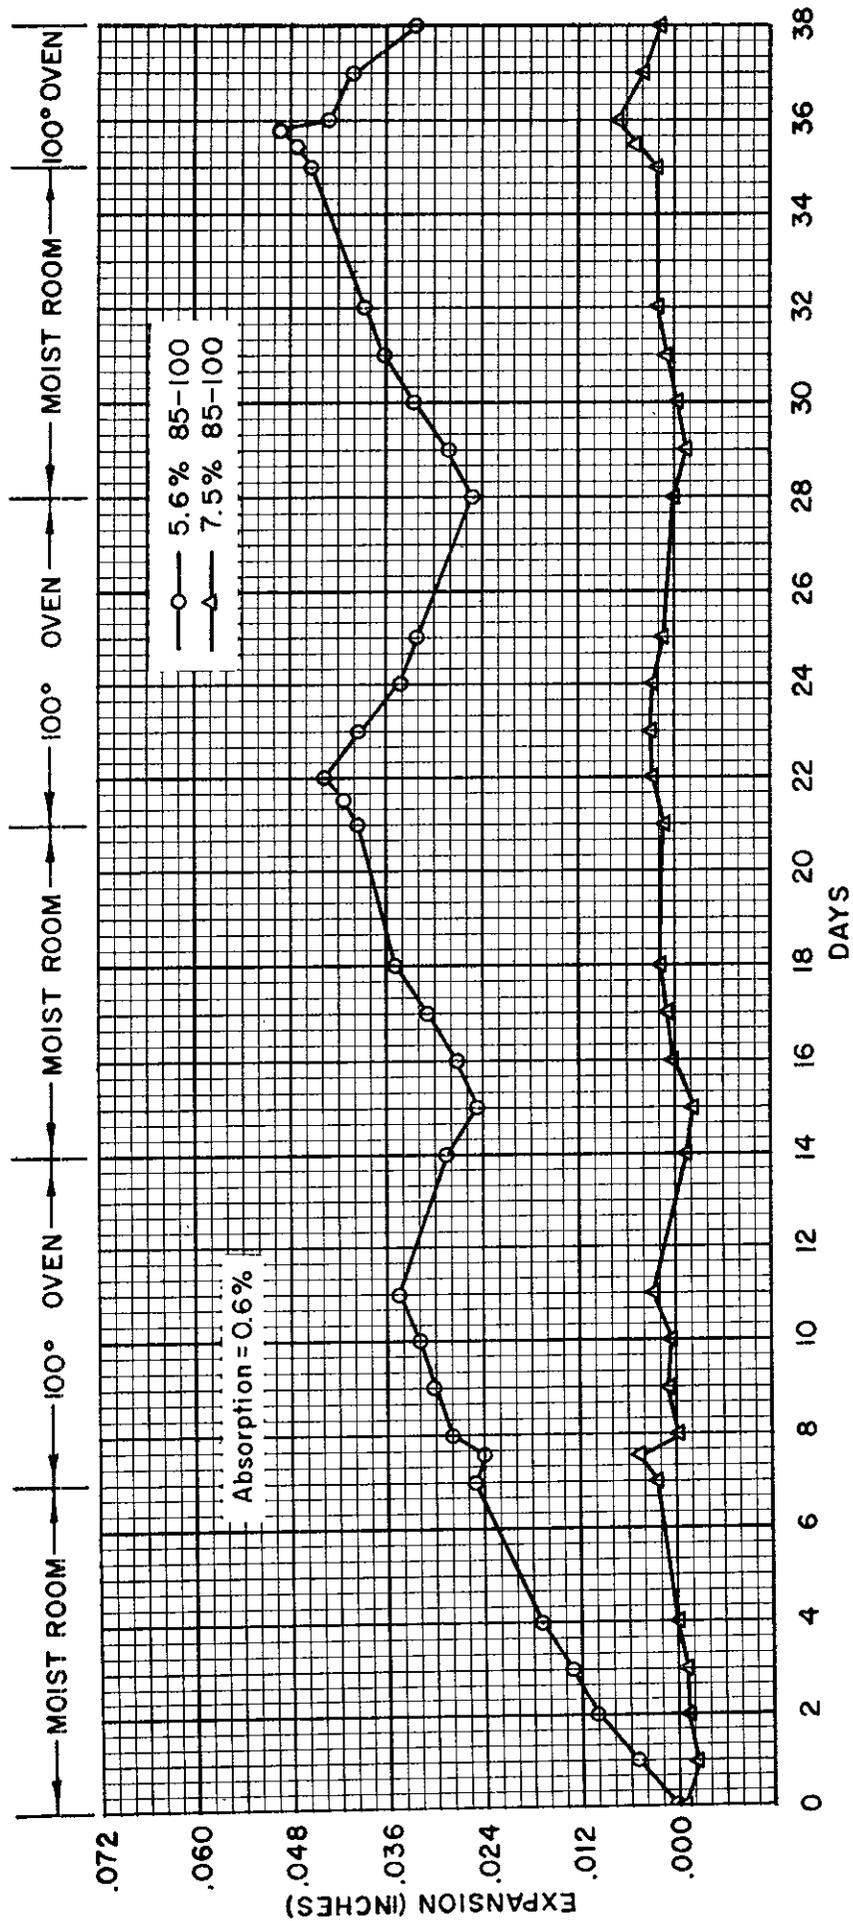
FIGURE 19

TEST NO. 64-1769

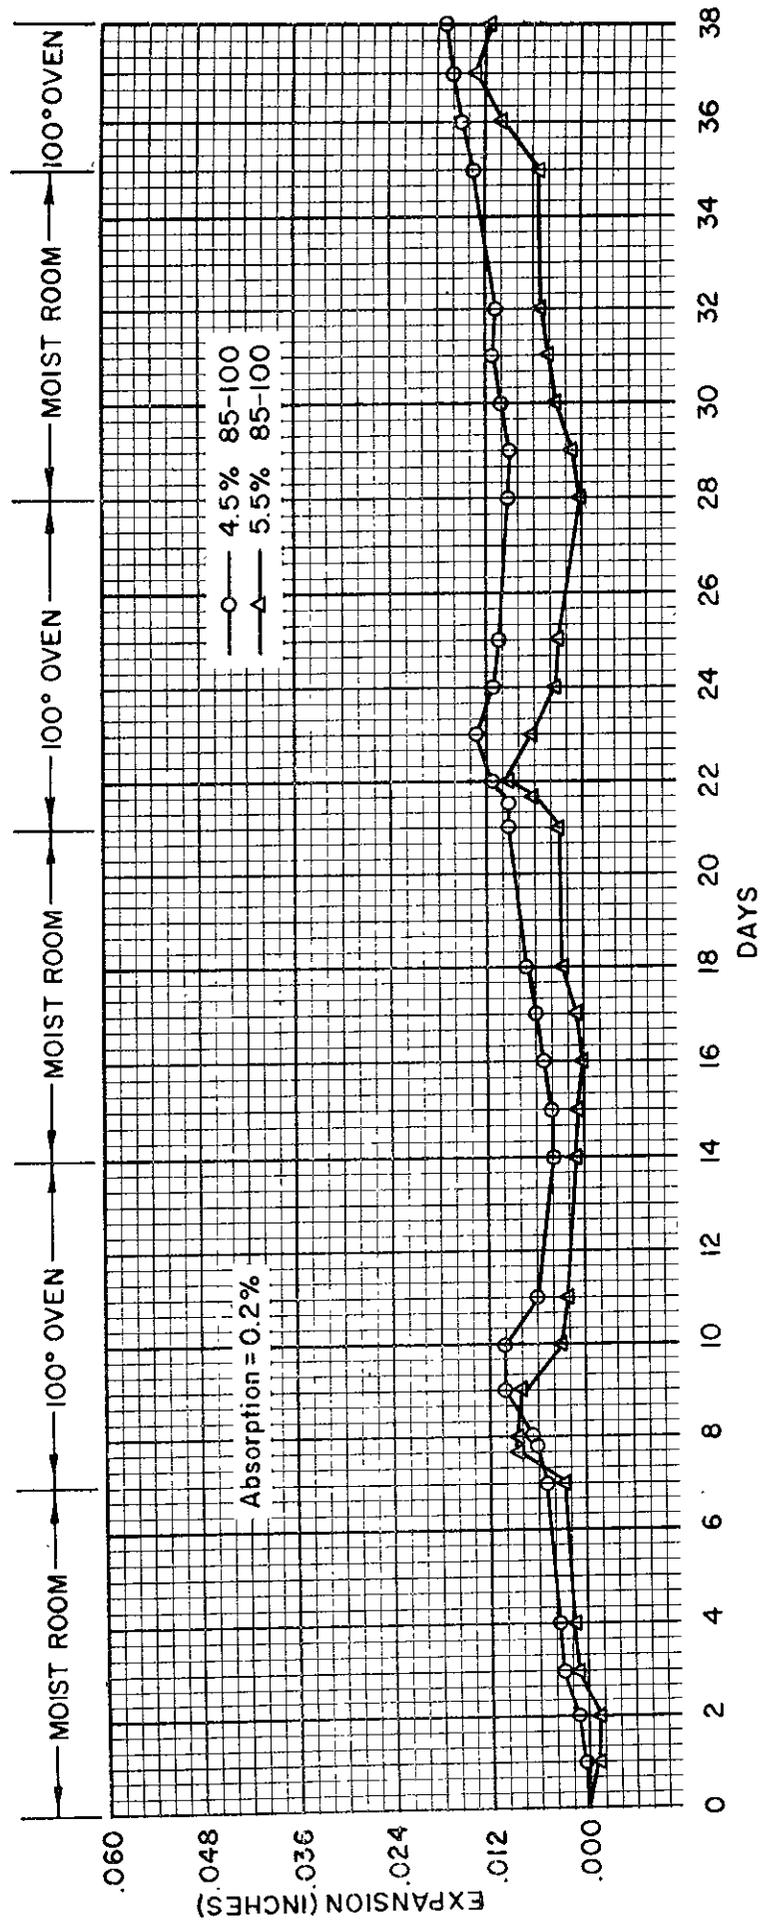
FIGURE 20

TEST NO. 64-1539

It is the policy of the California Division of Highways to recommend the highest possible asphalt content for asphalt concrete mixes, consistent with other specification requirements such as stability. This is particularly important when using absorptive aggregates. Figure 19, representing a fairly absorptive aggregate, shows that the maximum expansion has been decreased from 0.049" to 0.008" by increasing the average asphalt film thickness by one micron. The same increase in film thickness of a nonabsorptive or slightly absorptive aggregate will only reduce the expansion slightly, as illustrated in Figure 20.
