Secondary Mineral Alteration of Aggregate Base and Subbase

January 1967

State of California
Department of Public Works
Division of Highways
Materials and Research Department

FINAL REPORT
on
SECONDARY MINERAL ALTERATION
of
AGGREGATE BASE AND SUBBASE

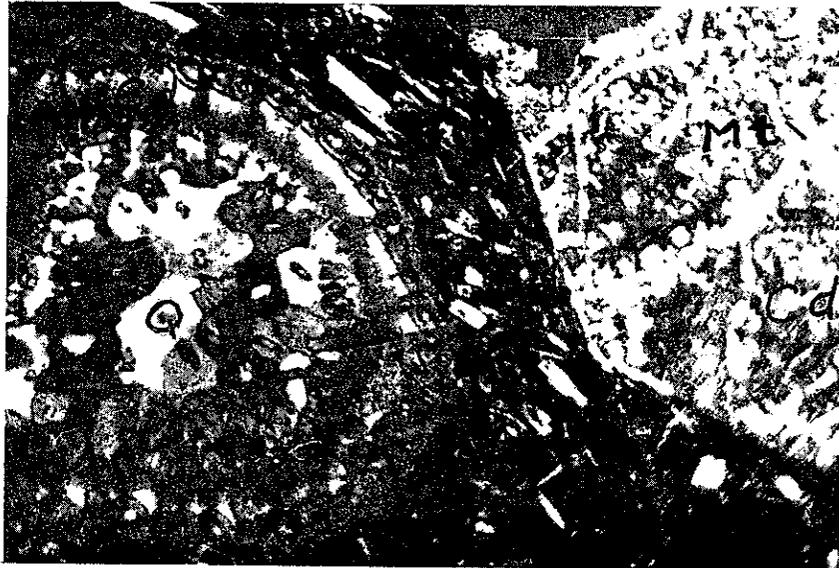
Photo 5 - Malibu Lake Streambed 63-2186 #4 X 100
Amygdules consisting of a rim of sperulitic
chalcedony with a core of cryptocrystalline
quartz. Note dark glassy groundmass and
relict amphibole altered to chalcedony with
montmorillonite-filled fractures. X-Nic.

4. Spherulitic chalcedony with montmorillonite-filled fractures.
5. Glassy volcanic with chalcedony, montmorillonite and cryptocrystalline quartz. X-nic.

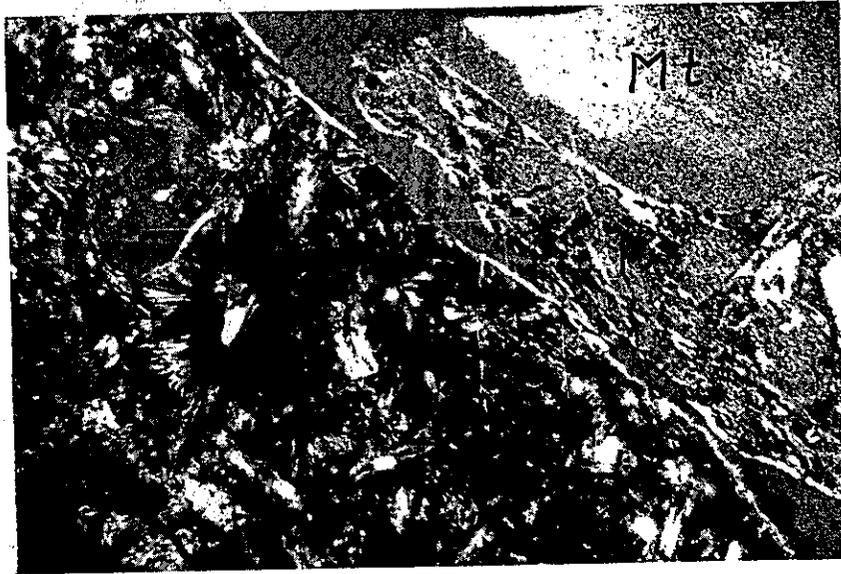
Photo 7 - Malibu Lake Streambed 63-2186 #5 X 100
Volcanic glass with spherulites, largely
altered to palagonite. Montmorillonite in
upper right hand corner.

6. Same as photo 5, but with plain polarized light.
7. Altered volcanic glass with spherulites.
8. Hematite-rich vesicular volcanic with chalcedony.
9. Crystalline montmorillonite and corroded feldspar.

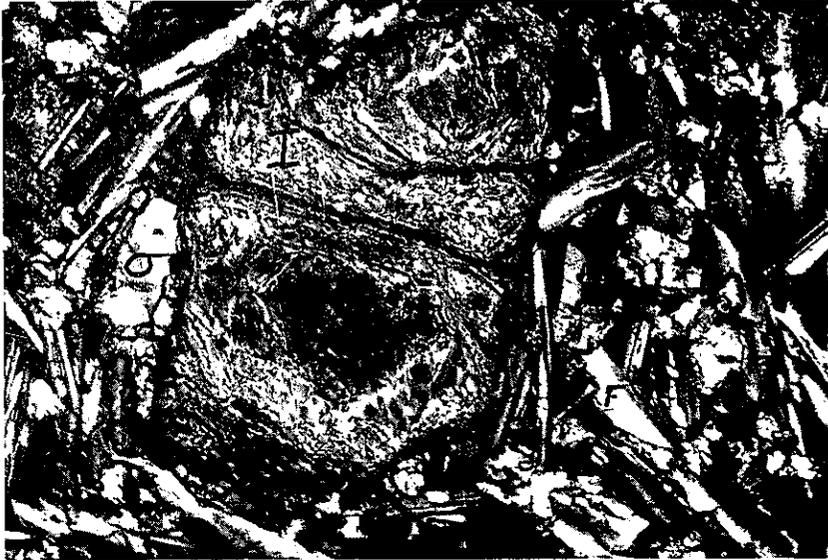
Photo 11 - South Mtns. Creek Bed 63-2188 #4 X 100
Olivine altered to iddingsite in basalt.

10. Complete replacement of relict amphibole by montmorillonite.
11. Olivine altered to iddingsite in basalt.
12. Relict pyroxene crystal altered to montmorillonite.

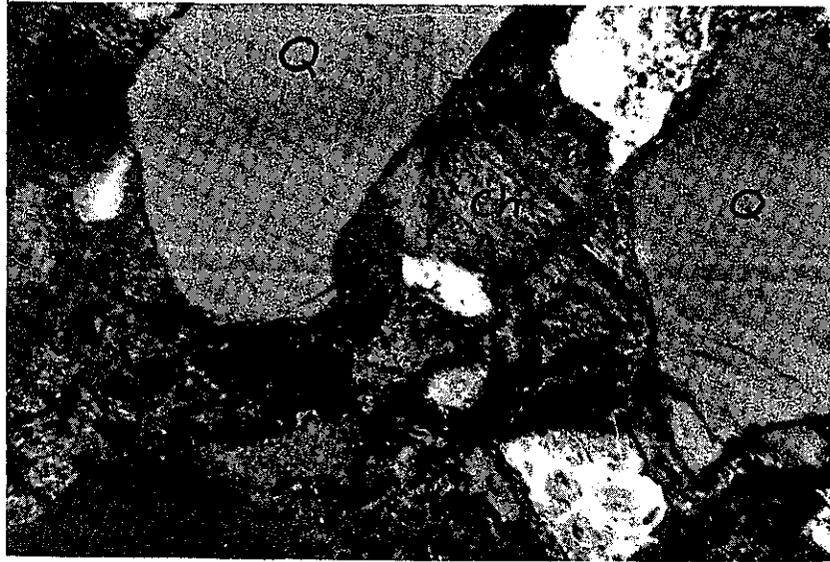
Photo 13 - Toro Point Sandstone 65-2053 X 100
Chloritized biotite between two large
quartz grains.

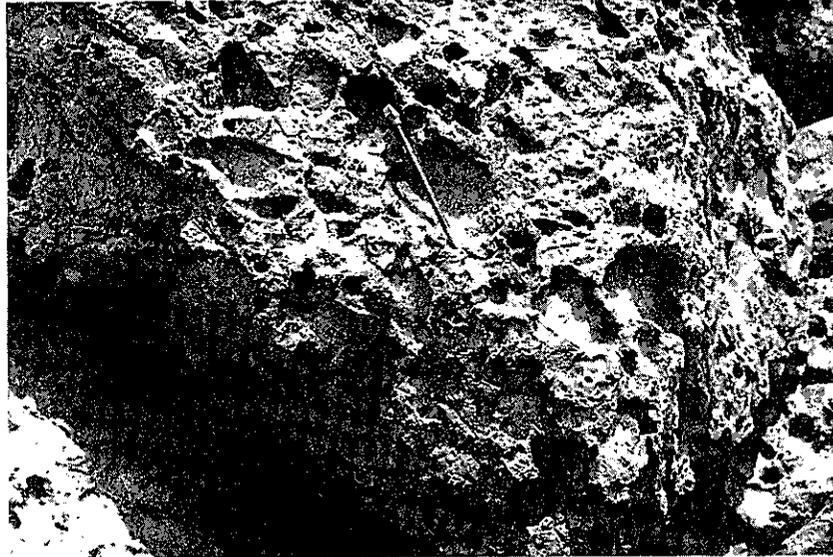
Photo 21 - Volcanic agglomerate from Hawley Quarry used as rock slope protection on La Jolla Canyon Beach. Note differential weathering.

Rock slope protection from the same source was used along Road 07-Ven-101 at La Jolla Canyon Beach a few miles south of Point Mugu. This installation was also made in 1956 and is weathered similarly to that of the Ventura County Small Boat Harbor. Rounding of the boulders with less differential weathering was noted, however, where wave action was active on the beach (photos 21 and 22).

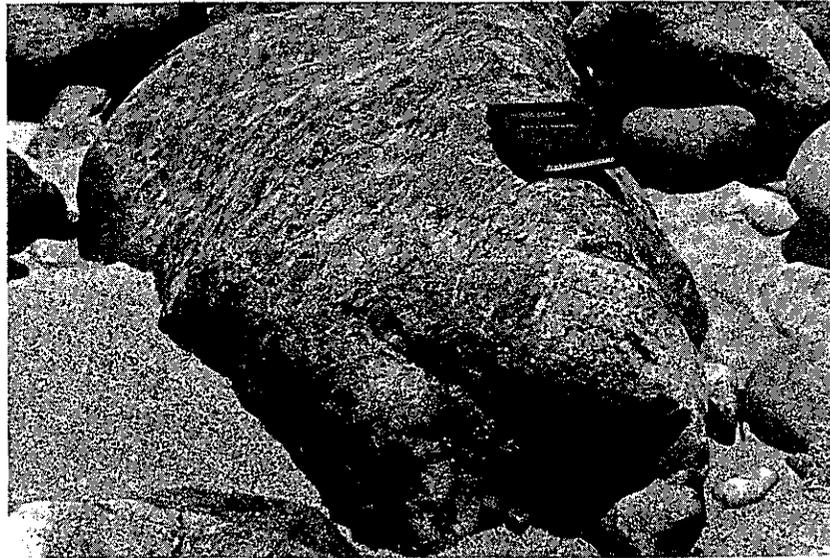
Photo 22 - Similar source and rock type as in Photo 21, but exposed to wave action. Note rounding, less differential weathering.
