NO. M & R 643308

FINAL REPORT ON THE
ZACA-WIGMORE TEST ROAD

FINAL REPORT ON THE ZACA-WIGMORE ASPHALT
TEST ROAD

CONT. 54-5VC12
Road V-SB-2-D,C
Zaca - Wigmore
Asphalt Test Road

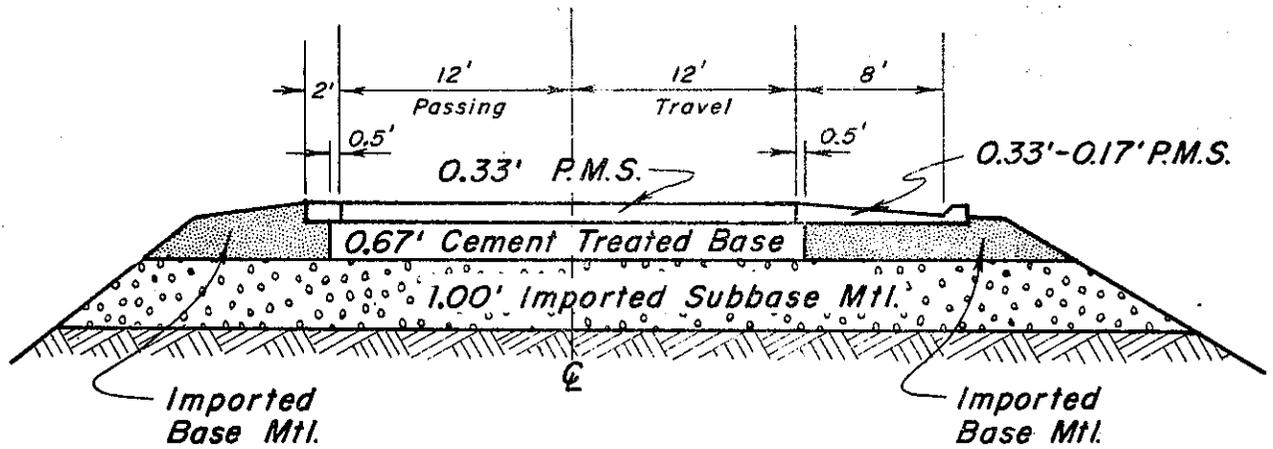
Figure 1

TYPICAL STRUCTURAL SECTION
NEW ALIGNMENT

The contract consisted of converting six miles of an existing two lane highway into a four lane divided expressway by constructing two new lanes, and widening the existing pavement. Based on soil surveys and an anticipated Traffic Index of 9.0, the typical structural section for the new alignment consisted of 1.0 ft. imported subbase material, 0.67 ft. of Class B, cement-treated base, and 0.33 ft. asphalt concrete Type B. The existing facility consisted primarily of an old portland cement concrete pavement constructed in the early 30's which was in fair to poor condition. The reconstruction design provided a minimum of 0.5 ft. Class B, cement-treated base to be placed over the existing pavement and to be surfaced with 0.33 ft. of asphalt concrete, Type B. The existing concrete pavement was also subsealed with asphalt prior to placing the new cement-treated base. The roadway was widened to provide a geometric section similar to the new construction. The typical sections for both new and existing pavements are shown in Figure 1.

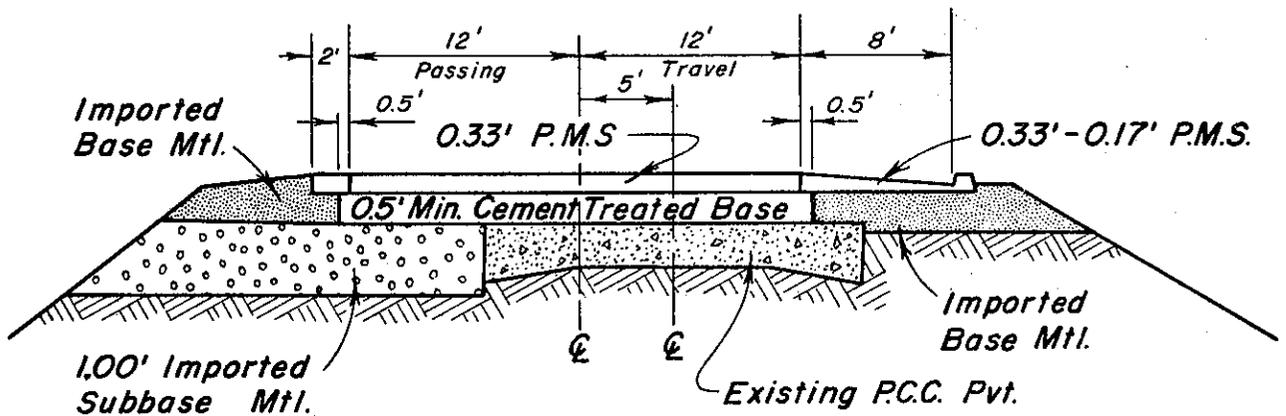
TYPICAL STRUCTURAL SECTION
OVER EXISTING PAVEMENT

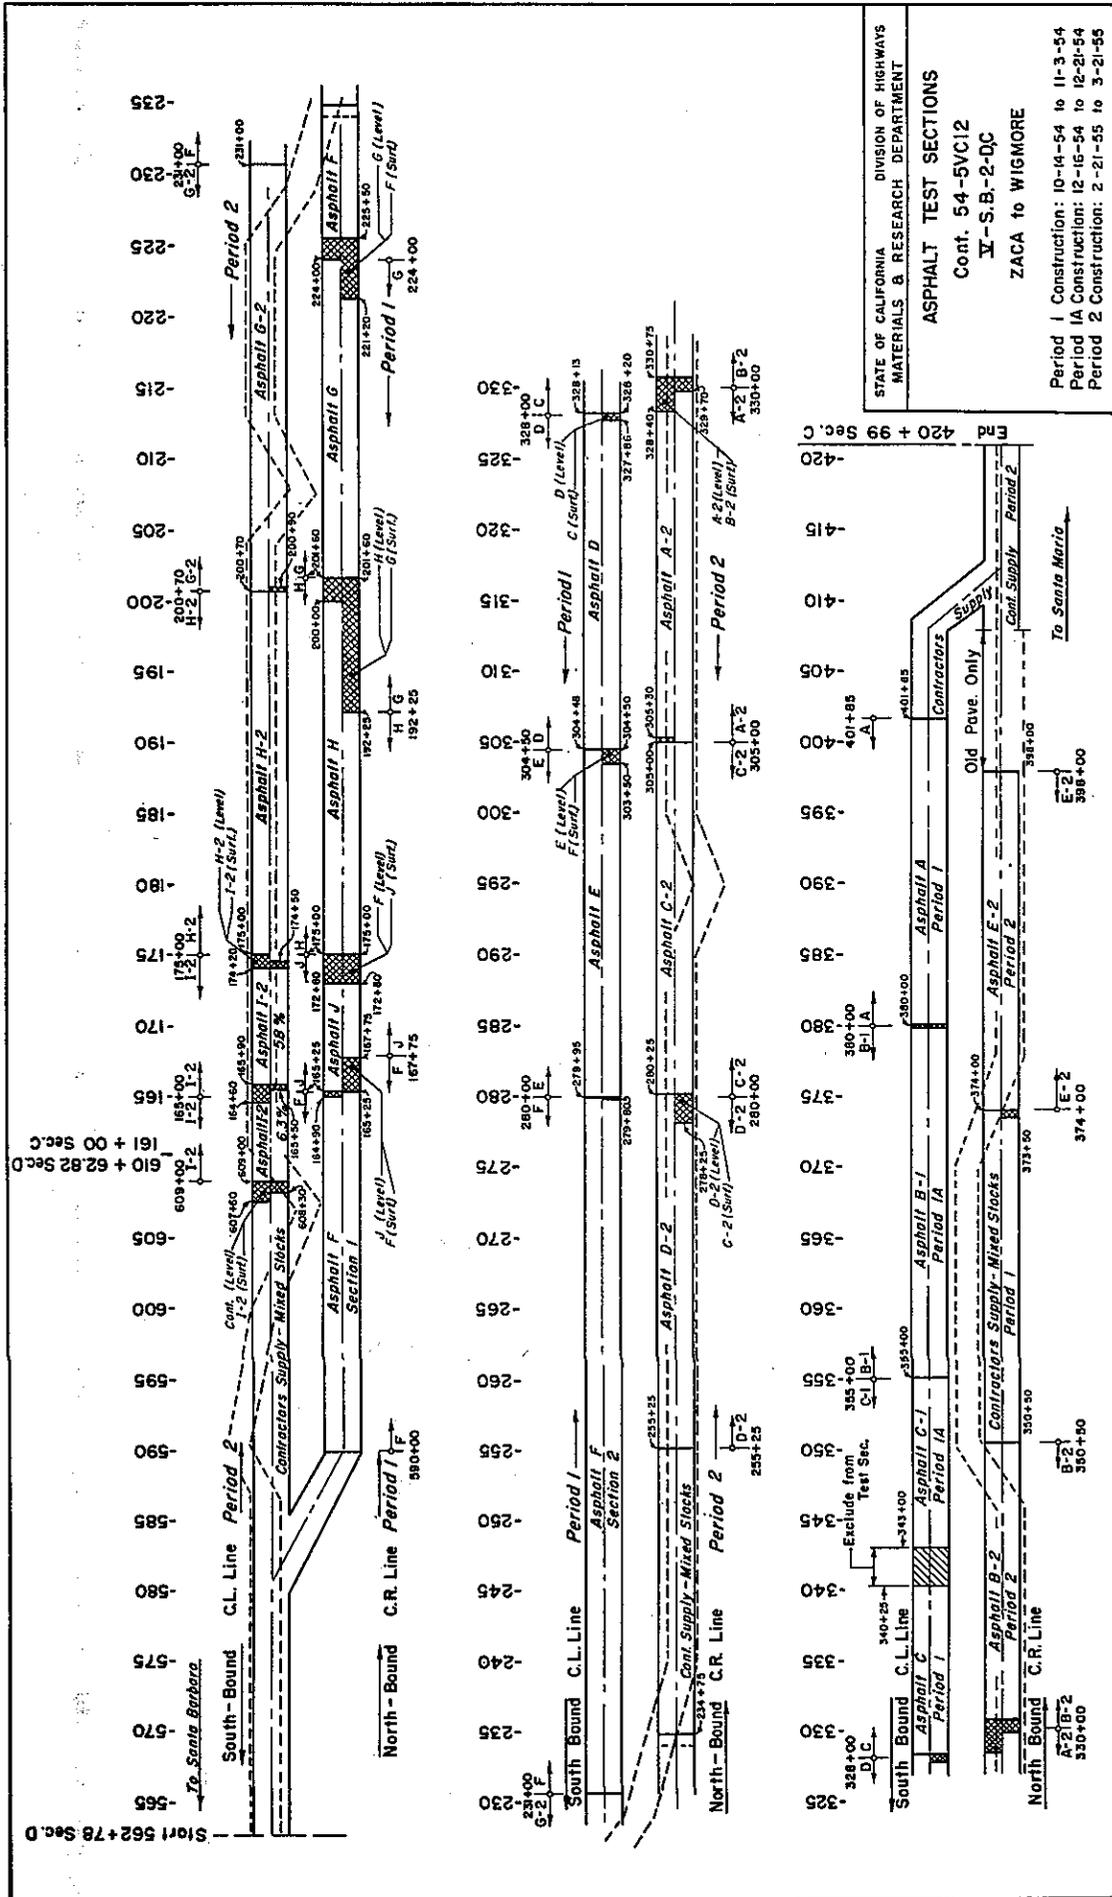
Figure 2

ASPHALT TEST SECTIONS

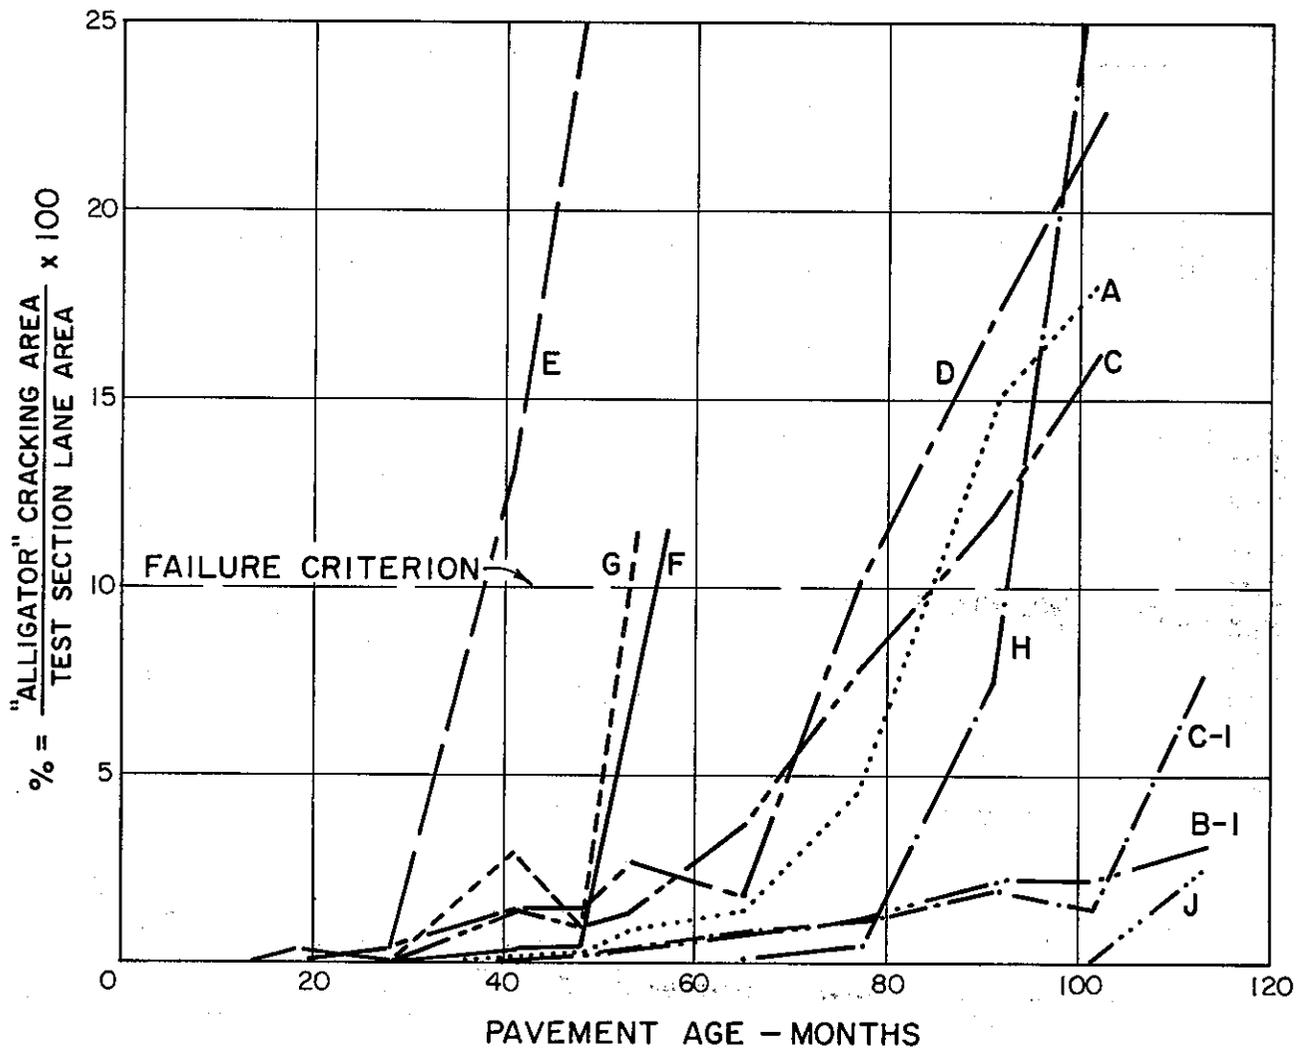
"ALLIGATOR" TYPE CRACKING IN THE TRAVEL LANE DURING SERVICE LIFE

NEW ALIGNMENT

An interesting finding in connection with the "alligator" type cracking in the various sections is the almost explosive increase in area after a certain period of service life, Figures 3 and 4.

The results from this test road clearly indicate that a very rapid increase in "alligator" type cracking may be expected after 10% of the lane area is reached. In other words it may be possible to predict the extent of future maintenance, and the time for required overlay construction by determining when the first rapid increase in "alligator" cracking occurs.

R. J. Schmidt (9) has found that the increase in "alligator" type cracking during service life as shown in Figures 3 and 4 produces a straight line when plotted on semi-log paper. This allows extrapolation of the curves to any service age. Using such a method the percentage of cracking at the end of 97 months of service life was determined and the consistency of the recovered asphalt determined from penetration and viscosity charts. The results, Table N and Figure 13, clearly indicate that the penetration of the recovered asphalt is related to the percentage of fatigue type cracking. On this specific project the results indicate that approximately thirty penetration is the critical consistency for the failure criterion adopted for the project for fatigue type cracking. The viscosity at 77°F and 0.05 Sec⁻¹ Shear Rate also provides a good correlation for the percentage of fatigue cracking.

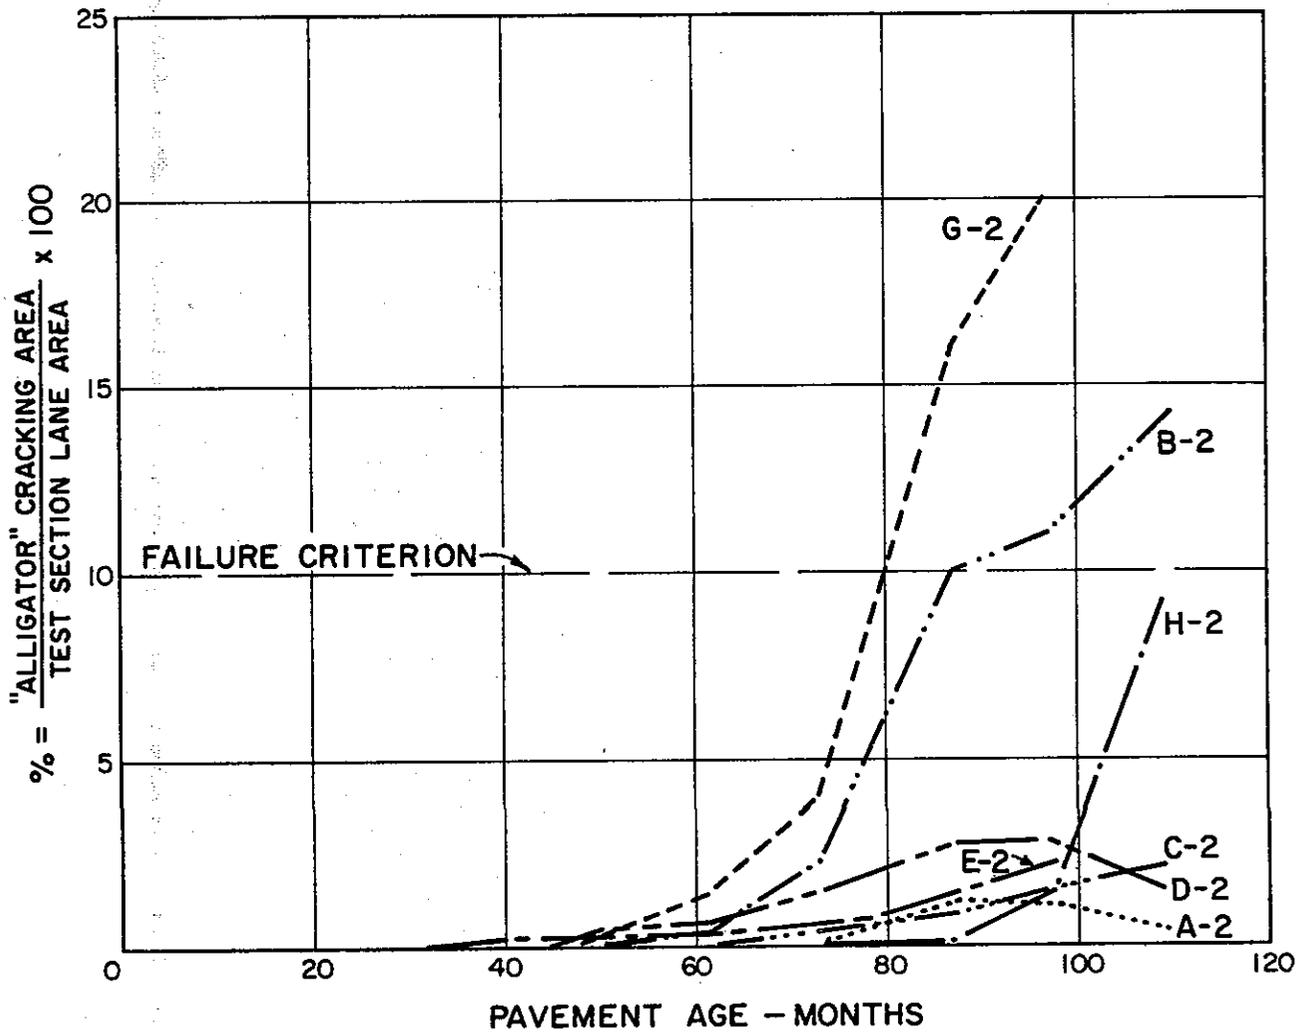
Figure 4

"ALLIGATOR" TYPE CRACKING IN THE TRAVEL LANE DURING SERVICE LIFE

EXISTING ALIGNMENT

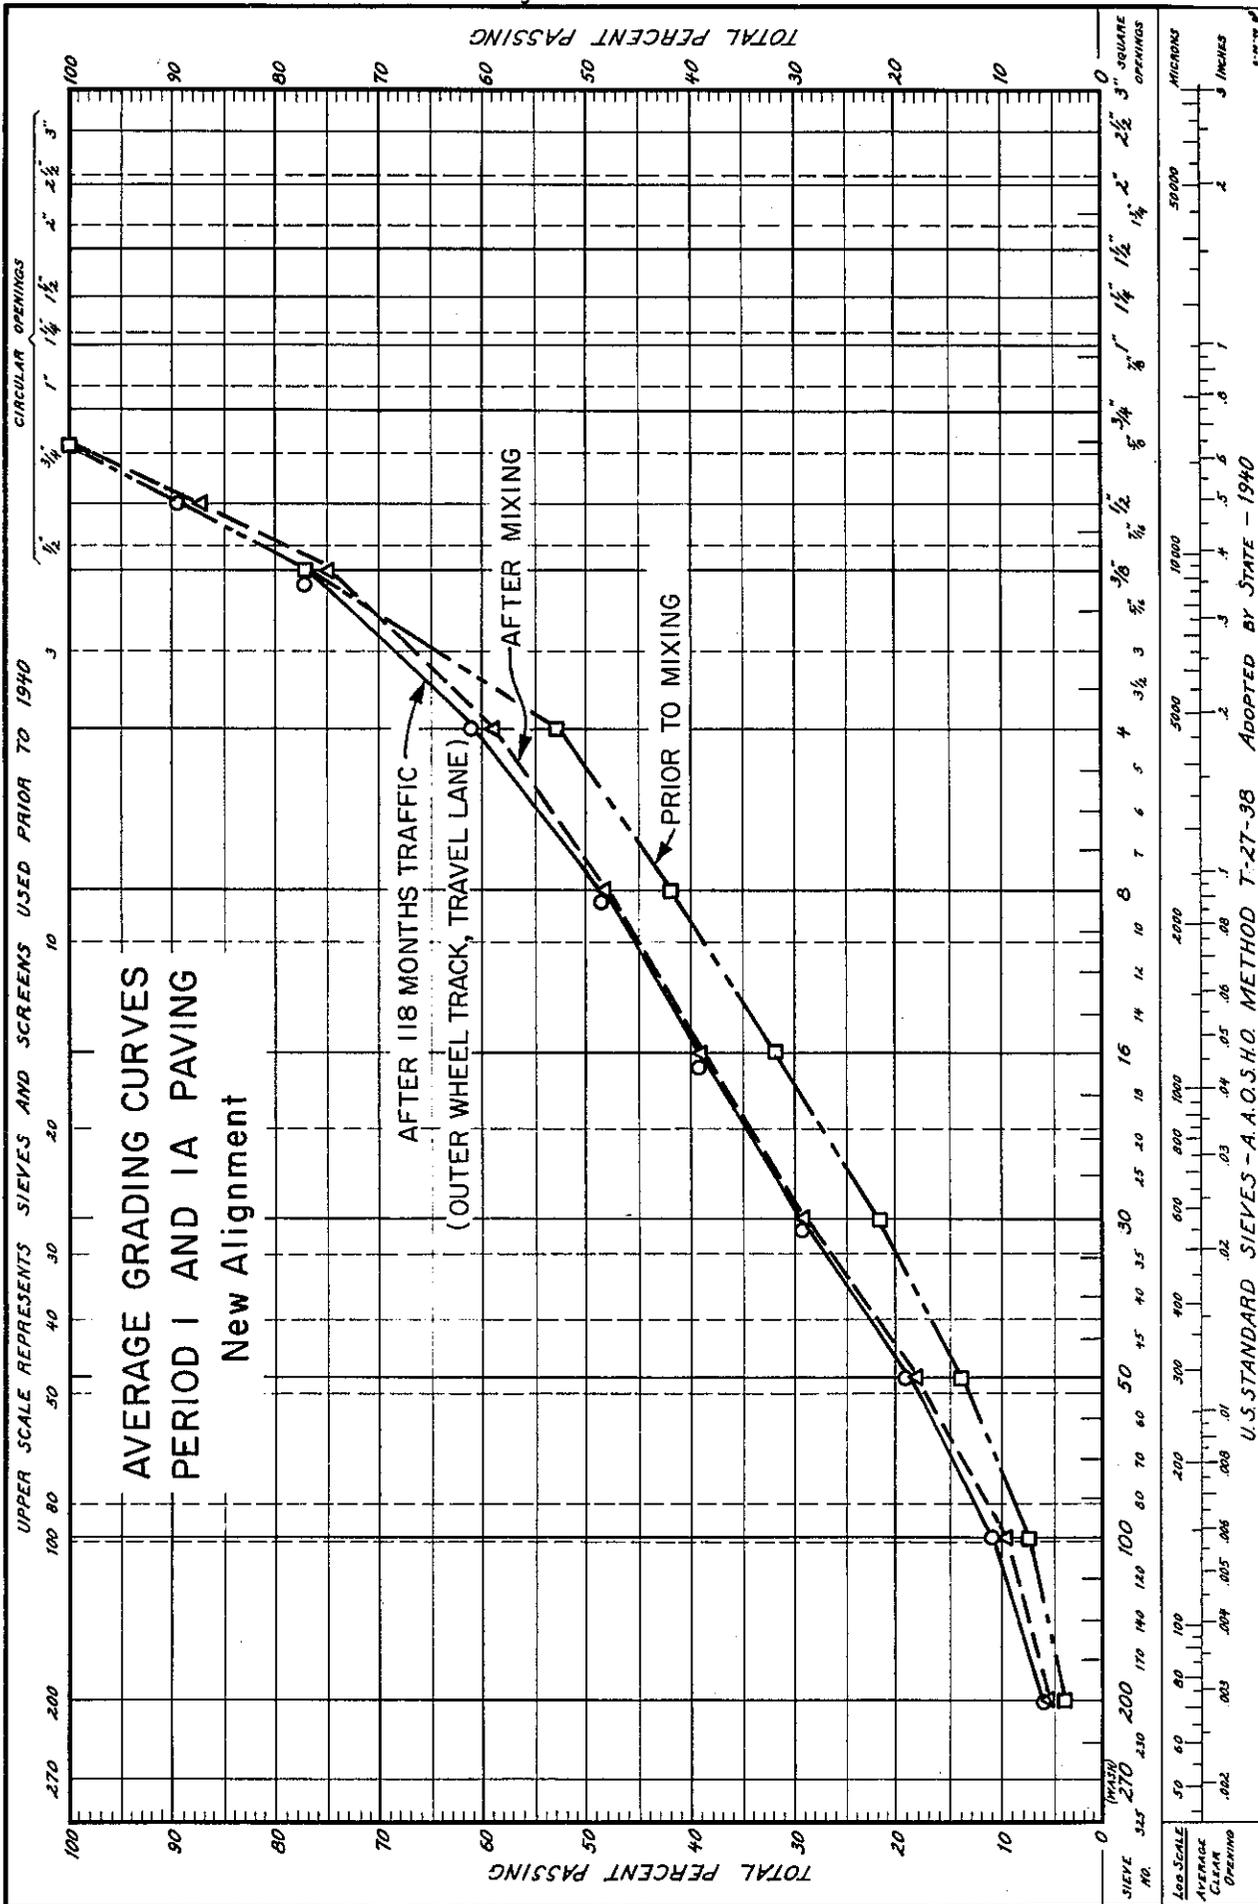
Figure 5

SEMI-LOG CHART FOR GRADING CURVES

U.S. STANDARD SIEVES - A.A.S.H.O. METHOD T-27-38 ADOPTED BY STATE - 1940

The average grading results from the various core series are shown in Figure 5. There has been virtually no degradation during service life although a definite change was found during the mixing operation.

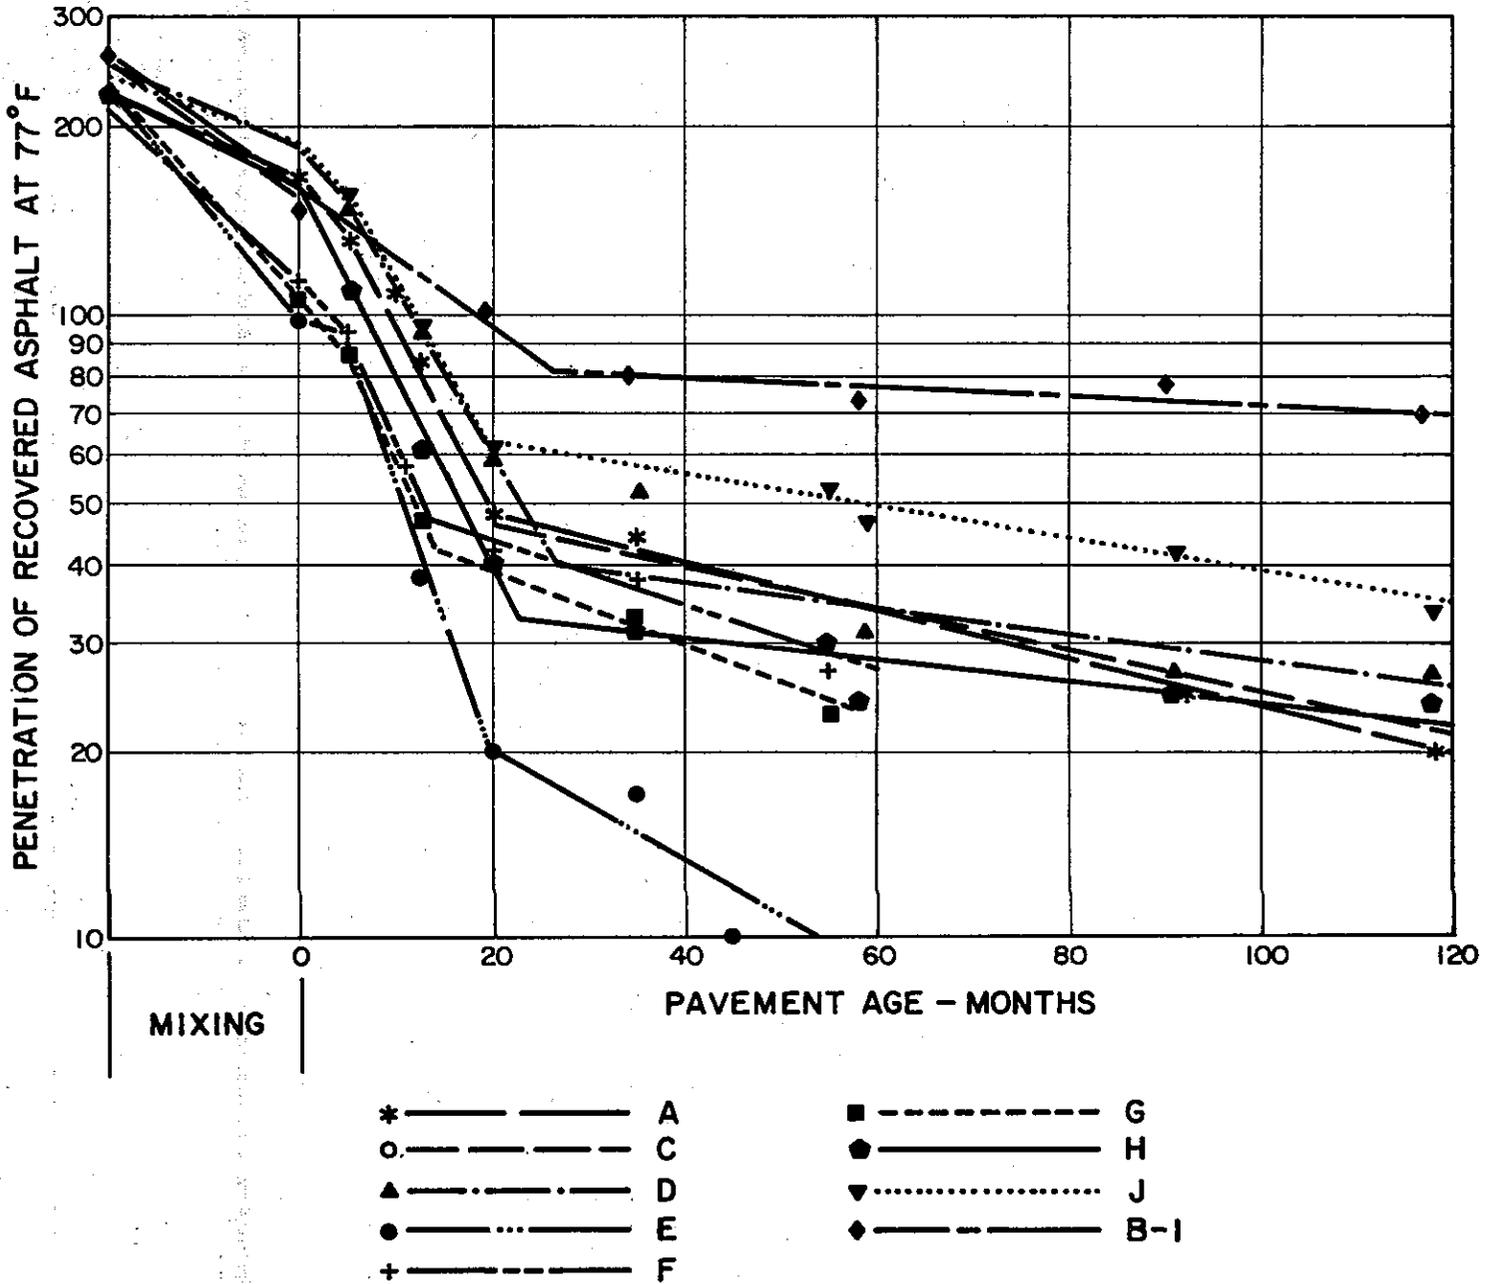
Figure 6

HARDENING OF 200-300 PAVING GRADE ASPHALT
ZACA-WIGMORE PROJECT
PERIOD I AND IA PAVING

ALL CORES FROM OUTER WHEEL TRACK OF TRAVEL LANE

The change in physical properties of the various asphalts during service life are shown in Tables J and K. The hardening with age as measured by the penetration test is shown in Figures 6 and 7. The curves have the normally expected shape with a rather rapid increase in hardening during the first 16 to 20 months, and a definite decrease in hardening rate thereafter. Although the hardening rate, as measured by the penetration test tends to decrease after 20 months, there are differences between asphalts in the period from 20 to 118 months of service life. Three asphalt sections which failed within 55 months of service life have continued high rates of hardening after 20 months. Many of the asphalts used in period 2 paving show very low rates of hardening following the high initial rate. This is probably caused by the additional 0.3% asphalt used in period 2 paving mixtures compared with period 1 mixtures. The additional asphalt appears to have aided in initial compaction with a considerable lowering of void content over that found in period 1, (See Table E).

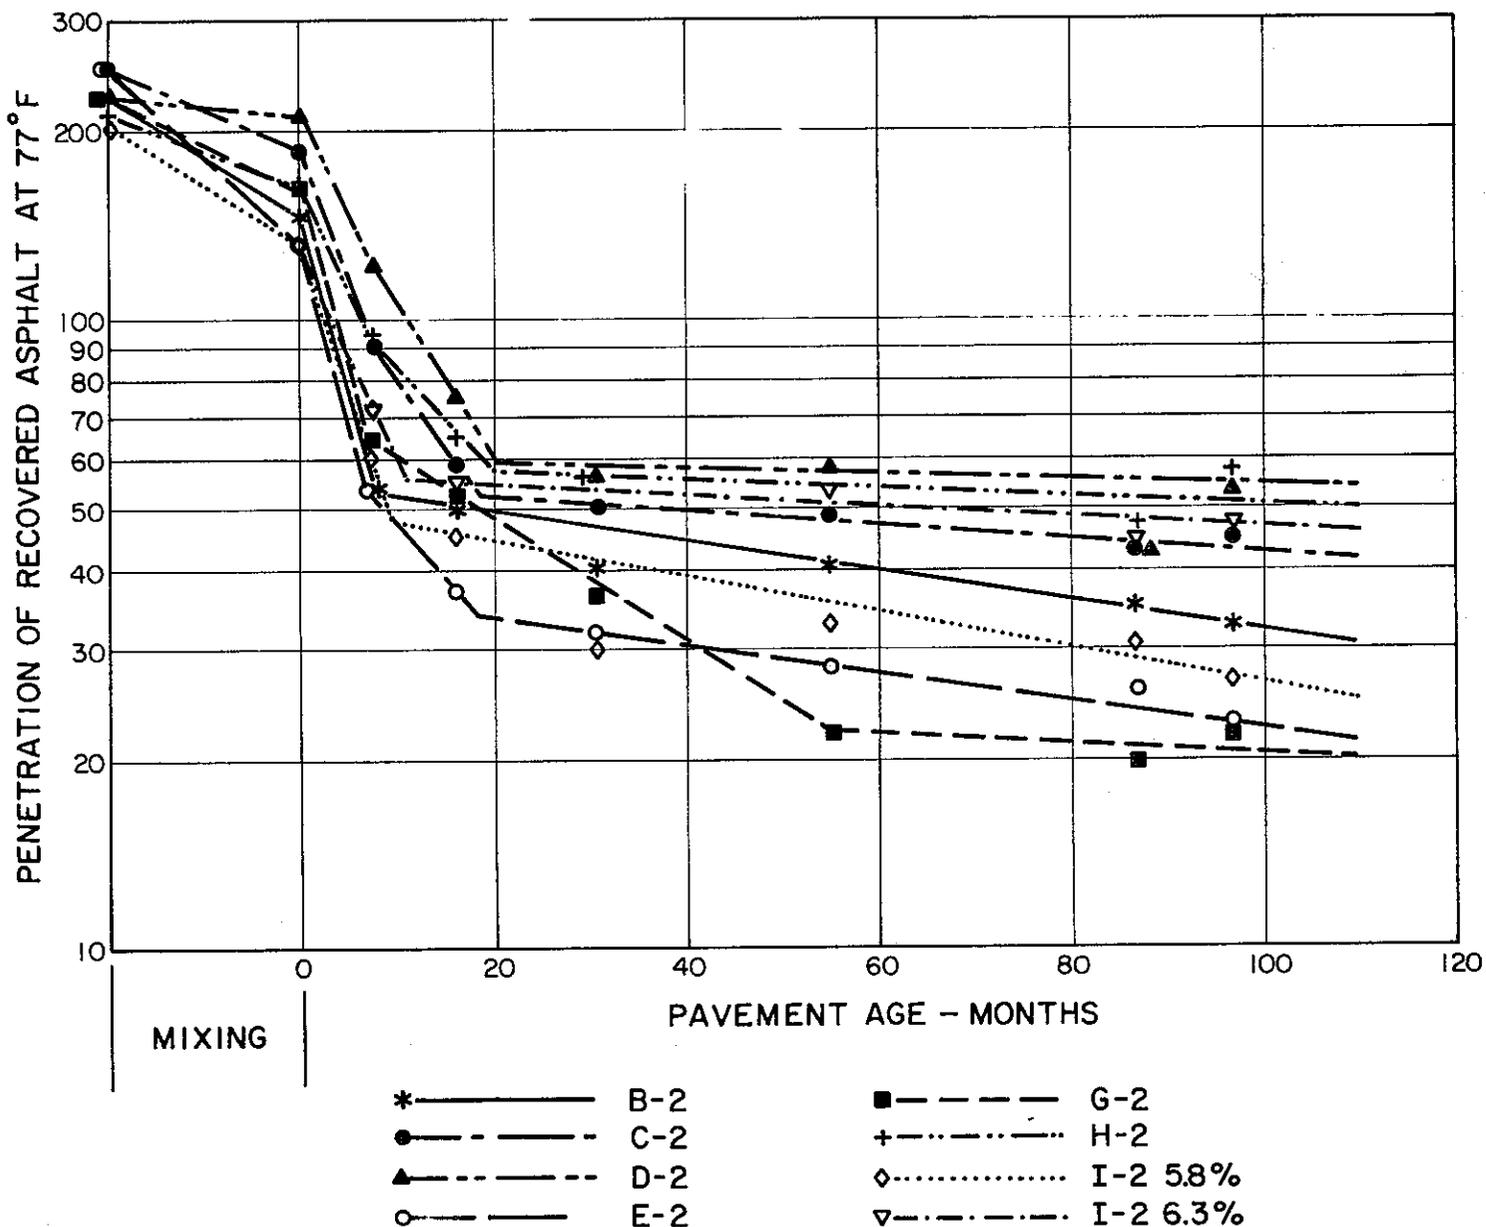
HARDENING OF 200-300 PAVING GRADE ASPHALT
 ZACA-WIGMORE PROJECT
 PERIOD 2 PAVING

ALL CORES FROM OUTER WHEEL TRACK OF TRAVEL LANE

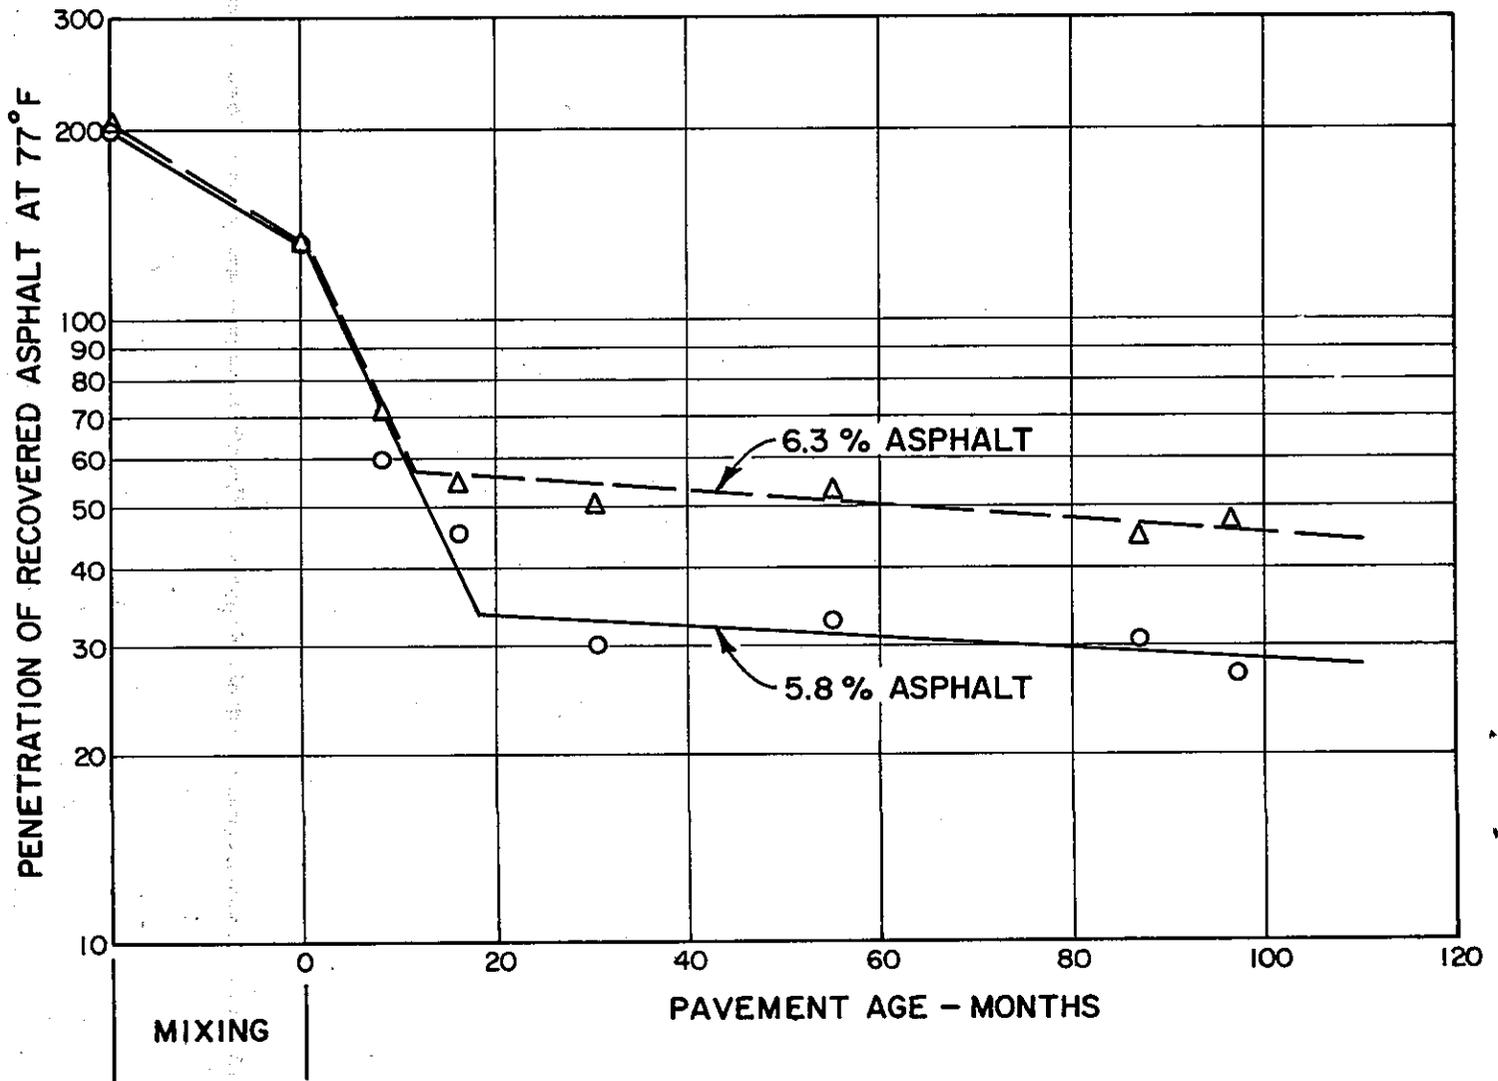
Figure 8

CHANGE IN PENETRATION DURING MIXING AND SERVICE LIFE ASPHALT I-2, PERIOD 2 PAVING

ALL CORES FROM OUTER WHEEL TRACK OF TRAVEL LANE

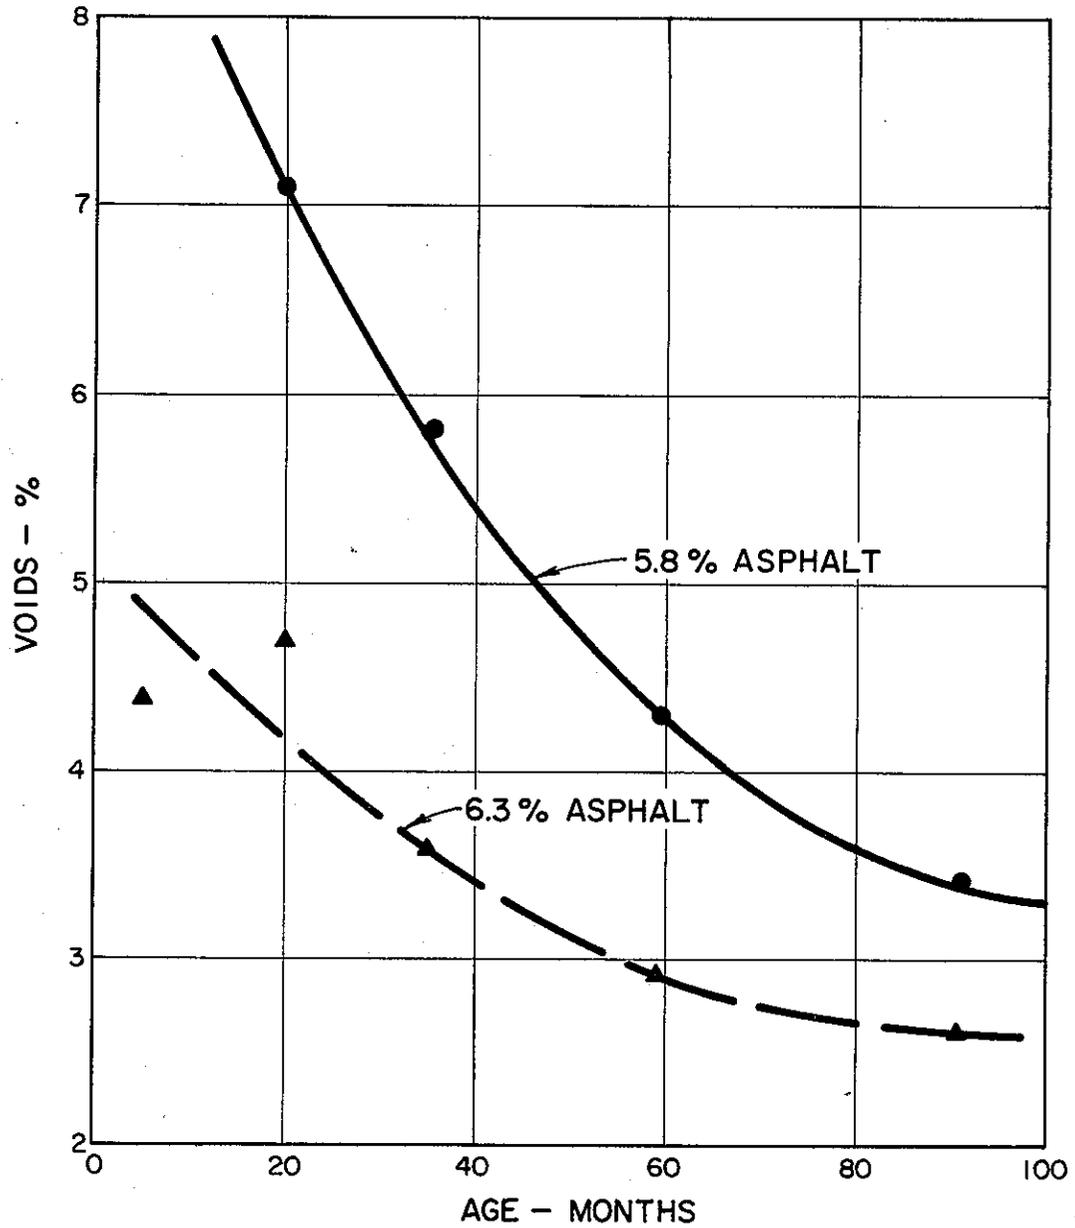
Figure 9

CHANGE IN VOID CONTENT DURING SERVICE
LIFE FOR TEST SECTIONS CONTAINING
5.8 % AND 6.3 % OF I-2 ASPHALT

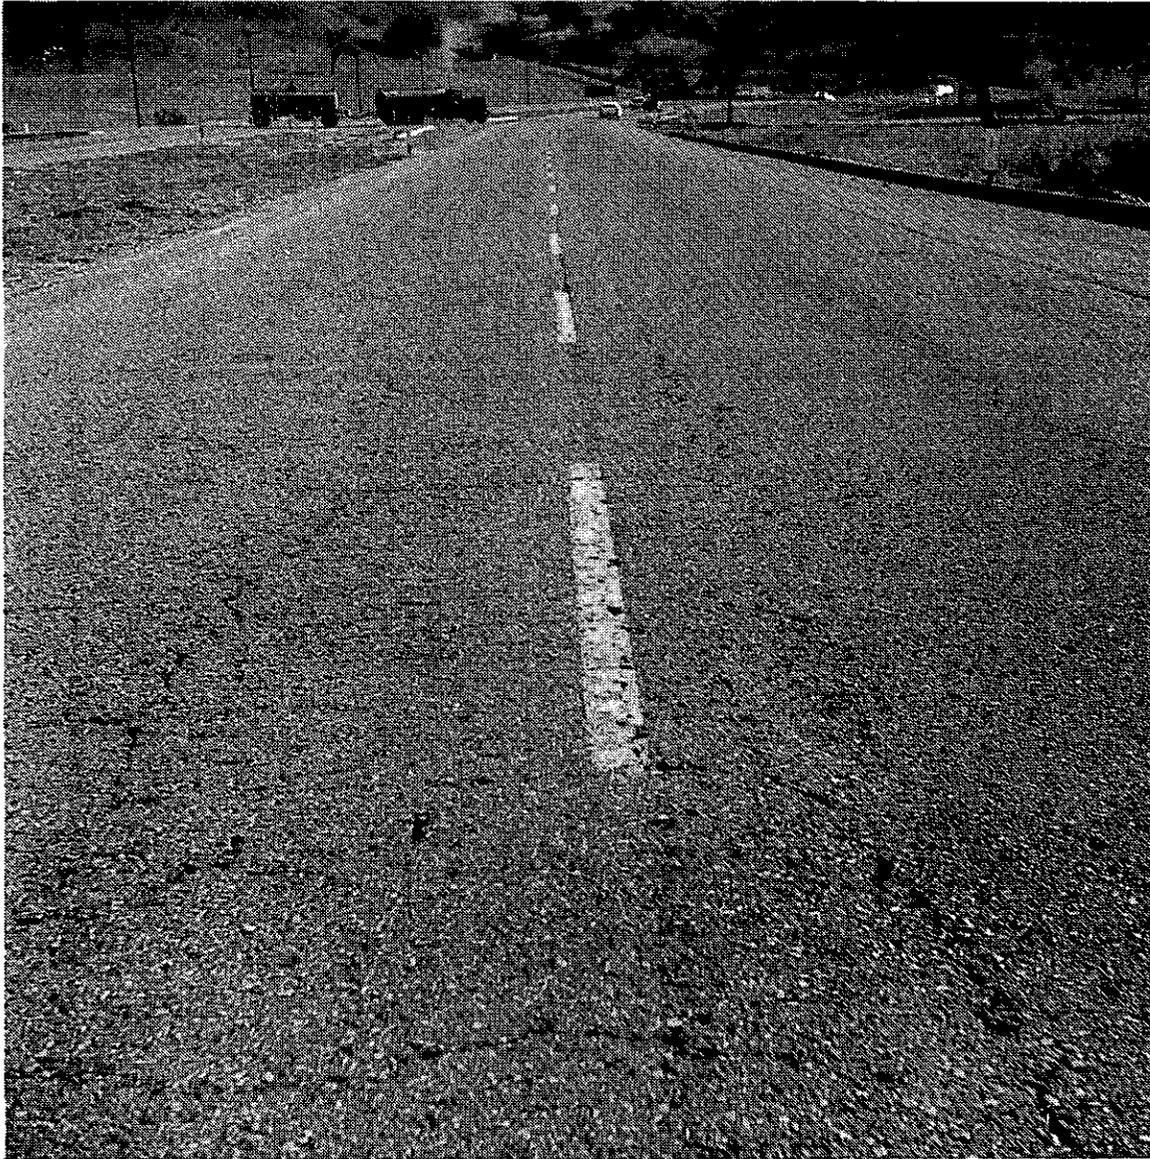
FIGURE 10

Pavement Condition of Asphalt I Test Section After
82 Months of Service Life

"Pitting" to a varying degree occurred in the pavement placed during both periods. The most serious amount was found in the asphalt I test sections, and in this case appears to be related to the asphalt source. The very light amount that was noted in all other sections appears to be caused by varying amounts of chalk-like particles which tended to abrade easily under traffic action.

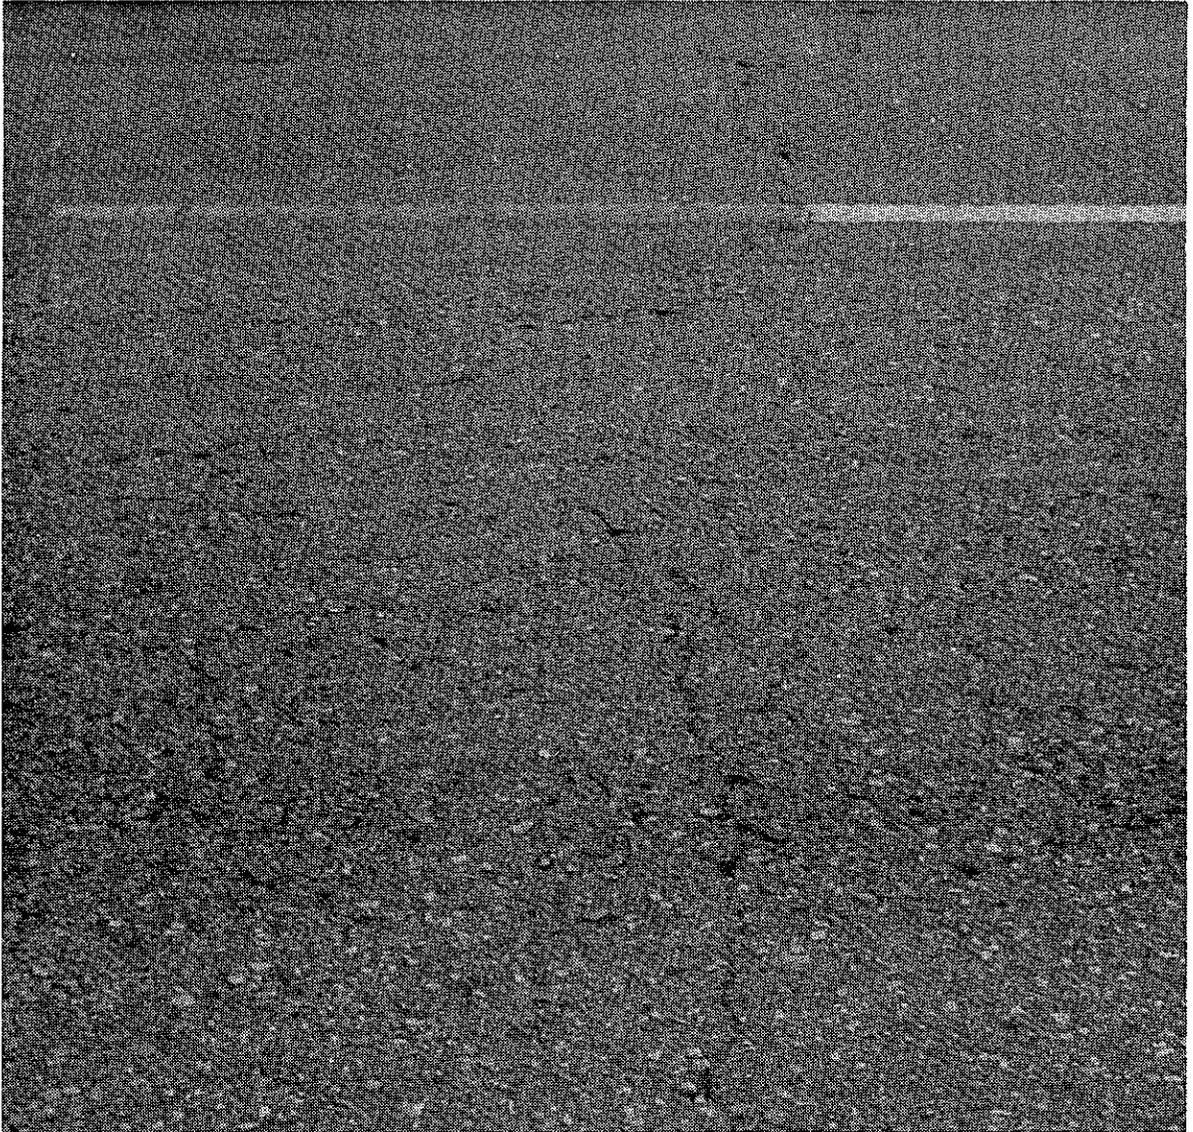
FIGURE 11

Pavement Condition of Passing Lane of Asphalt G Test Section
After 55 Months of Service Life

The large block cracking and partial raveling failures found in the I-2 and G passing lane test sections appear to be caused by the development of rather high shear susceptibility during weathering. The development of this form of failure indicates the importance of attaining proper balance in the engineering properties of a paving grade asphalt as discussed in reference (1).

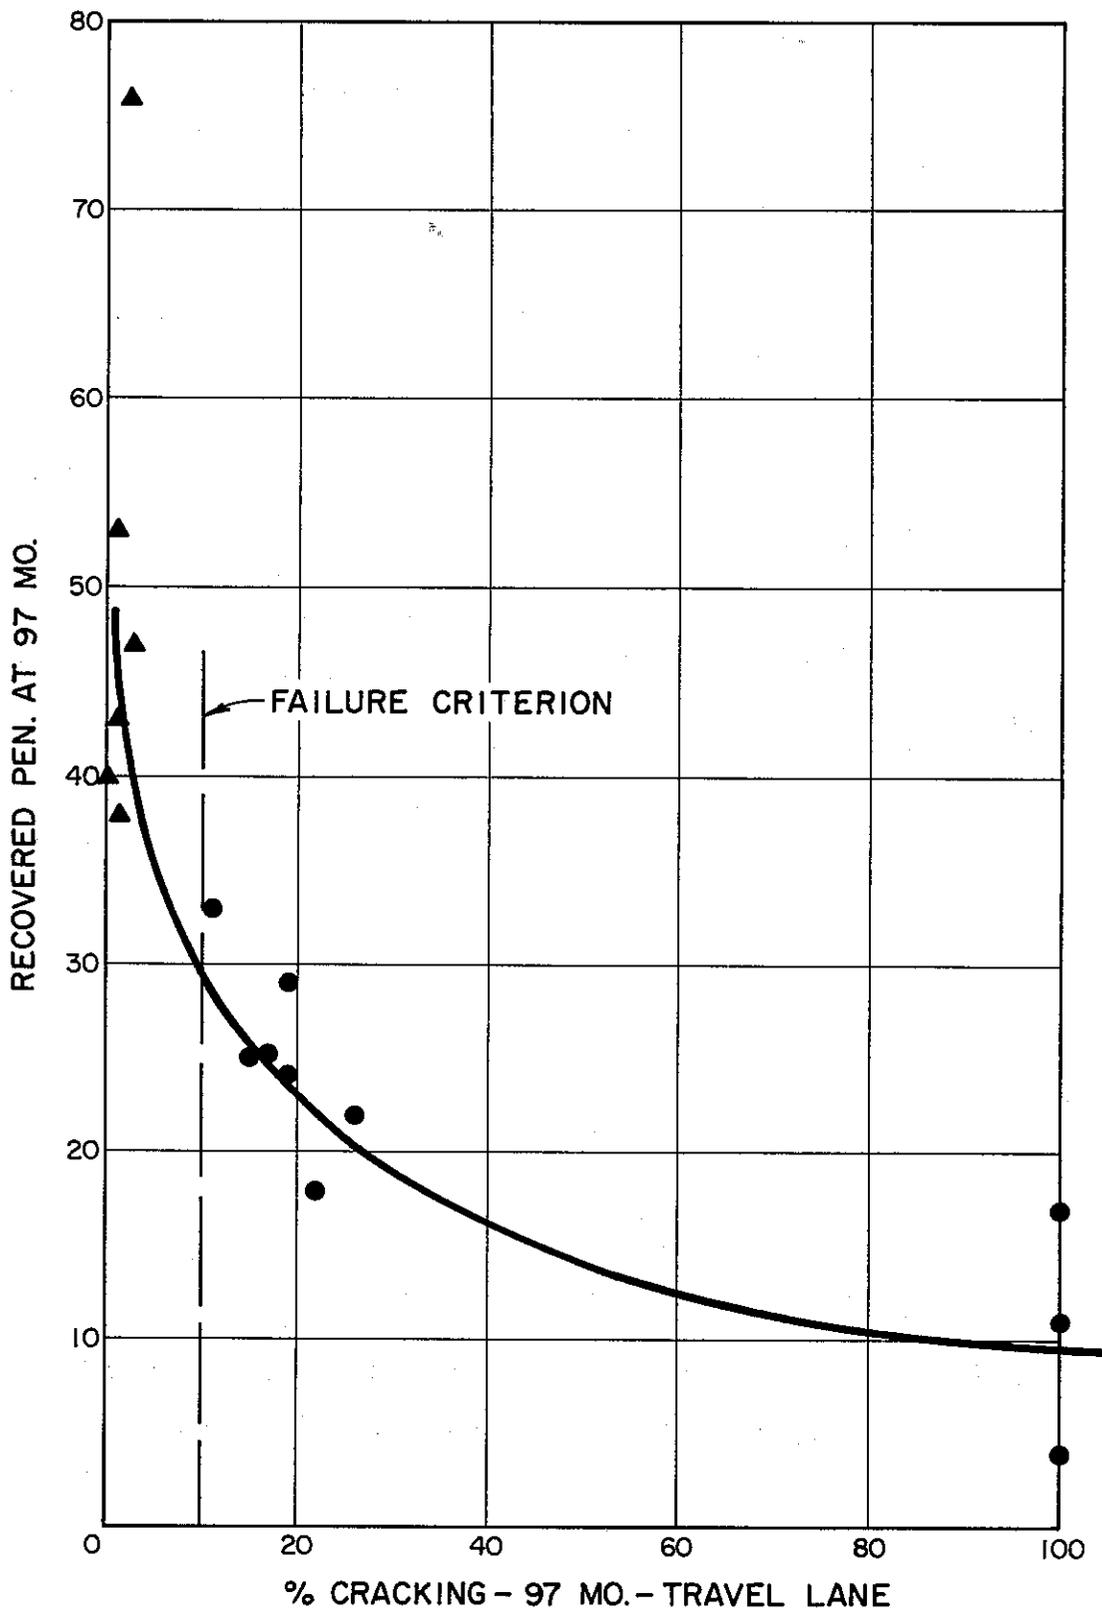
COMPARISON OF CONSISTENCY OF RECOVERED ASPHALTS AND PERCENTAGE OF "ALLIGATOR" TYPE CRACKING AFTER 97 MONTHS OF SERVICE LIFE
