NO. M & R 643308

FINAL REPORT ON THE
ZACA-WIGMORE TEST ROAD

FINAL REPORT ON THE ZACA-WIGMORE ASPHALT
TEST ROAD

CONT. 54-5VC12
Road V-SB-2-D,C
Zaca - Wigmore
Asphalt Test Road

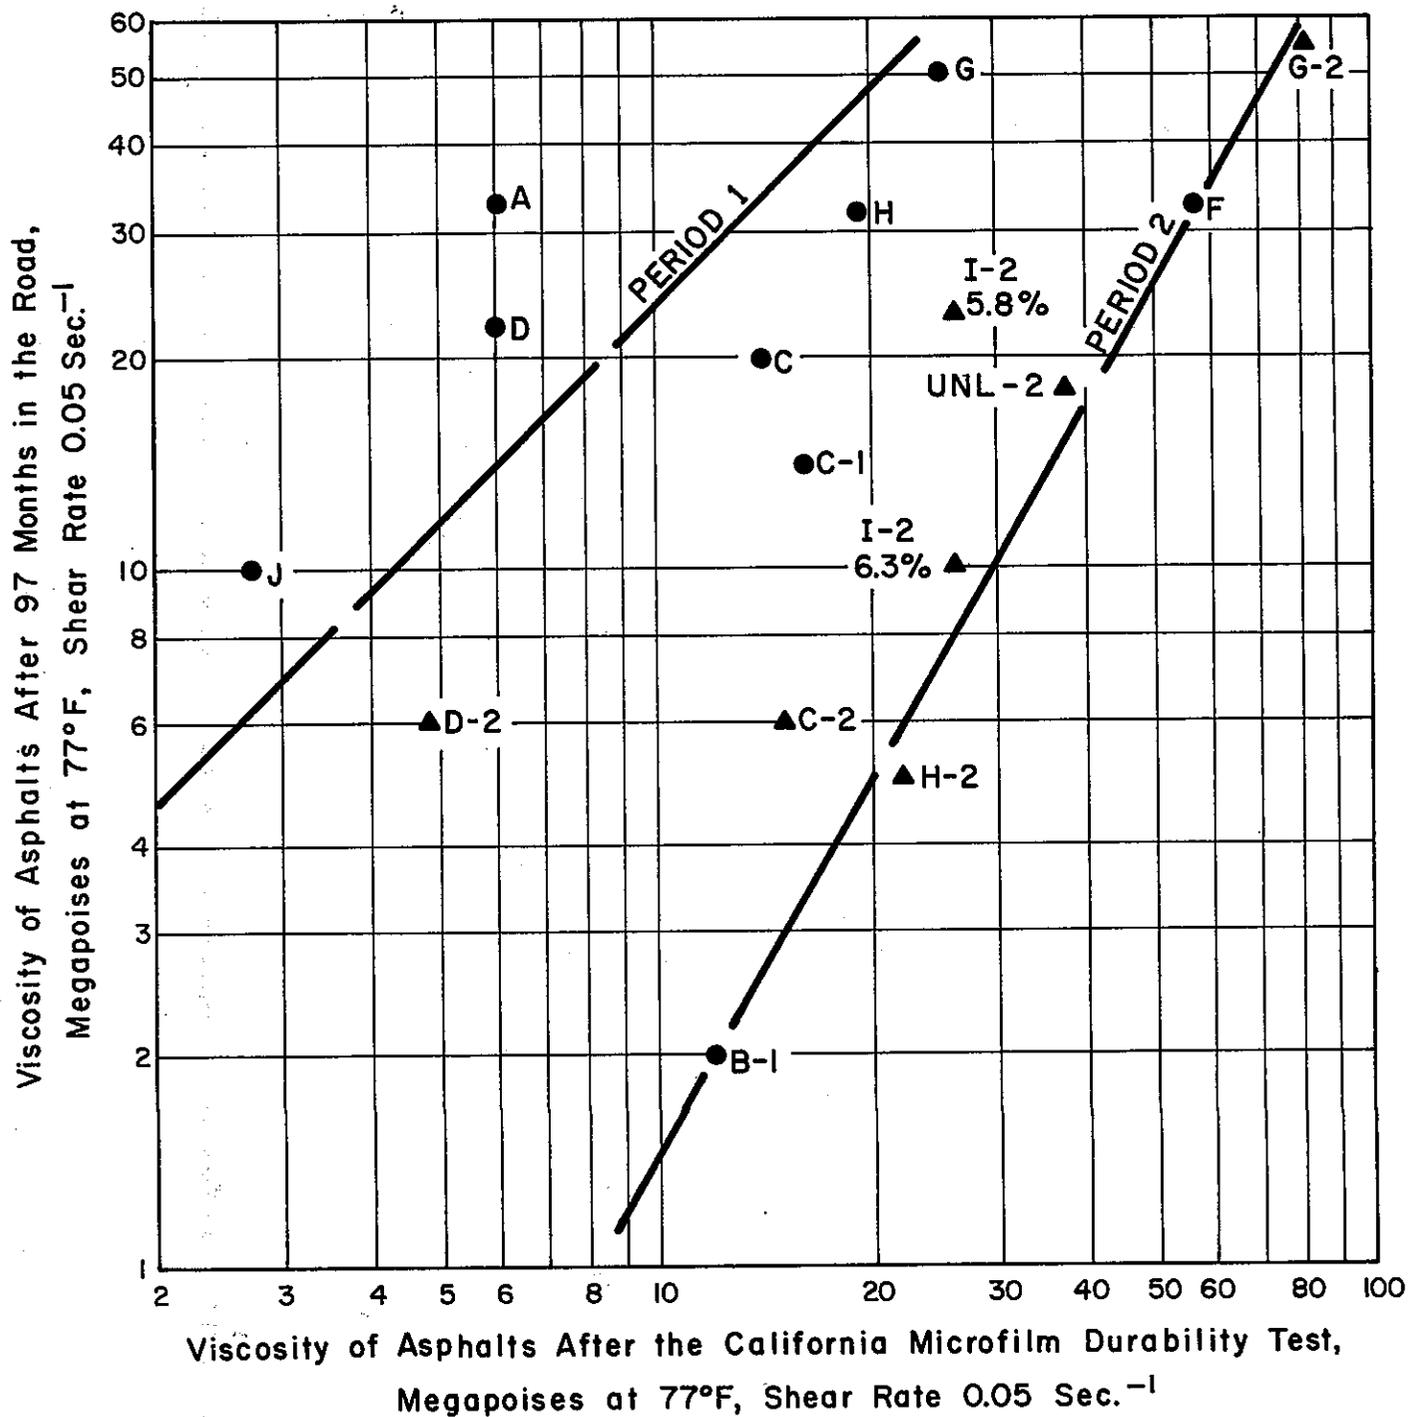
Figure 14

COMPARISON OF VISCOSITY AFTER 97 MONTHS OF SERVICE LIFE WITH VISCOSITY AFTER THE MICROFILM DURABILITY TEST

The best test for predicting durability of the asphalt used on this project appears to be the Modified Shell Durability test (10). W. C. Simpson, et al, (11) found a definite correlation between the viscosity after 16 and 30 months of service life and the viscosity after the microfilm durability test. These studies are further confirmed when the comparison is made after 97 months of service life, Figure 14. The data are more scattered, but most of the asphalts used in period 1 paving have weathered faster in the road than those used in period 2.
