CA-TL-79-10

Vehicular Tests Of A 6-Inch High Curbed Gore With and Without a Sand Barrel Crash Cushion

May 1979

Final Report

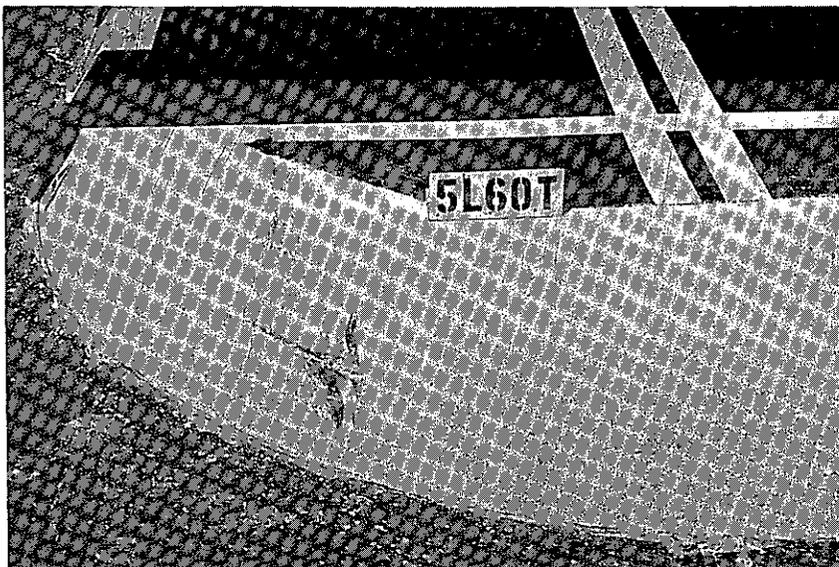
Figure 16. TEST 5:  
Tire Marks on  
Curbed Gore  
Large Car/62.7 mph/  
Head-on - Right Side  
Wheels Only

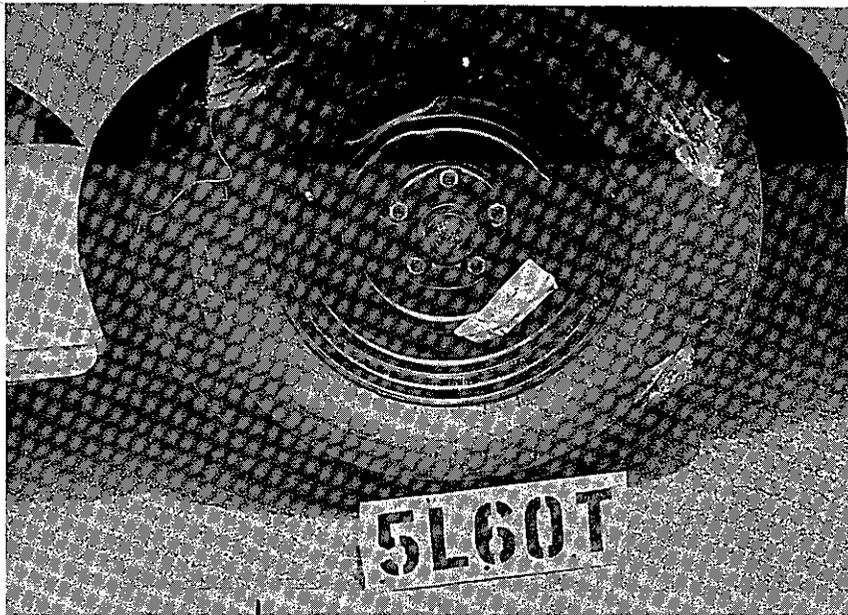
Figure 17. TEST 5:  
Bent Front Right  
Wheel;  
Large Car/62.7 mph/  
Head-on - Right Side  
Wheels Only

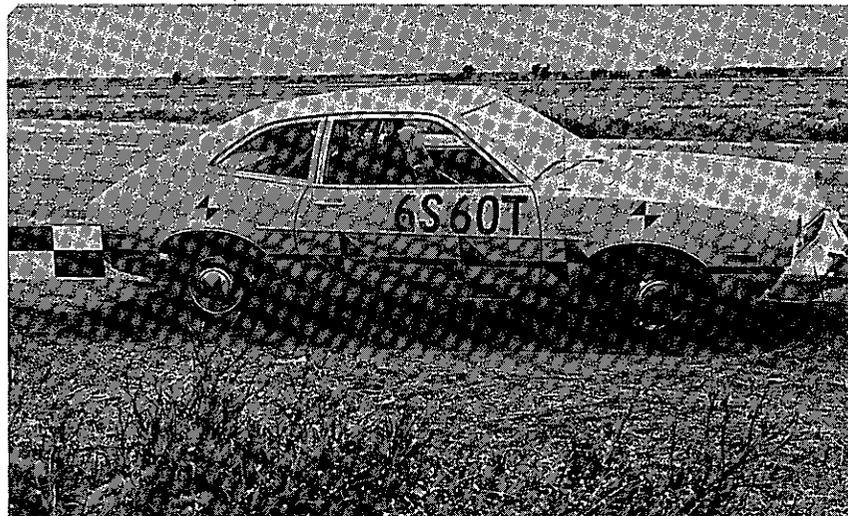
Figure 19. TEST 6:  
Vehicle Damage -  
Two Right Side  
Wheels and One Tire  
Replaced

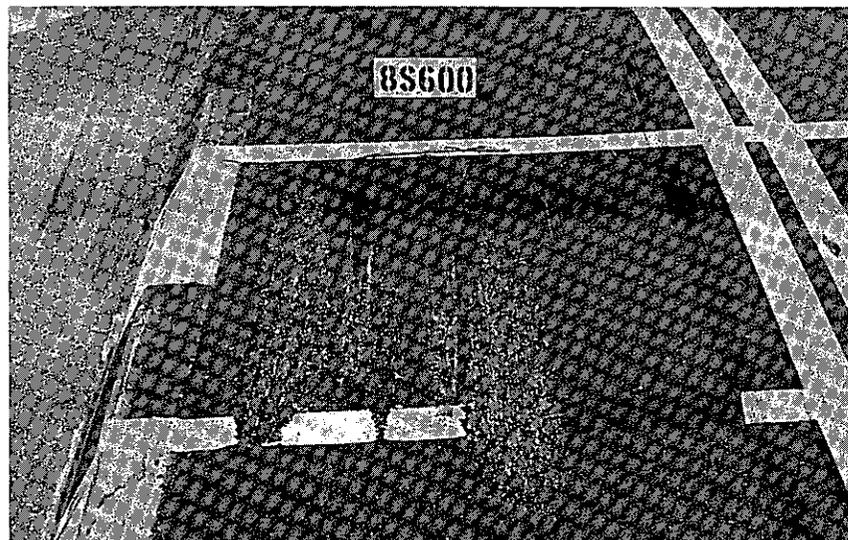
Figure 23. TEST 8:  
Gouges in Top A.C.  
Layer of Curbed  
Gore

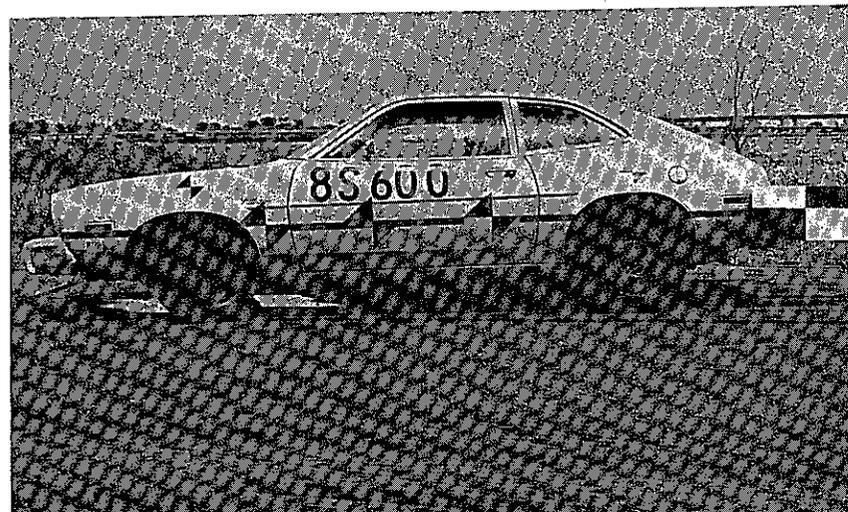
Figure 24. TEST 8:  
Vehicle Damage -  
Oil Pan Leak; Right  
Front and Right Rear  
Wheels Bent

Vehicle damage consisted primarily of bent wheels, loss of air in tires, front springs which were replaced after Tests 1 and 2, large and small size car head-on at 40 mph, and leaking oil pans in Test 1 and Test 8, small car head-on/offset at 60 mph. The front end of each vehicle was aligned before each test. The front cross member and the frame had to be straightened after Test 2, small car head-on impact at 40 mph. The front cross member was also straightened after Test 5, large car head-on/right side wheels at 60 mph. There was no apparent damage to the shock absorbers in any of the tests.

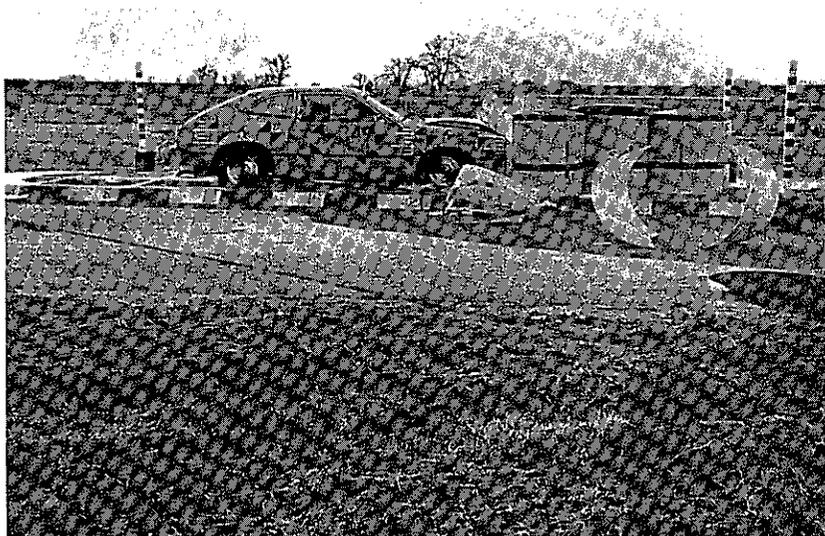
Figure 33.  
Barrier Damage  
Viewed from  
Passenger's  
Side of Vehicle

Photographs showing the barrier damage and the scattered debris are shown in Figures 31 through 33.

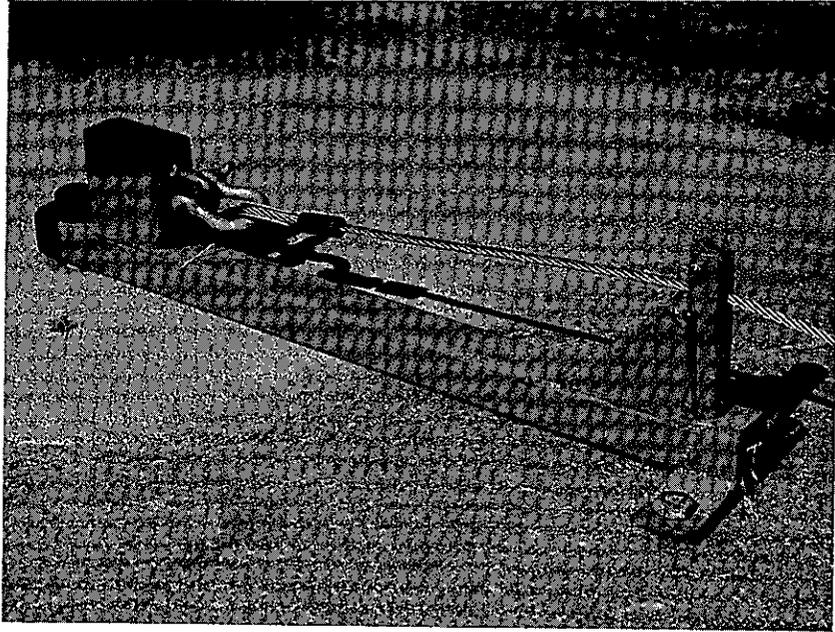
Figure A5. Steel Knockoff Bracket
