FHWA/CA/TL-85/06

California PCC Pavement Faulting Studies: A Summary

Office of Transportation Laboratory
California Department of Transportation
Sacramento, California 95819

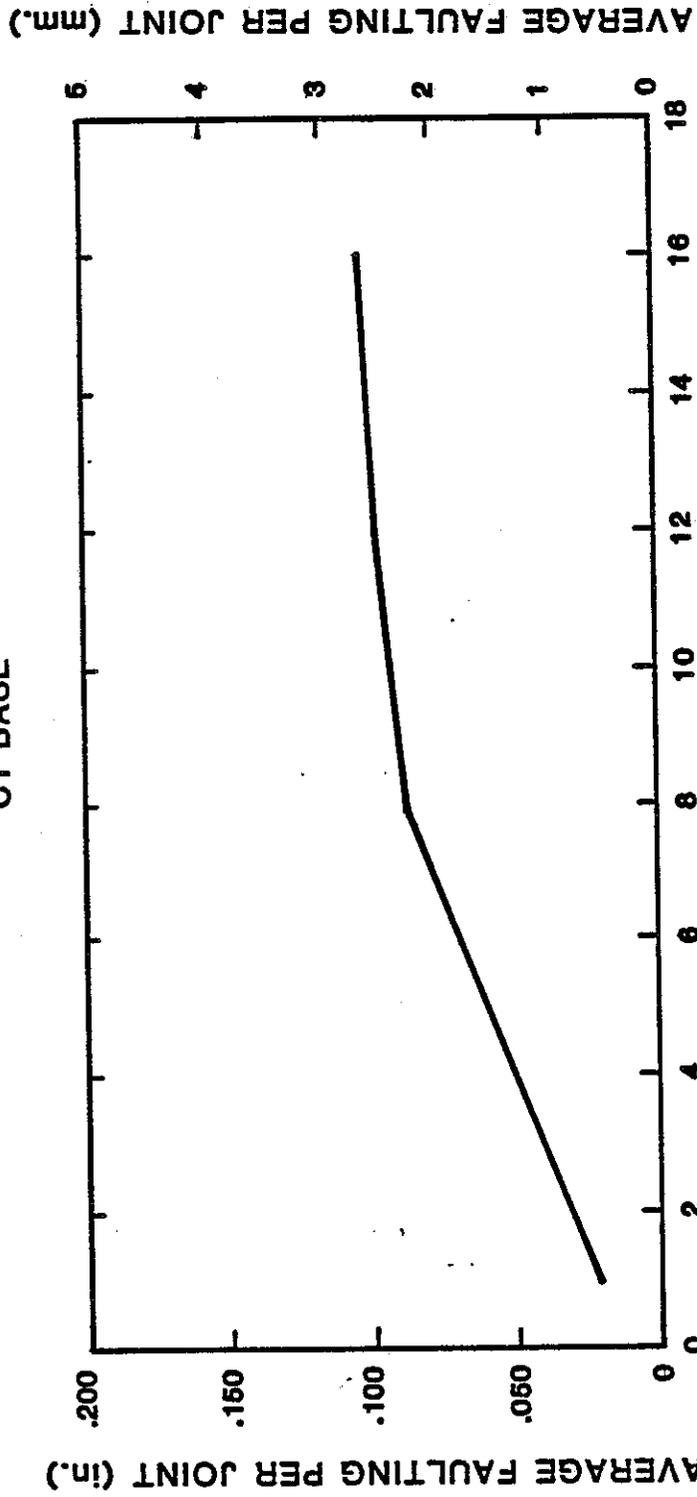
07 LA 14
ROSAMOND
(SEMI-ARID REGION)
PAVED 1968
CT BASE

PAVEMENT AGE IN YEARS

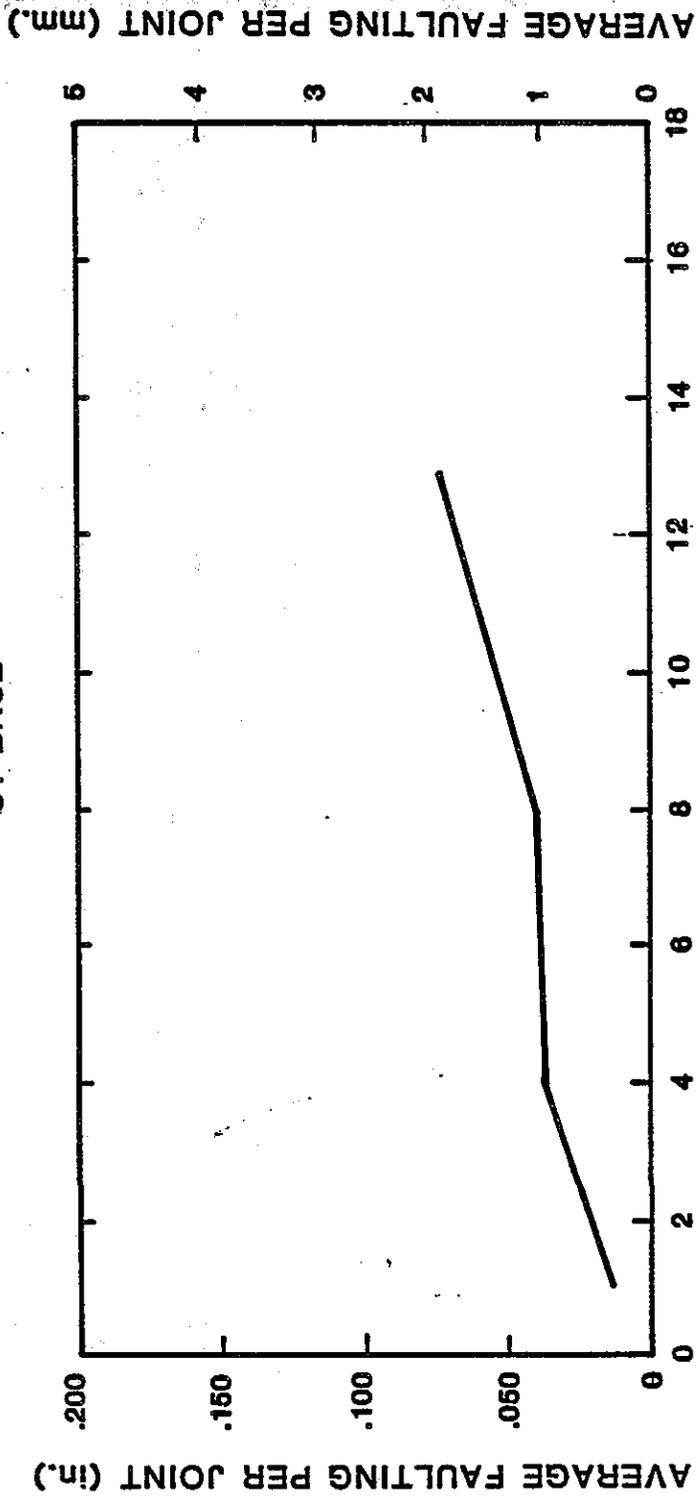
11 Riv 10
 INDIO
 (SEMI-ARID REGION)
 PAVED 1972
 CT BASE

PAVEMENT AGE IN YEARS
 FAULTING TREND LINE

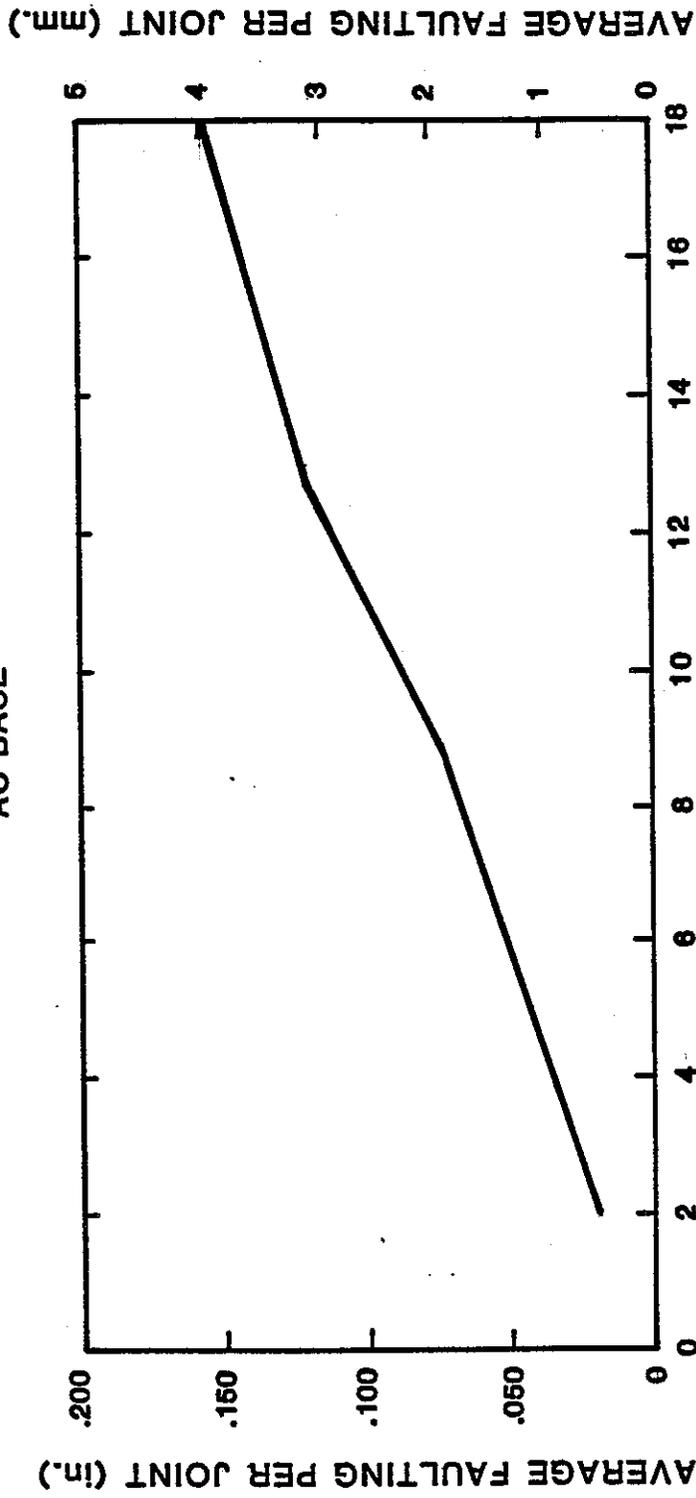
02 Sha 5
REDDING
(VALLEY REGION)
PAVED 1967
AC BASE

PAVEMENT AGE IN YEARS

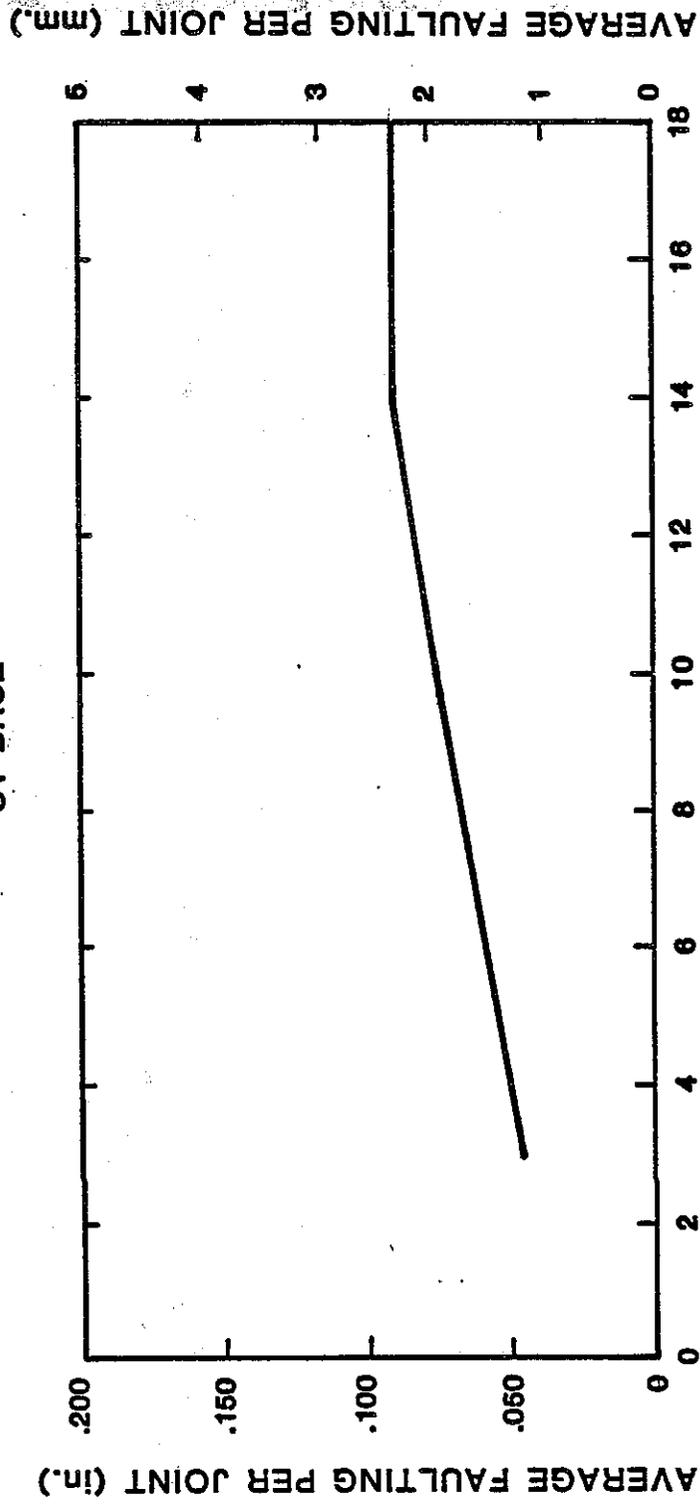
10 Mer 5
GUSTINE
(VALLEY REGION)
PAVED 1966
CT BASE

PAVEMENT AGE IN YEARS

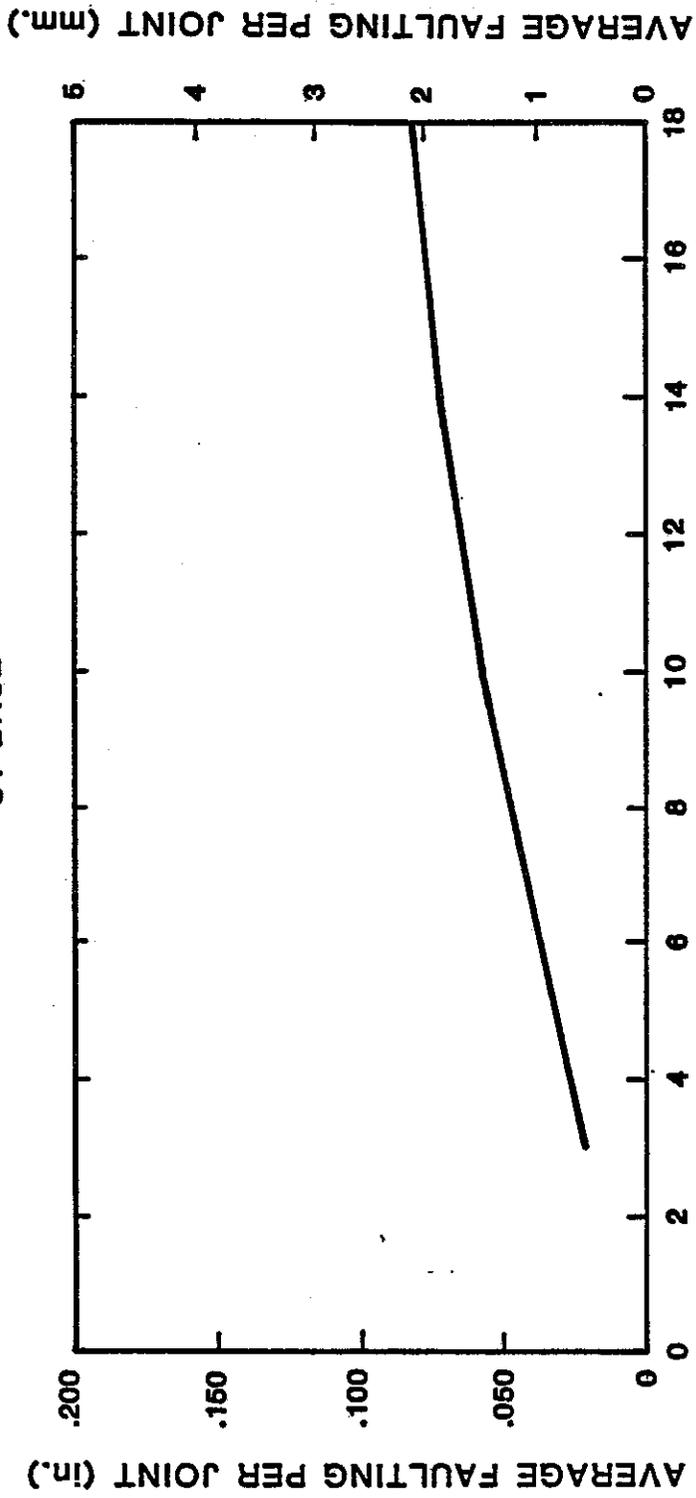
10 SJ 580
VERNALIS
(VALLEY REGION)
PAVED 1966
CT BASE

PAVEMENT AGE IN YEARS
FAULTING TREND LINE

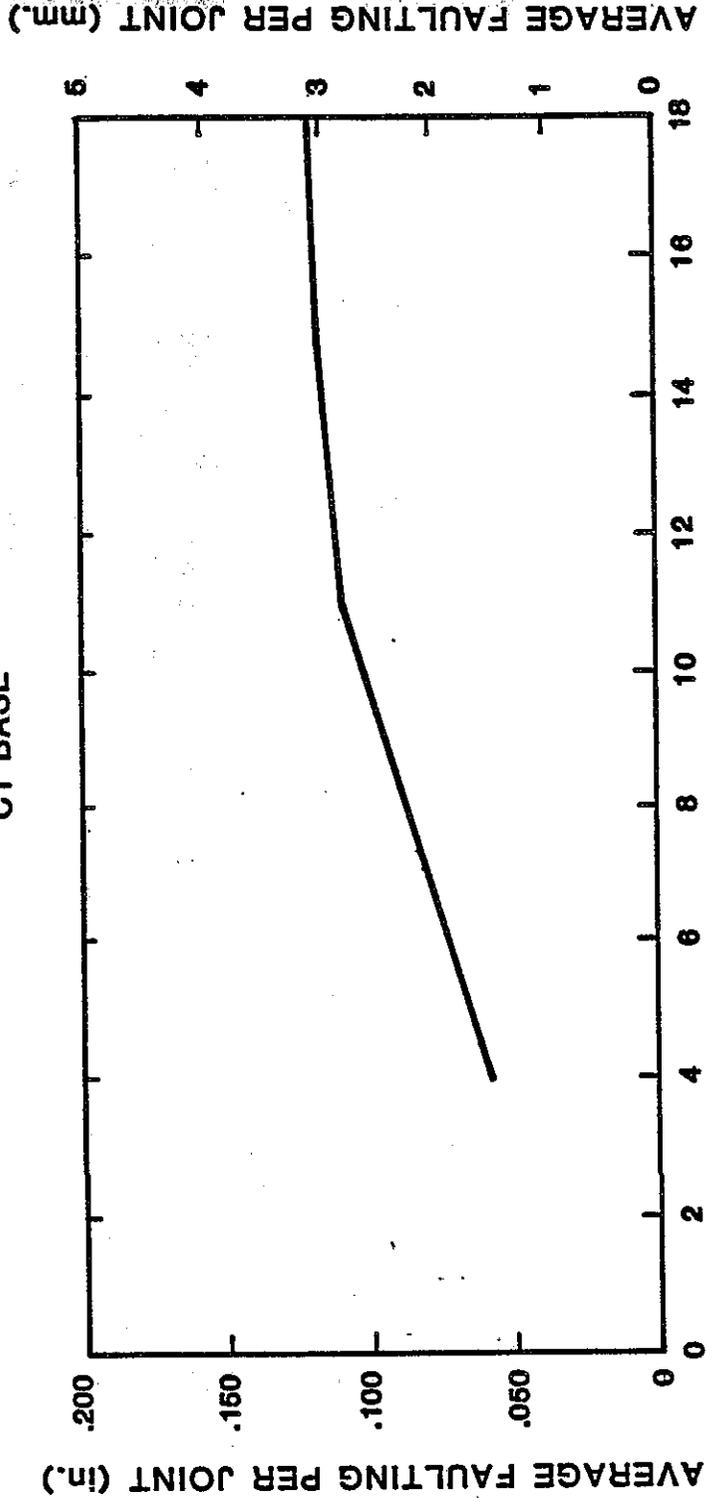
10 Mer 152
PACHECO PASS
(MOUNTAIN REGION)
PAVED 1965
CT BASE

PAVEMENT AGE IN YEARS
FAULTING TREND LINE

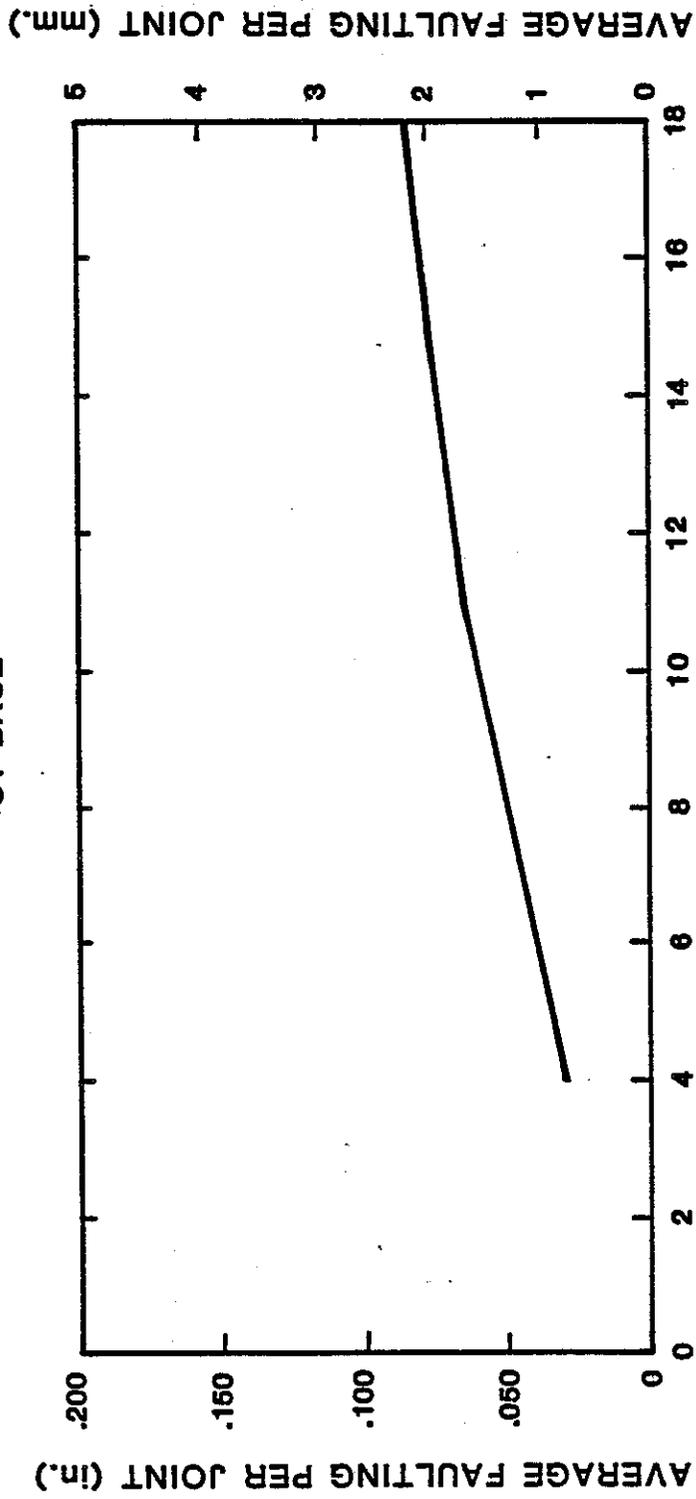
08 SBd 15
CAJON PASS
(MOUNTAIN REGION)
PAVED 1965
CT BASE

PAVEMENT AGE IN YEARS
FAULTING TREND LINE

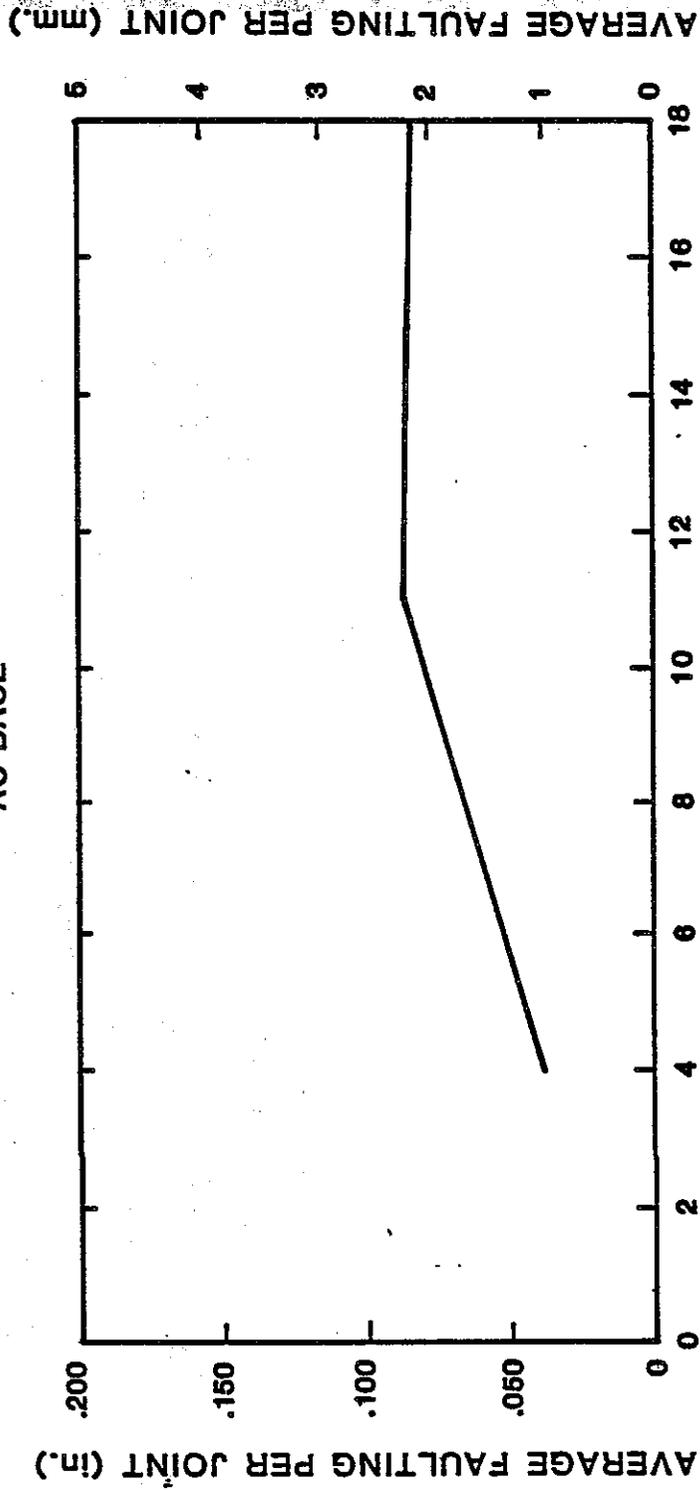
09 Kern 58
TEHACHAPI (WB)
(MOUNTAIN REGION)
PAVED 1965
AC BASE

PAVEMENT AGE IN YEARS

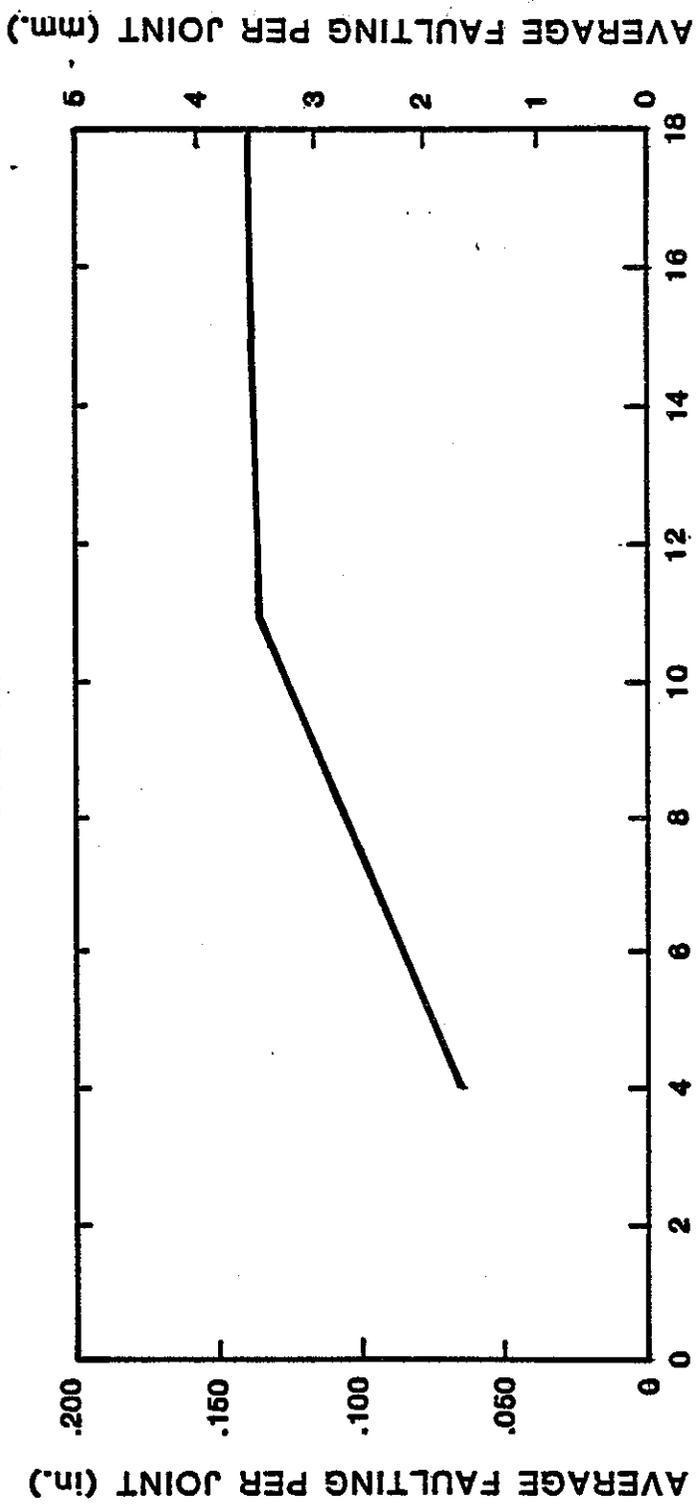
09 Ker 58
 TEHACHAPI (EB)
 (MOUNTAIN REGION)
 PAVED 1965
 CT BASE

PAVEMENT AGE IN YEARS
 FAULTING TREND LINE

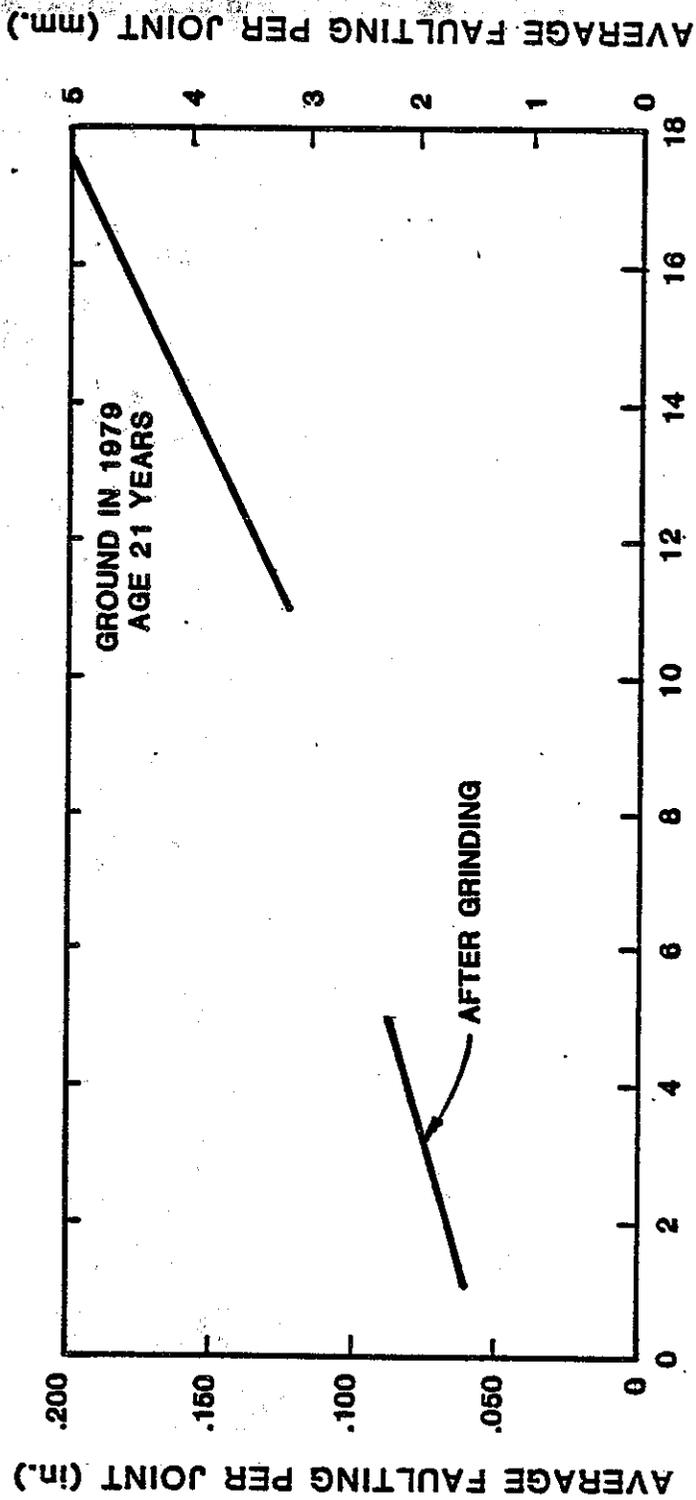
05 SB 101
ORELLA
(COASTAL REGION)
PAVED 1958
AT BASE

FAULTING TREND LINE

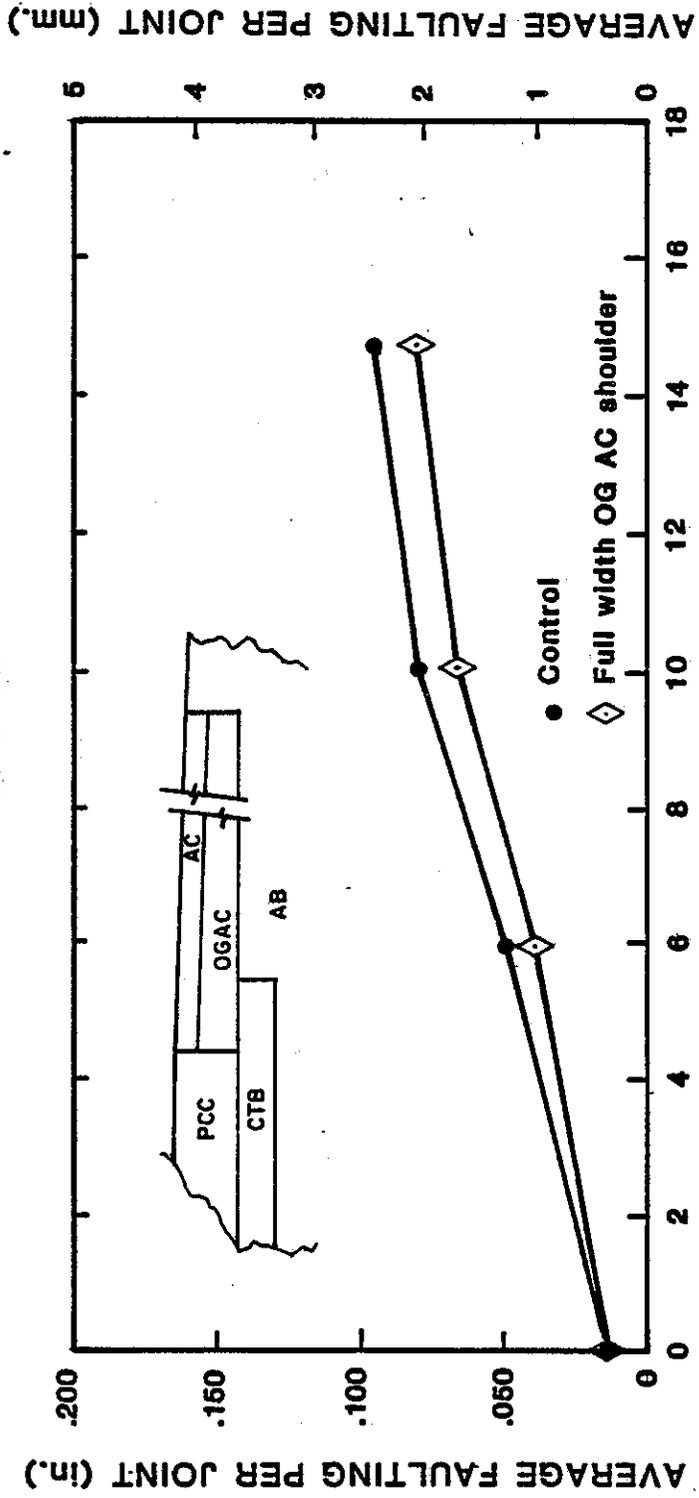
03 Col 5
 WILLOWS
 (VALLEY REGION)
 PAVED 1970
 CT BASE

PAVEMENT AGE IN YEARS
 FAULTING TREND LINE

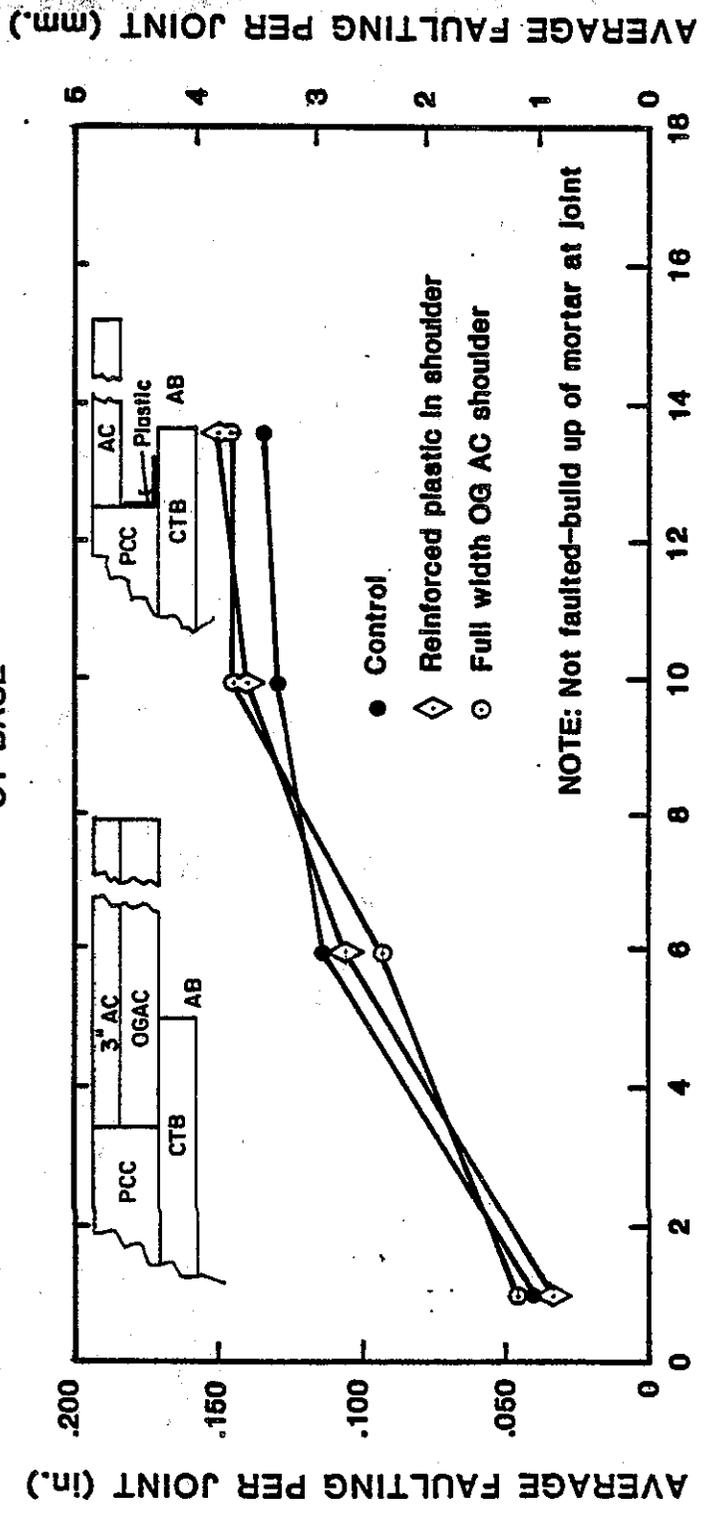
10 Sta 99
 SALIDA
 (VALLEY REGION)
 PAVED 1970
 CT BASE

PAVEMENT AGE IN YEARS

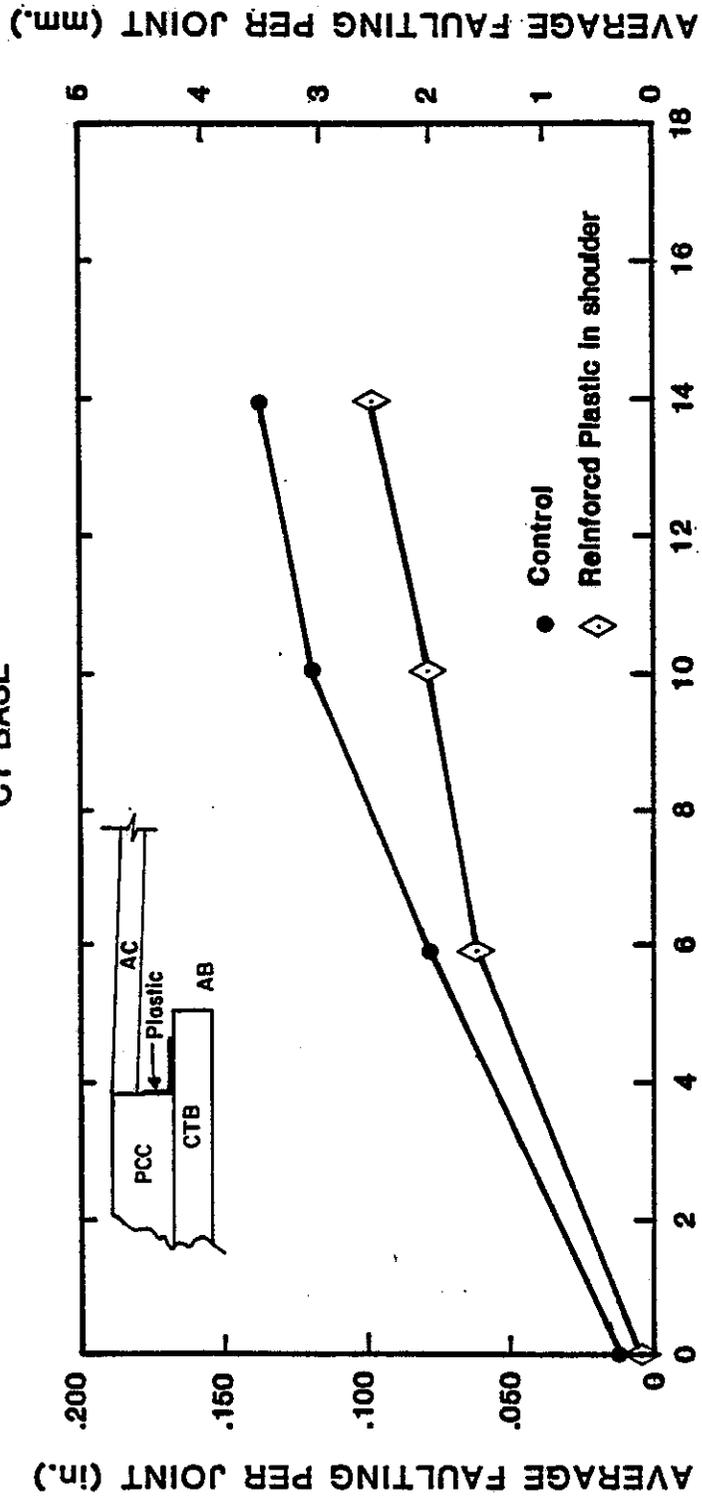
10 SJ 205
 N. TRACY
 (VALLEY REGION)
 PAVED 1970
 CT BASE

PAVEMENT AGE IN YEARS
 FAULTING TREND LINE

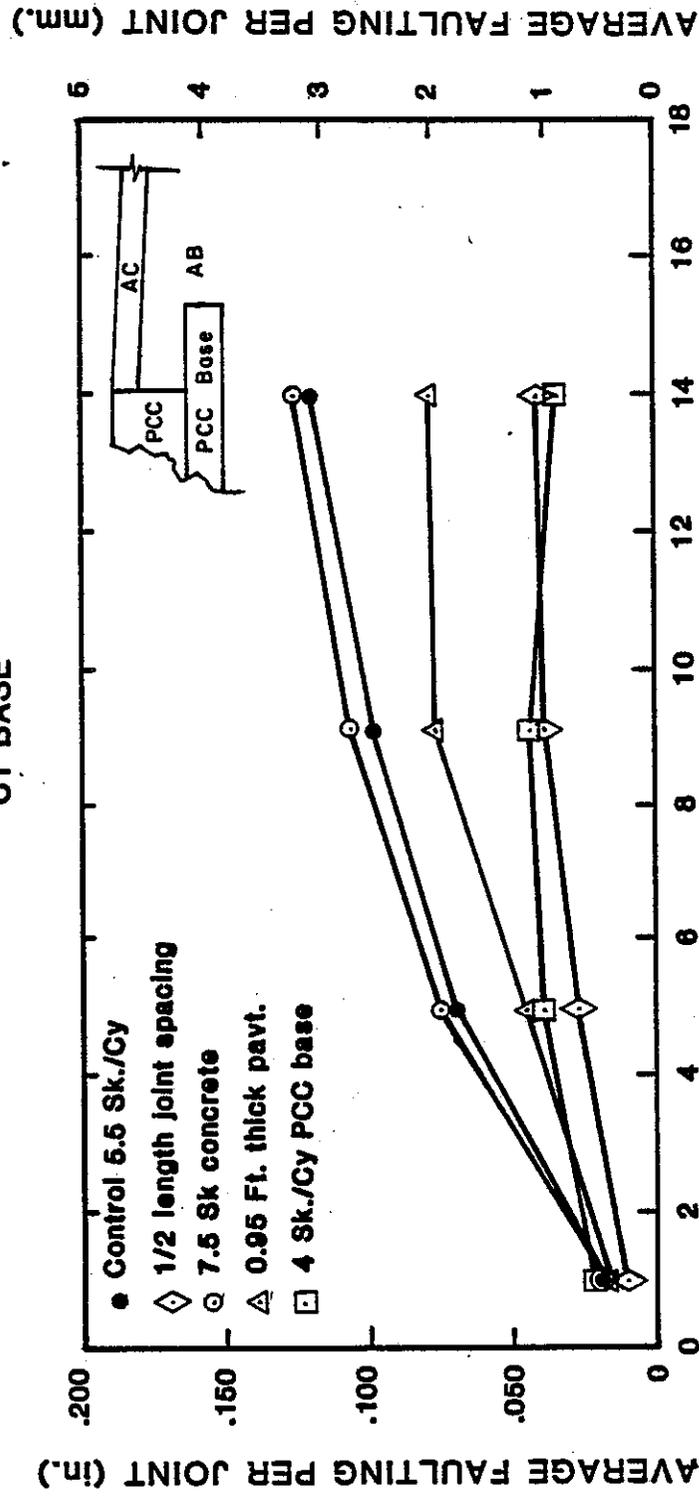
E. TRACY (SB)
(VALLEY REGION)
PAVED 1971
CT BASE

PAVEMENT AGE IN YEARS

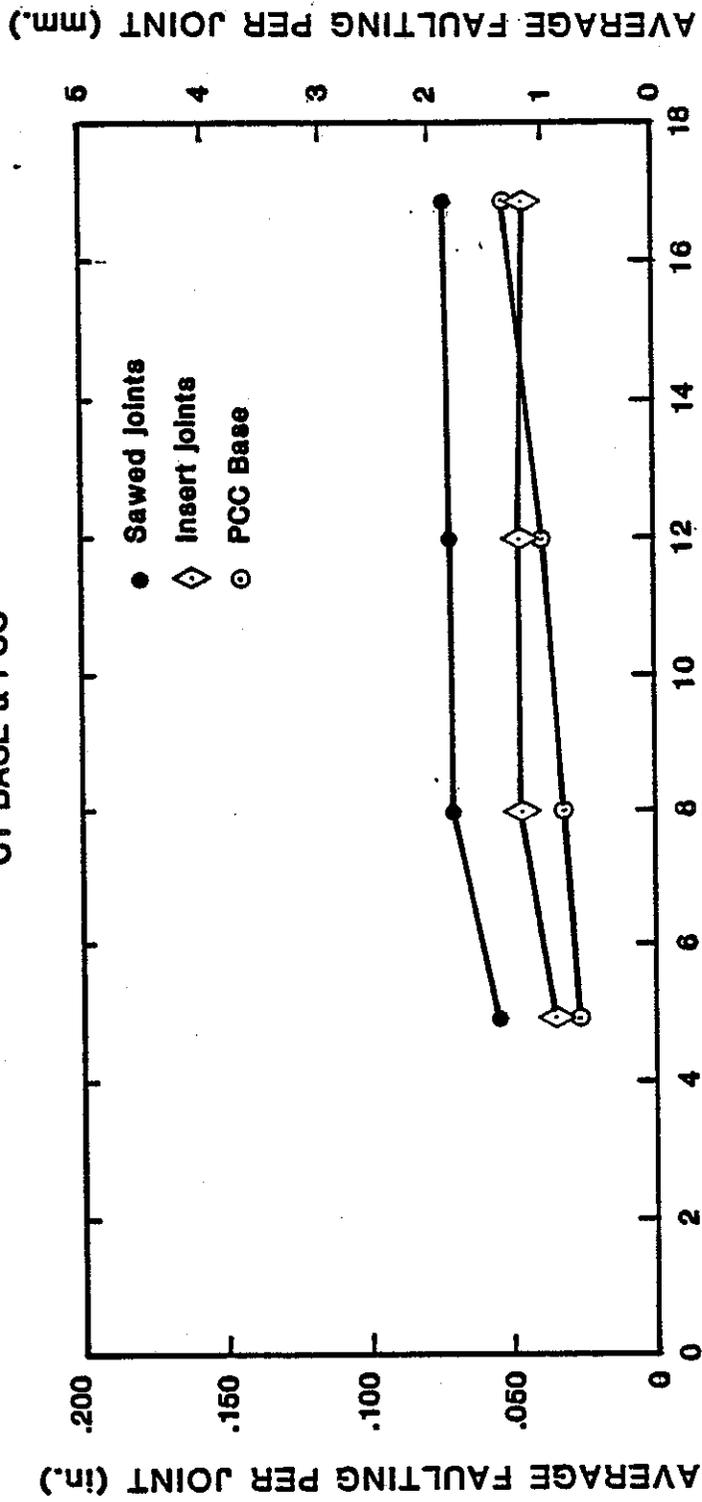
11 SD 8
 ALPINE
 (MOUNTAIN REGION)
 PAVED 1968
 CT BASE & PCC

PAVEMENT AGE IN YEARS
 FAULTING TREND LINE

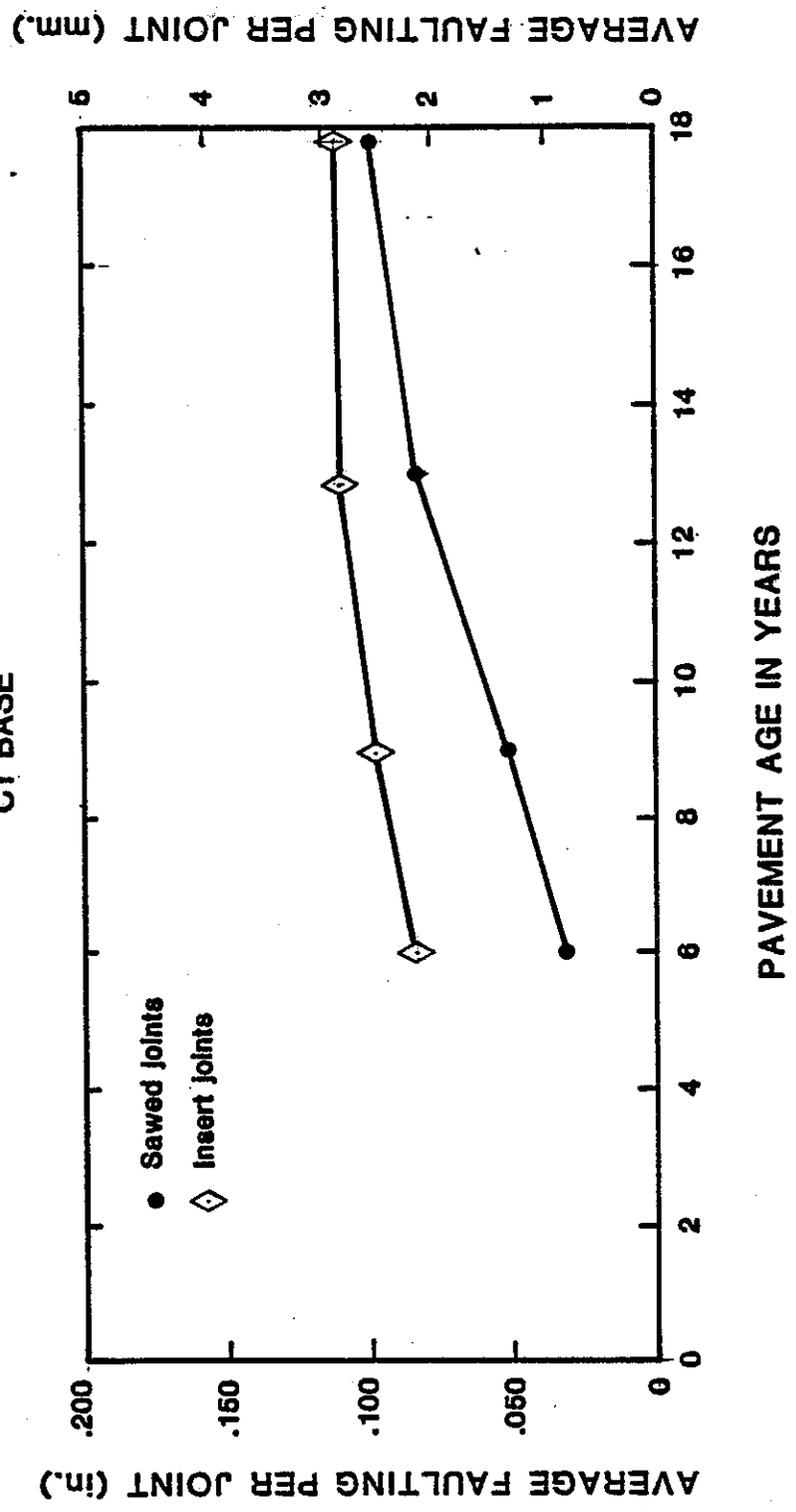
06 Mad 152
 RED TOP
 (MOUNTAIN REGION)
 PAVED 1967
 CT BASE

FAULTING TREND LINE

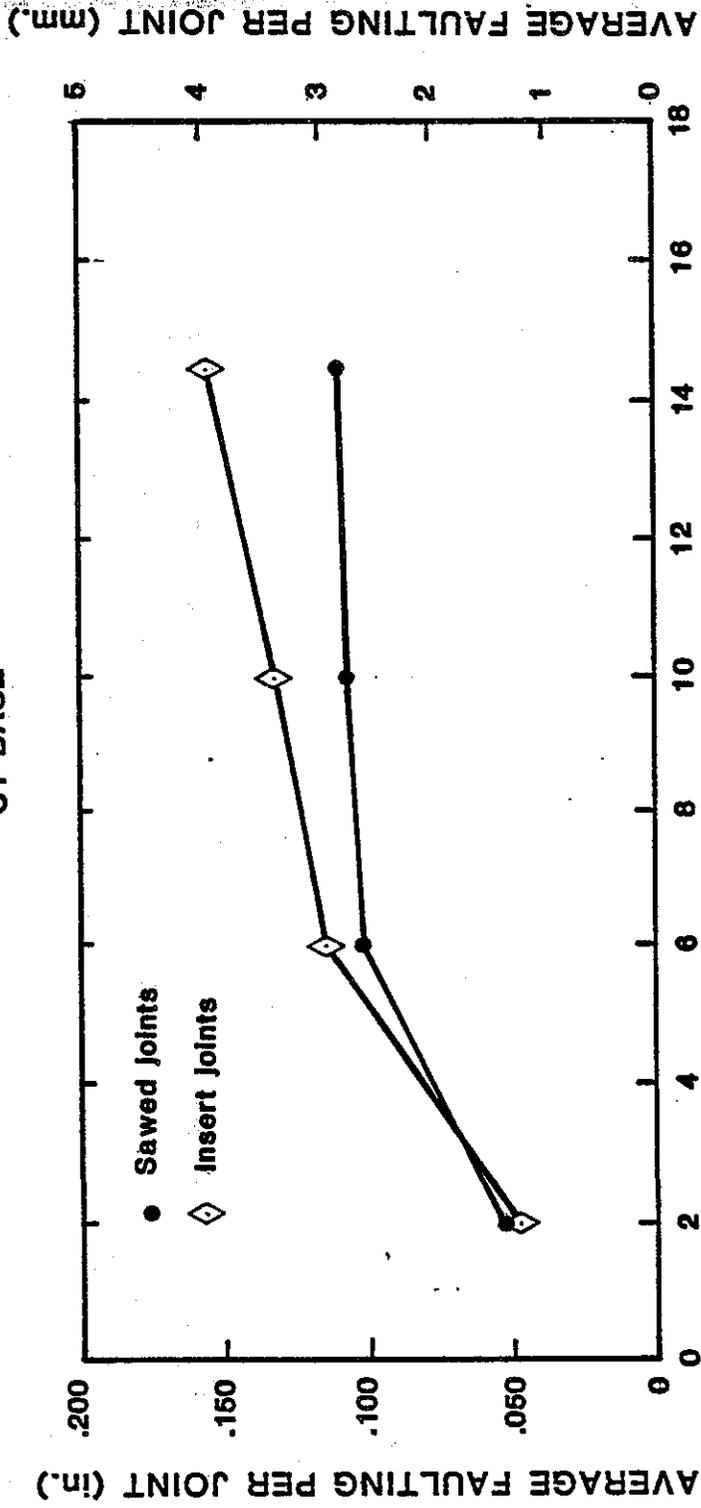
02 Sls 5
 YREKA
 (MOUNTAIN REGION)
 PAVED 1970
 CT BASE

PAVEMENT AGE IN YEARS
 FAULTING TREND LINE

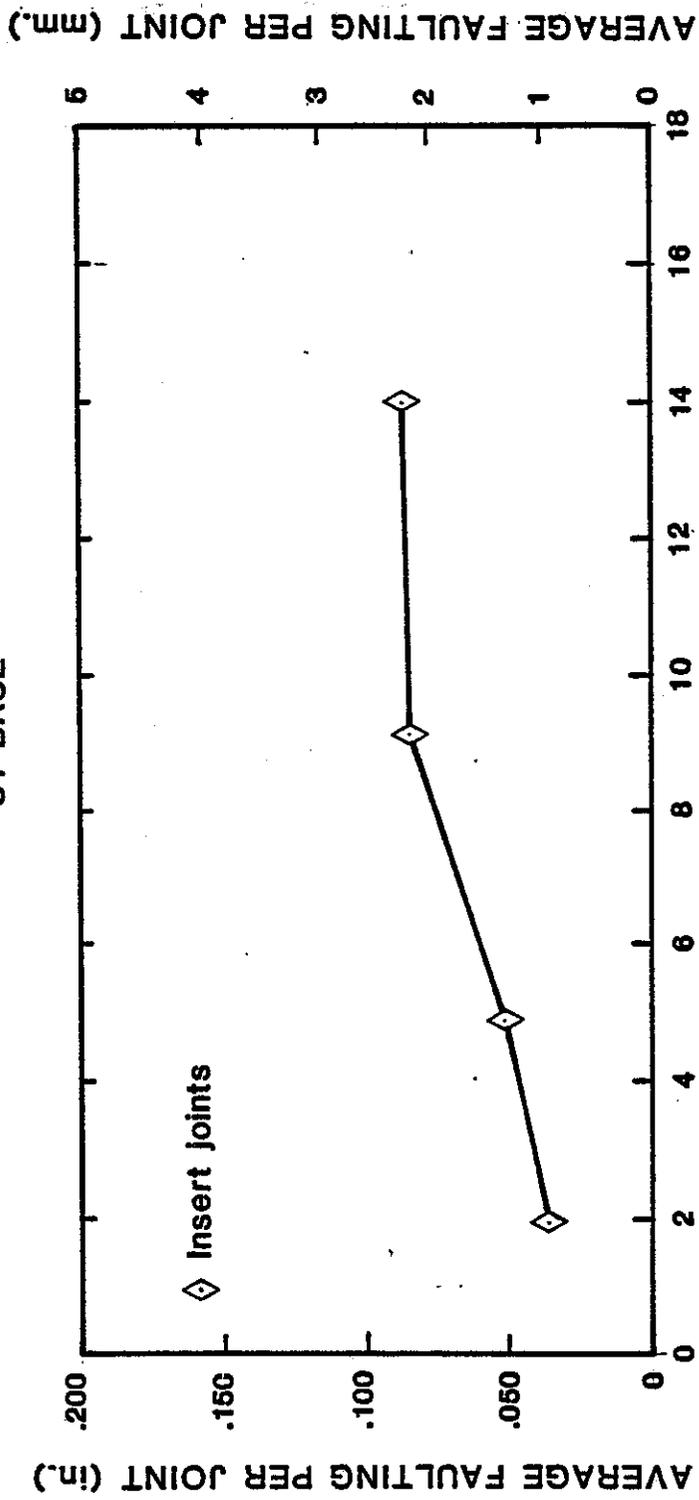
06 Tul 99
GOSHEN
(VALLEY REGION)
PAVED 1971
CT BASE

PAVEMENT AGE IN YEARS

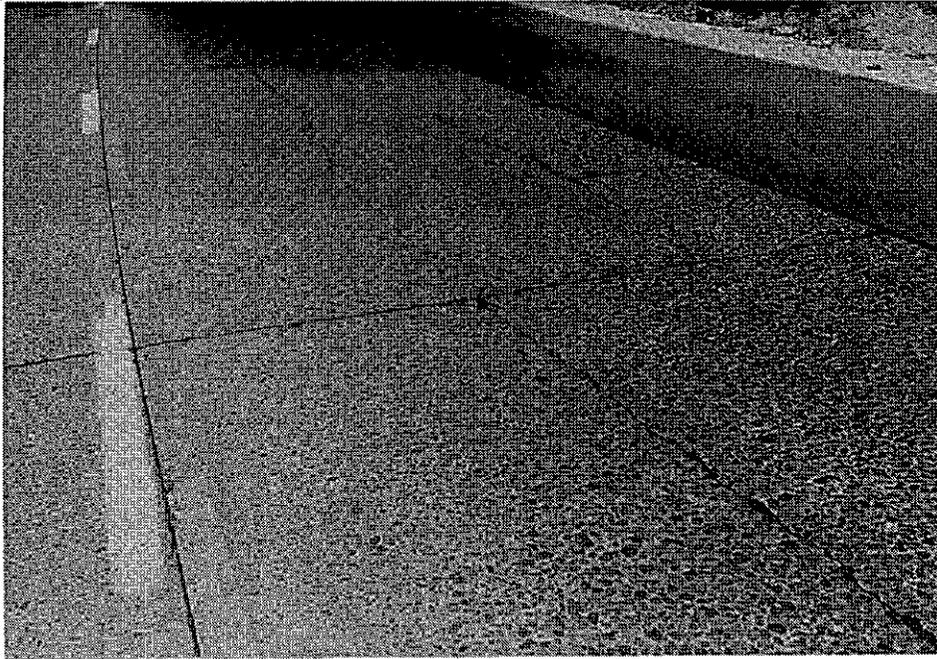
Figure 3
Existing Condition of Roadway

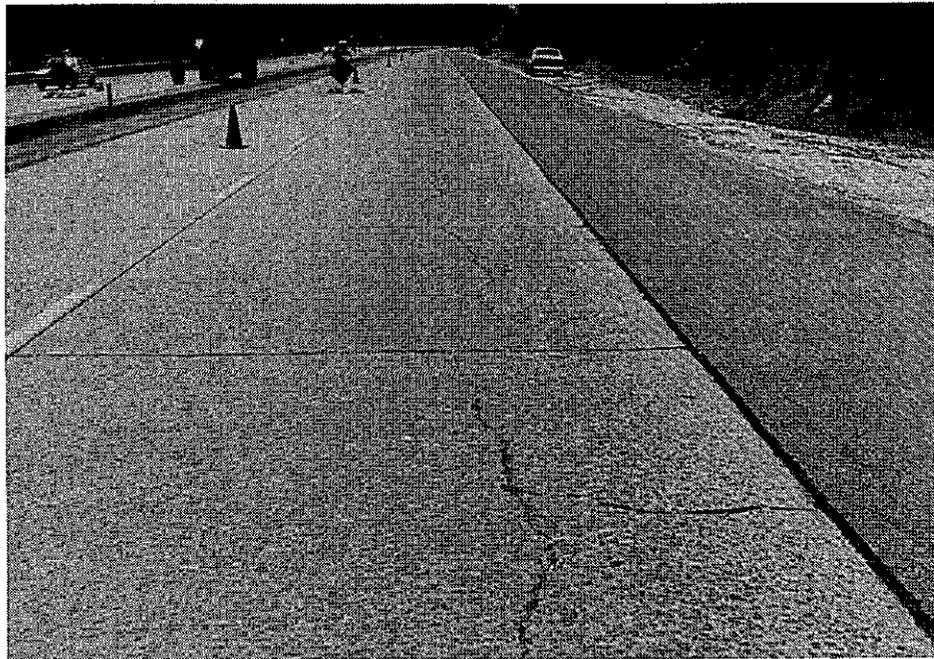
Figure 4
Existing Condition of Roadway

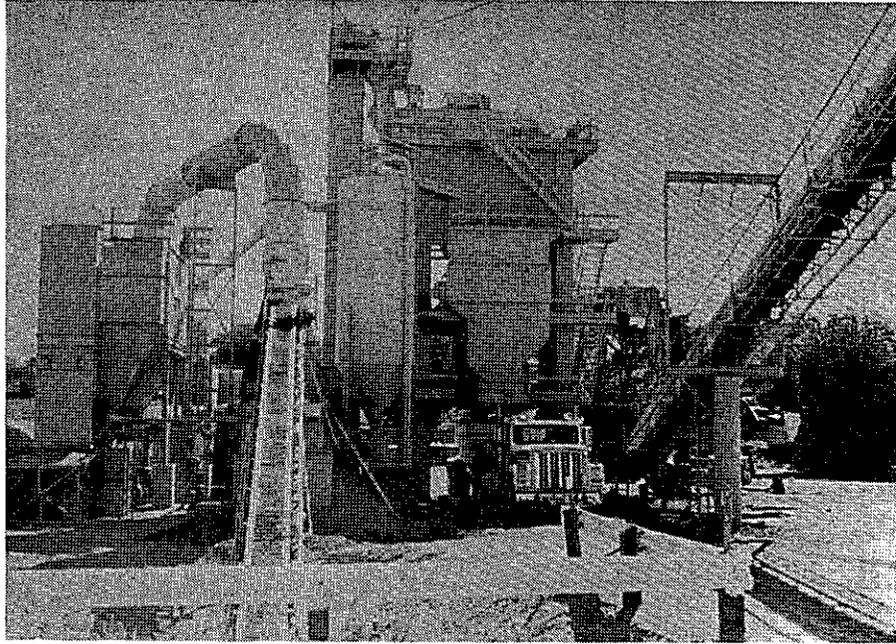
Figure 5
6000 lb Batch Plant

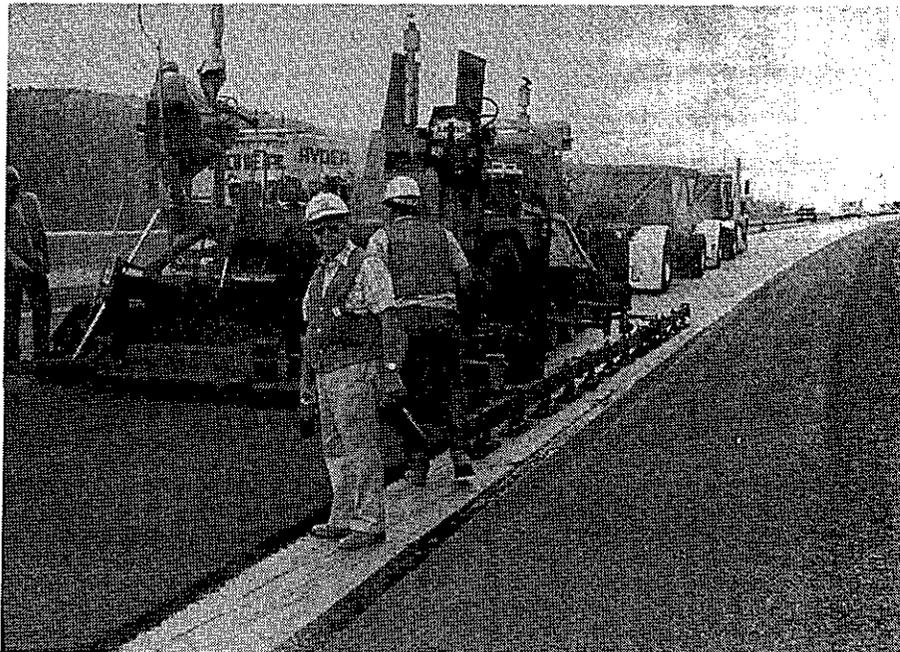
Figure 8
Blaw Knox Paver with KoCal Pickup Machine
