Willits Bypass: The Wait is Over

Six Decades After It Was First Proposed, North Coast Route Becomes Reality

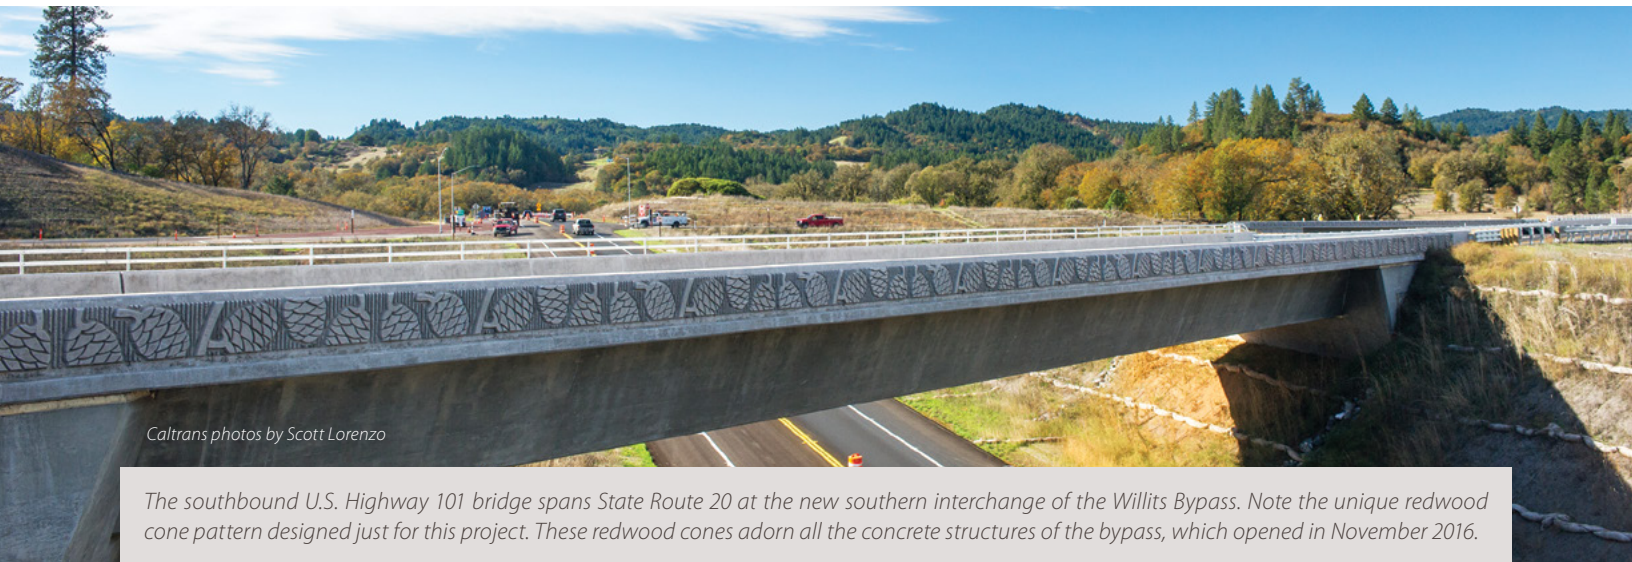
The southbound U.S. Highway 101 bridge spans State Route 20 at the new southern interchange of the Willits Bypass. Note the unique redwood cone pattern designed just for this project. These redwood cones adorn all the concrete structures of the bypass, which opened in November 2016.

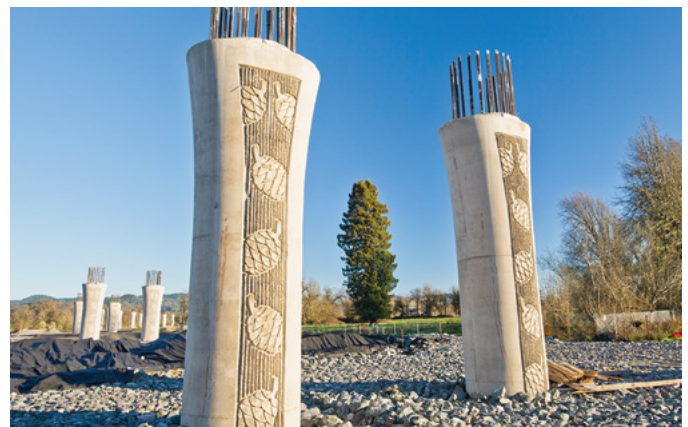
These columns, or bents, rise over 20 feet to support the 1.1 mile viaduct. In all, 64 of these columns support the viaduct's roadway.

The 1.1-mile-long viaduct is the type of challenging project that every structural engineer wants in their work history. Built in eight frames, or segments, its foundations rest on friction piles (steel

piles that do not extend into the bedrock) due to the very deep soils in that area of the valley. Designed to withstand large earthquakes, the viaduct crosses two local roads, several waterways and a 100-year floodplain.
