Final Report of Full Scale Dynamic Tests of Bridge Curbs and Rails

August 1957

State of California
Department of Public Works
Division of Highways
Materials and Research Department

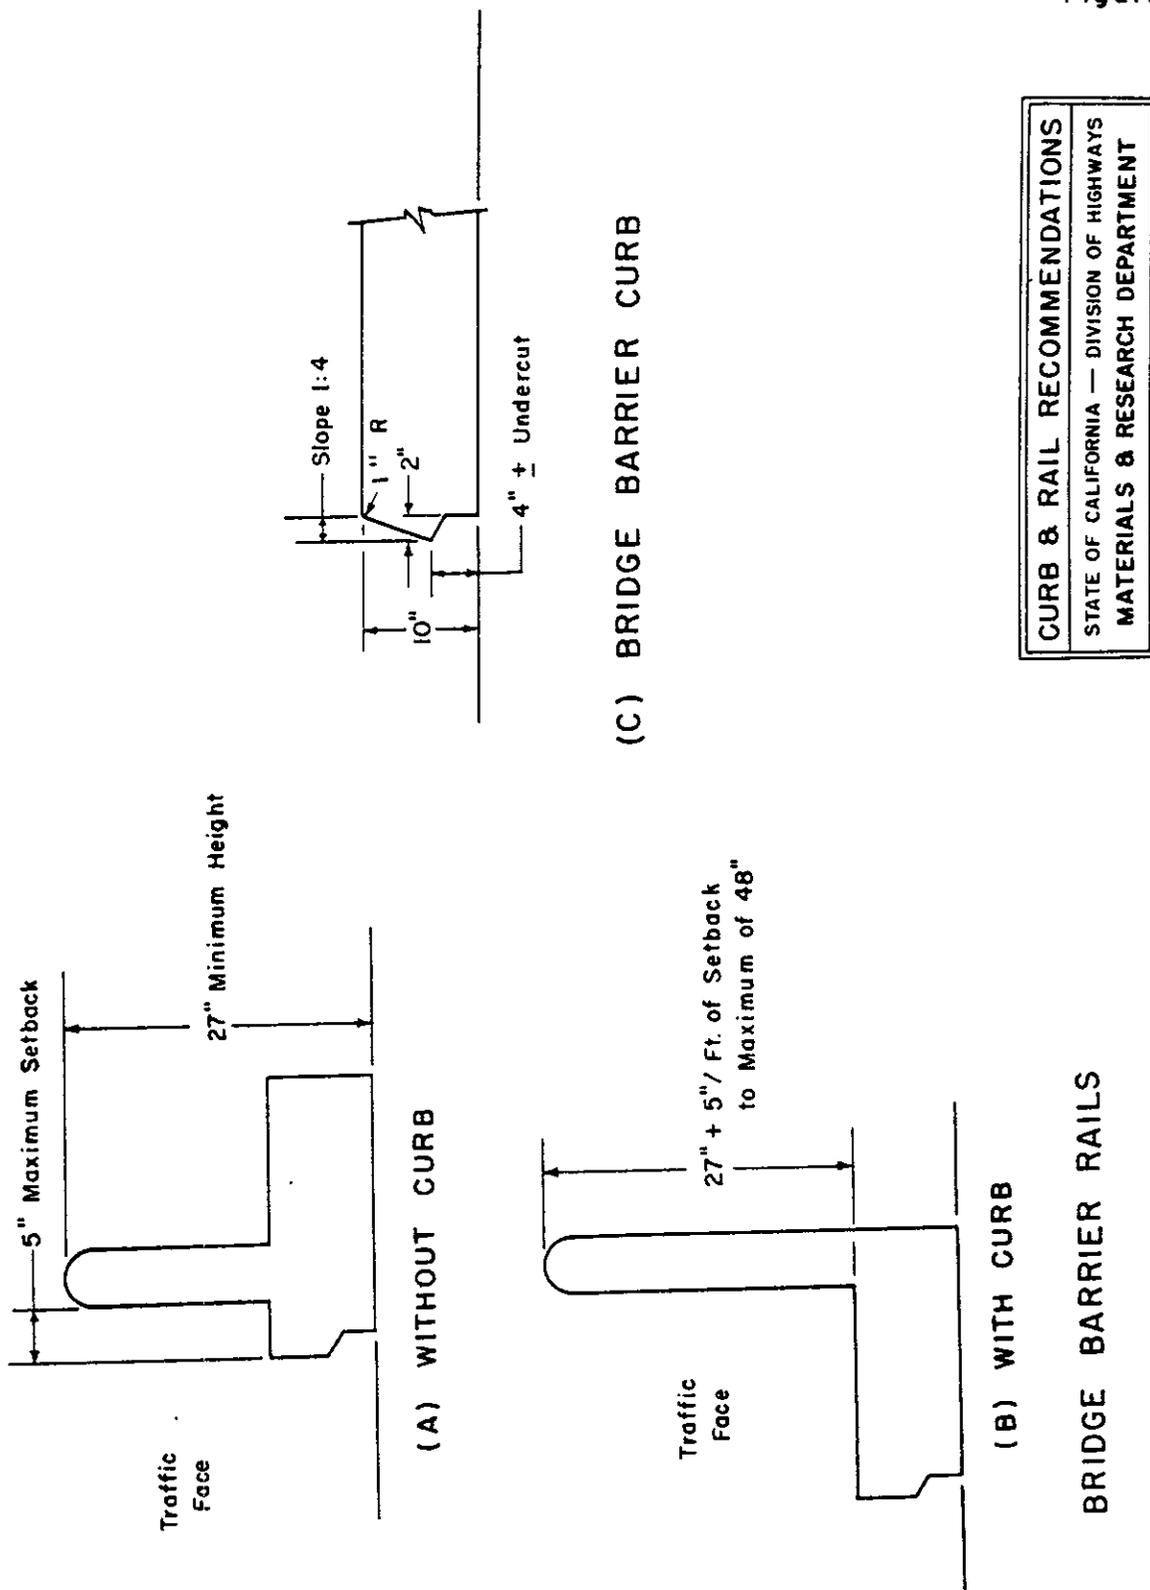
Figure 1

7. The results of these tests indicate that the proposed curb design shown in Figure 1C should result in the most efficient bridge curb design.

A barrier curb design which incorporates all the features proven the most desirable in the testing program is shown in Figure 1C. It is recommended that the material employed be either concrete, steel armored concrete, or steel, depending on location and service.

2. The amount of energy absorbed by vehicular damage during collision.
 3. The drag of the damaged portion of the vehicle.
 - b. When passing over a barrier, a vehicle will dynamically rise higher than the mere height of the barrier (see Figures 14 through 16). The height and length of jump of a vehicle was observed to be dependent primarily upon the mass and velocity of the vehicle and the height of the curb. The jump is dependent partly upon the failure or non-failure of the front wheel (affected by the construction of the particular front wheel suspension) during the initial collision.

velocity of a deflected vehicle is also markedly decreased by a sharp undercut at the base of a barrier curb. The undercut must be just high enough to contain the bulge of a tire (see Figure 1C).

1. If a concrete barrier rail is constructed on a plane flush with the pavement, without a curb between it and the traveled way, the rail should have a height of not less than 2'3" to be effective as a barrier against automobiles (see Figure 1A).

3. Bridge rails used in combination with a curb, set back greater than 5 inches, must be higher than bridge rails used without a curb. Analysis of the "jump curves" (Figures 14 through 16) indicates that the basic rail height (27" above curb) should be increased by 5 inches for each 12 inches of setback from the curb face to a maximum height of 48 inches (see Figure 1B).

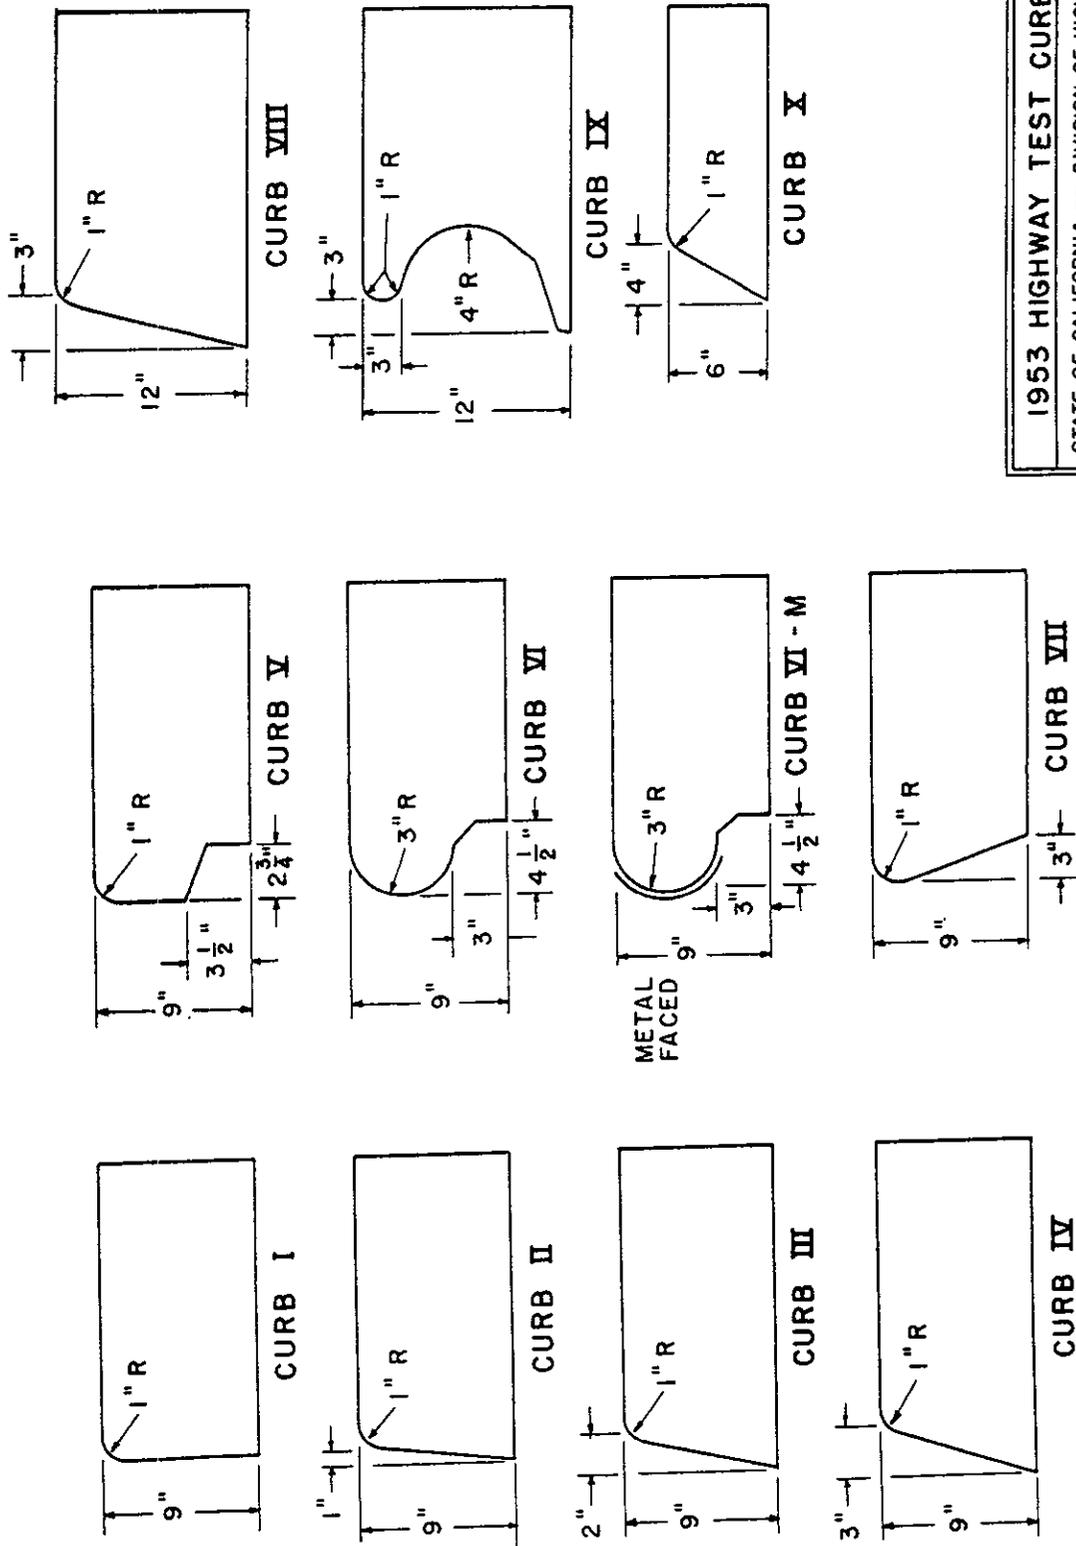
Figure 2

In 1953 eleven different designs of roadway curbing were tested, each represented by a section 100 feet long. These curbs are identified in Figure 2. All of the 1953 curbs were constructed of concrete except Curb VI-M. The three heights of curbing tested were 6", 9", and 12".

The 1953 test curb installation was 500 feet long and 3 feet wide. Ten different curbs were formed, five on each side. Wood forms were used (except for Curb VI-M, Figure 2) and the concrete was placed directly on the airport bituminous pavement surface. The curbs resisted sliding without the use of dowels. A metal form was used to construct Curb VI. This form was later reinstalled to serve as a metal facing (Curb VI-M) and additional comparative tests were made to determine the differences between concrete and metal as a curb surface.

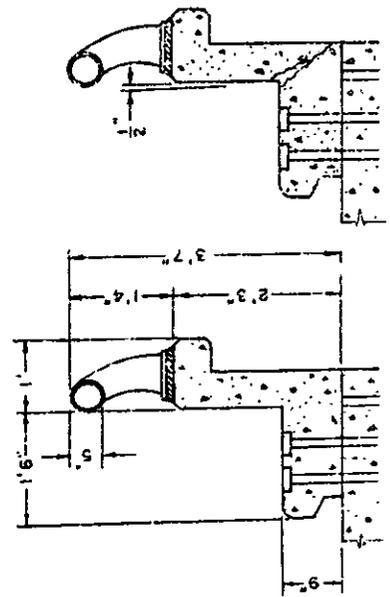
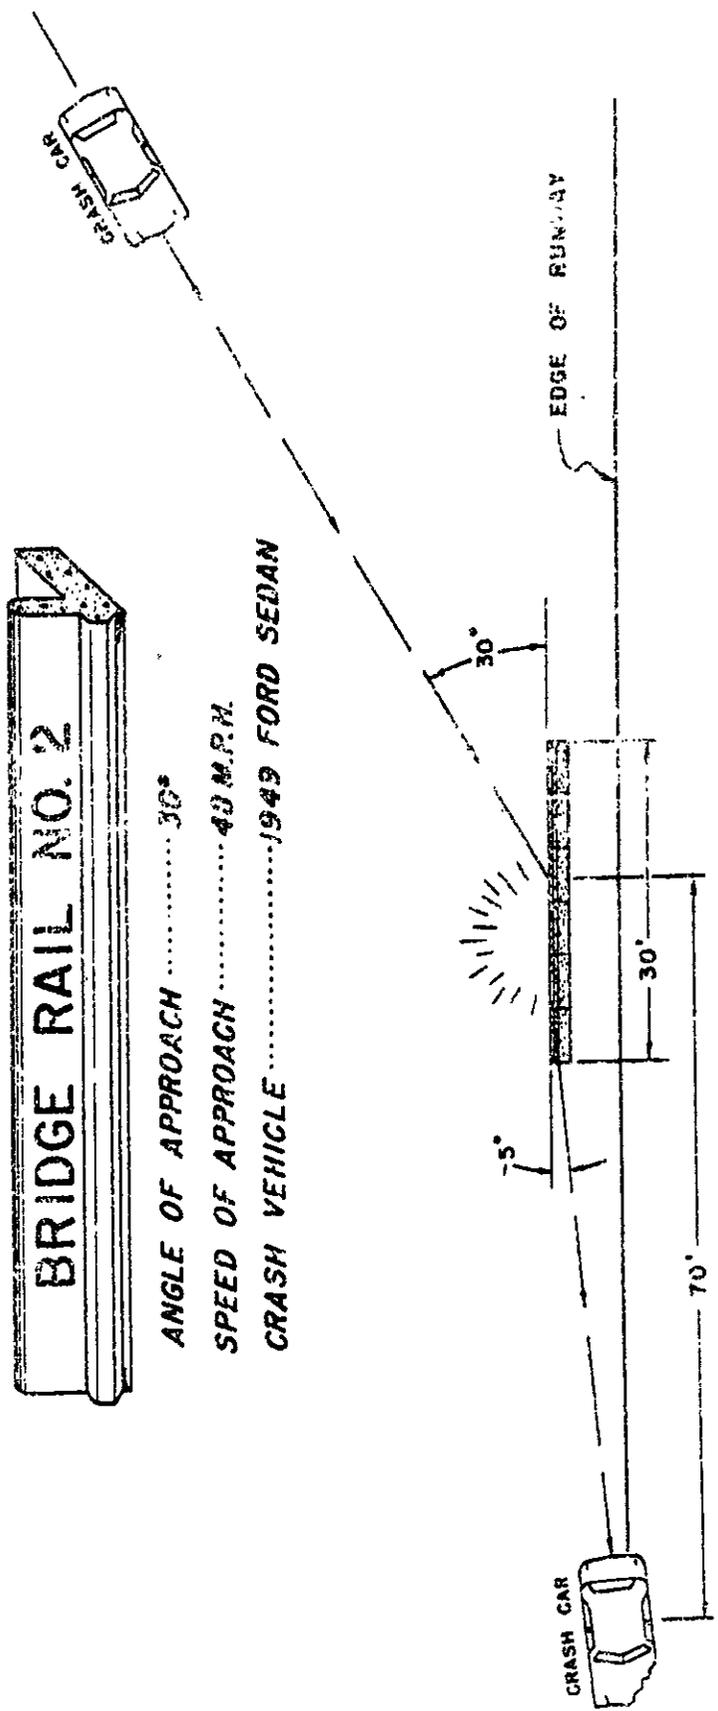
Due to secondary collision with camera barricade, final position of Crash Car is not a factor.

The crash vehicle was deflected by the bridge rail at an angle of approximately 2°. The collision caused only a slight hesitation in the cars forward travel with minor tipping action noticeable as the car deflected along and then away from the bridge rail. The car mounted the 9" curb readily and then slid along the rail for 10' before leaving the Bridge Rail. It appeared that the pipe rail prevented excessive tipping of the car.

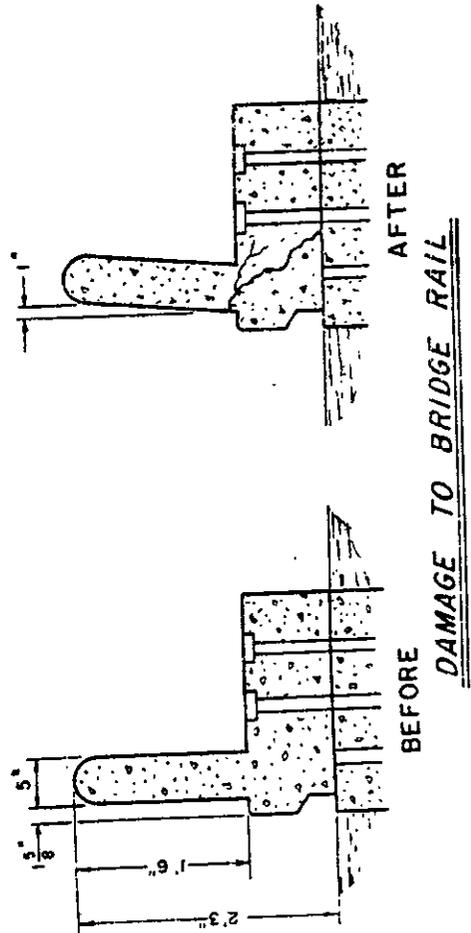
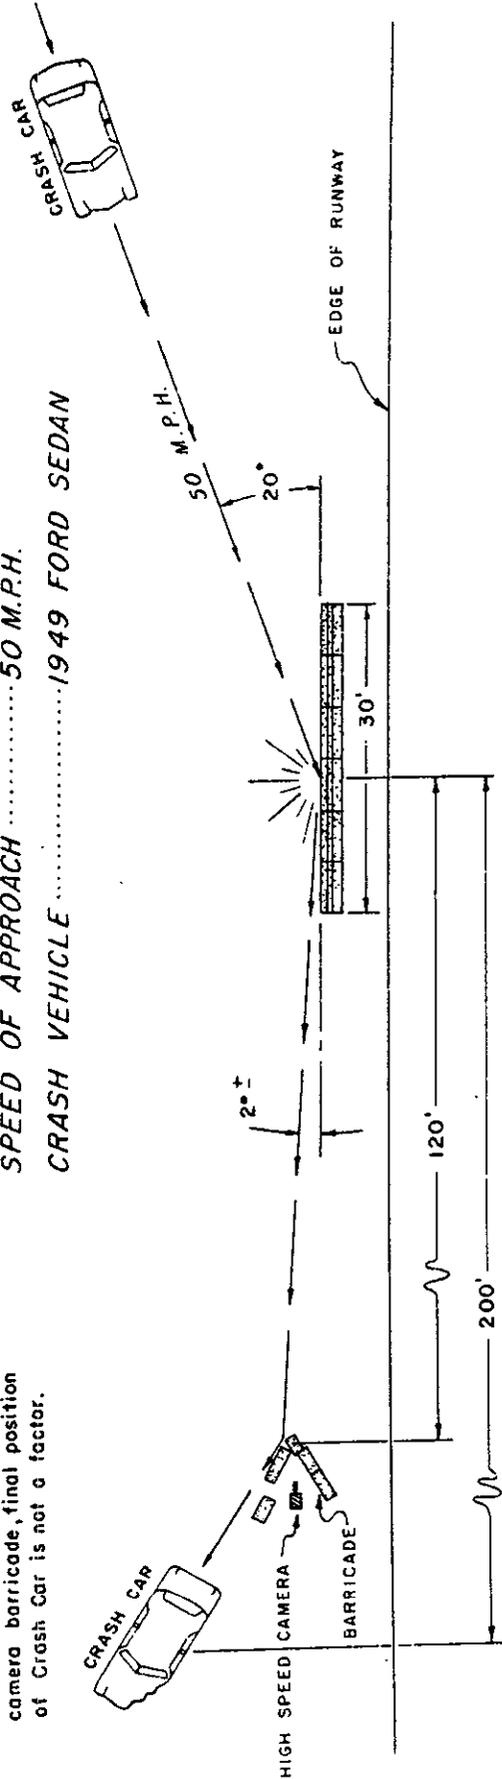
BRIDGE RAIL NO. 3

SPEED OF APPROACH 55 M.P.H.

CRASH VEHICLE 1949 FORD SEDAN

The crash vehicle was deflected by the bridge rail at an angle of approximately 1°. The collision caused only a slight hesitation in the forward travel with minor tipping action noticeable as the car deflected away from the bridge rail.

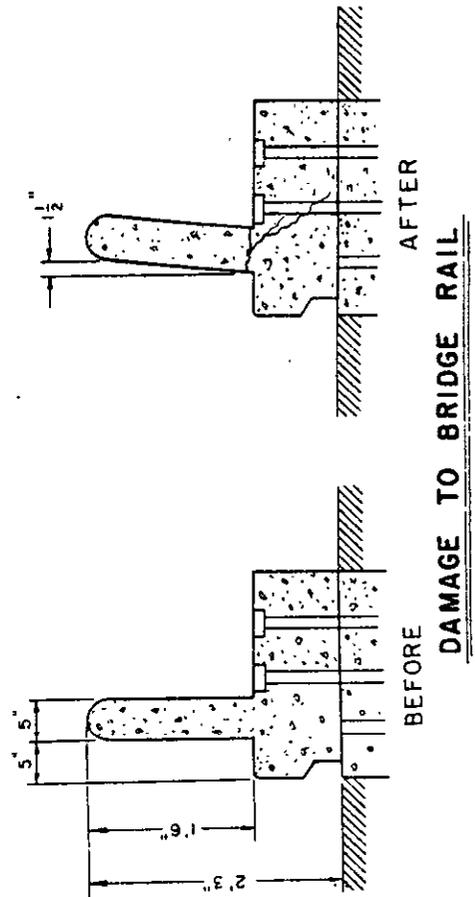
Due to secondary collision with camera barricade, final position of Crash Car is not a factor.

The crash vehicle was deflected by the bridge rail at an angle of approximately 2°. The collision caused only a slight hesitation in the car forward travel with minor tipping action noticeable as the car deflected away from the bridge rail.

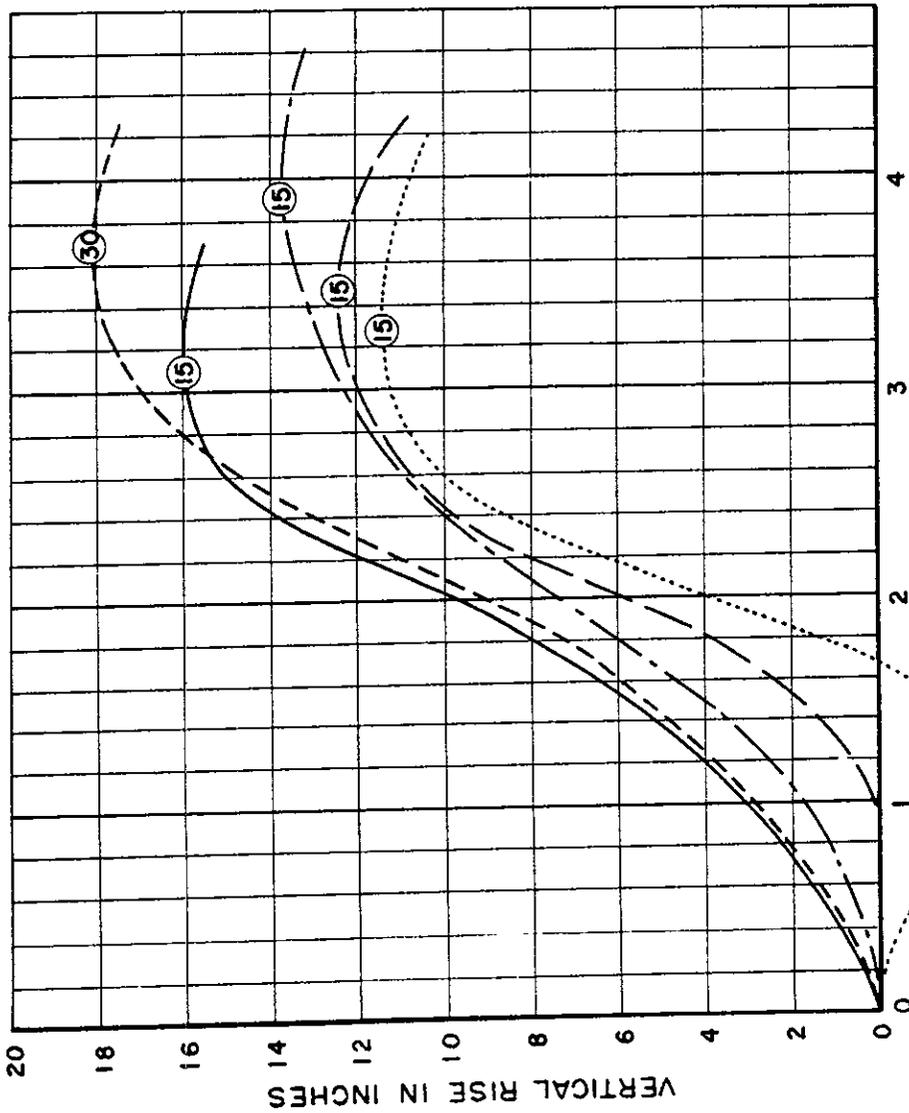
HORIZONTAL DISTANCE IN FEET
(Horizontal Components of Vehicle Path
Measured Perpendicular to Curb)

Curb	Angle	Speed	Curve
A 9	7.5°	60	---
A 9	15°	30	---
A 10	15°	45	---
A 10	20°	30
A 11	20°	30	---

A series of "dynamic jump curves" (Figures 14 through 16) was developed from cine films of vehicles which mounted and passed over the curb (the motion of the vehicle frame nearest the colliding wheel was traced from the pictures). These curves, which show the height of rise of the vehicle at various distances after collision with the barrier curb can be correlated with the action of the vehicles during collision studies of bridge rail and curb combinations. During the bridge railing tests (Figures 5 through 9), it was determined that the position of the frame at its collision point with the barrier is critical.

The "jump curves" illustrate that when a wheel first starts to mount a curb, the wheel deforms with little rise in the car. The wheel later recovers, thus helping to raise the car during the general upward flight after mounting the curb. (See cine film strip reproduction, Figure 19).

The curves also illustrate that the velocity of the vehicle is a primary factor affecting the height and length of the jump after a vehicle mounts a curb. The height of the curb and the angle of collision also have a marked effect. The shape and material of the curb influence whether or not the car mounts the curb but seem to have little effect on the height or length of jump once the mounting is accomplished.

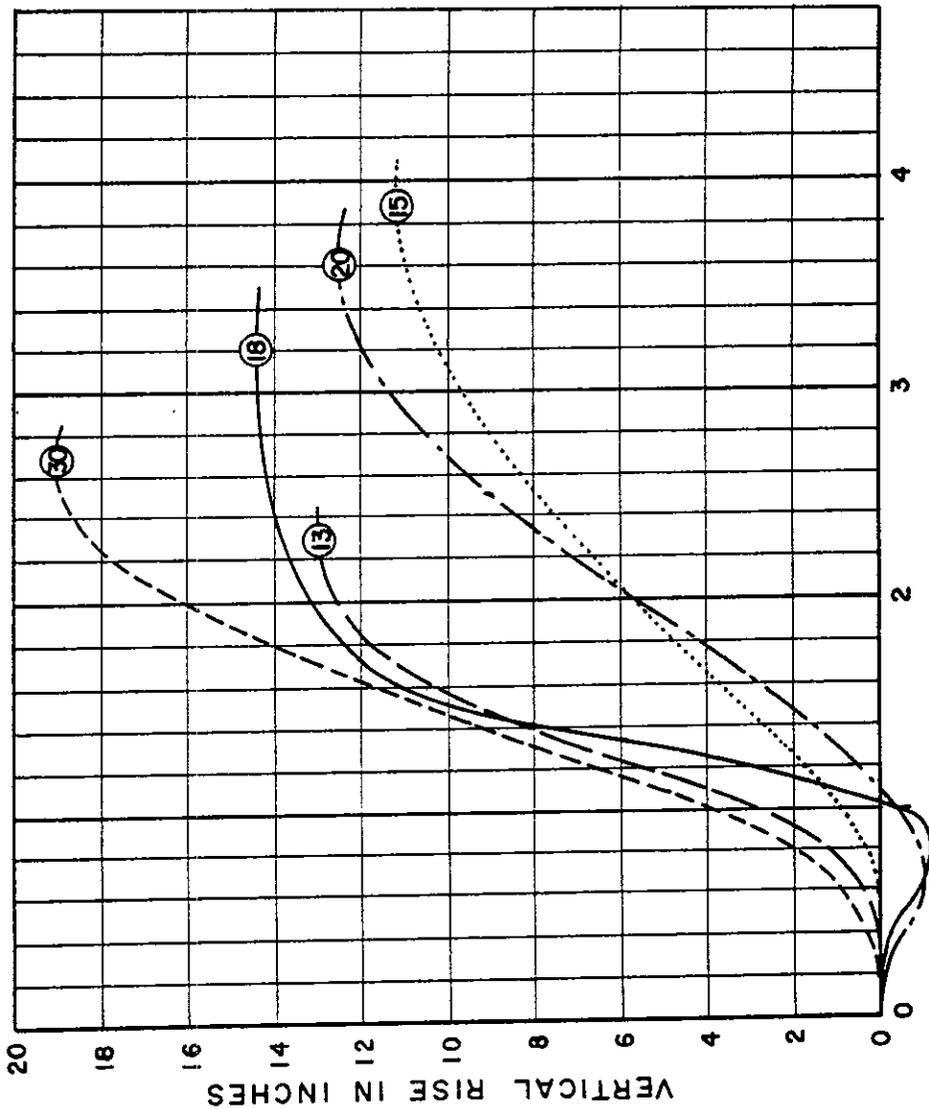
Figure 15

Curb	Angle	Speed	Curve
B 9	7.5°	60	---
B 9	15°	20	---
B 9	15°	30	---
B 9	20°	30
B 11	15°	45	---

Note: Circled numbers indicate distance in feet along vehicle path from point of impact to crest of jump.
 Vertical rise is referenced to right front of car frame.

HORIZONTAL DISTANCE IN FEET
 (Horizontal Components of Vehicle Path
 Measured Perpendicular to Curb)

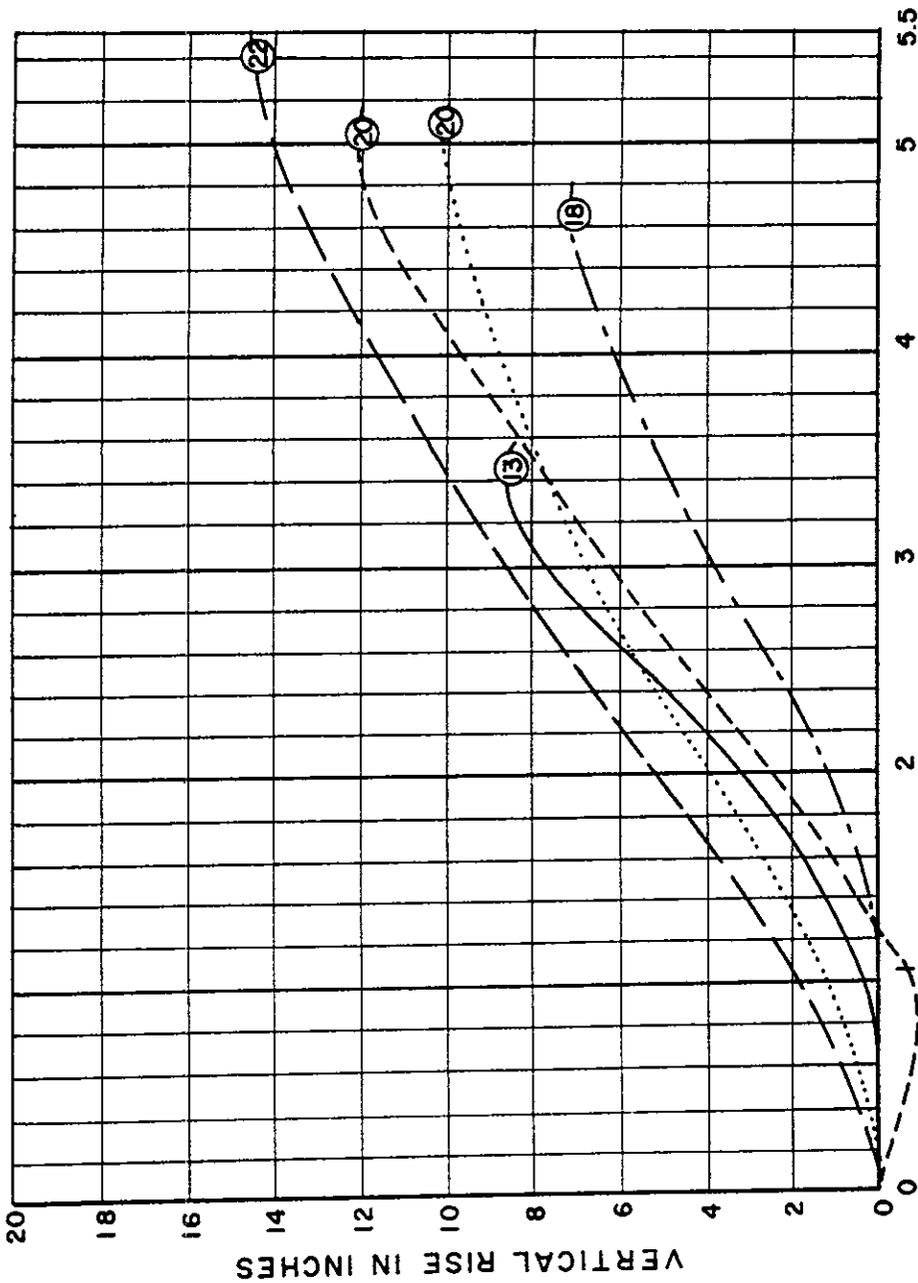
Figure 16

Curb	Angle	Speed	Curve
C12	20°	45	---
C9	20°	30	---
C10	15°	45	---
C11	20°	45
C10	20°	45	-.-.-

Note: Circled numbers indicate distance in feet along vehicle path from point of impact to crest of jump.
 Vertical rise is referenced to right front of car frame.

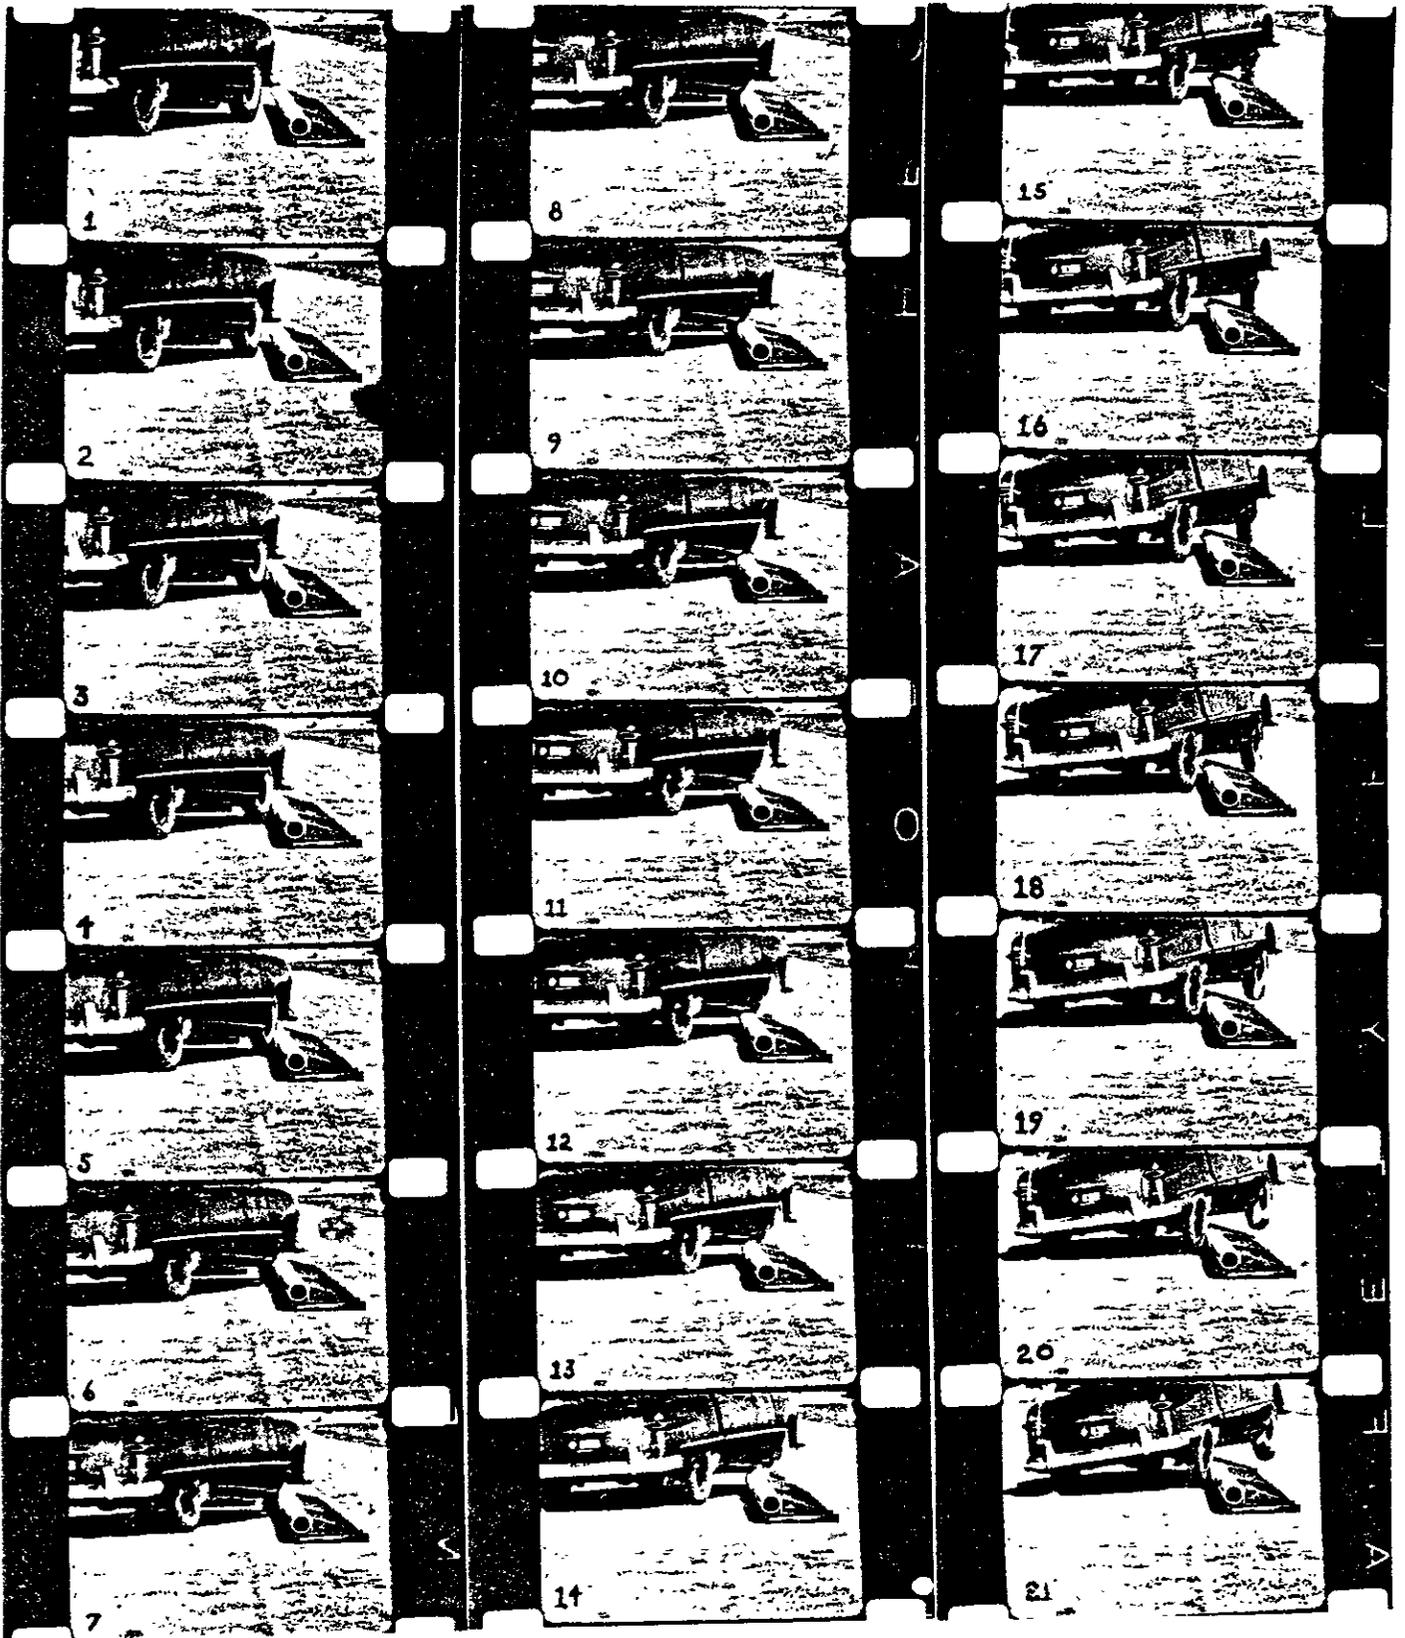
Cine Film Strip Reproduction
Note action of front wheel as it passes over curb.

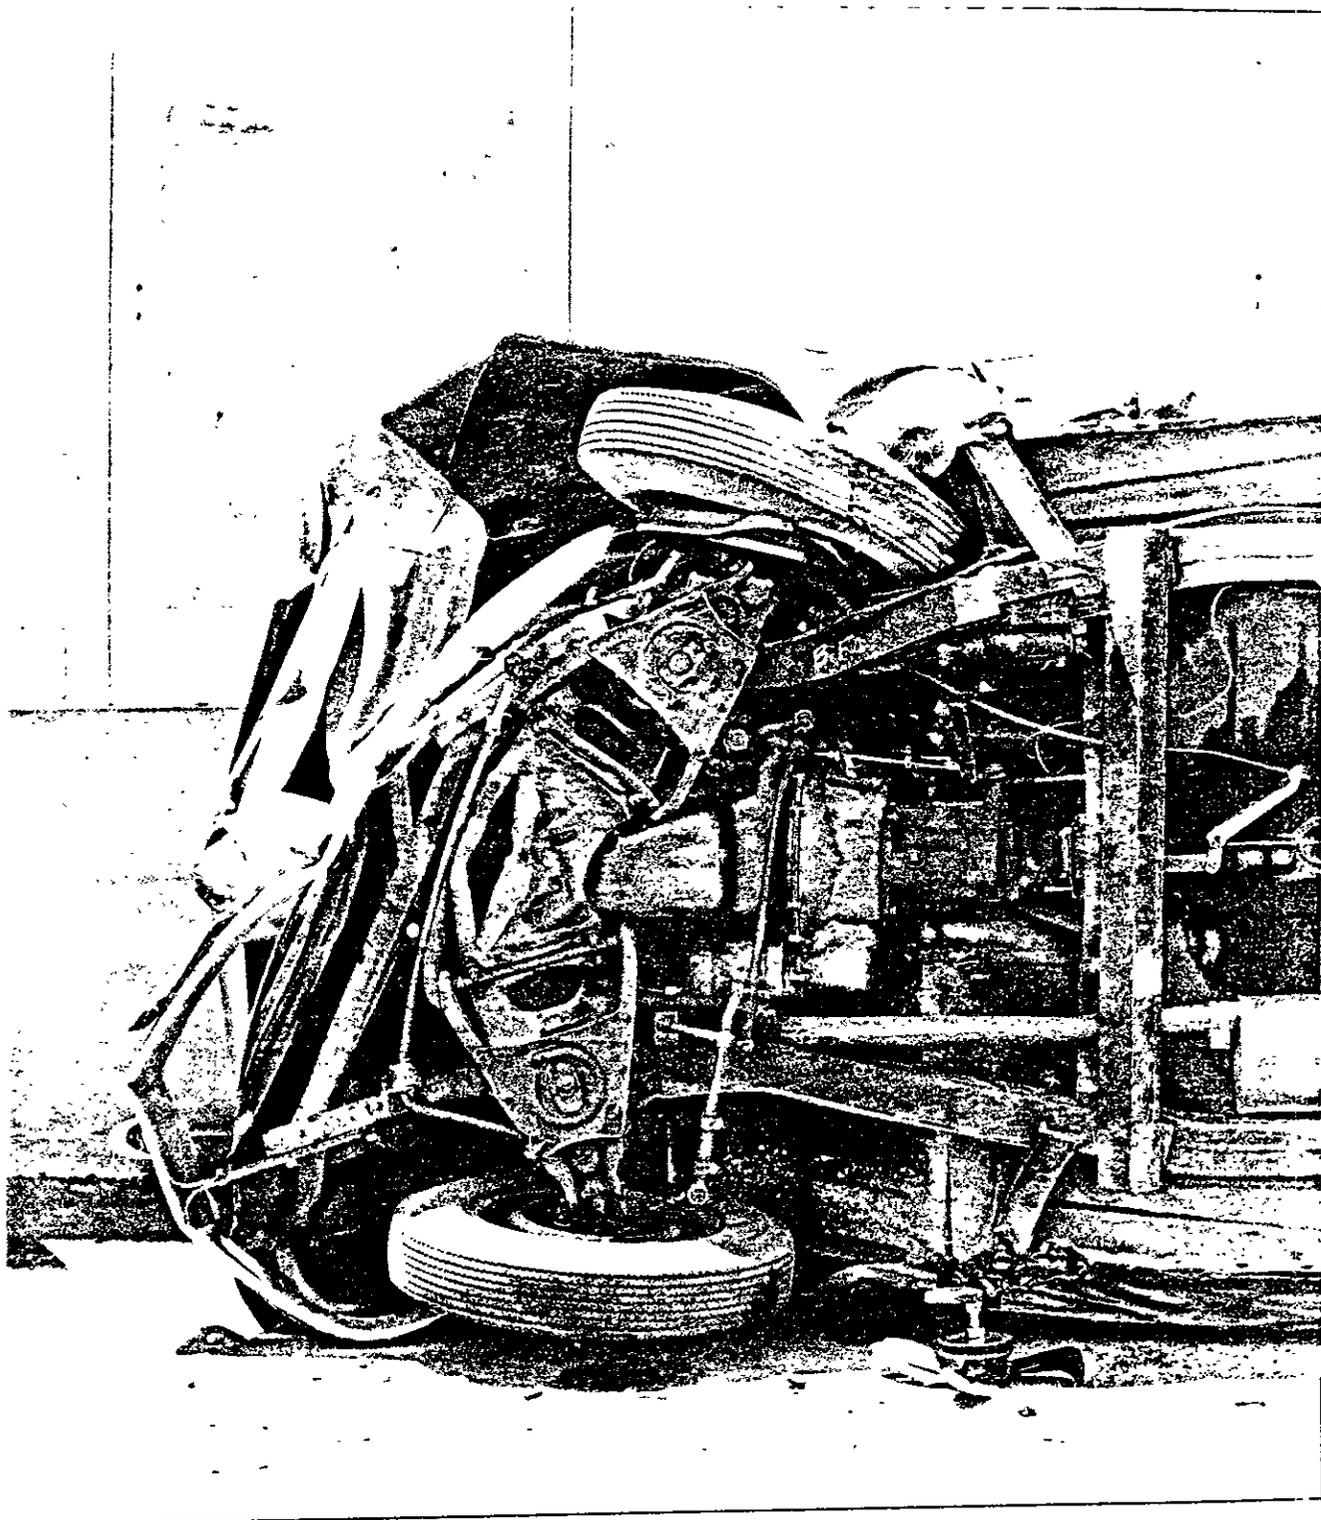
View showing steel angle welded across frame and additional side plate stiffeners welded to front end of frame members.

of the frame and by welding a 2" x 2" structural steel angle across the frame directly under the front seat (Figure 20). This duplicated structural alterations made in the 1953 tests. In addition the engine was snubbed tightly to the frame with cable to keep the clutch from disengaging when the car struck the curb. A comparison of actions with and without this bracing and alteration during the 1955 barrier curb tests revealed no appreciable external change in action.
